Inspection Photos

12/8/2020

Operator: LARAMIE ENERGY LLC - 10433

Location ID: 324315

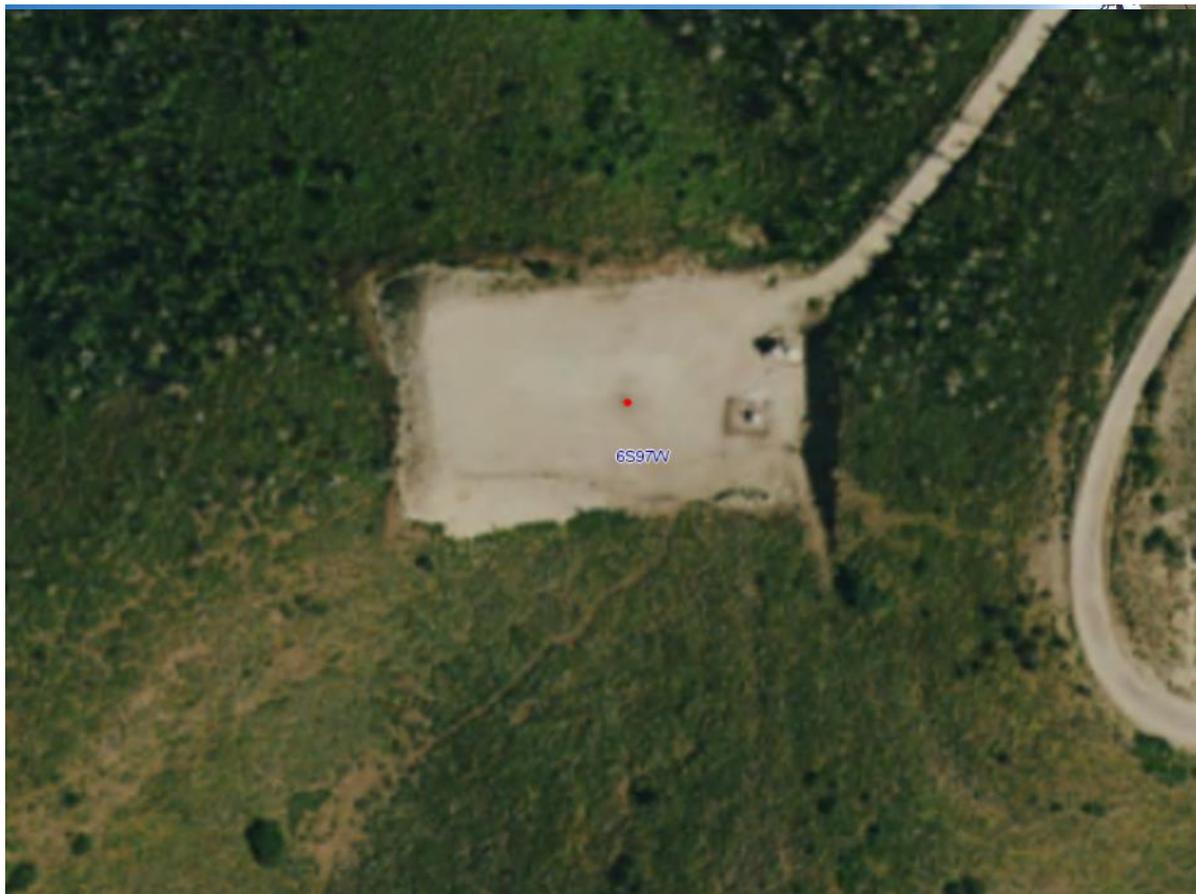
Photo 1: 2019 COGIS Aerial image. Photo shows overview of the Location. Photo shows Location does not comply with Rule 1003.b.

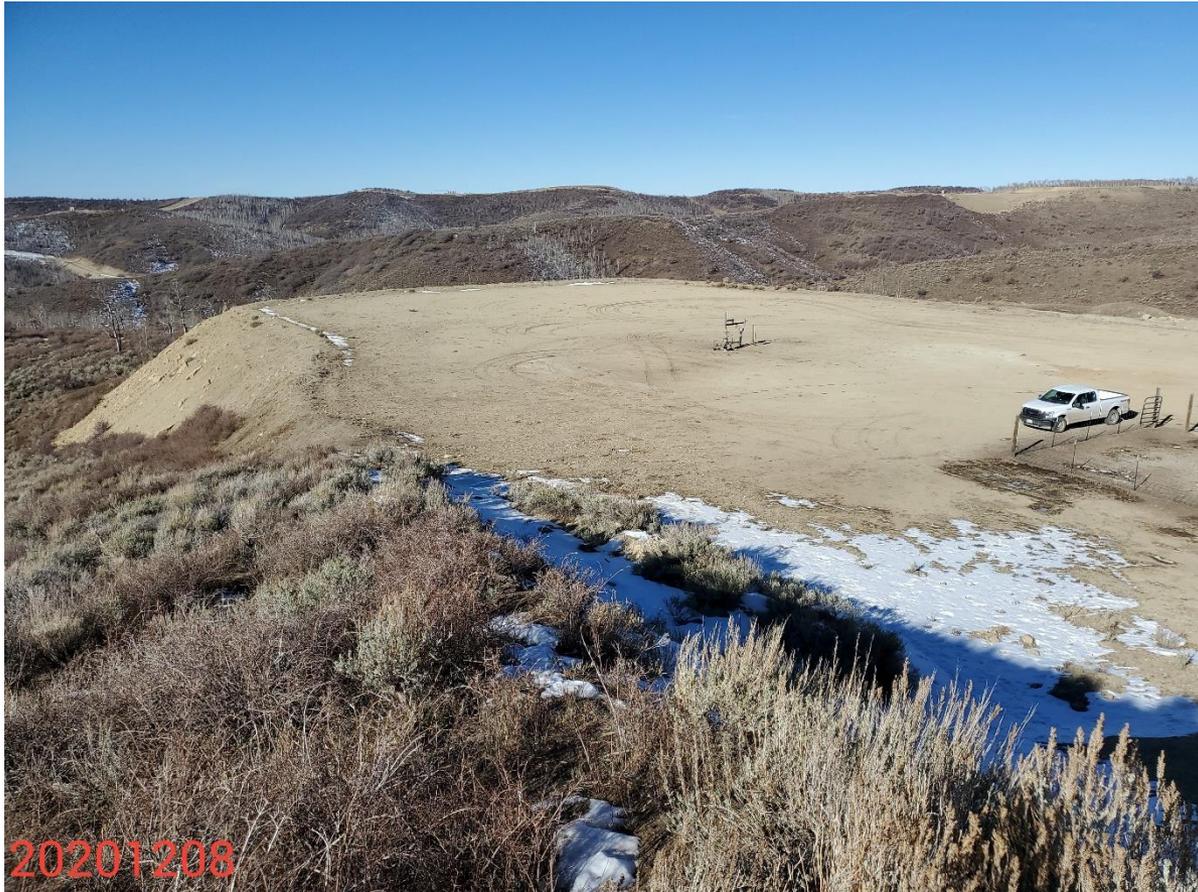
Photo 2: Photo taken from the southeast end of the Location, facing west. Photos 1-2 provide an overview of the Location from west to north. Photo also shows areas not reasonably needed for production on the Location have not been reclaimed in accordance with 1003 Rules.

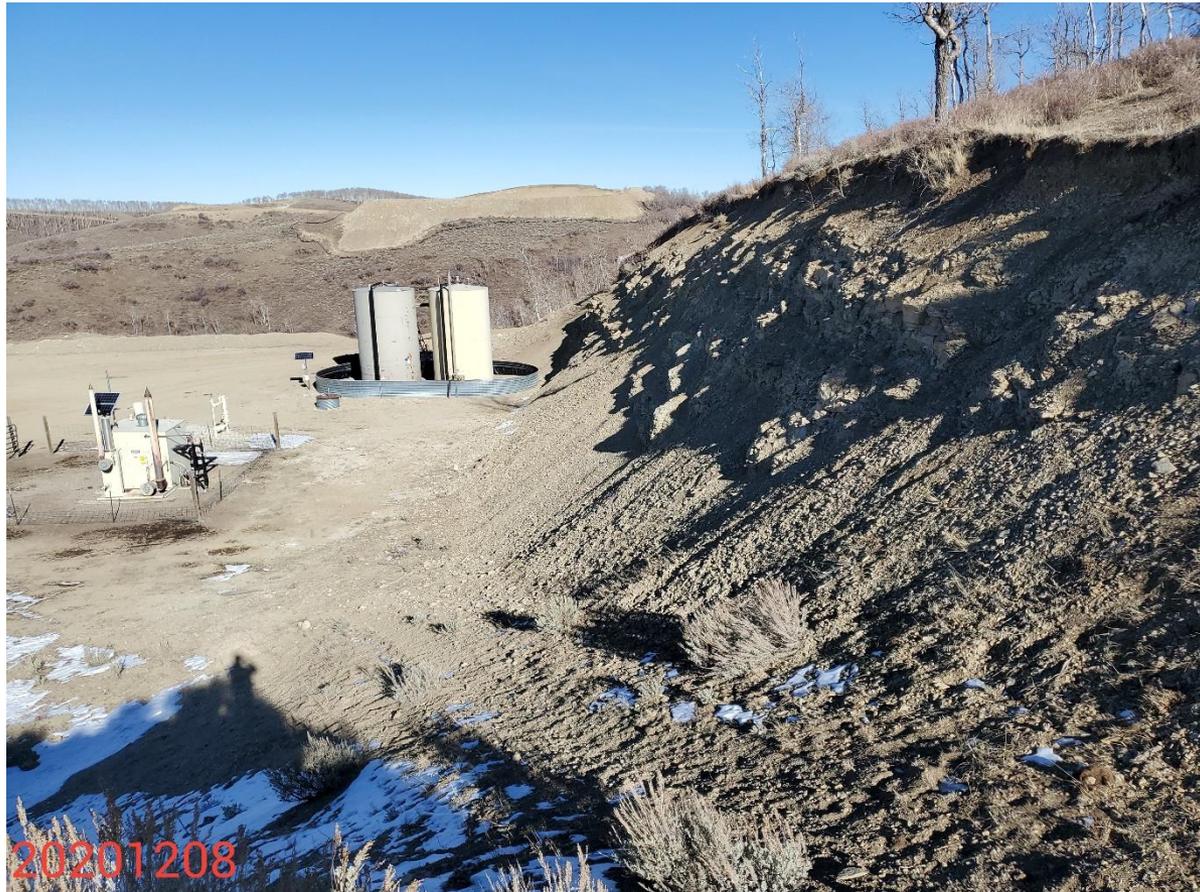
Photo 3: See comments under photo 1.

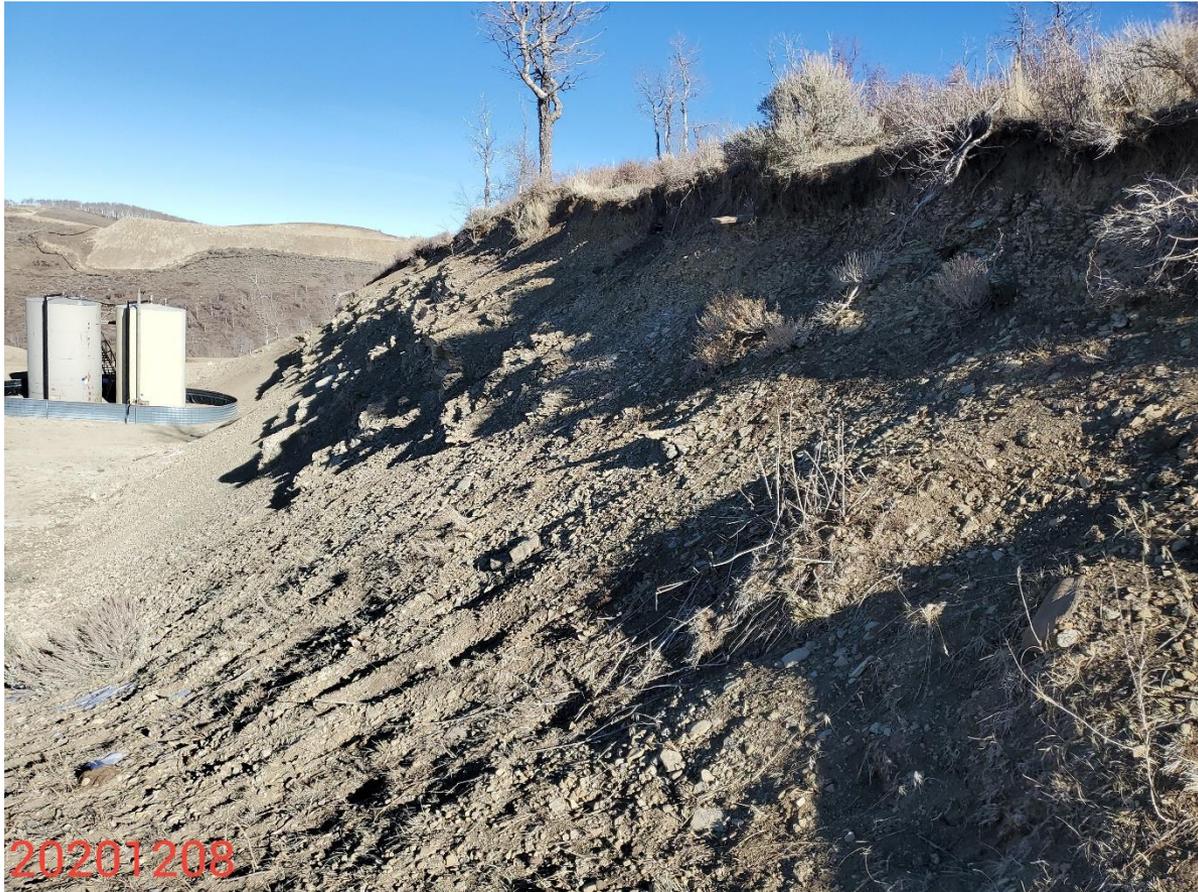
Photo 4: Photo taken from the southeast end of the Location, facing north. Photo shows BMPs to stabilize the cut slopes of the Location are missing, or insufficient.

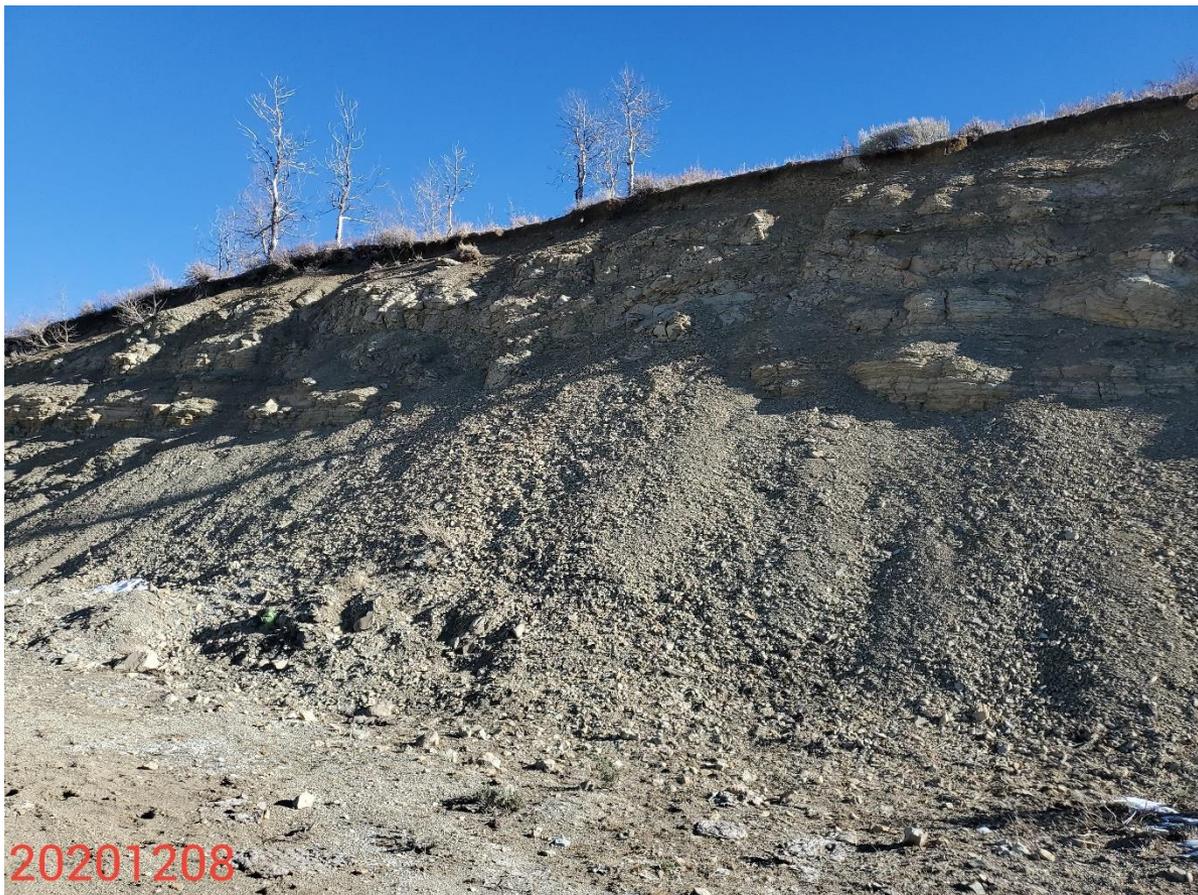
Photo 5: Photo taken from the east end of the Location, facing northeast. Photo shows BMPs to stabilize the cut slopes of the Location are missing, or insufficient.

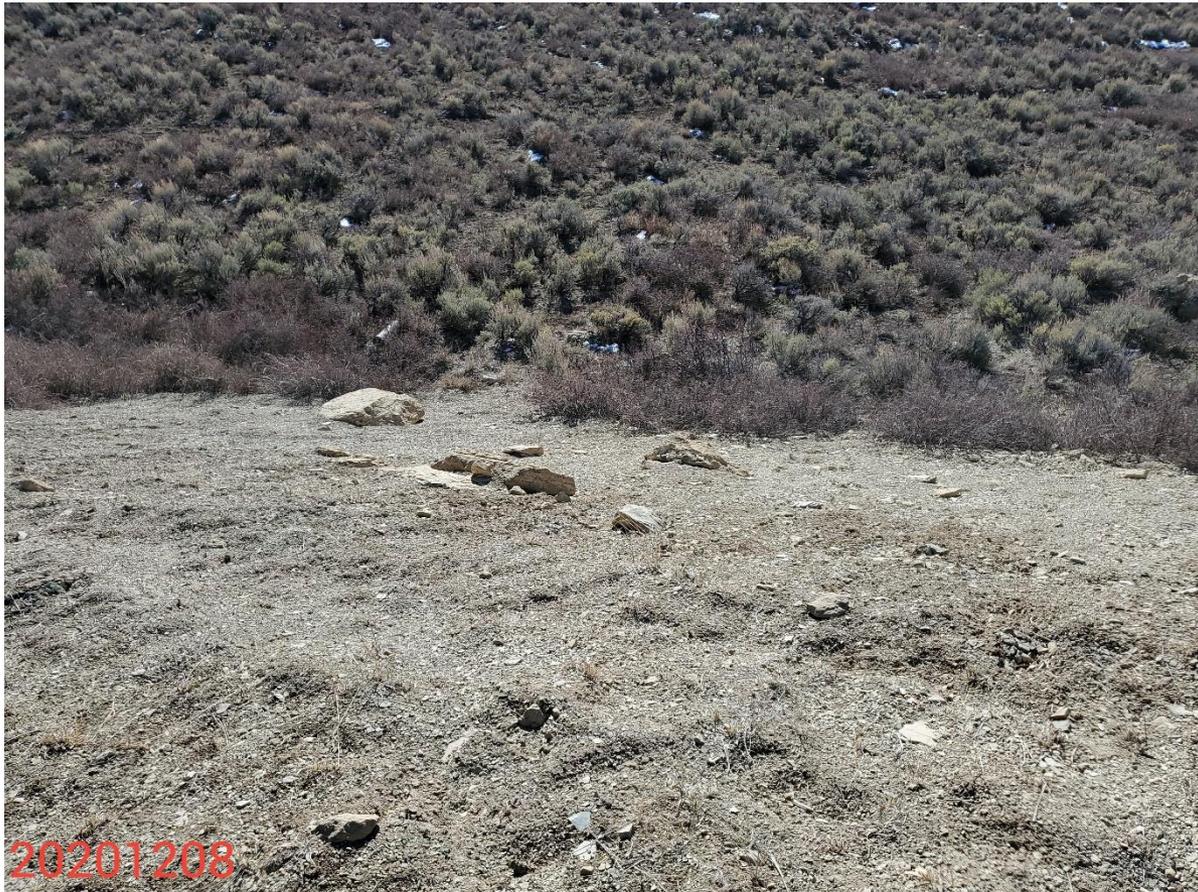
Photo 6: Photo taken from the south end of the Location, facing south. Photo shows BMPs to stabilize/protect the fill slopes, and prevent off-site sediment transport are missing or insufficient.

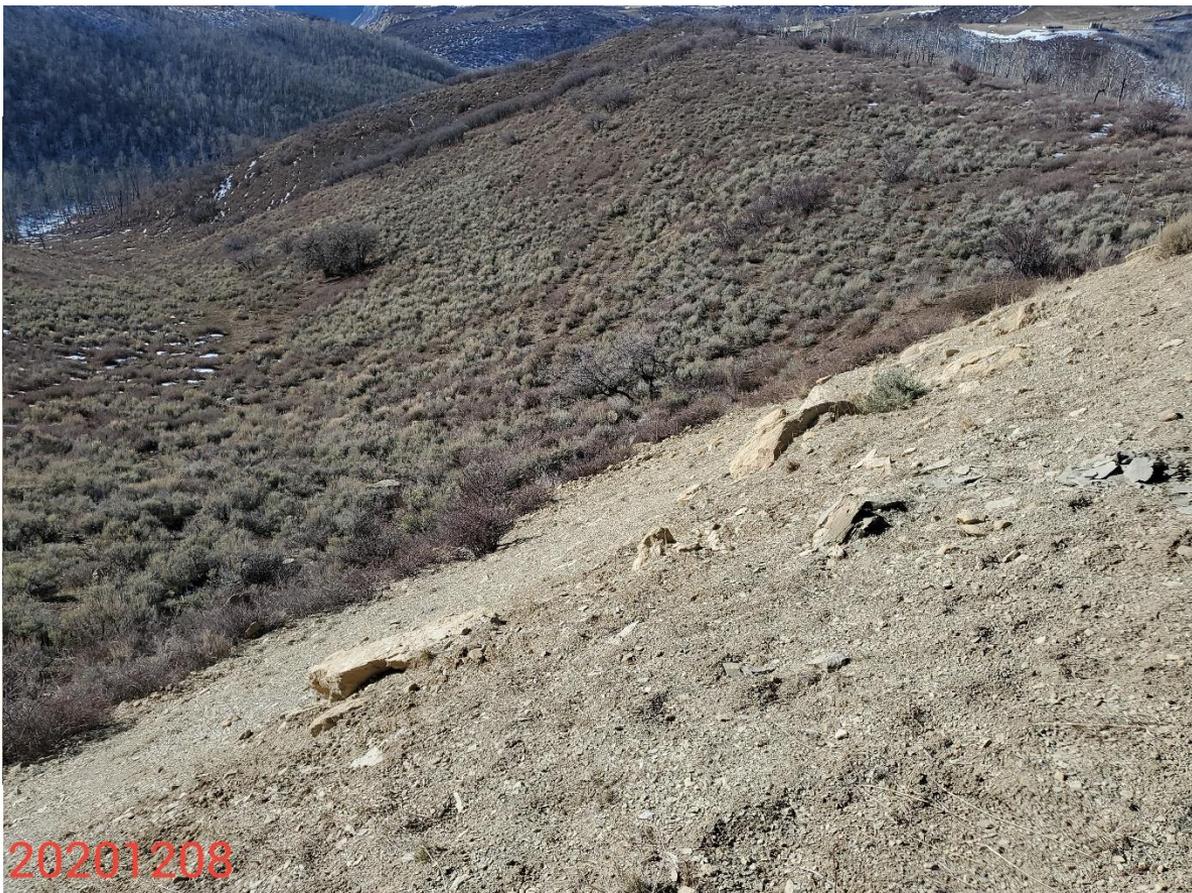
Photo 7: Photo taken from the south end of the Location, facing southwest. See comments under photo 6.

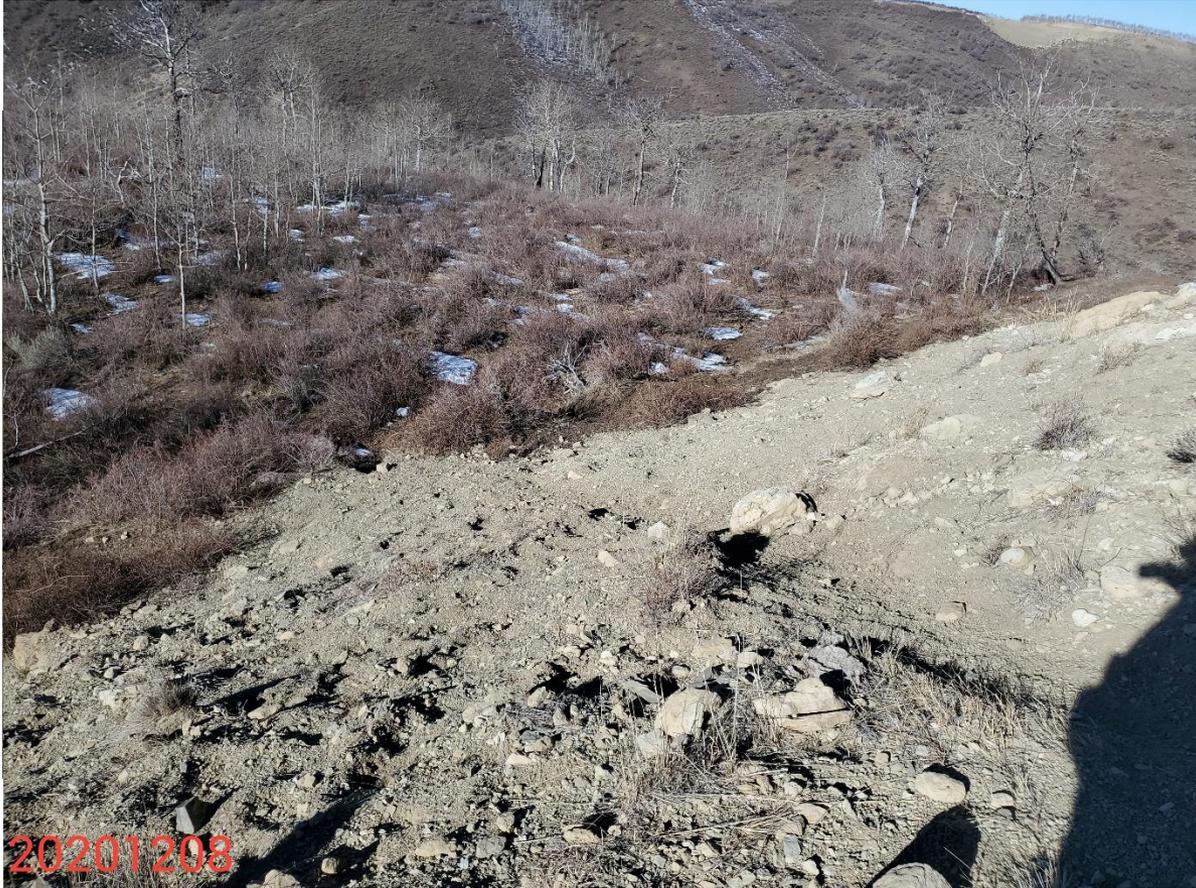
Photo 8: Photo taken from the west end of the Location, facing northwest. See comments under photo 6.

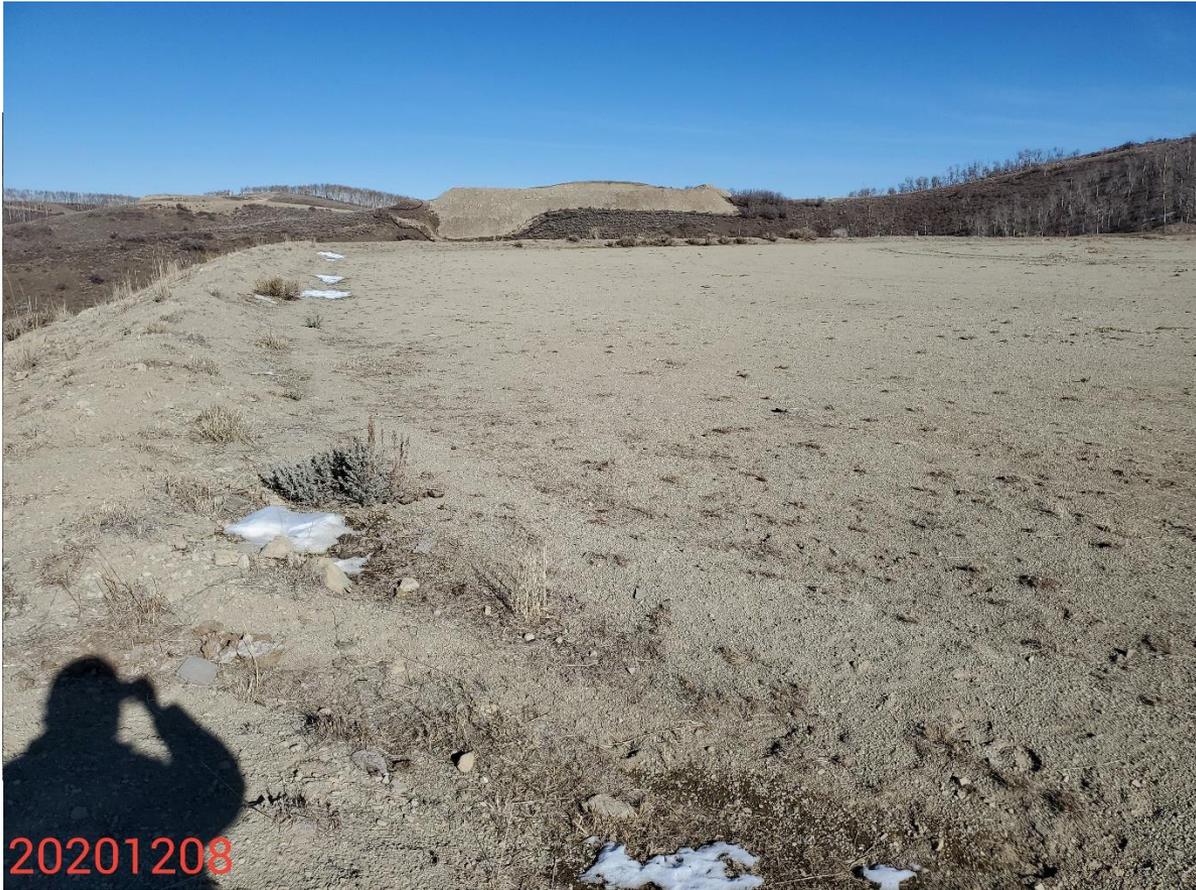
Photo 9: Photo taken from the southwest corner of the Location, facing north. Photos 9-11 provide an overview of the Location from north, northeast to east. Photos show areas not reasonably needed for production on the Location have not been reclaimed in accordance with 1003 Rules.

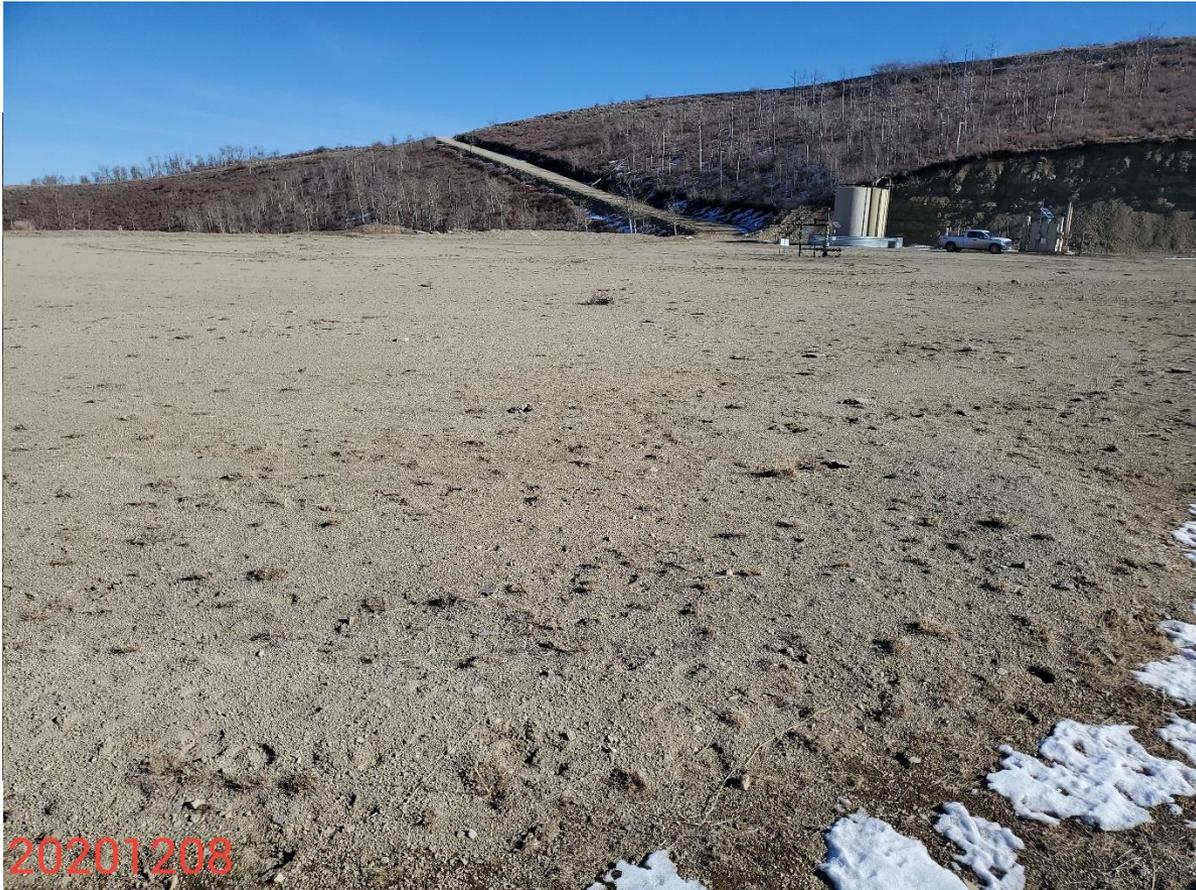
Photo 10: See comments under photo 9.

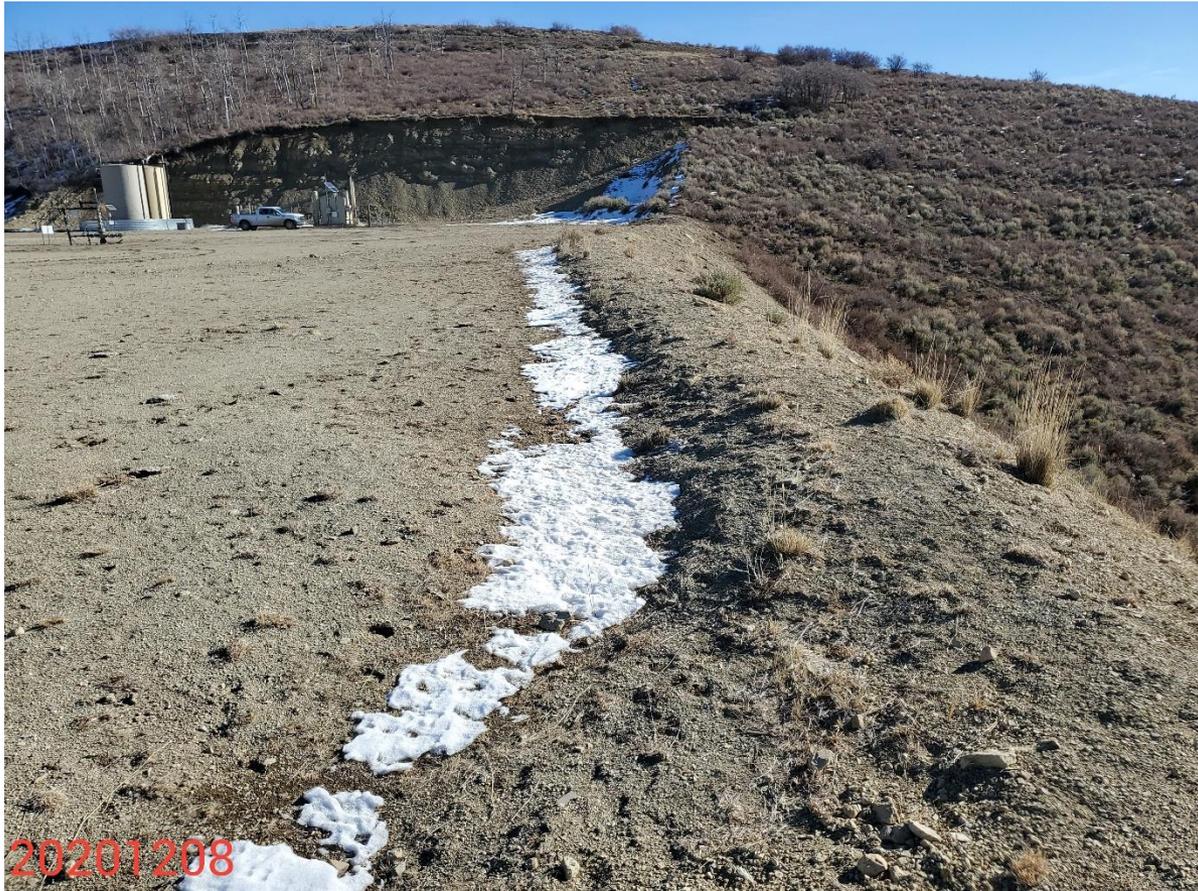
Photo 11: See comments under photo 9.

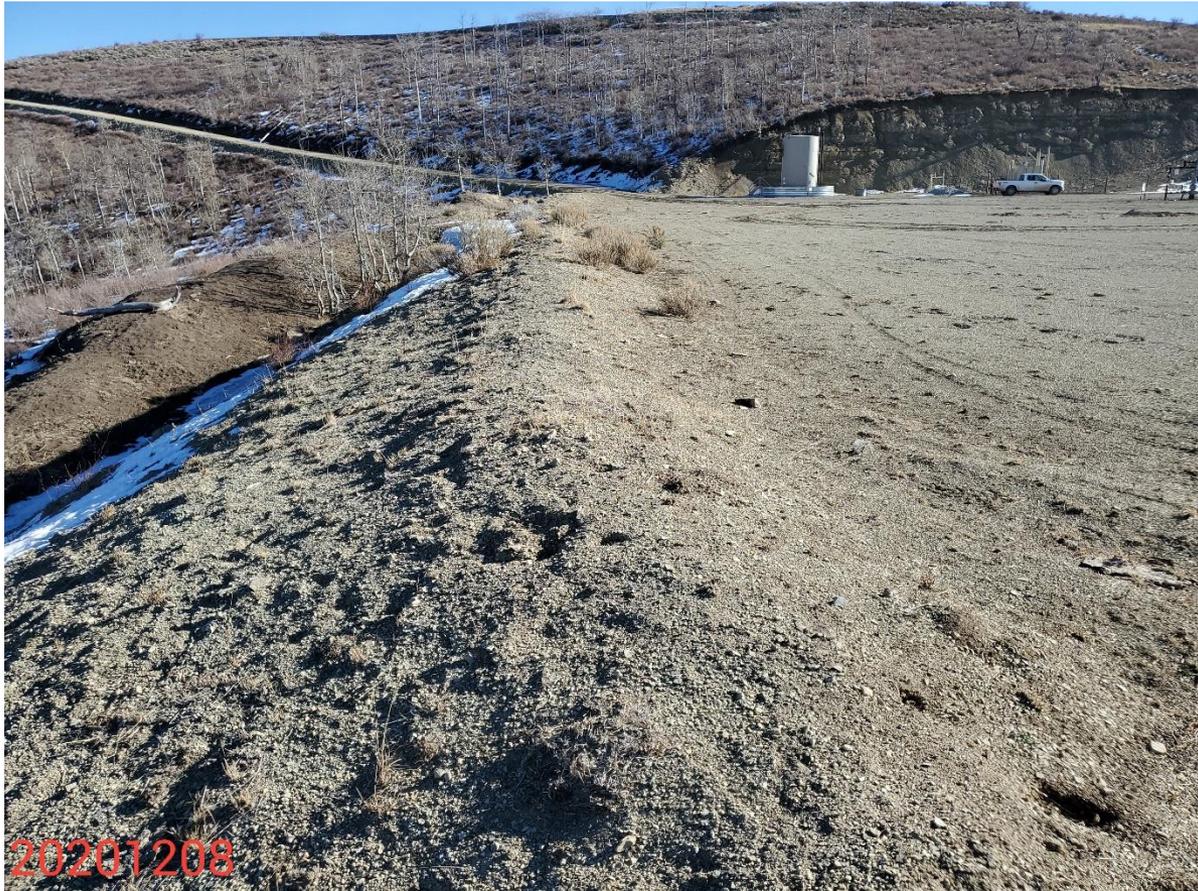
Photo 12: Photo taken from the northwest corner of the Location, facing north. Photos 12-14 provide an overview of the Location from east, southeast to south. Photos show areas not reasonably needed for production on the Location have not been reclaimed in accordance with 1003 Rules.

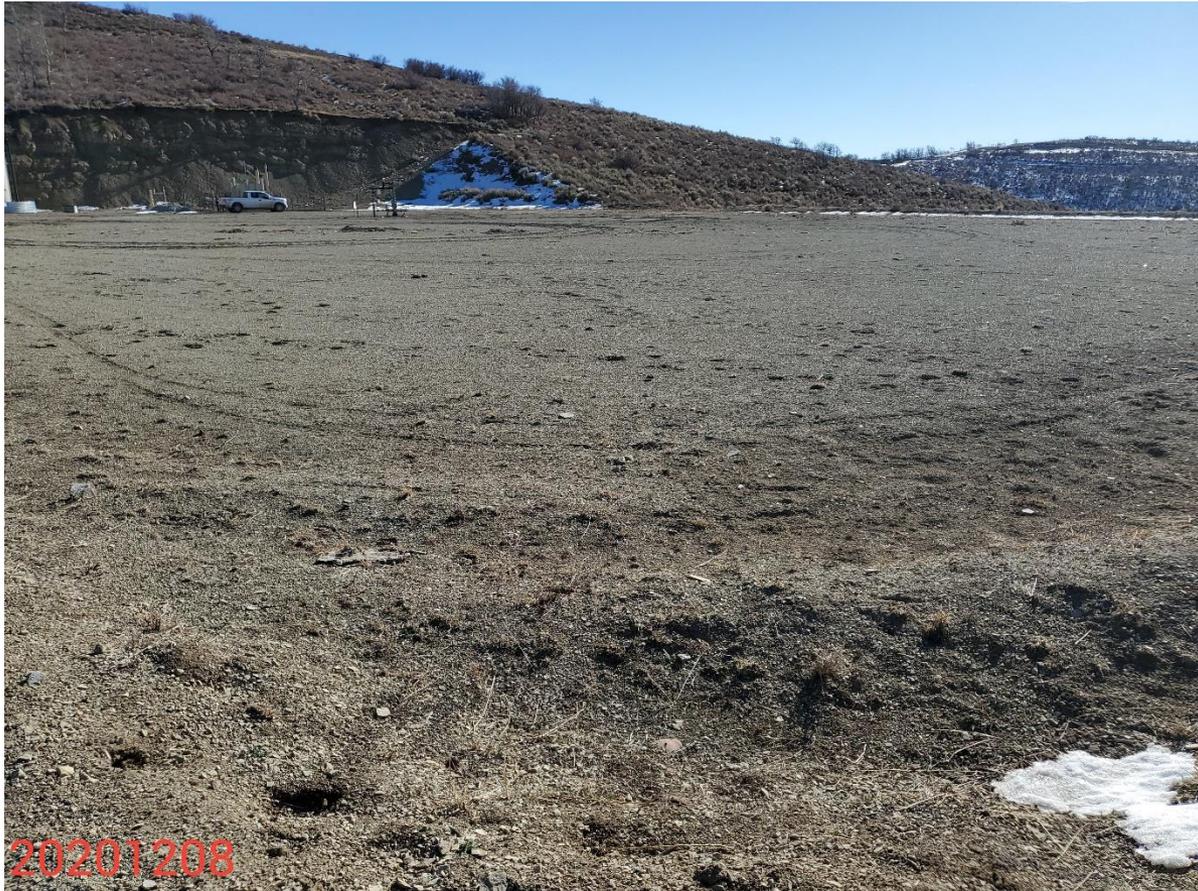
Photo 13: See comments under photo 12.

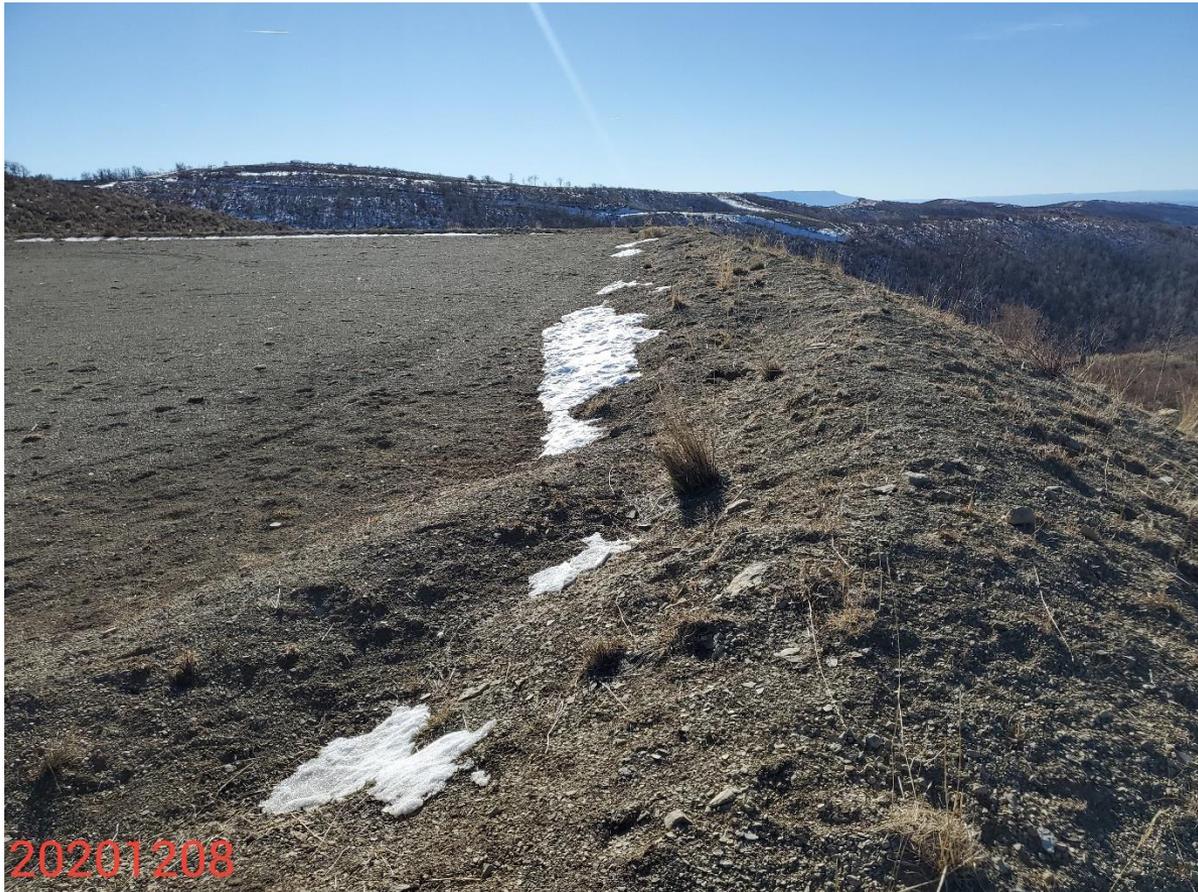
Photo 14: See comments under photo 12.

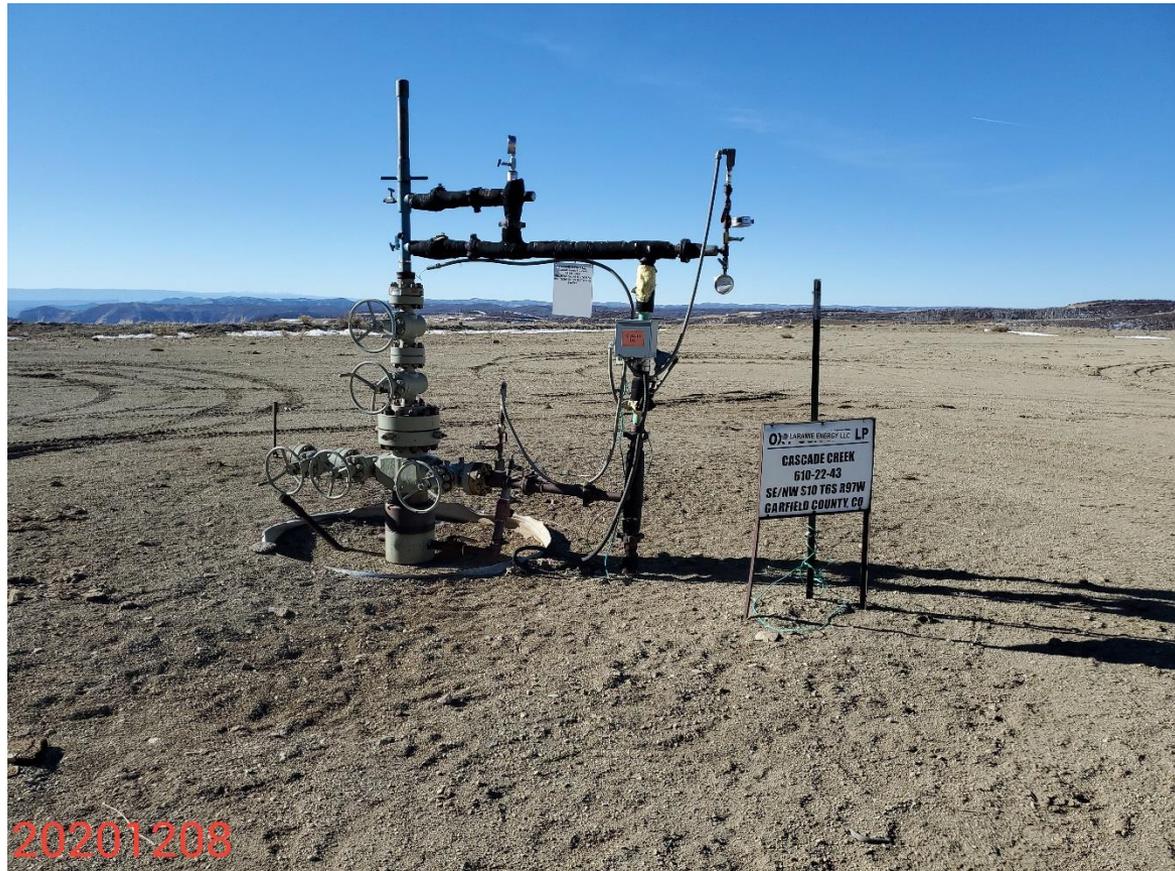
Photo 15: Photo of well on Location.
