Inspection Photos

12/8/2020

Operator: LARAMIE ENERGY LLC - 10433

Location ID: 335647

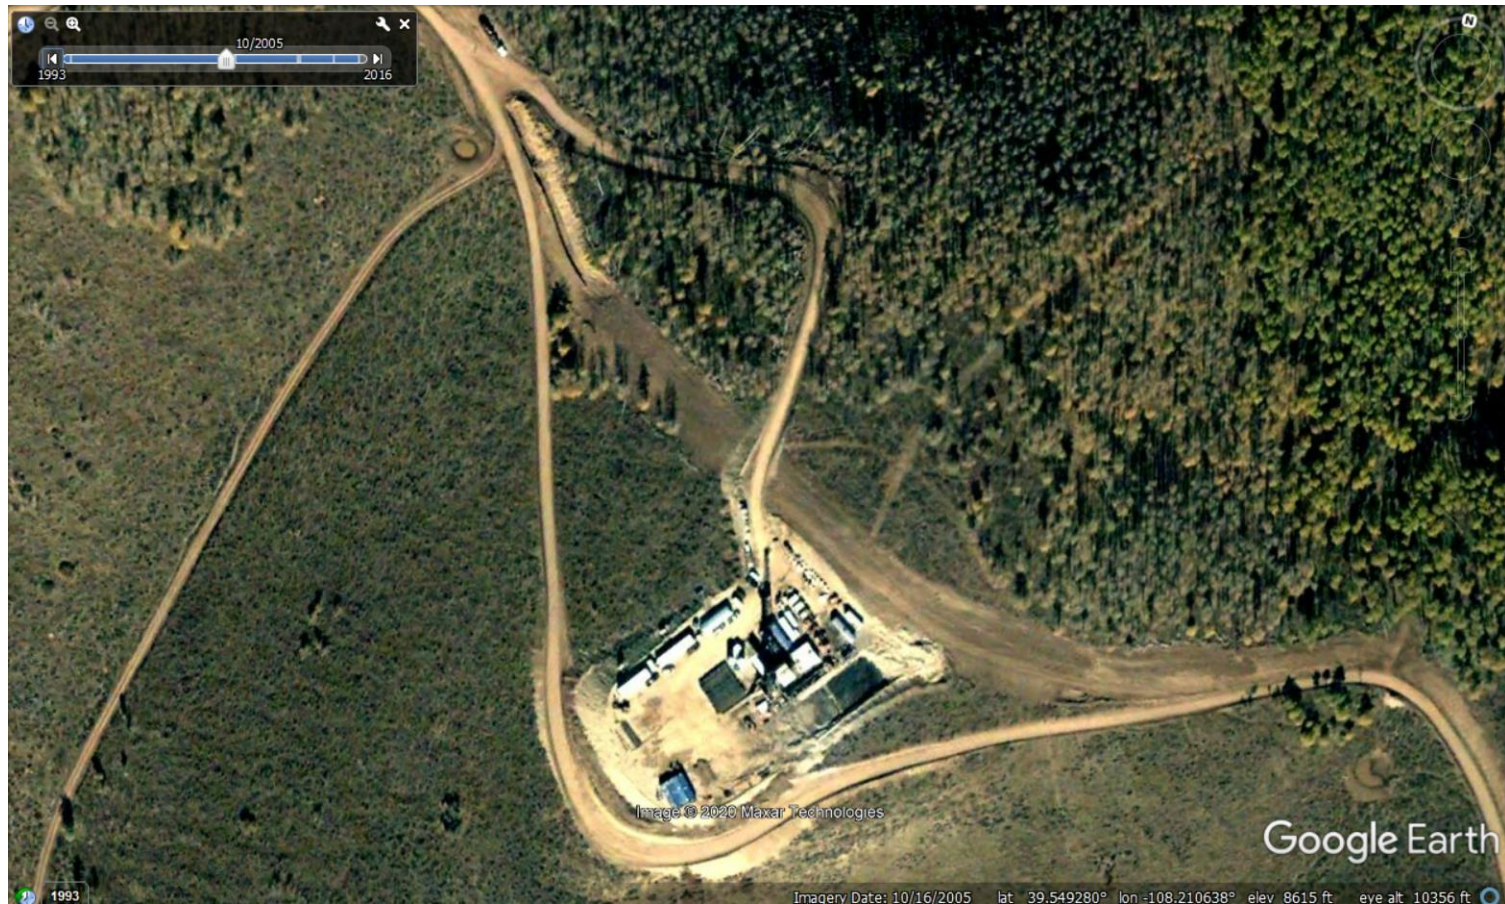
Photo 1: 2005 Google Earth aerial imagery. Photo shows rig equipment for drilling operations. Photo also shows an access road was constructed north of the location.

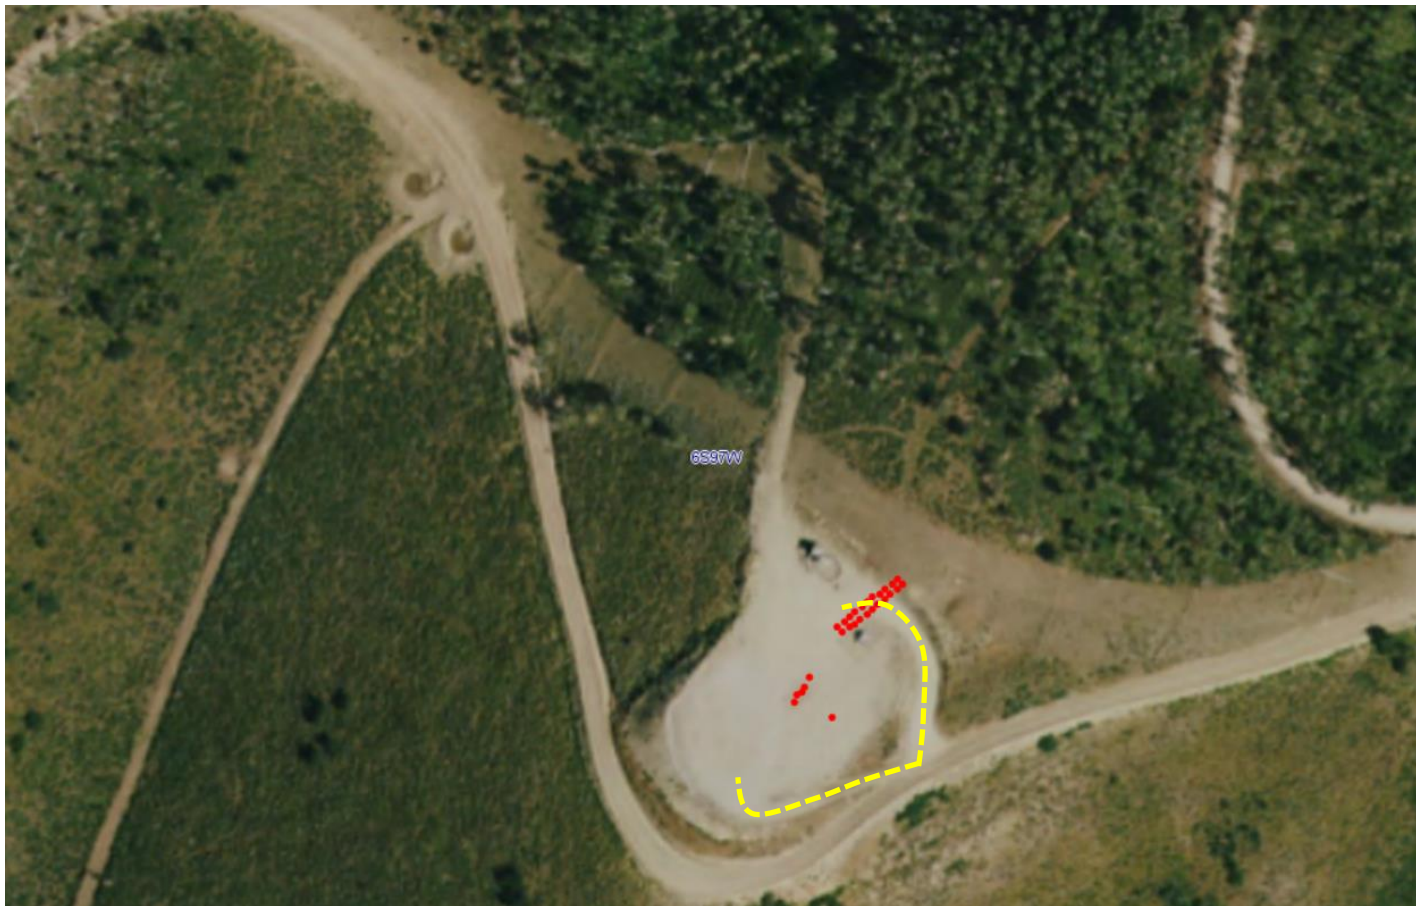
Photo 2: 2019 COGIS Aerial imagery. Photo shows Location size remains relatively unchanged. Two additional access points/roads have been constructed on the south end of the Location (dotted yellow lines); Reclamation work conducted on the northern access road. Additional reclamation to north road required.

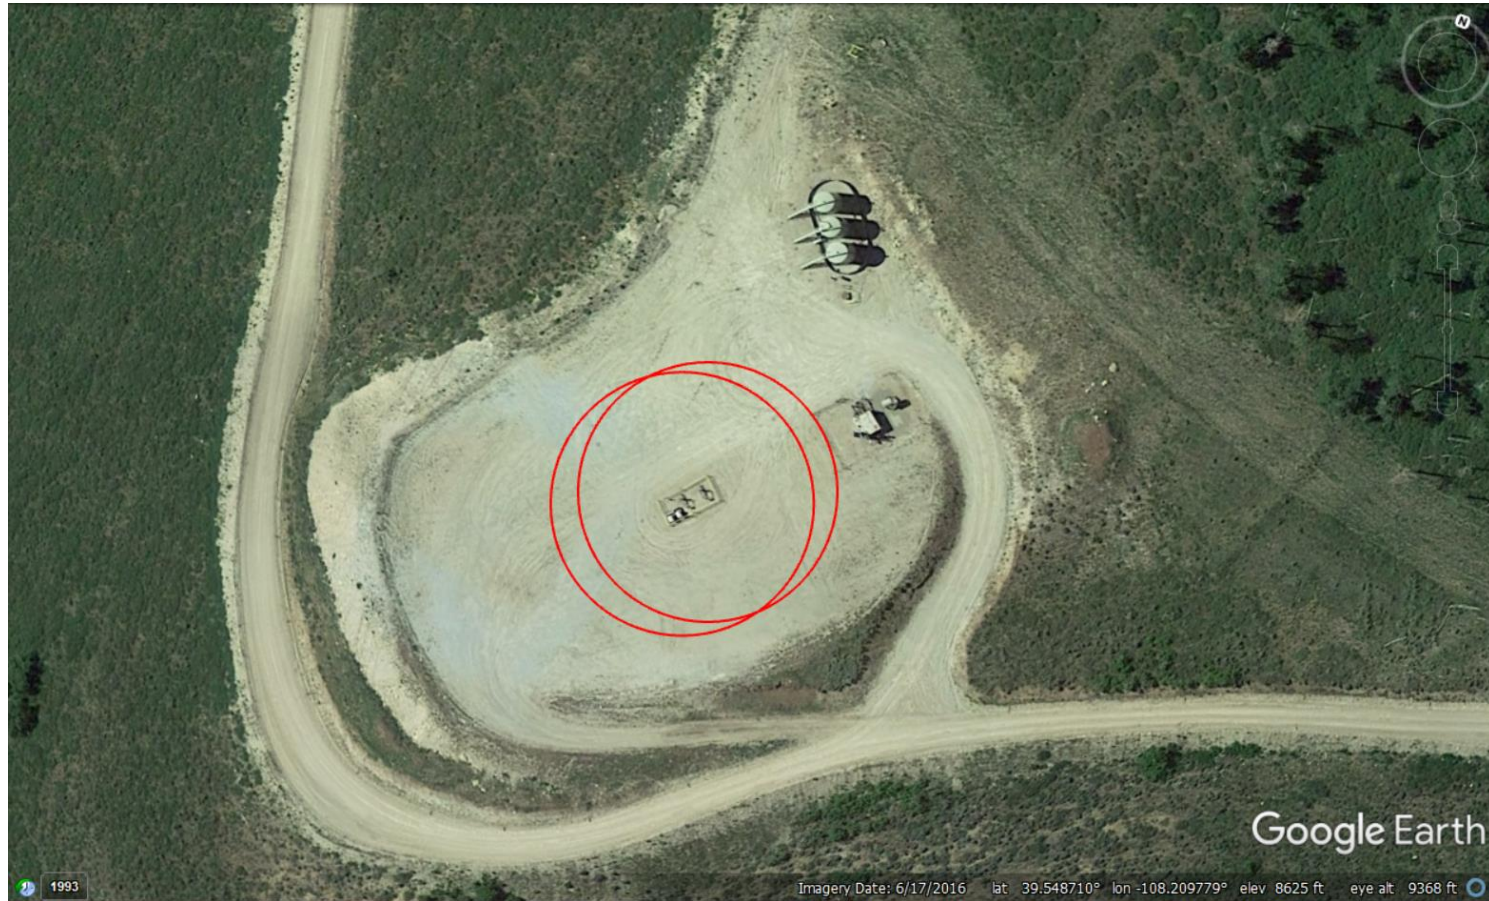
Photo 3: Google Earth aerial imagery. Photo shows areas of the Location not needed for production operations have not been reclaimed. Red circles represent a 75 foot buffer around producing wells.

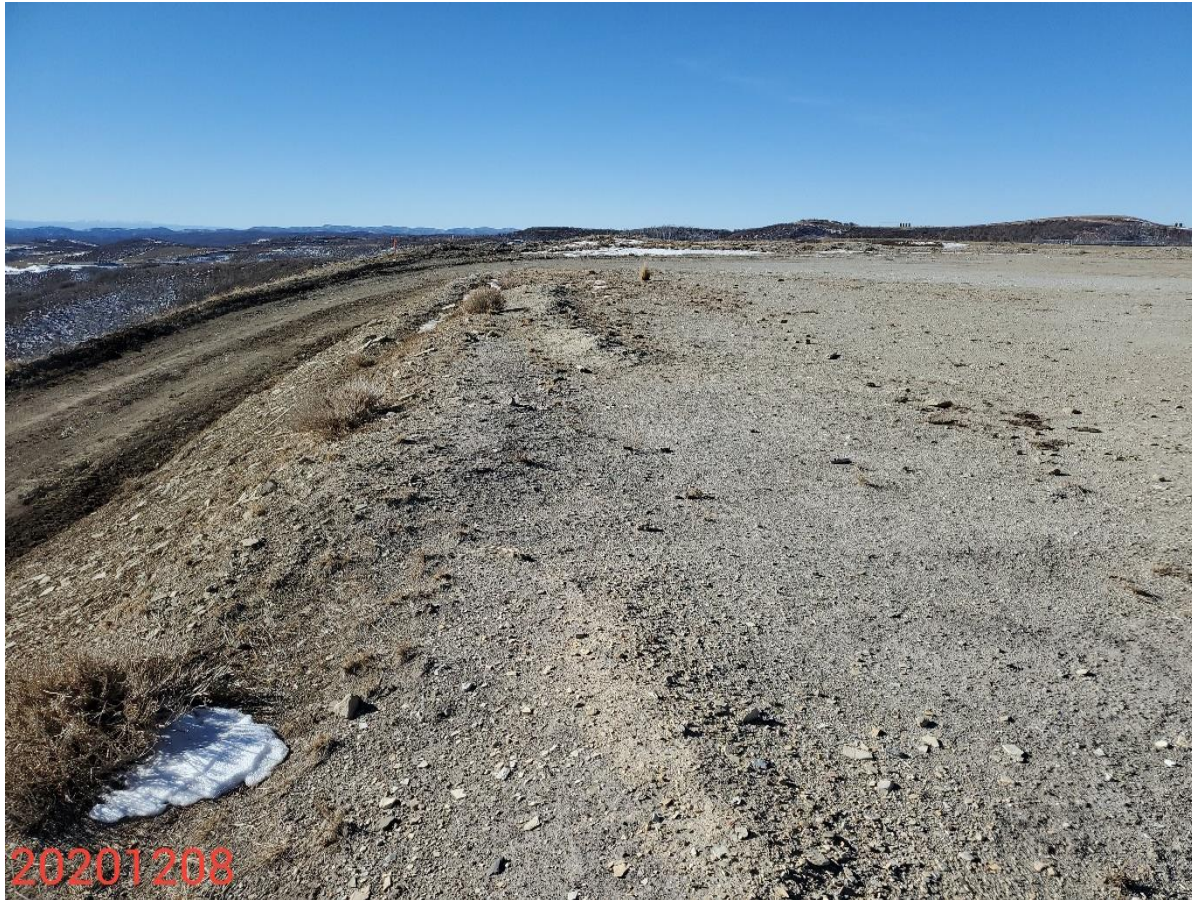
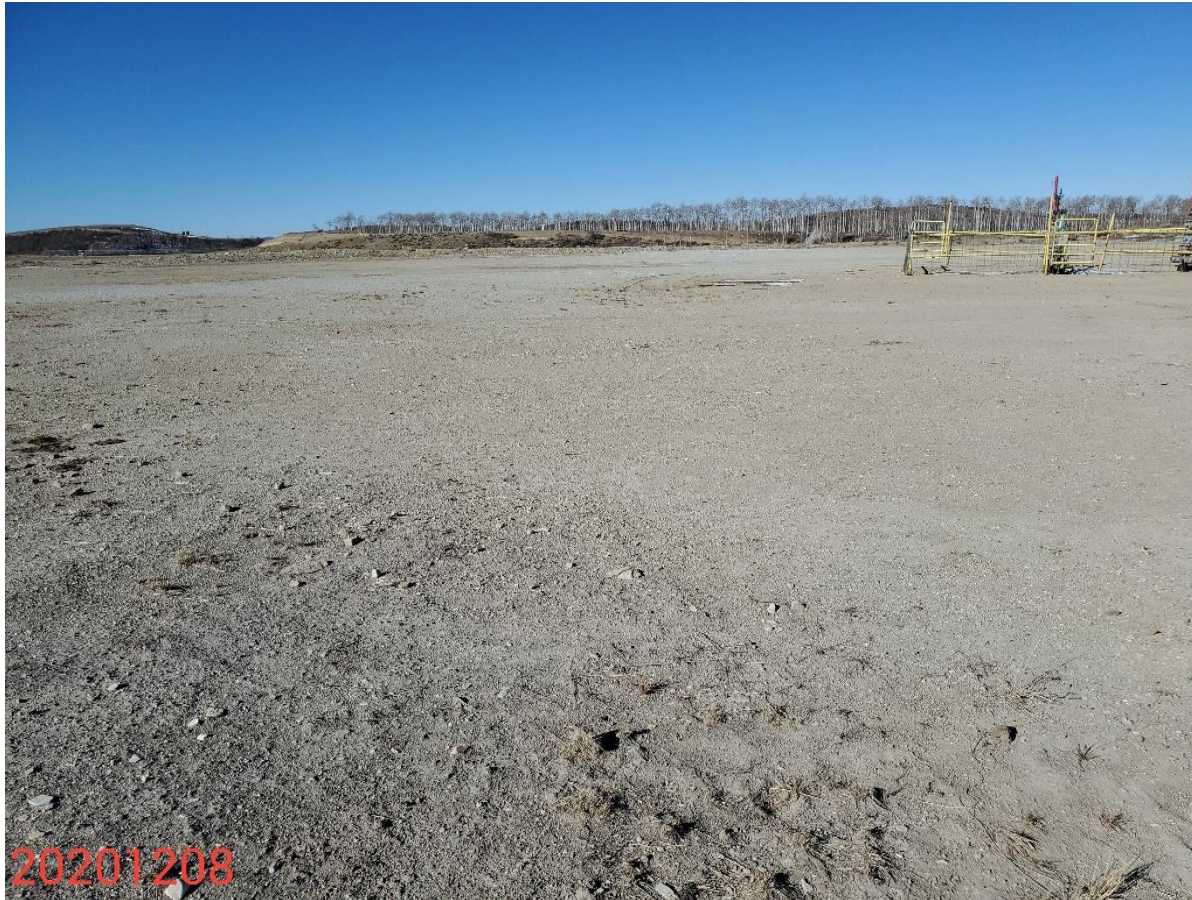
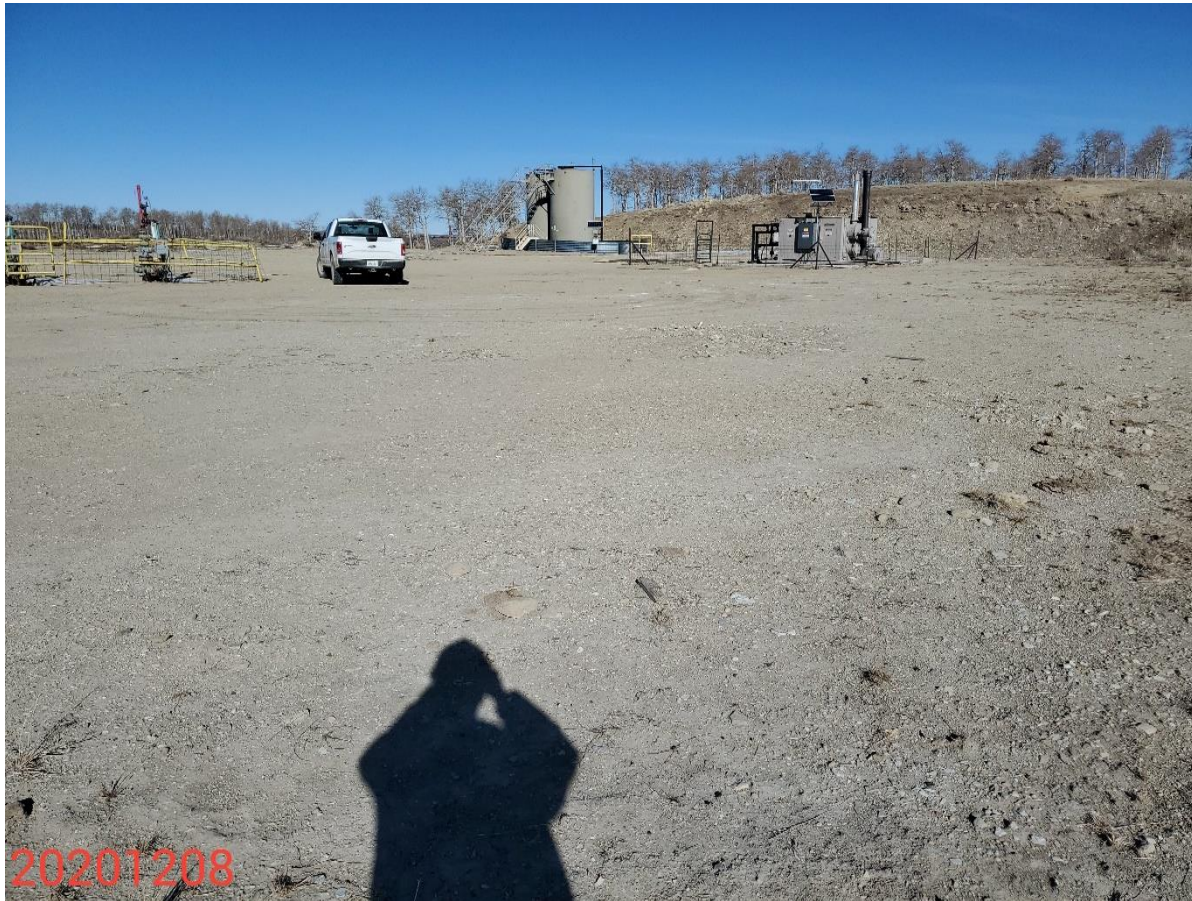
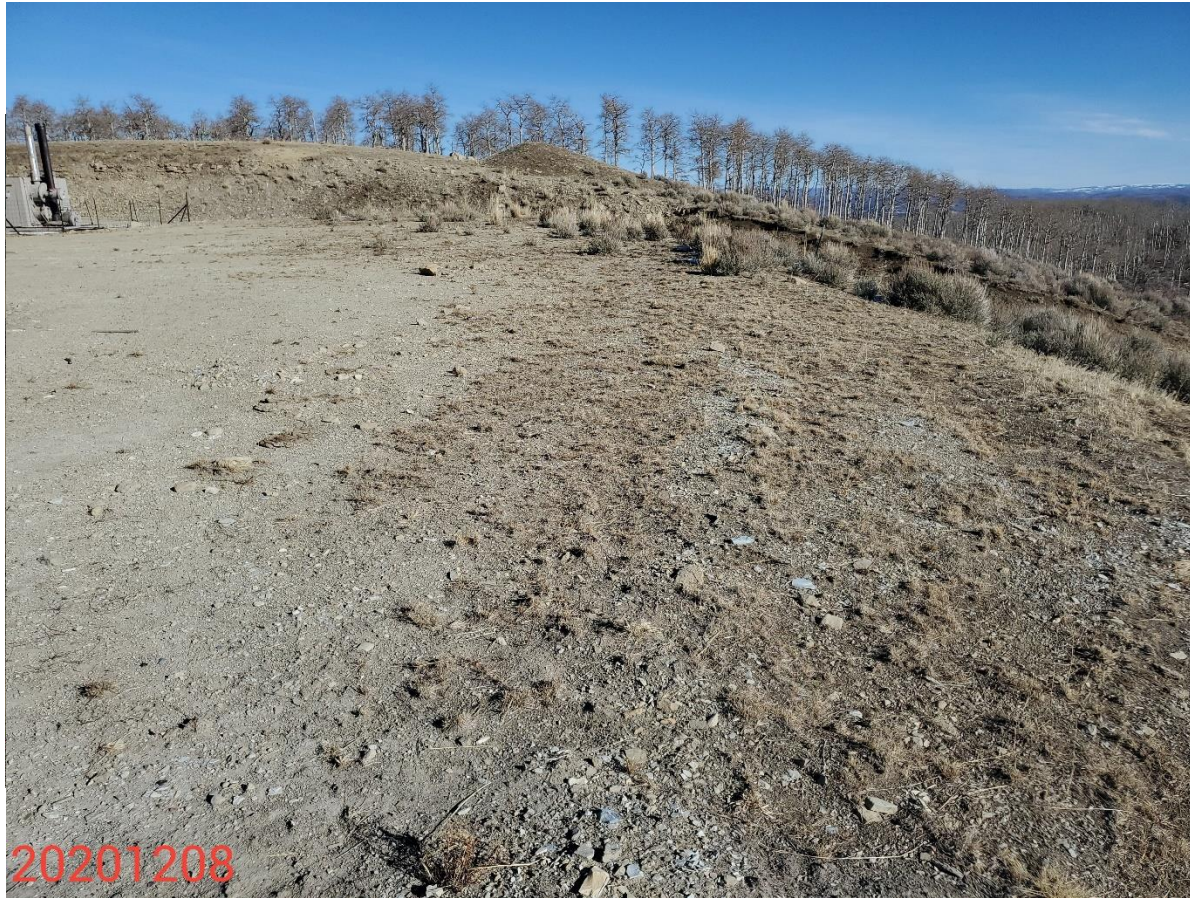
Photo 4: Photo taken from the south end of the Location, facing west. Photos 4-7 provide an overview of the Location from west, northwest, northeast to east. Photos show areas not reasonably needed for production on the Location have not been reclaimed in accordance with 1003 rules.

Photo 5: See comments under photo 4.

Photo 6: See comments under photo 4.

Photo 7: See comments under photo 4.

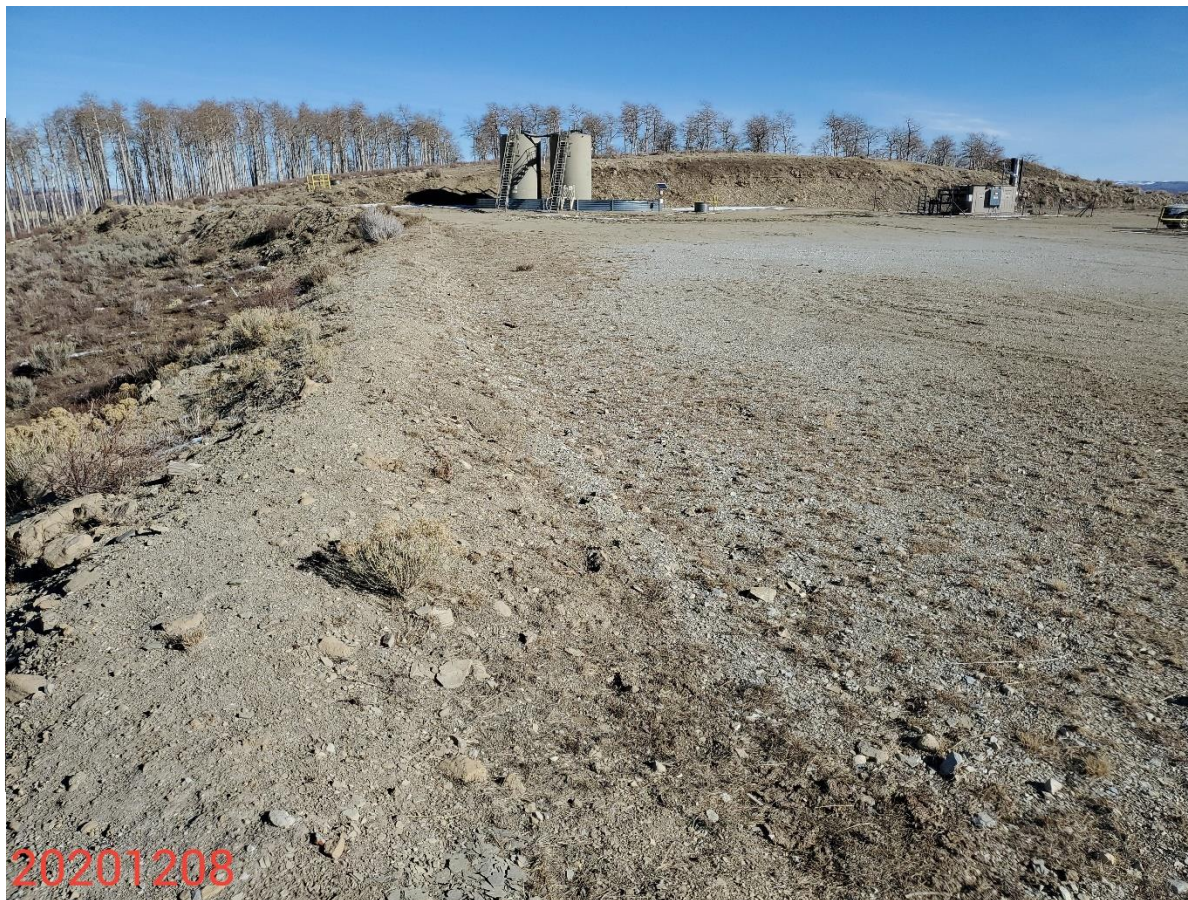
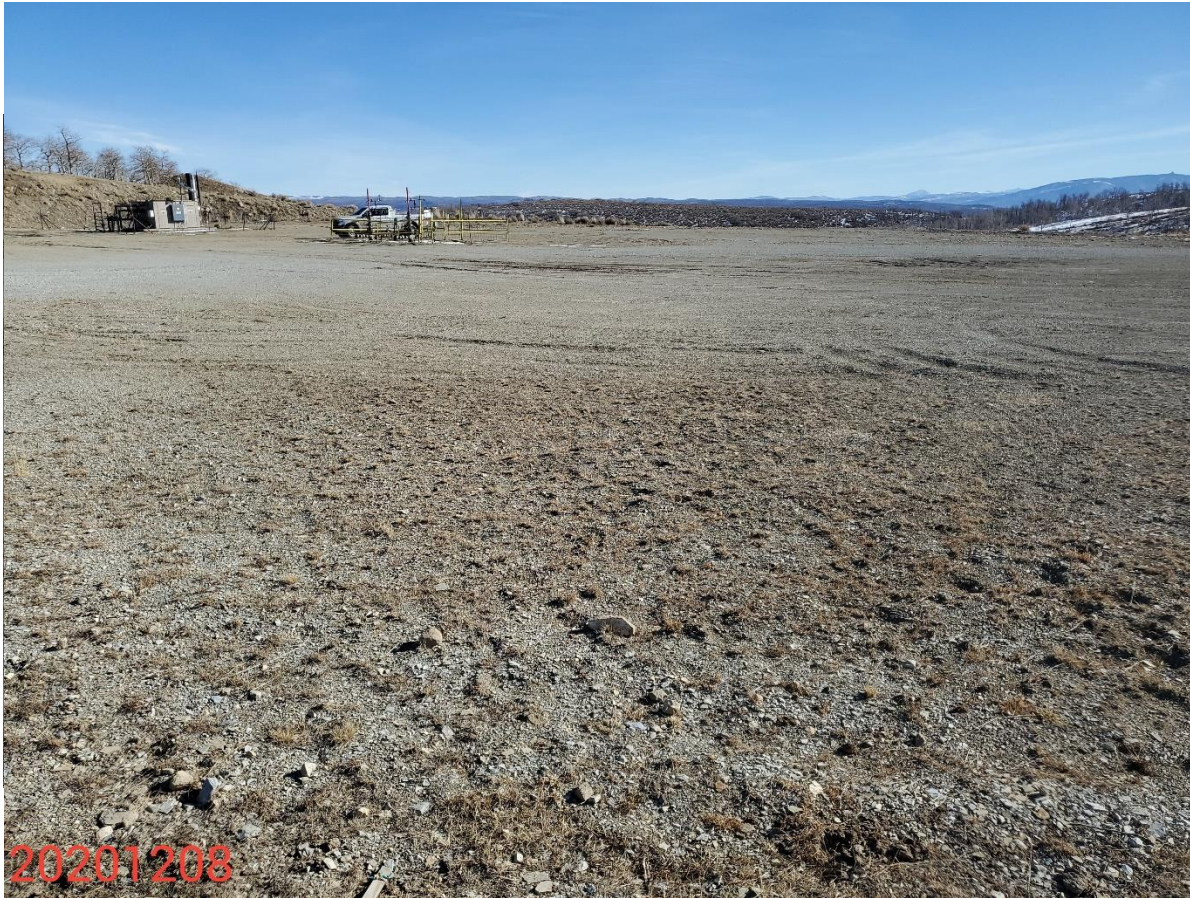
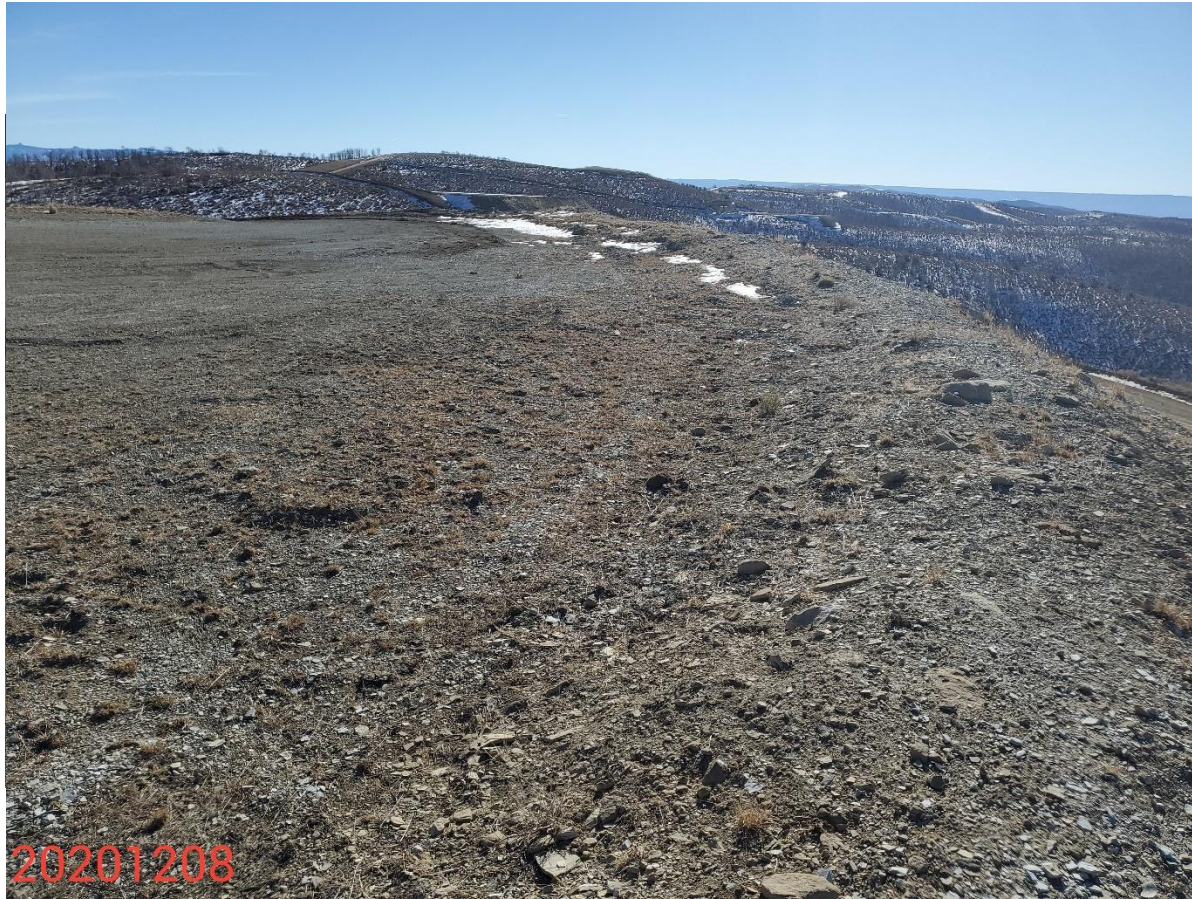
Photo 8: Photo taken from the northwest end of the Location, facing east. Photos 8-10 provide an overview of the Location from east, southeast to south. Photos show areas not reasonably needed for production on the Location have not been reclaimed in accordance with 1003 rules.

Photo 9: See comments under photo 8.

Photo 10: See comments under photo 8.

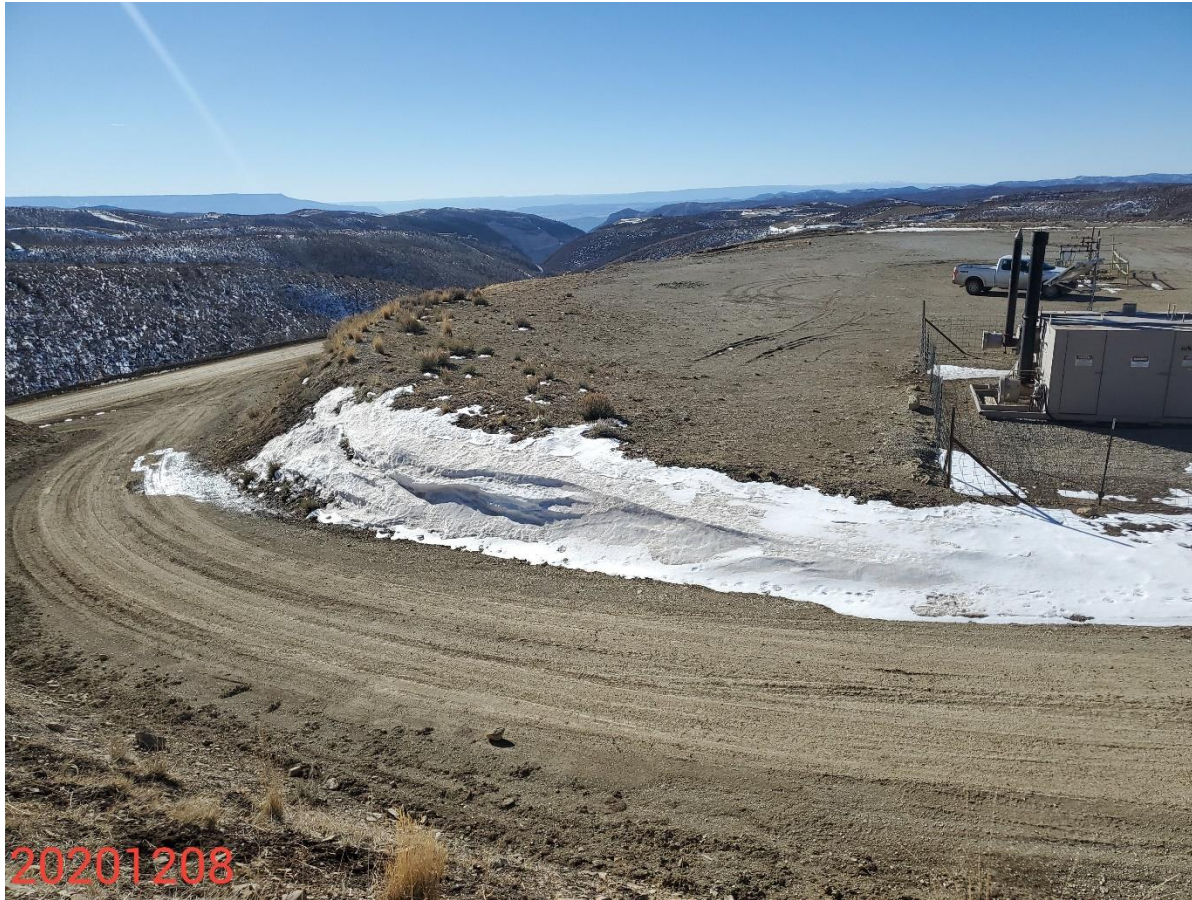
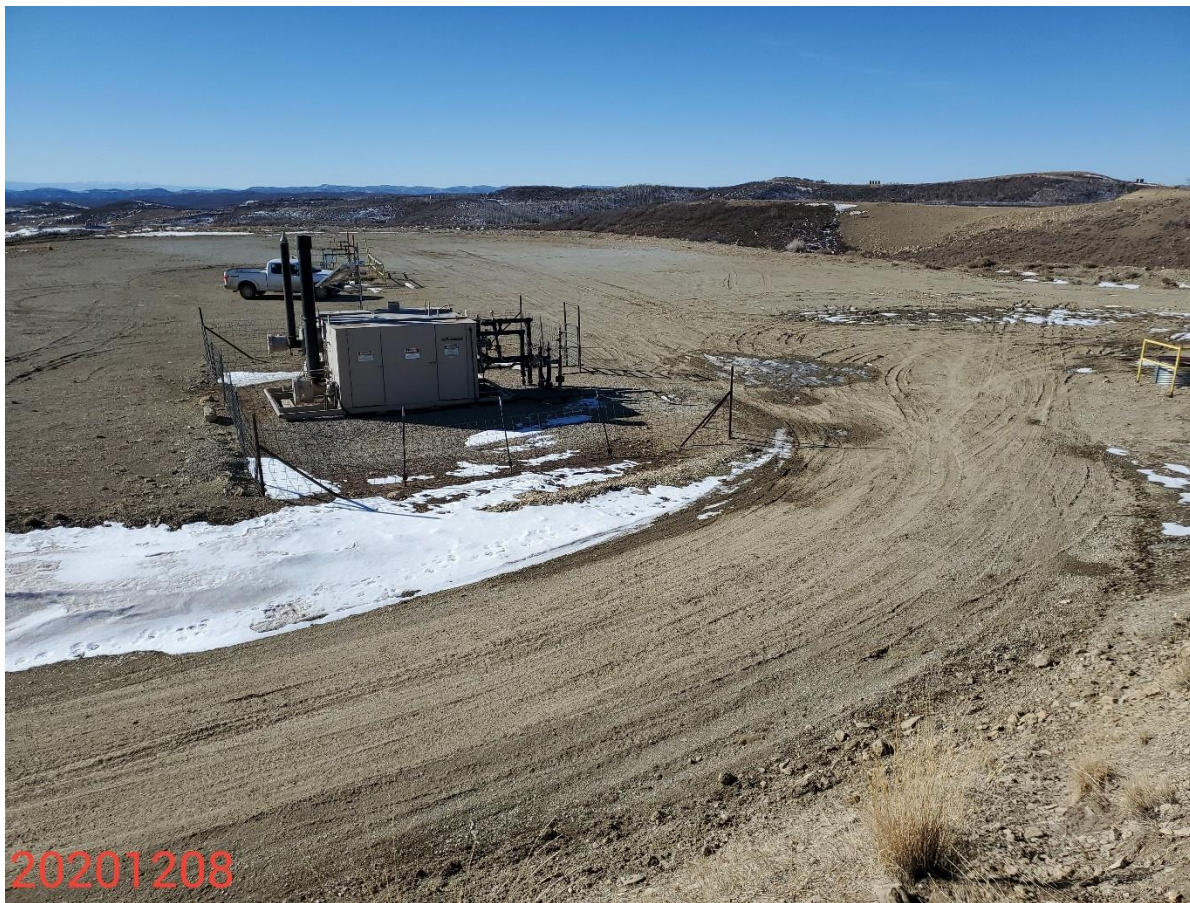
Photo 11: Photo taken from the east end of the Location, facing southwest. Photos 11-12 provide an overview of the Location from southwest to northwest. Photos show areas not reasonably needed for production on the Location have not been reclaimed in accordance with 1003 rules.

Photo 12: See comments under photo 11.

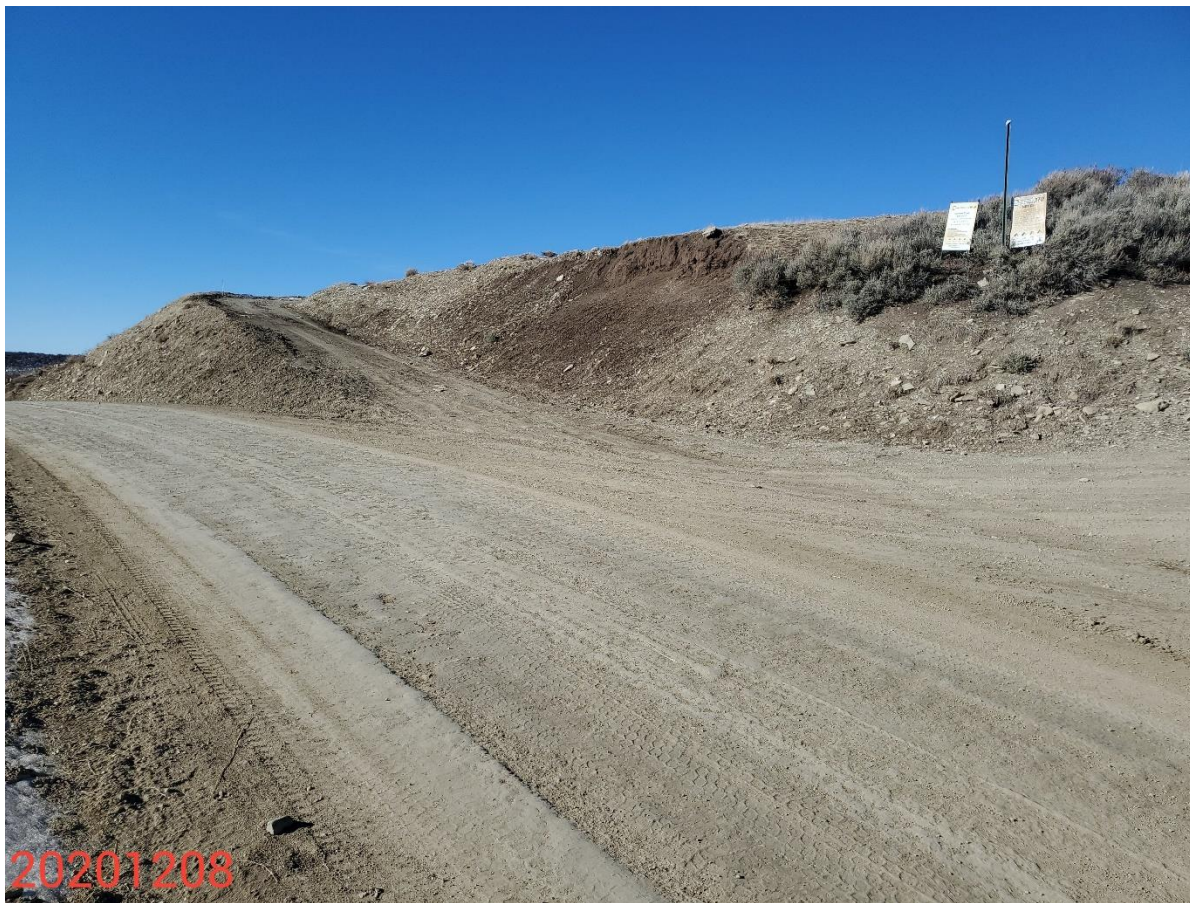
Photo 13: Photo taken from the south of the location, facing northwest. Photo shows 1 of the two access roads leading to the pad on the south end of the Location. Access road in photo will require reclamation during interim reclamation activities.

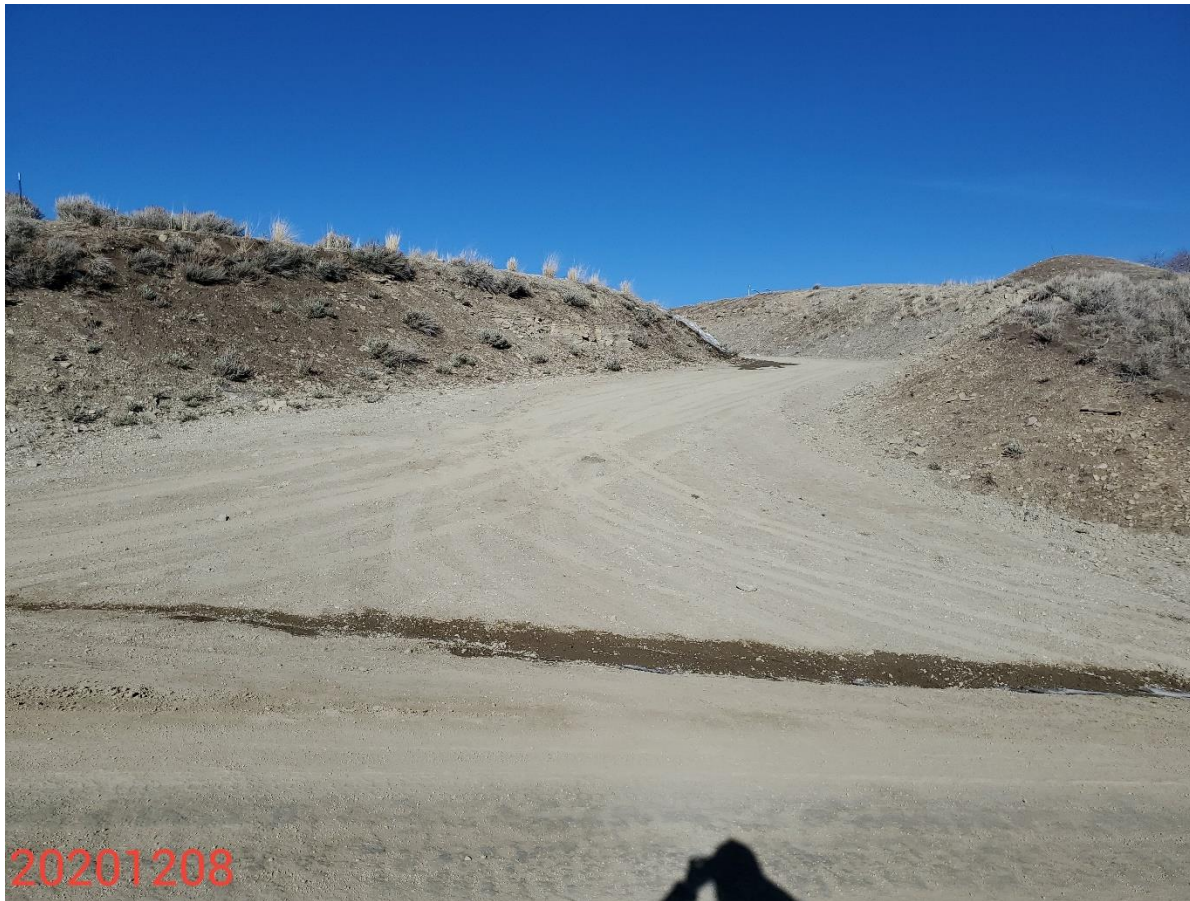
Photo 14: Photo taken from the south of the location, facing north. Photo shows the second access road leading to the pad on the south end of the Location.

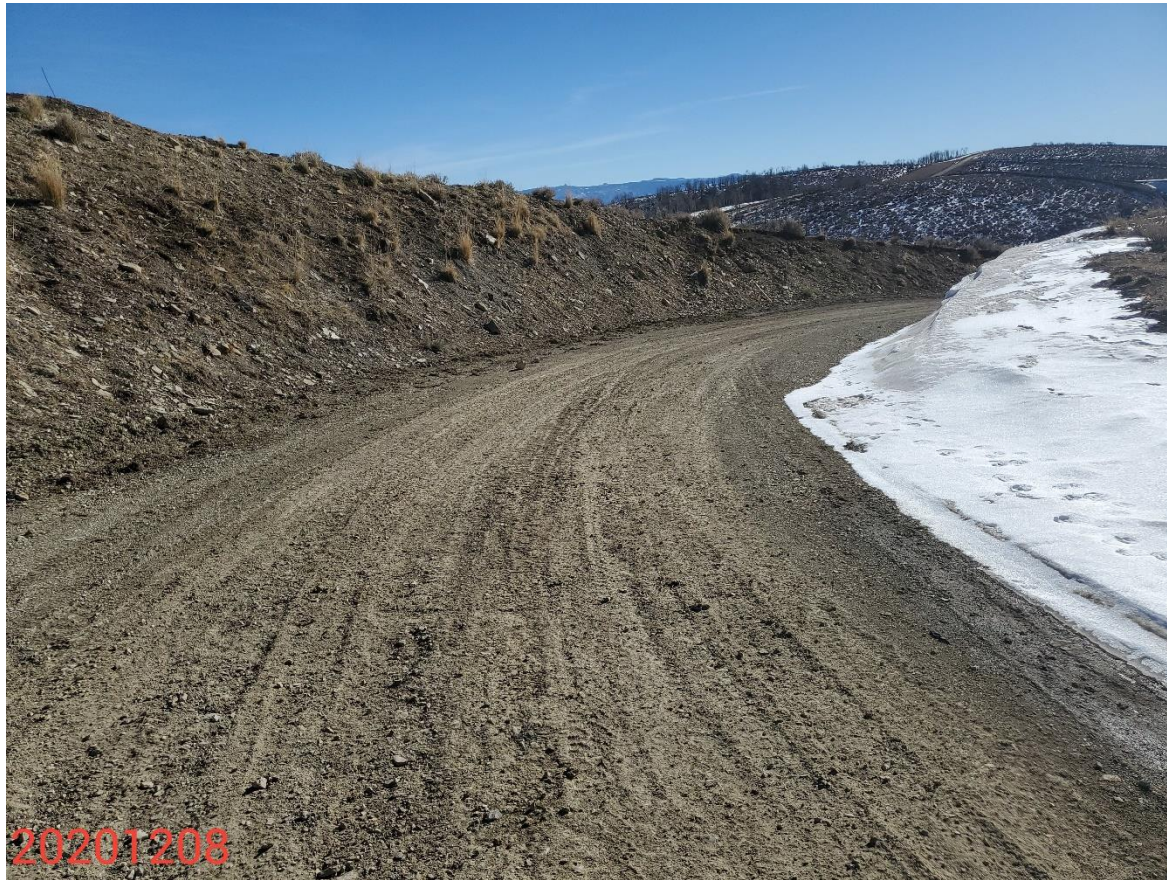
Photo 15: Photo taken from the access road on the southeast end o the Location, facing south. Photo shows BMPs to stabilize slopes on the Location are missing, or insufficient.

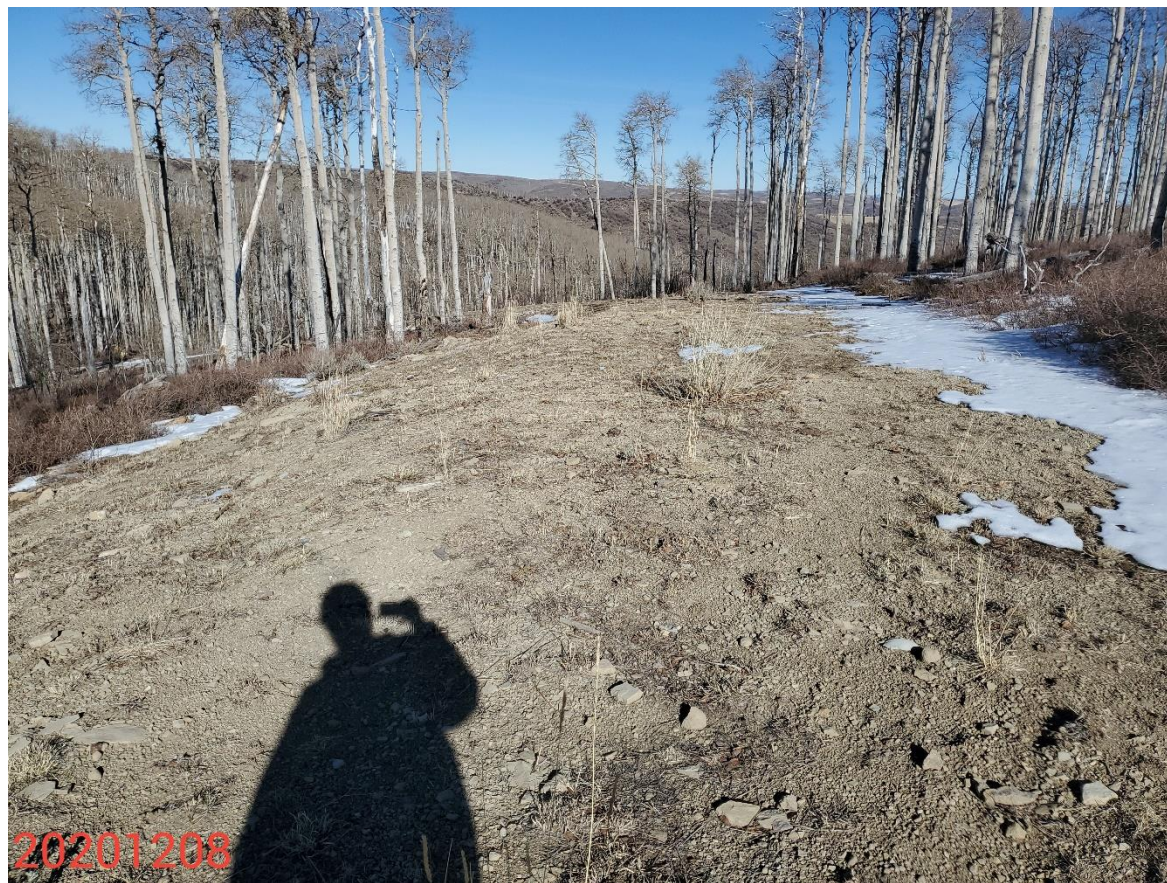
Photo 16: Photo taken from the reclaimed access road north of the Location. Photo shows reclamation of the access road is not progressing towards reclamation requirements.

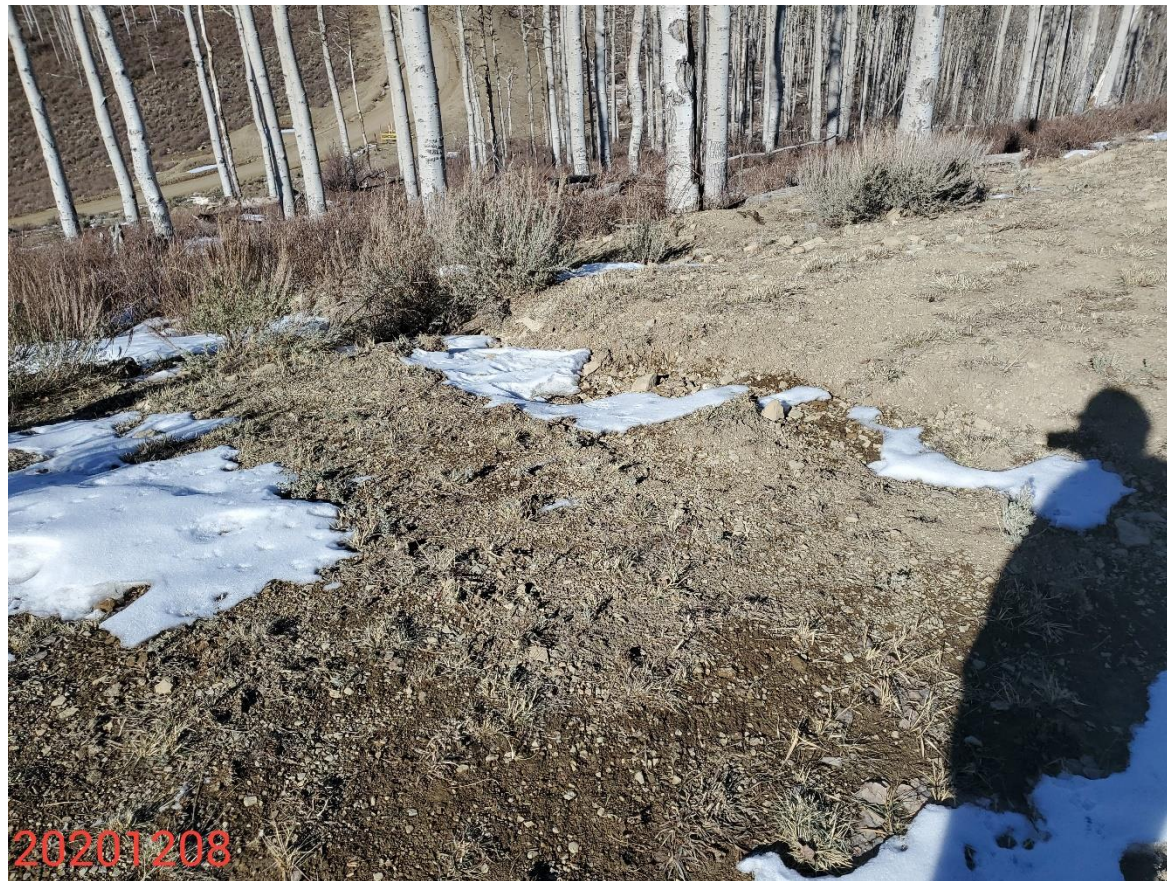
Photo 17: Photo taken from the reclaimed access road north of the Location. Photo shows erosion degradation observed along access road.

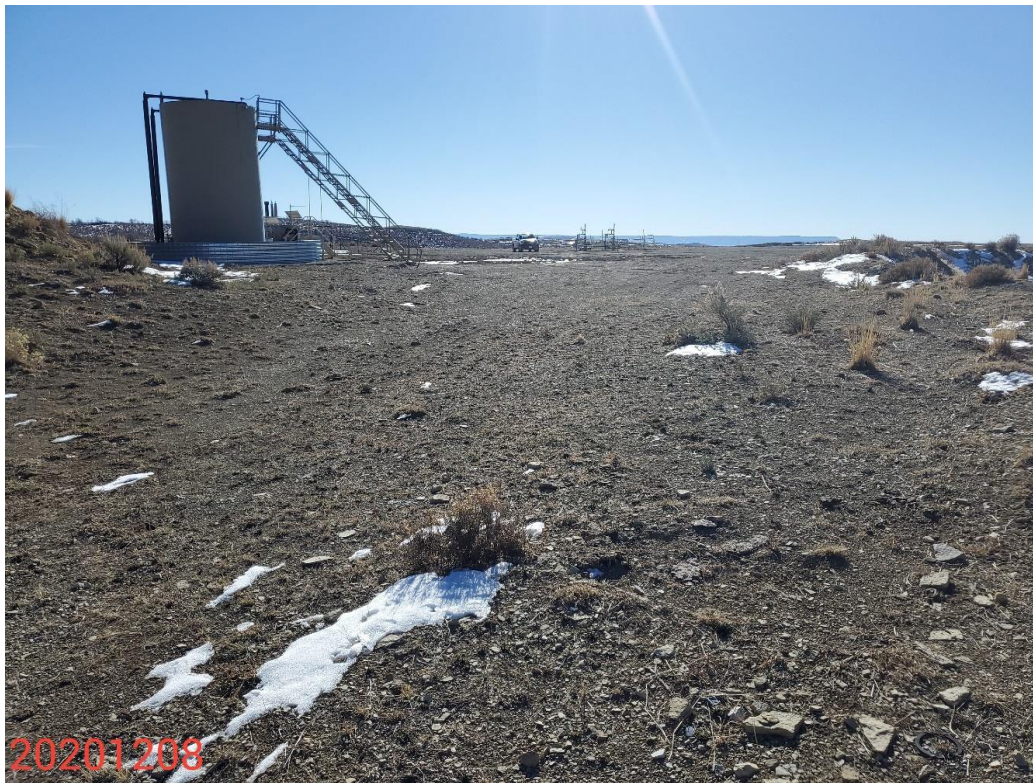
Photo 18: Photo taken from the northern access road, facing southwest. Areas of access road not progressing towards reclamation standards.

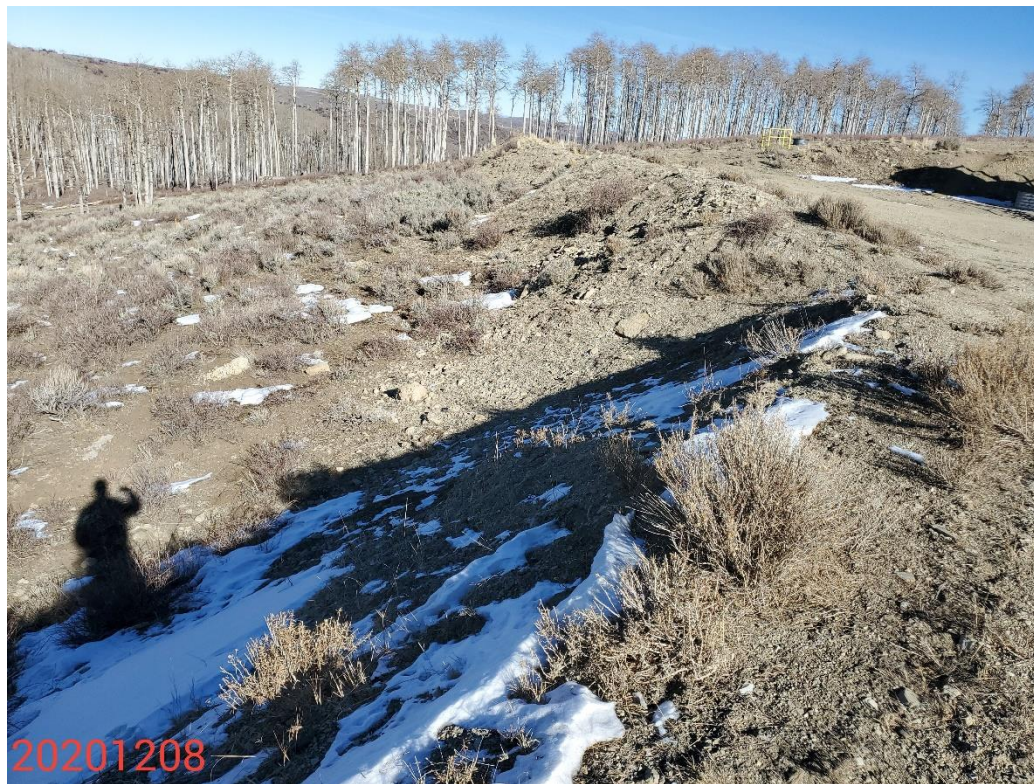
Photo 19: Photo taken from the north end of the Location, facing northeast. Photos shows BMPs to stabilize/protect the fill slopes, and prevent off-site sediment transport are missing or insufficient.

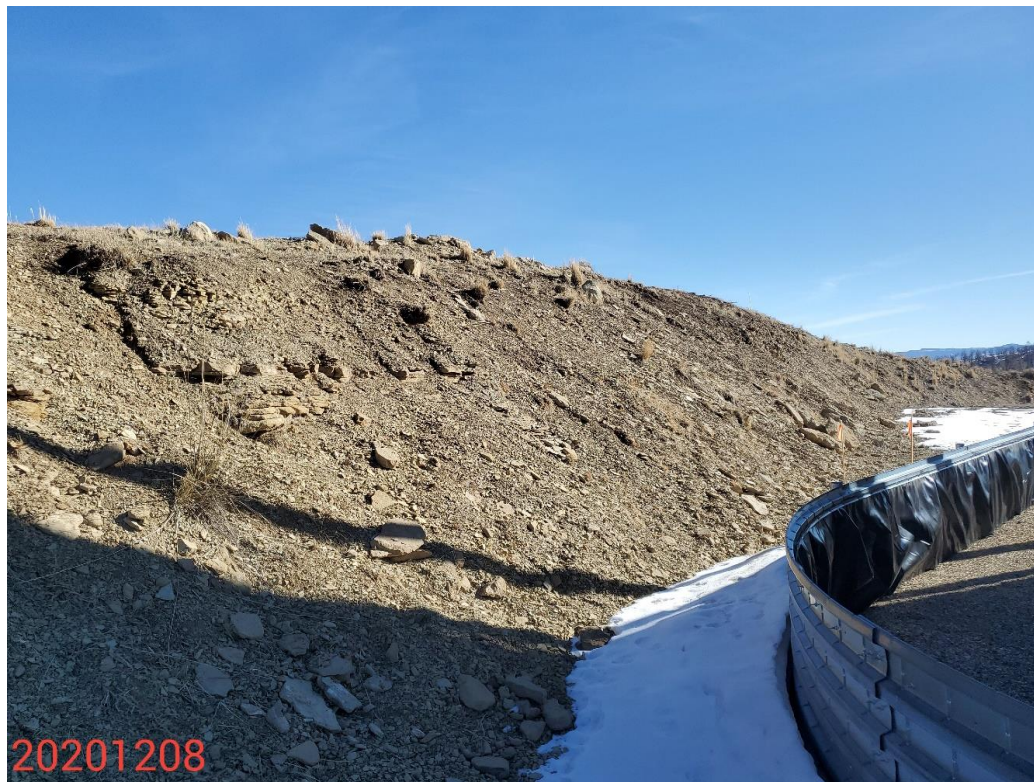
Photo 20: Photo taken from the northeast end of the Location, facing south. Photos shows BMPs to stabilize/protect the cut slopes, and prevent off-site sediment transport are missing or insufficient.

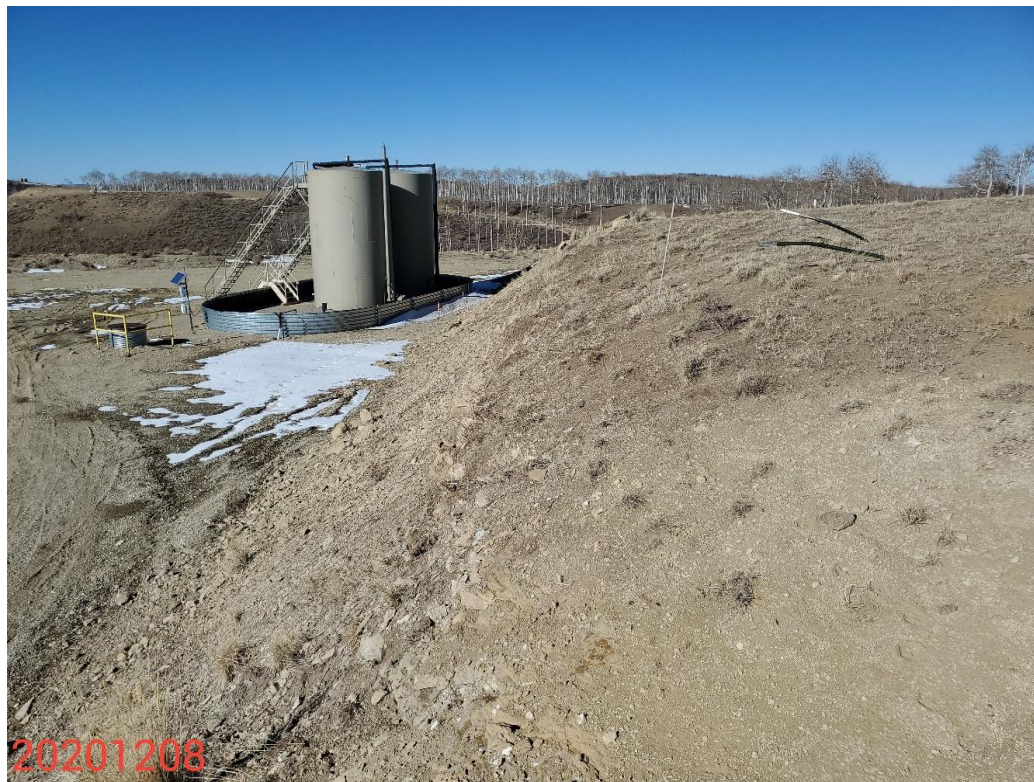
Photo 21: Photo taken from the southeast end of the Location, facing north. Photos shows BMPs to stabilize/protect the cut slopes, and prevent off-site sediment transport are missing or insufficient.
