Inspection Photos

12/8/2020

Operator: LARAMIE ENERGY LLC - 10433

Location ID: 335647

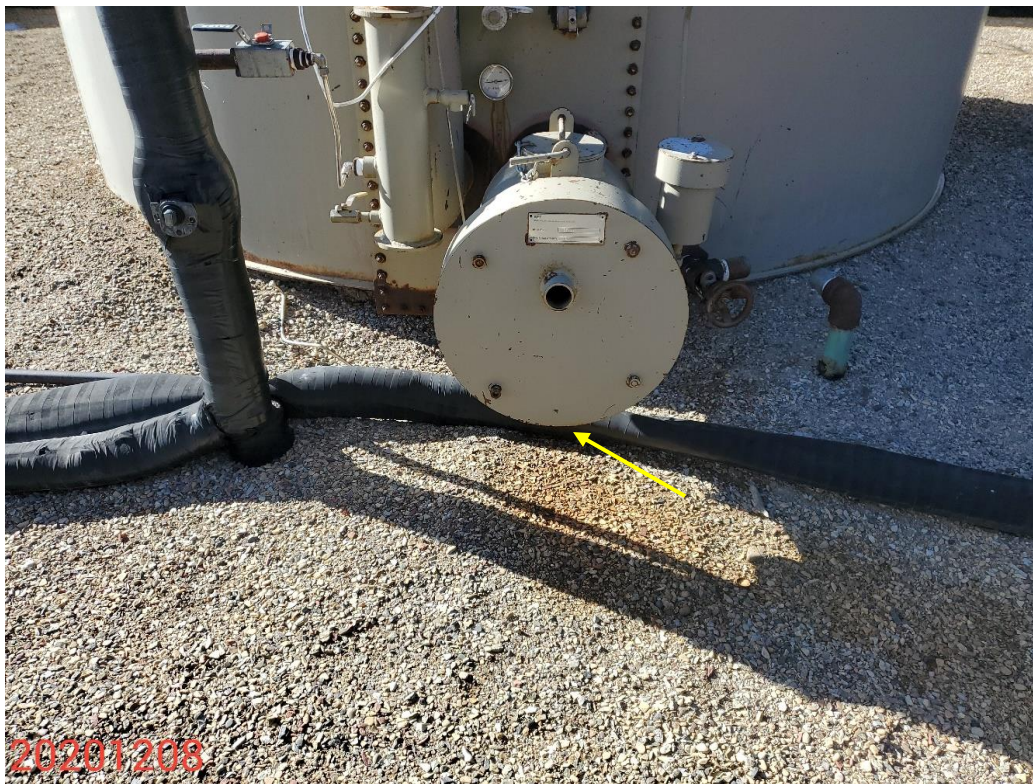
Photo 22: Photo taken from the back end of the southern tank. Leaking was observed from equipment.
