Inspection Photos

API: 017-06899

Operator: MCCOY PETROLEUM CORPORATION

Inspection Date: 12/8/2020

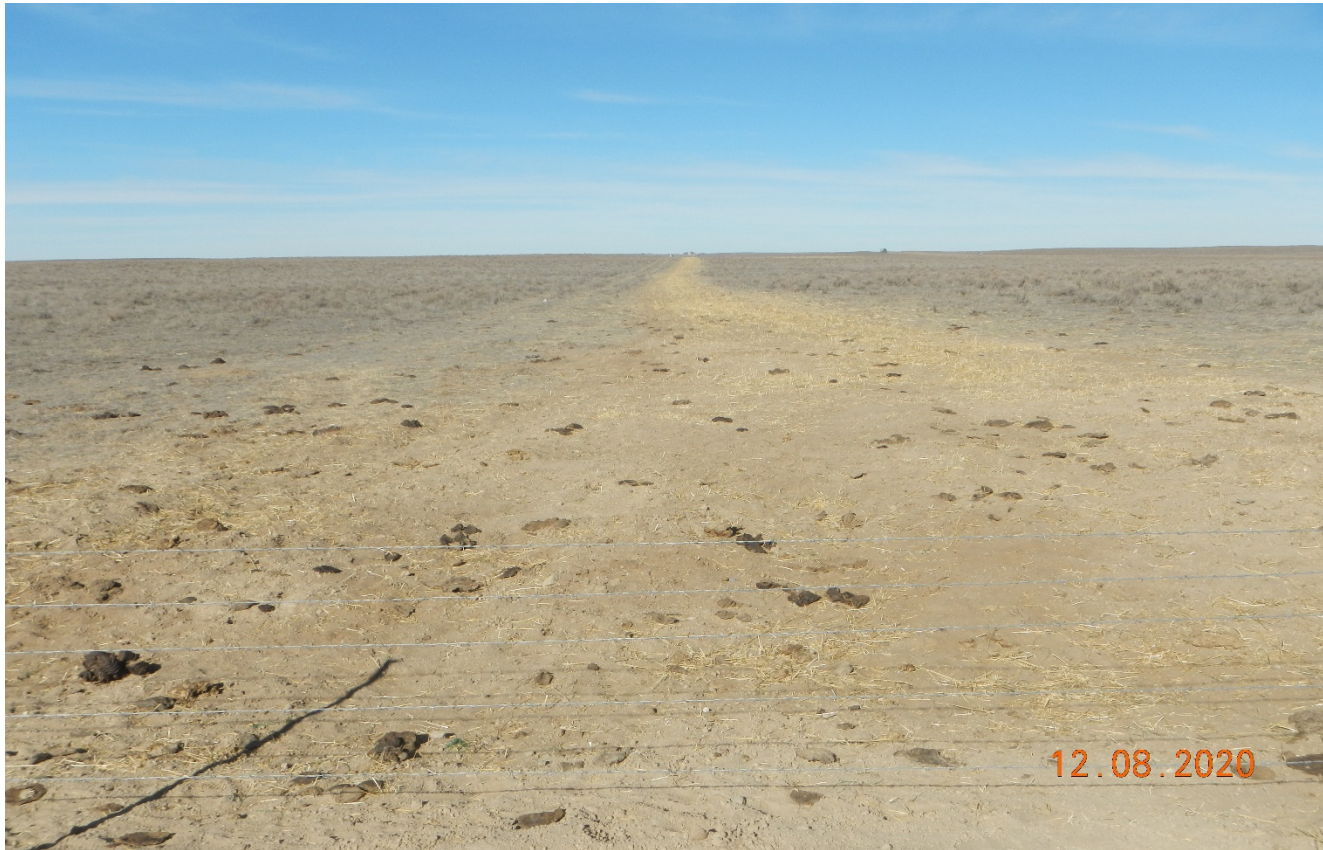
Photo 1. Facing north toward the access road. The road has been reclaimed and temporarily stabilized with straw mulch. It appears livestock have been utilizing the area near the fenceline and reclaimed road.

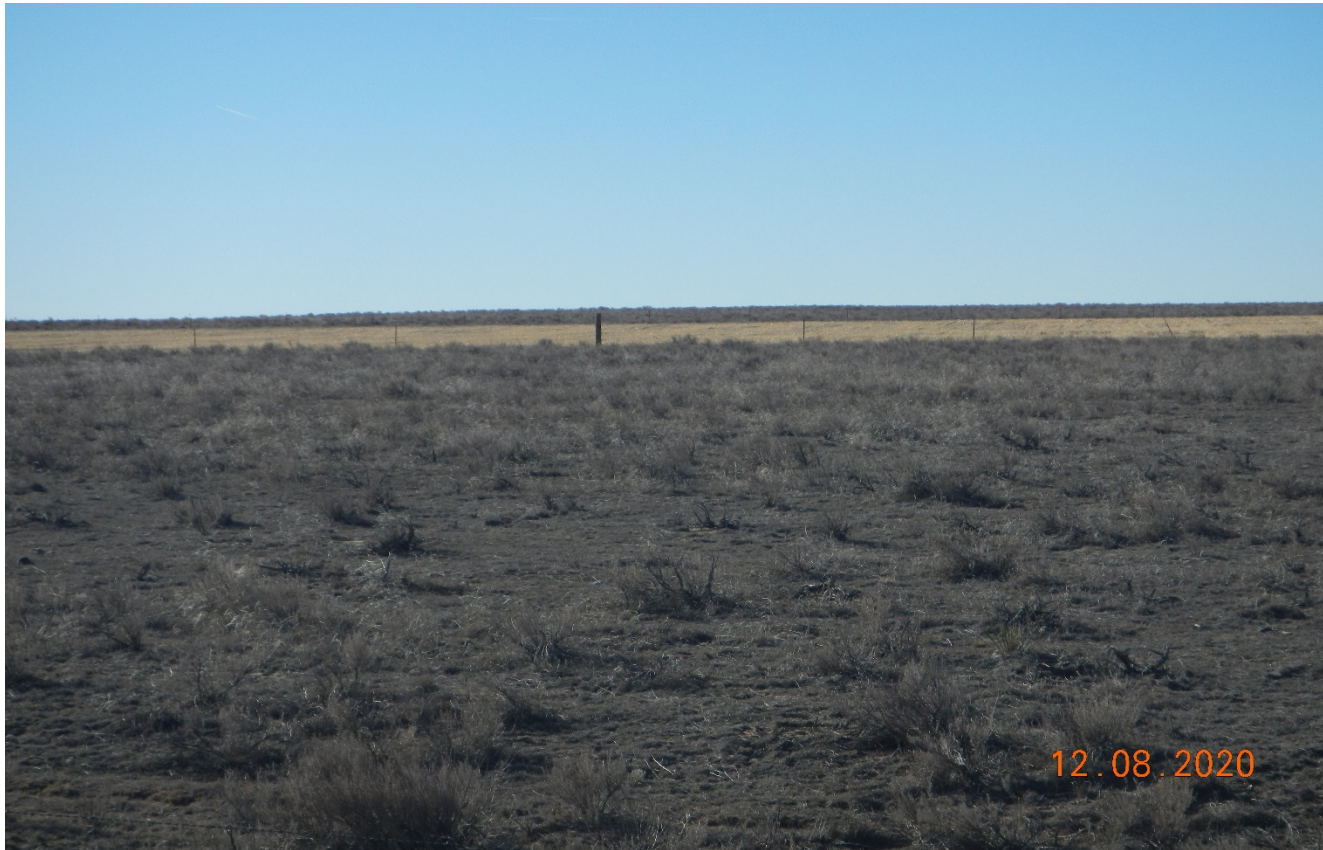
Photo 2. Facing west toward the location standing from a distance. The location is fenced and appears to be reclaimed and straw mulch applied.
