Inspection Photos
Operator: BP America
API: 067-07003
Date: 12/7/2020

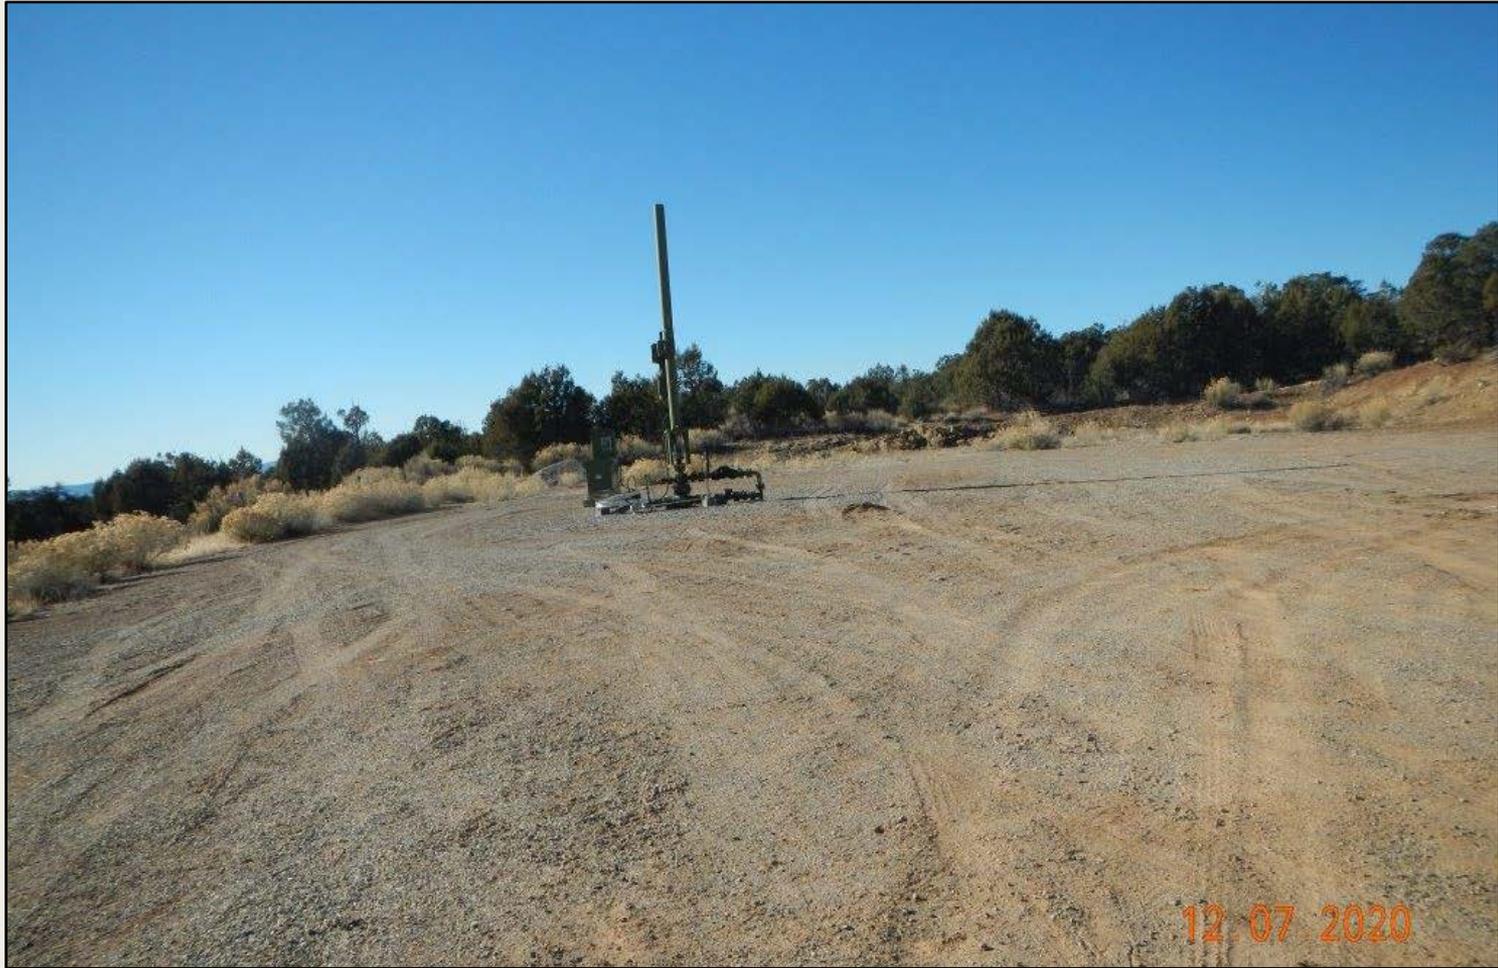
Photo 1. View of the project area from the well pad entrance facing center.

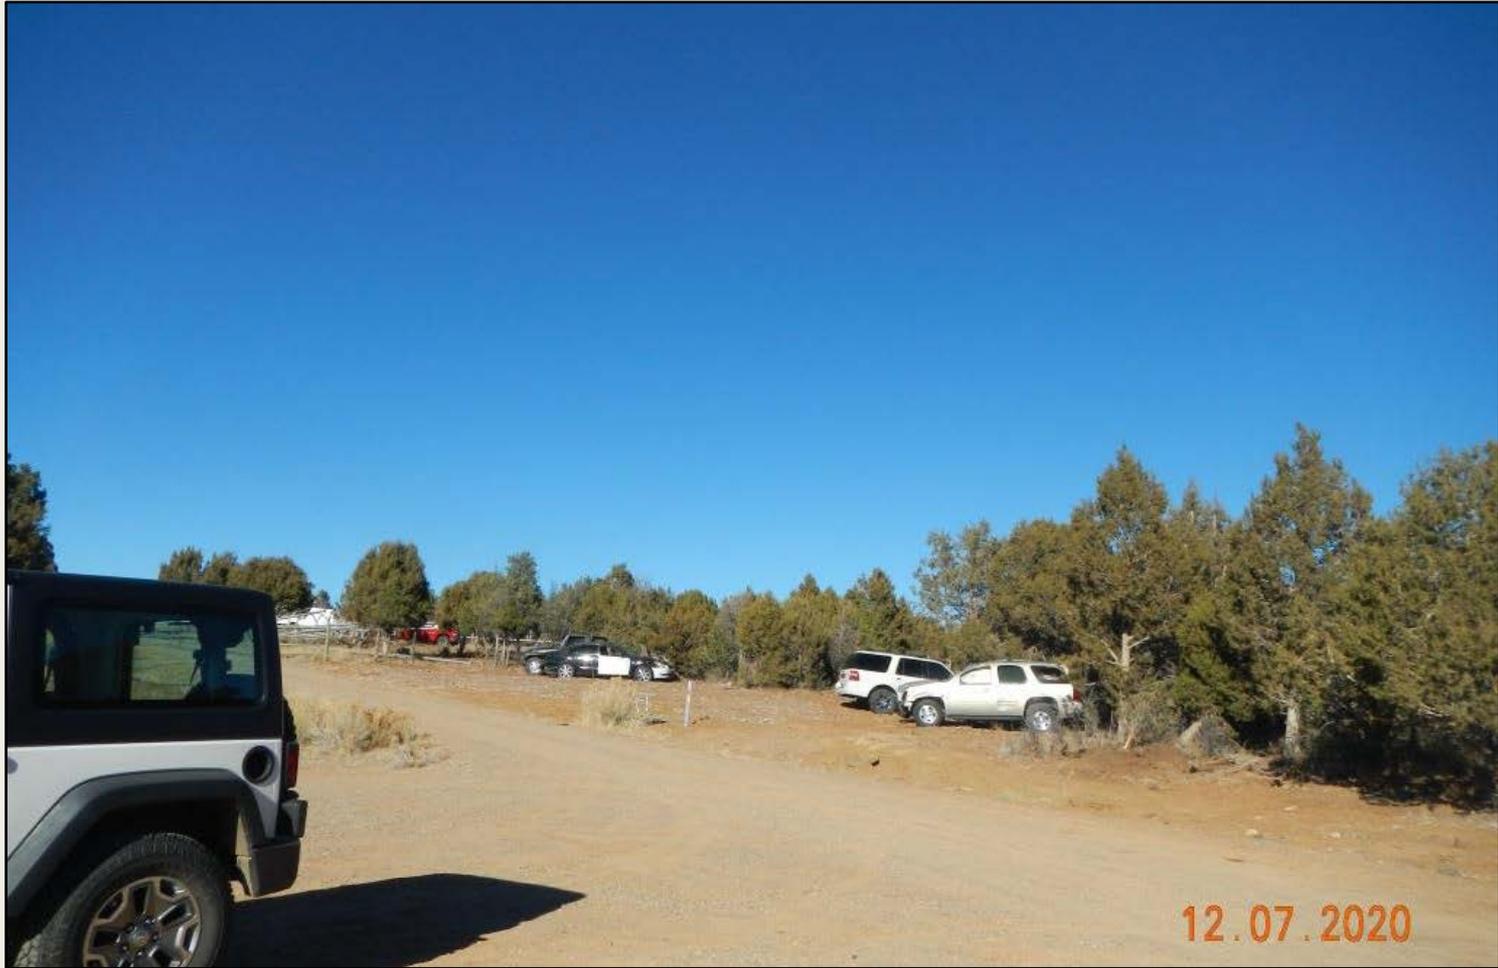
Photo 2. View of the eastern project area facing northward. Cars identified within the project area during a previous reclamation inspection, are moved off of the project area.

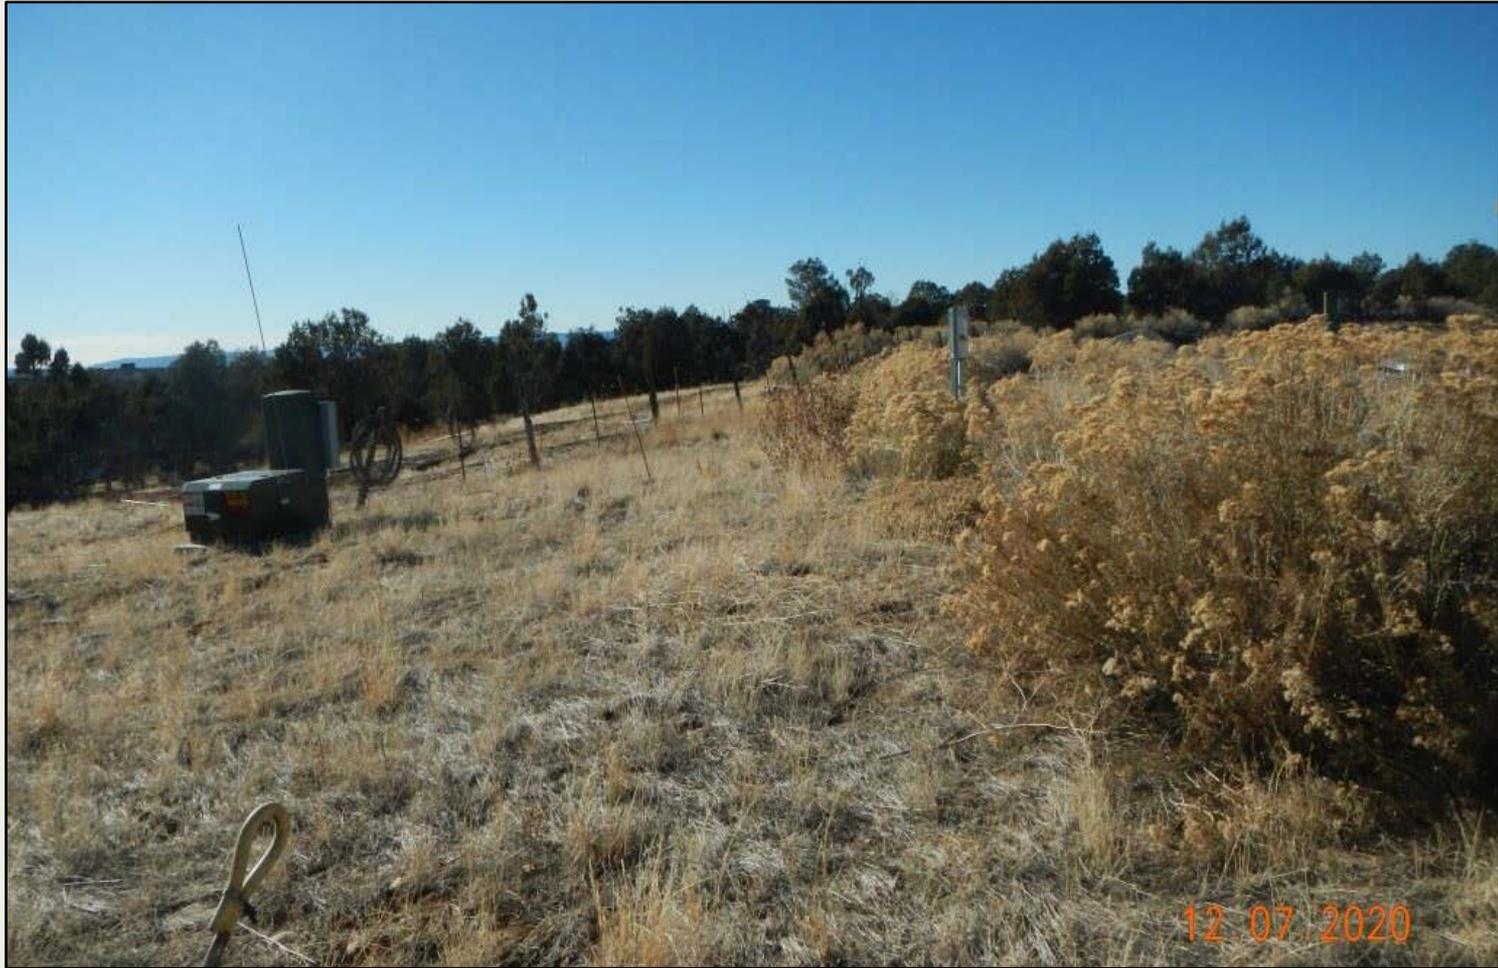
Photo 3. View of the southern fill slope from the southeastern corner facing westward. Revegetation is progressing with western wheatgrass, intermediate wheatgrass, and sand dropseed, as well as weeds such as cheatgrass. As jointed goatgrass was identified during previous inspections, spring monitoring and treatment will likely be needed.

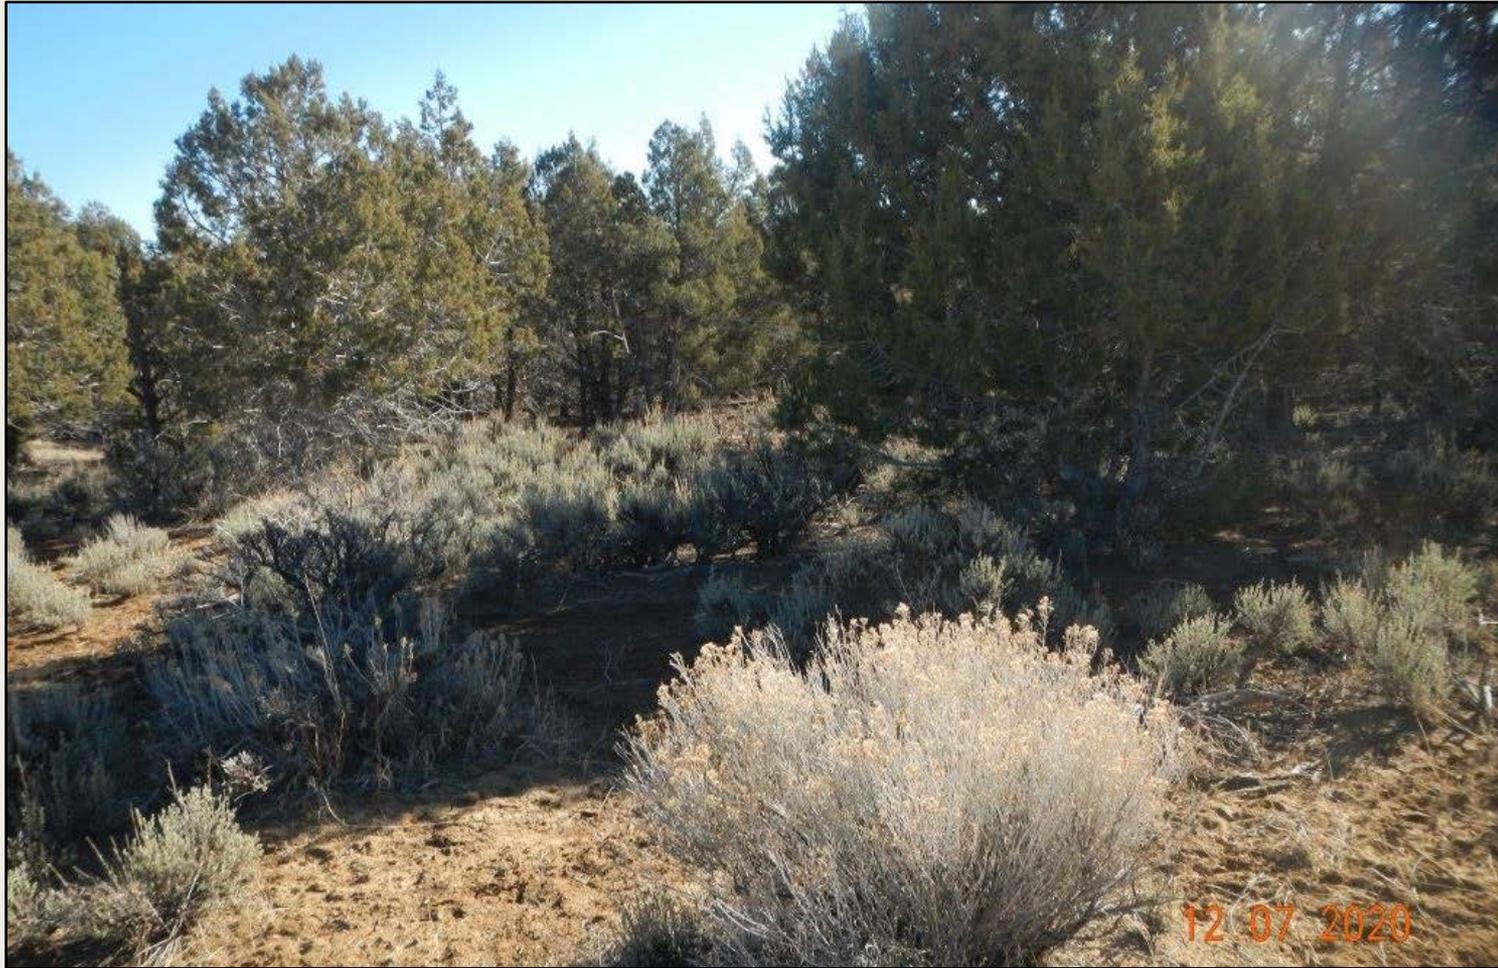
Photo 4 View of the reference area comprised of sagebrush shrubland and pinyon/juniper woodland with understory of squirreltail, blue grama, and penstemon spp.
