Inspection Photos

12/8/2020

Operator: LARAMIE ENERGY LLC - 10433

Location ID: 335902

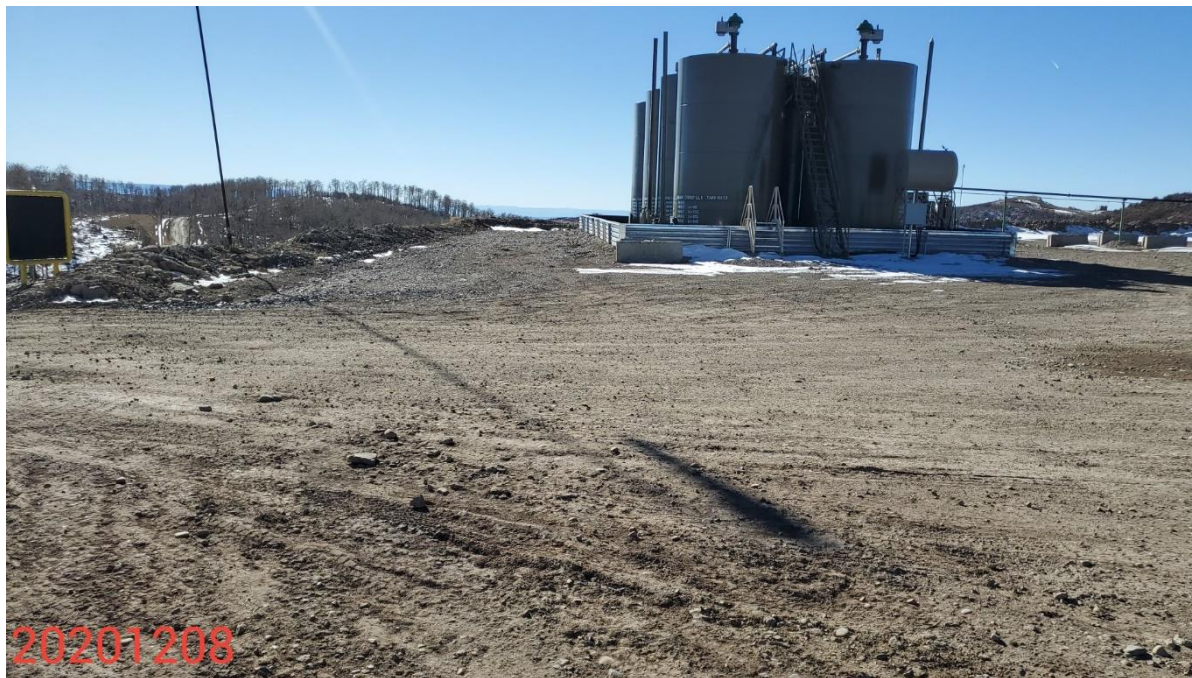
Photo 1: Photo taken from the east end of the Location, facing south. Photos 1-4 provide an overview of the Location from south, southwest, northwest to north. Photos also show areas not reasonably needed for production on the Location have not been reclaimed.

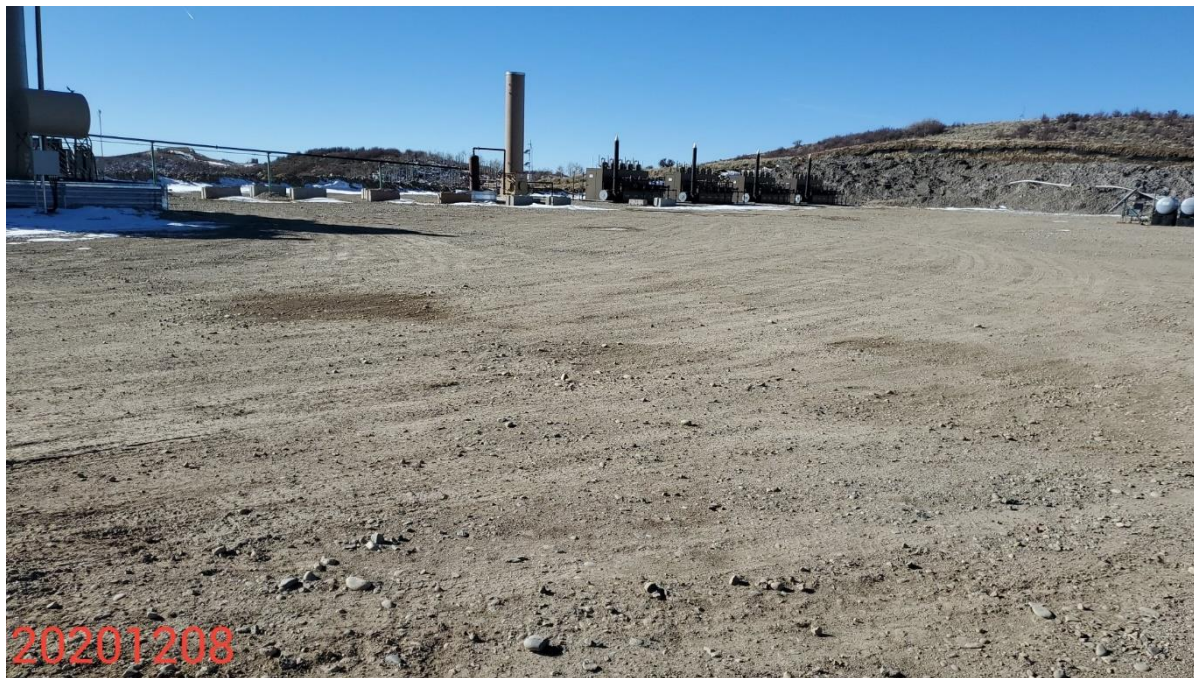
Photo 2: See comments under photo 1.

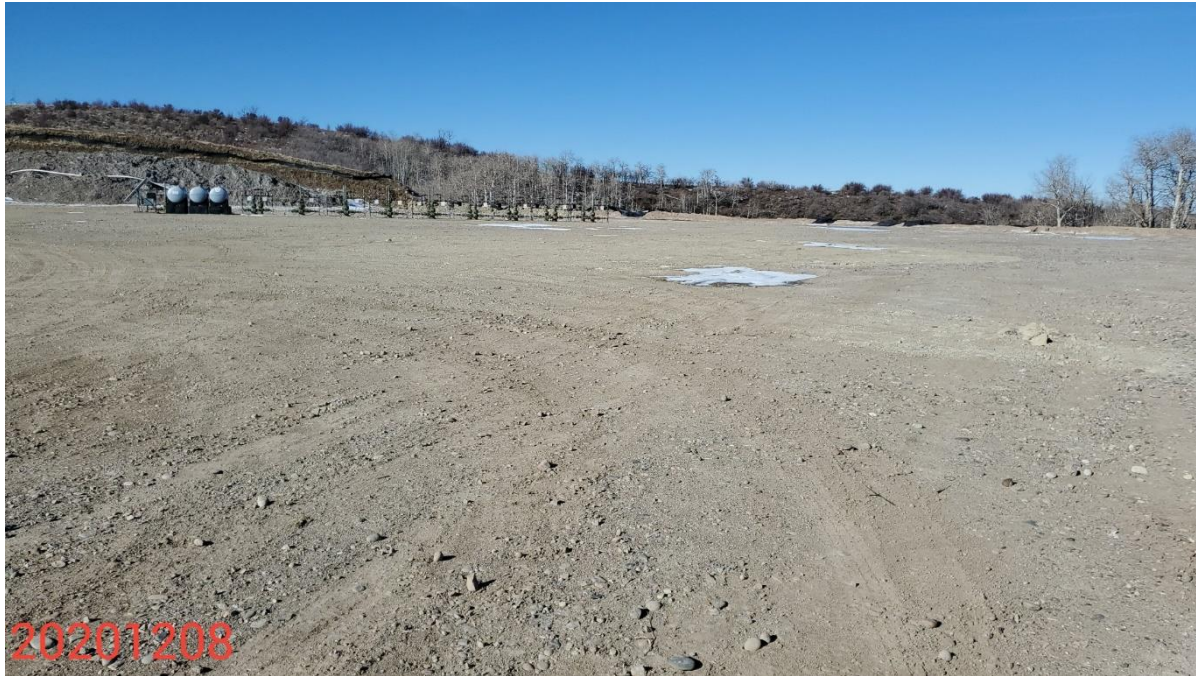
Photo 3: See comments under photo 1.

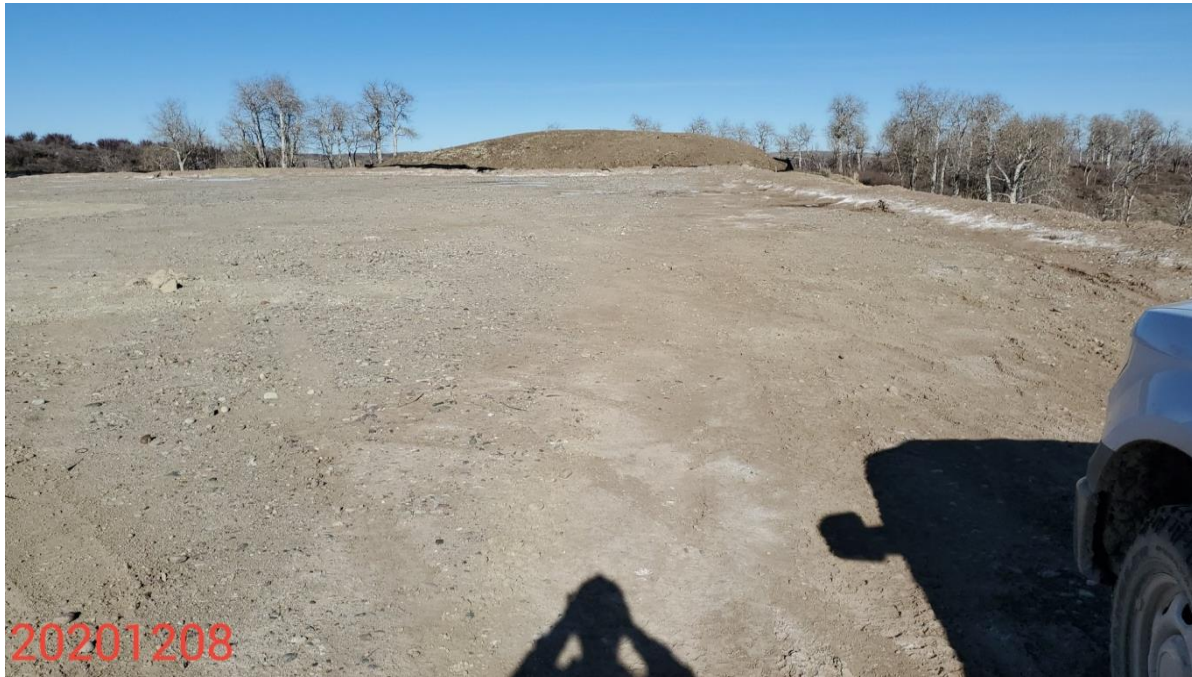
Photo 4: See comments under photo 1.

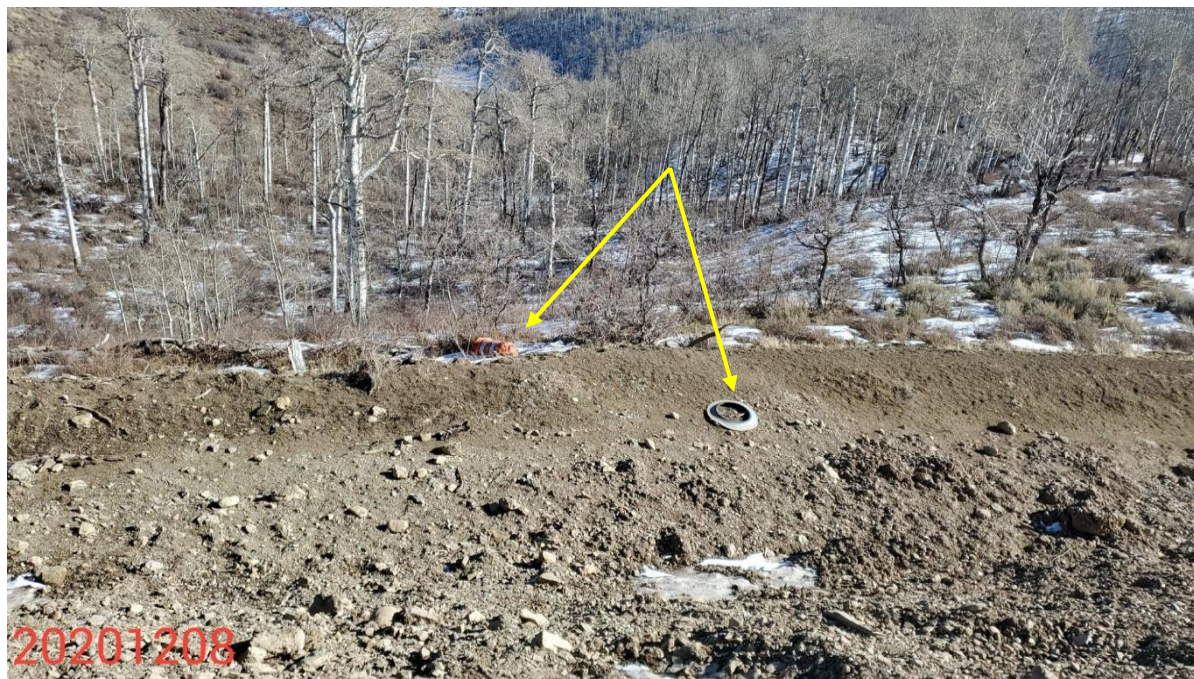
Photo 5: Photo taken from the east end of the Location, facing east. Photo shows trash debris (orange barrel) on the slopes east of the Location.

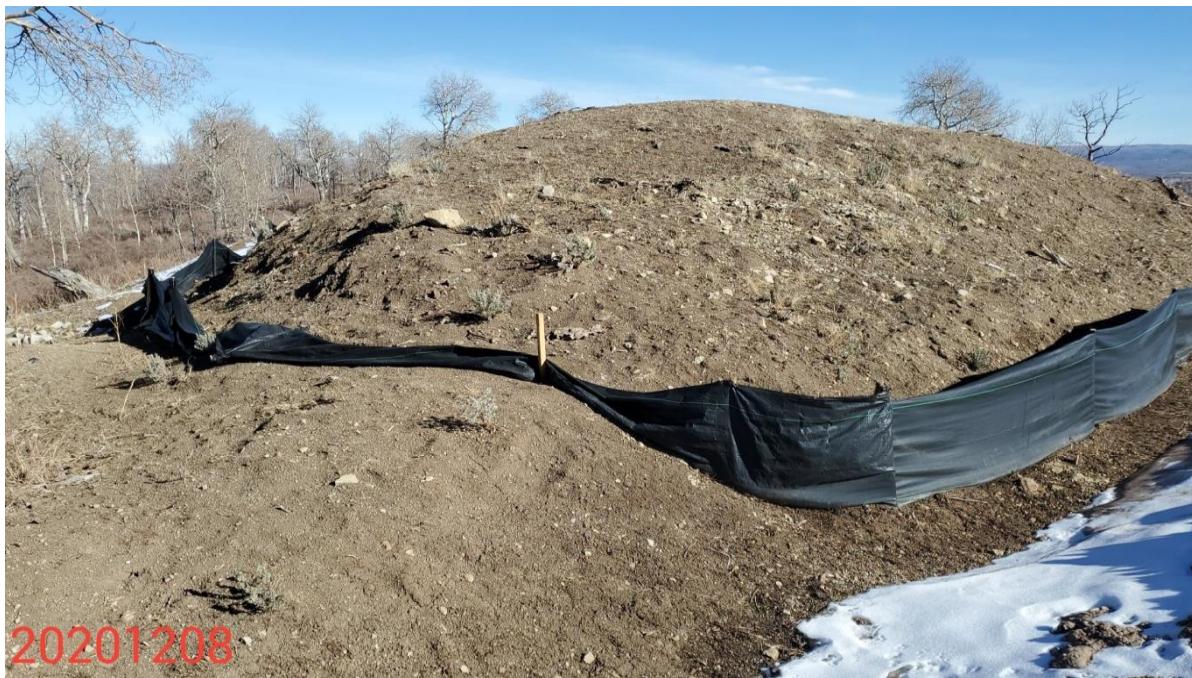
Photo 6: Photo taken from the northeast corner of the Location, facing northeast. Photo shows BMPs at the soil stockpile are missing or insufficient.

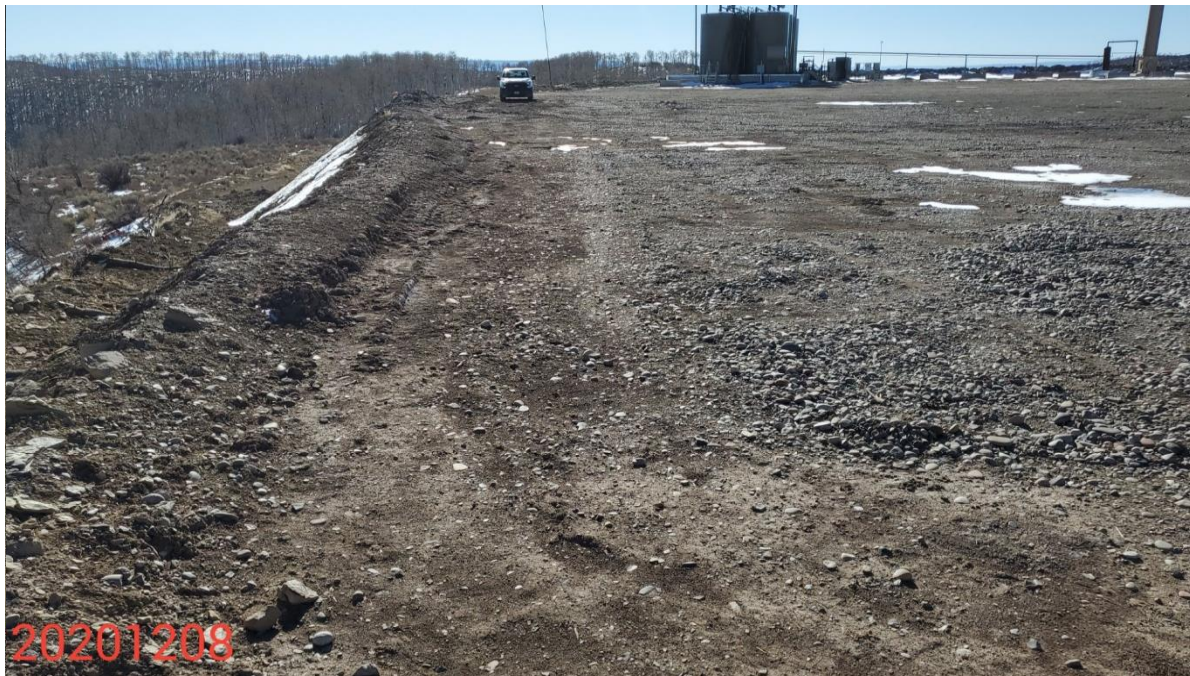
Photo 7: Photo taken from the northeast end of the Location, facing south. Photos 7-9 provide an overview of the Location from south, southwest, to west. Photos also show areas not reasonably needed for production on the Location have not been reclaimed.

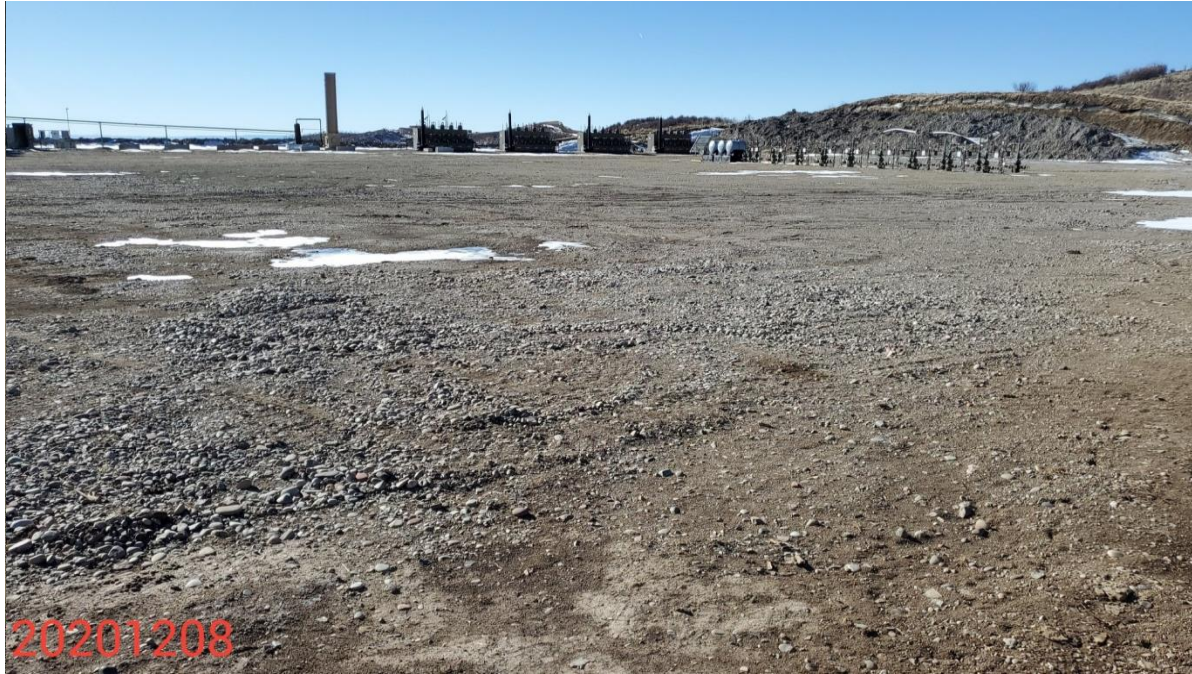
Photo 8: See comments under photo 7.

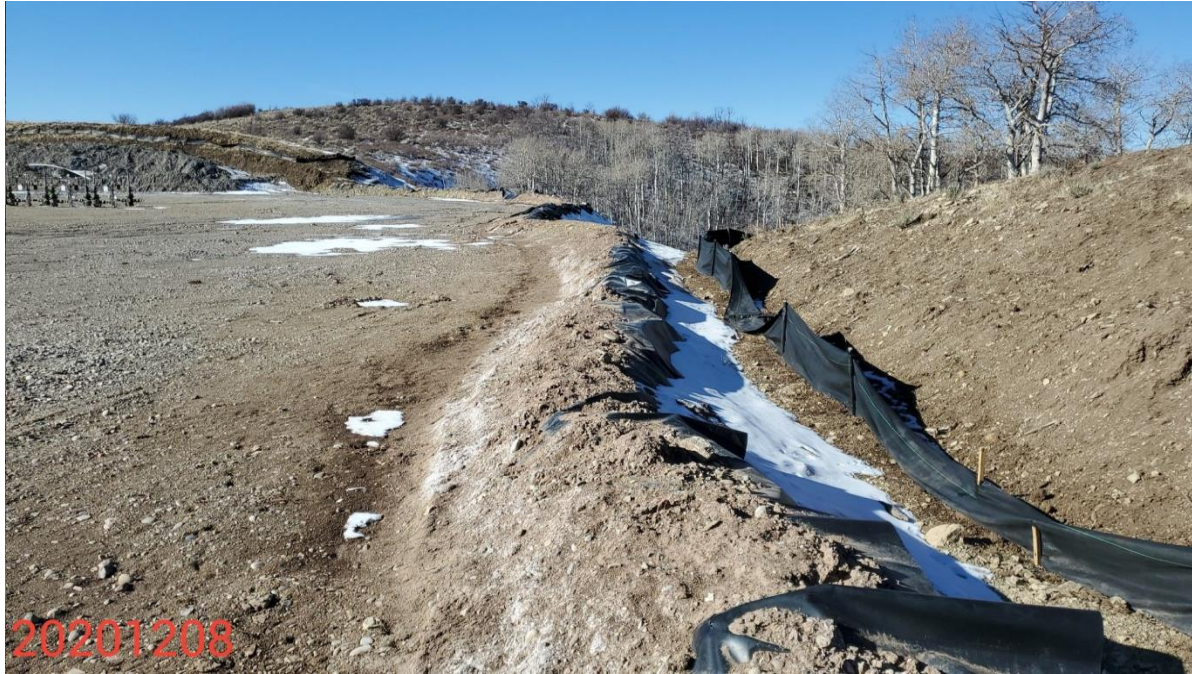
Photo 9: See comments under photo 7.

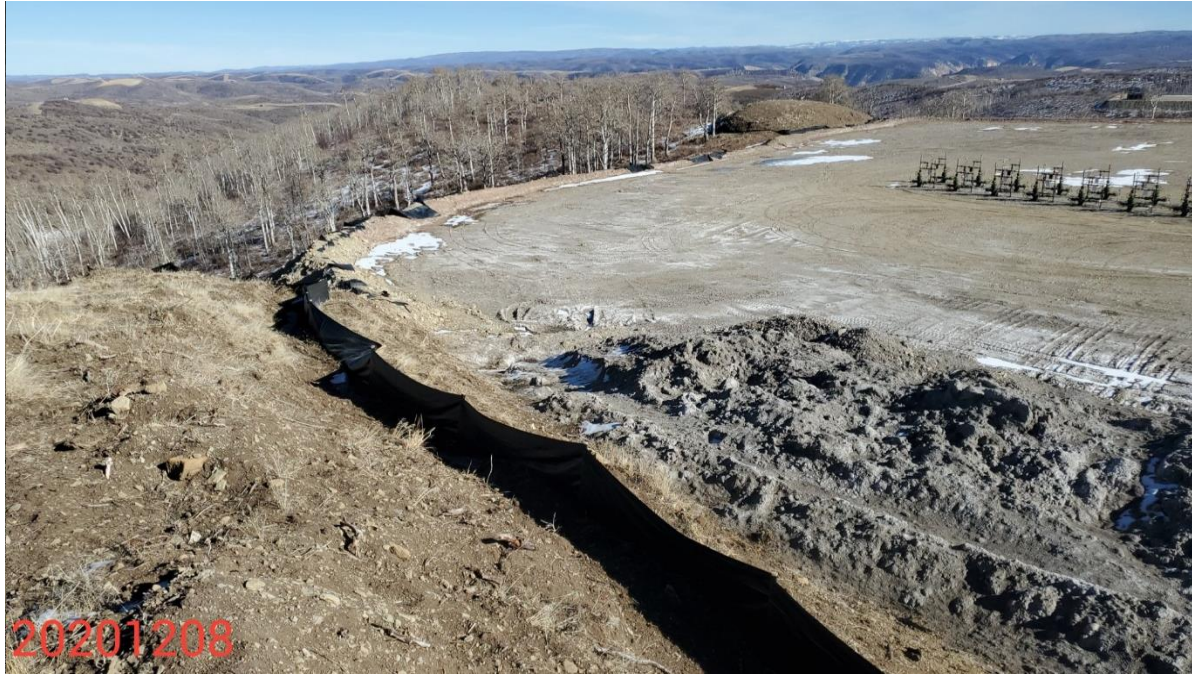
Photo 10: Photo taken from the west end of the Location, facing south. Photos 10-12 provide an overview of the Location from northeast, east to southeast. Photos also show areas not reasonably needed for production on the Location have not been reclaimed. Photos also show cuttings on Location.

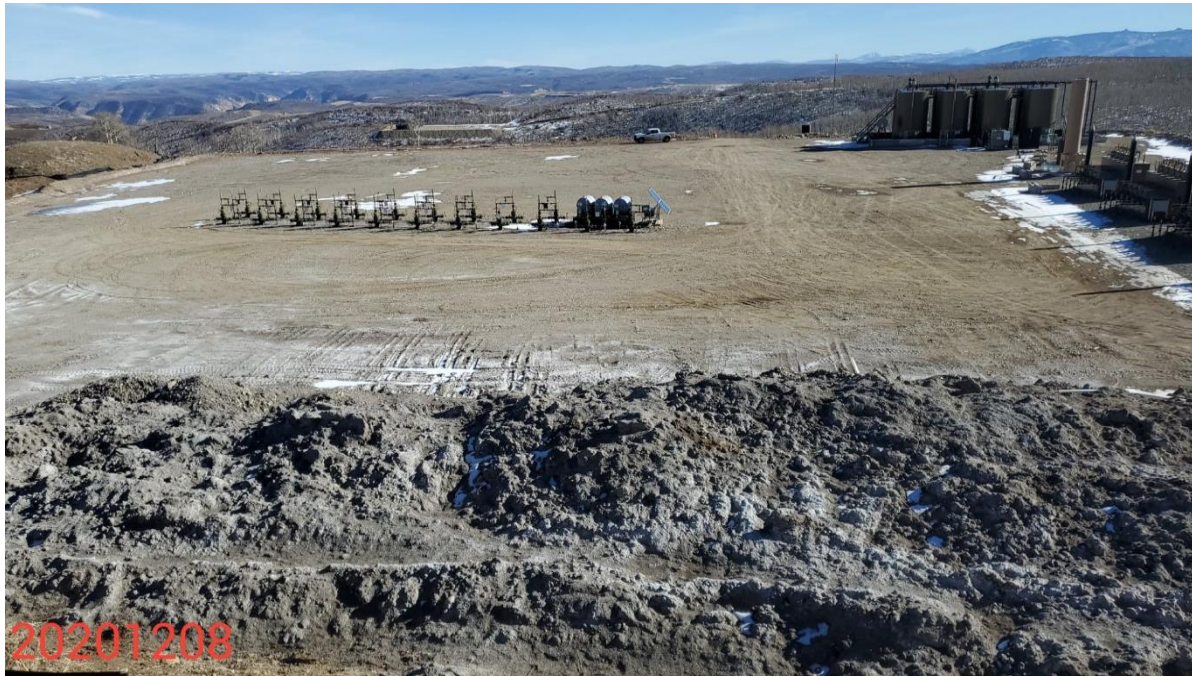
Photo 11: See comments under photo 10.

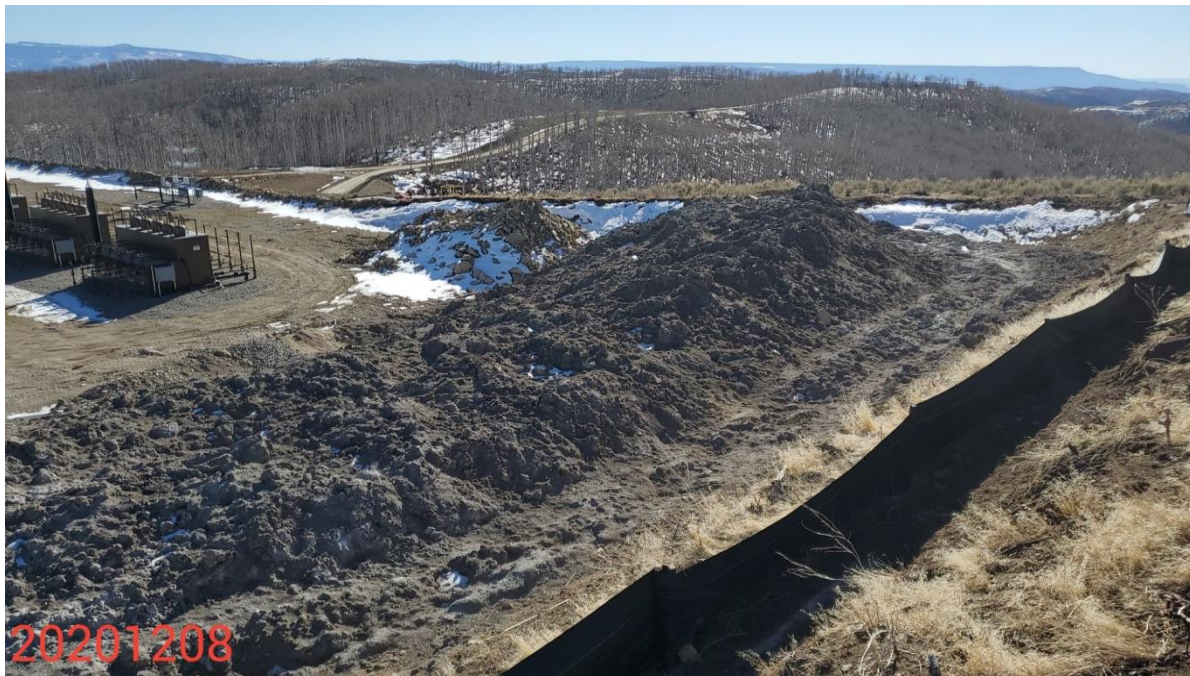
Photo 12: See comments under photo 110.

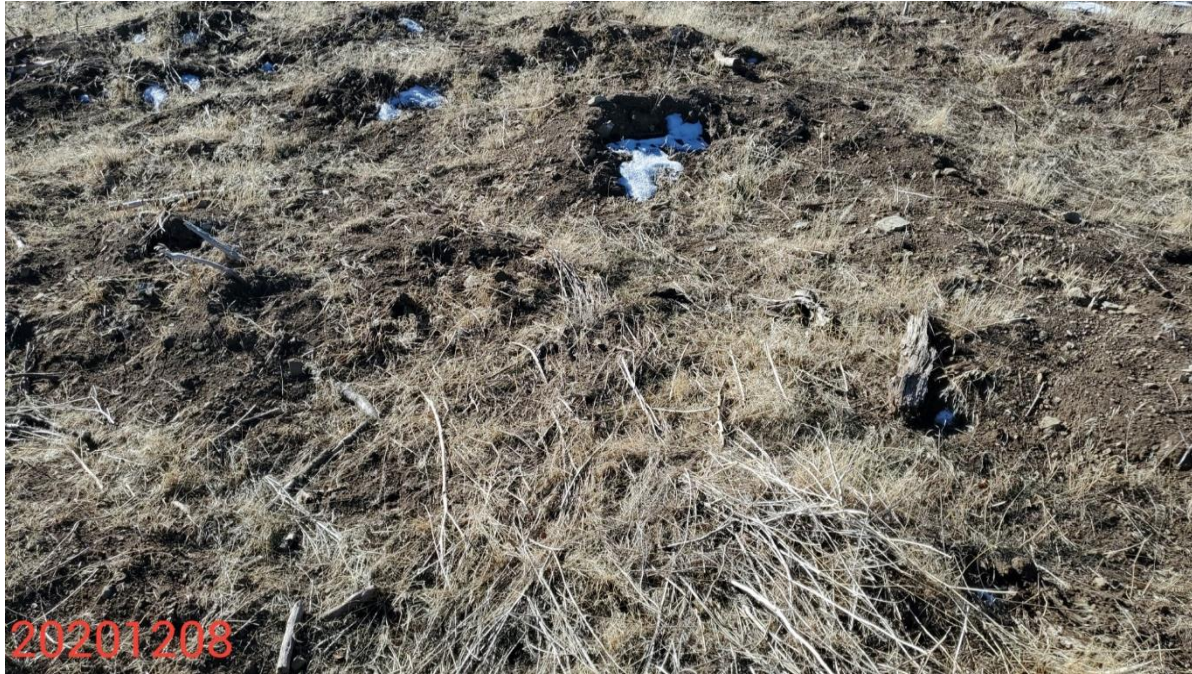
Photo 13: Photo taken from the soil stockpile on the west end of the Location. Vegetation observed on soil stockpile predominantly undesirable weedy plant species such as cheatgrass; This does not comport with Rule 1002.c.

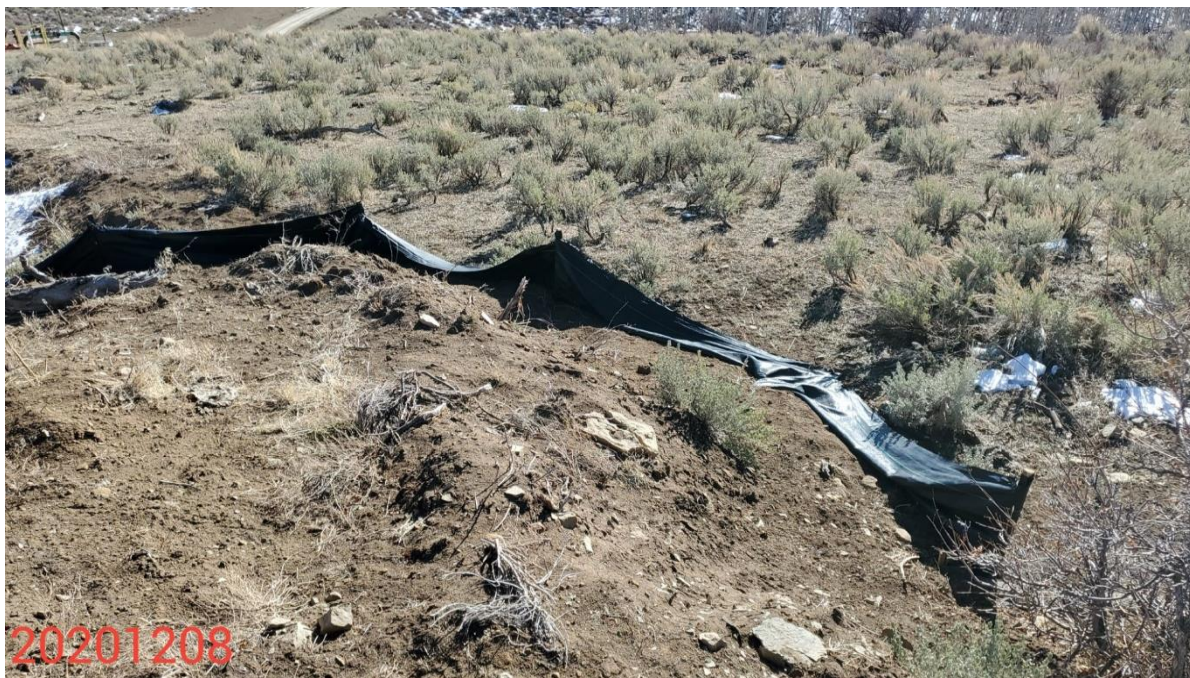
Photo 14: Photo taken from the southwest end of the Location, facing south. Photo shows BMPs at the soil stockpile are missing or insufficient.

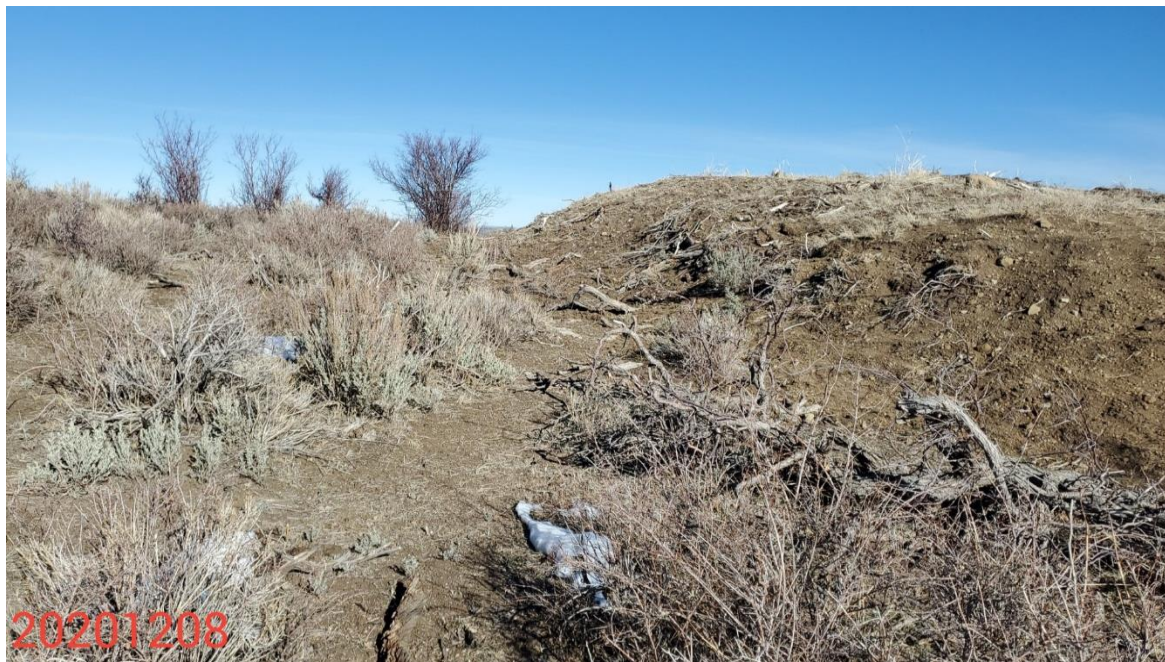
Photo 15: Photo taken from the southwest end of the Location, facing north. Photo shows BMPs at the soil stockpile are missing or insufficient.

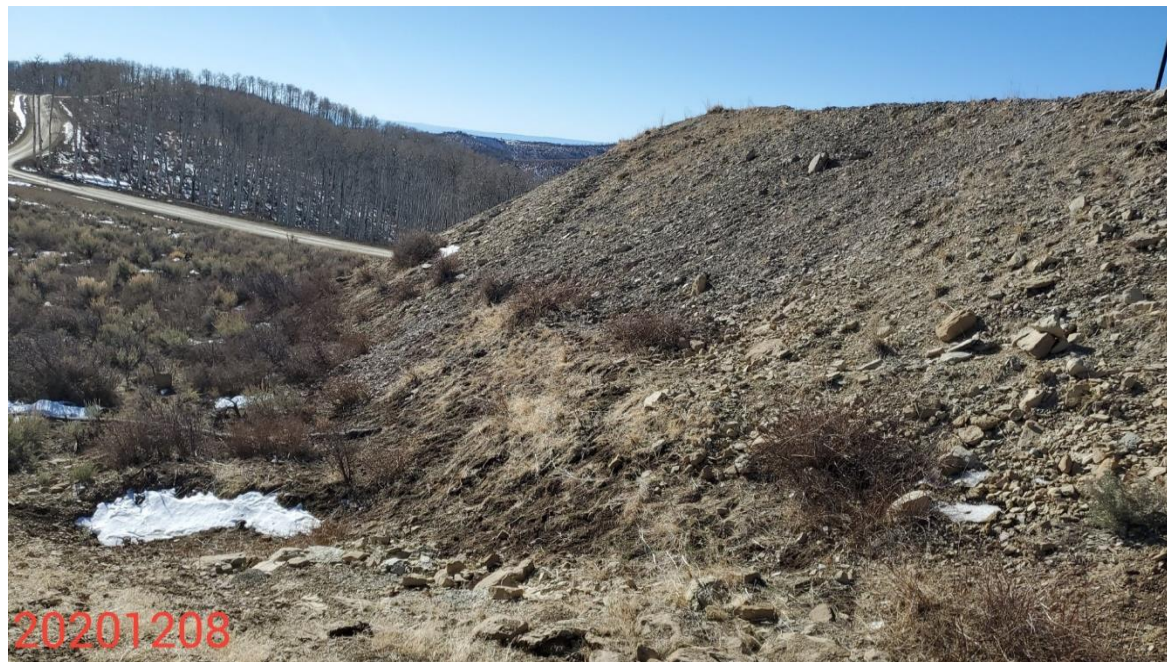
Photo 16: Photo taken from east end of the Location, facing south. Photo shows BMPs to stabilize/protect slopes, and prevent off-site sediment transport are missing, or insufficient

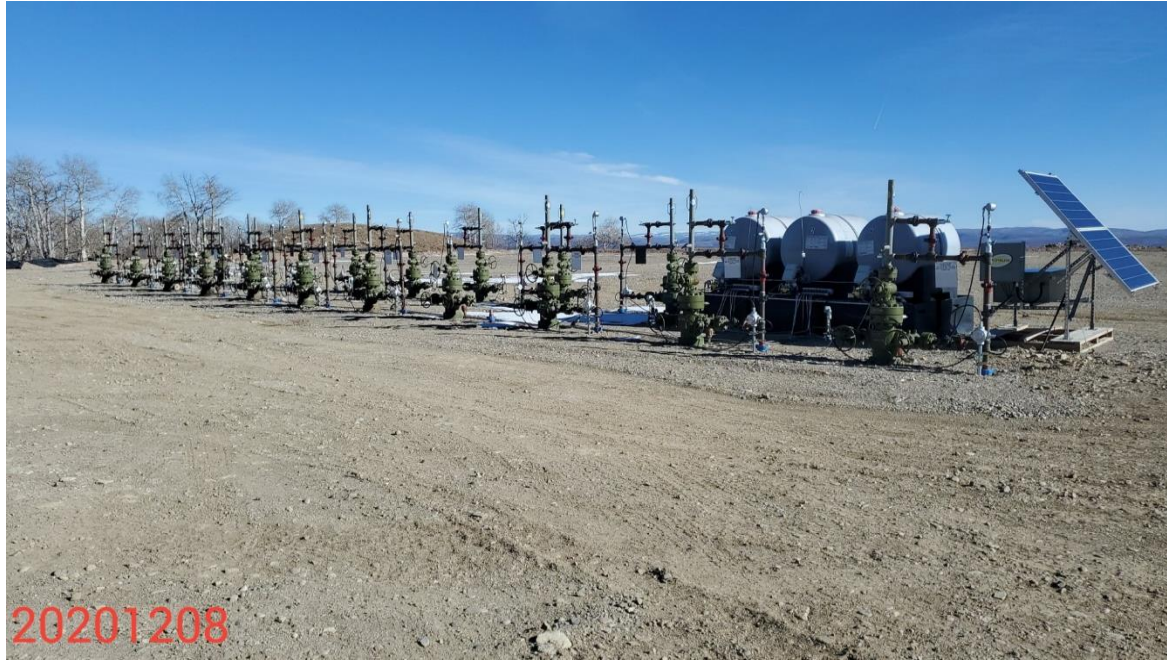
Photo 17: Photo shows active wells on the Location.
