Inspection Photos

Operator: LARAMIE ENERGY LLC - 10433

Location ID: 335902

COGCC

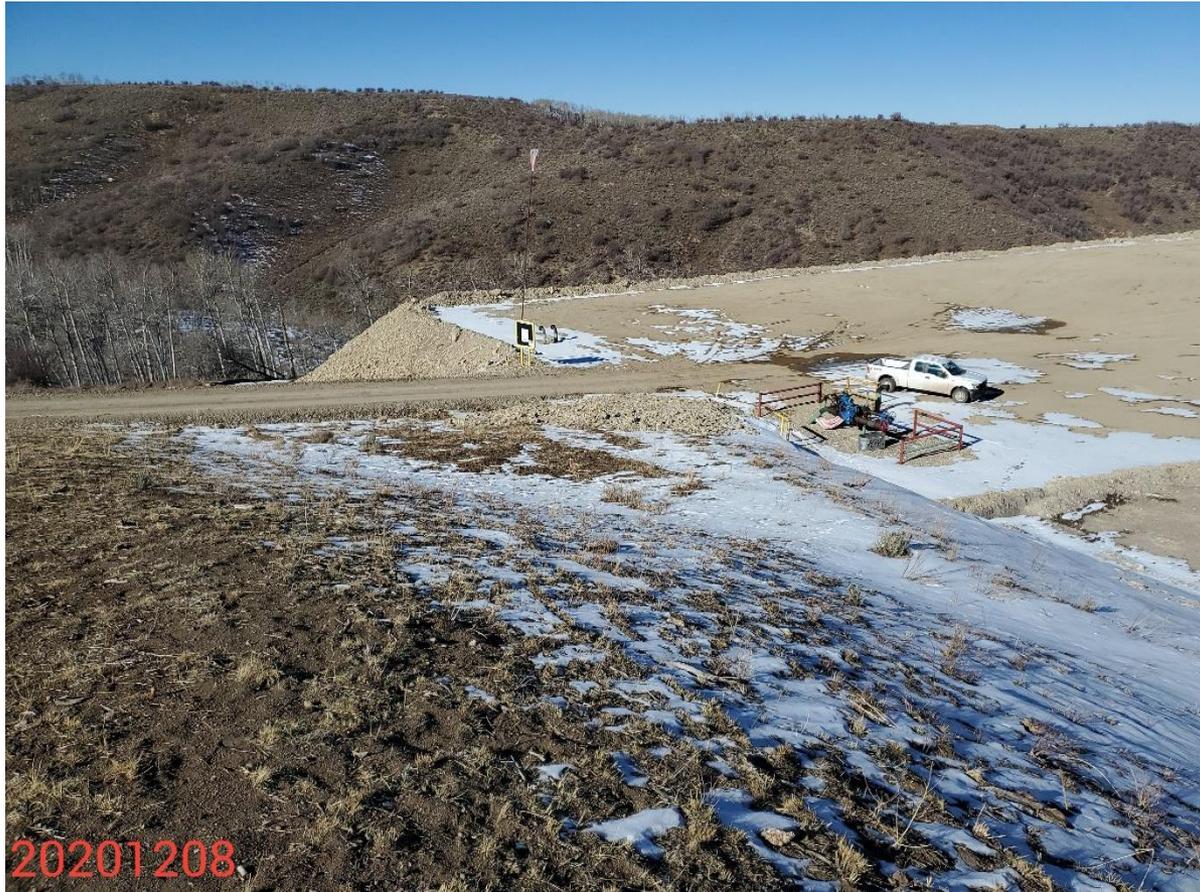
Photo 1: Photo taken from the south end of the Location, facing west. Photos 1-3 provide an overview of the Location from west, north, to east. Photos also show areas not reasonably needed for production on the Location have not been reclaimed.

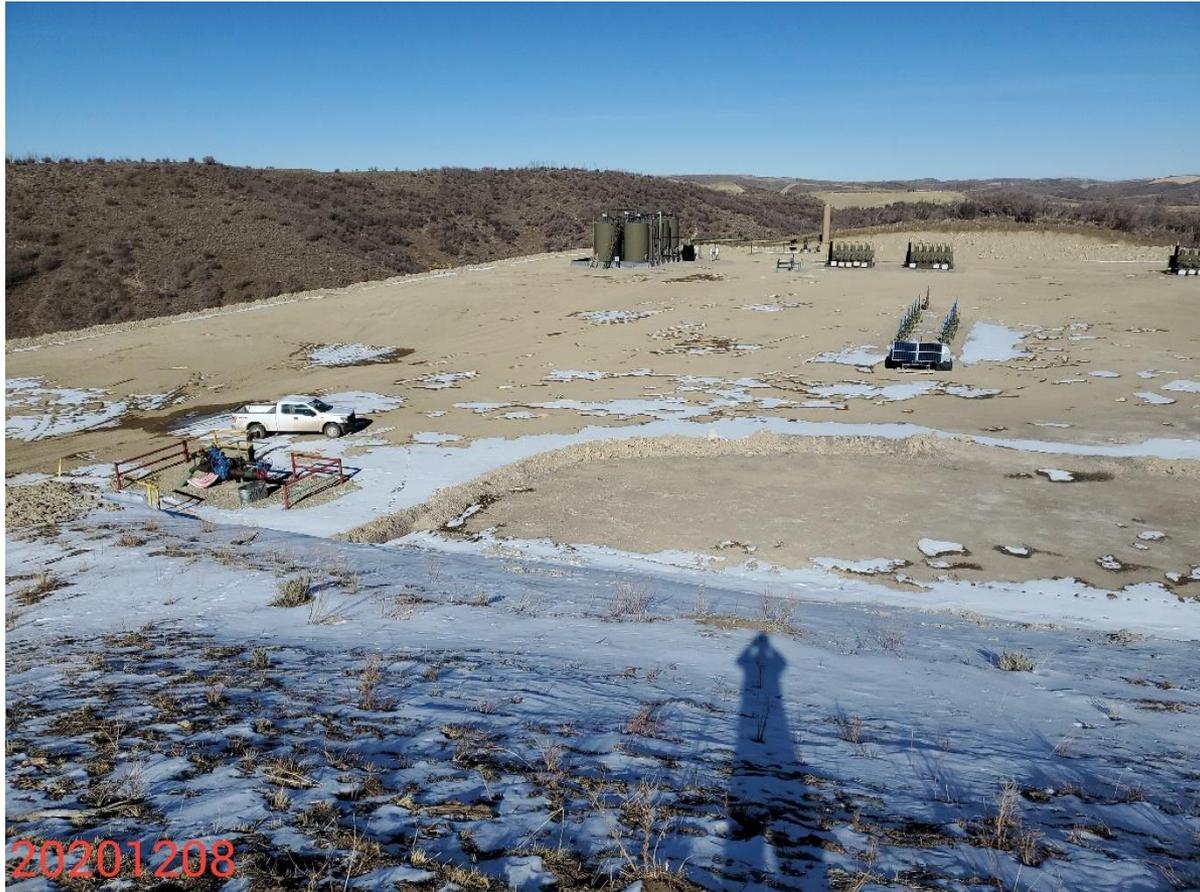
Photo 2: See comments under photo 1.

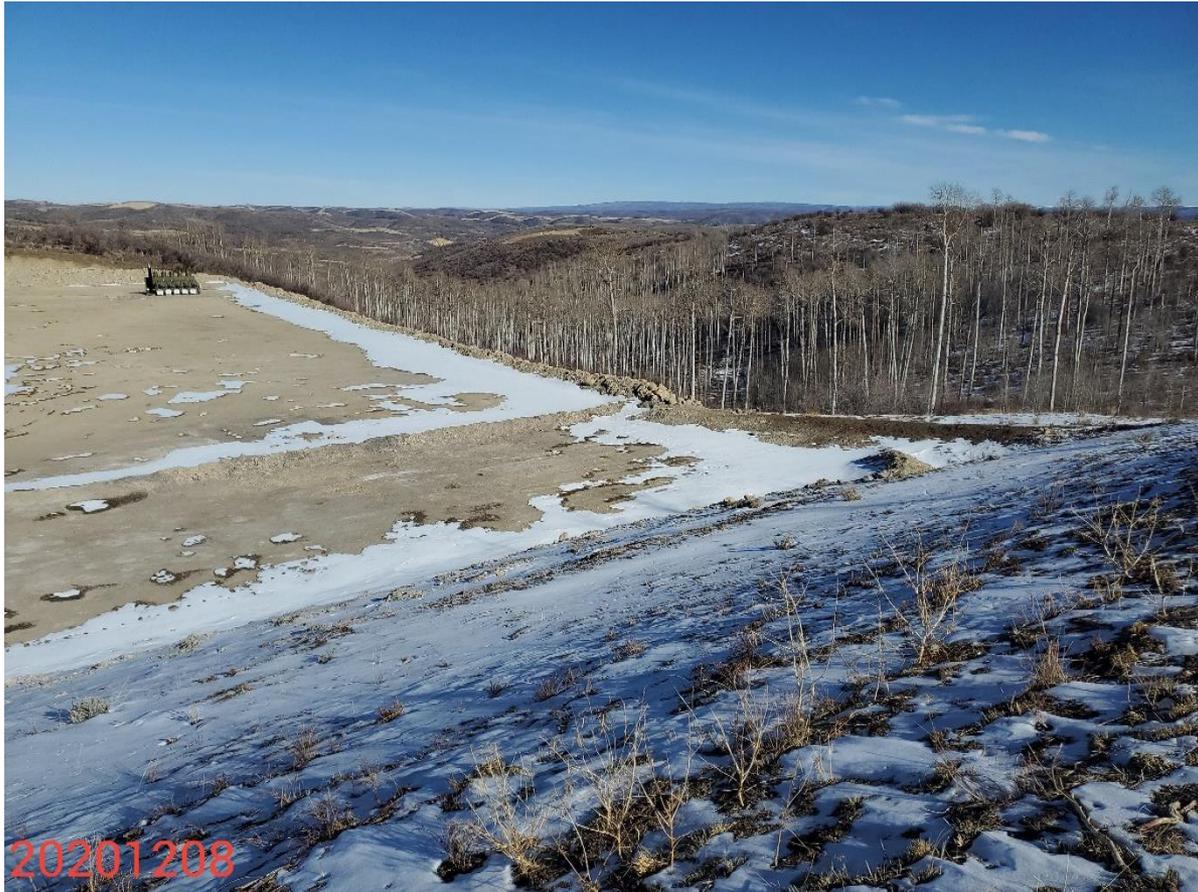
Photo 3: See comments under photo 1.

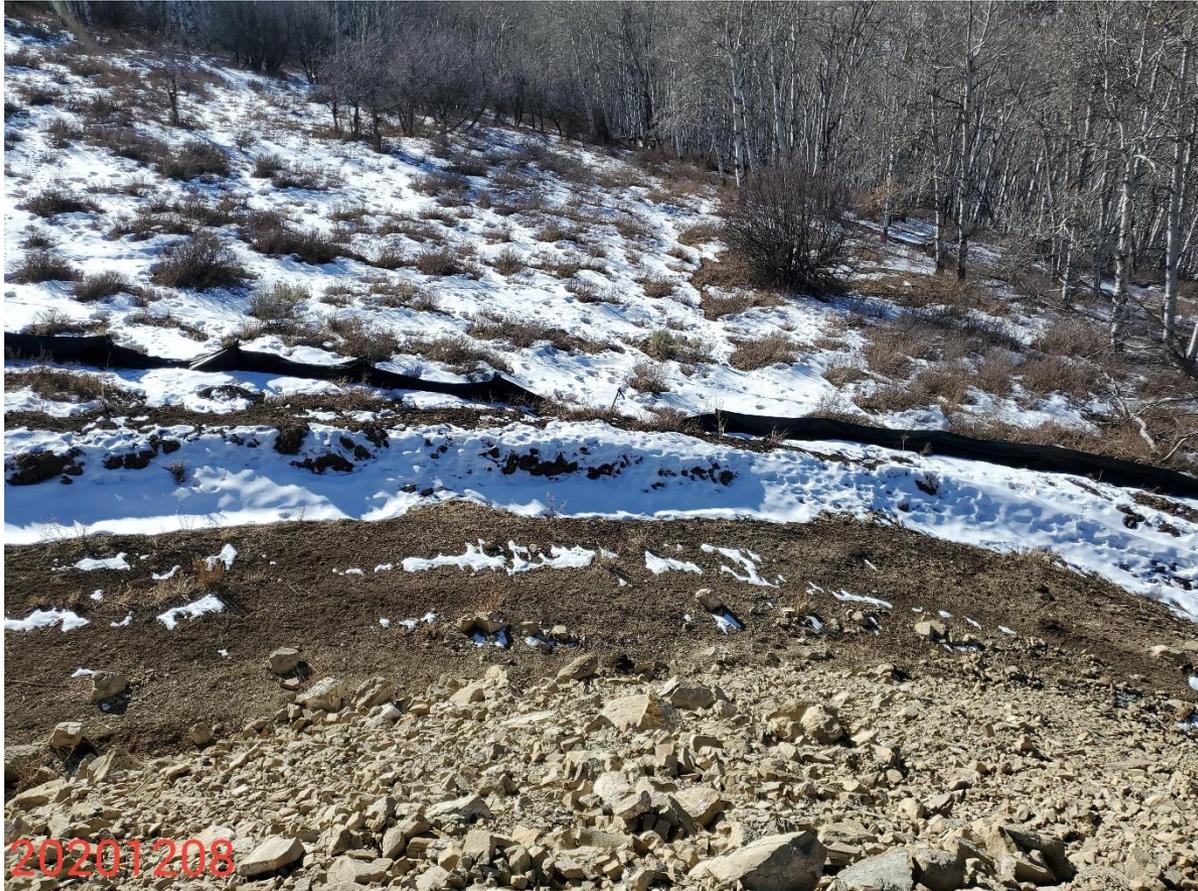
Photo 4: Photo taken from the southwest corner of the Location, facing southwest. Photo shows BMPs to stabilize/protect slopes, and prevent off-site sediment transport are missing, or insufficient.

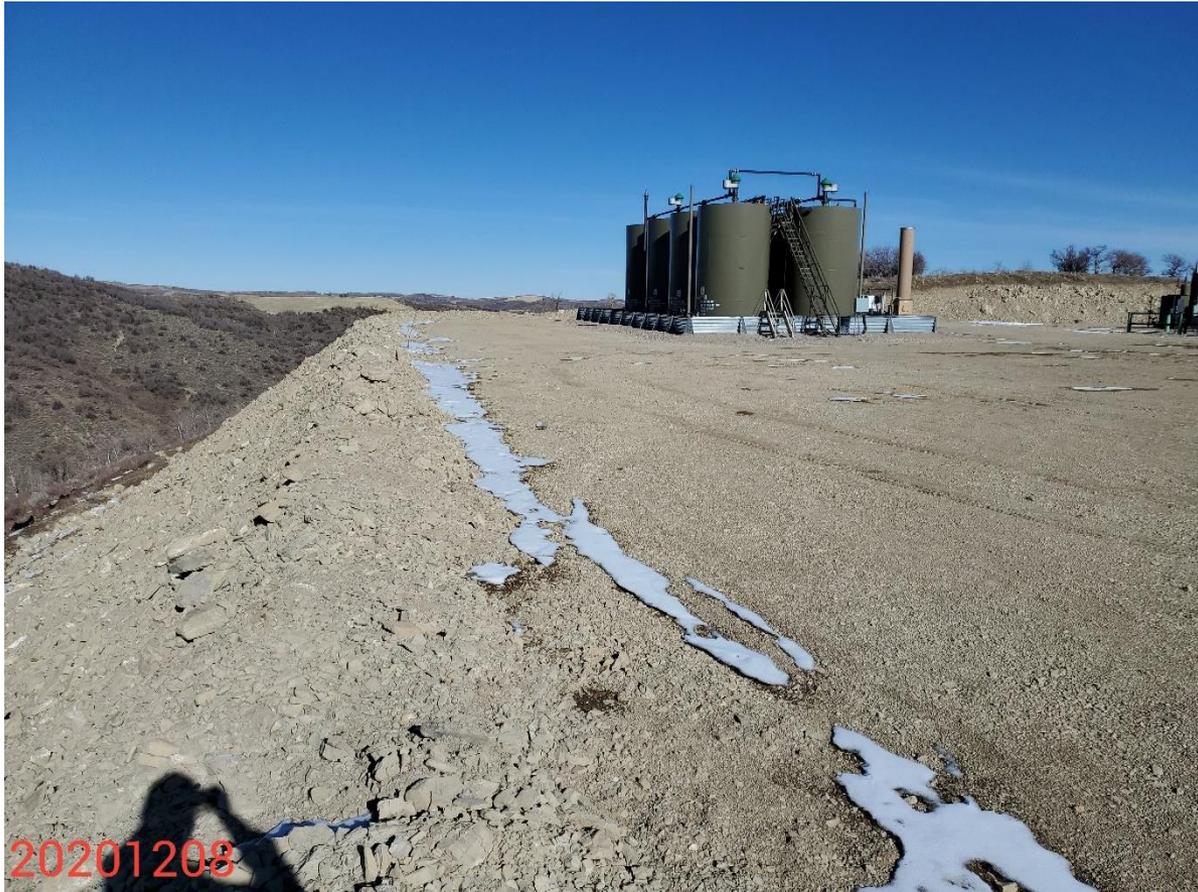
Photo 5: Photo taken from the west end of the Location, facing north. Photos 5-8 provide an overview of the Location from north, northeast, southeast to south. Photos also show areas not reasonably needed for production on the Location have not been reclaimed.

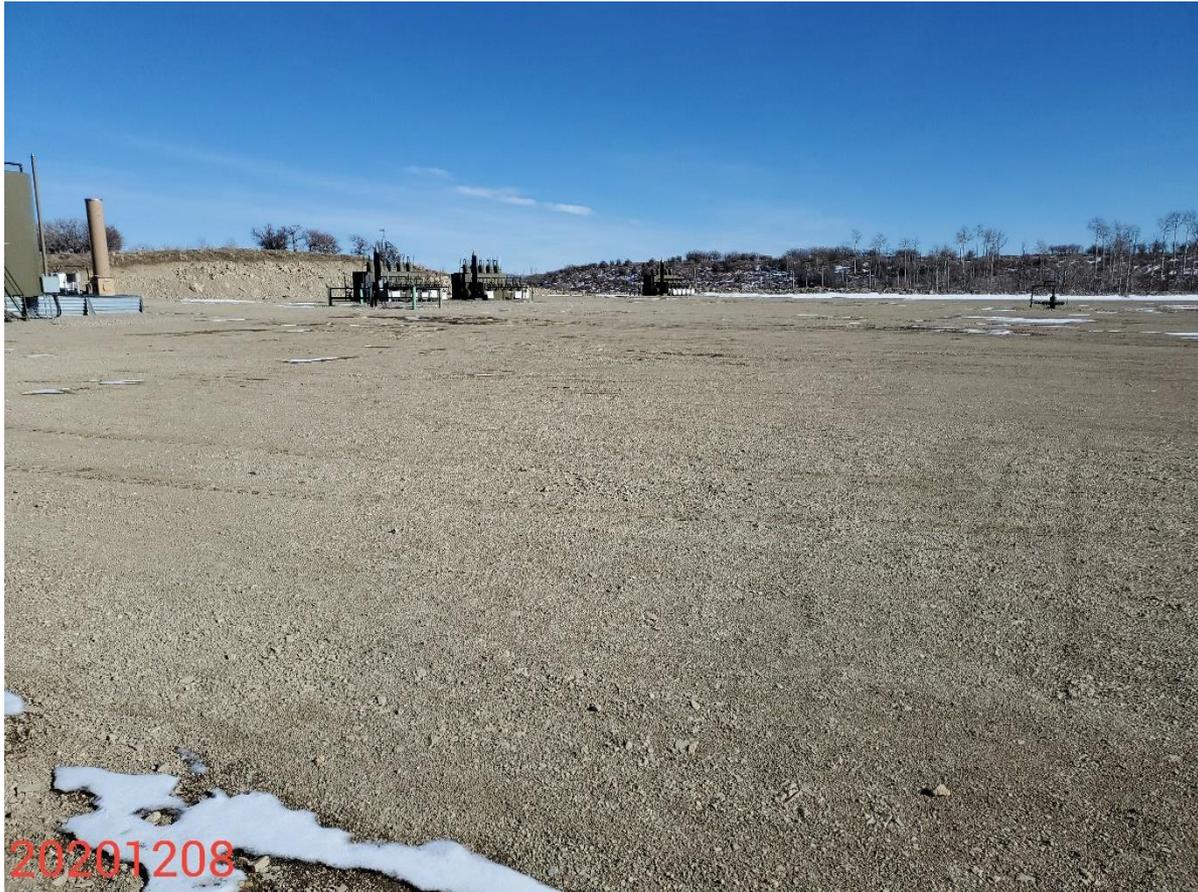
Photo 6: See comments under photo 5.

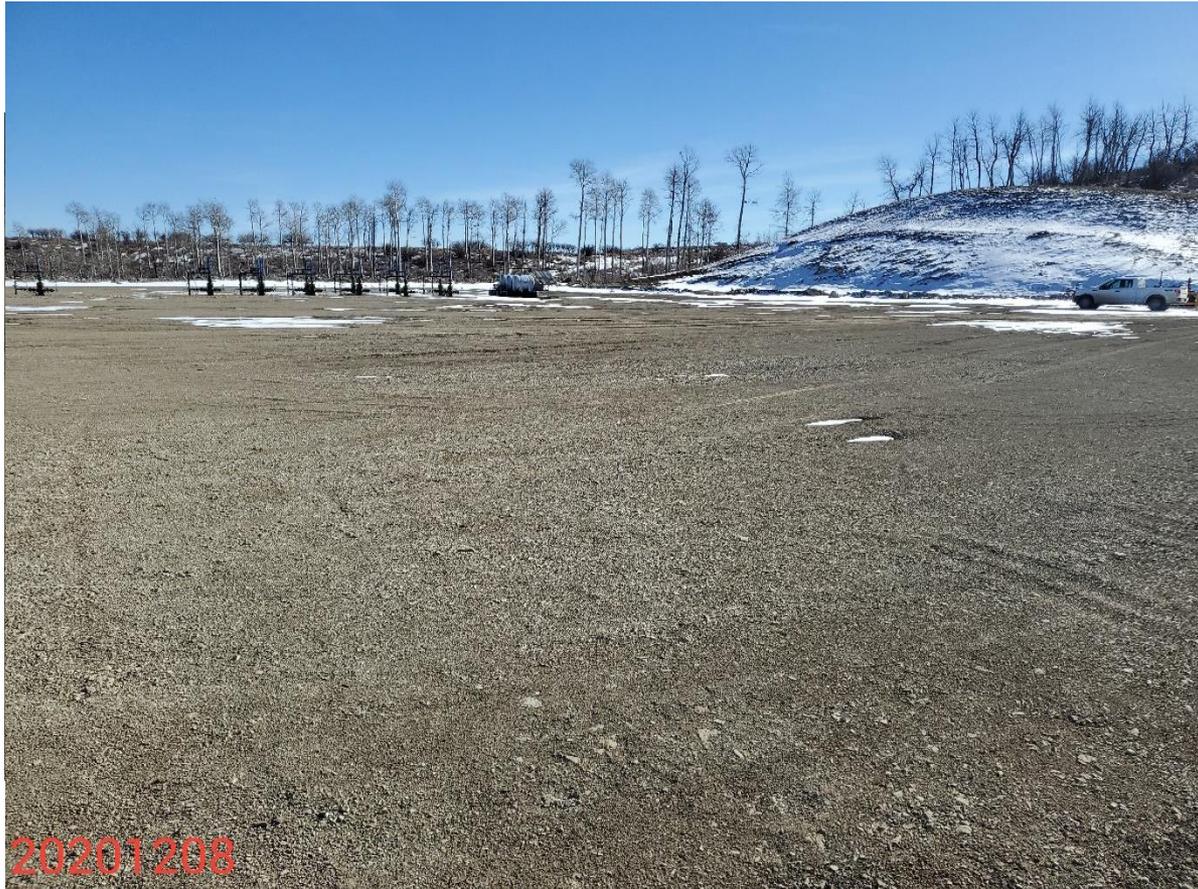
Photo 7: See comments under photo 5.

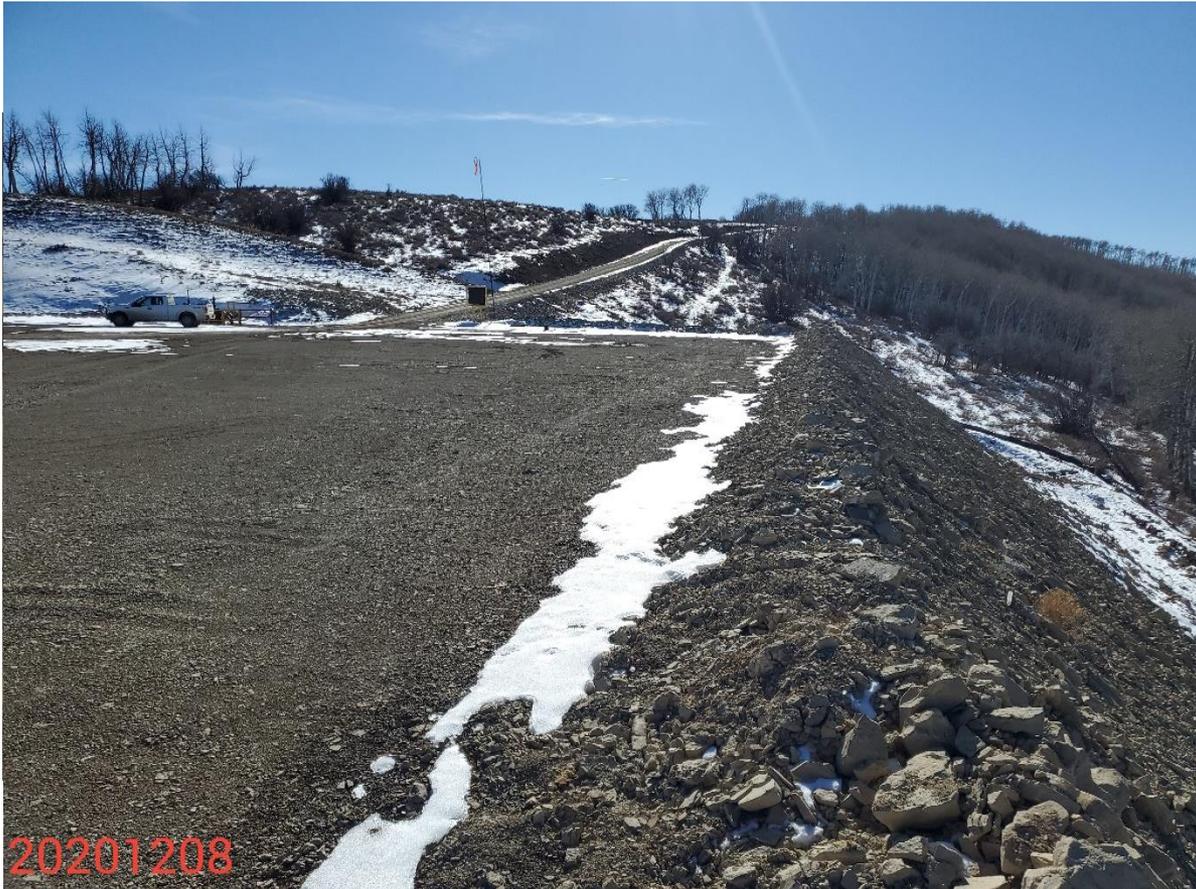
Photo 8: See comments under photo 5.

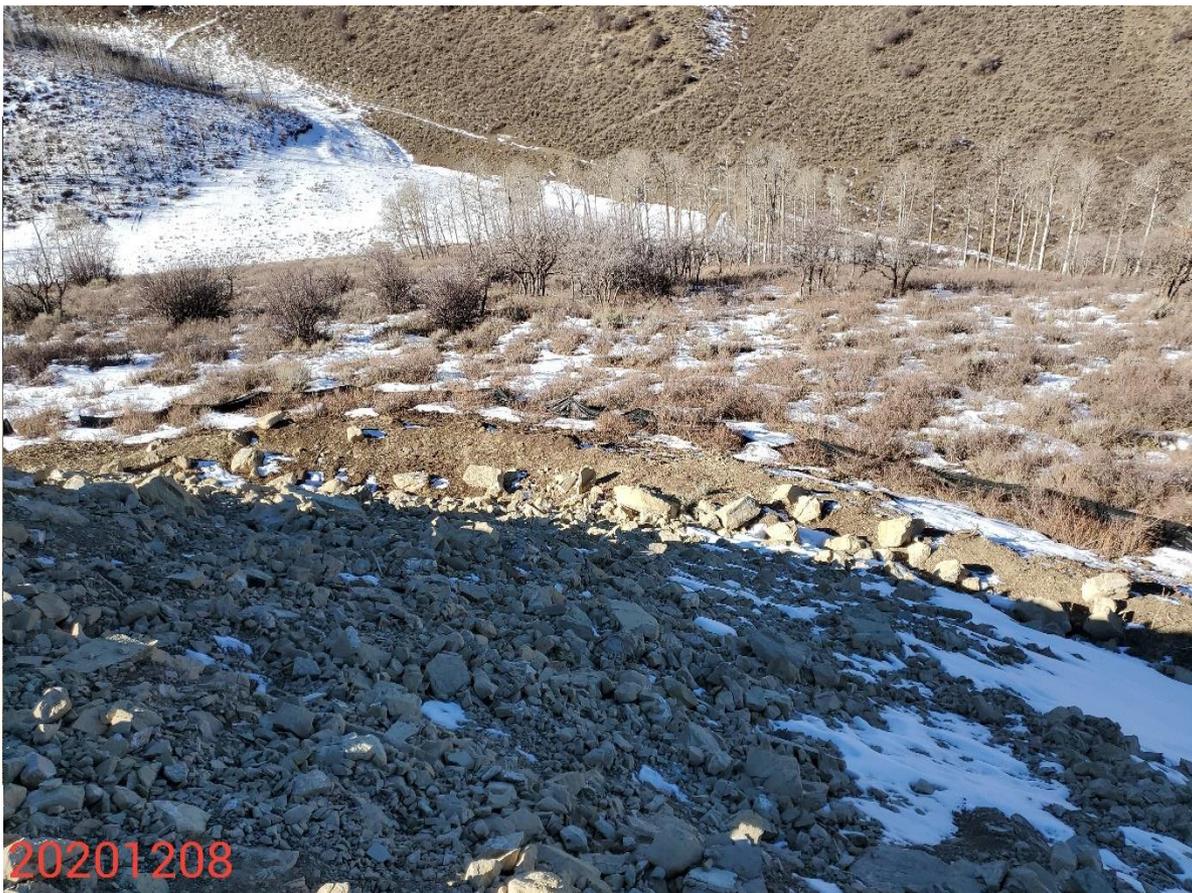
Photo 9: Photo taken from the northwest corner of the Location, facing northwest. Photo shows BMPs to stabilize/protect slopes, and prevent off-site sediment transport are missing, or insufficient.

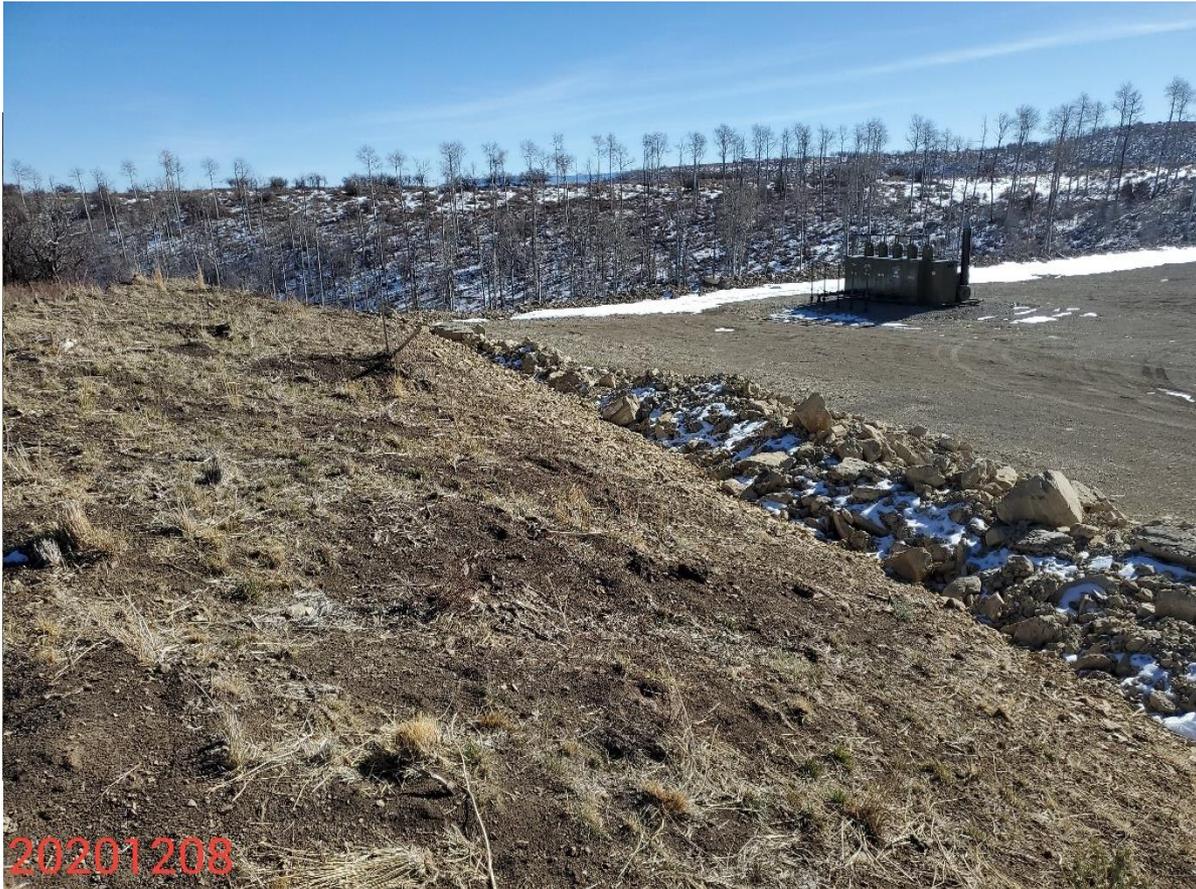
Photo 10: Photo taken from the north end of the Location, facing east. Photos 10-13 provide an overview of the Location from east, southeast, southwest to west. Photos also show areas not reasonably needed for production on the Location have not been reclaimed. Photos also show cuttings on Location.

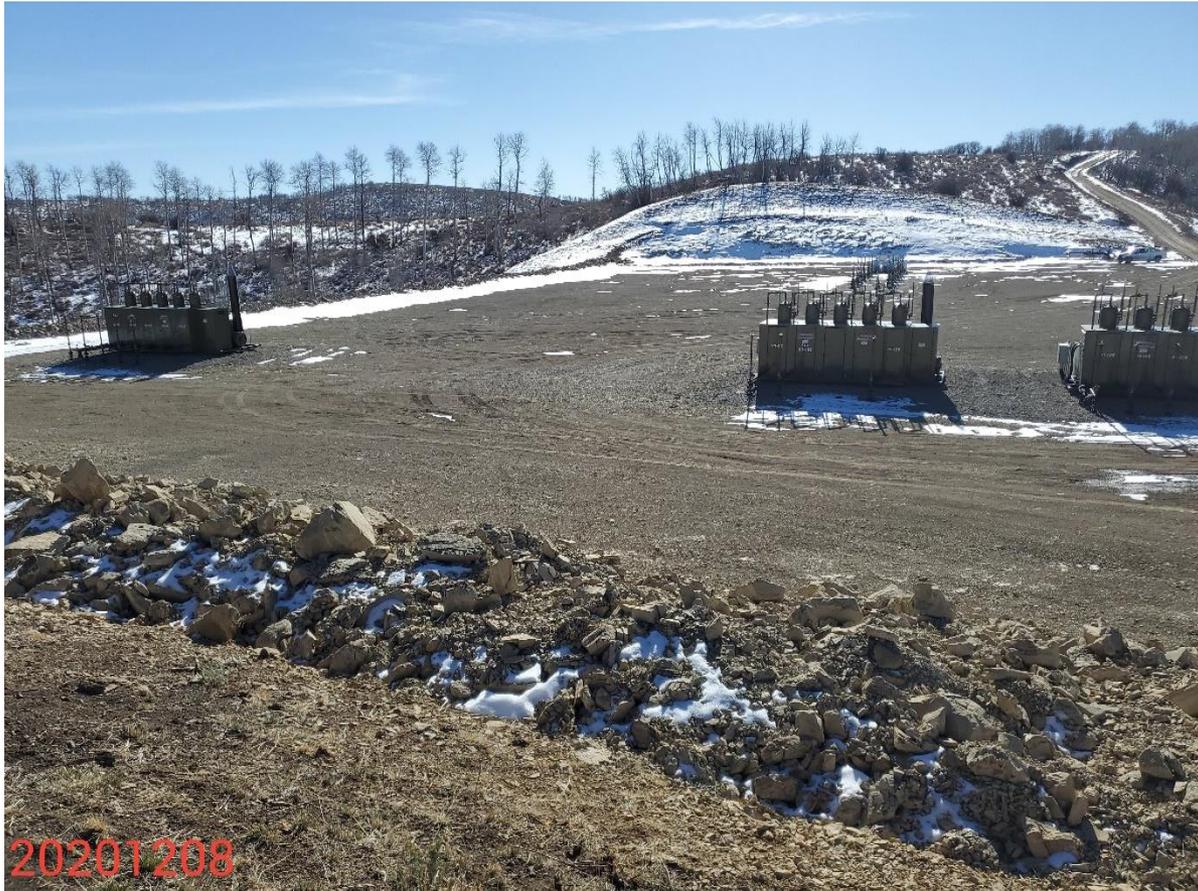
Photo 11: See comments under photo 10.

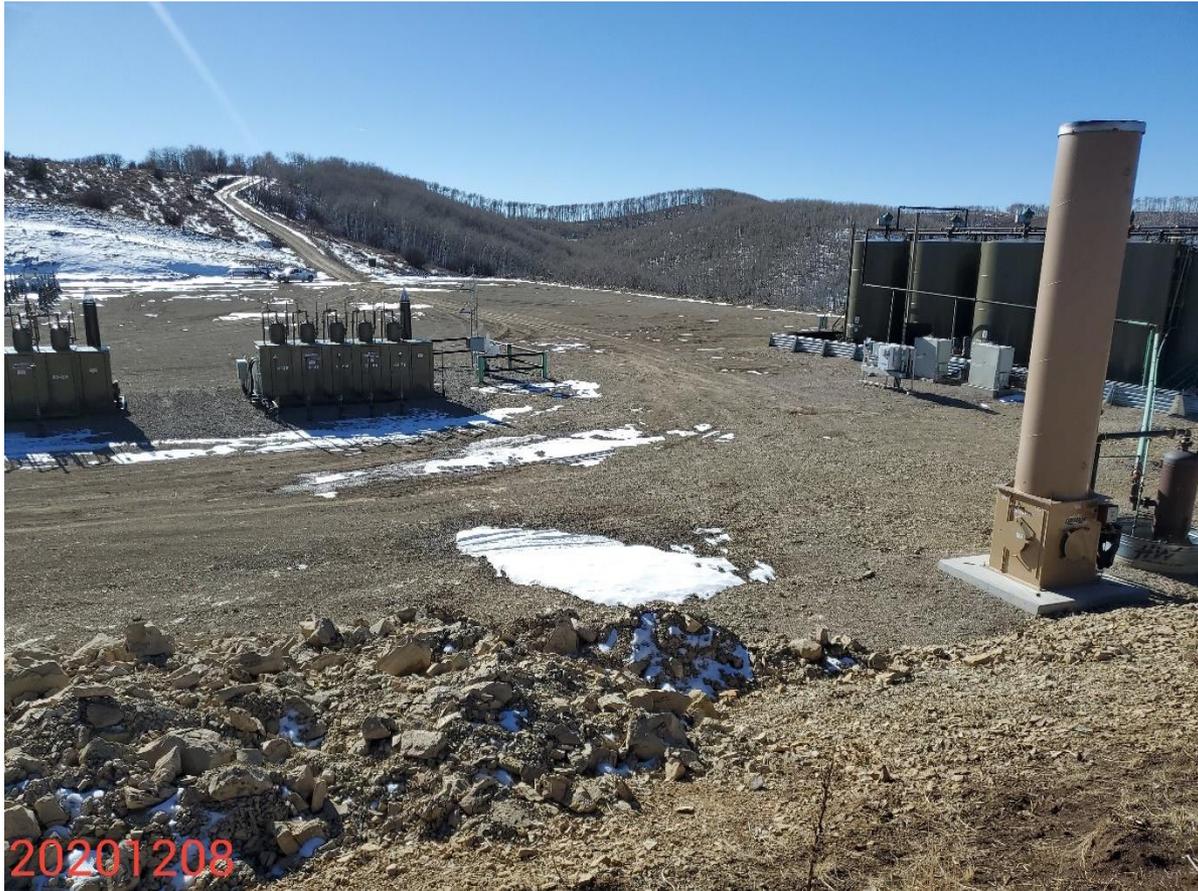
Photo 12: See comments under photo 10.

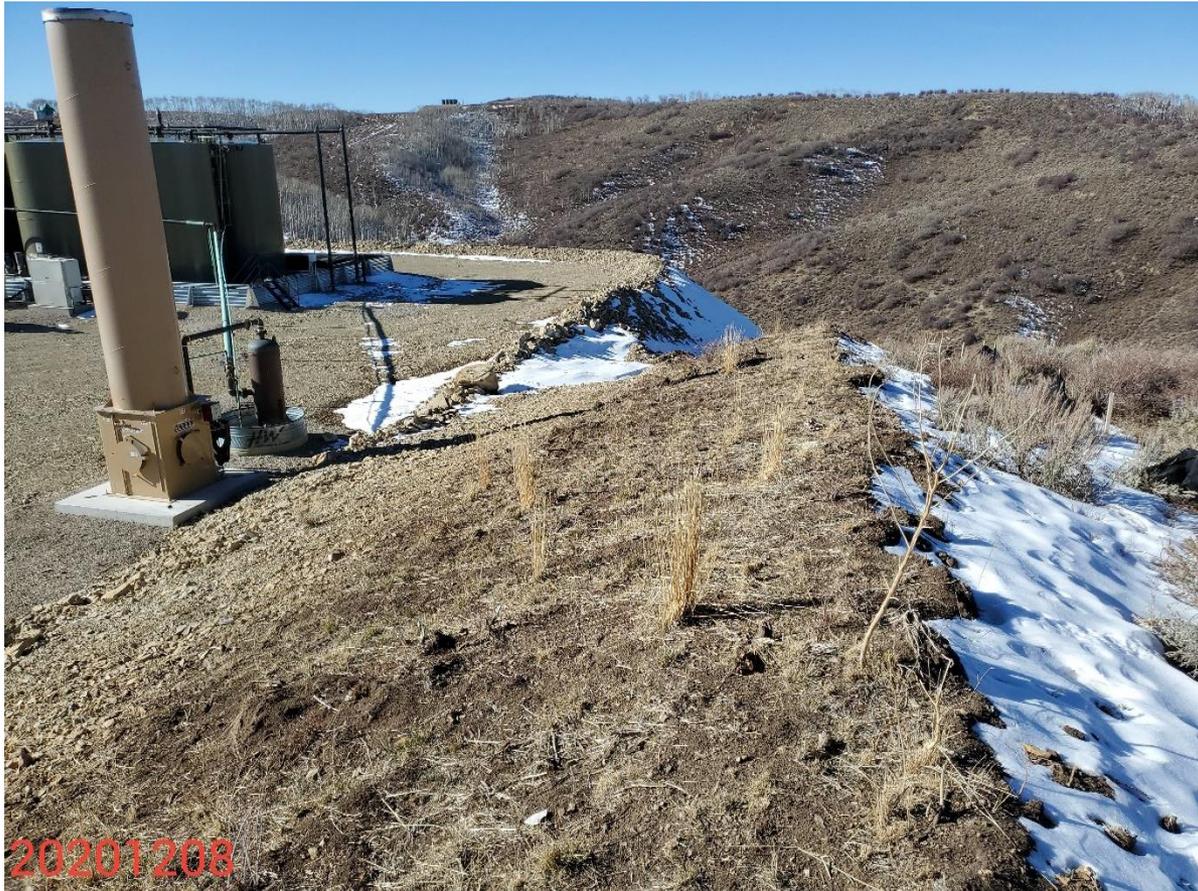
Photo 13: See comments under photo 10.

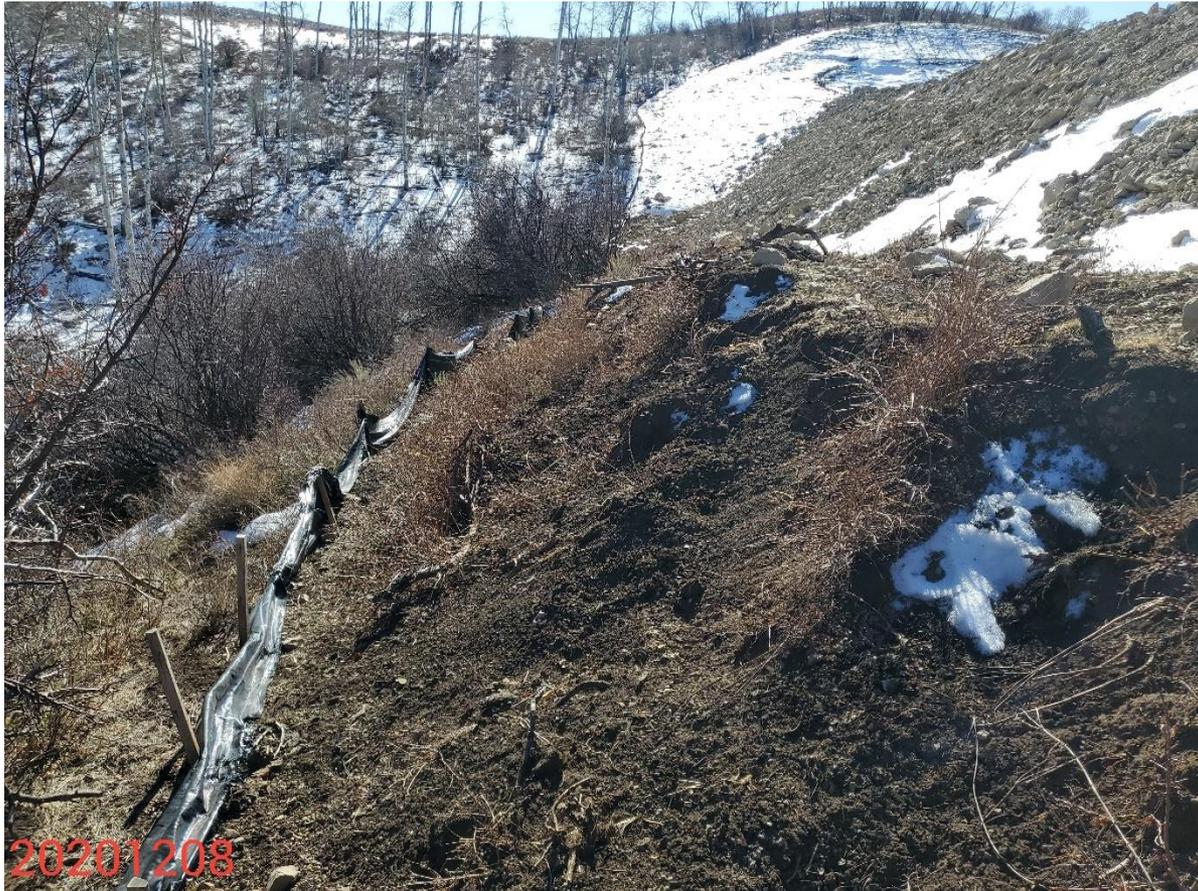
Photo 14: Photo taken from the east end of the Location, facing south. Photo shows BMPs to stabilize/protect slopes, and prevent off-site sediment transport are missing, or insufficient.

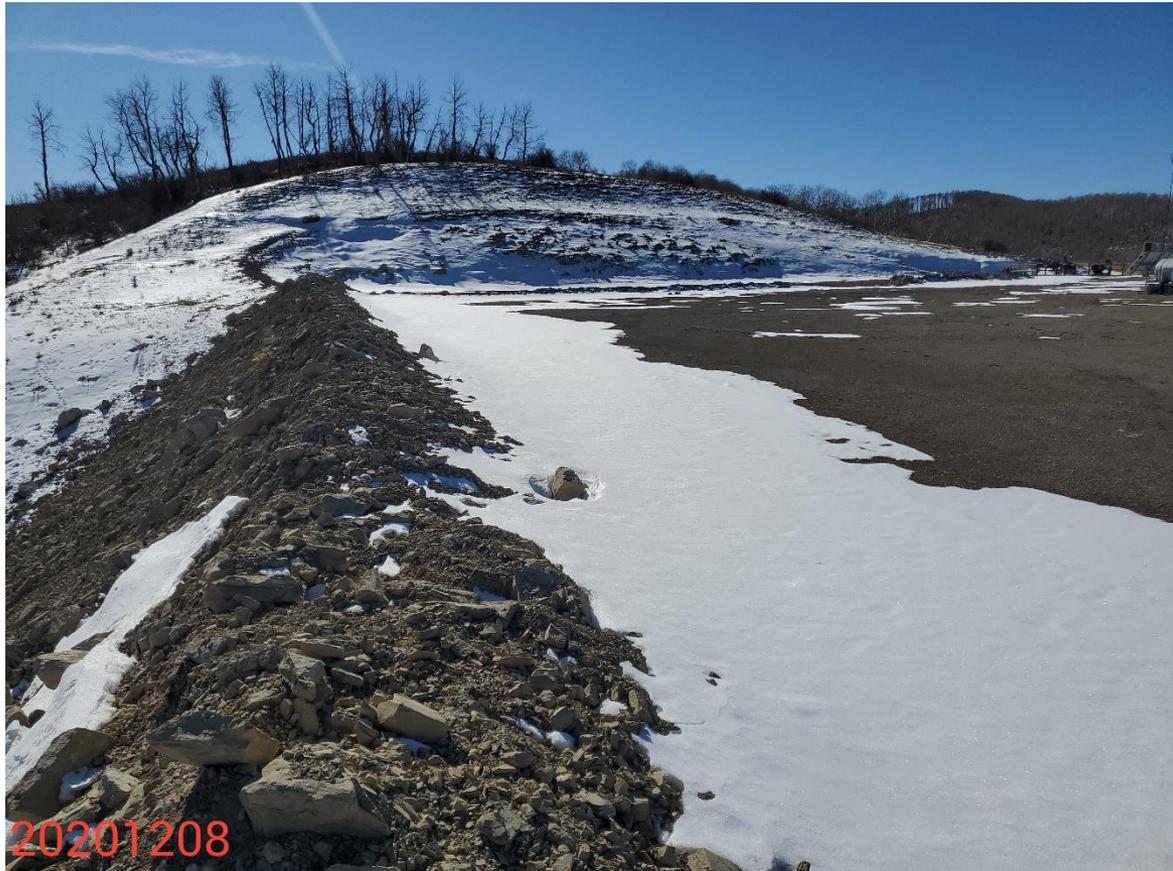
Photo 15: Photo taken from the east end of the Location, facing south. Photos 15-18 provide an overview of the Location from south, southwest, northwest to north. Photos also show areas not reasonably needed for production on the Location have not been reclaimed.

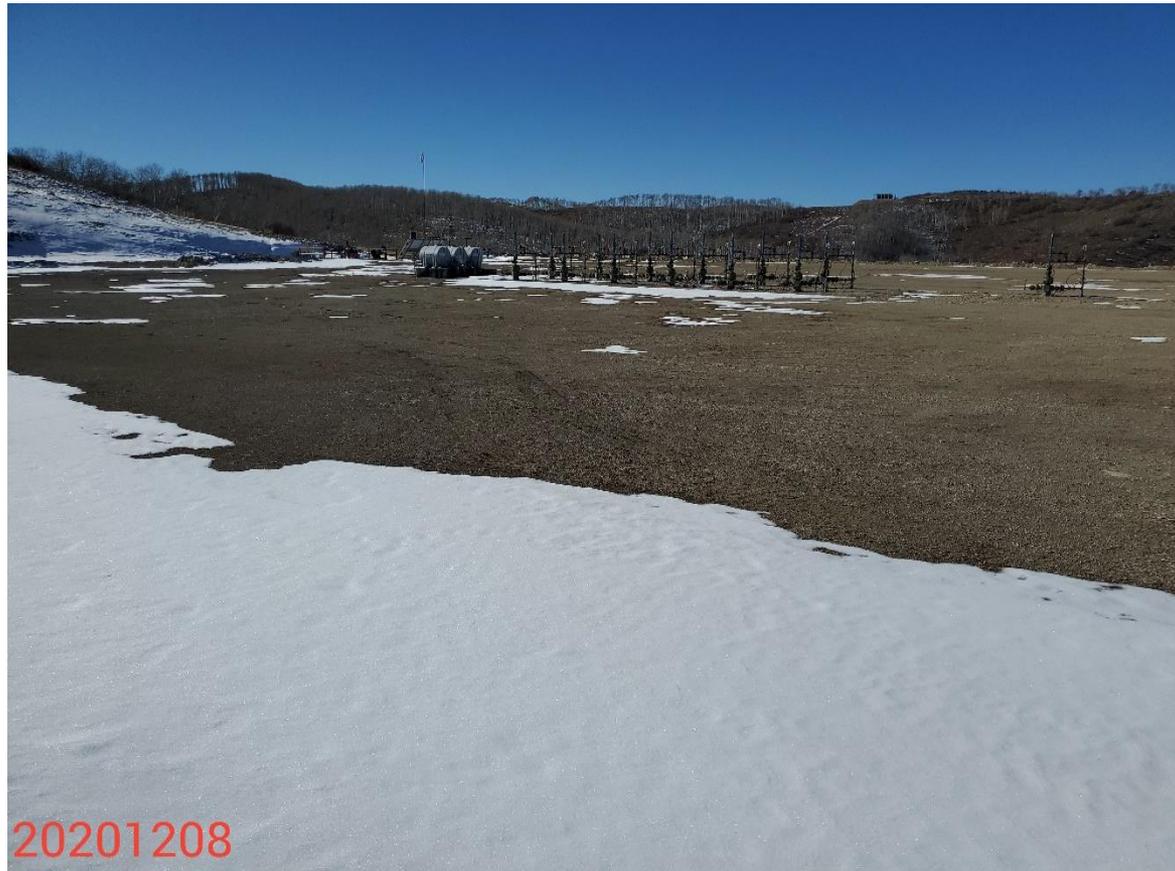
Photo 16: See comments under photo 15.

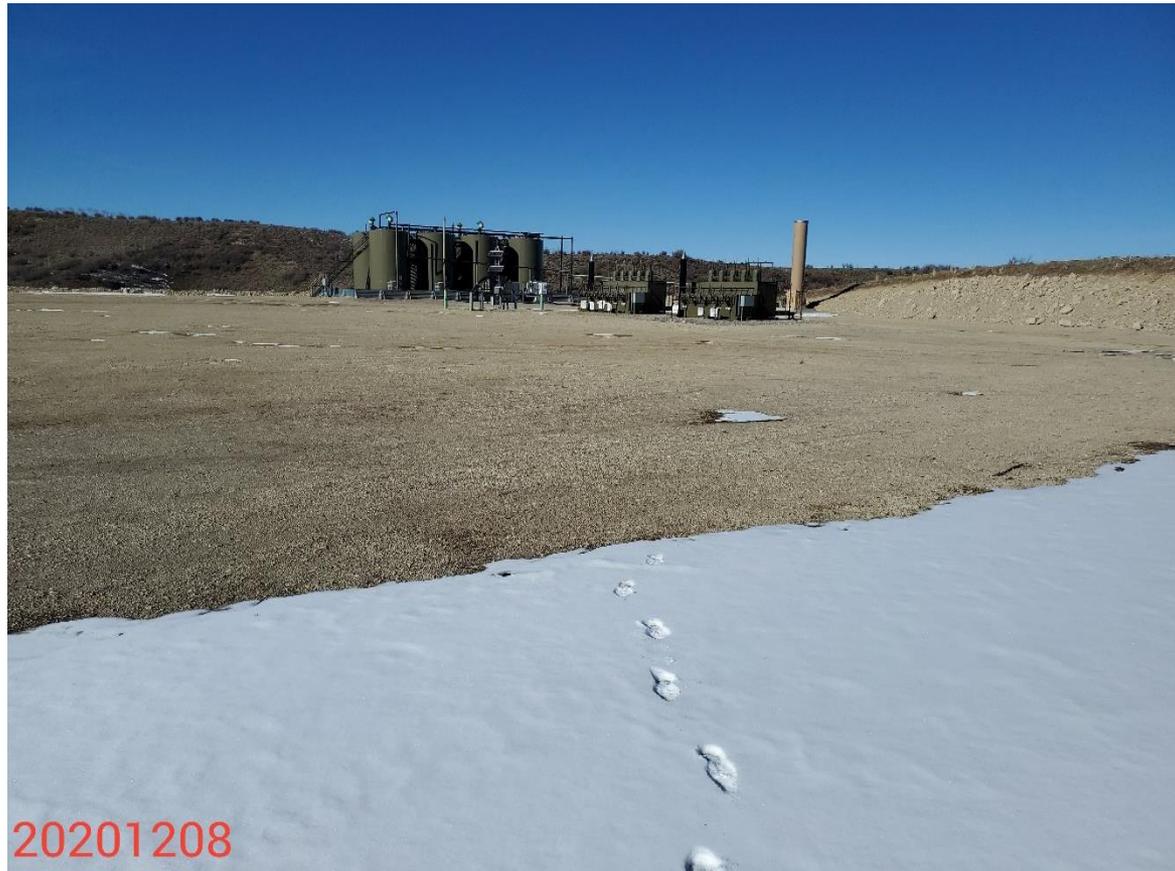
Photo 17: See comments under photo 15.

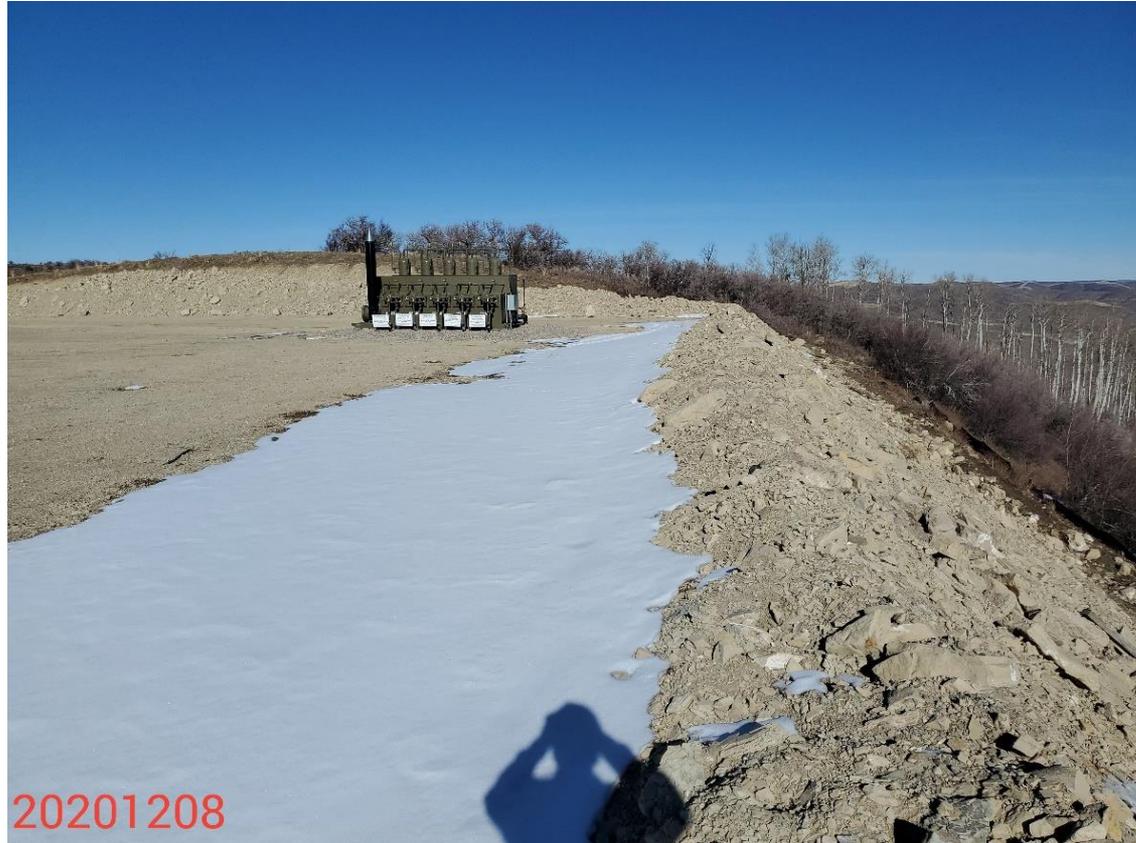
Photo 18: See comments under photo 15.

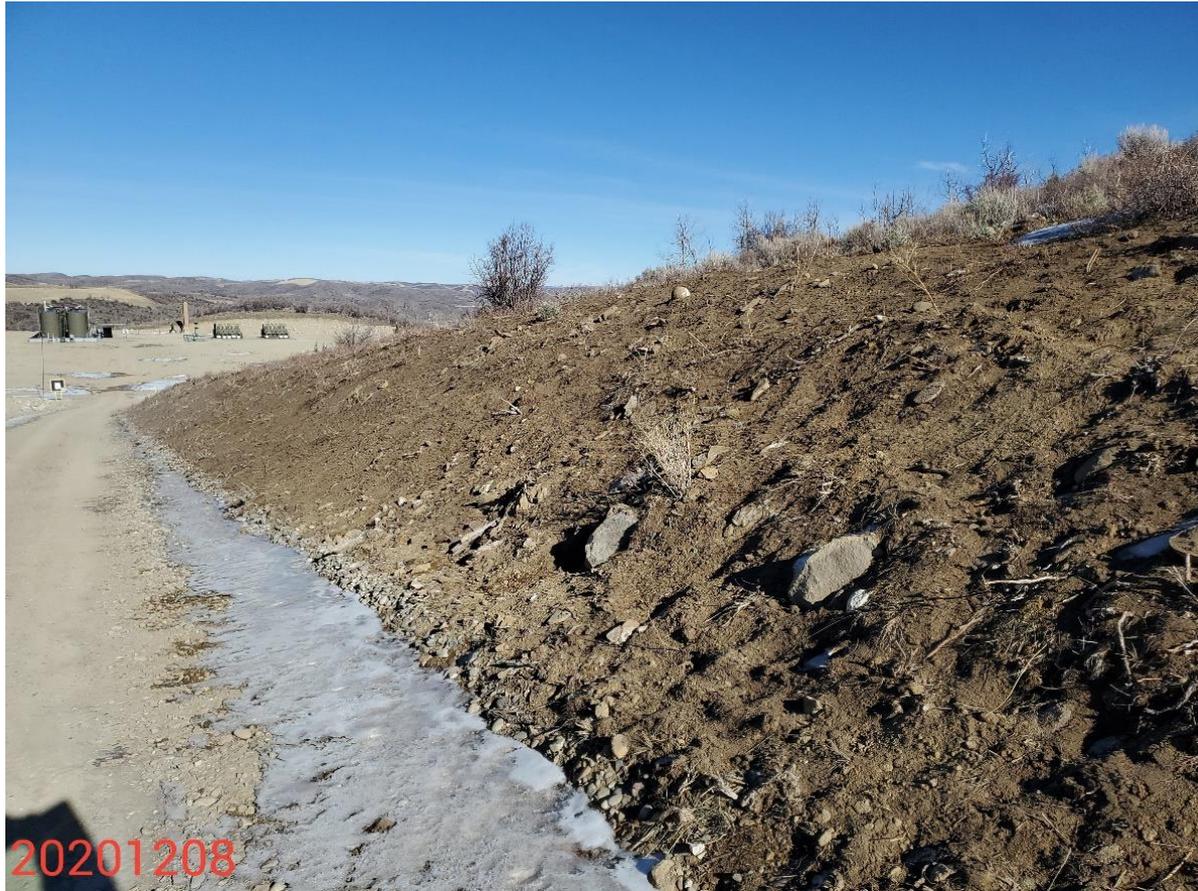
Photo 19: Photo taken from the access road, facing northeast. Photo shows BMPs to stabilize/protect slopes of access road are missing, or insufficient. Slopes predominantly bare/exposed soils, revegetation activities required.
