Inspection Photos

12/8/2020

Operator: LARAMIE ENERGY LLC - 10433

Location ID: 335815

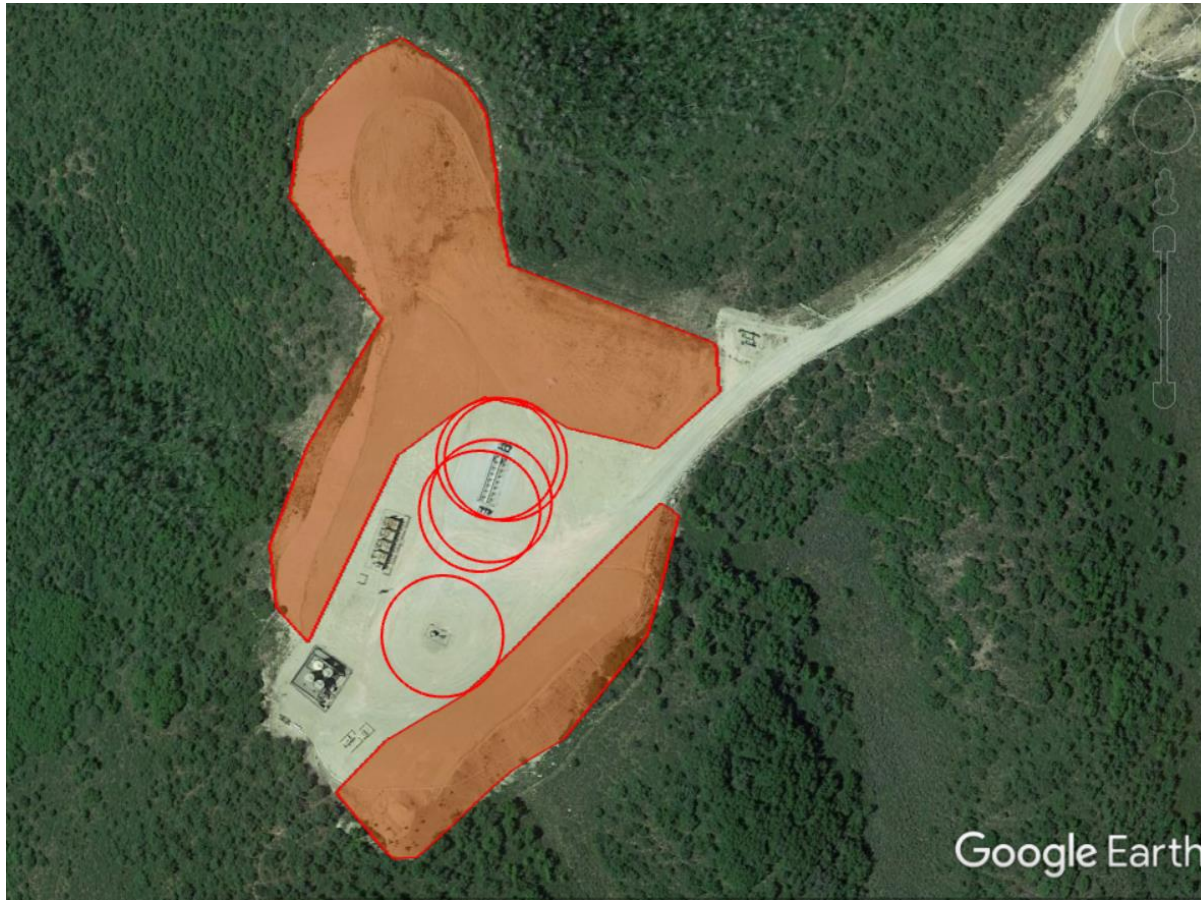
Photo 1: Google Earth aerial imagery. Photo shows areas not reasonably needed for production on the south, southeast north, northwest and western areas of the Location have not been reclaimed. Red circles represent a 75 foot buffer around the drilled wells on the Location.

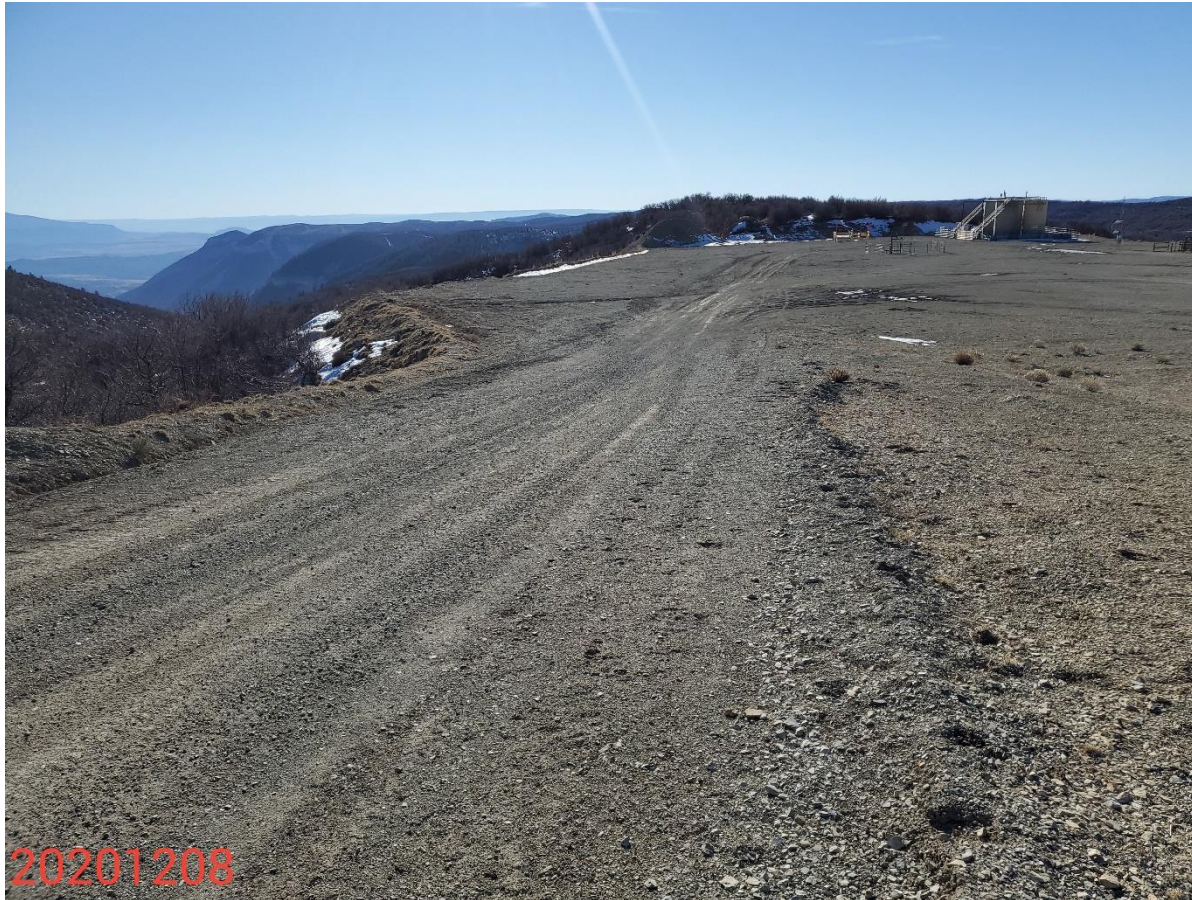
Photo 2: Photo taken from the northeast end of the Location, facing south. Photos 2-4 provide an overview of the Location from south, southwest to west. Photos also show areas not reasonably needed for production on the Location have not been reclaimed.

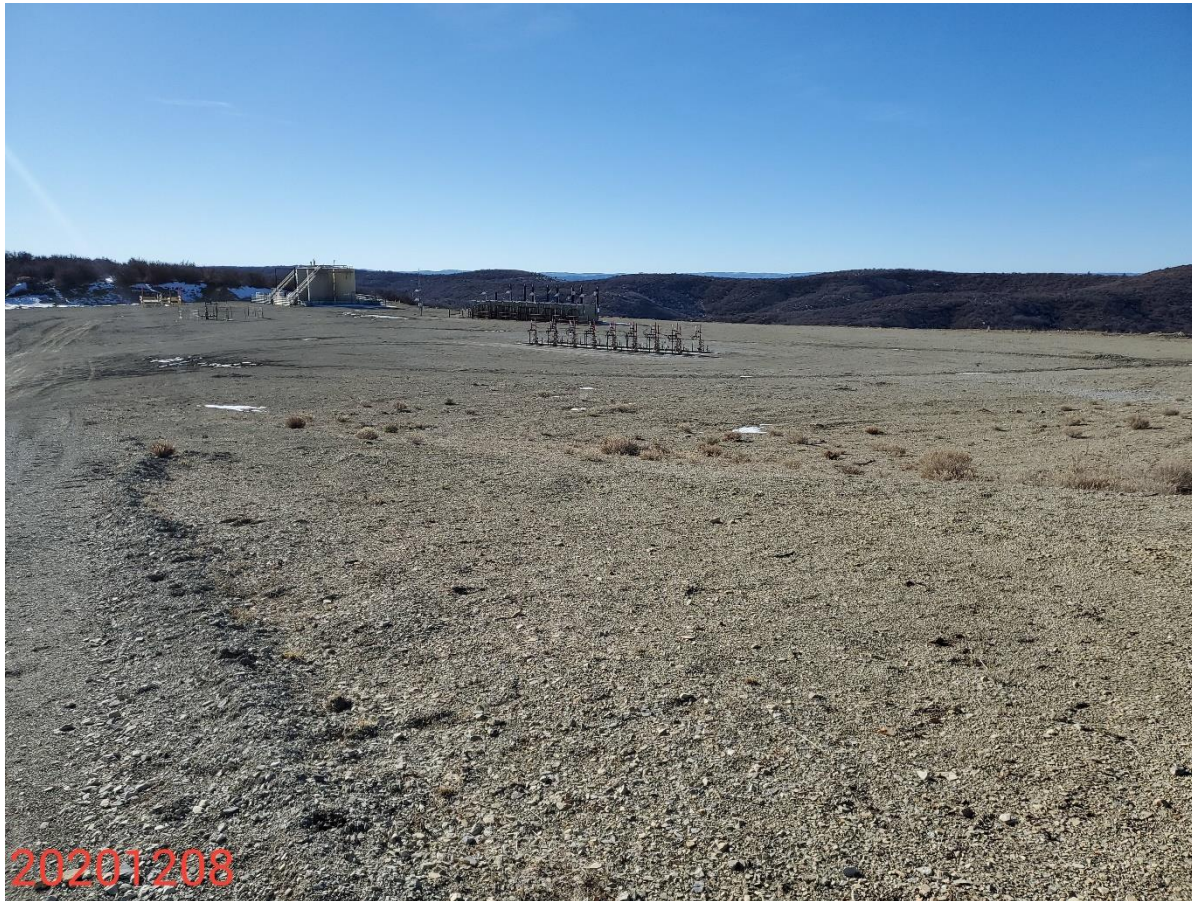
Photo 3: See comments under photo 2.

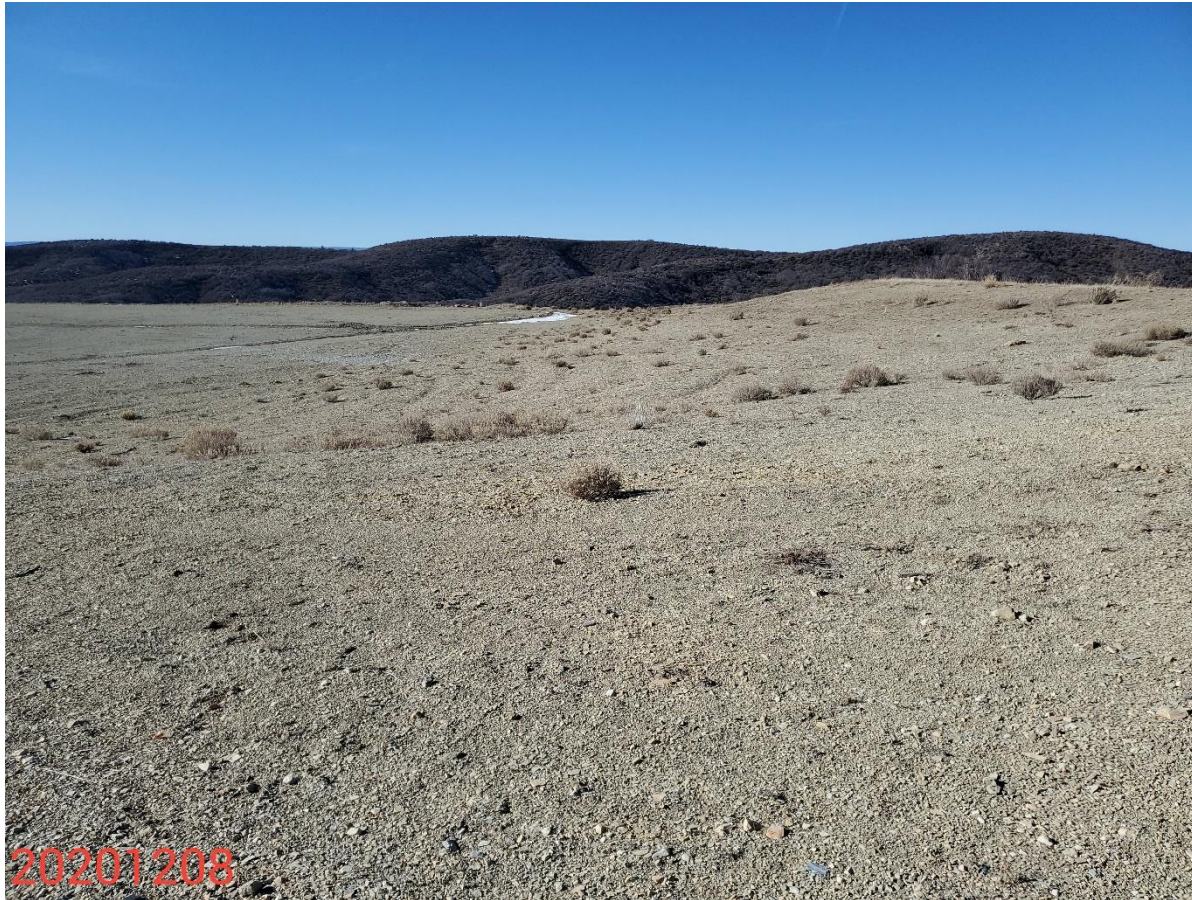
Photo 4: See comments under photo 2.

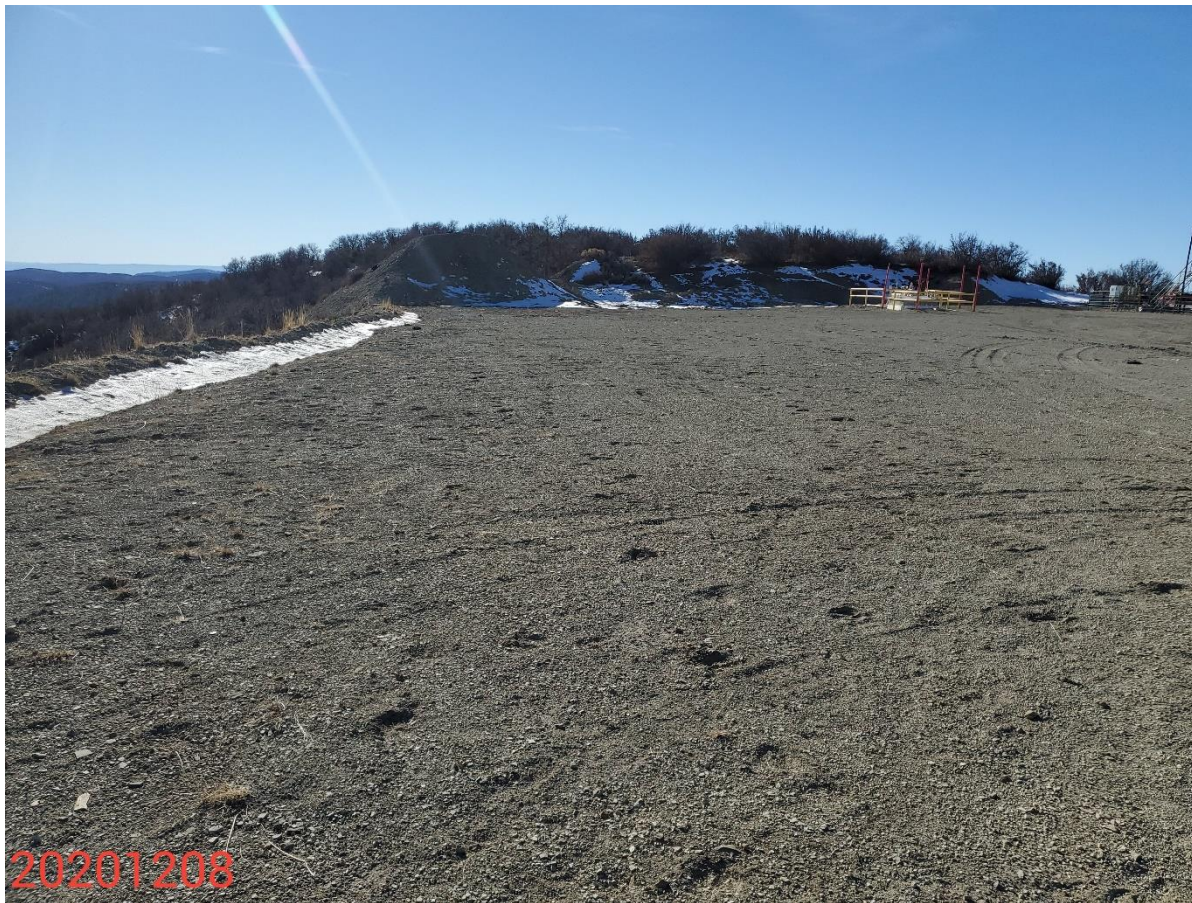
Photo 5: Photo taken from the east end of the Location, facing south. Photos 5-8 provide an overview of the Location from south, southwest northwest to north. Photos also show areas not reasonably needed for production on the Location have not been reclaimed.

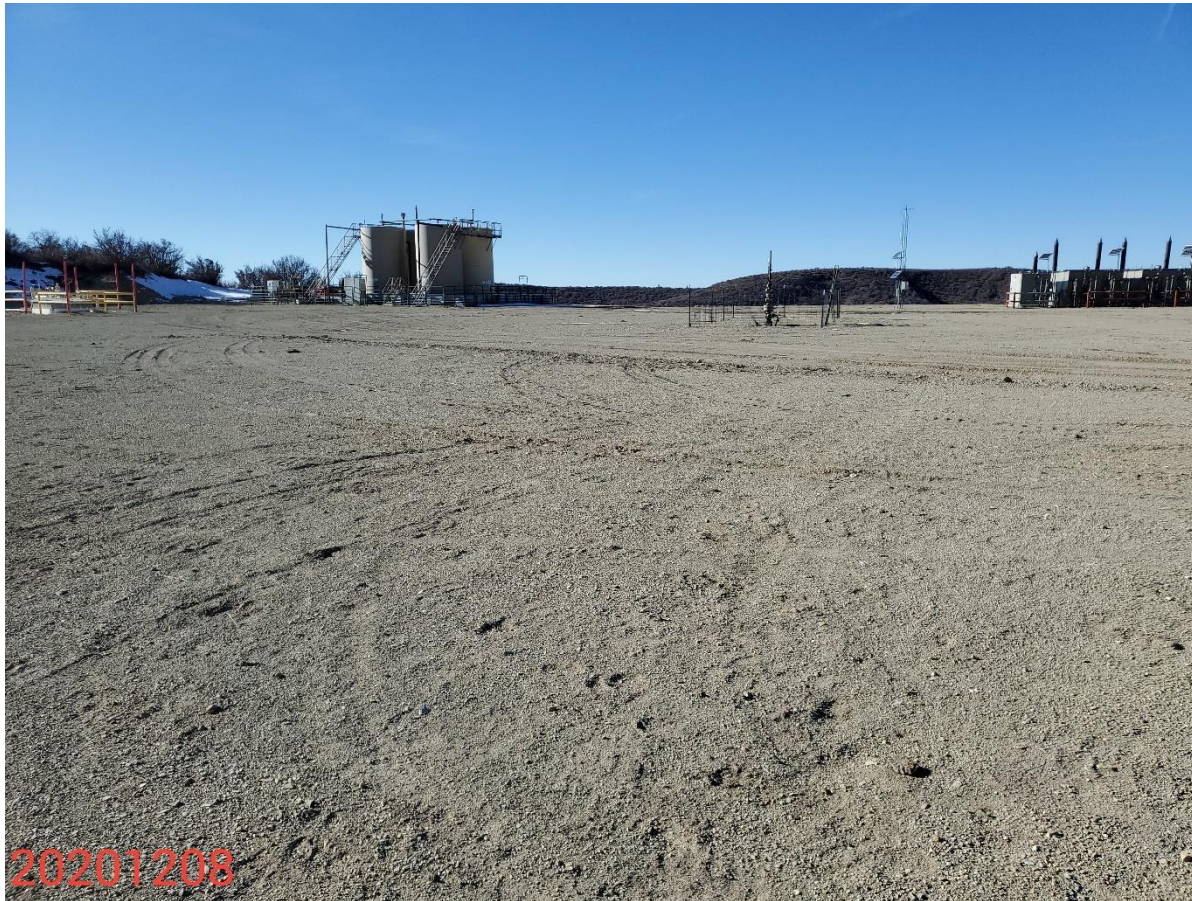
Photo 6: See comments under photo 5.

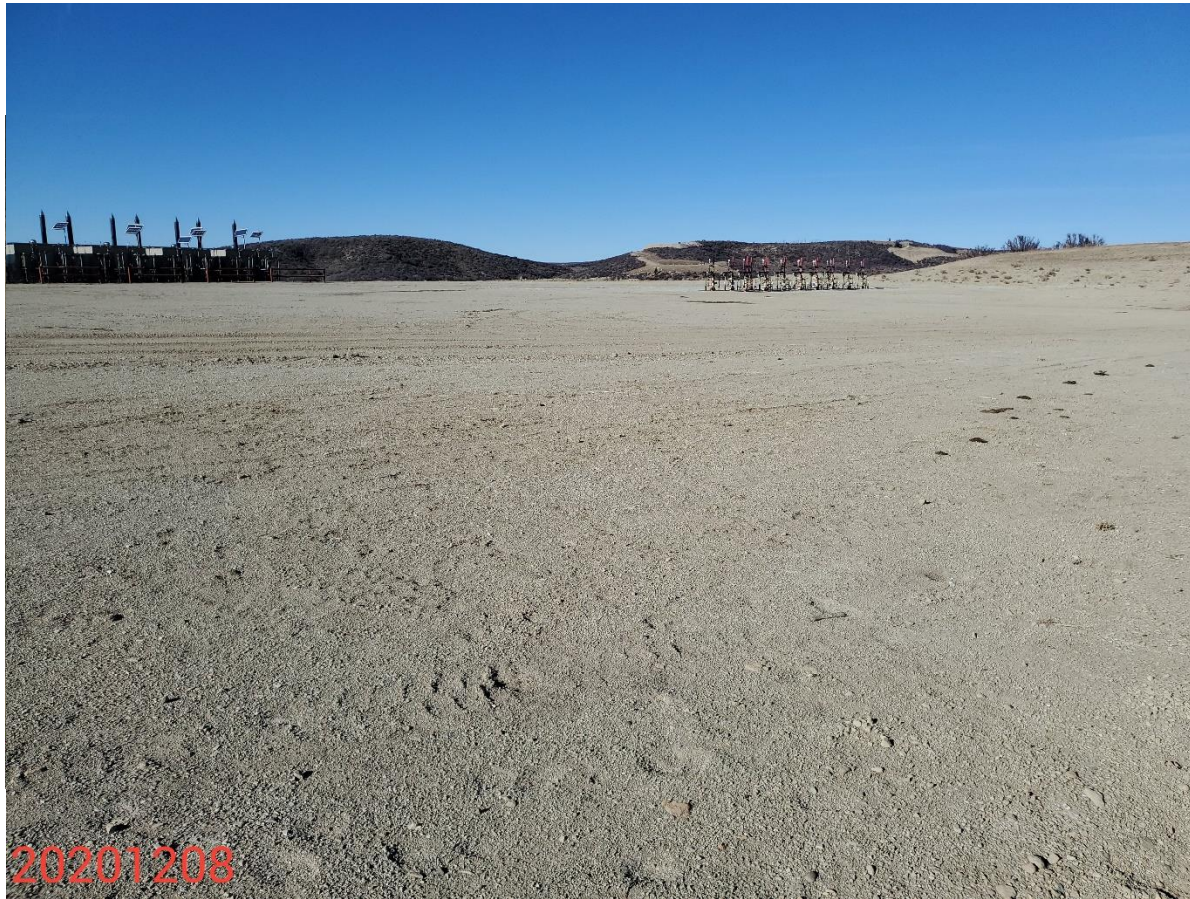
Photo 7: See comments under photo 5.

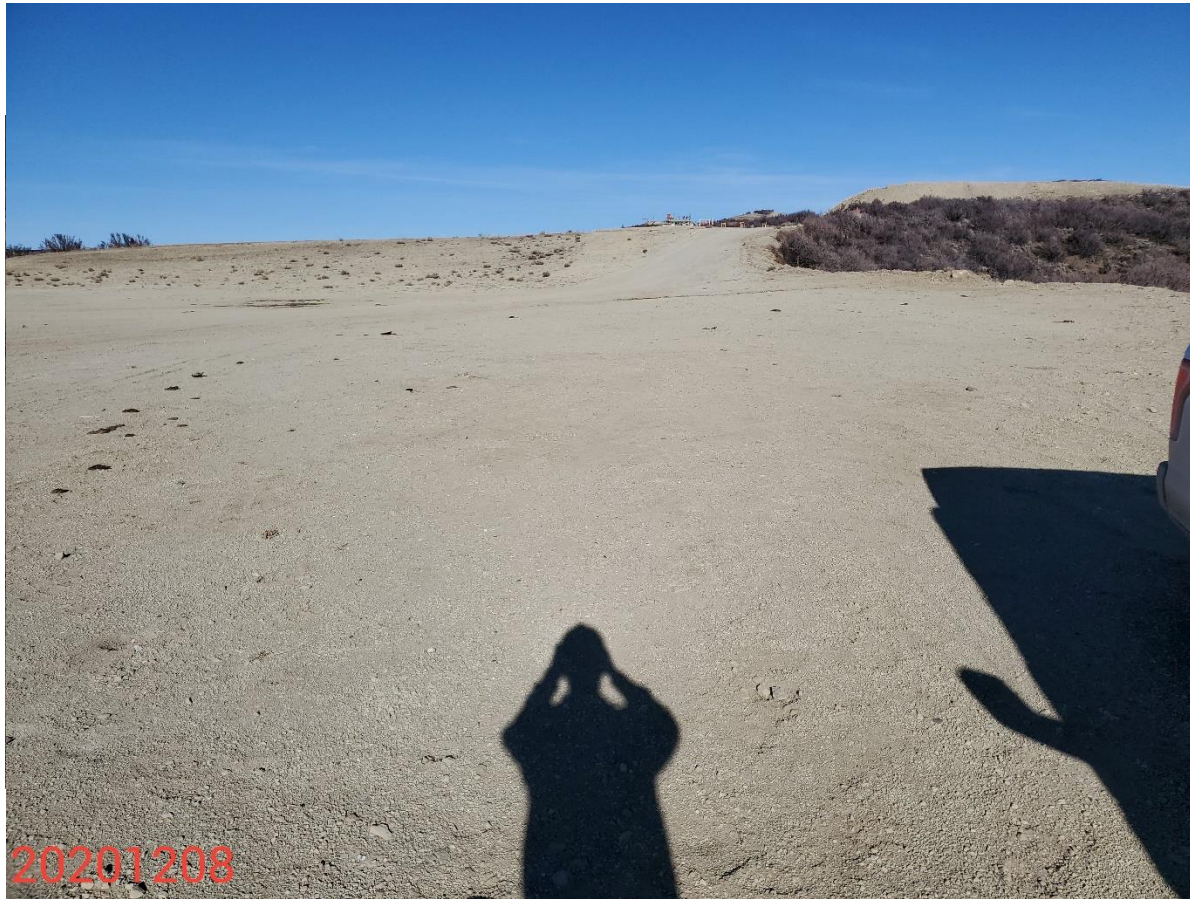
Photo 8: See comments under photo 5.

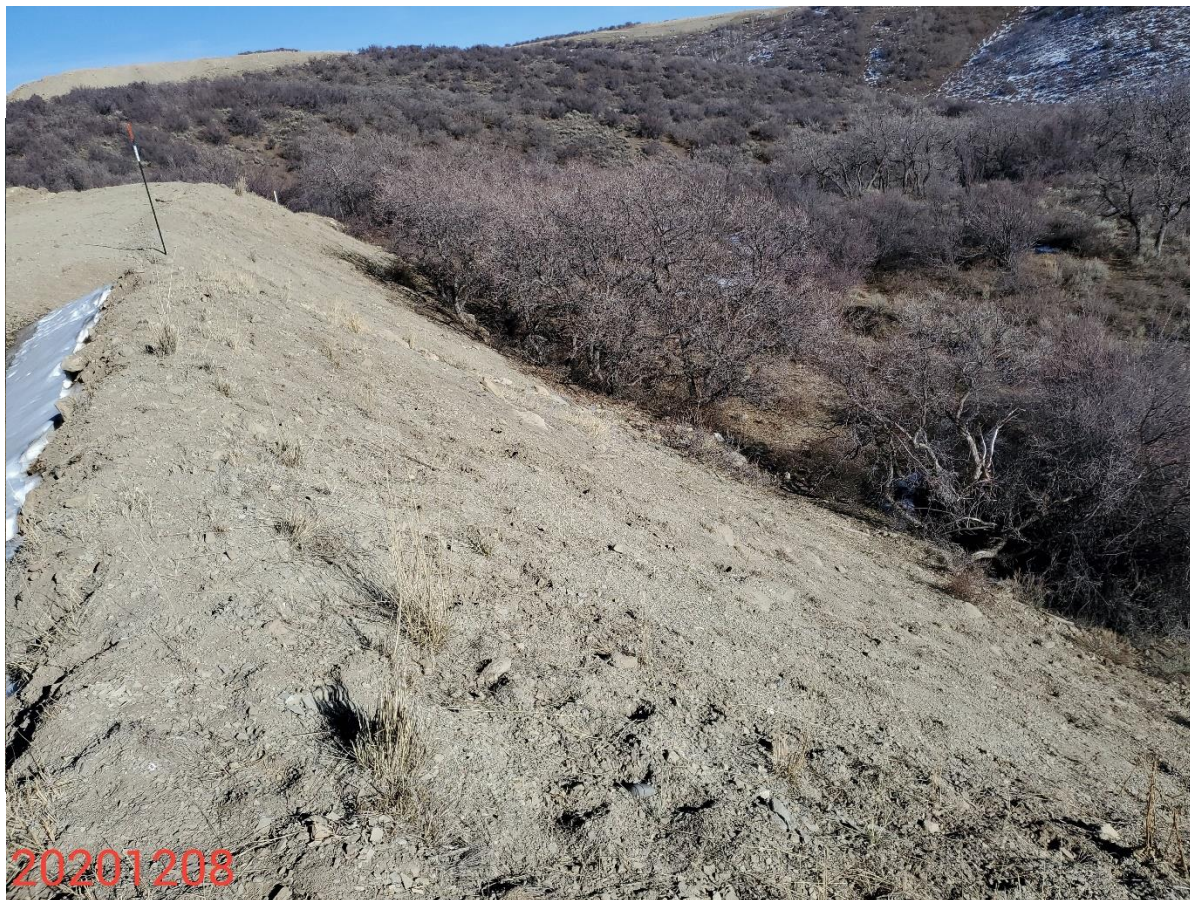
Photo 9: Photo taken from the east end of the Location, facing north. Photo shows BMPs to stabilize/protect slopes, and prevent off-site sediment transport are missing, or insufficient.

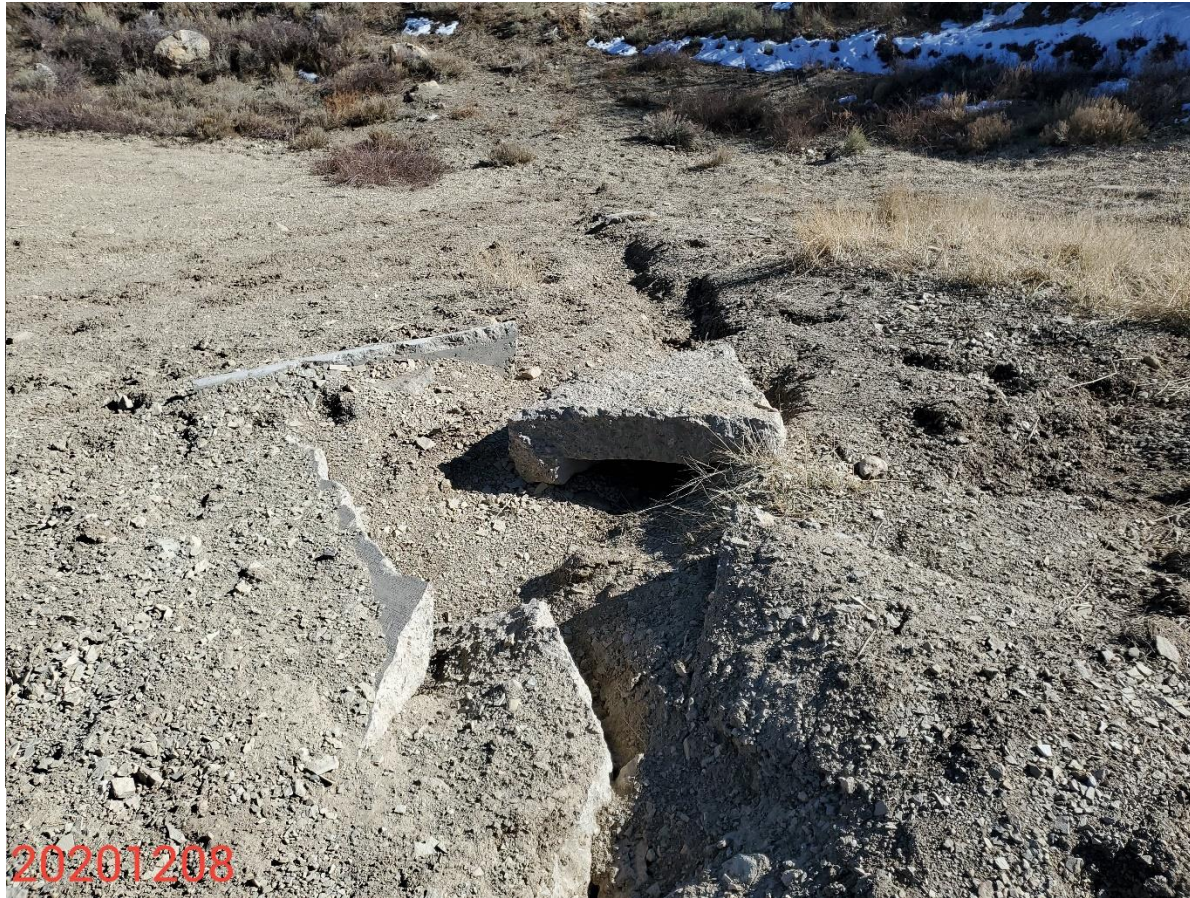
Photo 10: Photo taken from the east end of the Location, facing east. Photo shows BMPs to stabilize/protect slopes, and prevent off-site sediment transport are missing, or insufficient. Photo also shows concrete debris on the slope; this is considered trash debris and requires removal.

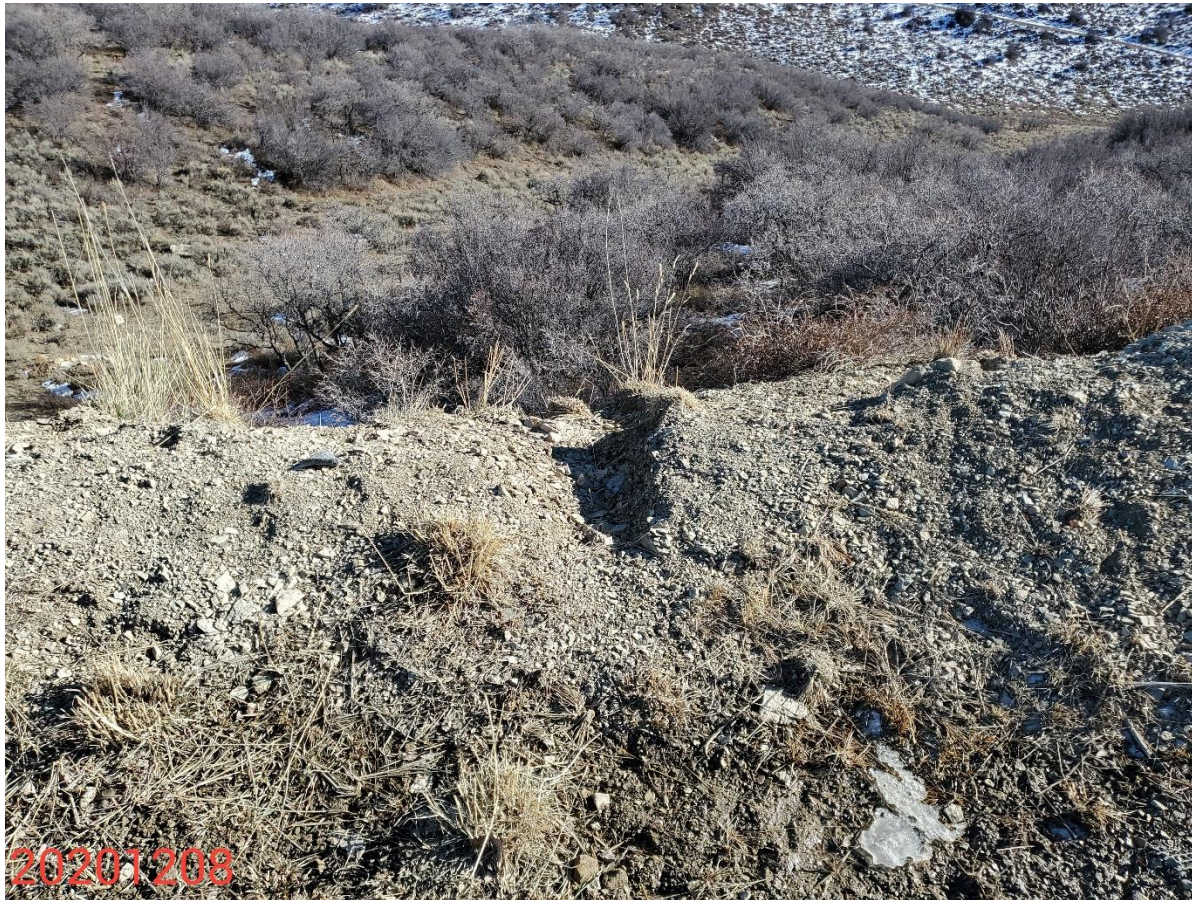
Photo 11: Photo taken from the southeast end of the Location, facing southeast. Photo shows BMPs to stabilize/protect slopes, and prevent off-site sediment transport are missing, or insufficient

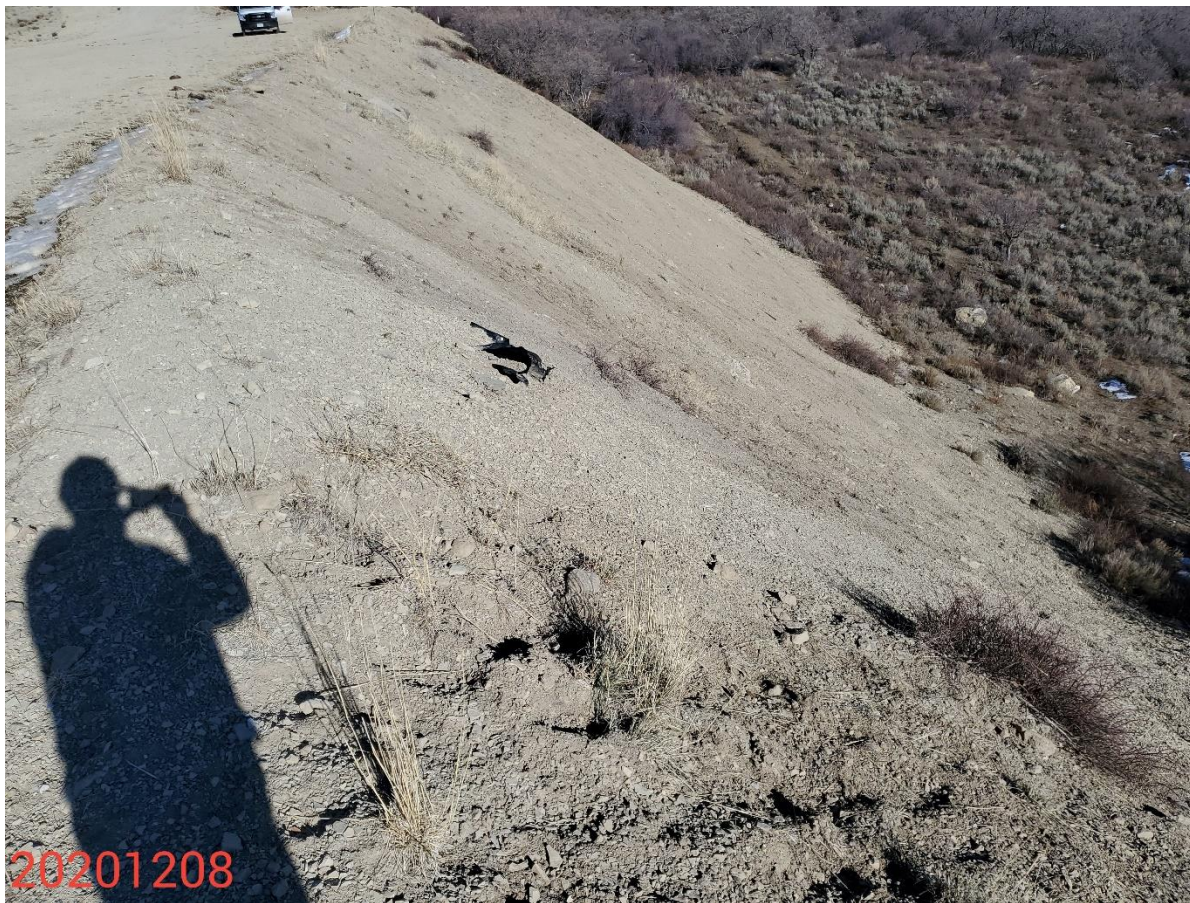
Photo 13: Photo taken from the southeast end of the Location, facing northeast. Photo shows BMPs to stabilize/protect slopes, and prevent off-site sediment transport are missing, or insufficient. Photo also shows plastic trash debris on slopes.

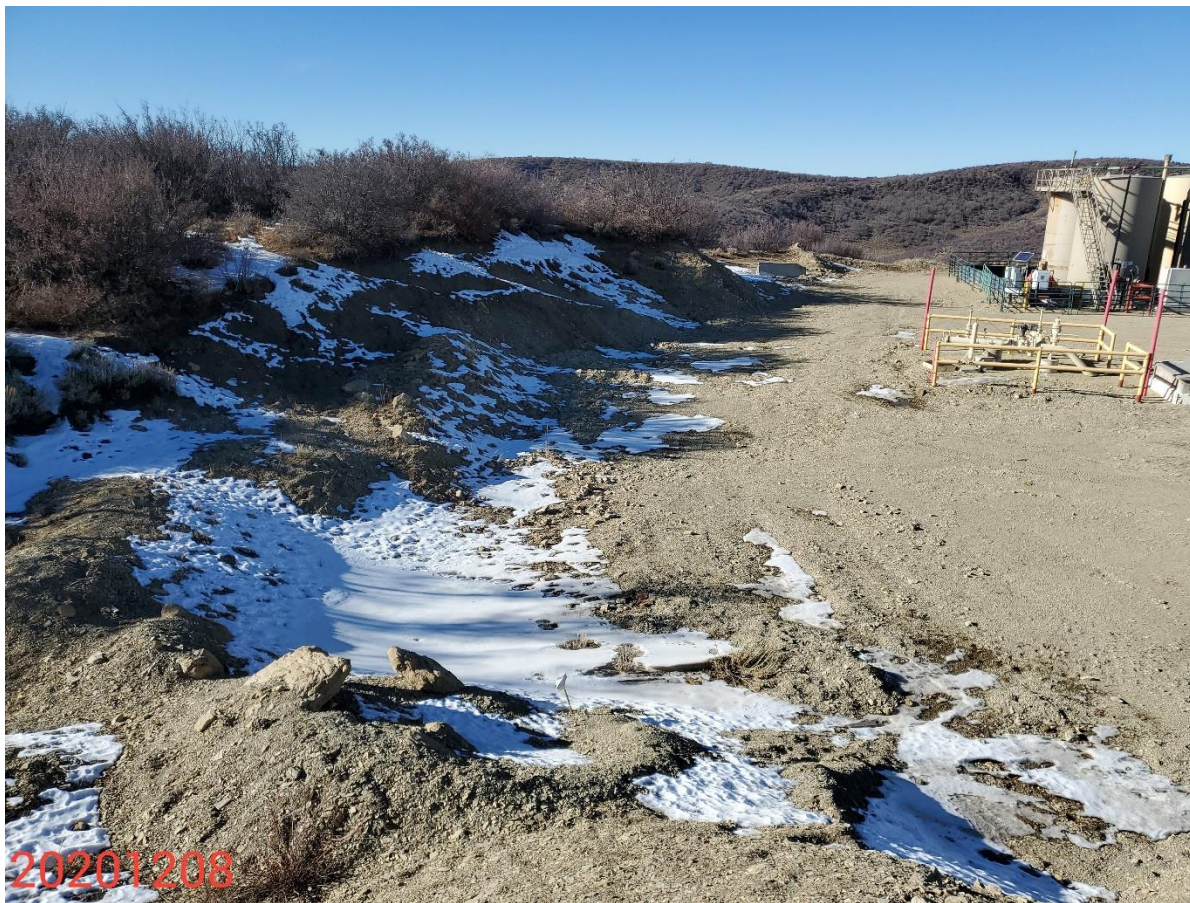
Photo 14: Photo taken from the south end of the Location, facing west. Photos 14-16 provide an overview of the Location from west, northwest to north. Photos also show areas not reasonably needed for production on the Location have not been reclaimed.

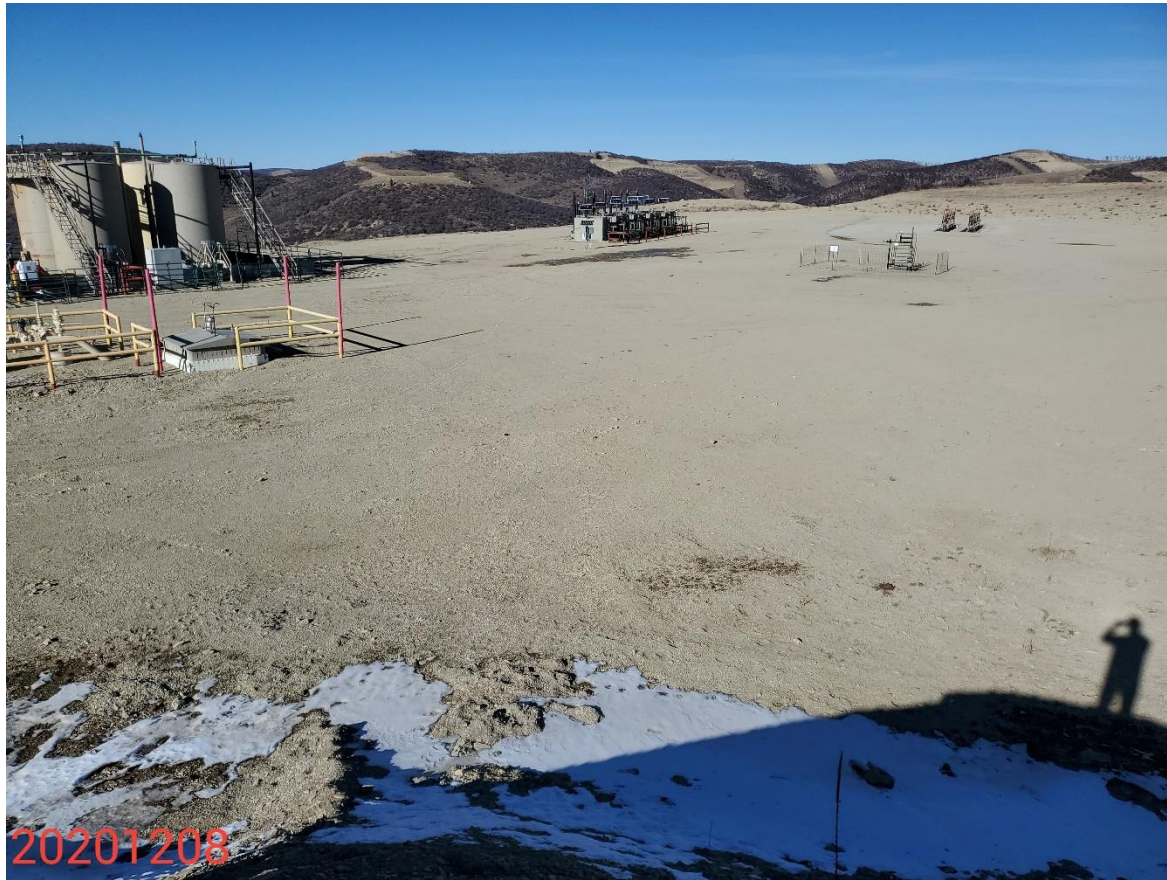
Photo 15: See comments under photo 14.

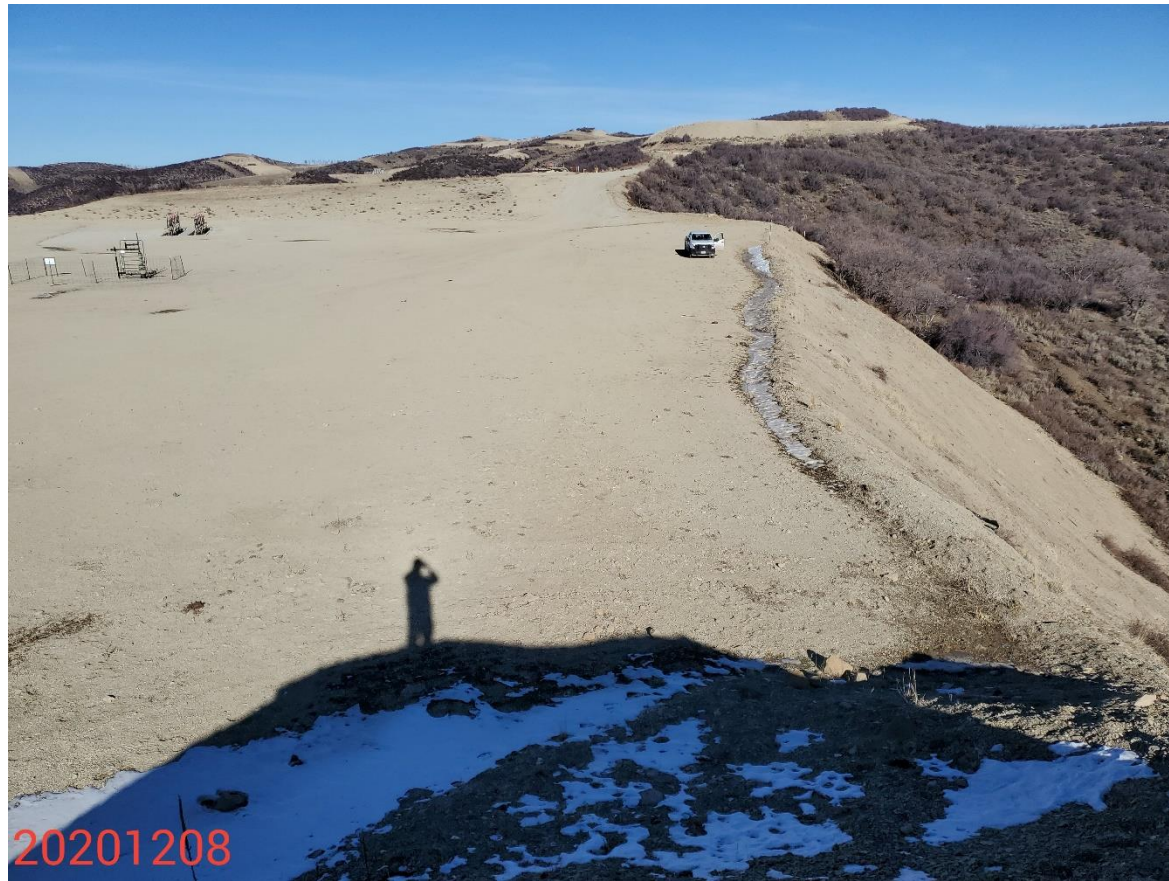
Photo 16: See comments under photo 14.

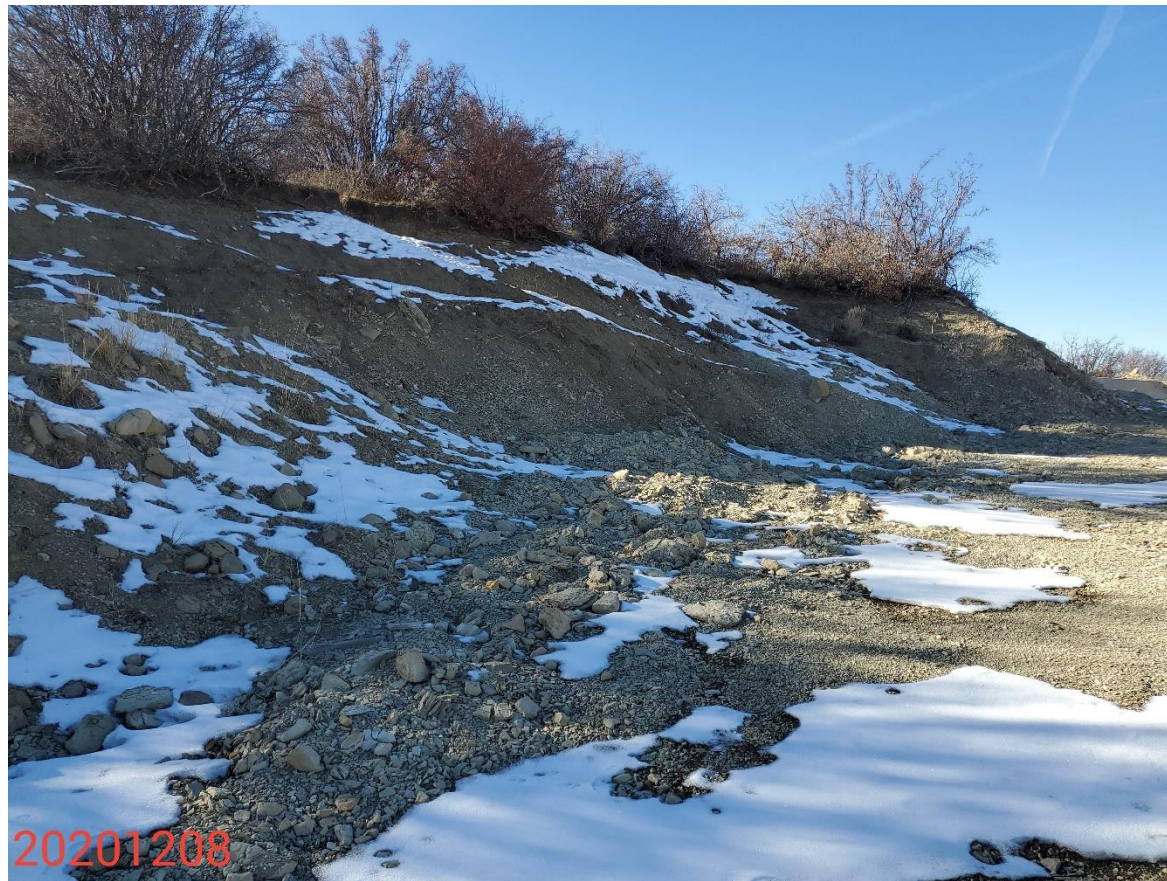
Photo 17: Photo taken from the cut slopes on the south end of the Location, facing west. Photo shows BMPs remain missing or insufficient to stabilize and protect slopes.

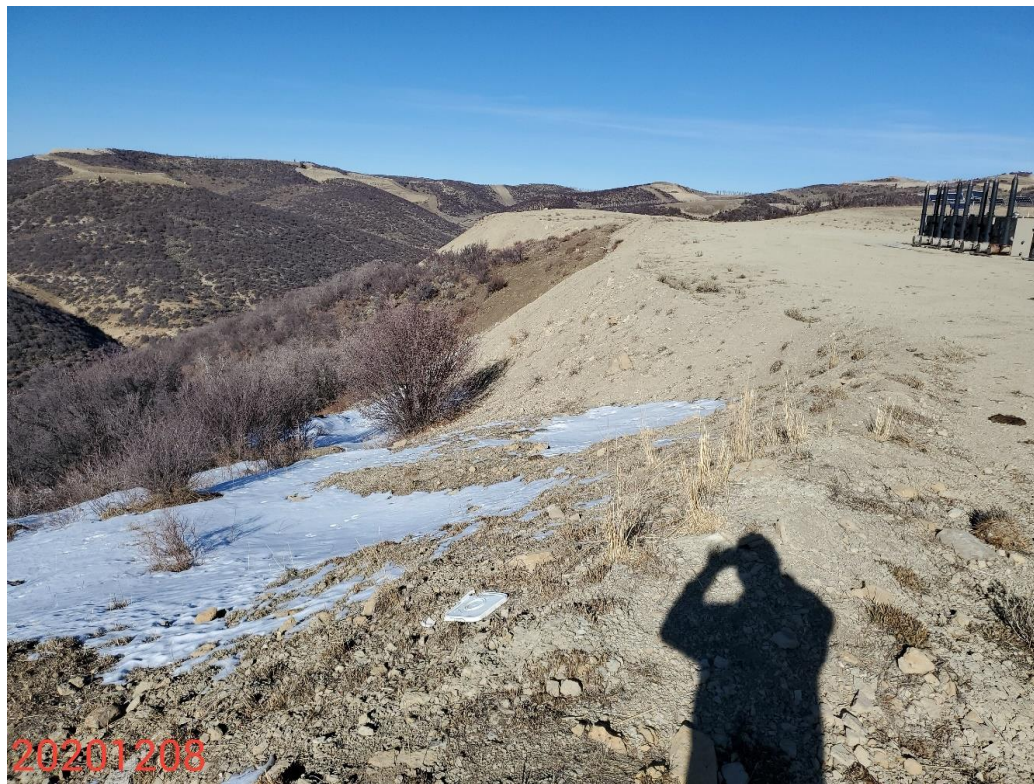
Photo 18: Photo taken from the southwest end of the Location, facing north. Photo shows BMPs to stabilize/protect slopes, and prevent off-site sediment transport are missing, or insufficient.

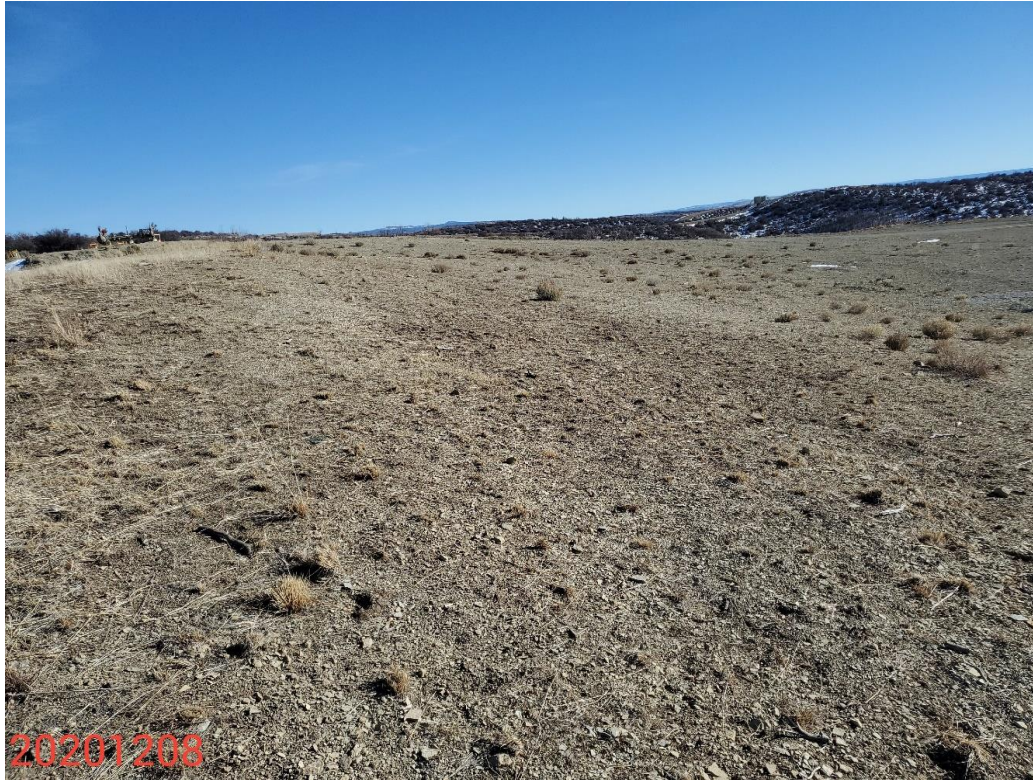
Photo 19: Photo taken from the north end of the Location, facing east. Photos 19-23 provide an overview of the Location from east, southeast, southwest, west to northwest. Photos also show areas not reasonably needed for production on the Location have not been reclaimed.

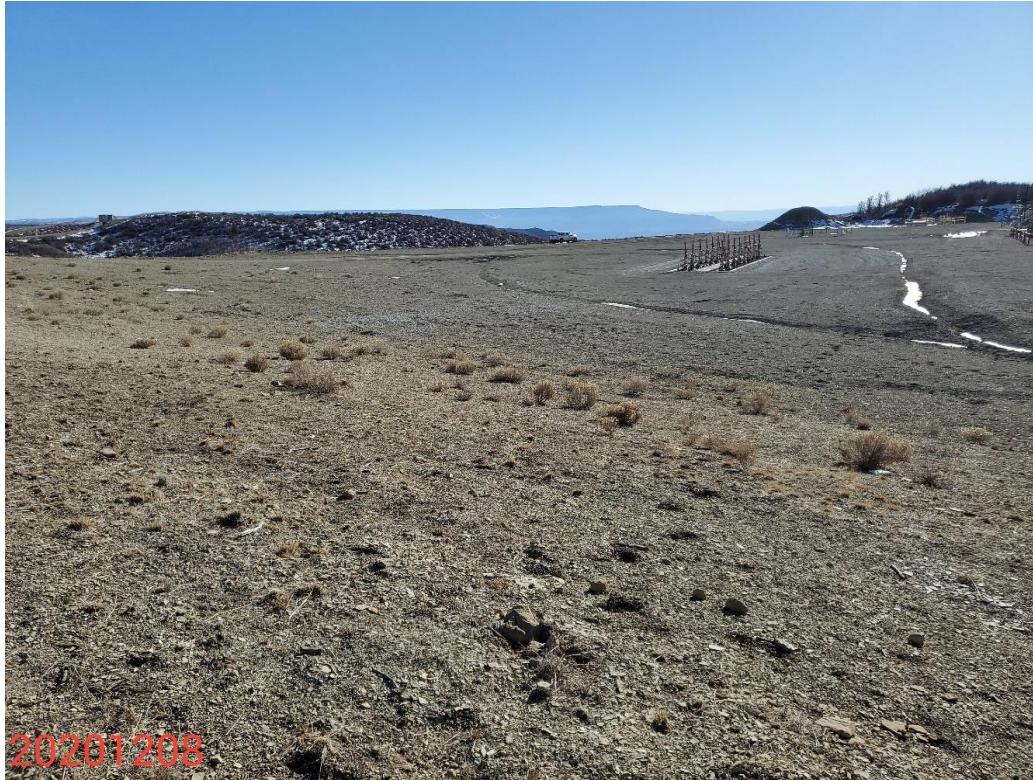
Photo 20: See comments under photo 19.

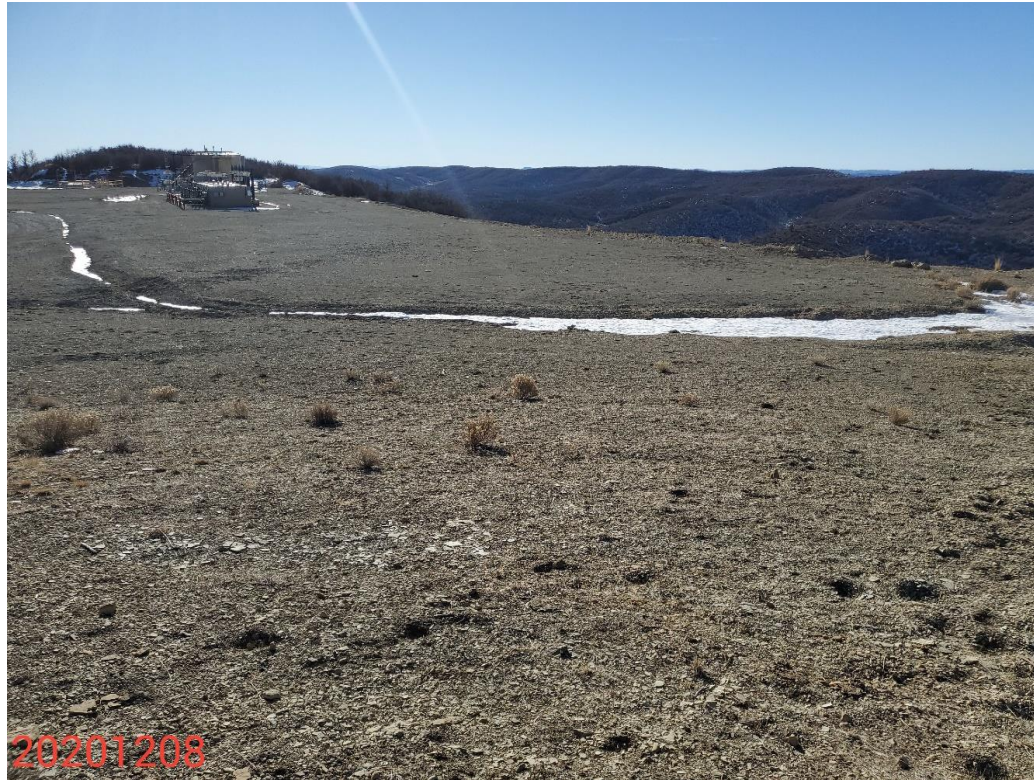
Photo 21: See comments under photo 19.

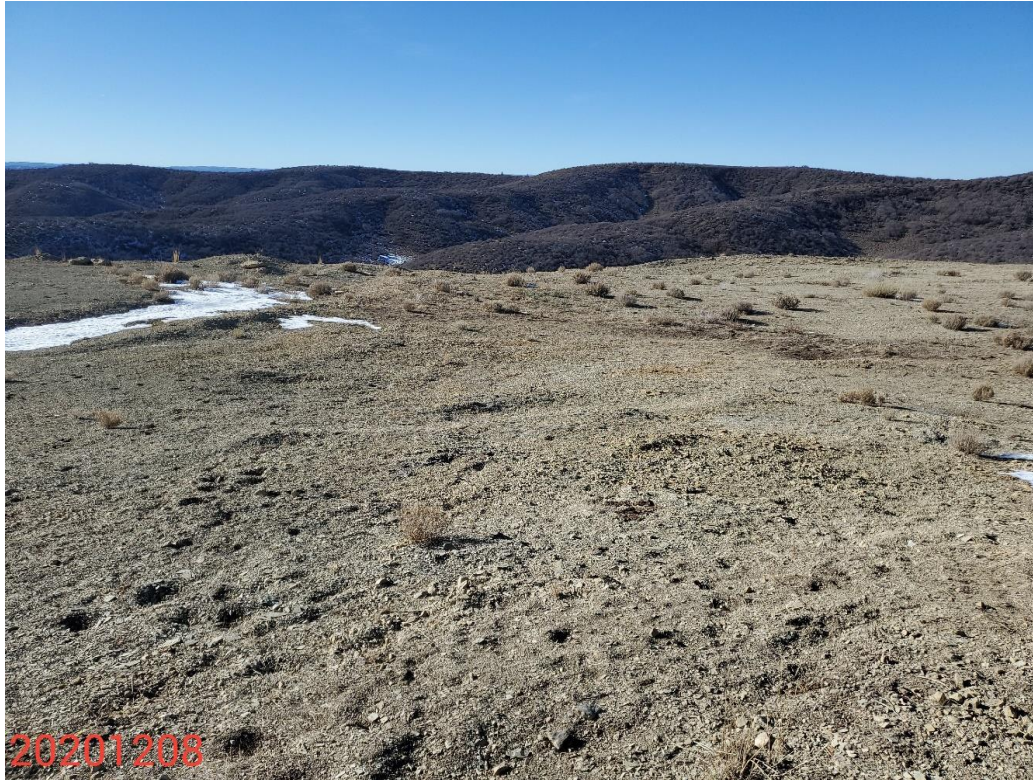
Photo 22: See comments under photo 19.

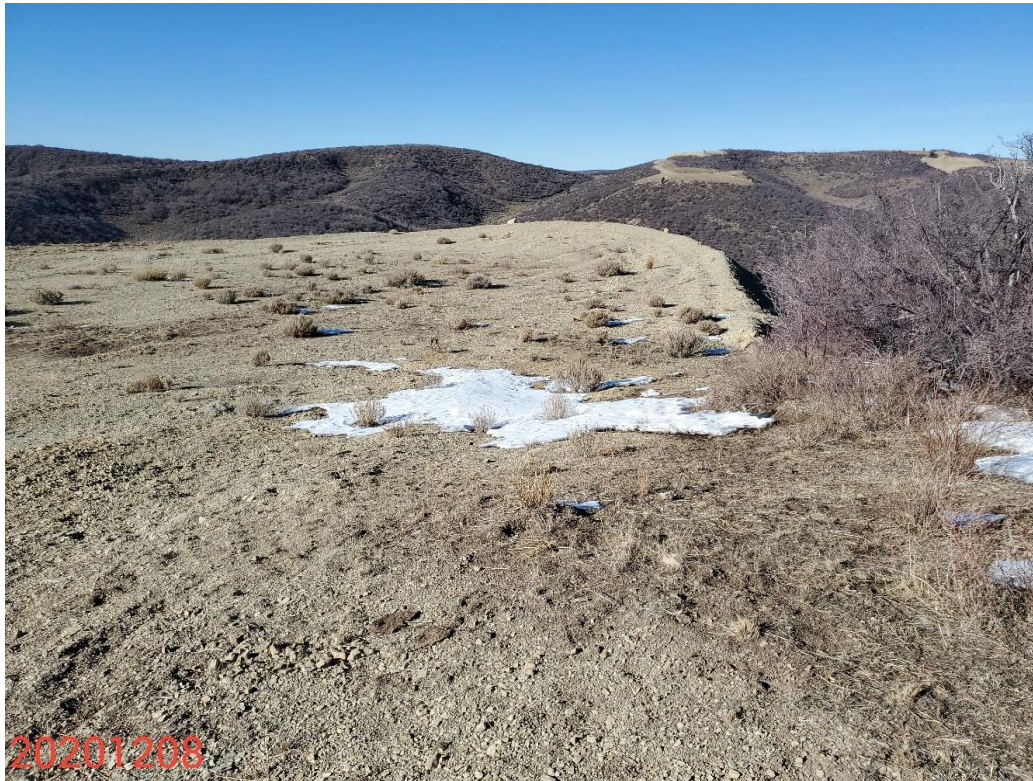
Photo 23: See comments under photo 19.
