Inspection Photos

12/8/2020

Operator: LARAMIE ENERGY LLC - 10433

Location ID: 335815

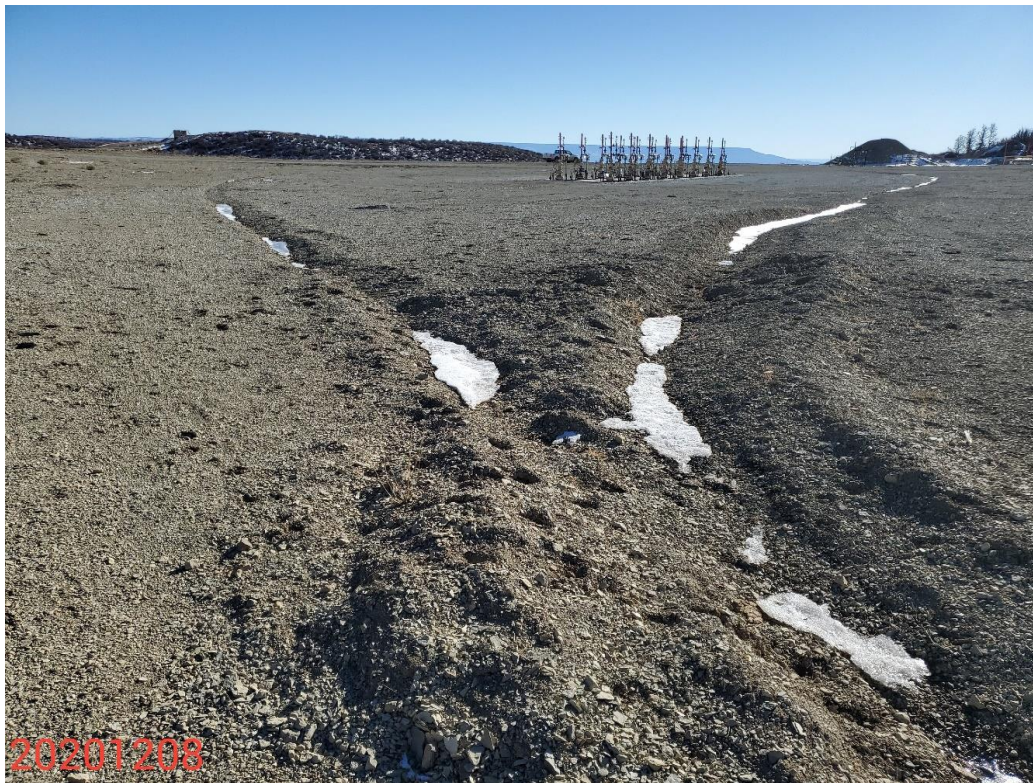
Photo 24: Photo taken from the north end of the Location, facing southeast. Photo shows ditch on the Location.

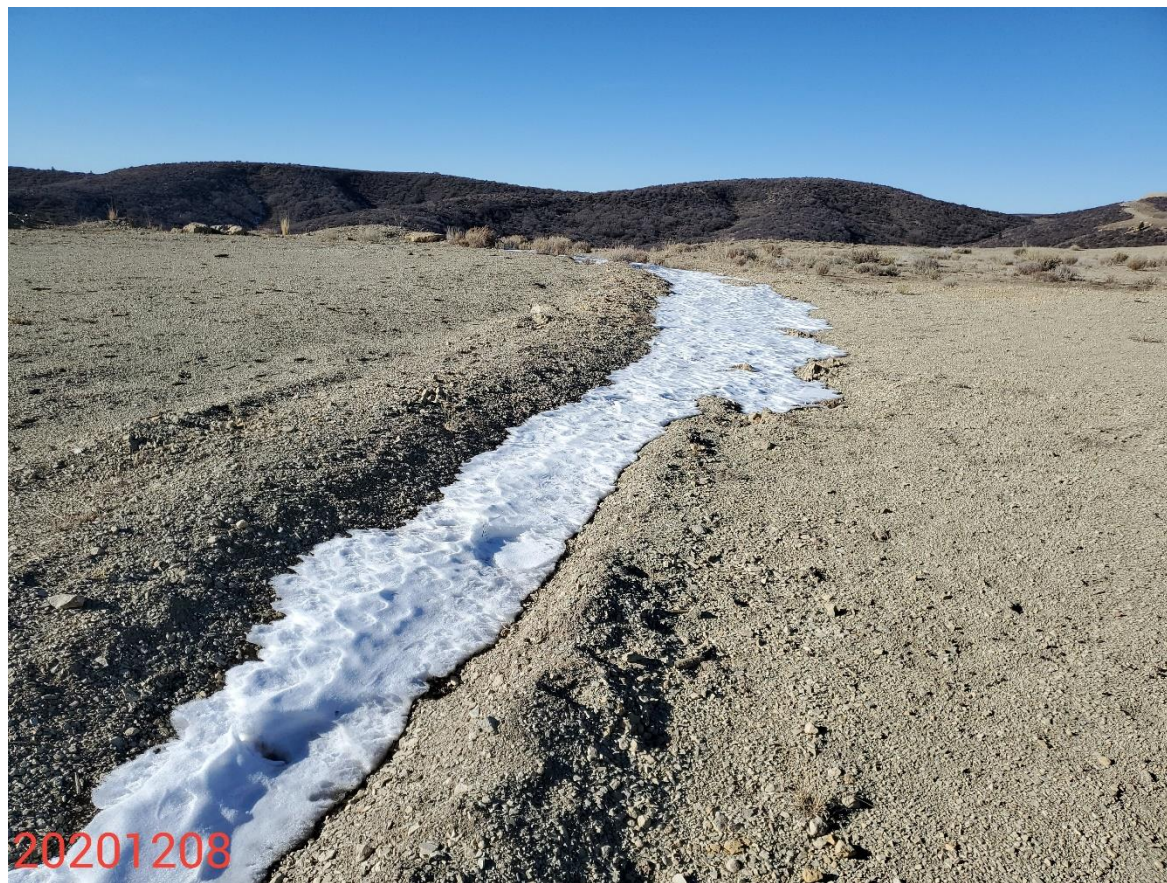
Photo 25: Continued from photo 24. Photo taken from the north end of the Location, facing west. Photo shows ditch on the Location.

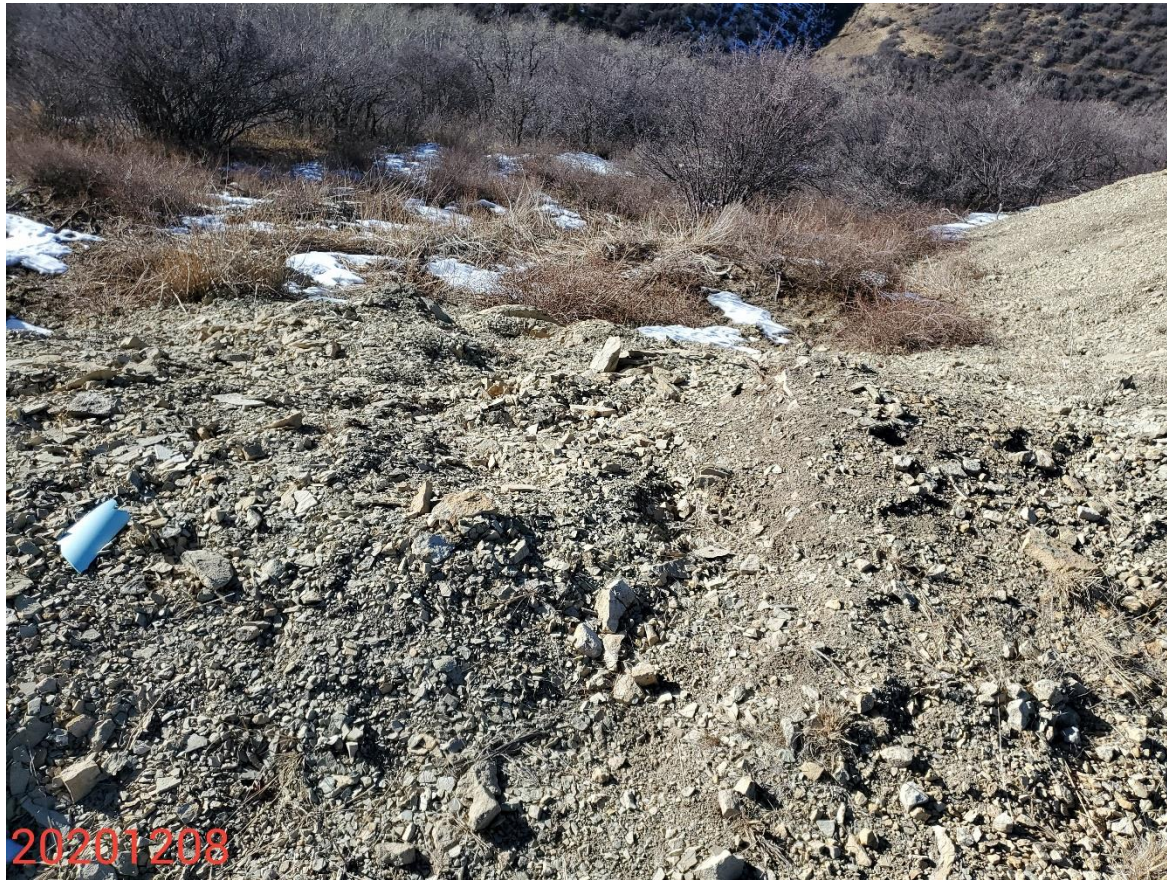
Photo 26: Continued from photo 24. Photo shows ditch outlet. Photo shows BMPs have not been constructed in accordance with good engineering practices; BMPs to stabilize/protect slopes, and prevent off-site sediment transport are missing, or insufficient.

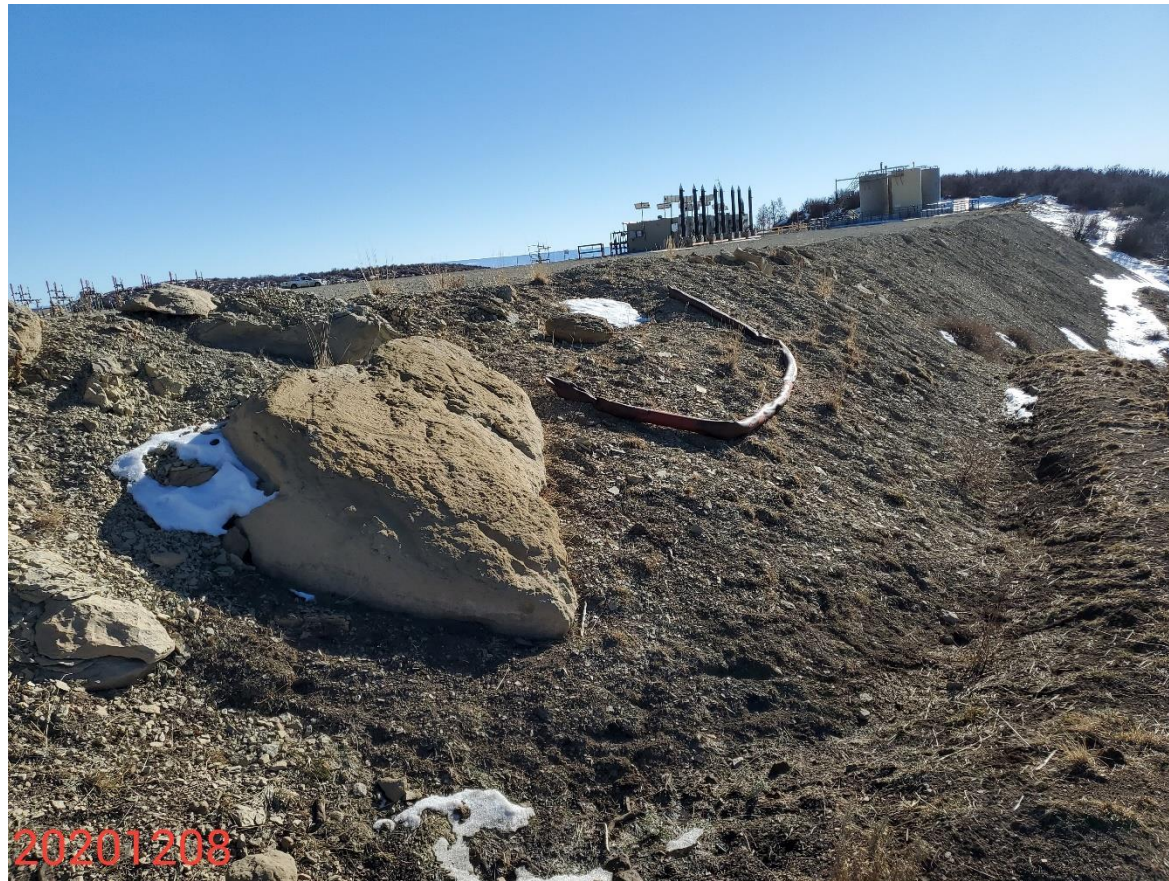
Photo 27: Photo taken from the northwest end of the Location, facing southeast. Photo shows trash debris observed on the slopes.

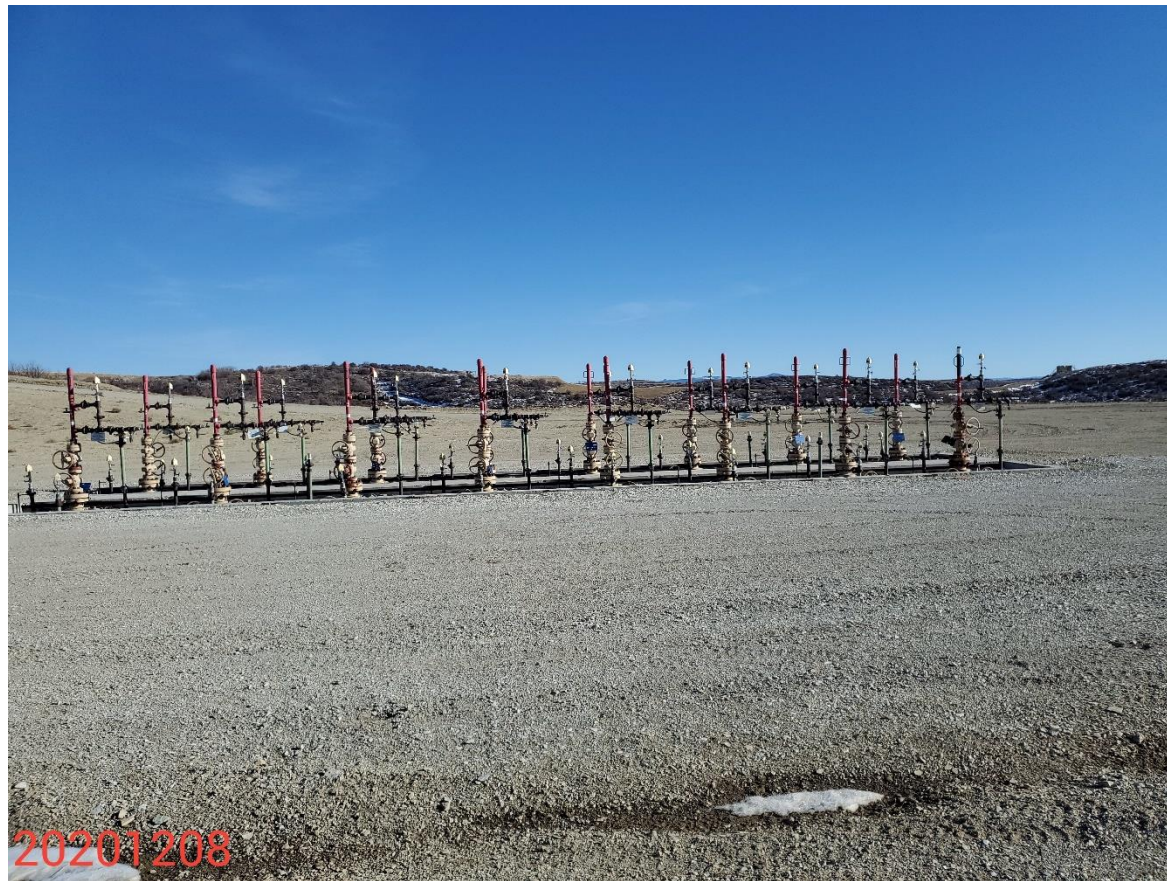
Photo 28: Photo taken from the west end of the Location, facing east. Photo shows producing wells on the north end of the Location.

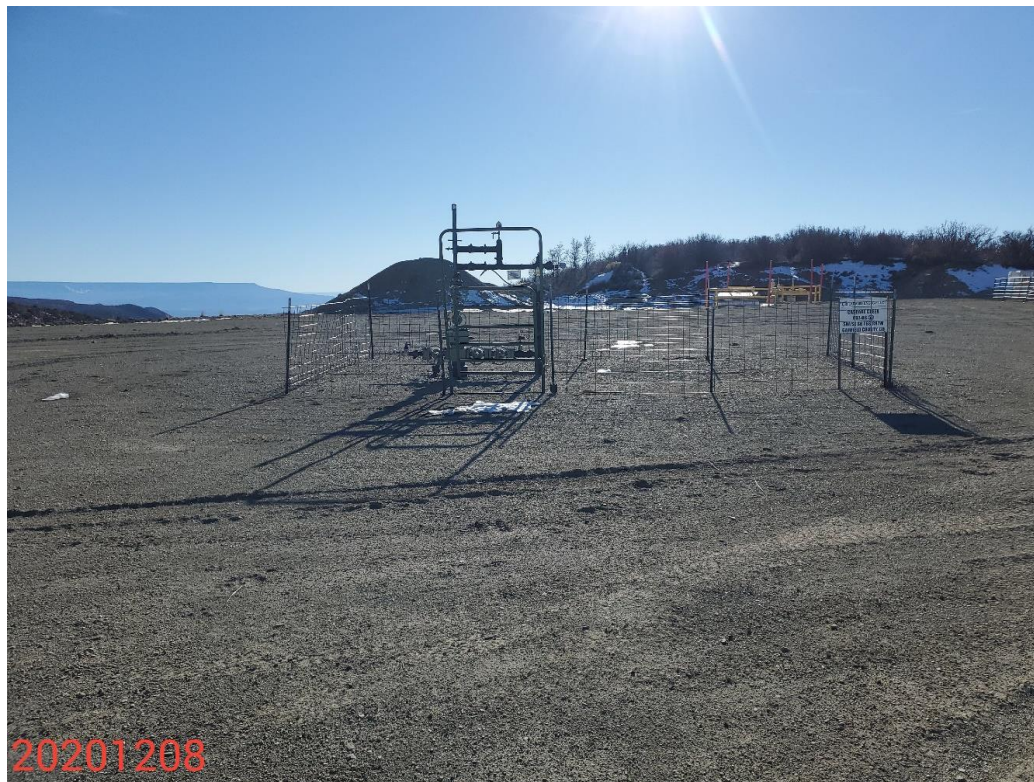
Photo 29: Photo taken from the southern end of the Location, facing south. Photo shows the 1 producing well on the south end of the Location.
