**TEP ROCKY MOUNTAIN LLC**  
**ARCO-66S96W 29NESE**  
**Location ID: 335184**

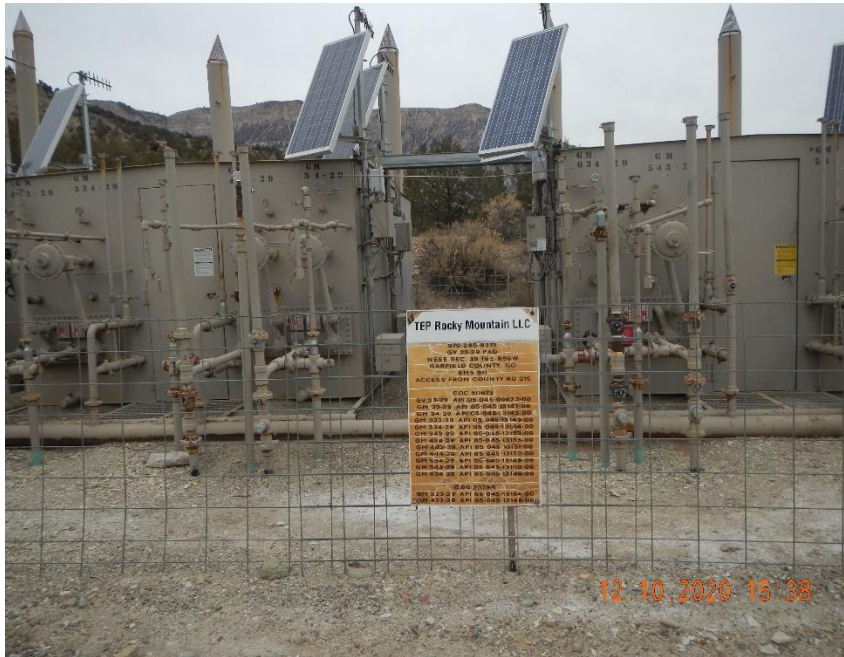
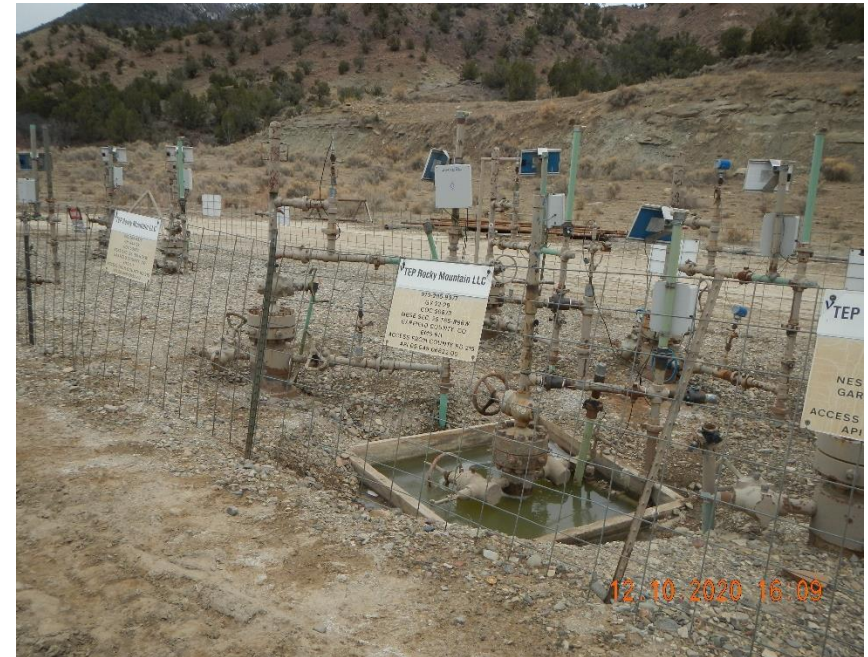
**GV 22-29 well has gas bubbling up from around casing.**

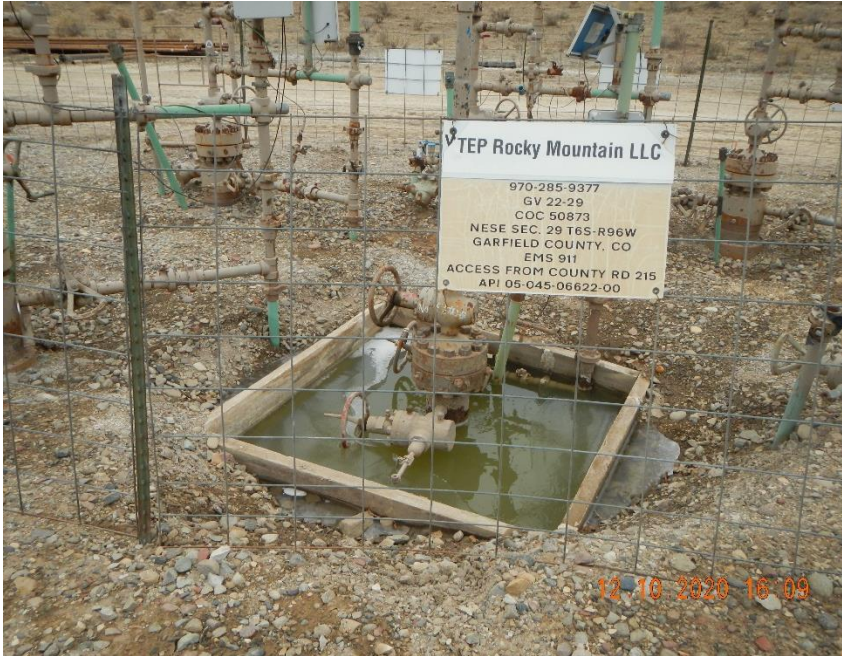
**GV 22-29 well has gas bubbling up from around casing.**

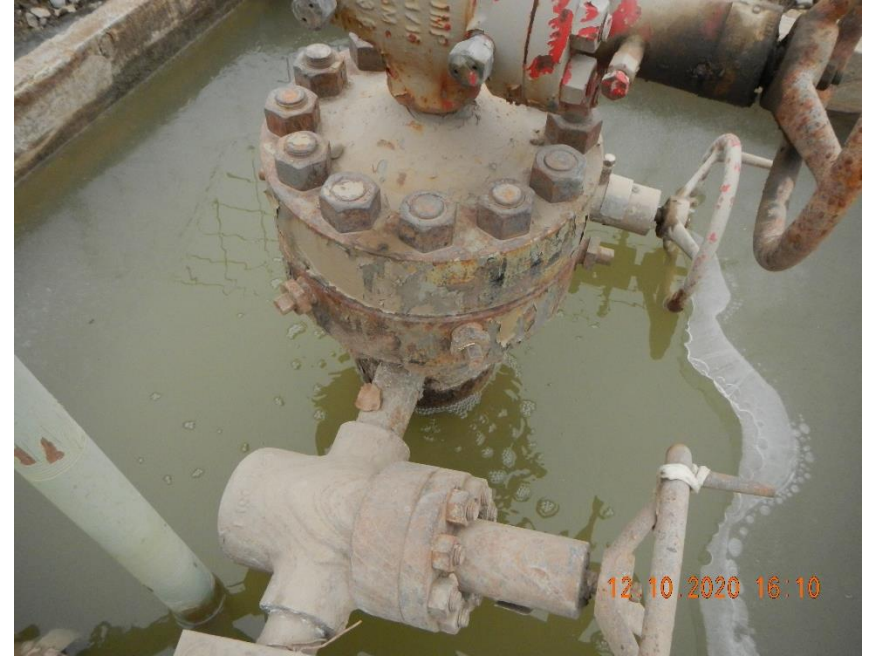
**GV 22-29 well has gas bubbling up from around casing.**

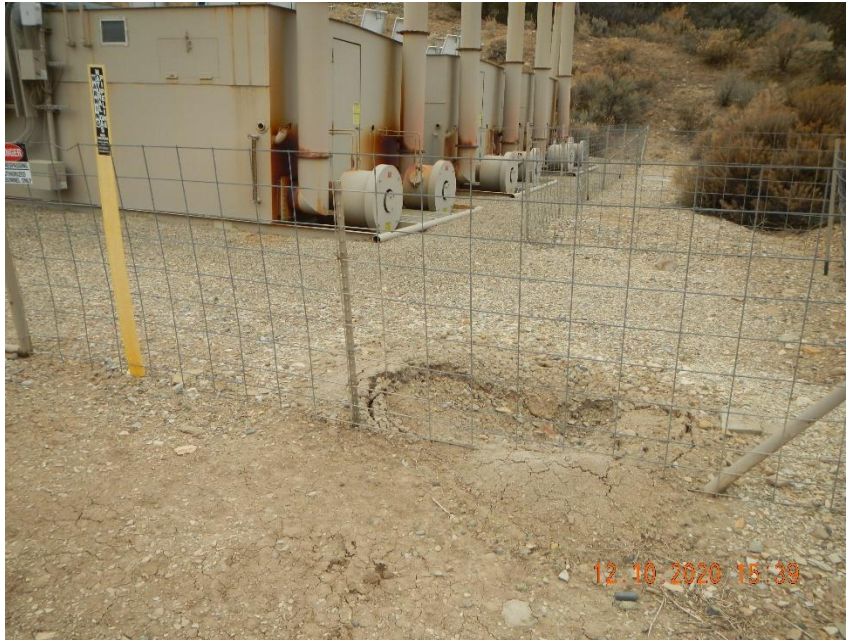
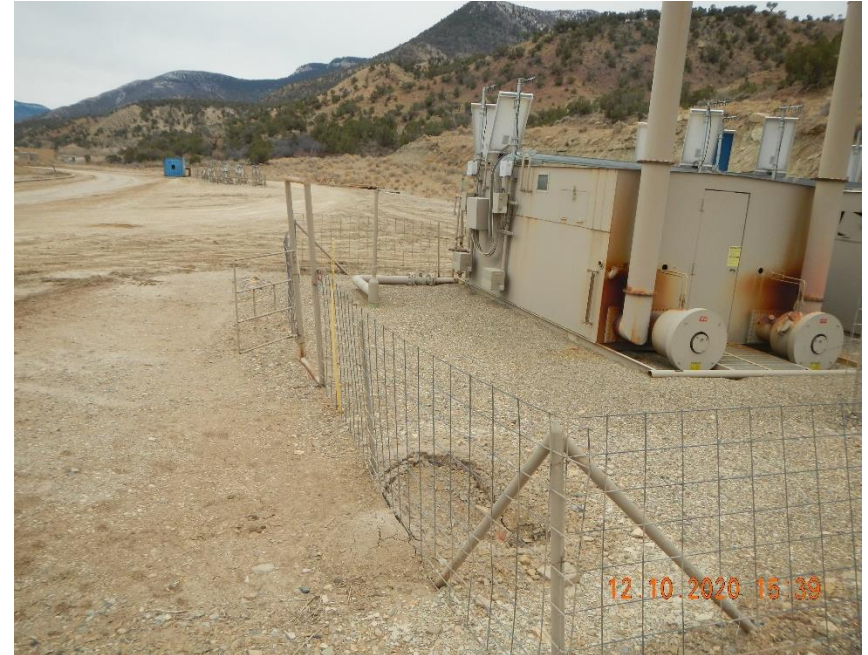
**Subsidence at separators.**

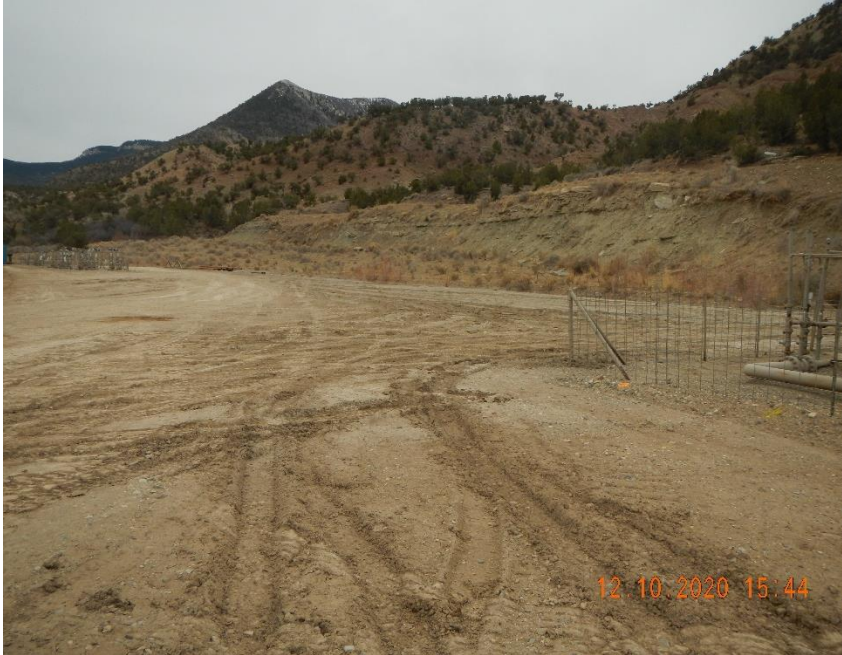
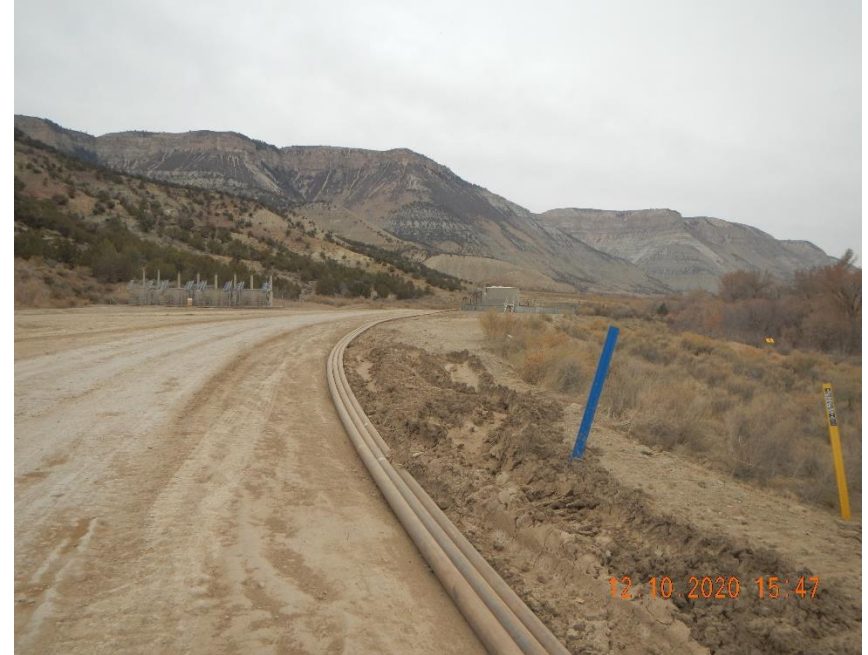
**Rutting on location.**

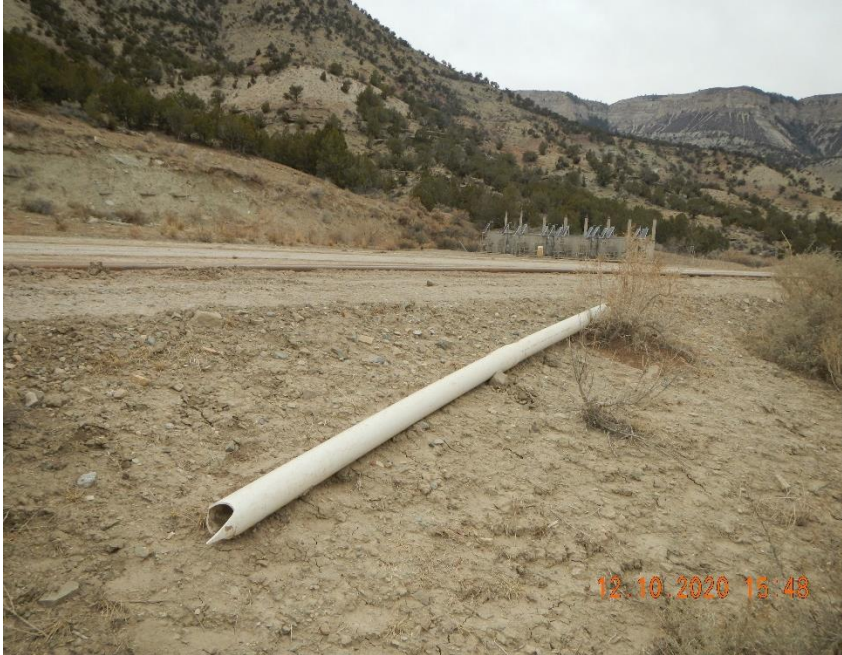
**PVC pipe over the edge of location.**

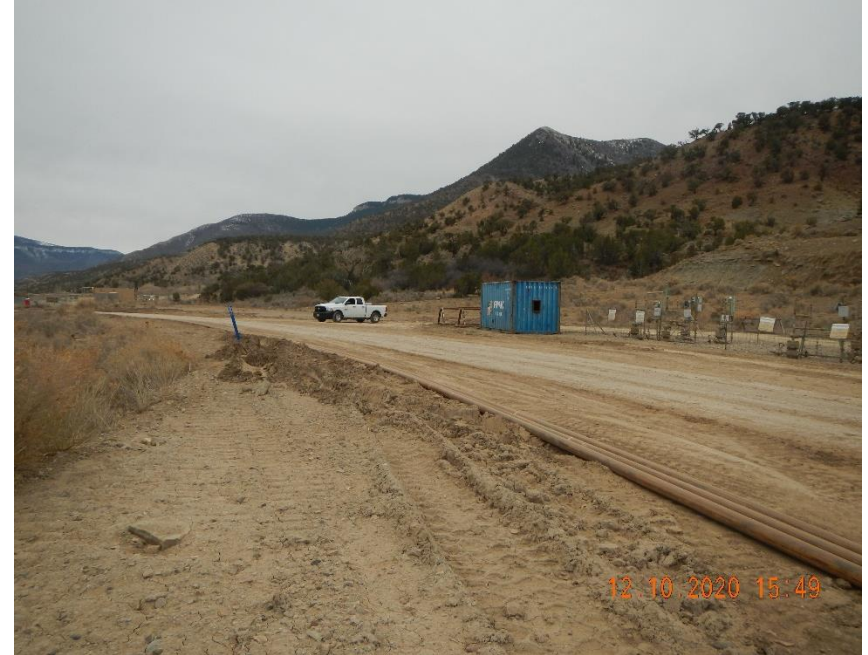
**Rutting on location**

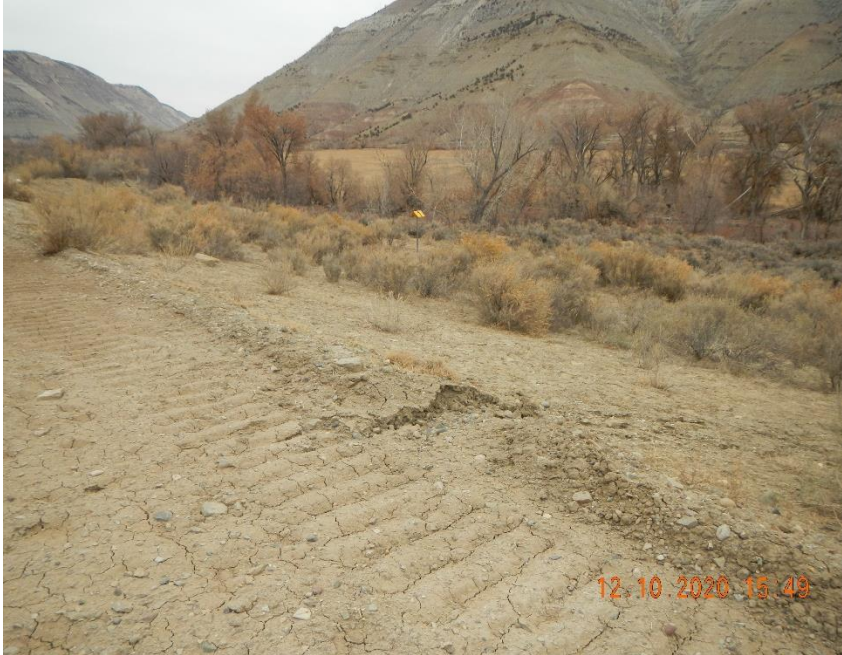
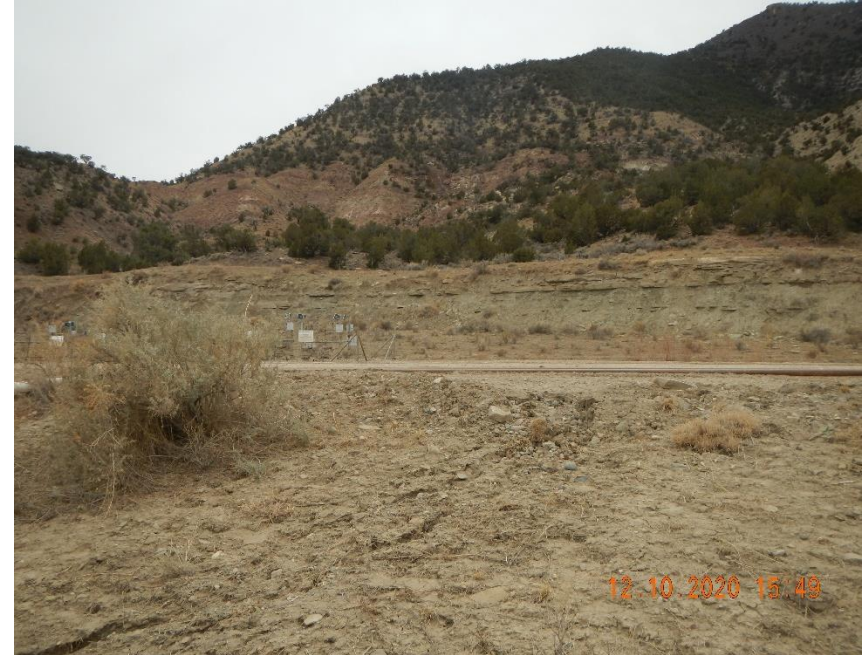
**Riling running off road running through location.**

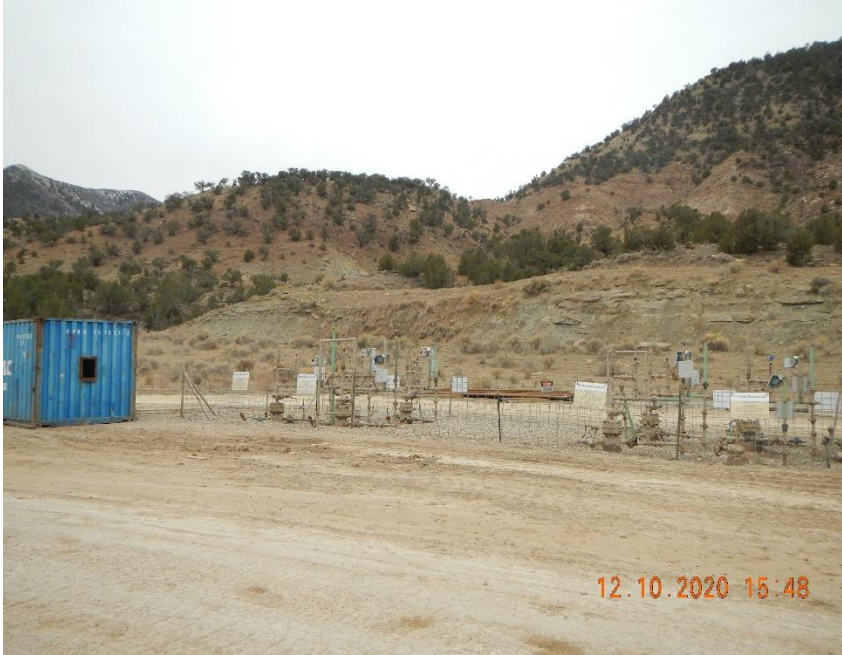
**Equipment and materials on location not needed for production of wells.**

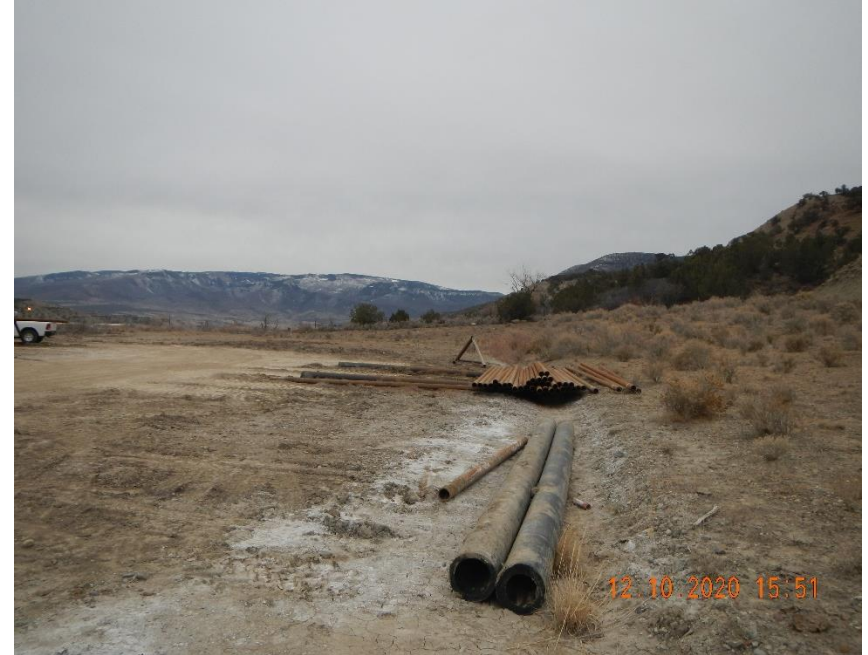
**Pipe stored in location drainage ditch.**

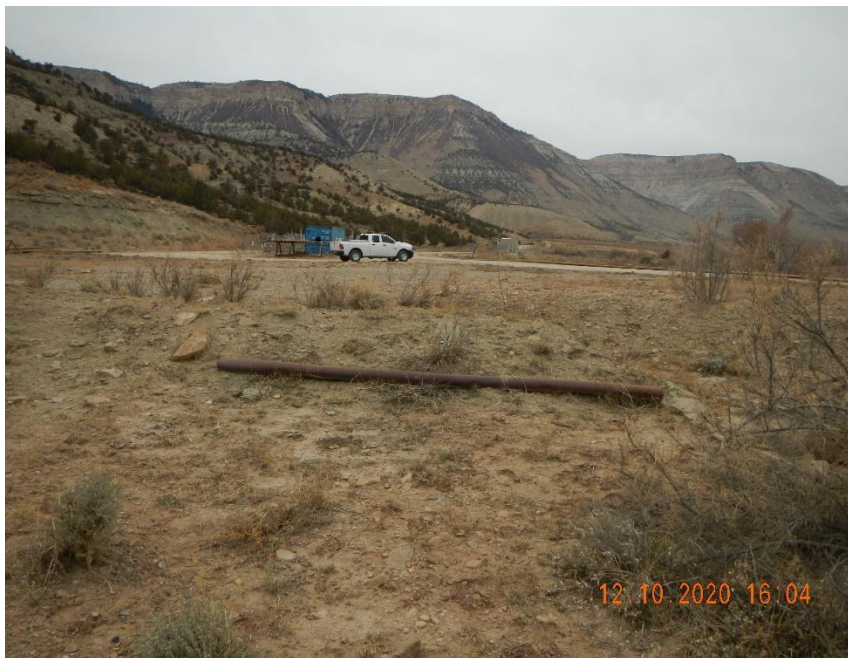
**Pipe over the edge of location. South end of location.**

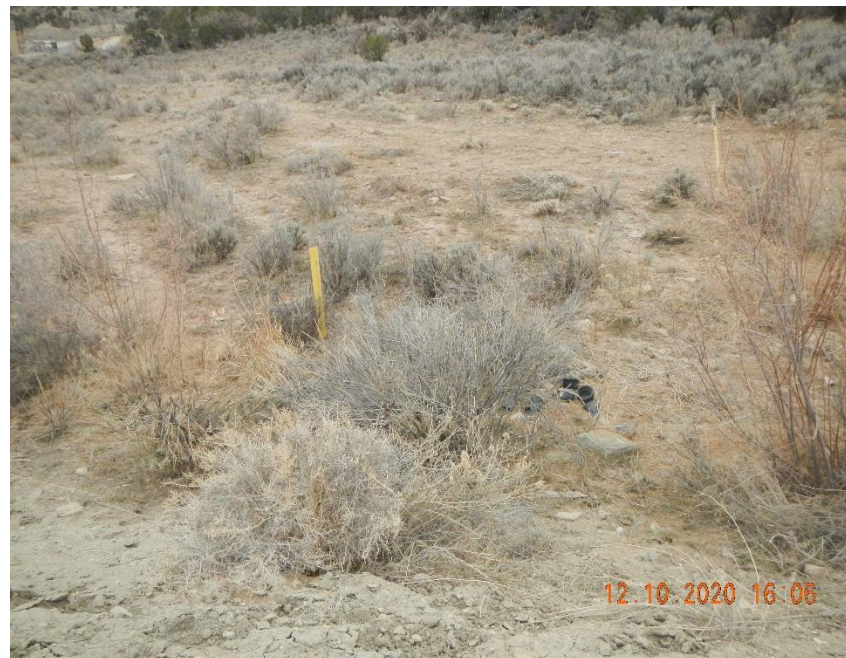
**Tread protectors and junk over the edge of location. South end of location.**

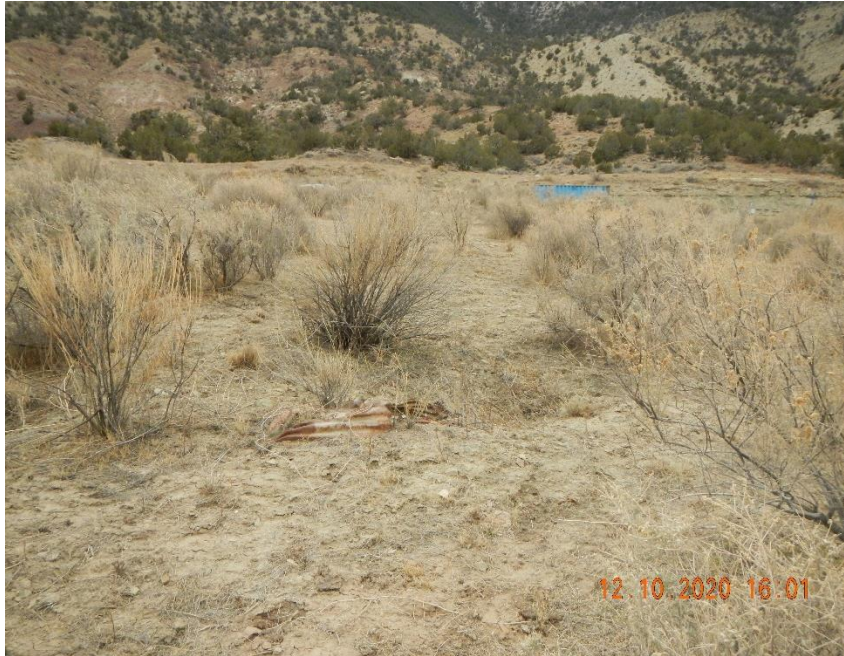
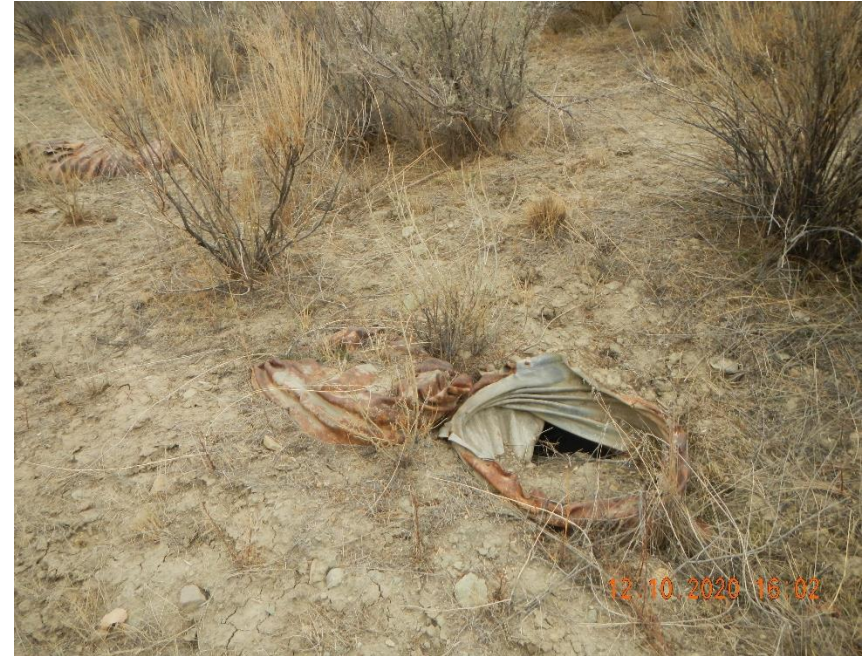
**Pieces of culvert off the edge of location.  
East side along roadway.**

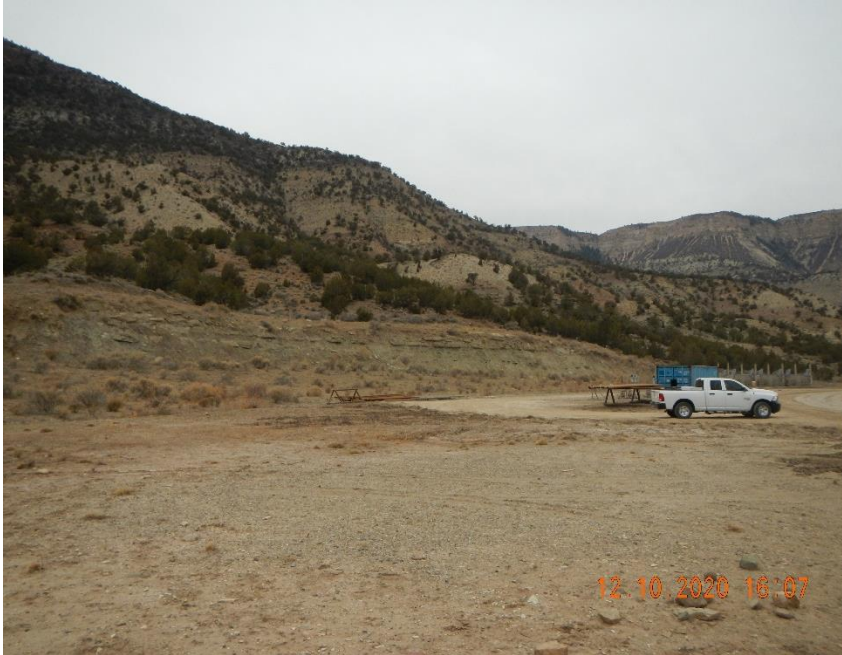
**Rutting on location.**

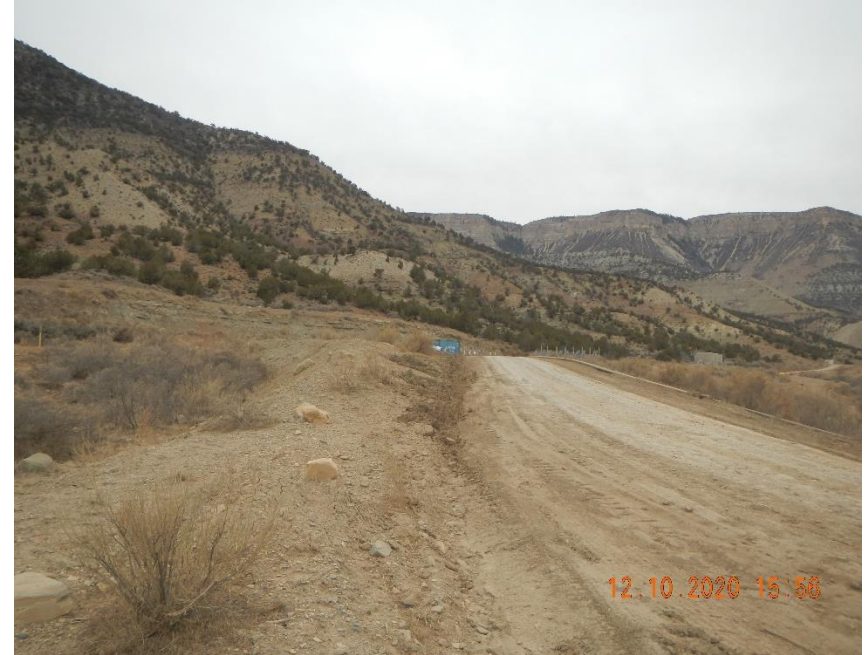
**Ruts on roadway and in ditch.**

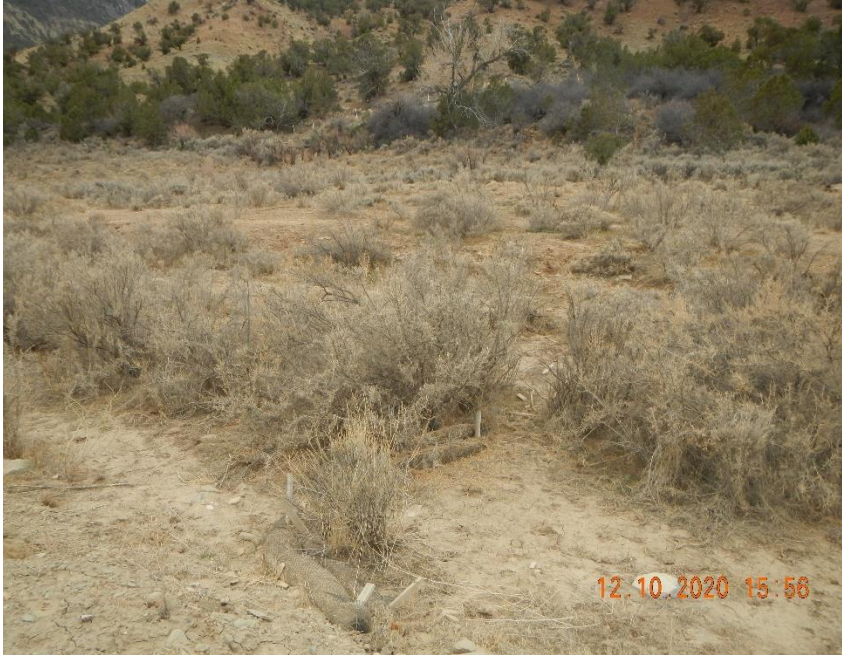
**Unmaintained waddles south of location  
on west side of road.**

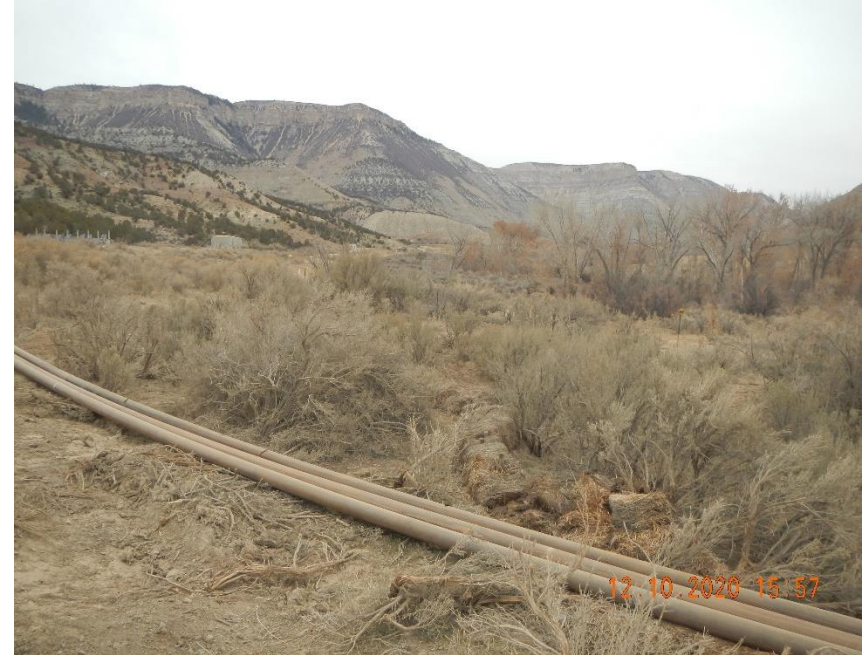
**Unmaintained straw bales running along  
east edge of location.**

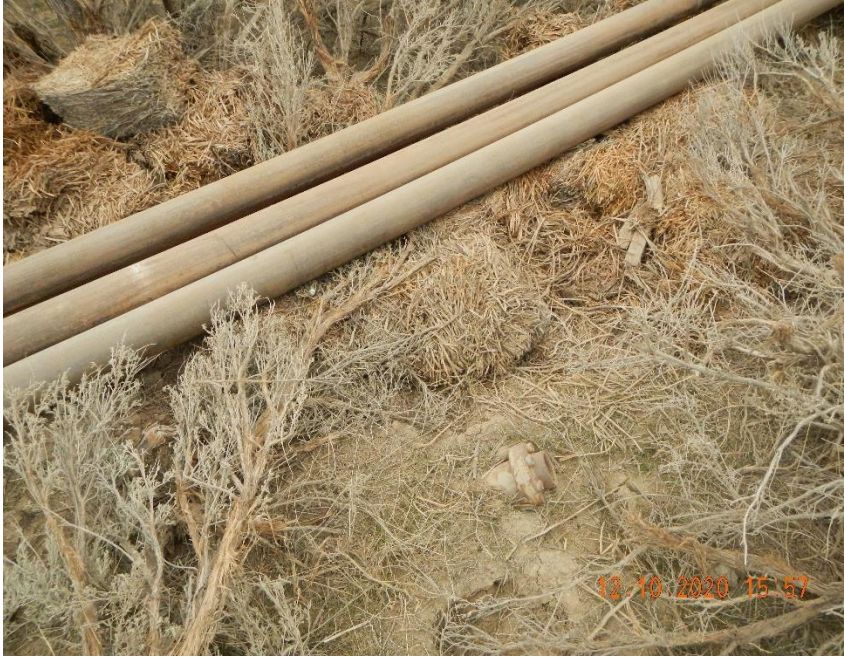
**Unused equipment south east of location  
at frac lines.**

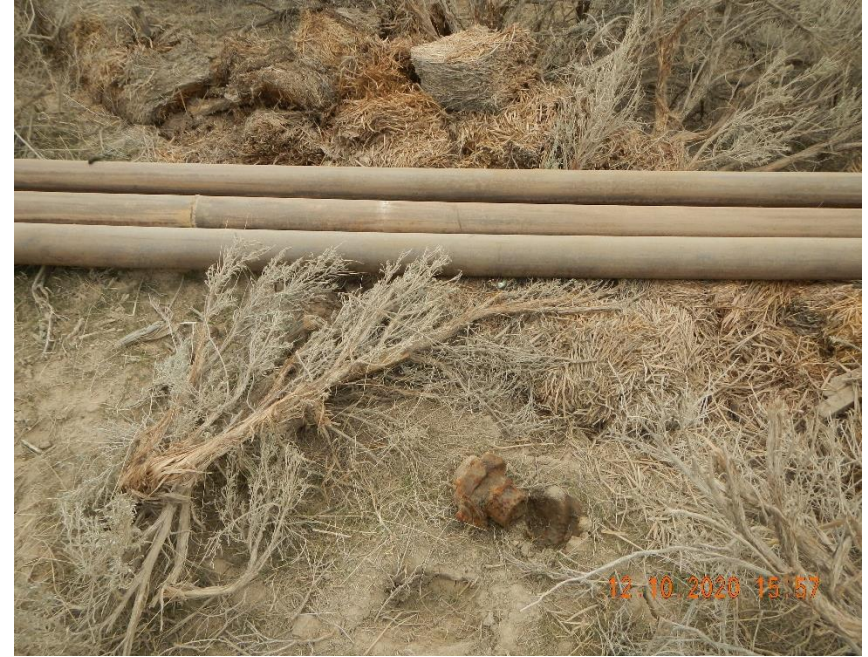
**Unused 2" ball valve.**

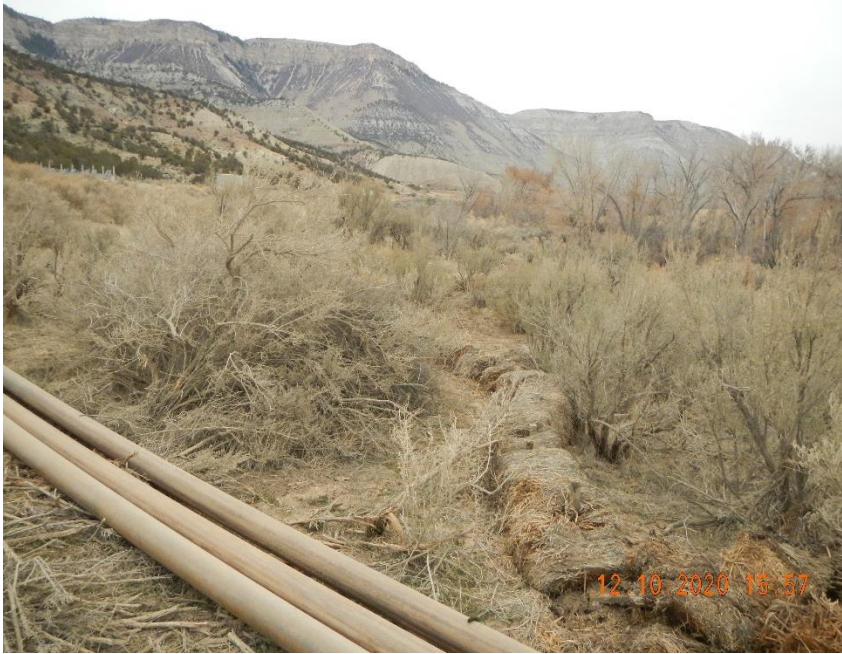
**Unmaintained straw bales running along  
east edge of location.**

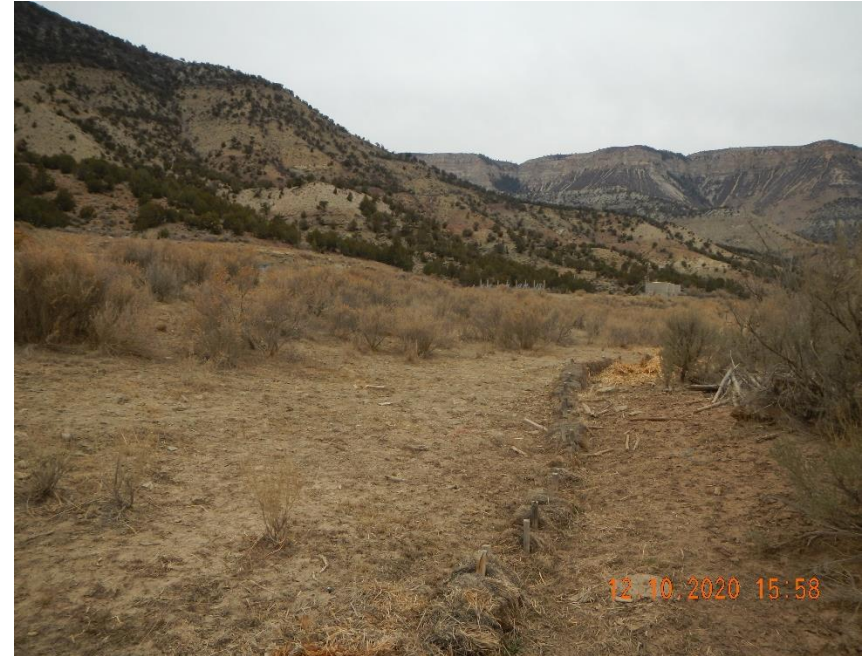
**Unmaintained straw bales running along  
east edge of location.**

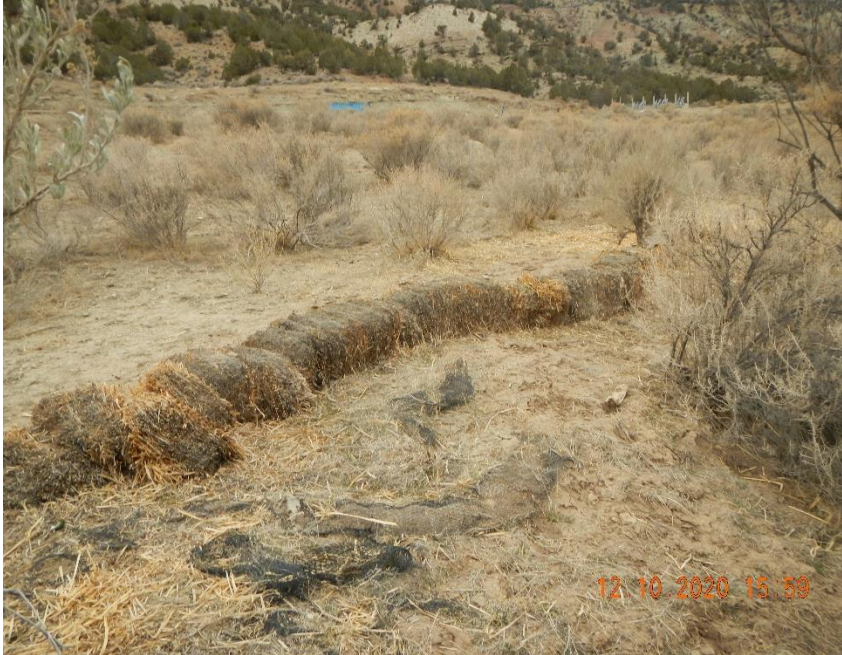
**Unmaintained waddles and straw bales  
running along east edge of location.**

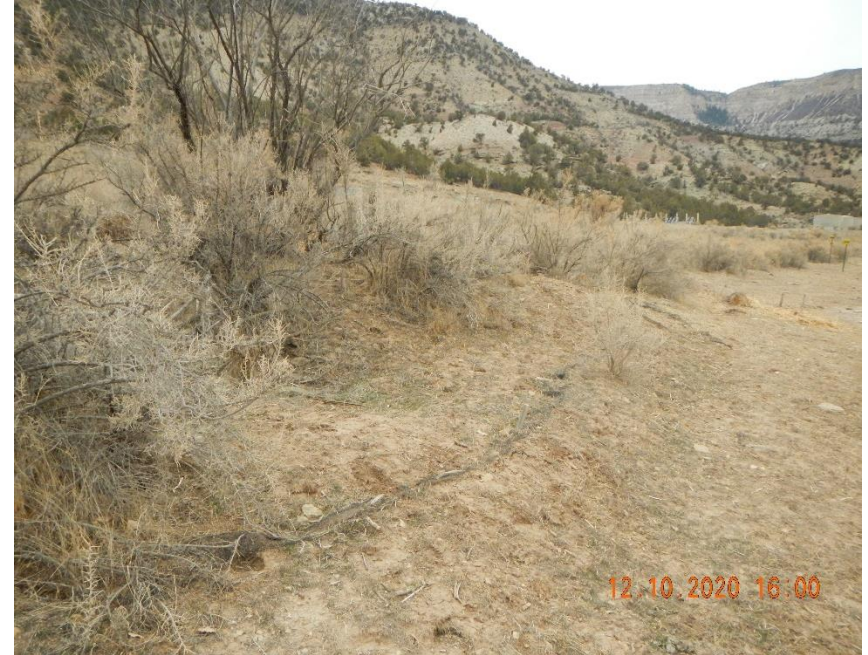
**Unmaintained waddles and straw bales  
running along east edge of location.**

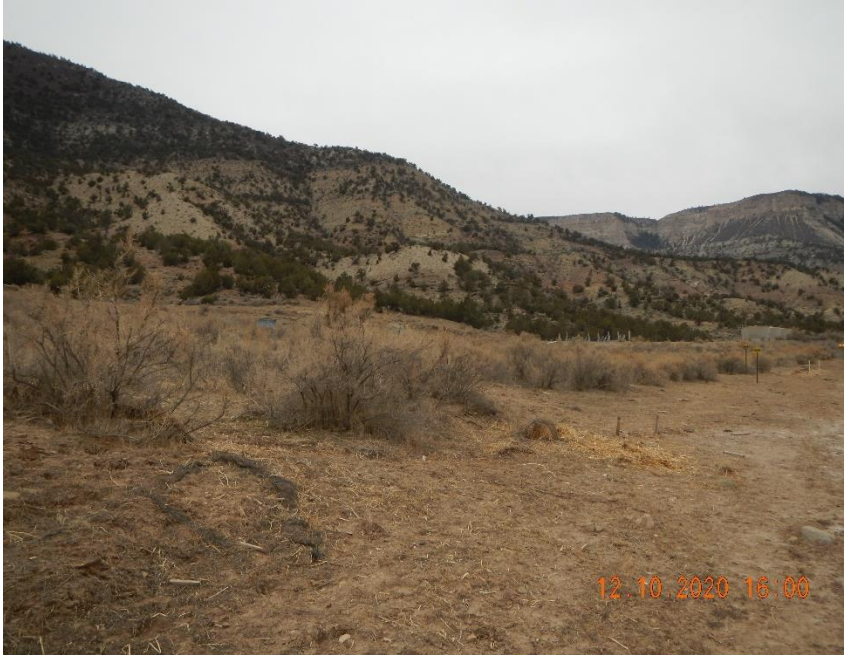
**Unmaintained waddles and straw bales  
running along east edge of location.**
