Inspection Photos

Location Name: MARALEX RESOURCES INC SULFUR GULCH 9-98-1-69S98W /1SWNE

Location ID: 312658

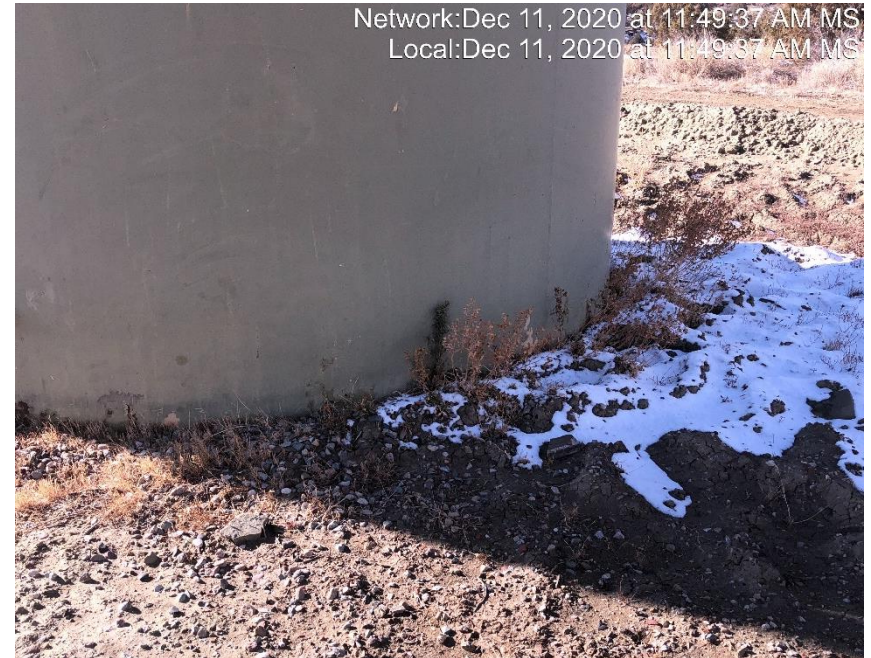
Photo #2456 Debris inside tank containment.

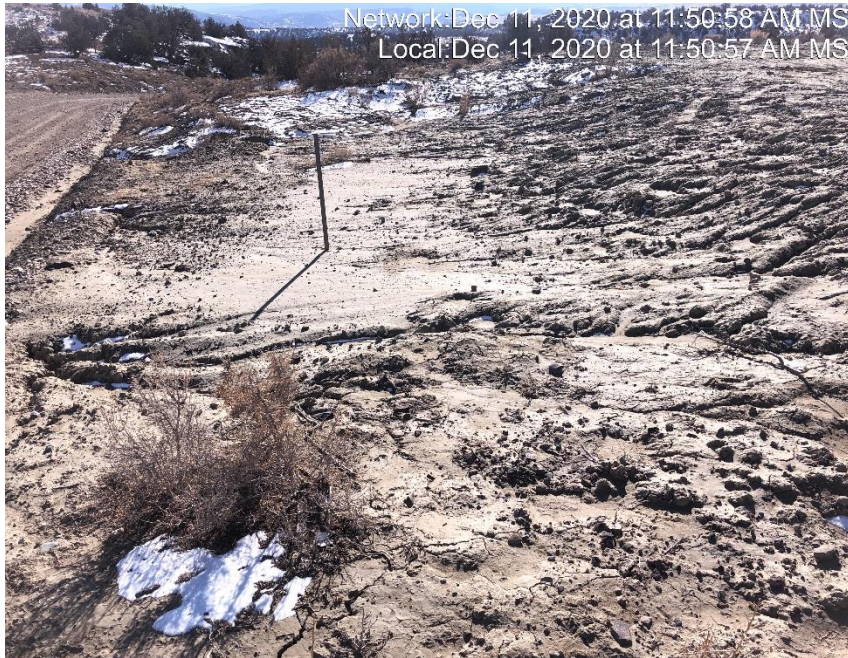
Photo #2457 Sediment migrating off of location and into access road ditch.

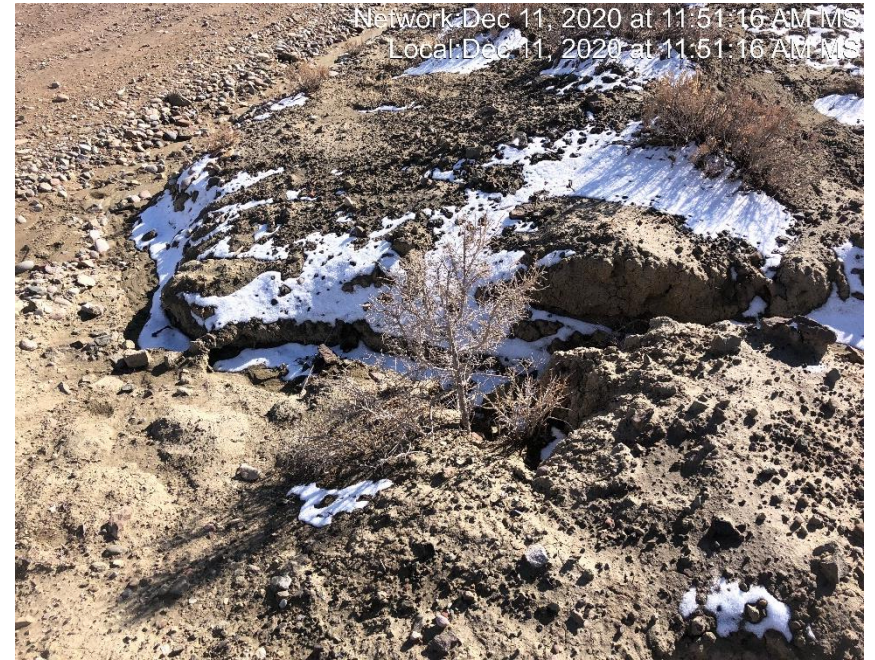
Photo #2458 Rill erosion occurring on SE side of location.

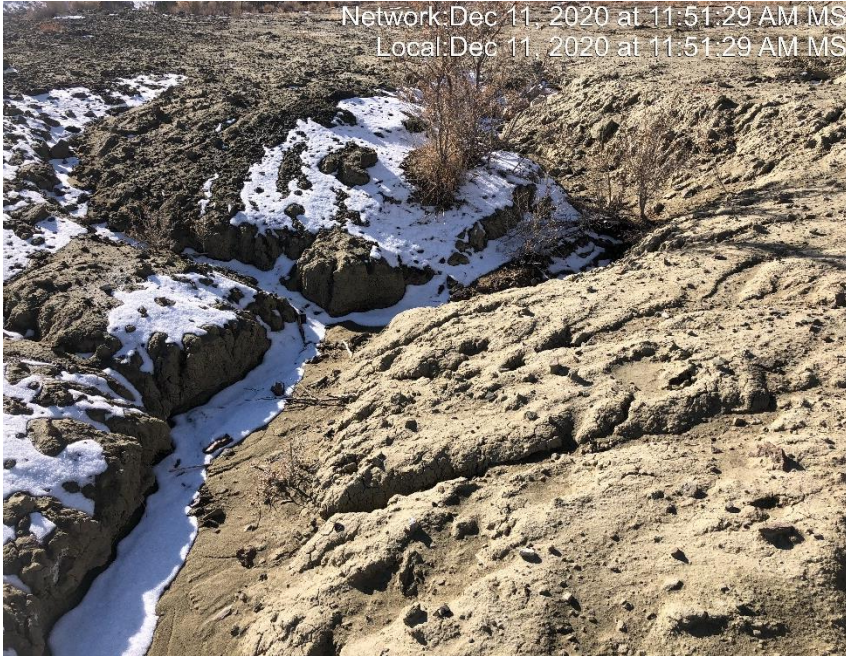
Photo #2459 Rill erosion occurring on SE side of location.
