Inspection Photos
Operator: Logos Operating
API: 067-08122
Date: 12/9/2020

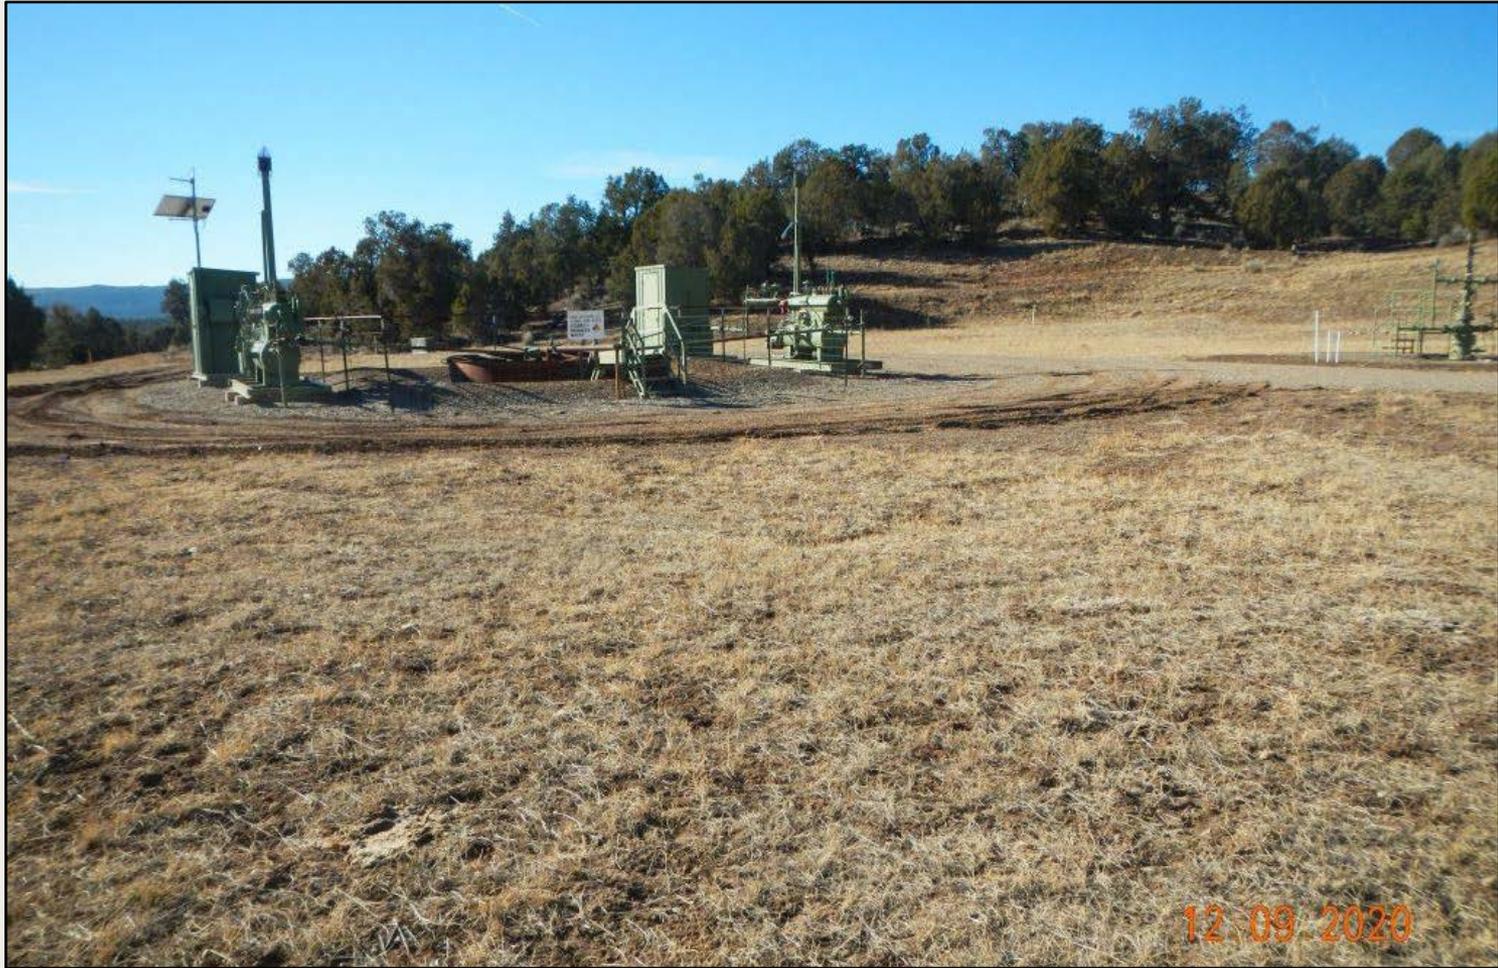
Photo 1. View of the project area from the northeastern corner facing center.

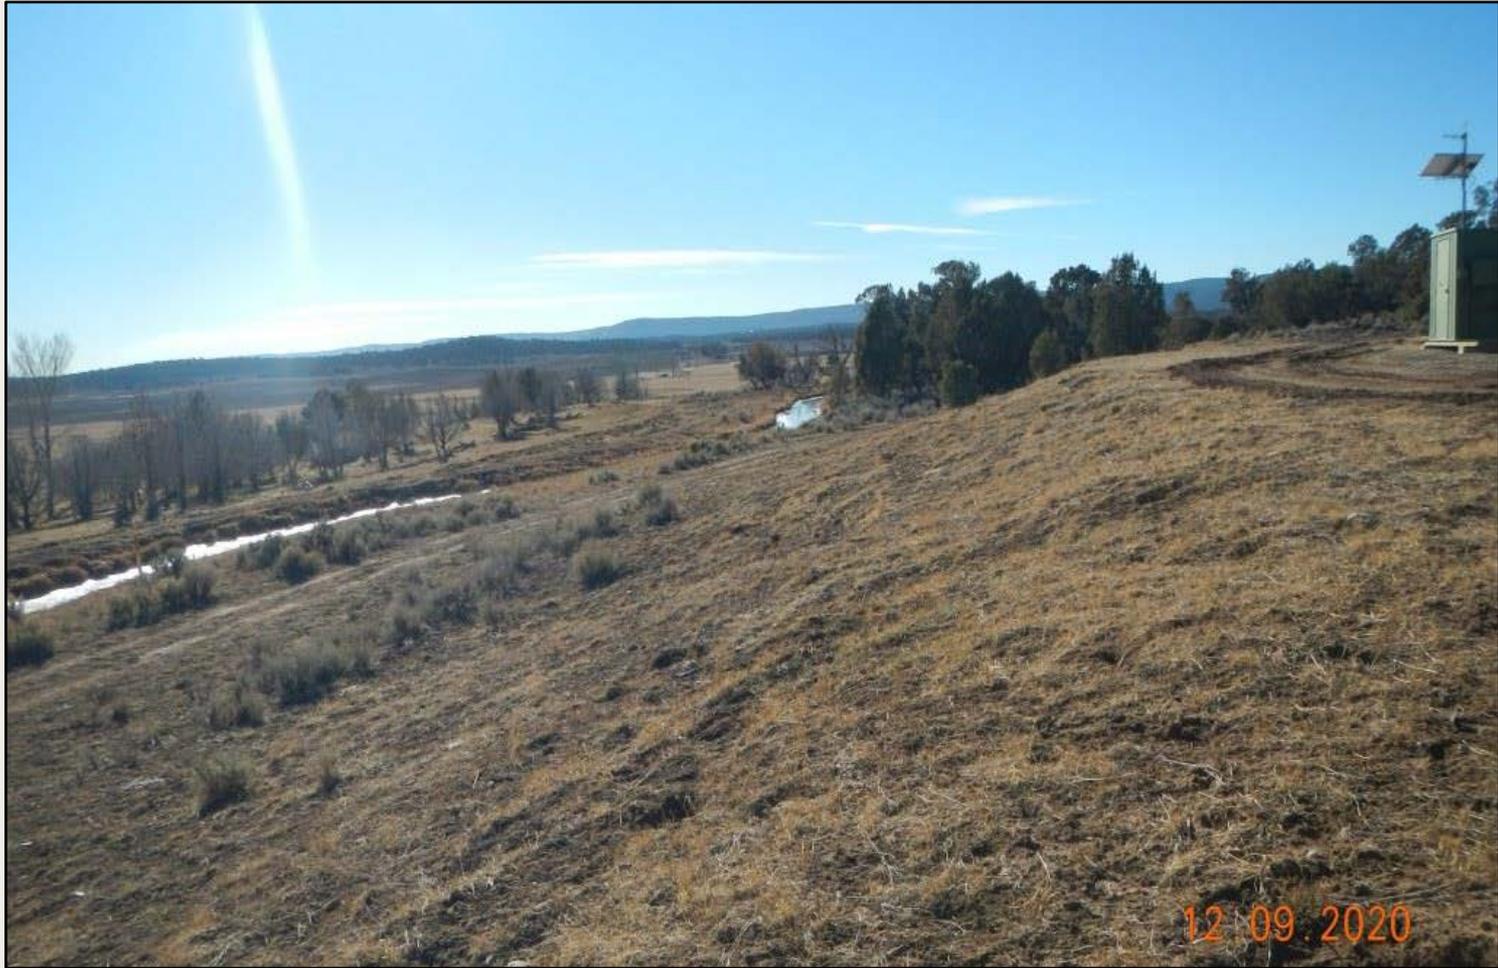
Photo 2. View of the eastern reclamation area from the northeastern corner facing southward. Revegetation is progressing with grasses such as western wheatgrass, and others in a grazed vegetative condition.

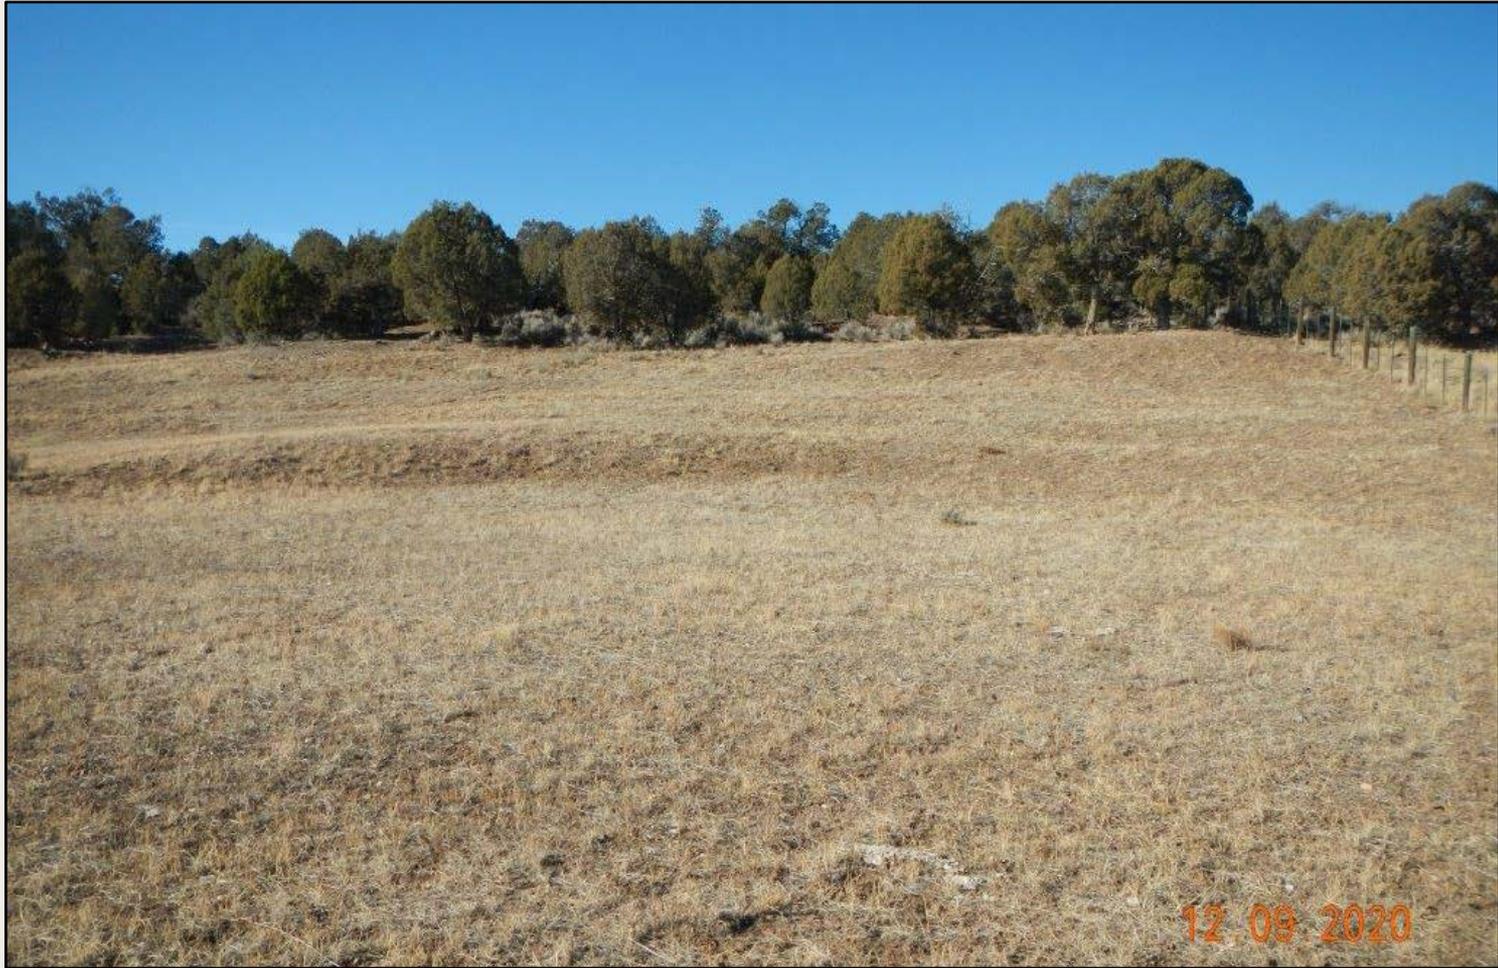
Photo 3. View of the northern project area from the northeastern corner facing westward.

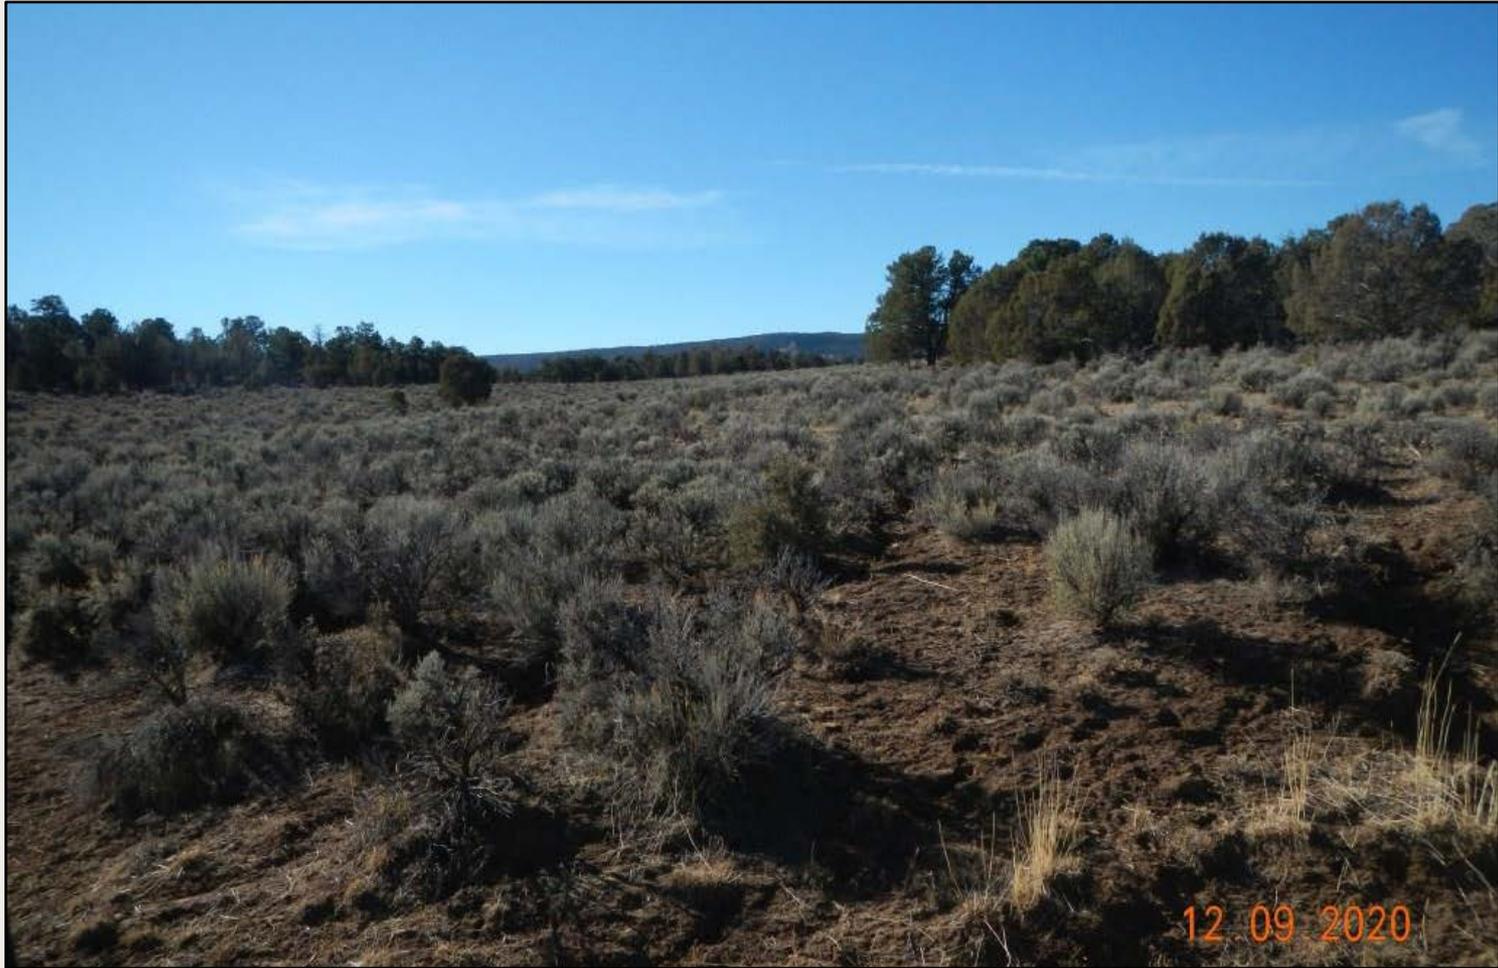
Photo 4. View of the reference area comprised of mixed sagebrush shrubland and pinyon/juniper woodland with grasses such as western wheatgrass and blue grama in the understory. Forbs were not observable at this time.
