Inspection Photos
Operator: Simcoe
API: 067-08831
Date: 12/9/2020

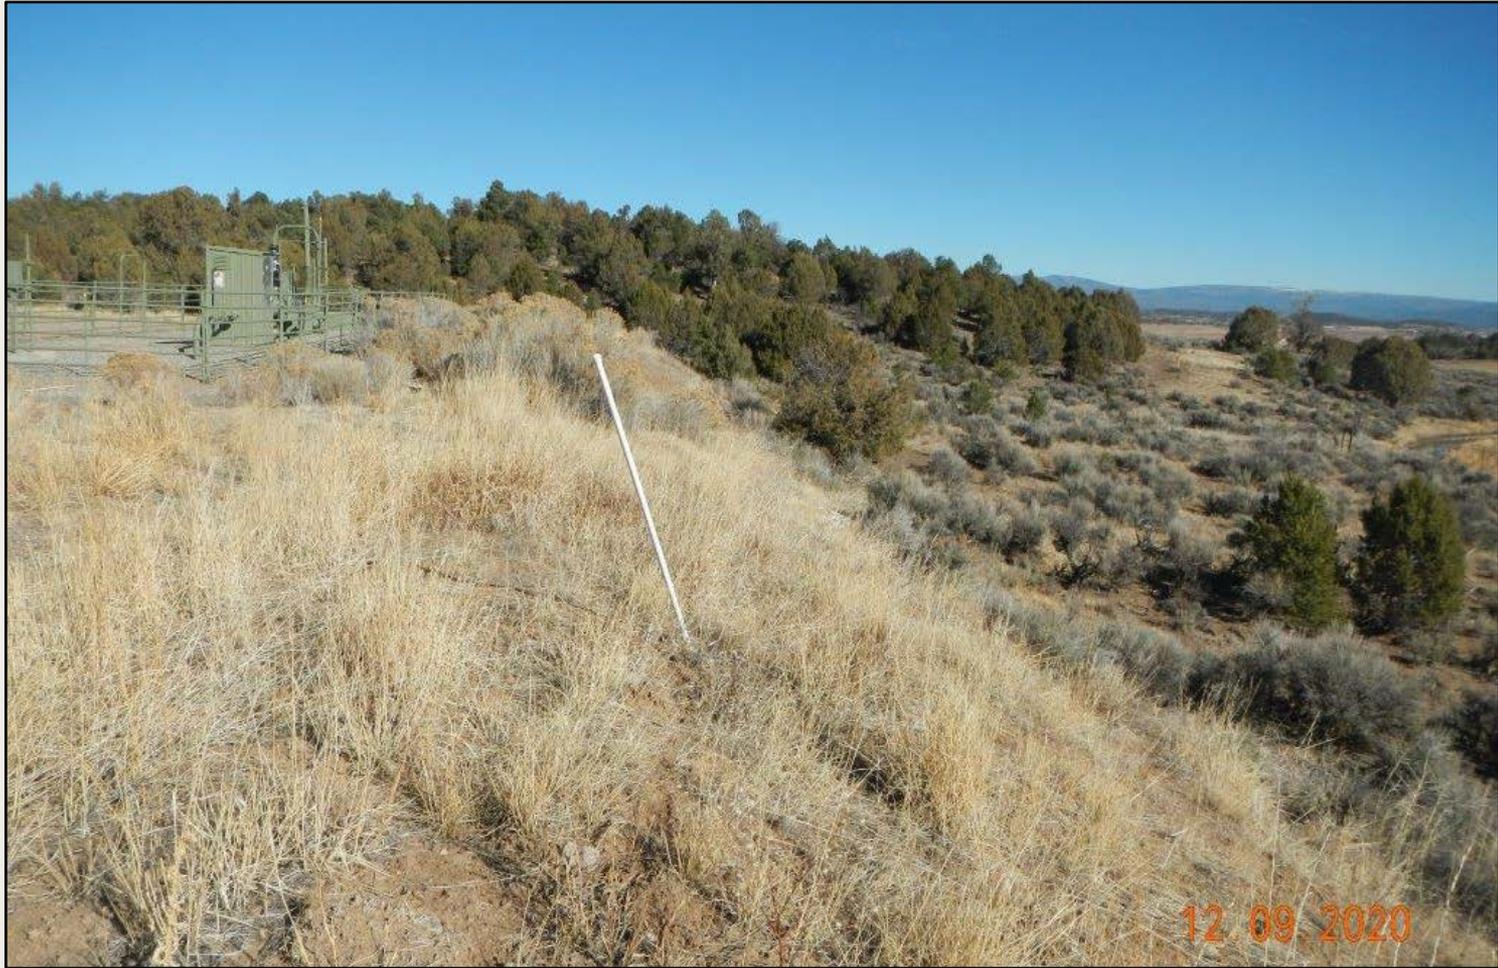
Photo 1. View of the eastern fill slope from the southeastern corner facing northward. Revegetation is progressing with grasses such as western wheatgrass, intermediate wheatgrass, and sand dropseed.

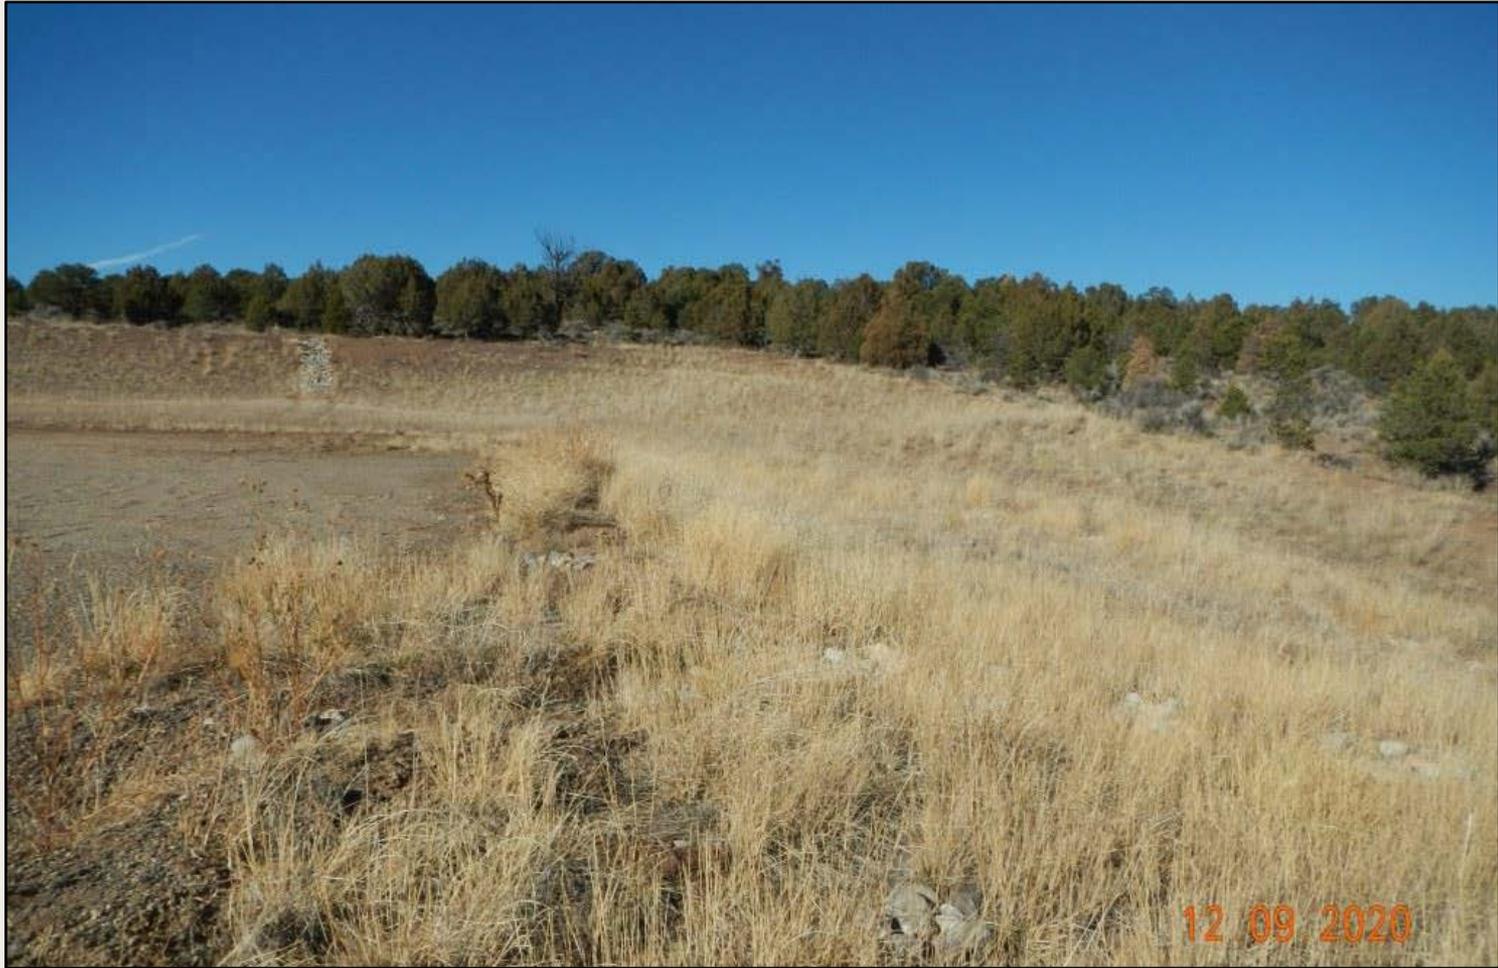
Photo 2. View of the northern reclamation area from the northeastern corner facing westward.
