Inspection Photos
Operator: Logos Operating
API: 067-08297
Date: 12/9/2020

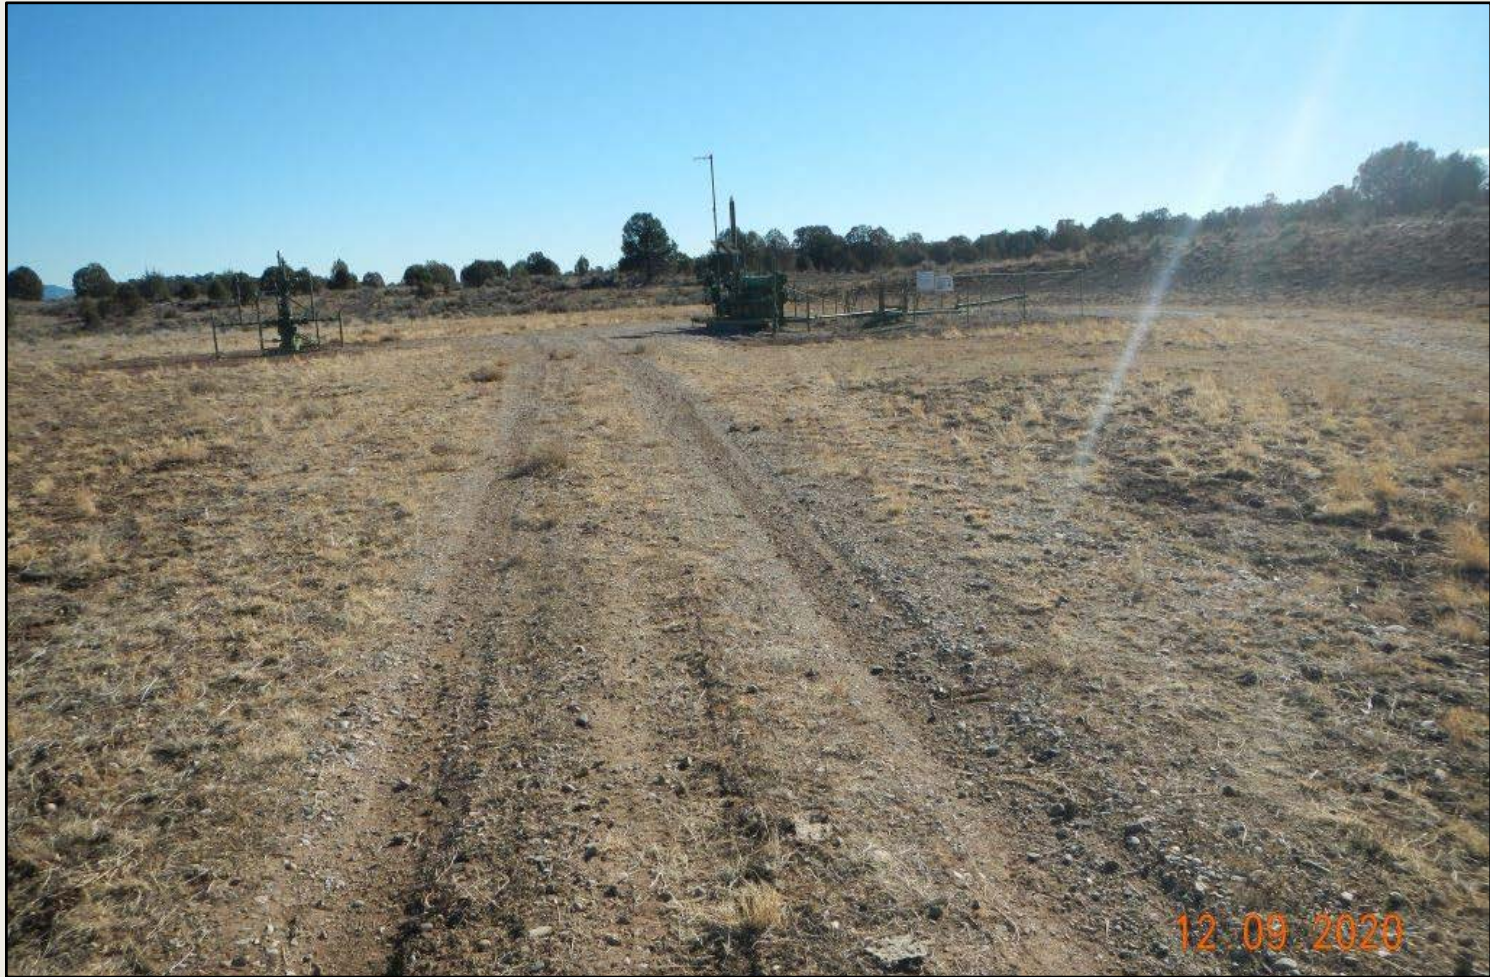
Photo 1. View of the project area from the well pad entrance facing center.

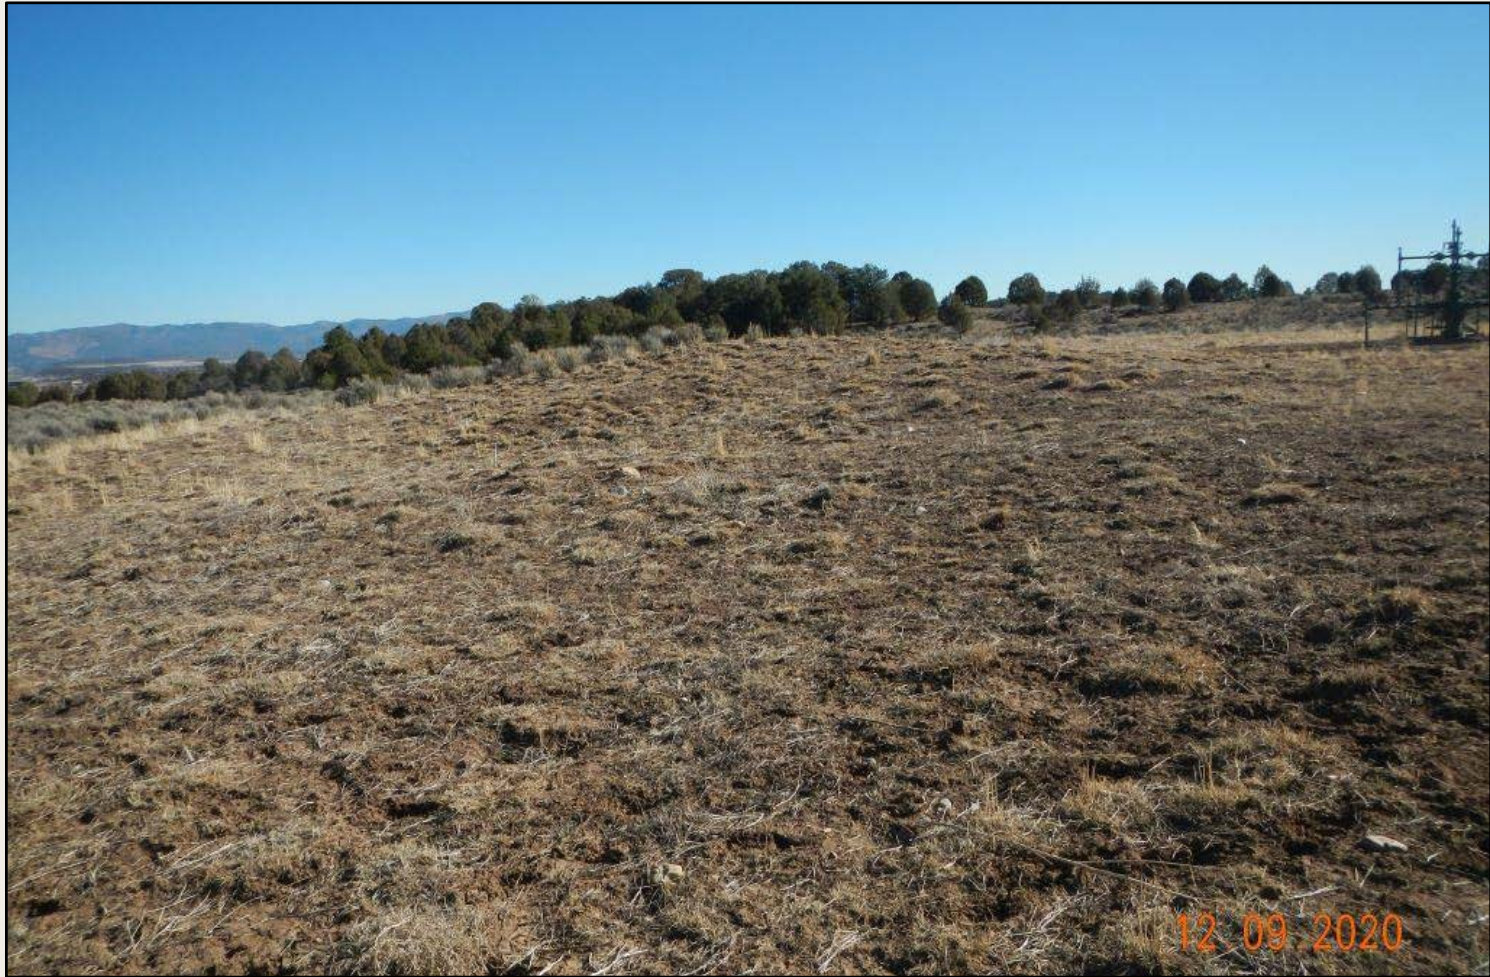
Photo 2. View of the northern reclamation area from the northwestern corner facing eastward. Revegetation is progressing with grasses such as western wheatgrass, intermediate wheatgrass, and sand dropseed, largely in a grazed vegetative condition.

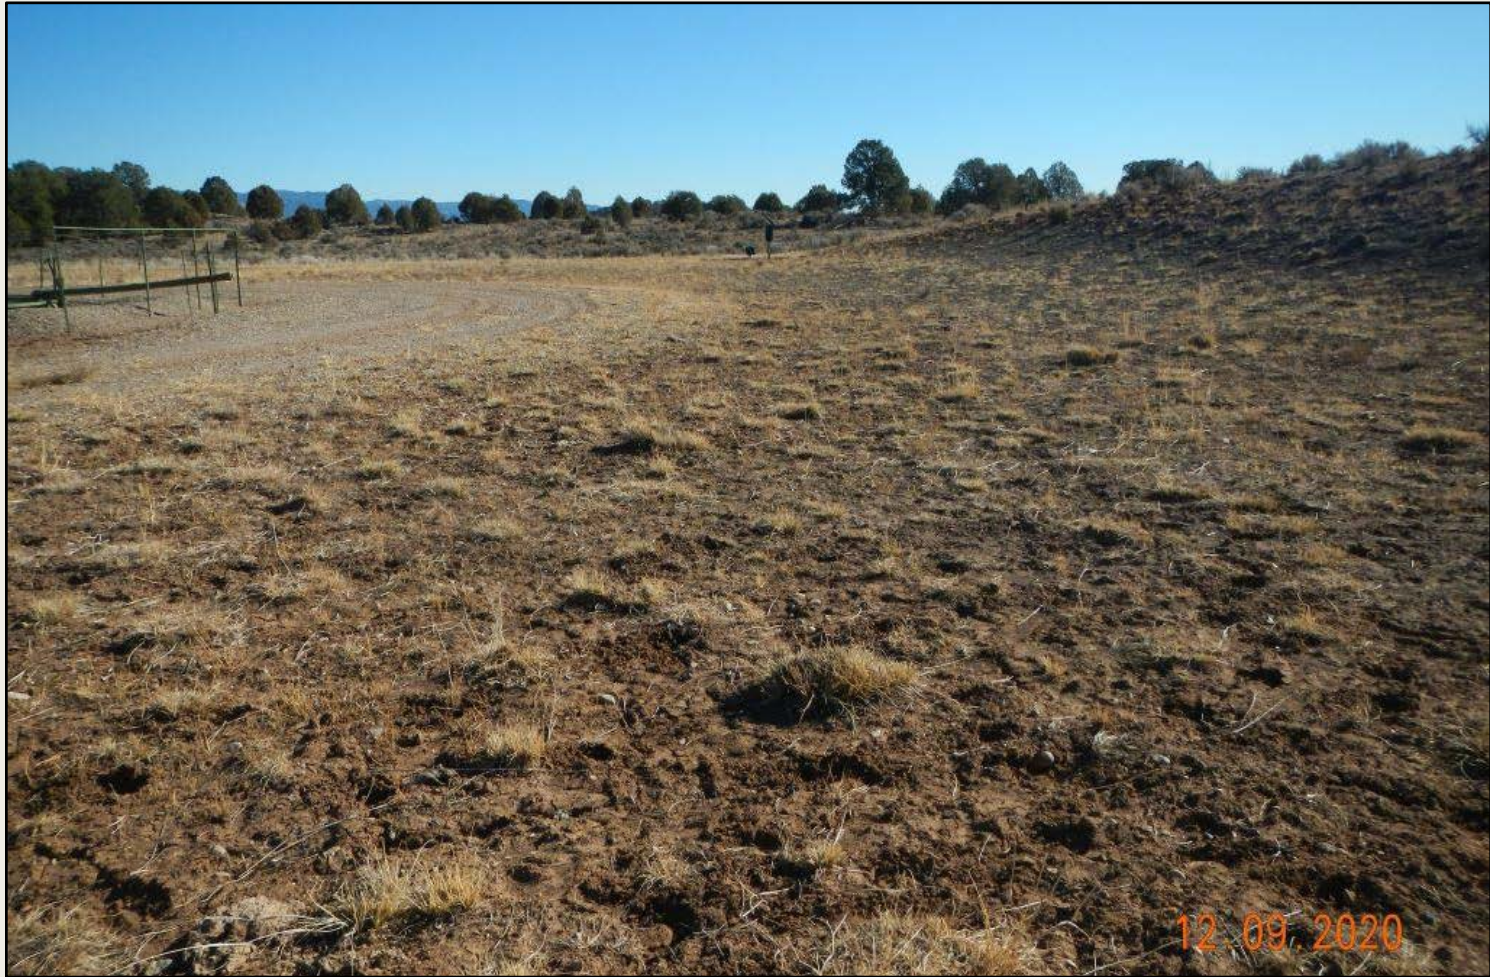
Photo 3. View of the southern reclamation area from the southeastern corner facing westward.

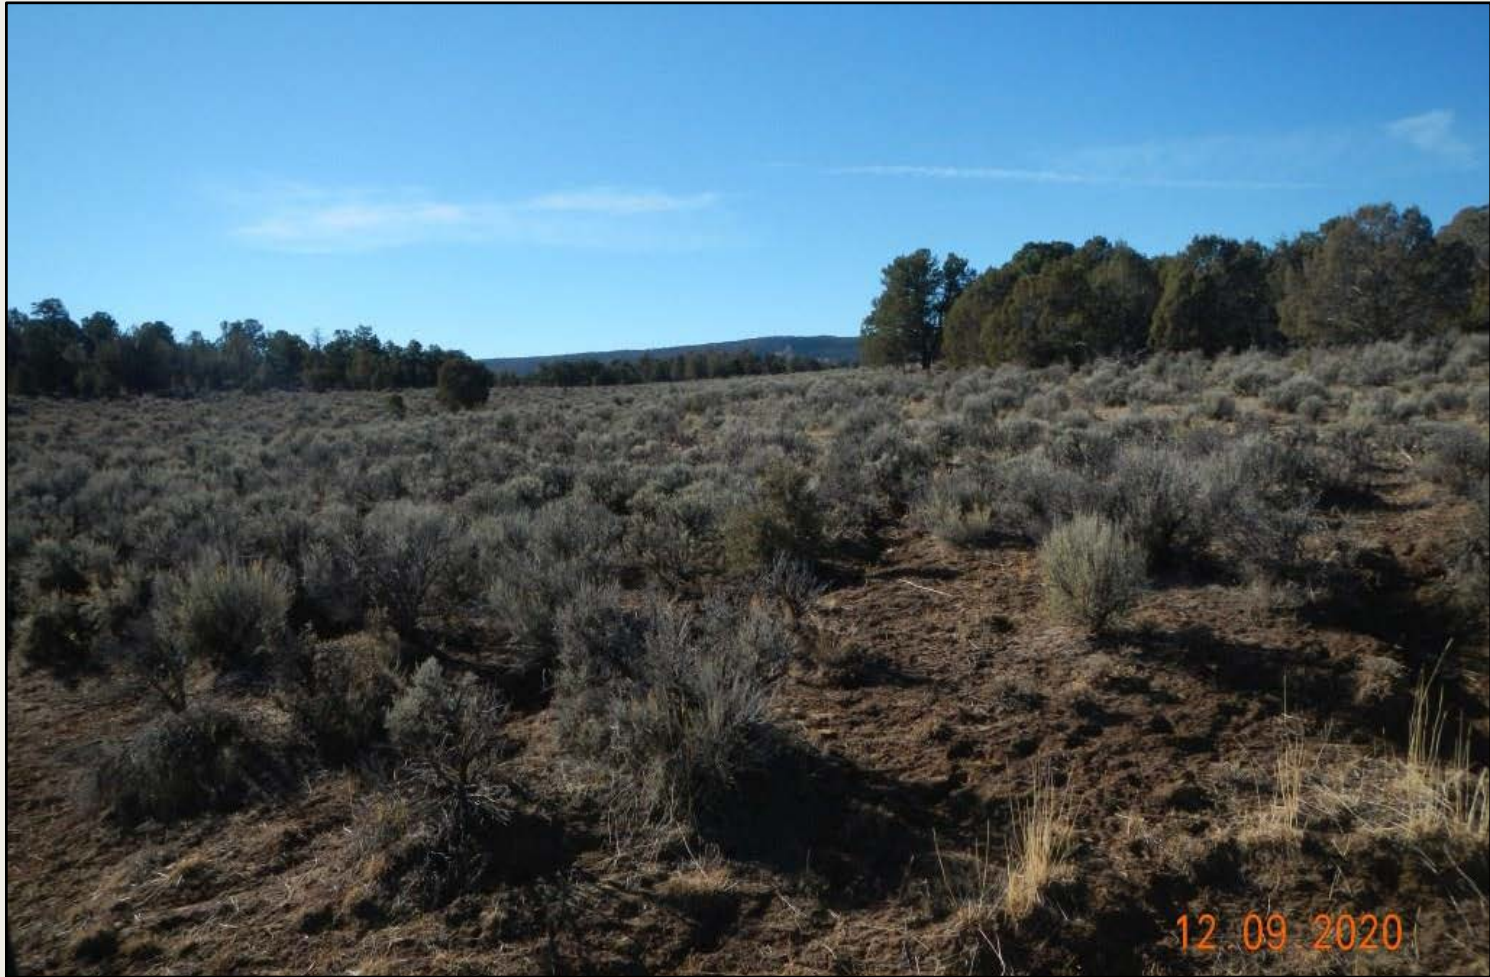
Photo 4. View of the reference area comprised of mixed sagebrush shrubland and pinyon/juniper woodland with grasses such as western wheatgrass and blue grama in the understory. Forbs were not observable at this time.
