Inspection Photos
Operator: Logos Operating
API: 067-08121
Date: 12/9/2020

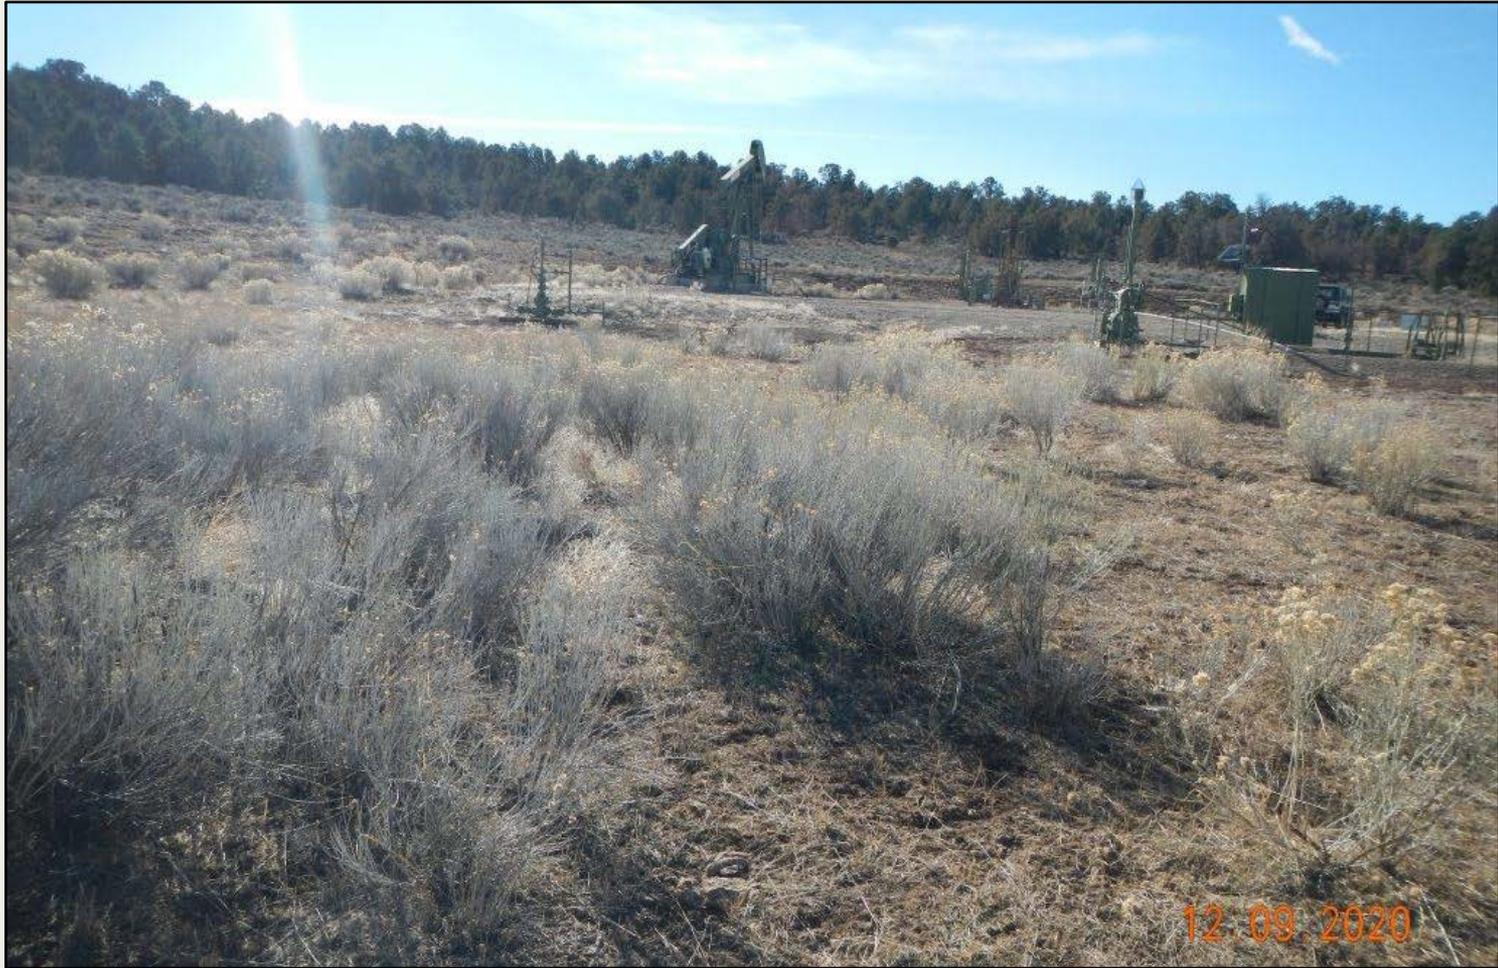
Photo 1. View of the project area from the northeastern corner facing center.

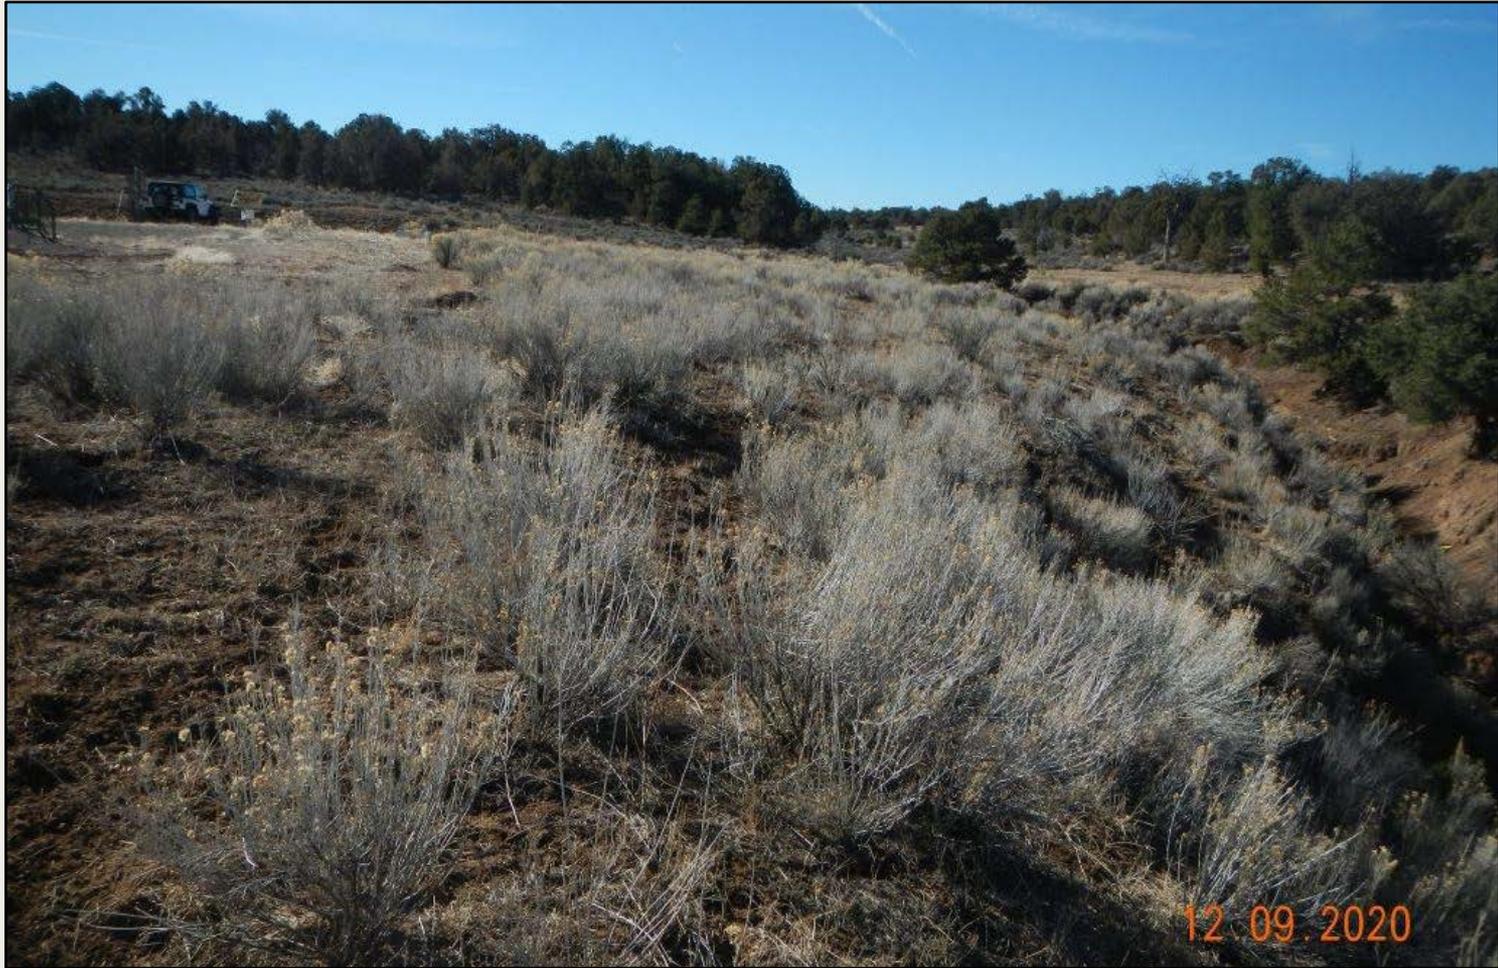
Photo 2. View of the fill slope from the northeastern corner facing westward. Revegetation is progressing with grasses and shrubs such as western wheatgrass and rubber rabbitbrush.

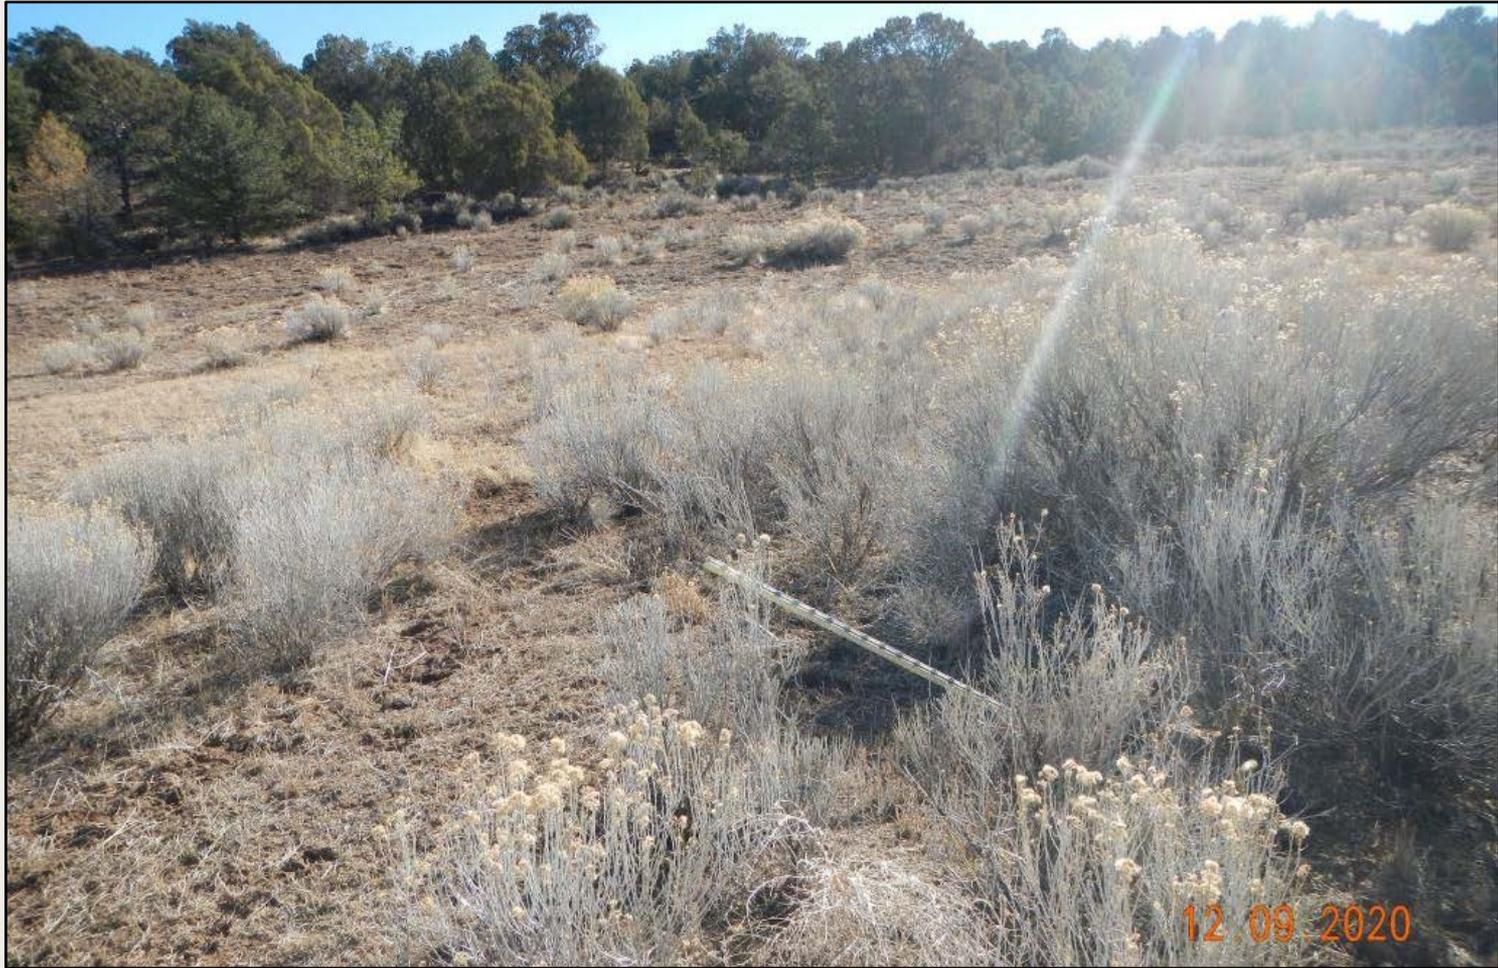
Photo 3. View of the eastern reclamation area from the northeastern corner facing southward.
