**Re: Pit Closure Summary Letter Report
Investment Equipment LLC - Operator # 10330
Chester Kincheloe #1 Tank Battery
API: 05-121-09205
Facility ID: 107531
Legal: SESW Sec 11-3S-R51W**

Investment Equipment
Chester Kincheloe #1 Pit Closure
SESW Sec 11-3S-R51W

Photo Log

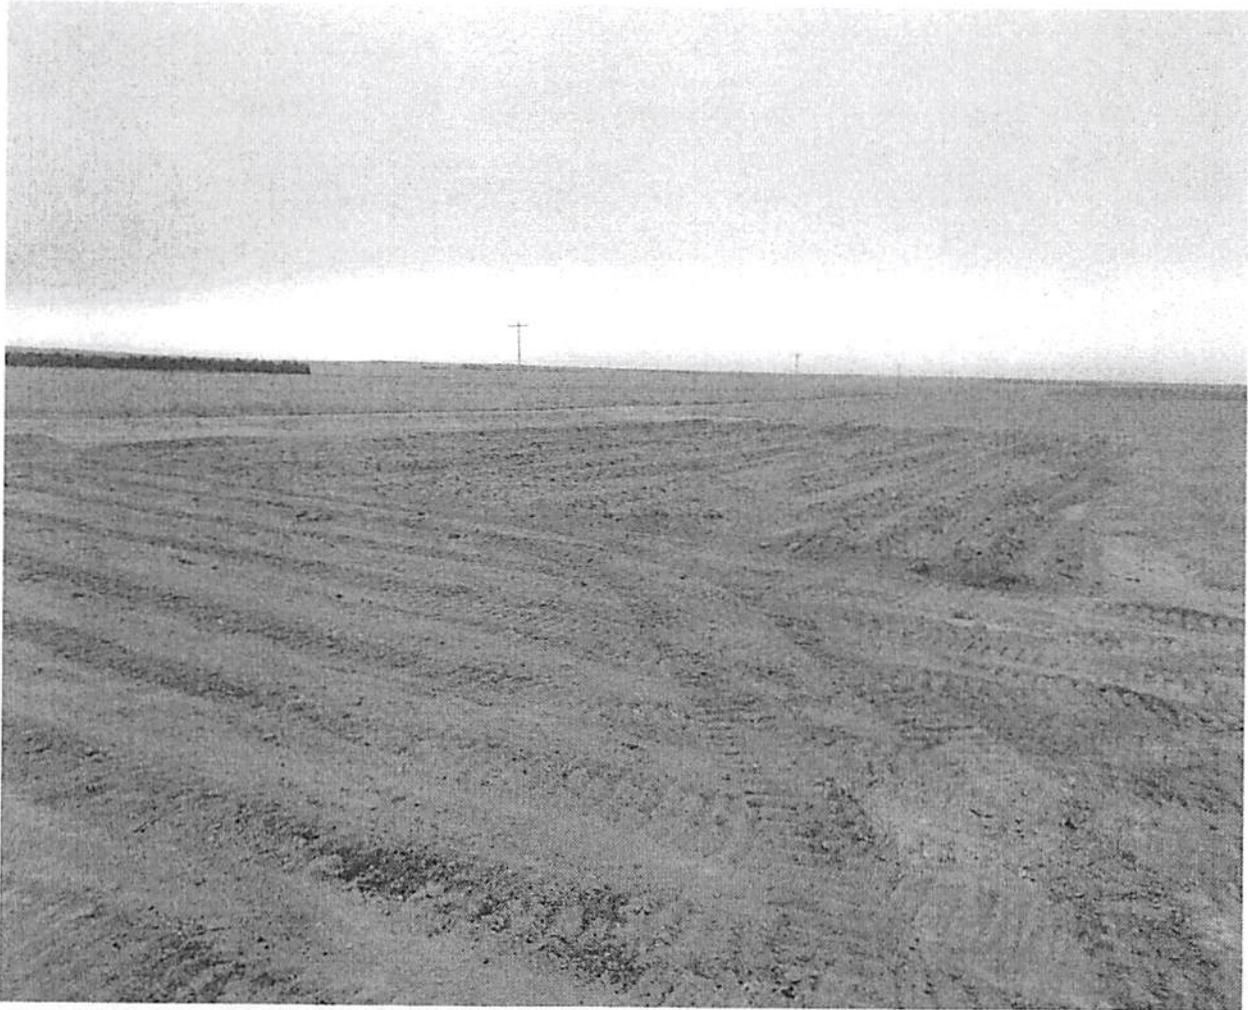
Topsoil bringing pits up to grade. Northeast corner of pits looking Southwest

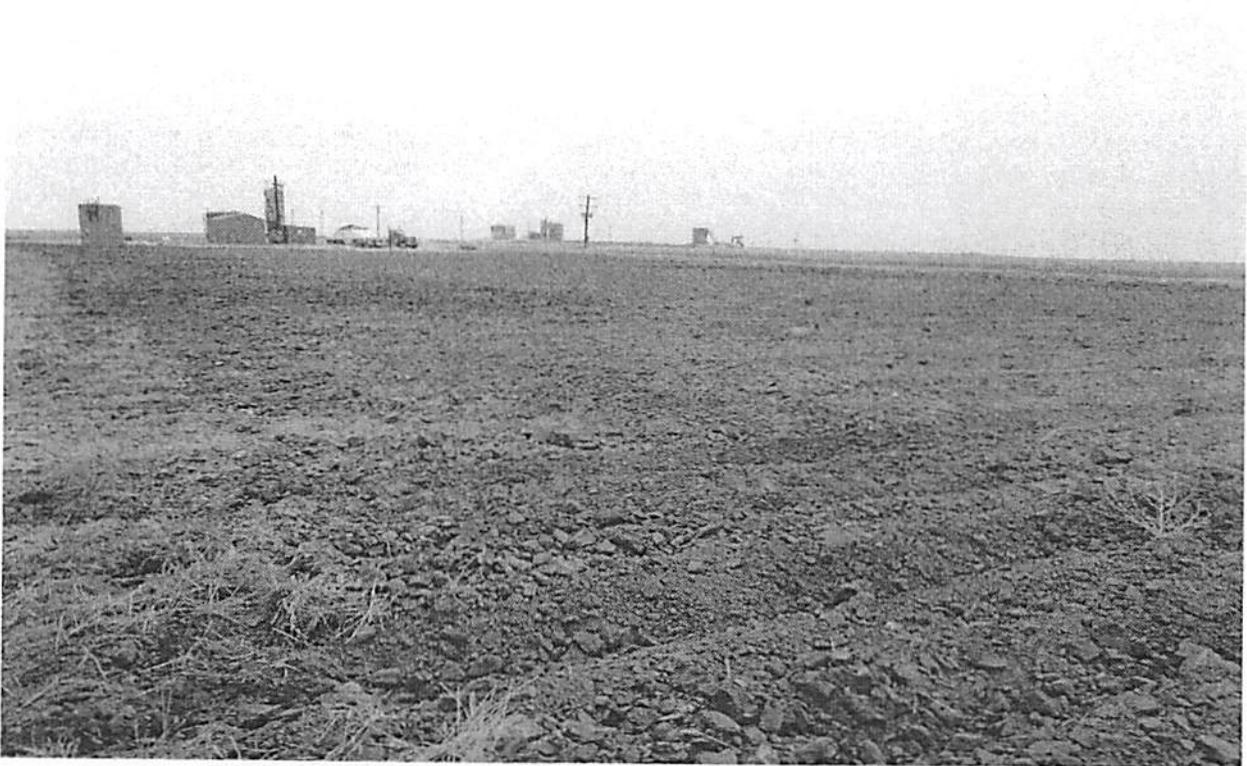
Cross-ripped to alleviate compaction. Northwest corner looking Southeast

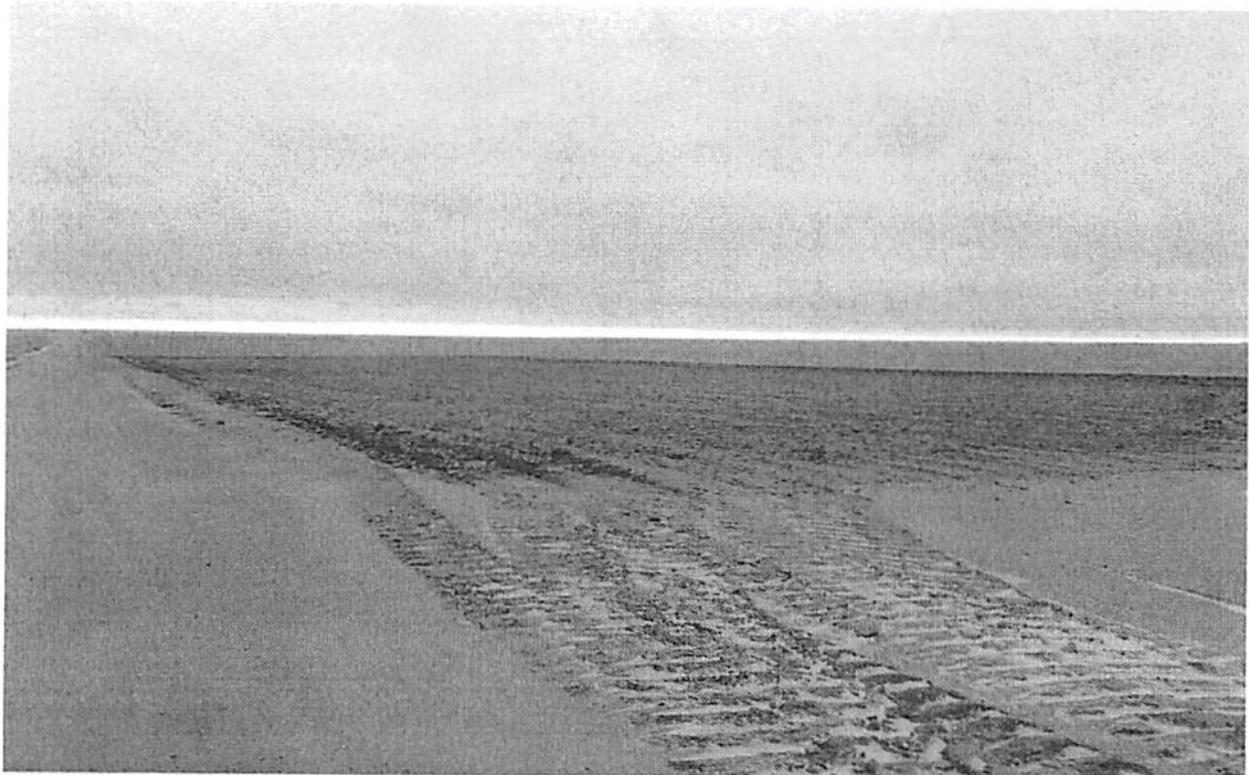
Cross-ripped Southeast corner looking Northwest

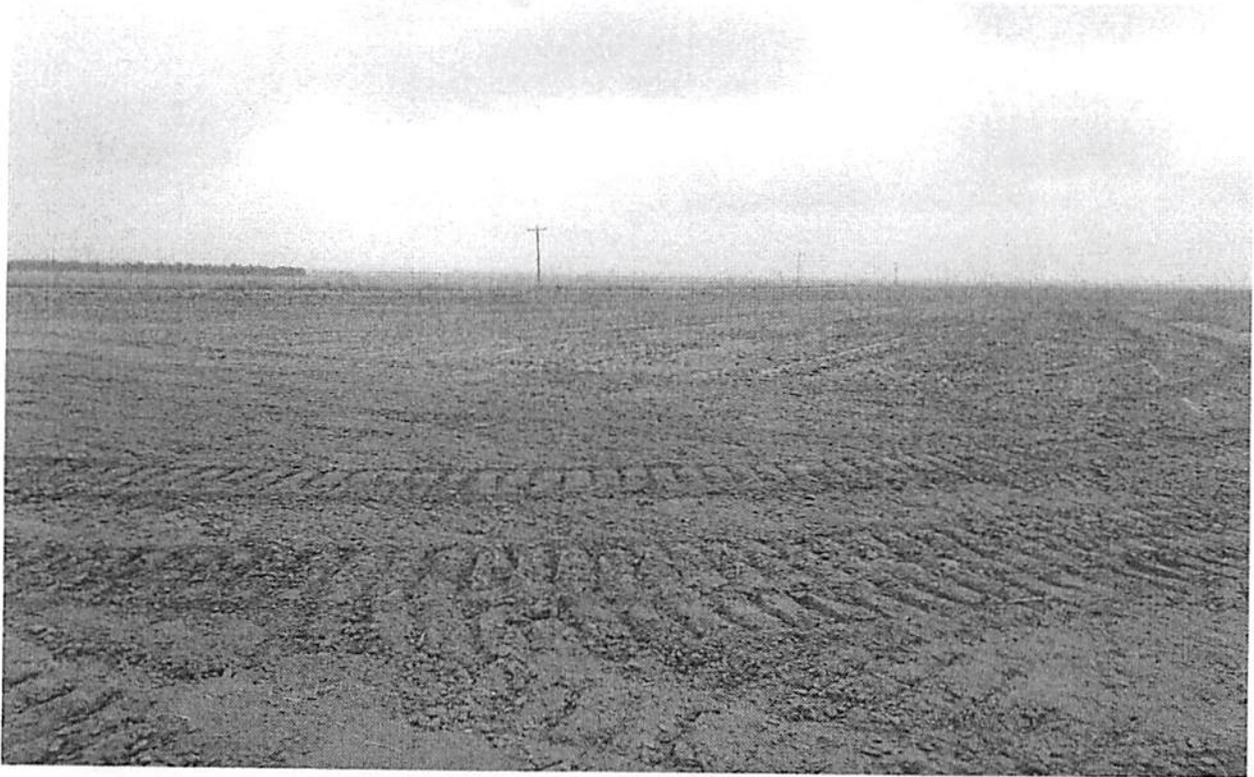
Final grade Northeast corner looking Southwest

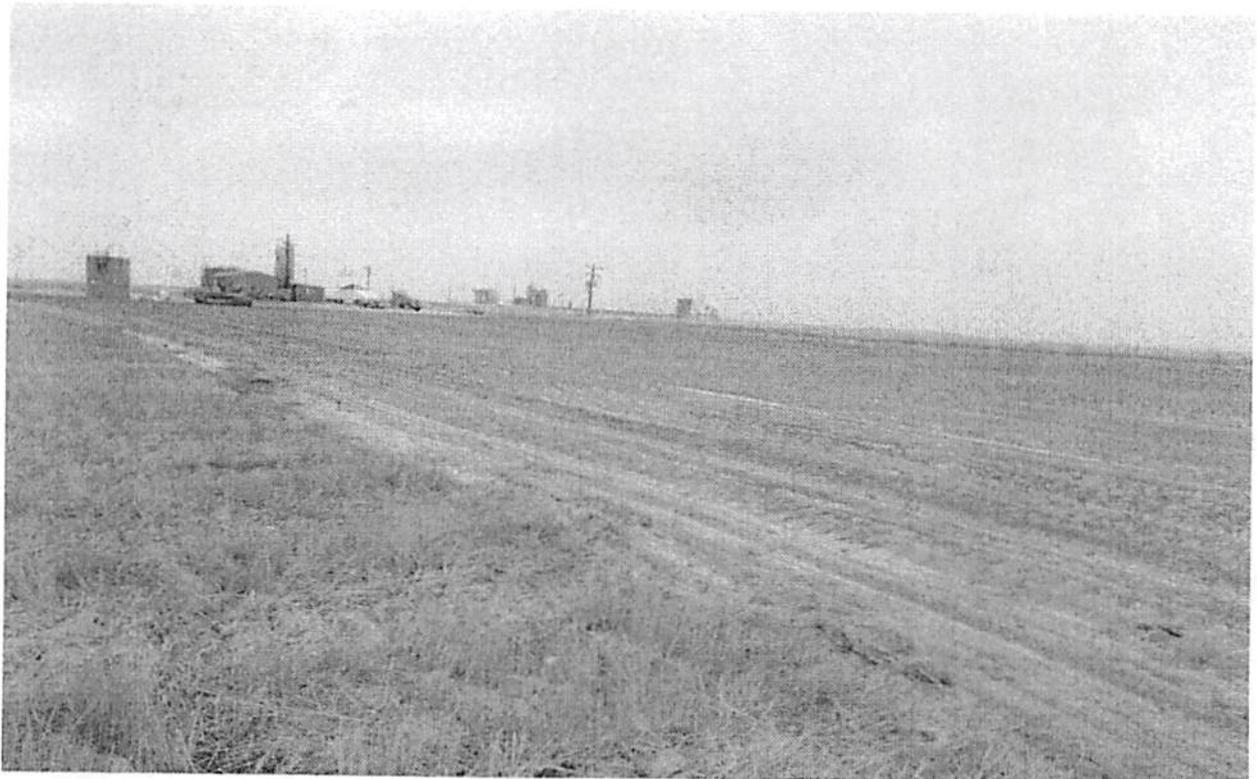
Final grade Northwest corner looking Southeast

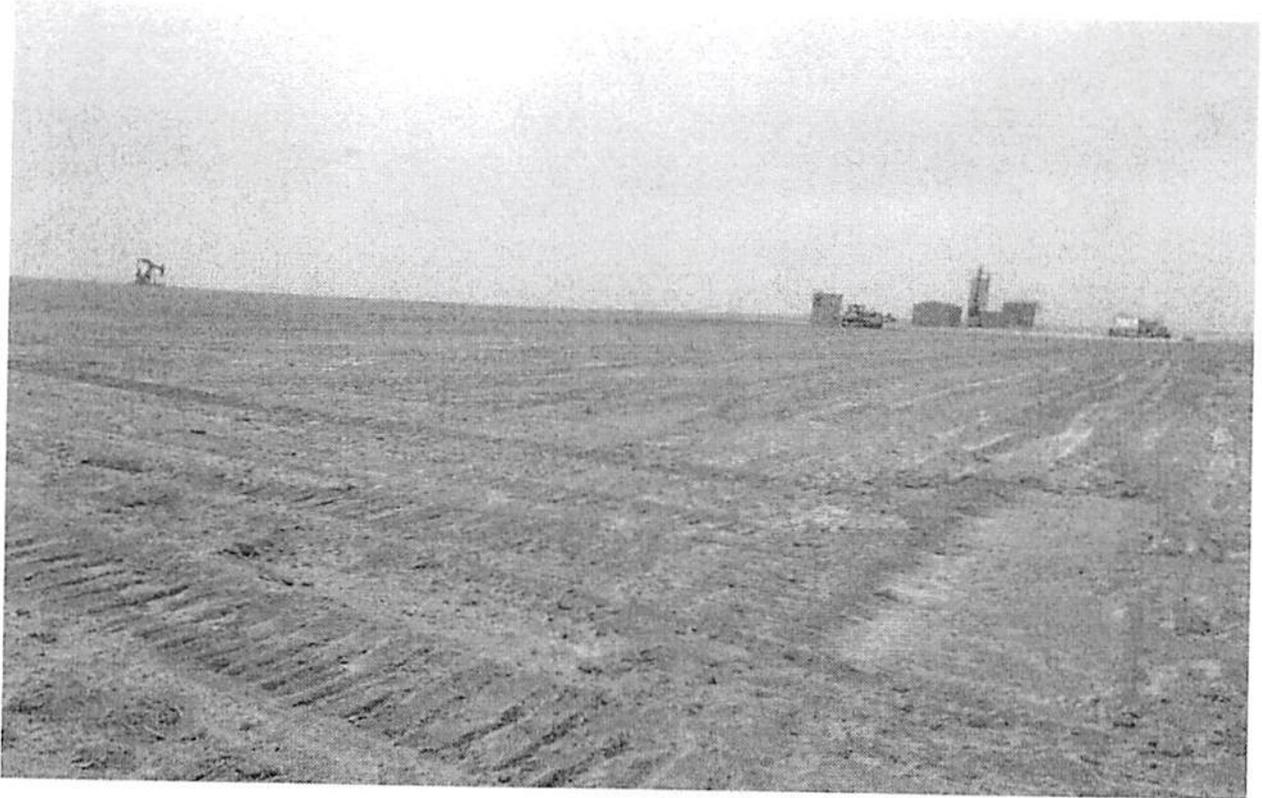
Final grade Southwest corner looking Northeast

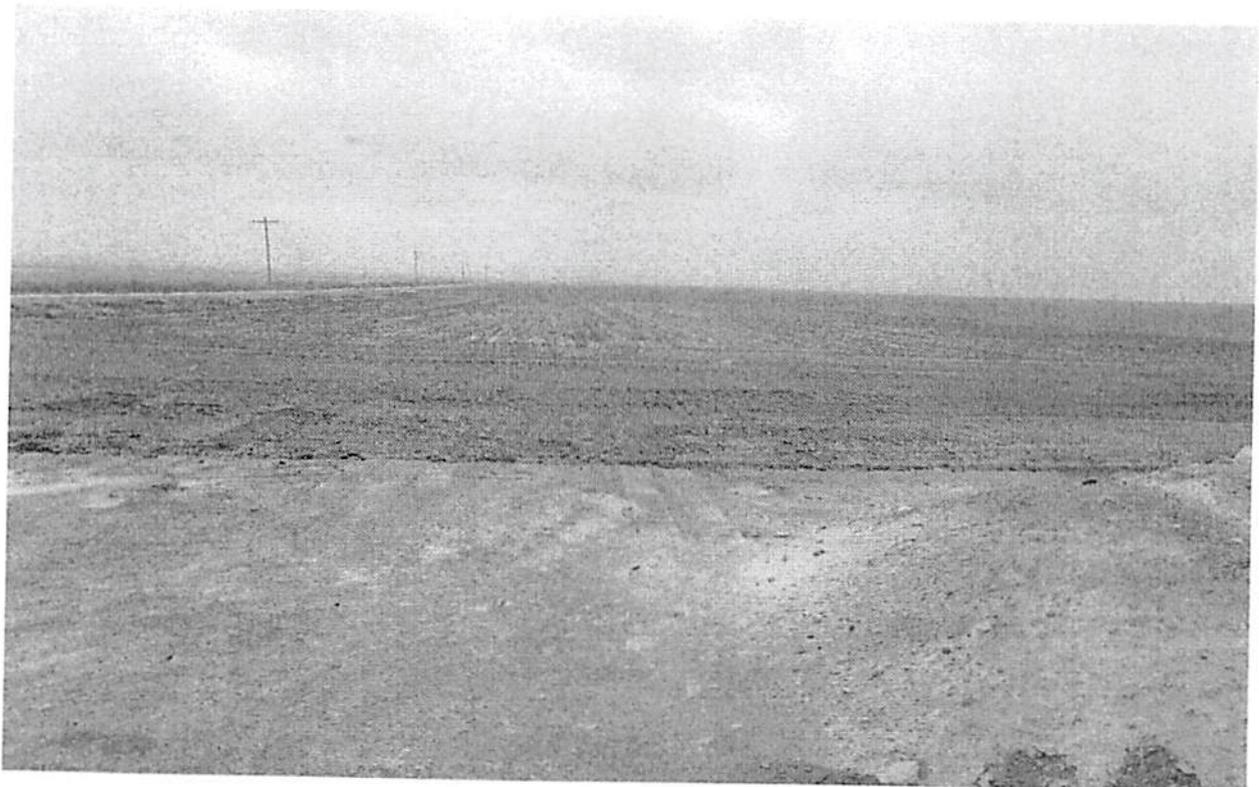
Final grade East end looking West

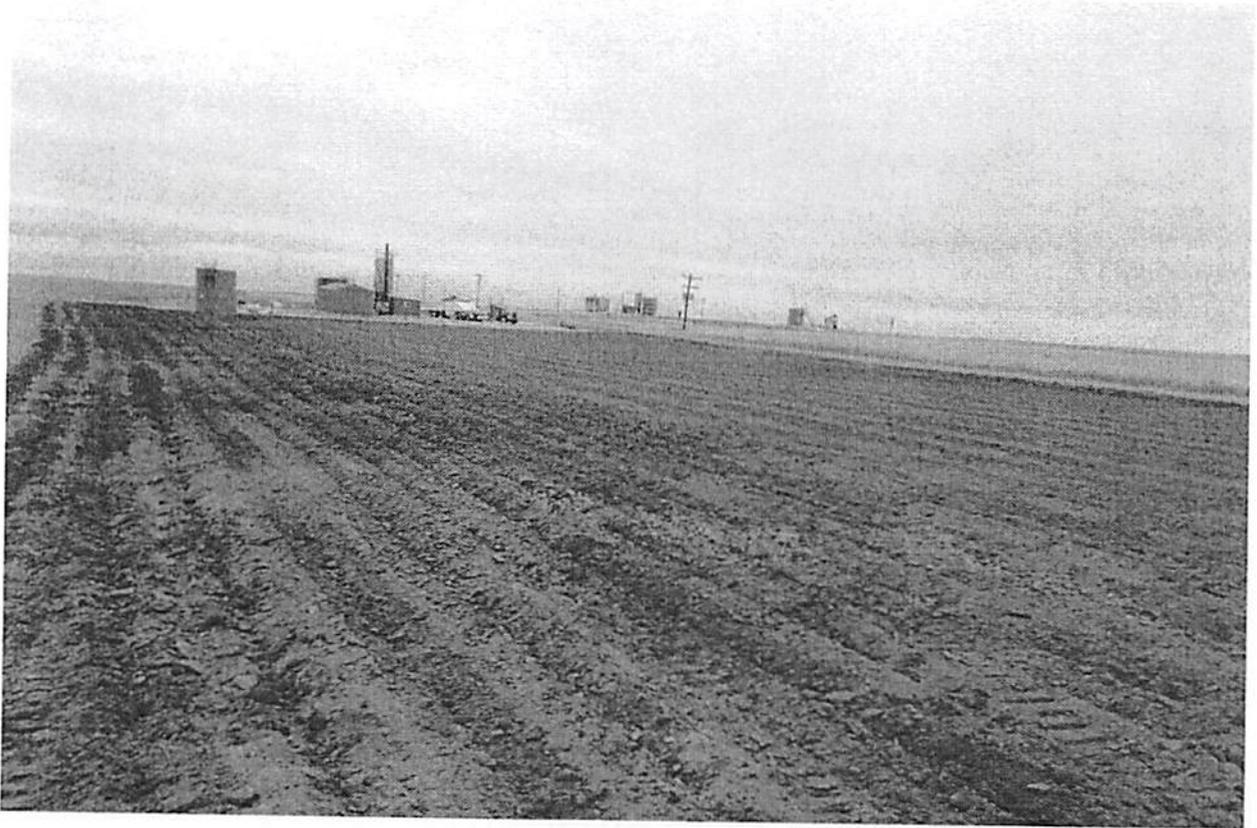
Final Rip Northwest Corner looking Southeast

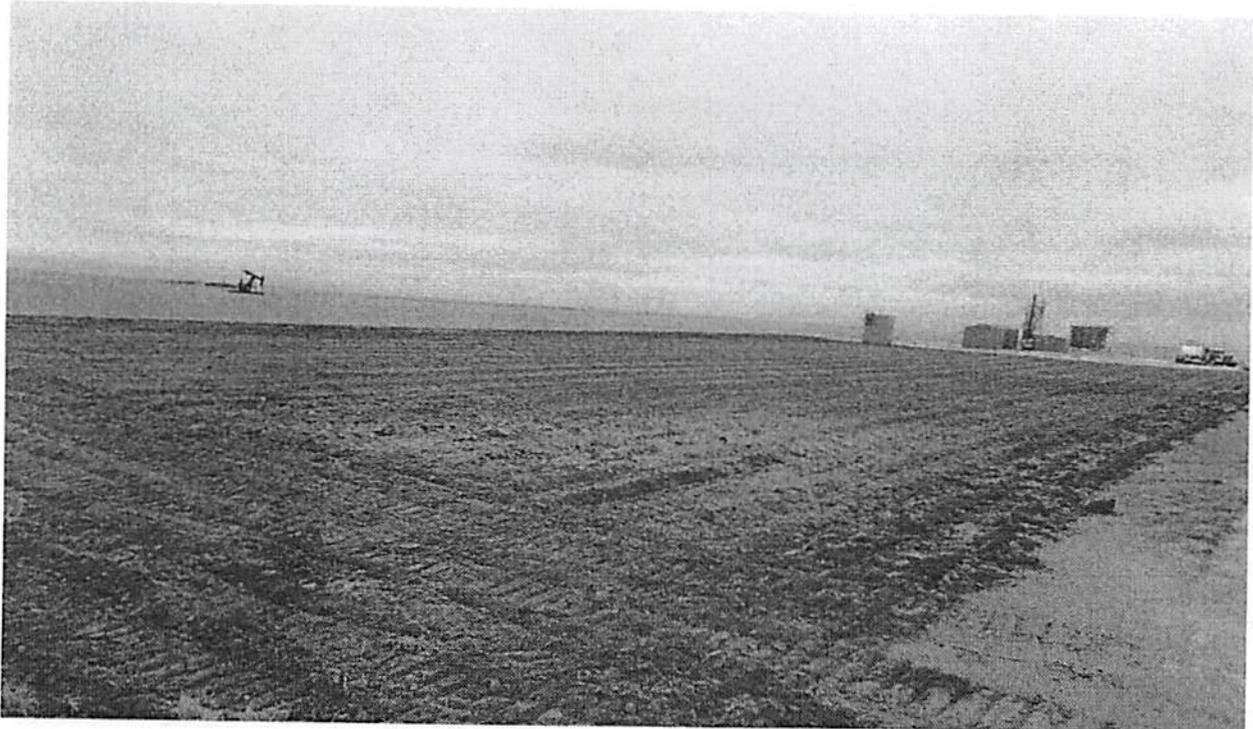
Final Rip Southwest corner looking Northeast
