# Inspection Photos

API: 043-40000

Operator: JAVERNICK OIL

Inspection Date: 12/16/2020

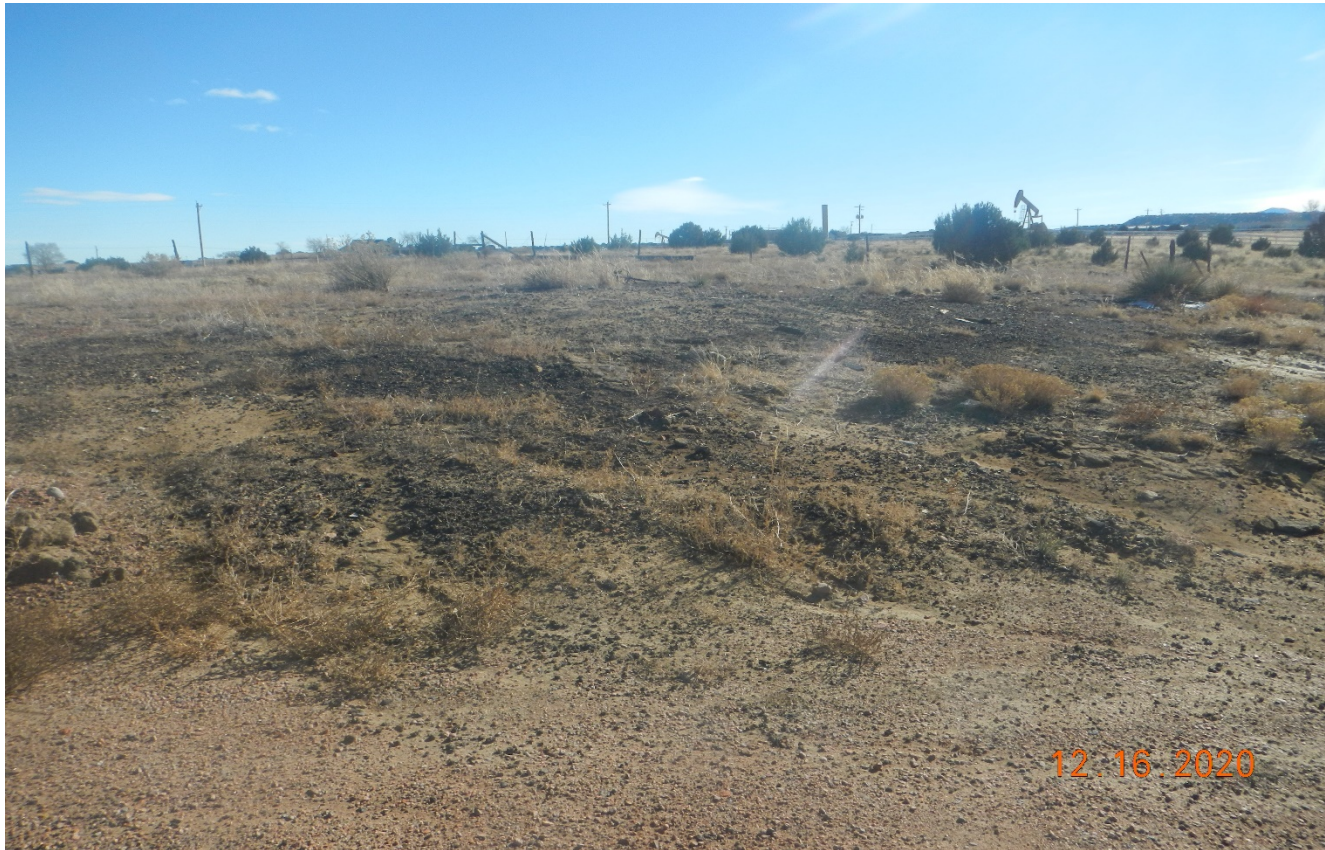
**Photo 1.** Facing southeast toward the location. The vegetation has not established at the location.

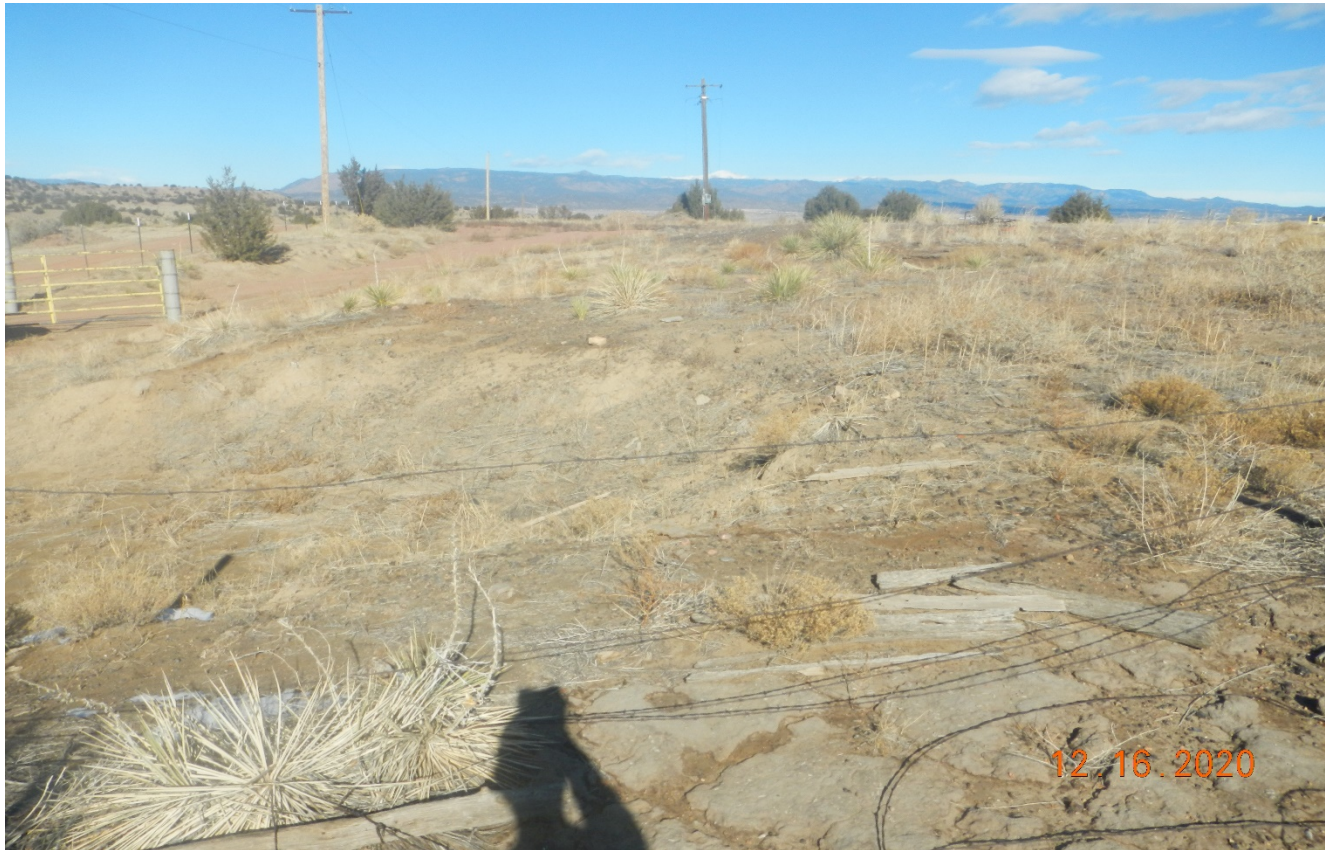
**Photo 2.** The location has not been recontoured and reclaimed..

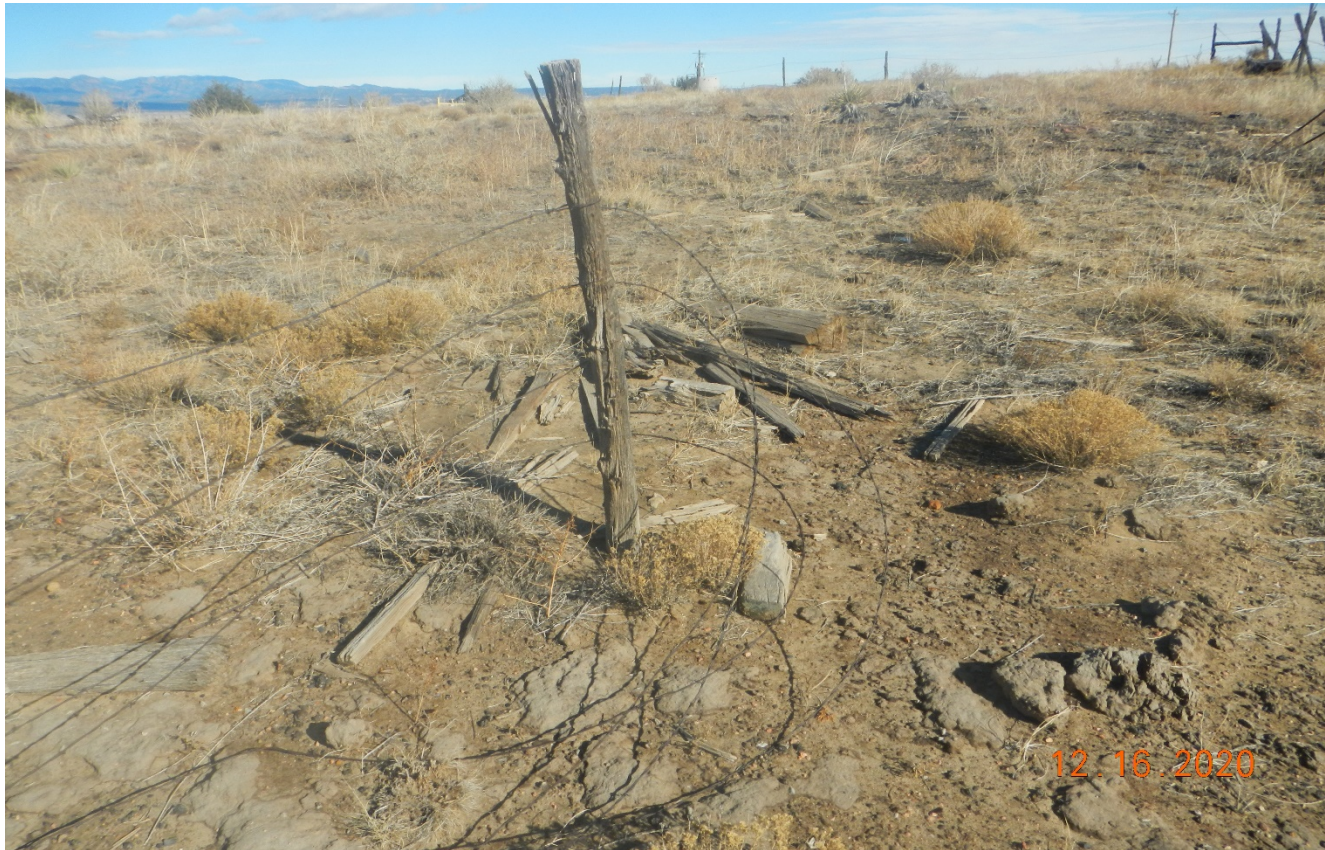
**Photo 3.** There is debris and a fence in disrepair around the location.

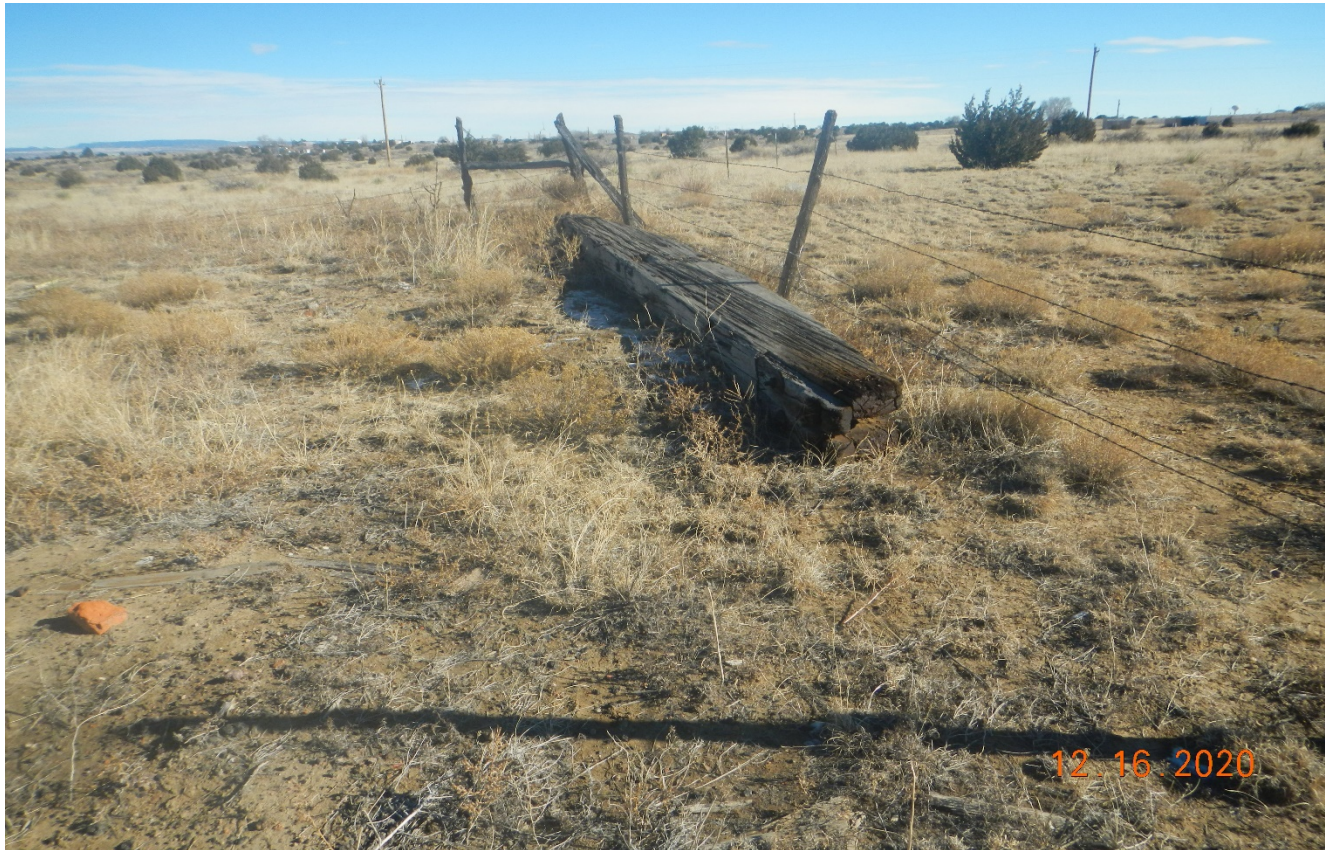
**Photo 4.** There is a wood beam left at the location.

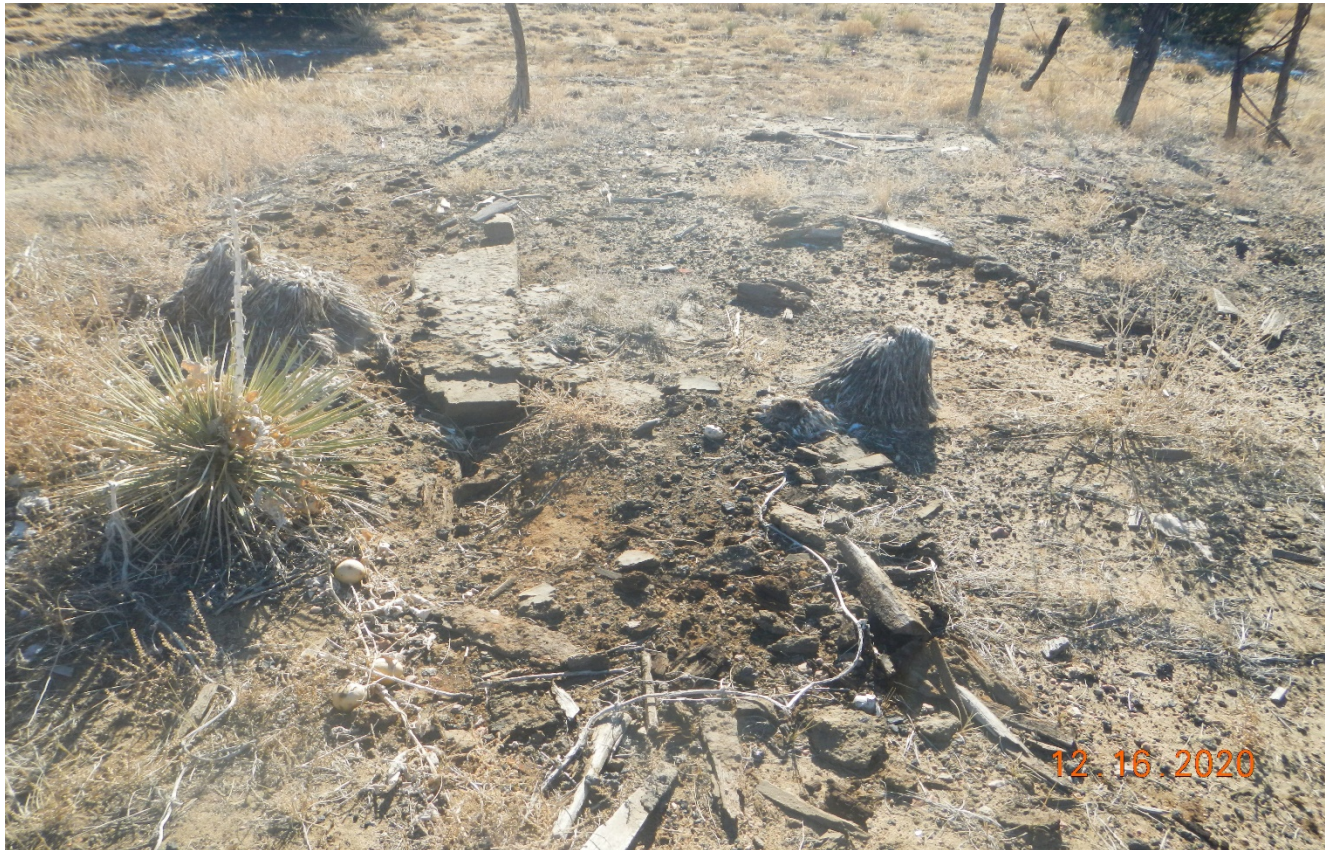
**Photo 5.** There is various remnants of debris left tat the location.

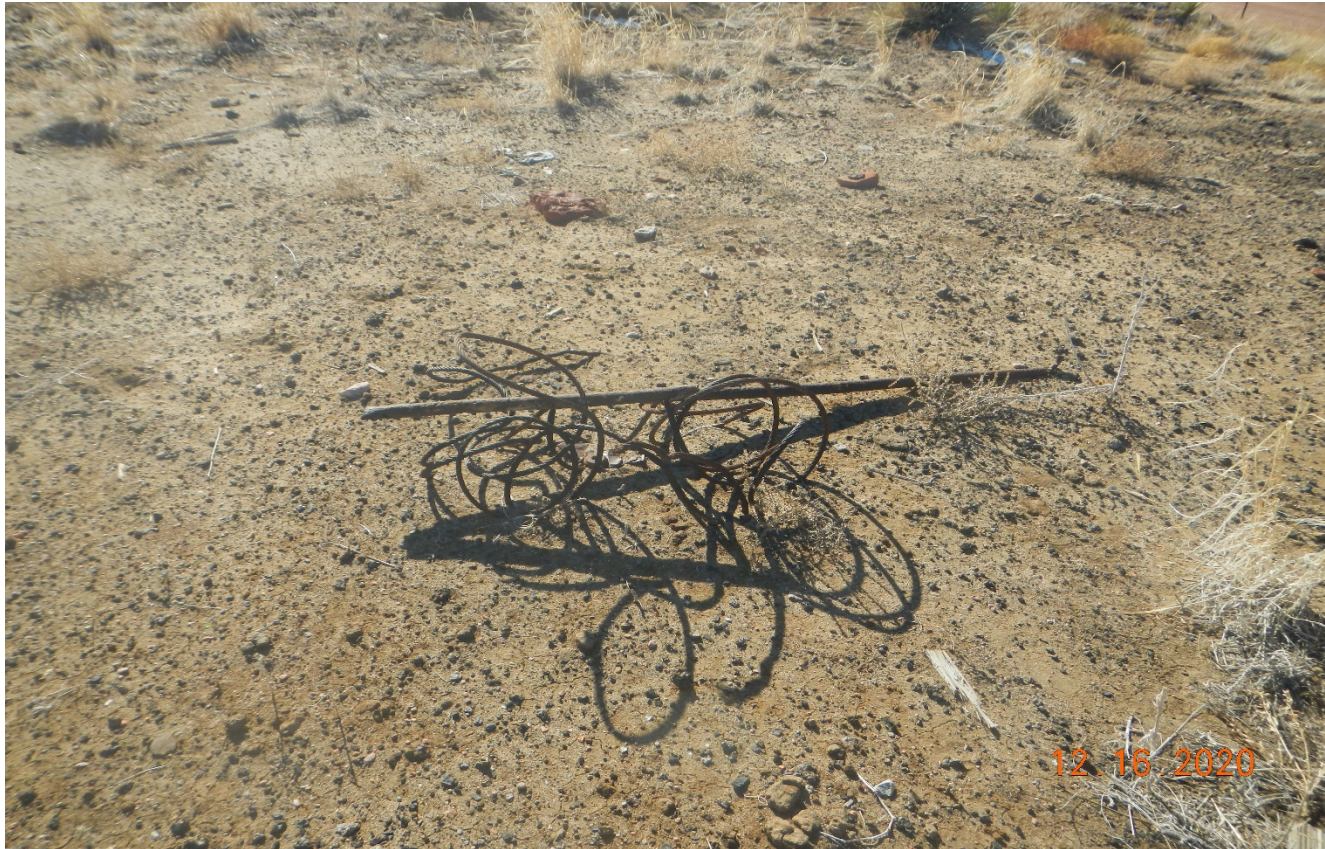
**Photo 6.** There is cable left at the location. Also note in this picture that soils are bare of vegetation.

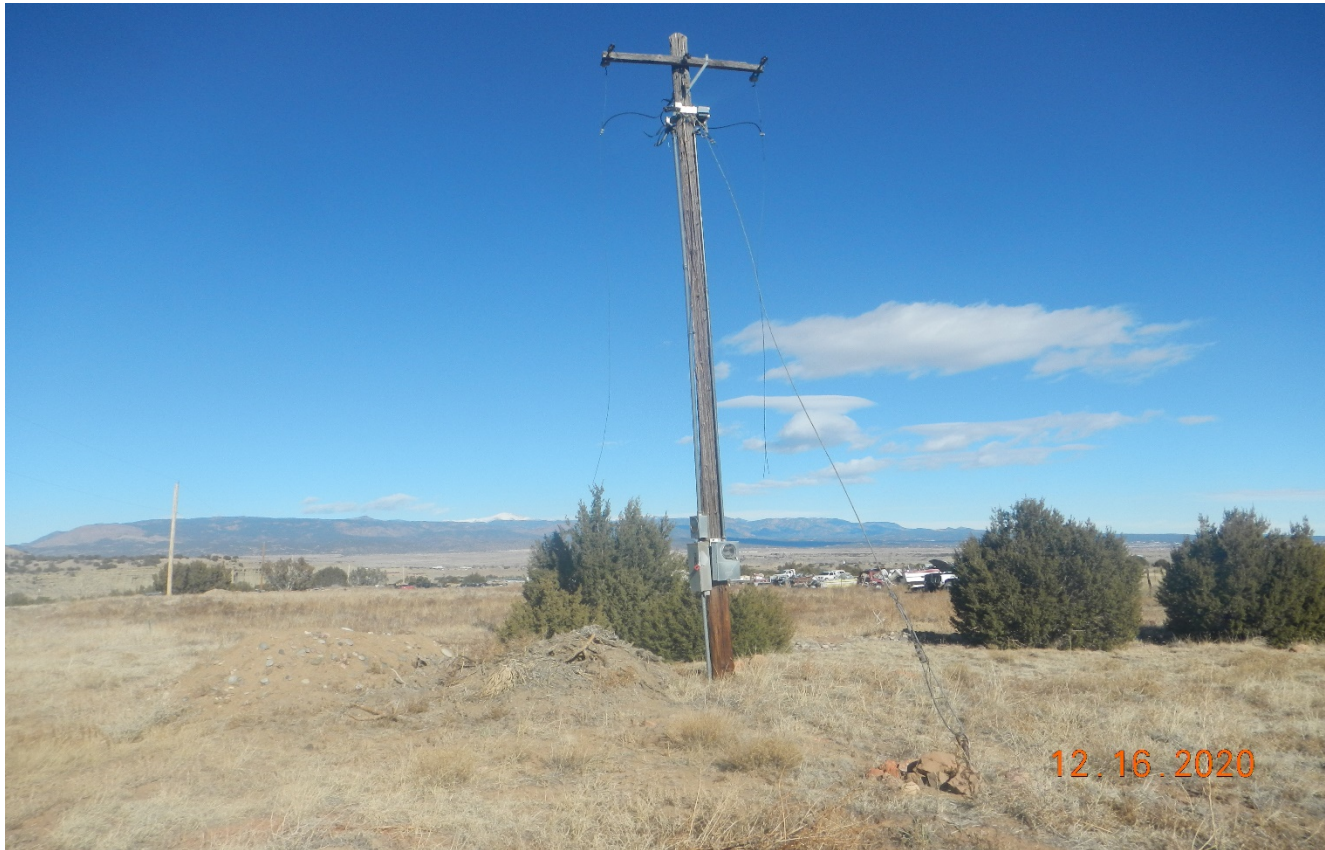
**Photo 7.** There is an old electric powerpole that remains at the location.
