Inspection Photos

API: 043-40001

Operator: JAVERNICK OIL

Inspection Date: 12/16/2020

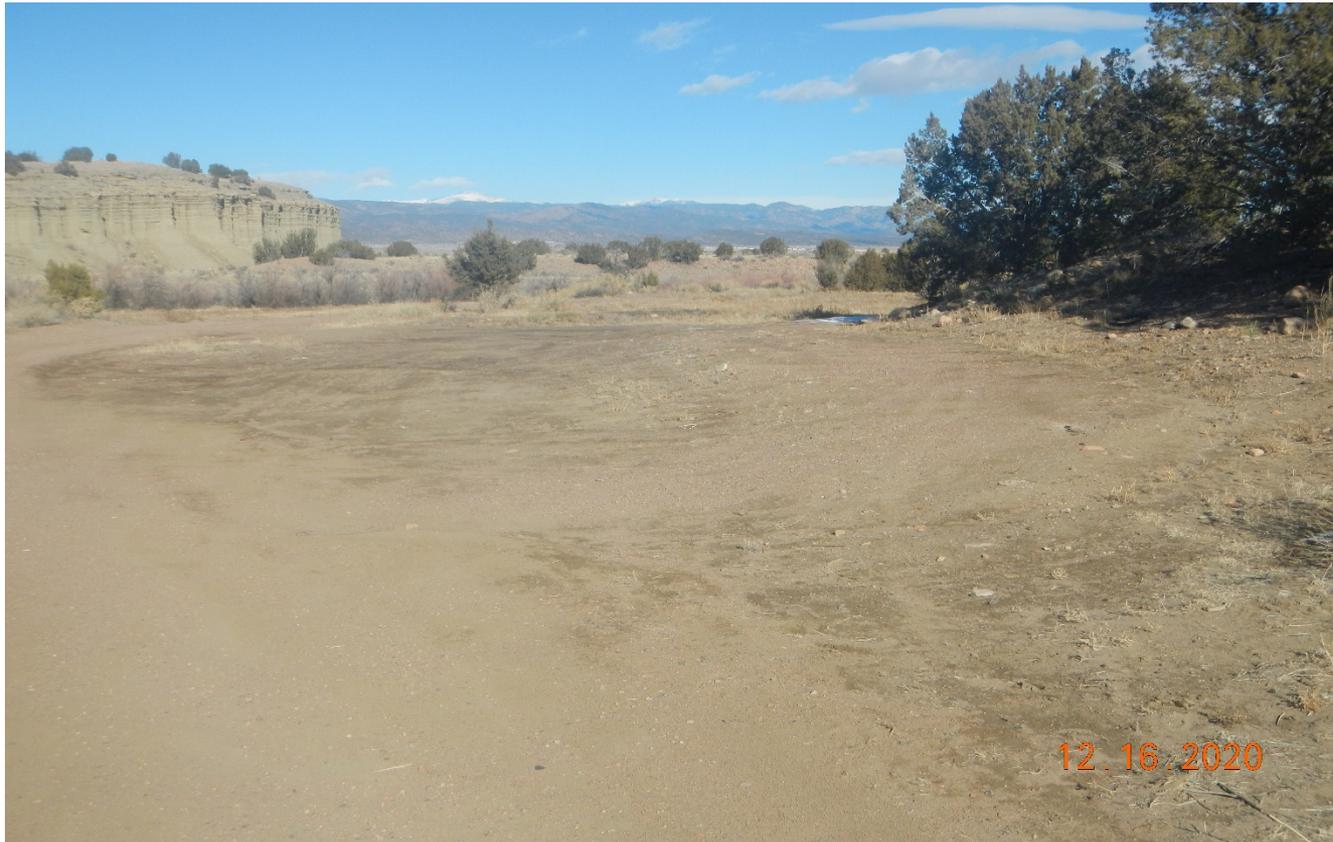
Photo 1. Facing northeast toward the location. The location has not been reclaimed and is bare of vegetation.

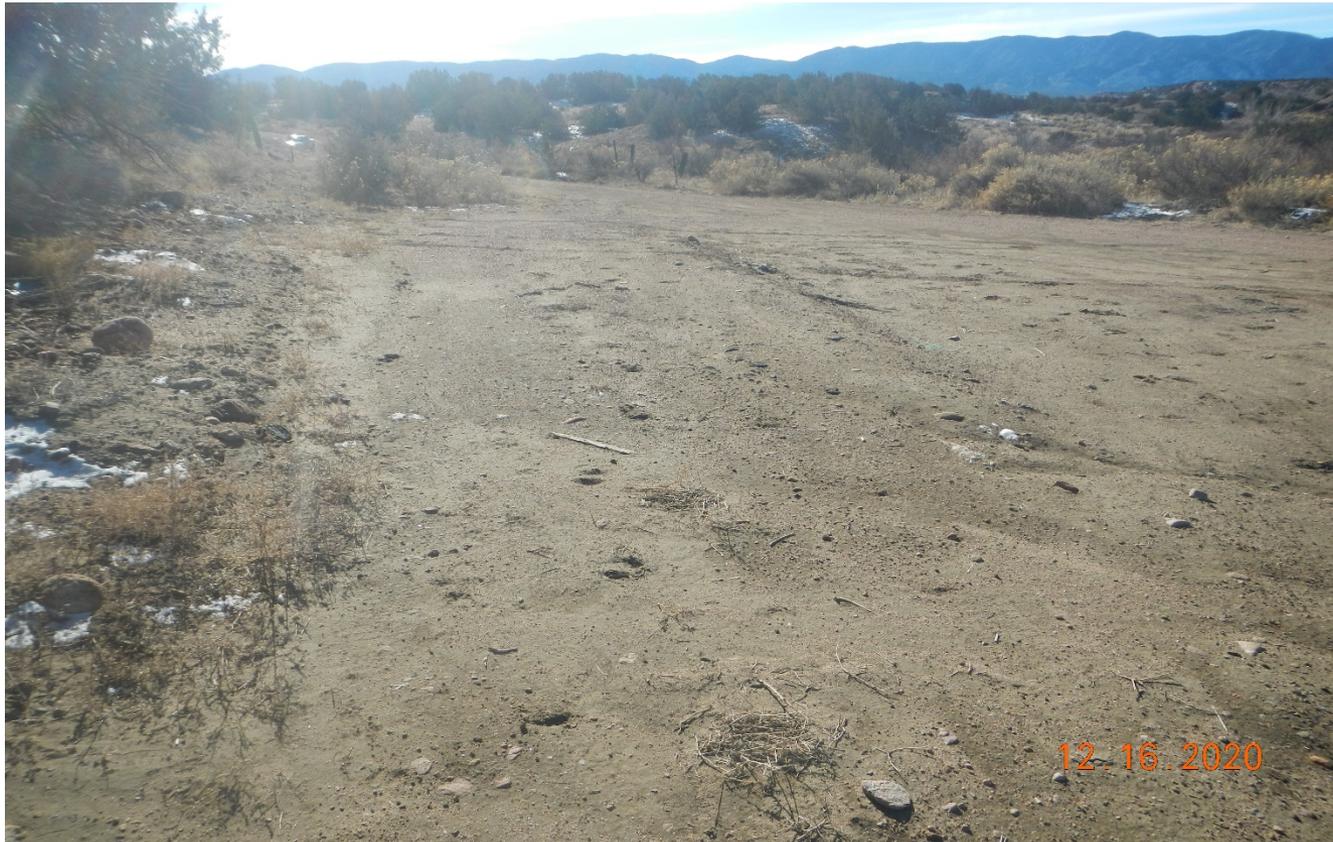
Photo 2. The southwest at the location. The location is bare of vegetation.

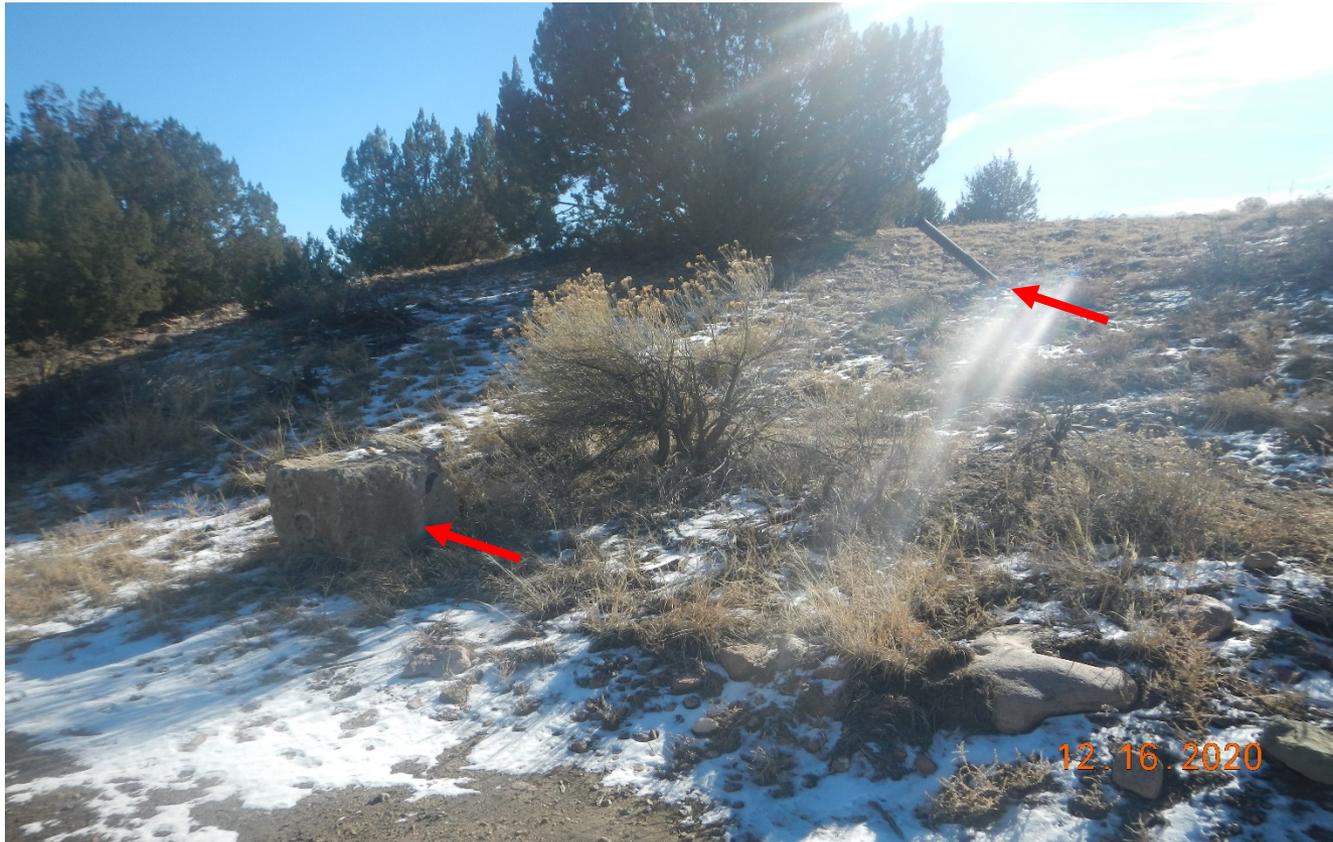
Photo 3. There is a cement block and metal pipe extending out of the ground at the northeast side of the location.

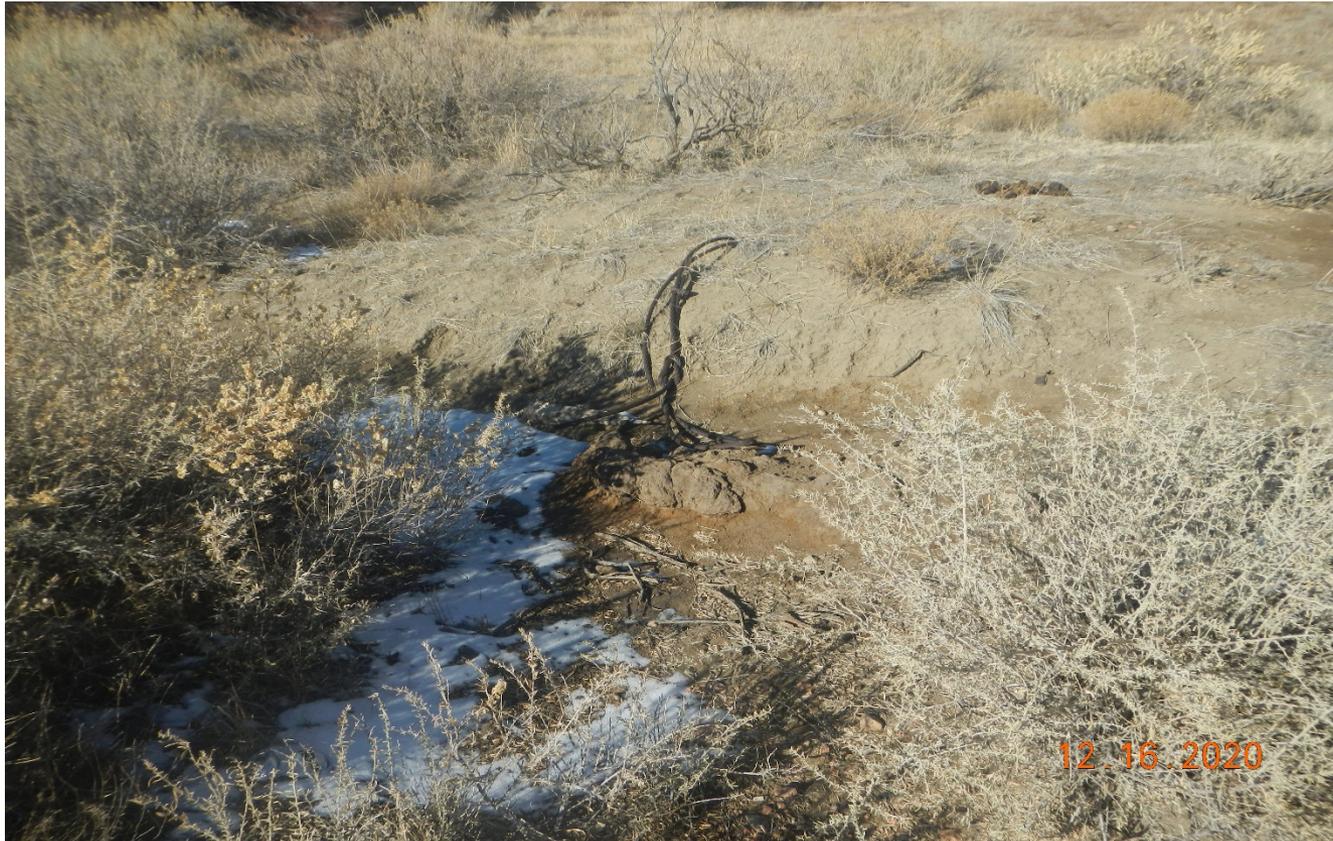
Photo 4. There is a metal cable and anchor that remains at the northwest side of the location next to the road.

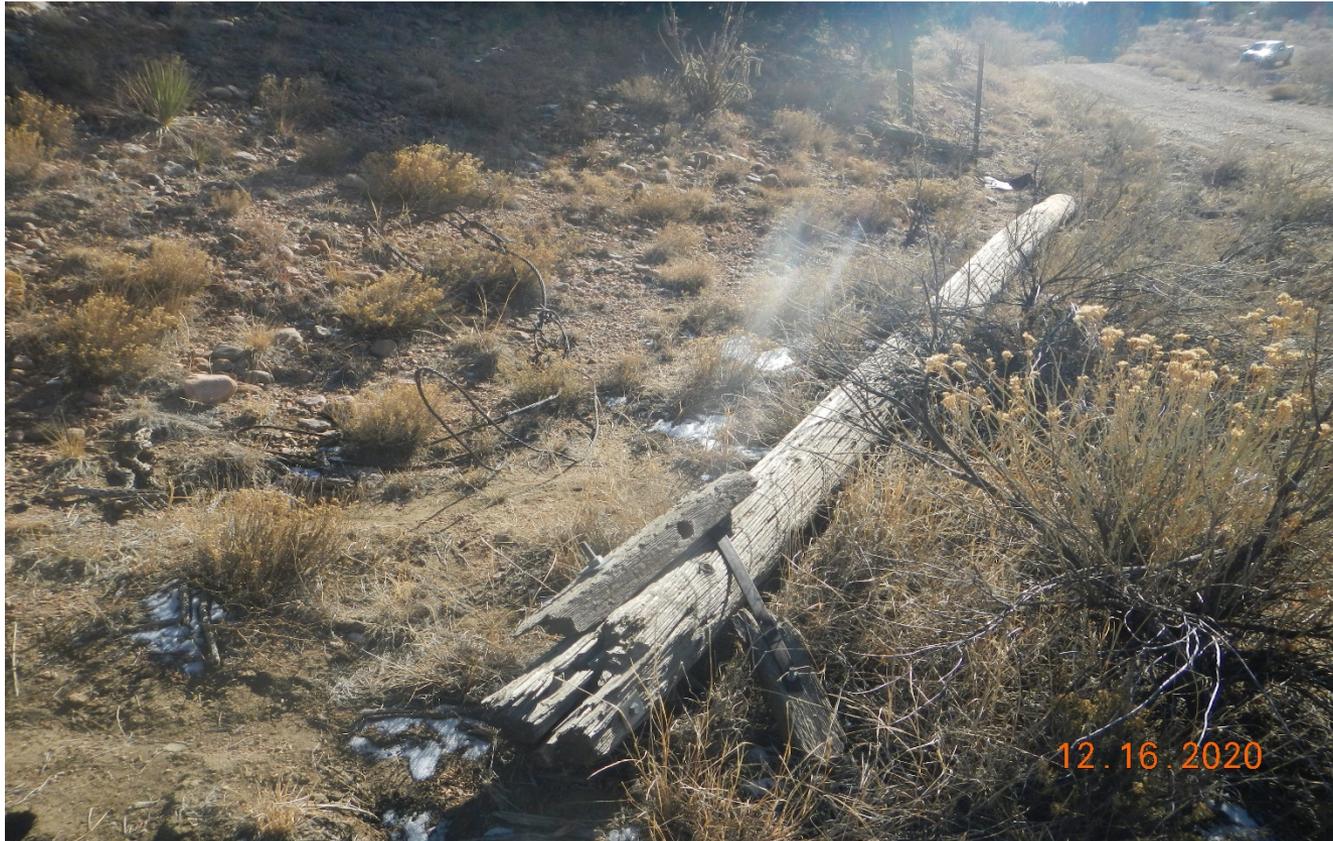
Photo 5. There is an old power pole that remains at the location.
