**Inspection Photos**  
**Operator: Enduring Resources**  
**API: 067-07758**  
**Date: 12/22/2020**

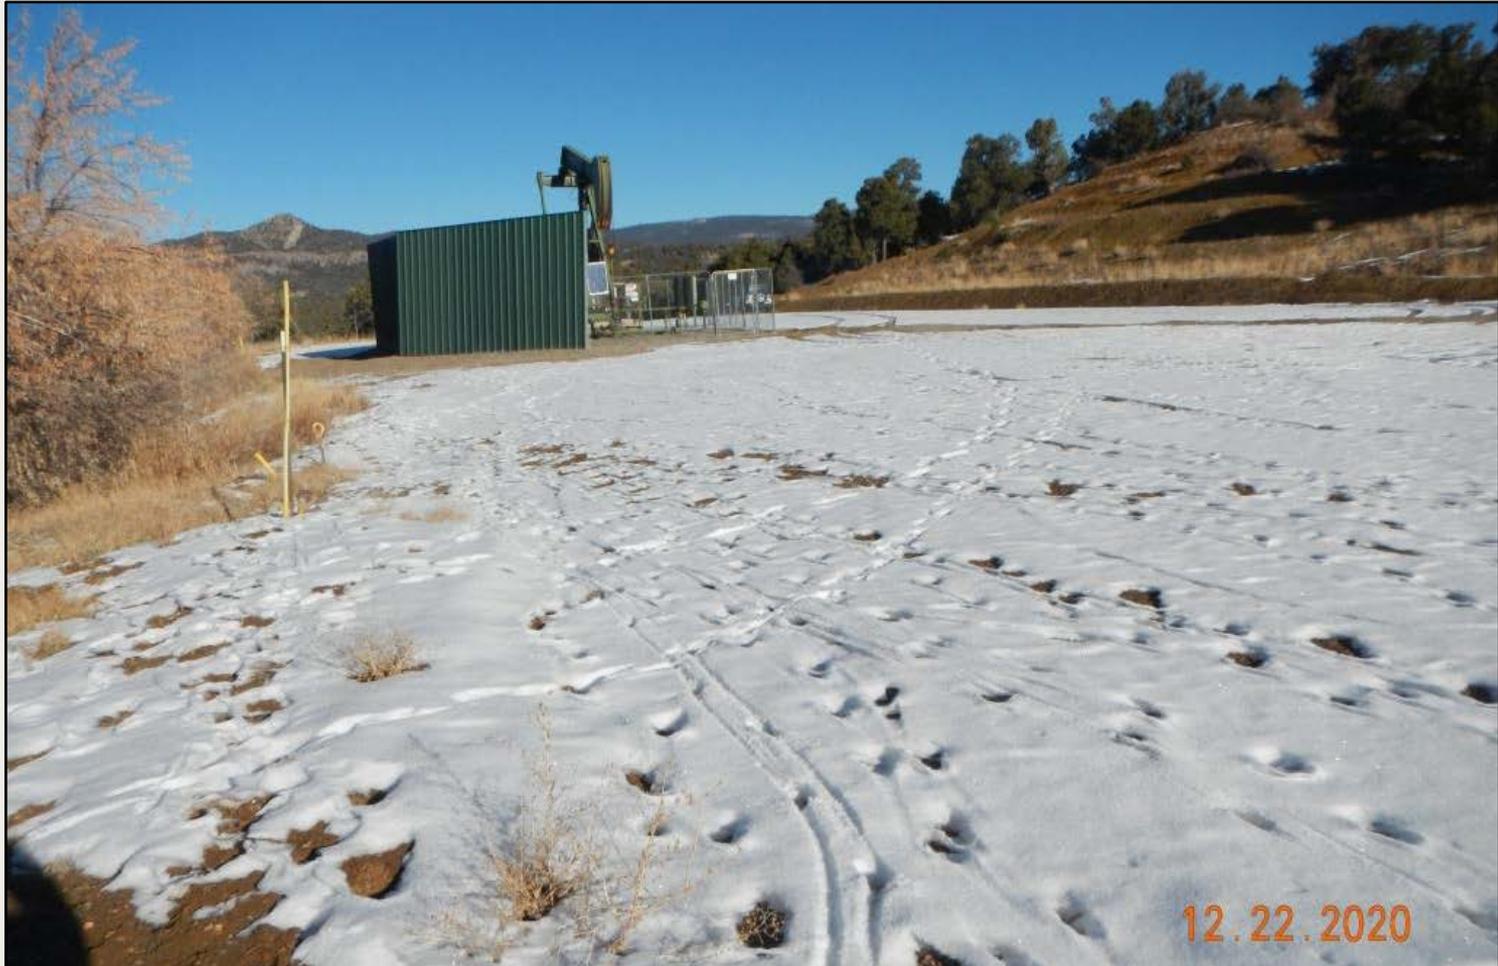
Photo 1. View of the project area from the southwestern corner facing center.

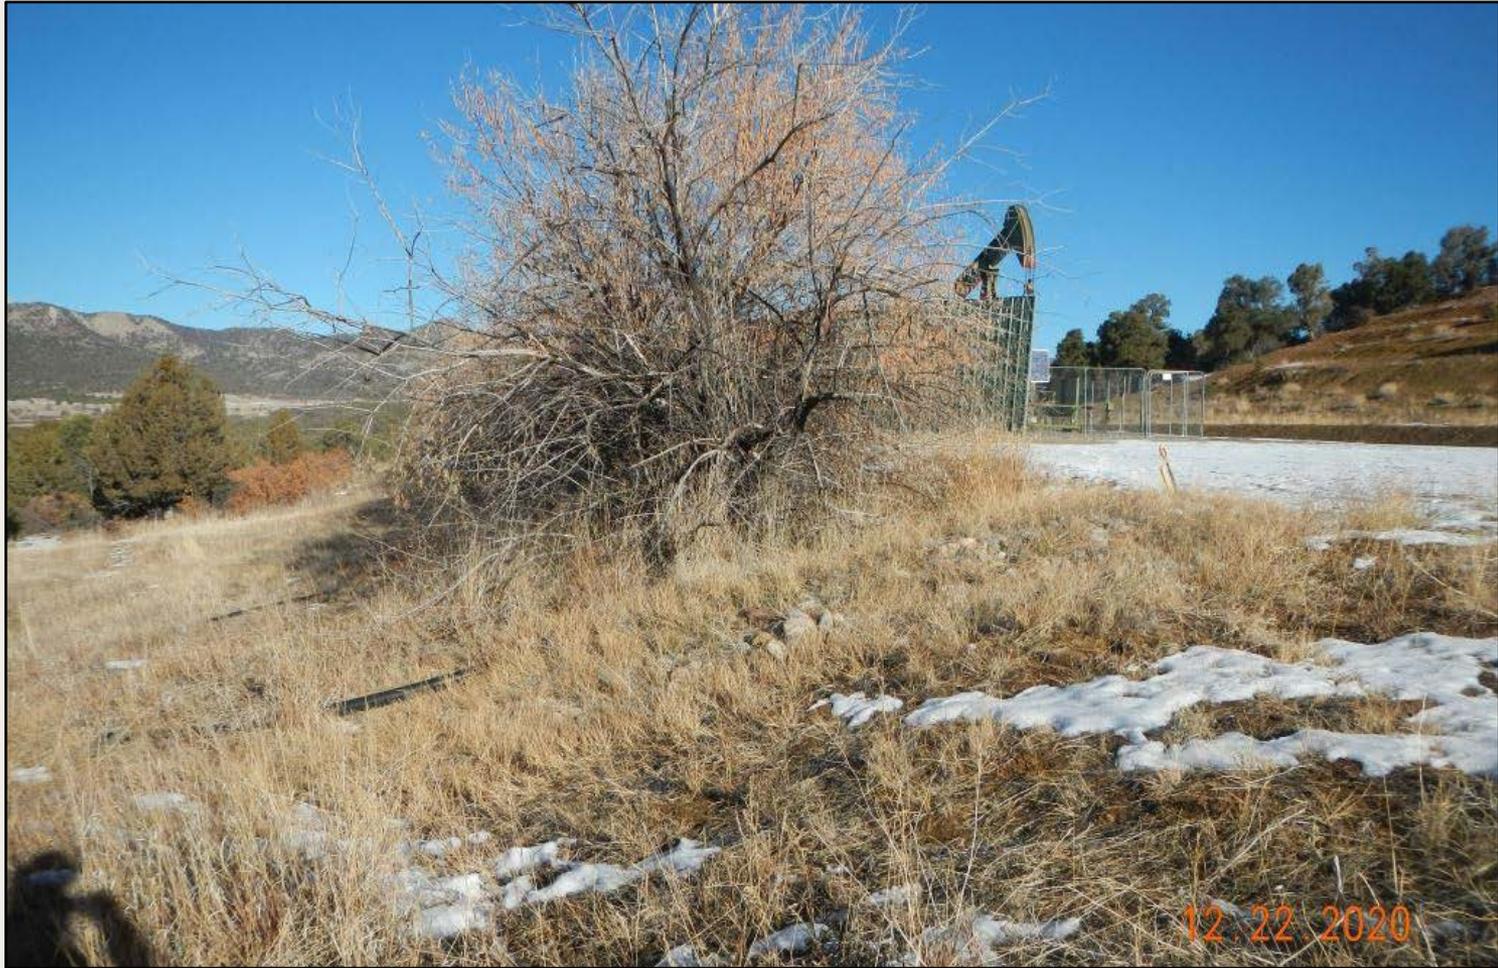
Photo 2. View of Russian olive trees along the western edge of the project area.

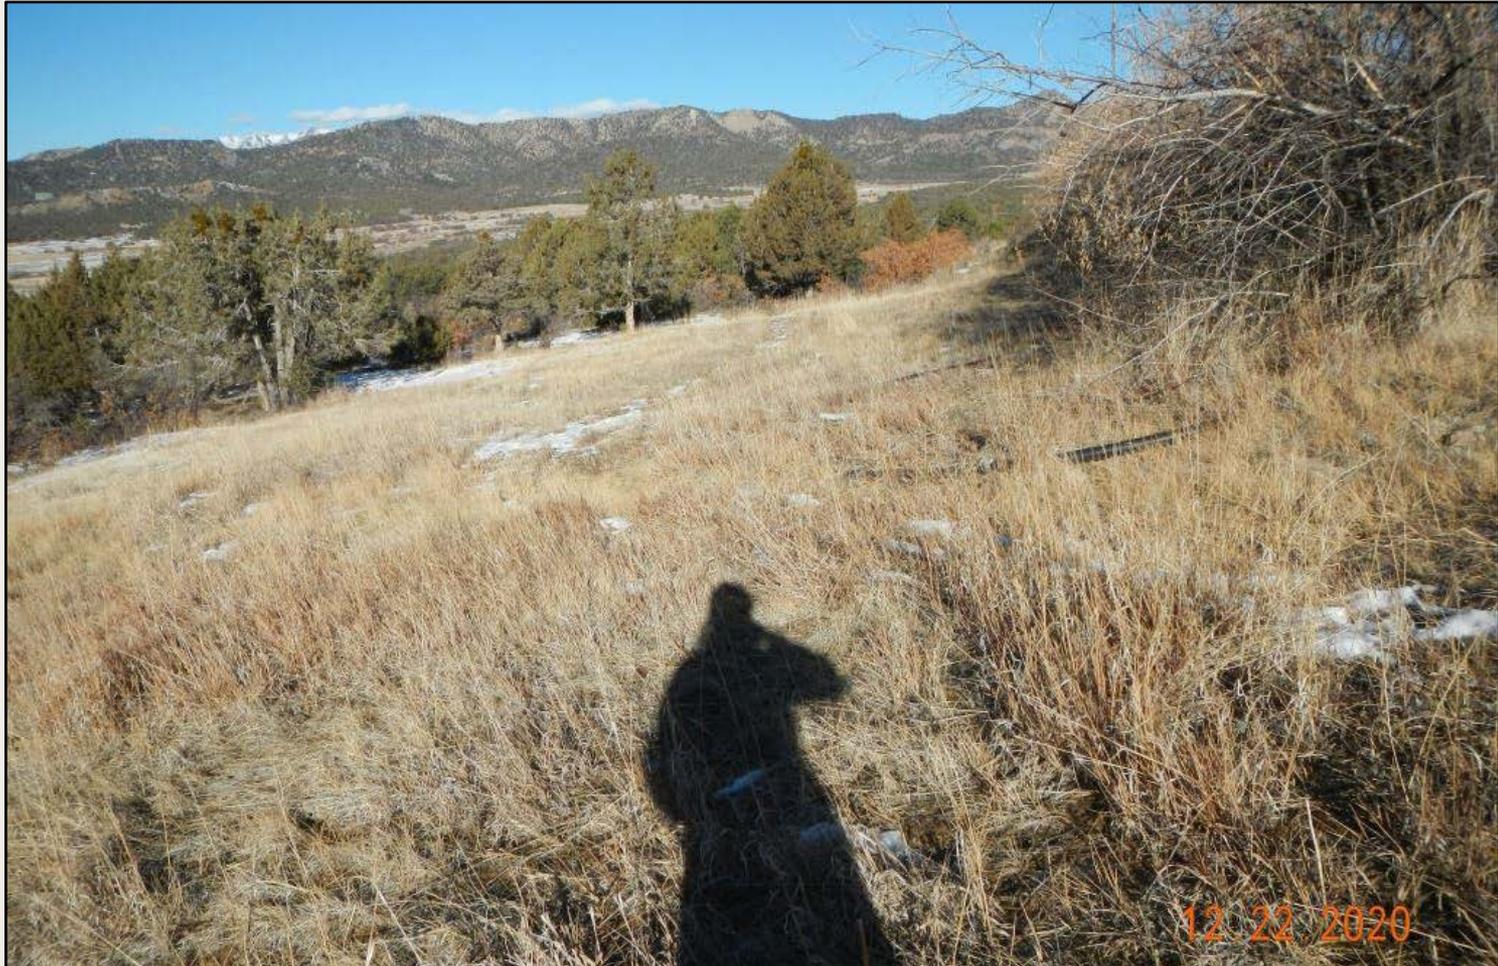
Photo 3. View of revegetation within the western project area.

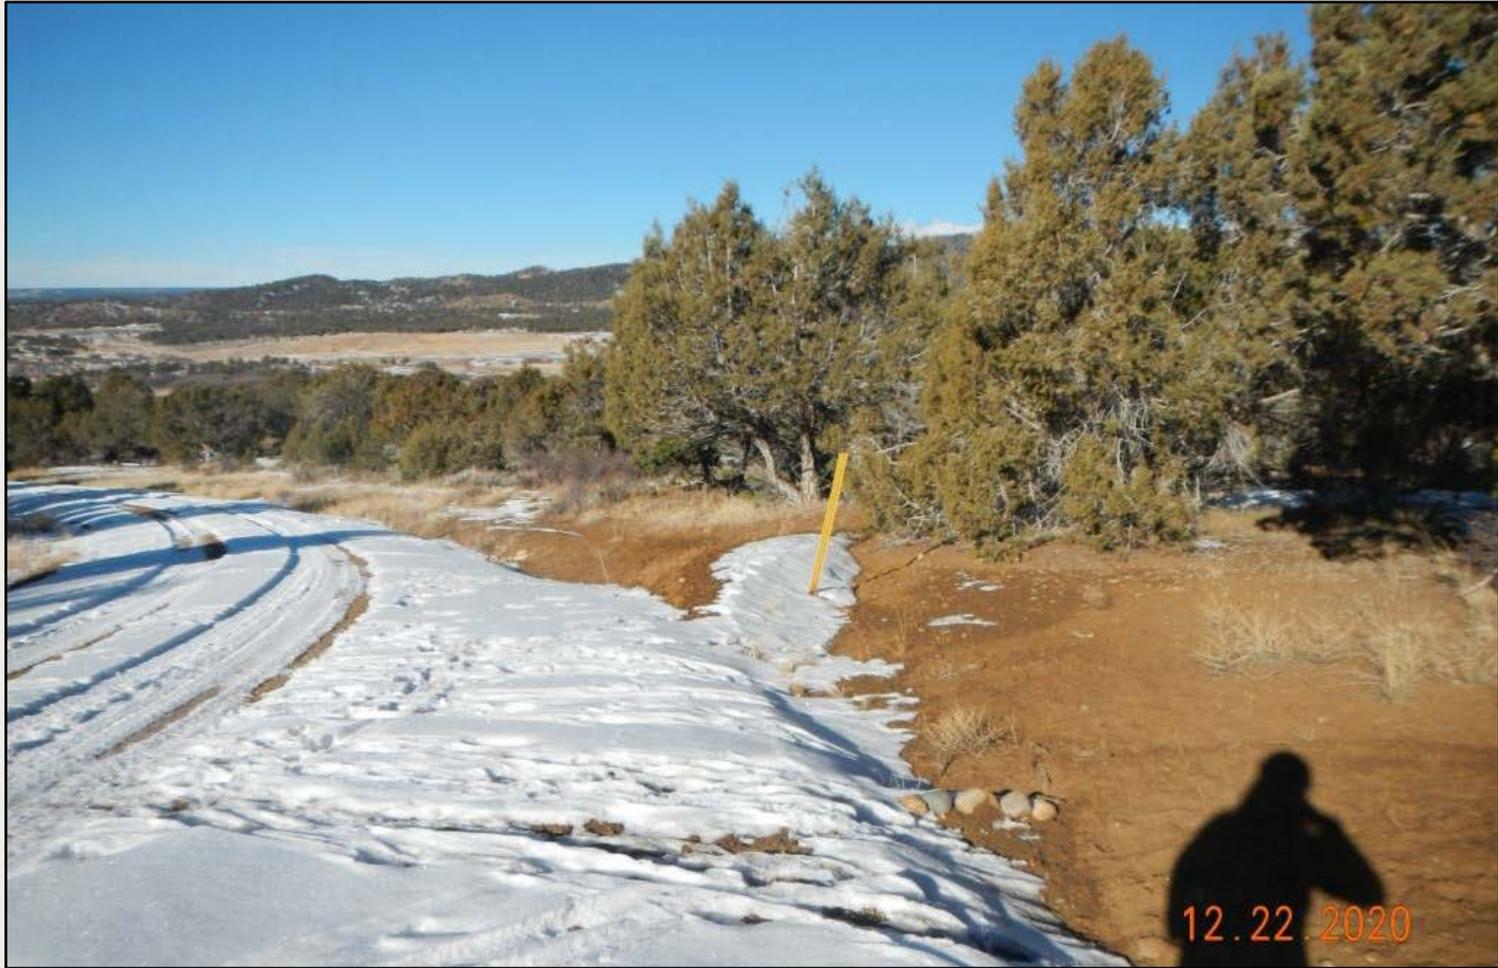
Photo 4. View of cobble along roadside drainage full of sediment. BMP is not adequate here.

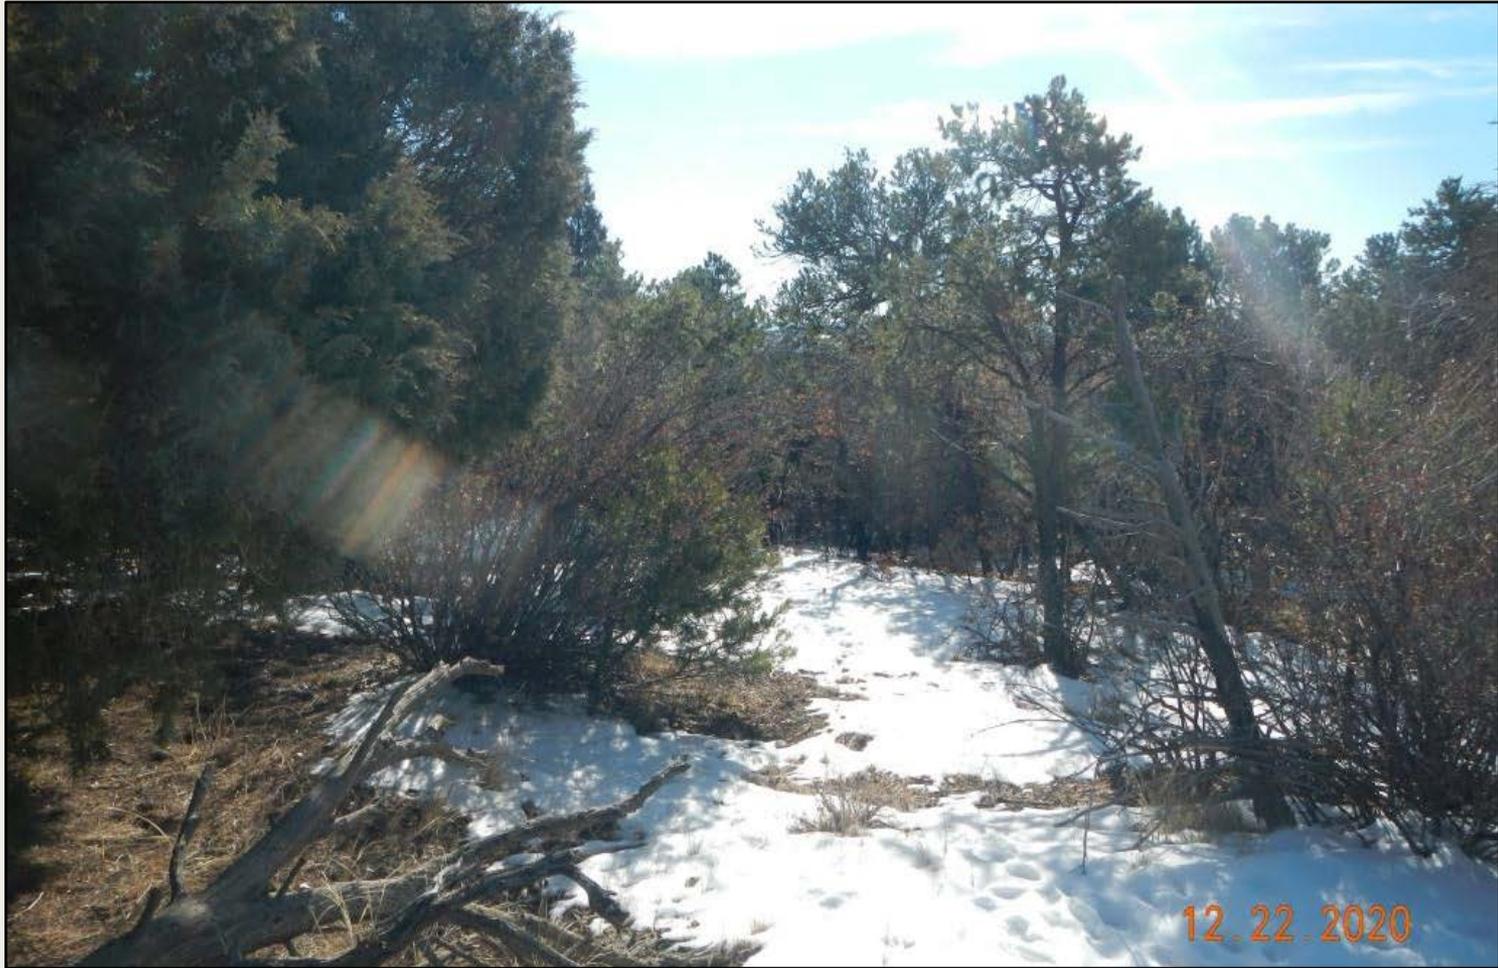
Photo 5. View of reference area comprised of pinyon and juniper woodland with understory of mountain mahogany, gambel oak, and antelope bitterbrush.
