Inspection Photos

Operator: Enduring Resources
API: 067-08771
Date: 12/22/2020

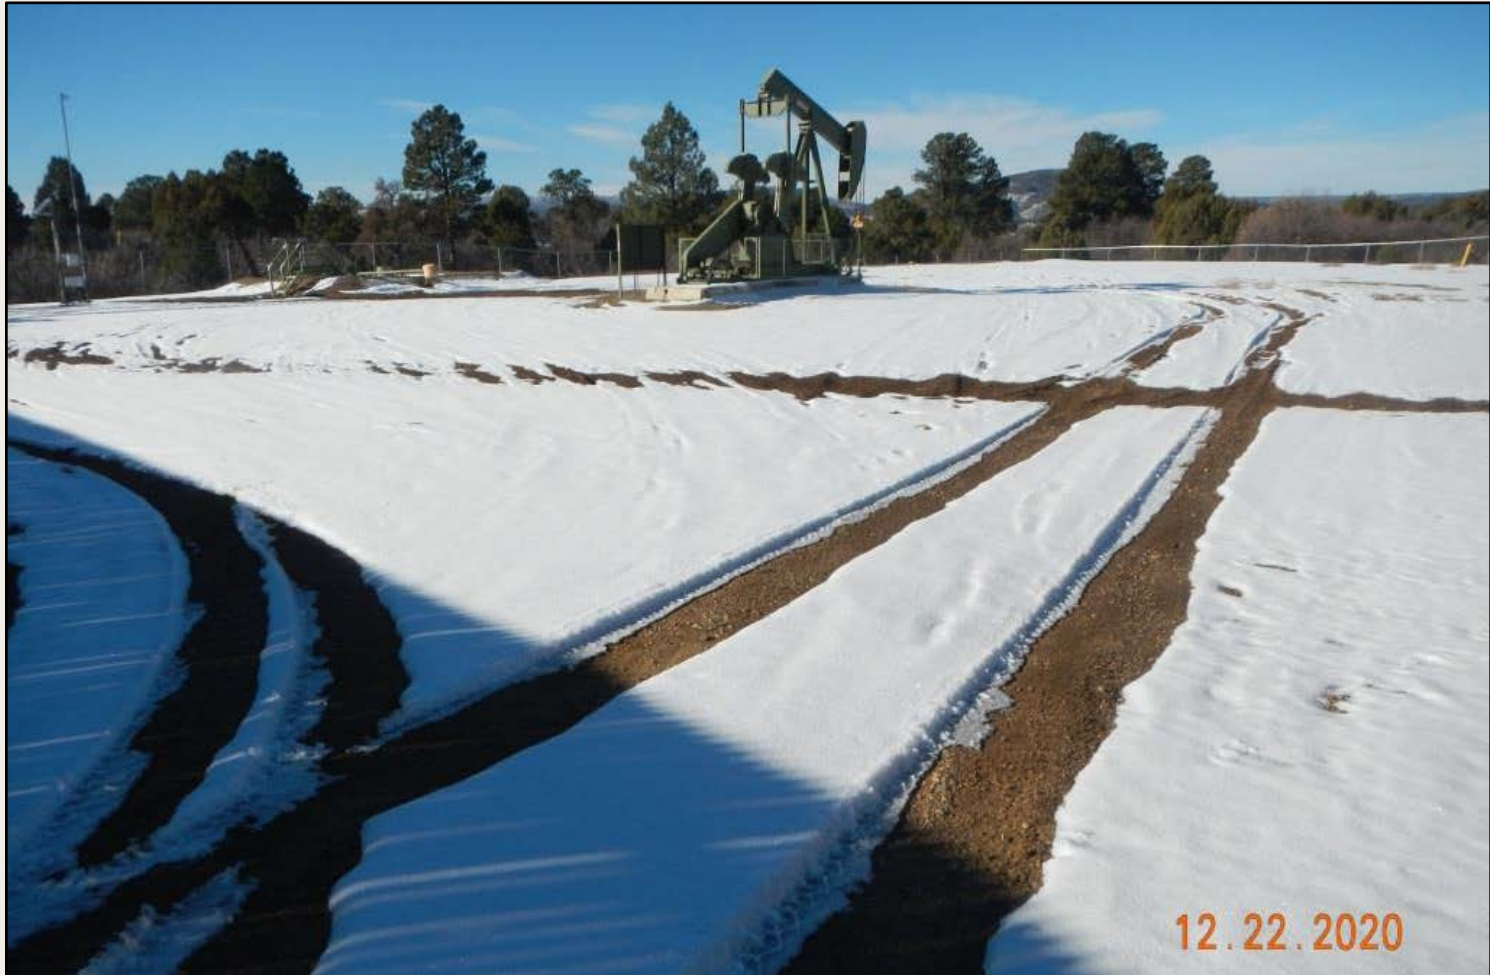
Photo 1. View of the project area from the well pad entrance facing center.

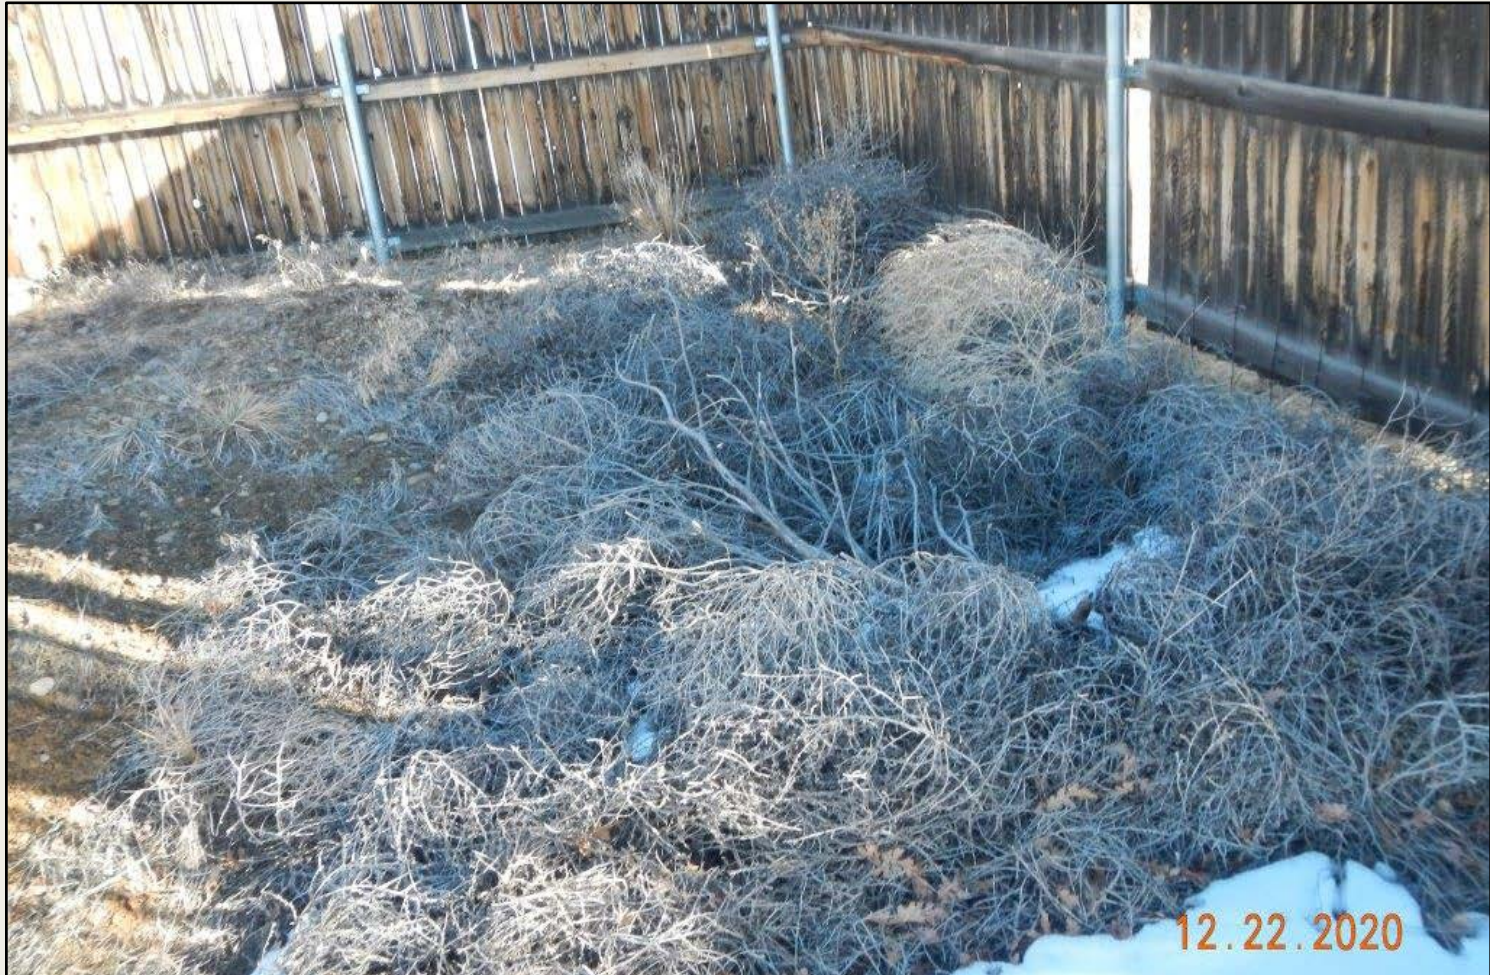
Photo 2. View of Russian thistle debris within the northeastern corner of the project area.

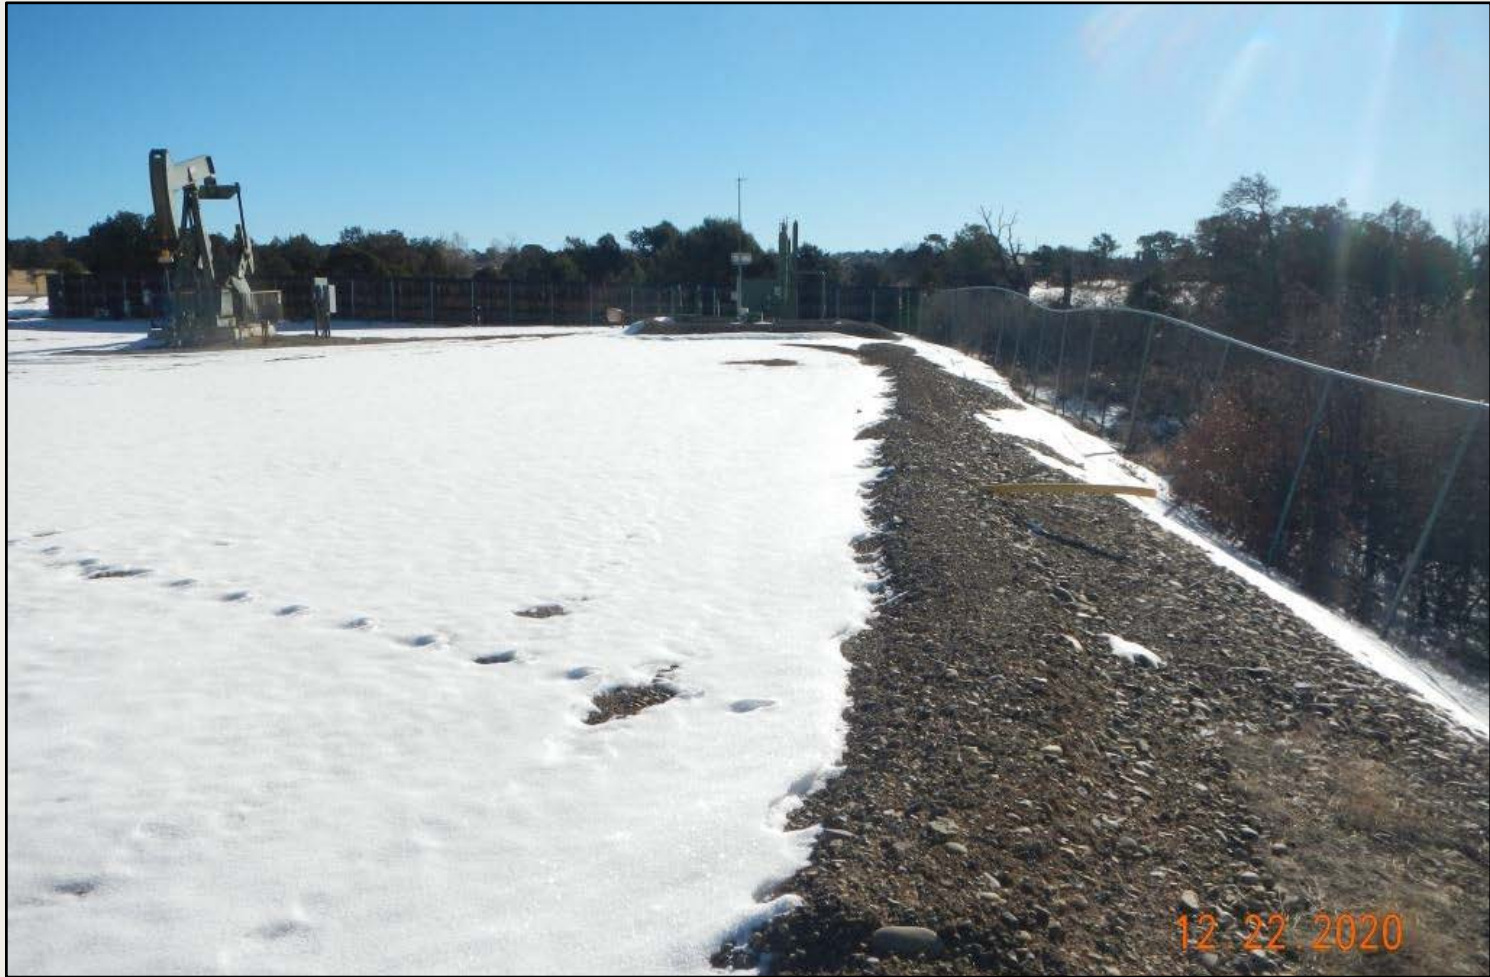
Photo 3. View of the southern project area from the southwestern corner facing eastward. Vegetation outside of the fenced working area is established. This slope is bermed and appears stabilized.

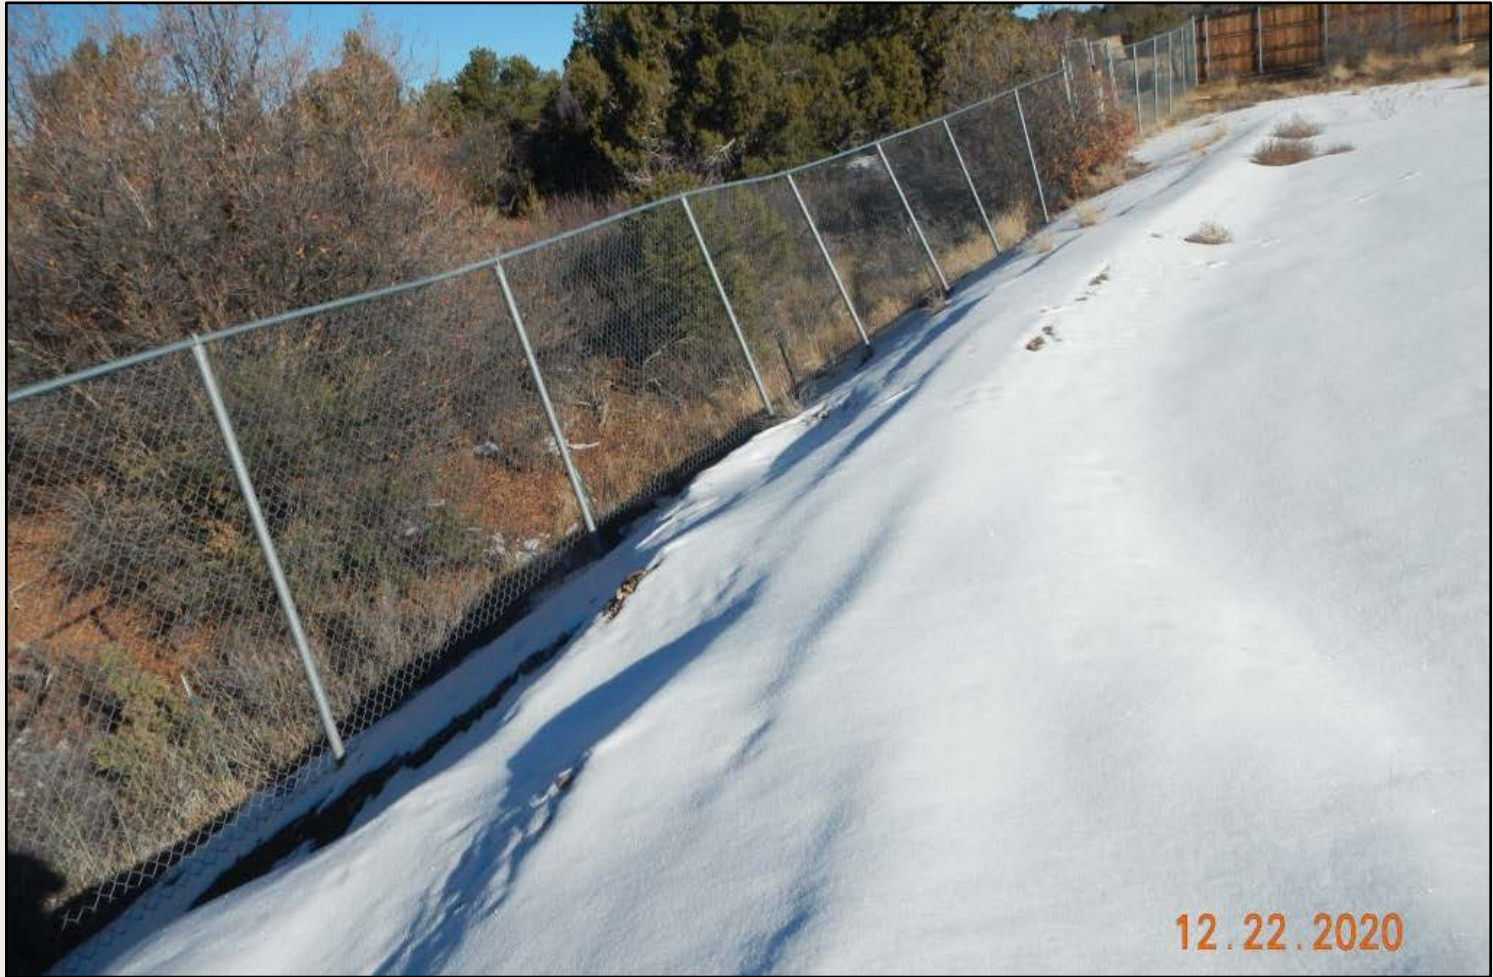
Photo 4. View of the western project area from the southwestern corner facing northward.
