Inspection Photos
Operator: Enduring Resources
API: 067-07769
Date: 12/22/2020

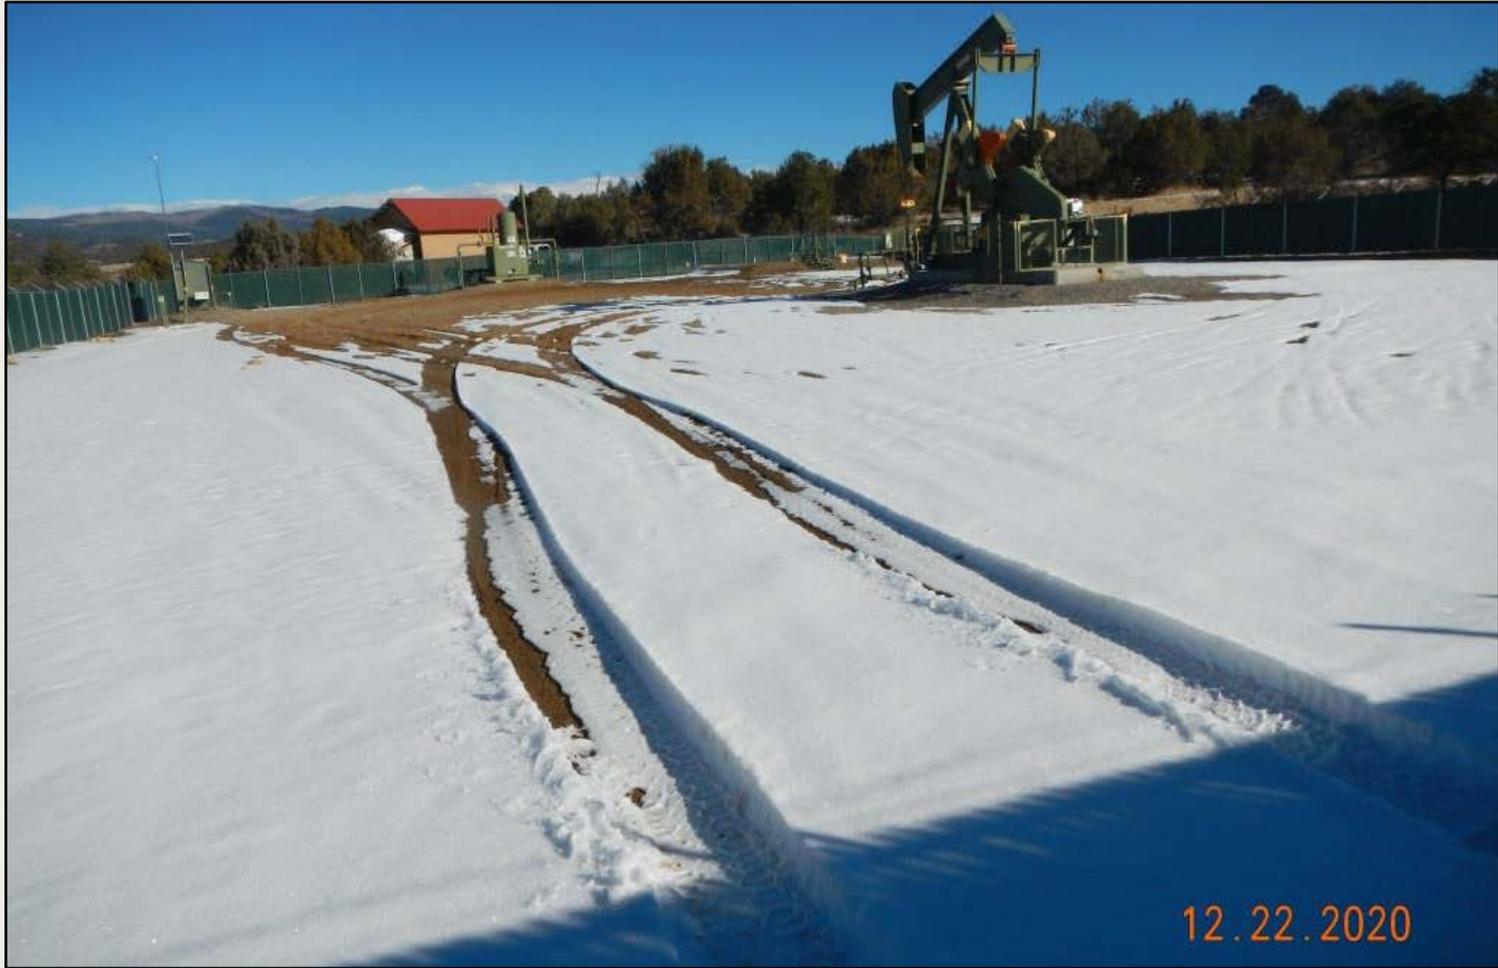
Photo 1. View of the project area from the well pad entrance facing center.

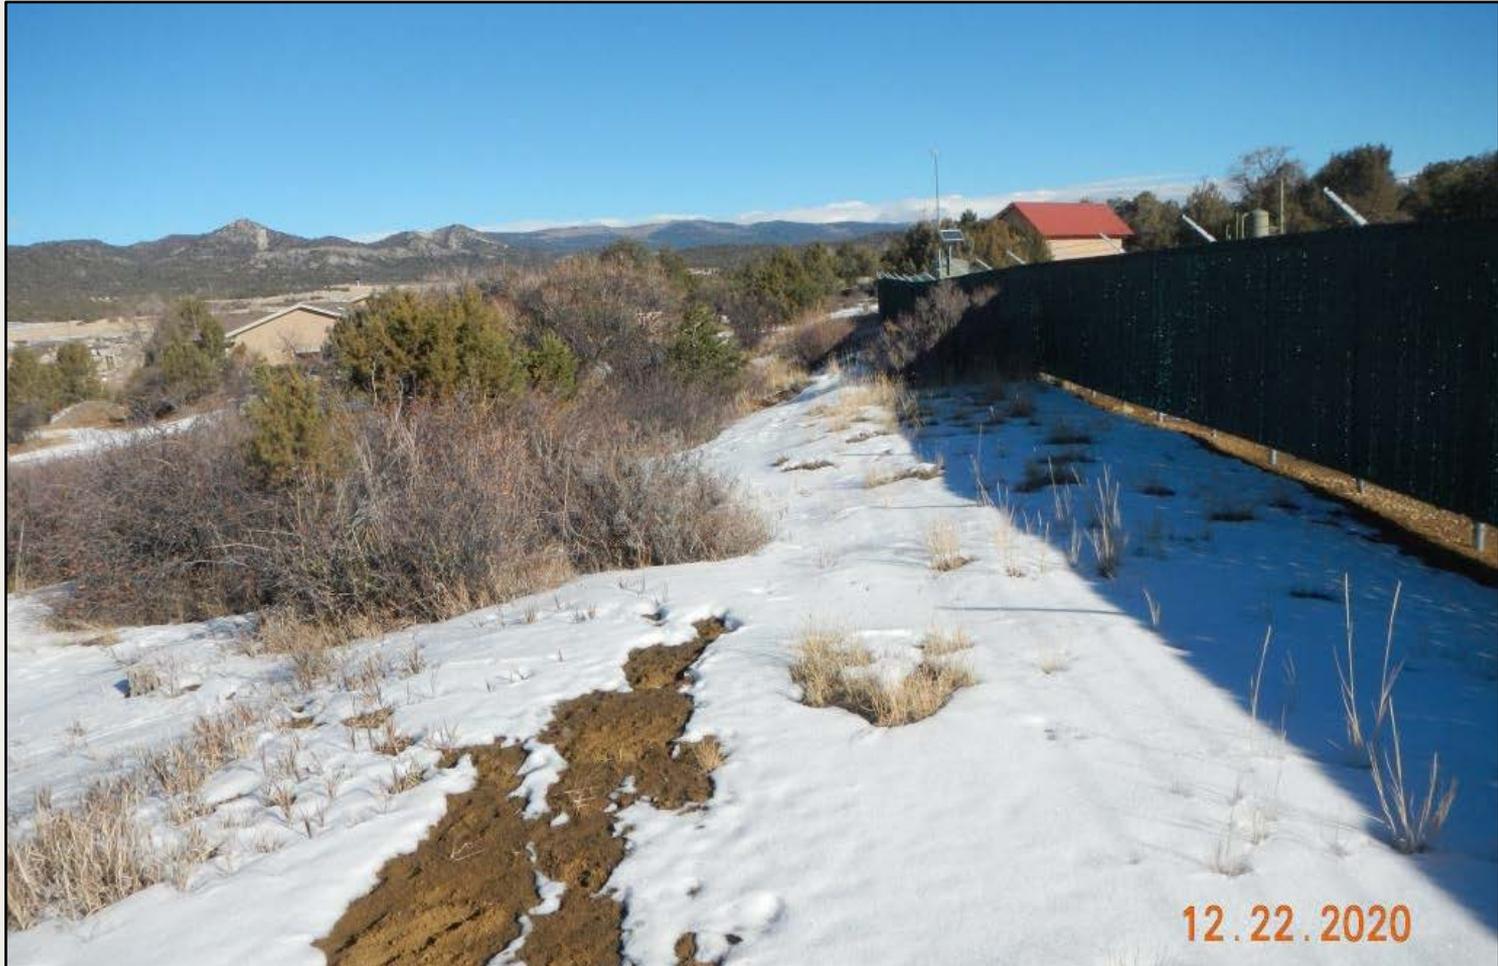
Photo 2. View of the western project area from the southwestern corner facing northward.

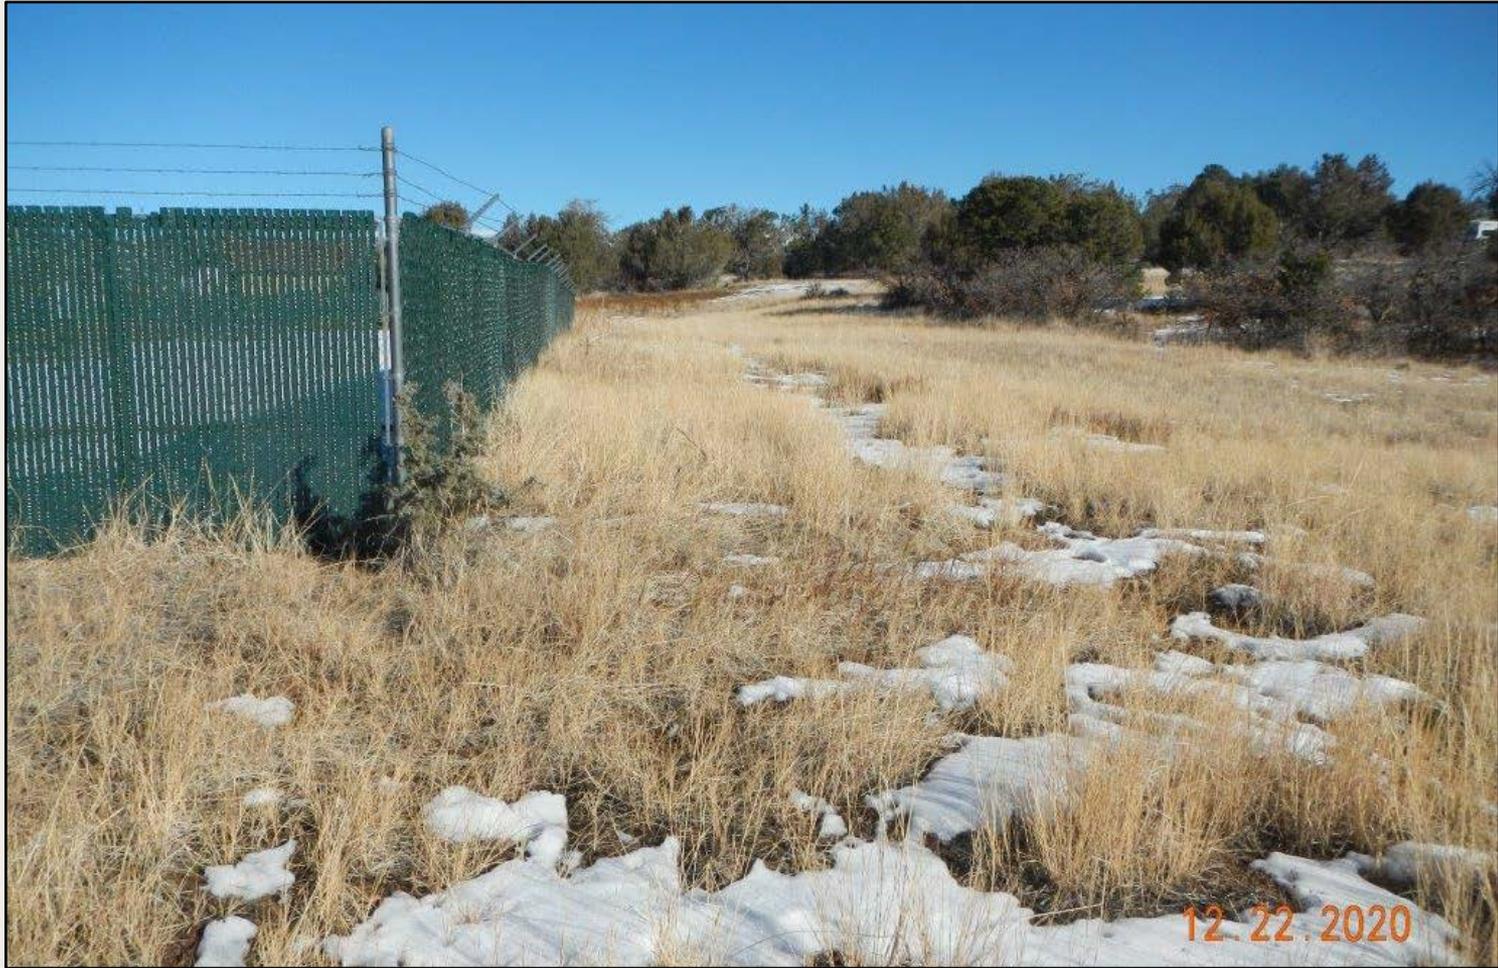
Photo 3. View of the eastern project area from the southeastern corner facing northward. Revegetation is comprised of western wheatgrass, smooth brome, and sand dropseed.
