Inspection Photos
Operator: Enduring Resources
API: 067-08398
Date: 12/22/2020

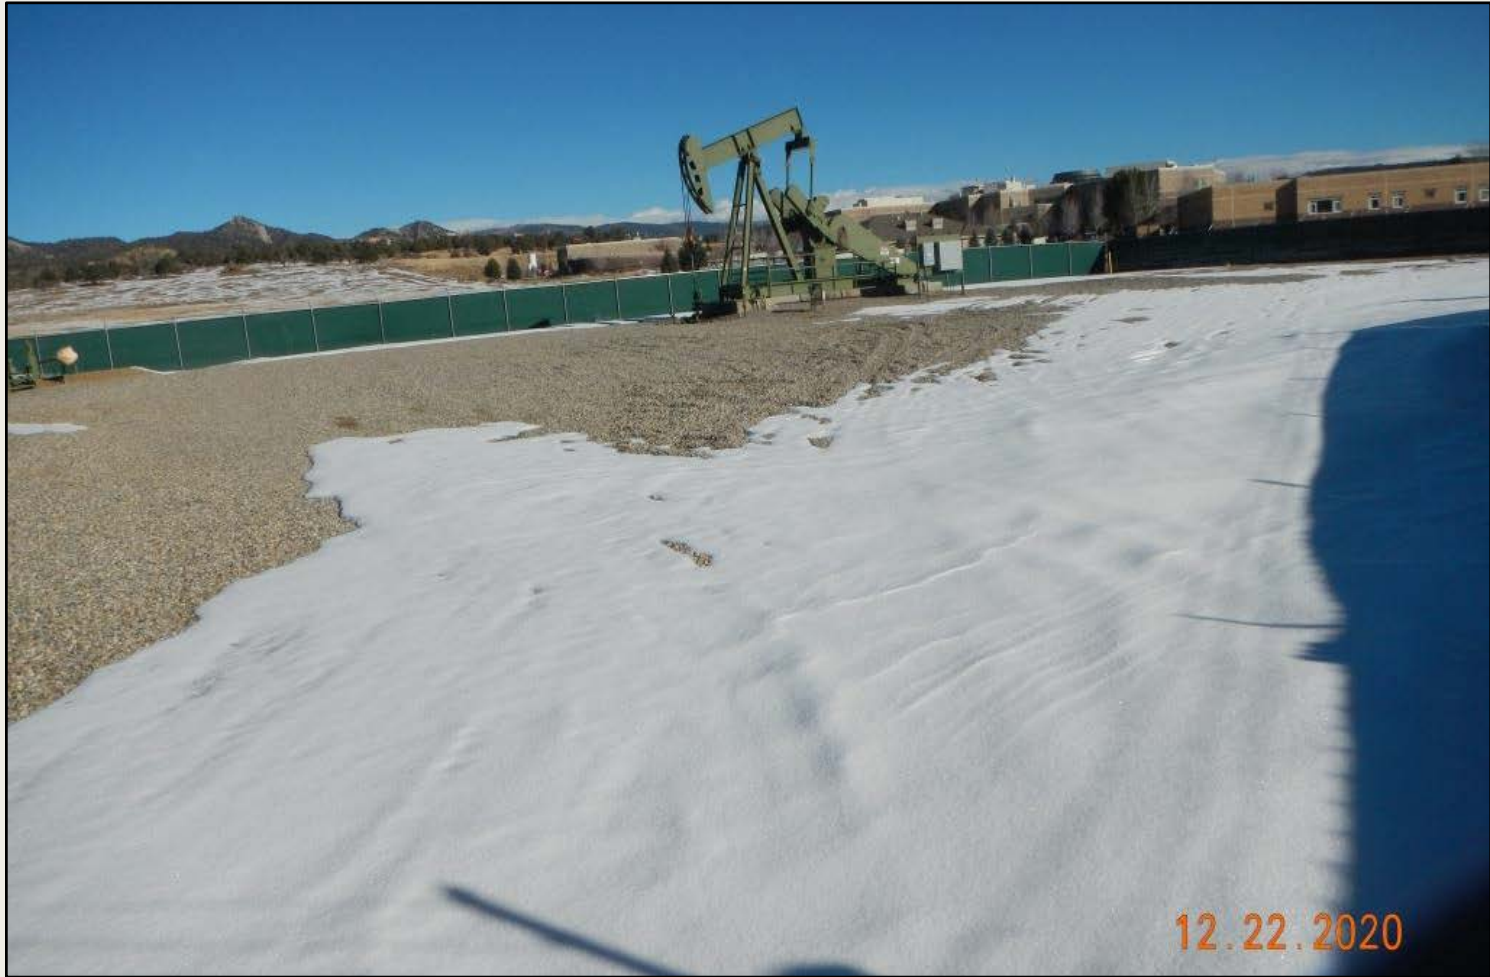
Photo 1. View of the project area from the well pad entrance facing center.

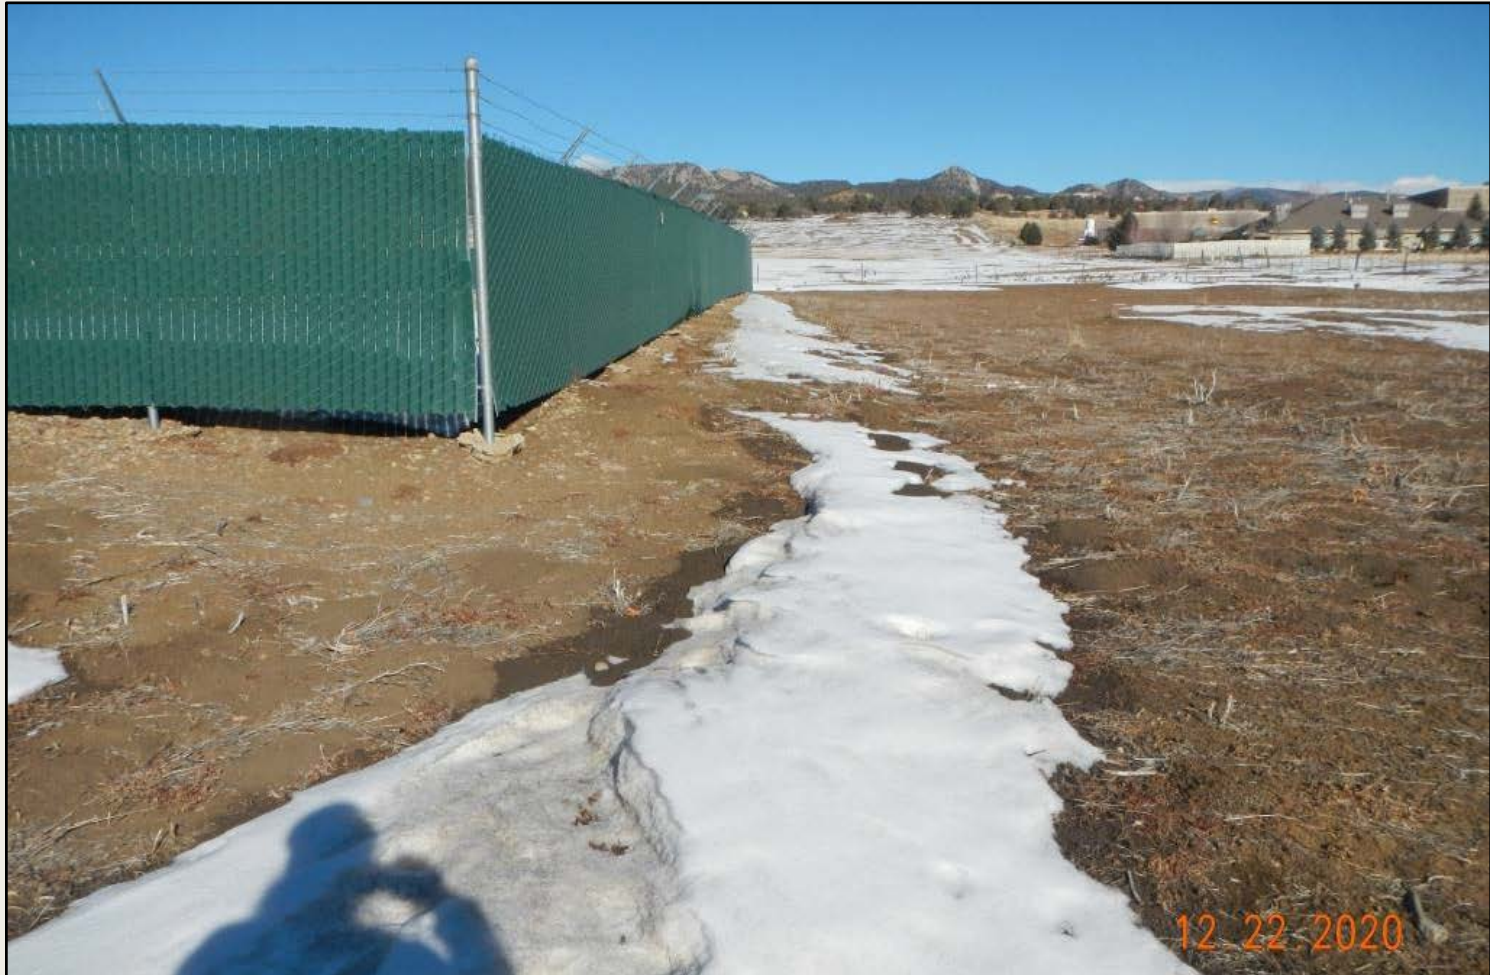
Photo 2. View of the eastern project area from the southeastern corner facing northward. Vegetation is sparse, weeds appear to be grazed.

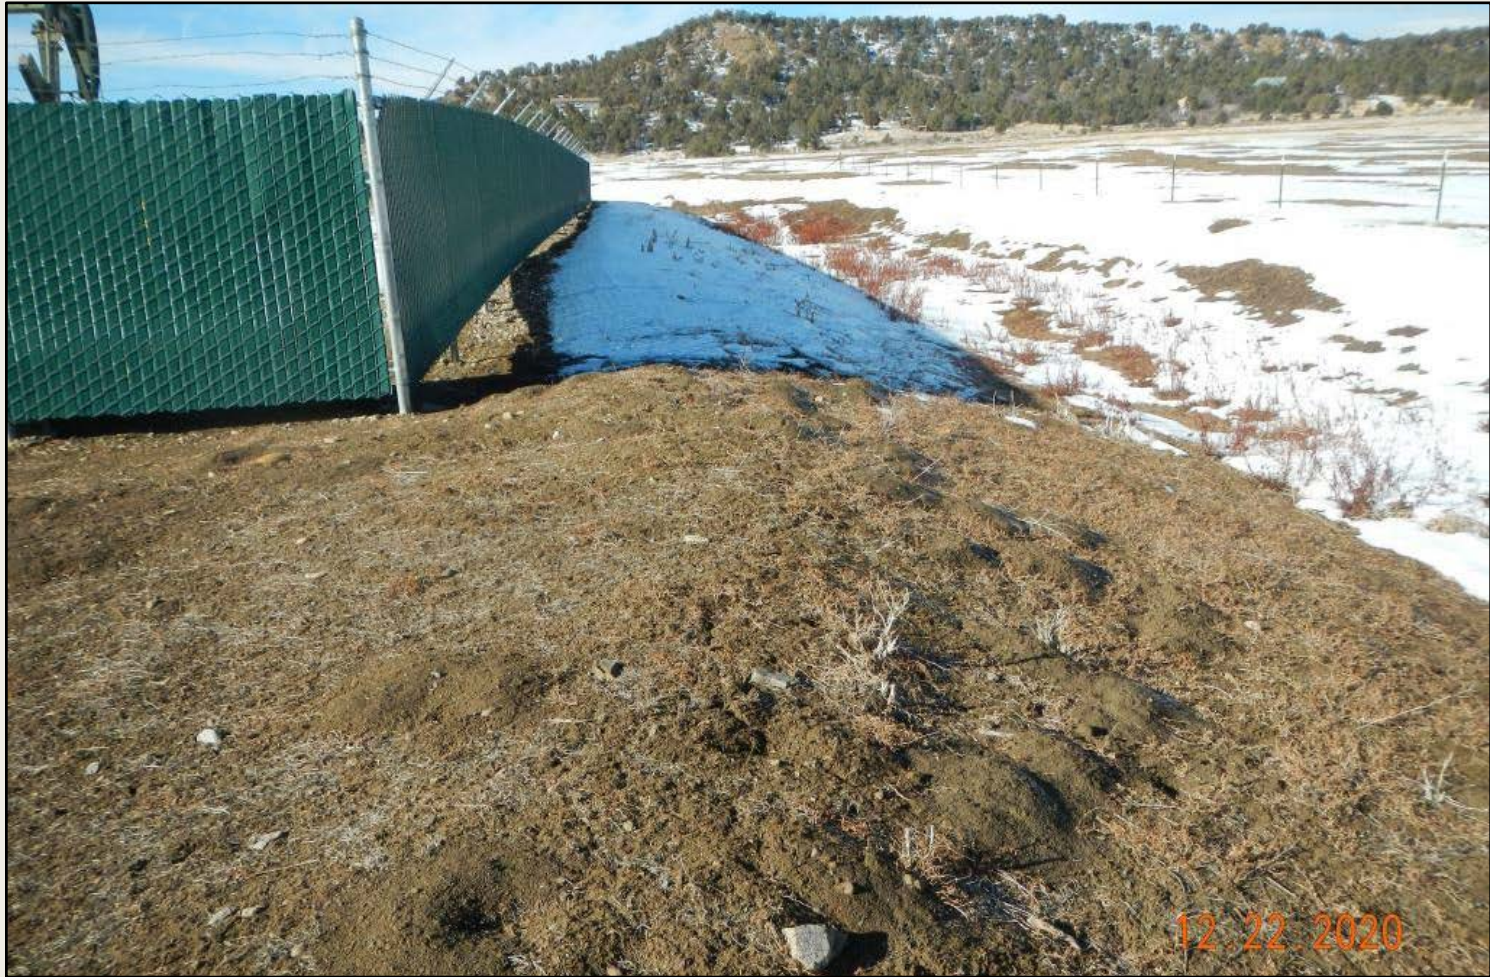
Photo 3. View of the northern project area from the northeastern corner facing westward.

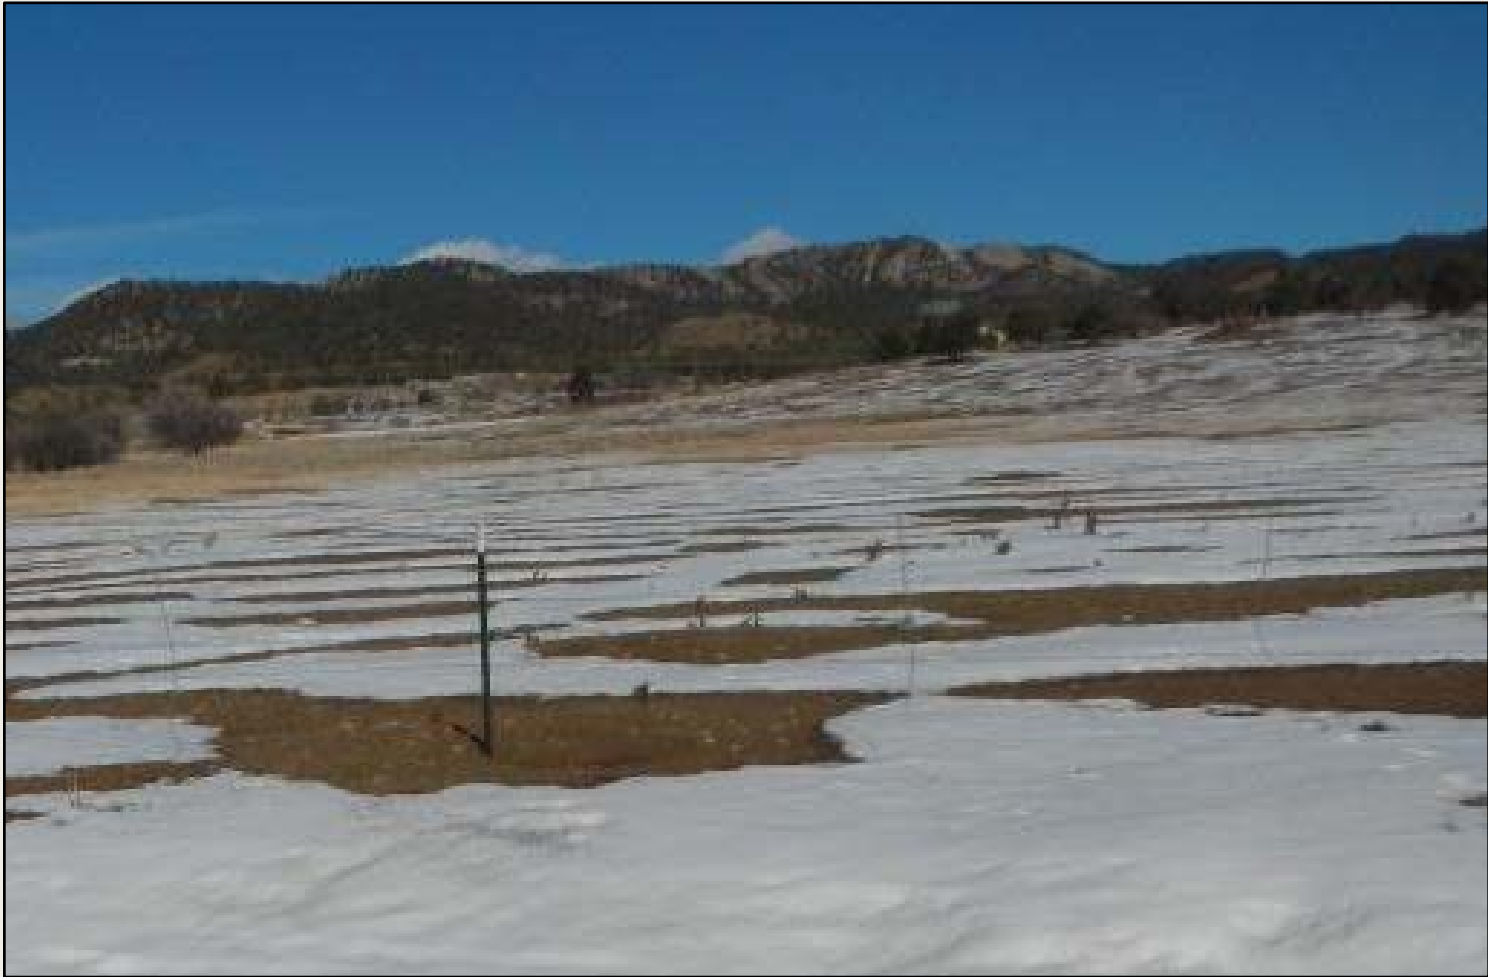
Photo 4. View of reference area comprised of open grass field, largely snow covered at this time.
