# Inspection Photos

Operator: Enduring Resources  
API: 067-07468  
Date: 12/22/2020

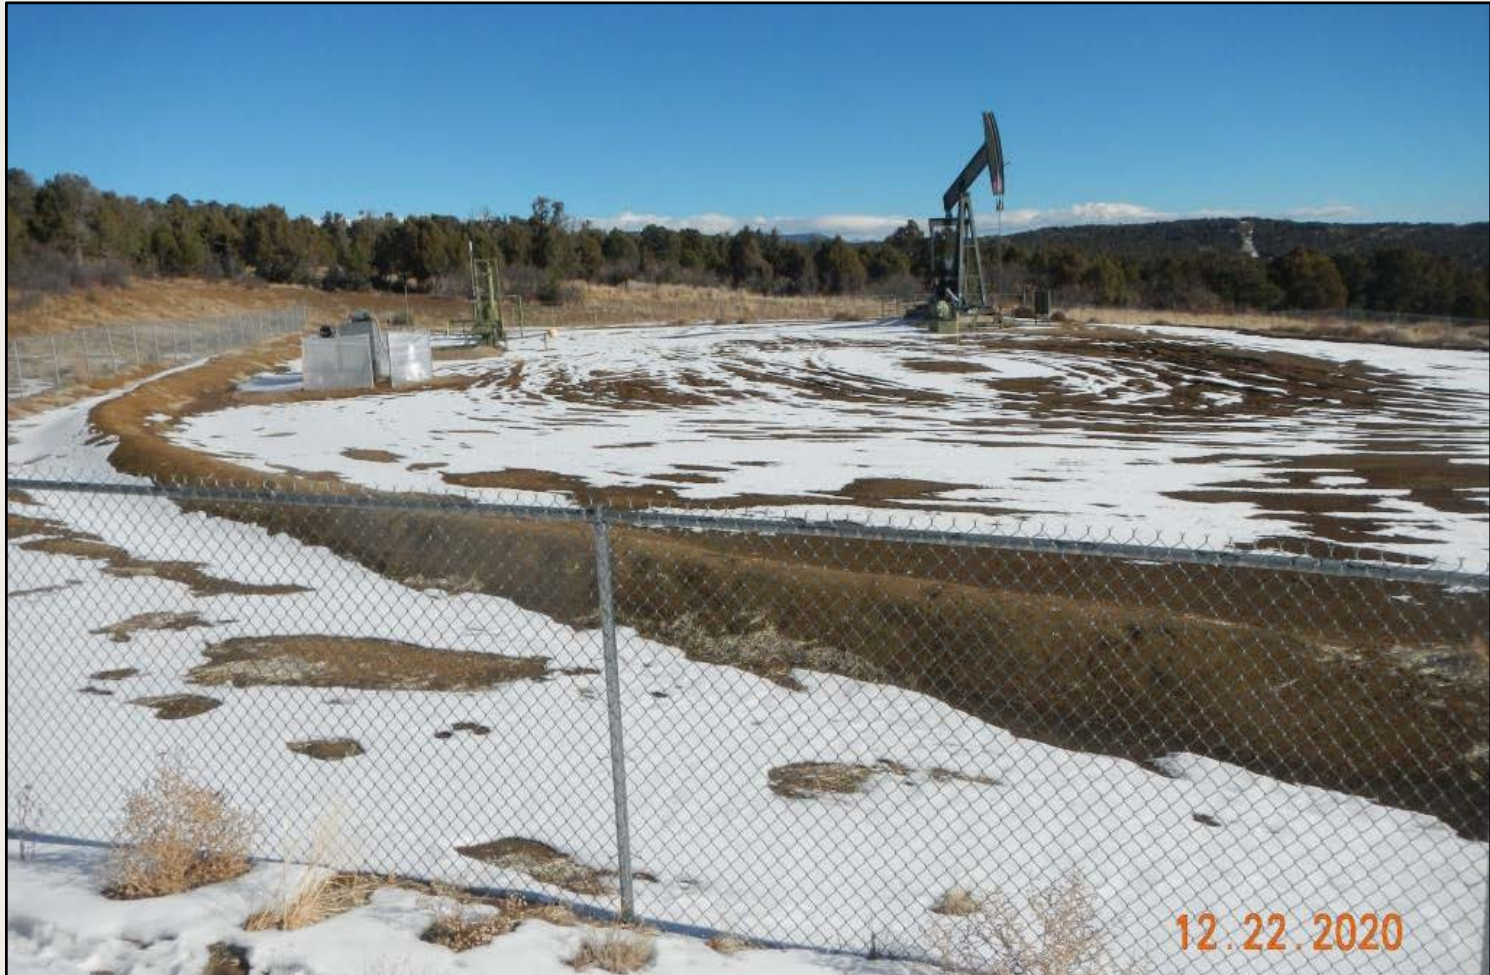
Photo 1. View of the project area from the southwestern corner facing center.

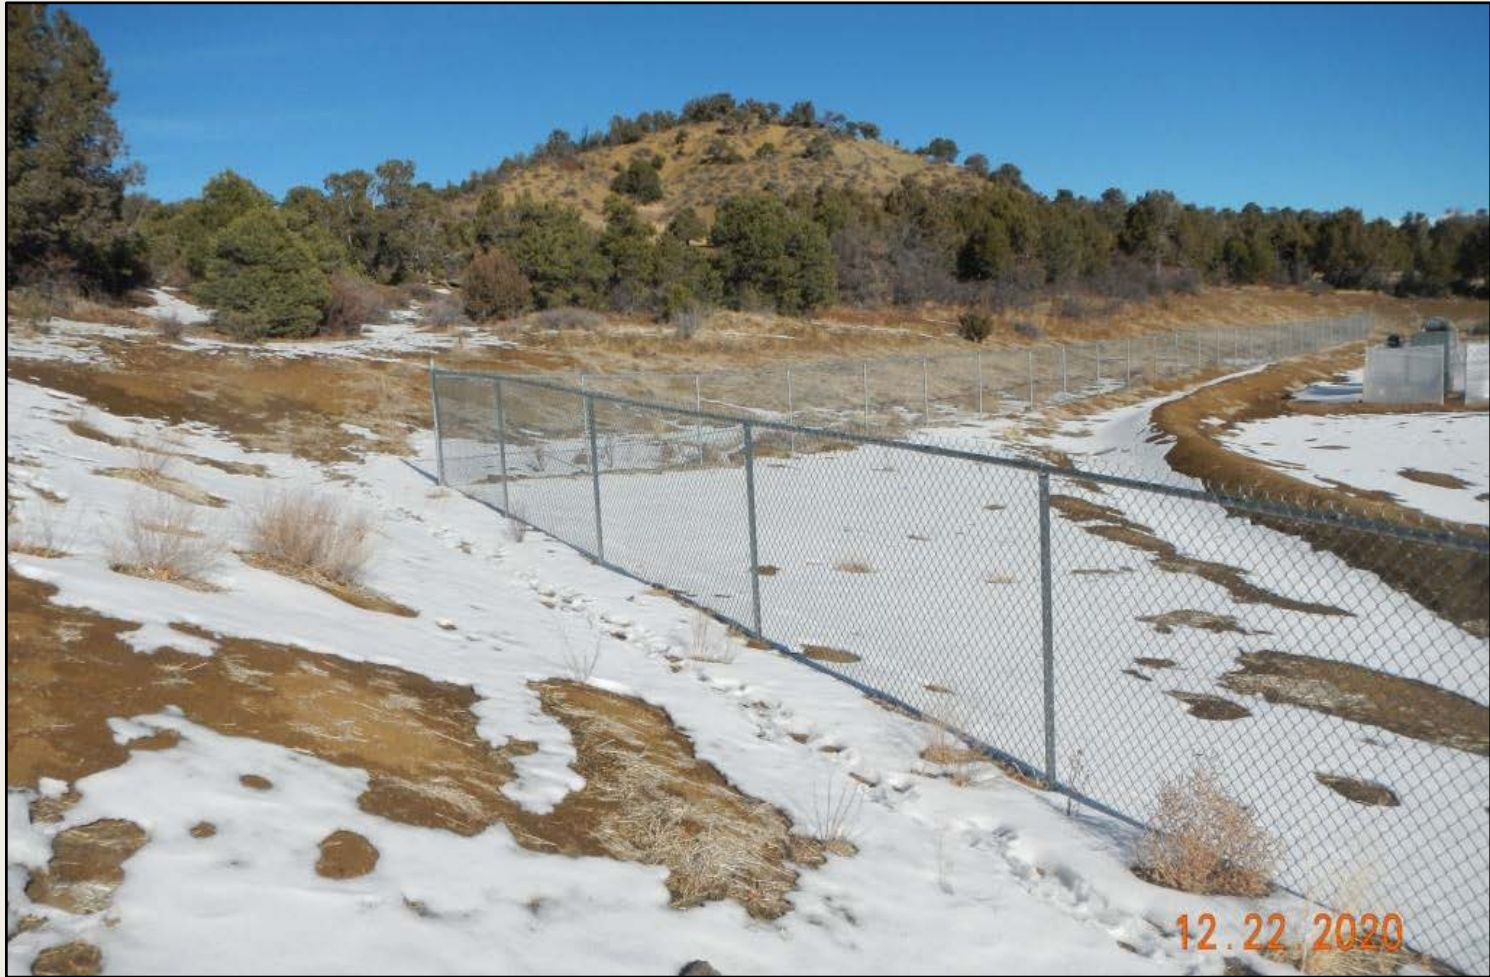
Photo 2. View of the western project area from the southwestern corner facing northward. Vegetation is sparse. Evidence of mulching and installation of BMPs observable, although a thorough stormwater and vegetation assessment was not conducted due to snow cover.

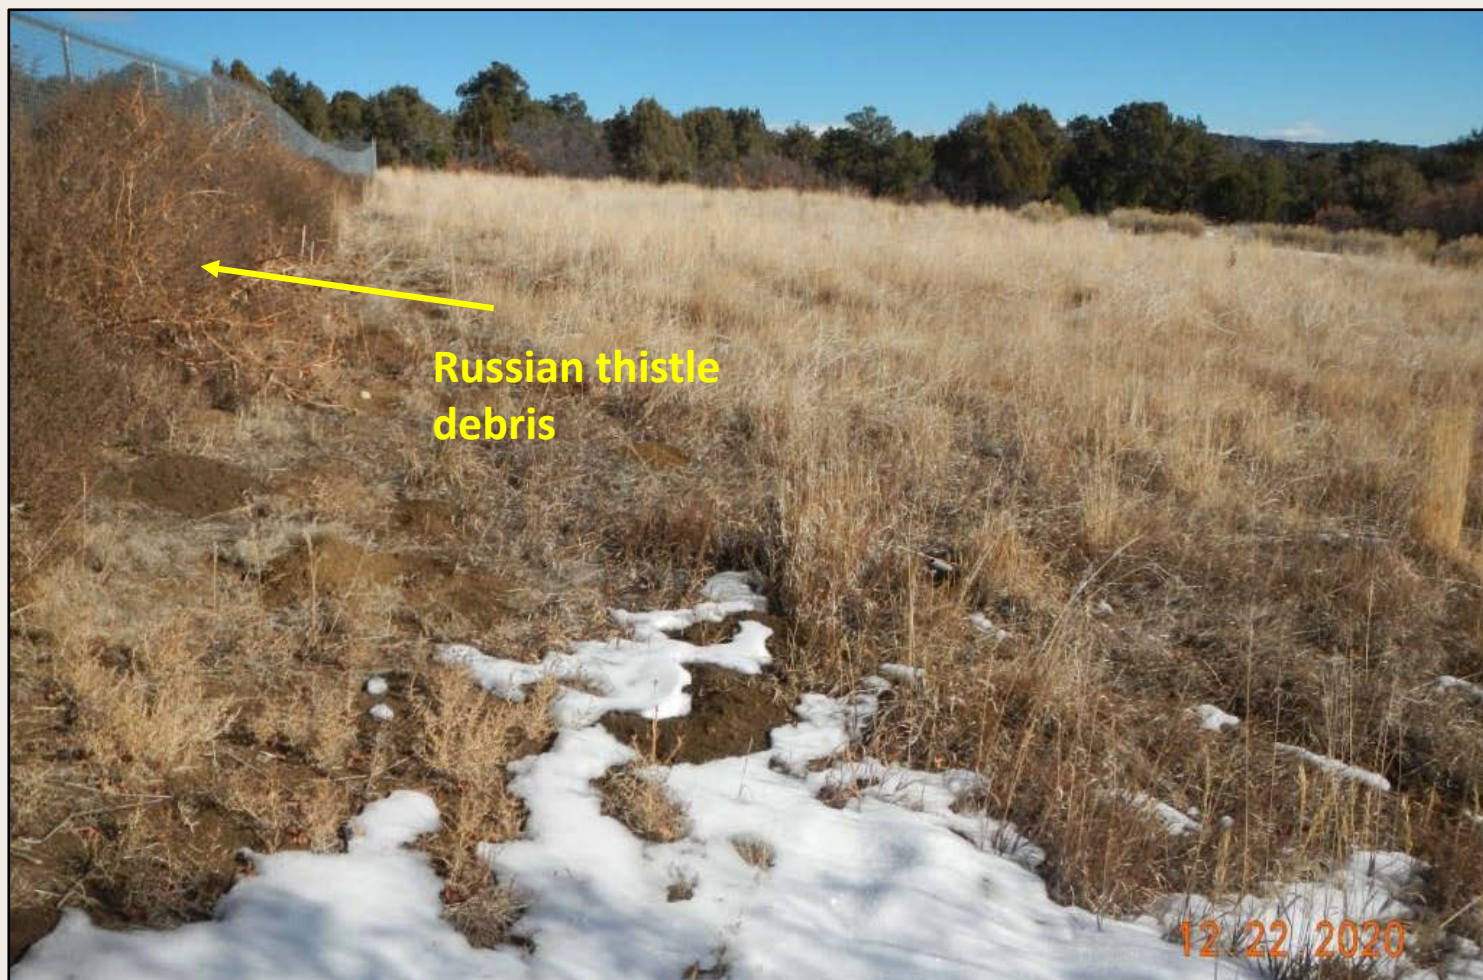
Photo 3. View of the eastern project area from the southeastern corner facing northward. Dense Russian thistle debris observed along the fenceline.

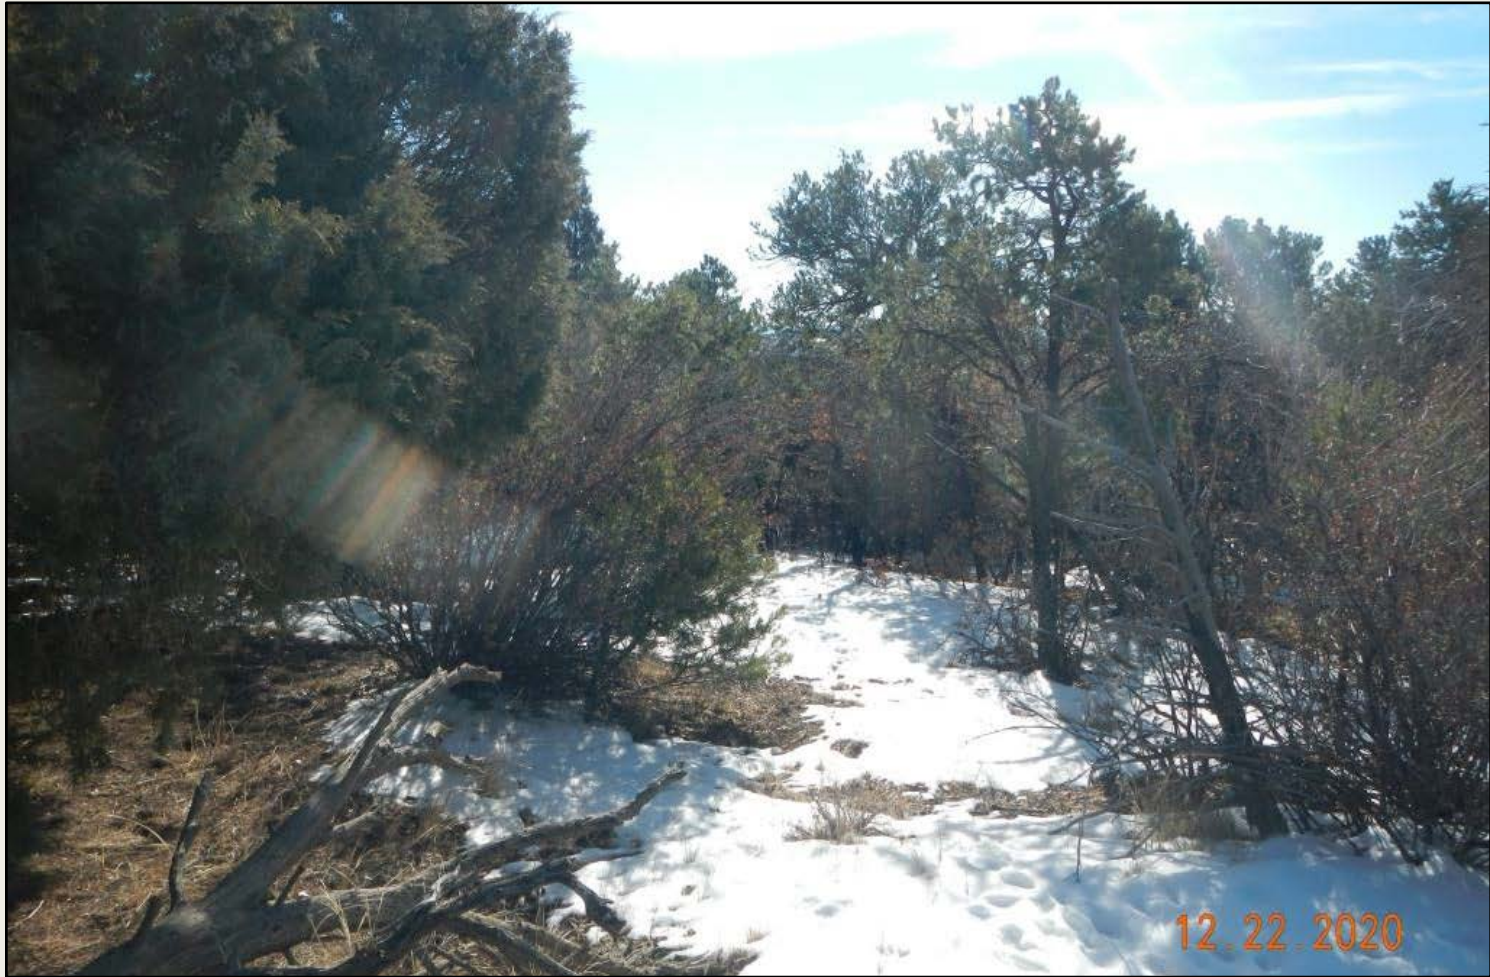
Photo 4. View of reference area comprised of pinyon and juniper woodland with gambel oak, mountain mahogany, antelope bitterbrush and grasses and forbs such as sand dropseed, Indian ricegrass, and prickly pear.

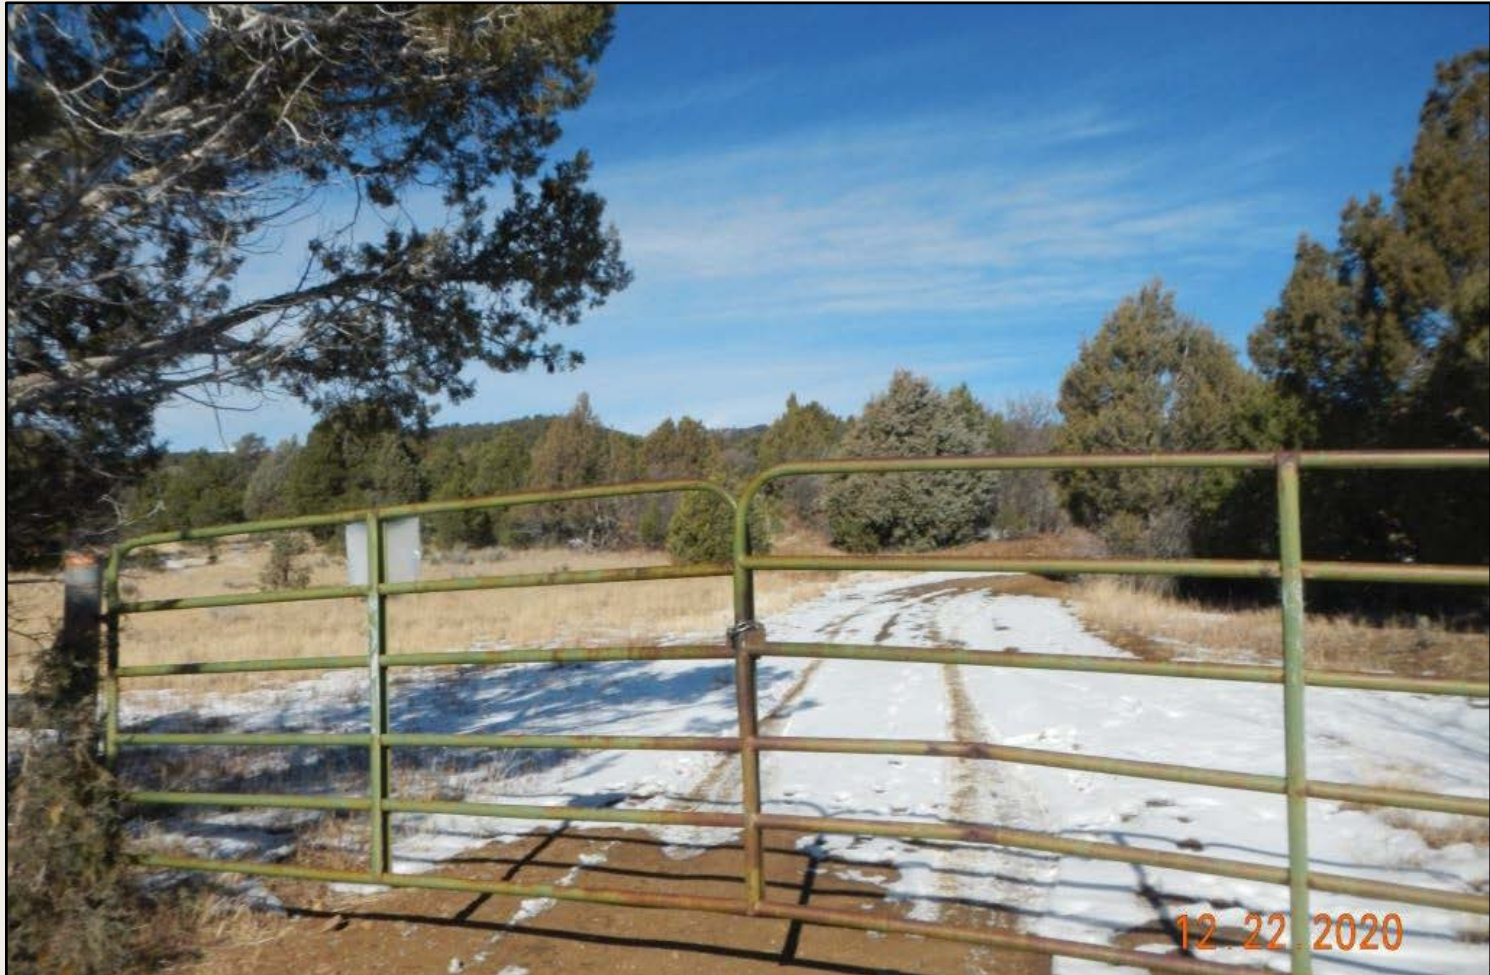
Photo 5. View of closed gate after leaving location
