Inspection Photos
Operator: Enduring Resources
API: 067-07759
Date: 12/22/2020

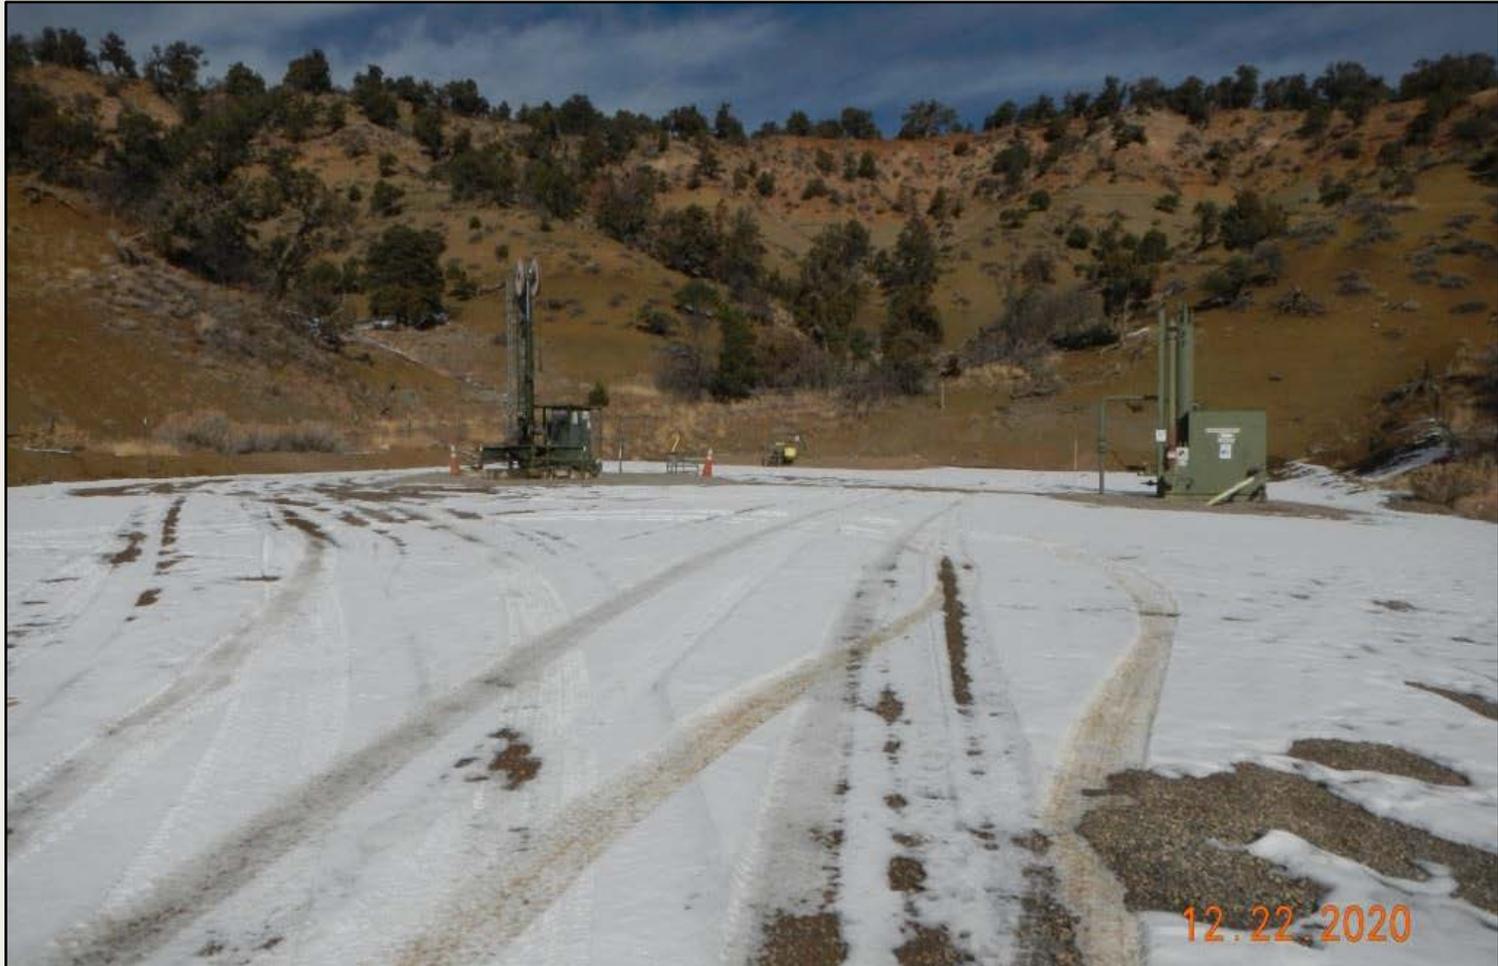
Photo 1. View of the project area from the well pad entrance facing center.

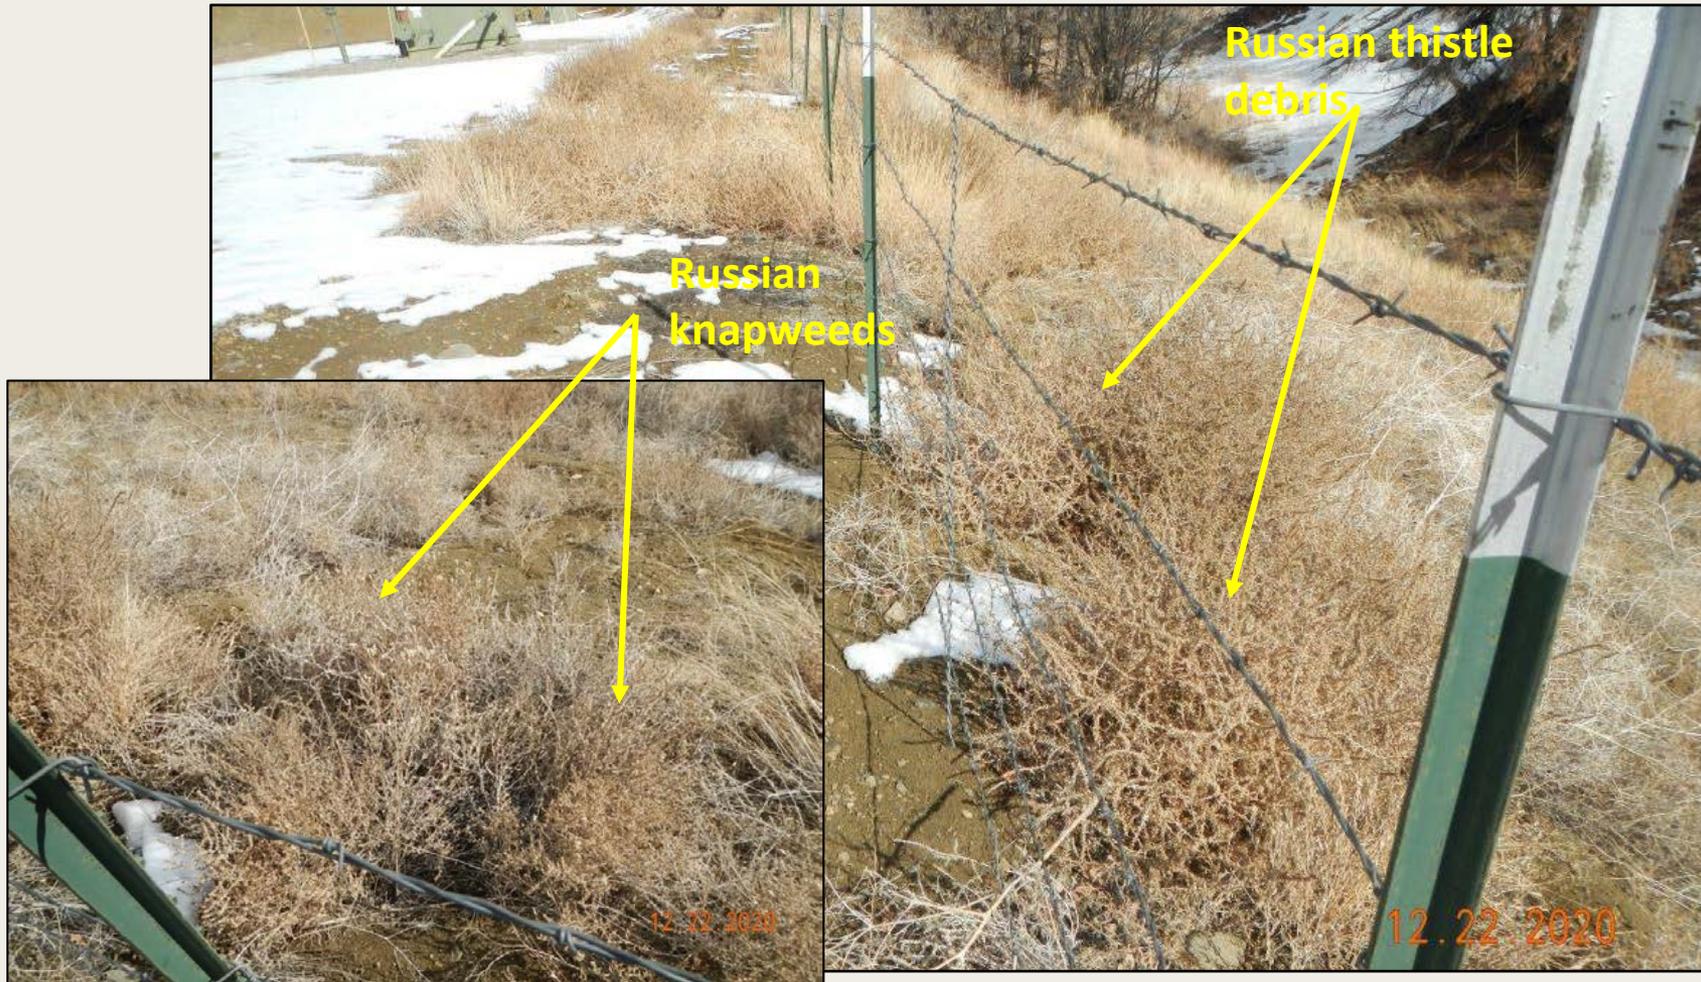
Photo 2. View of the eastern fill slope from the southeastern corner facing northward. Approximately 200 Russian knapweeds observed on the fill slope (shown in inset). Infestation is not being controlled. Russian thistle debris along the fenceline.

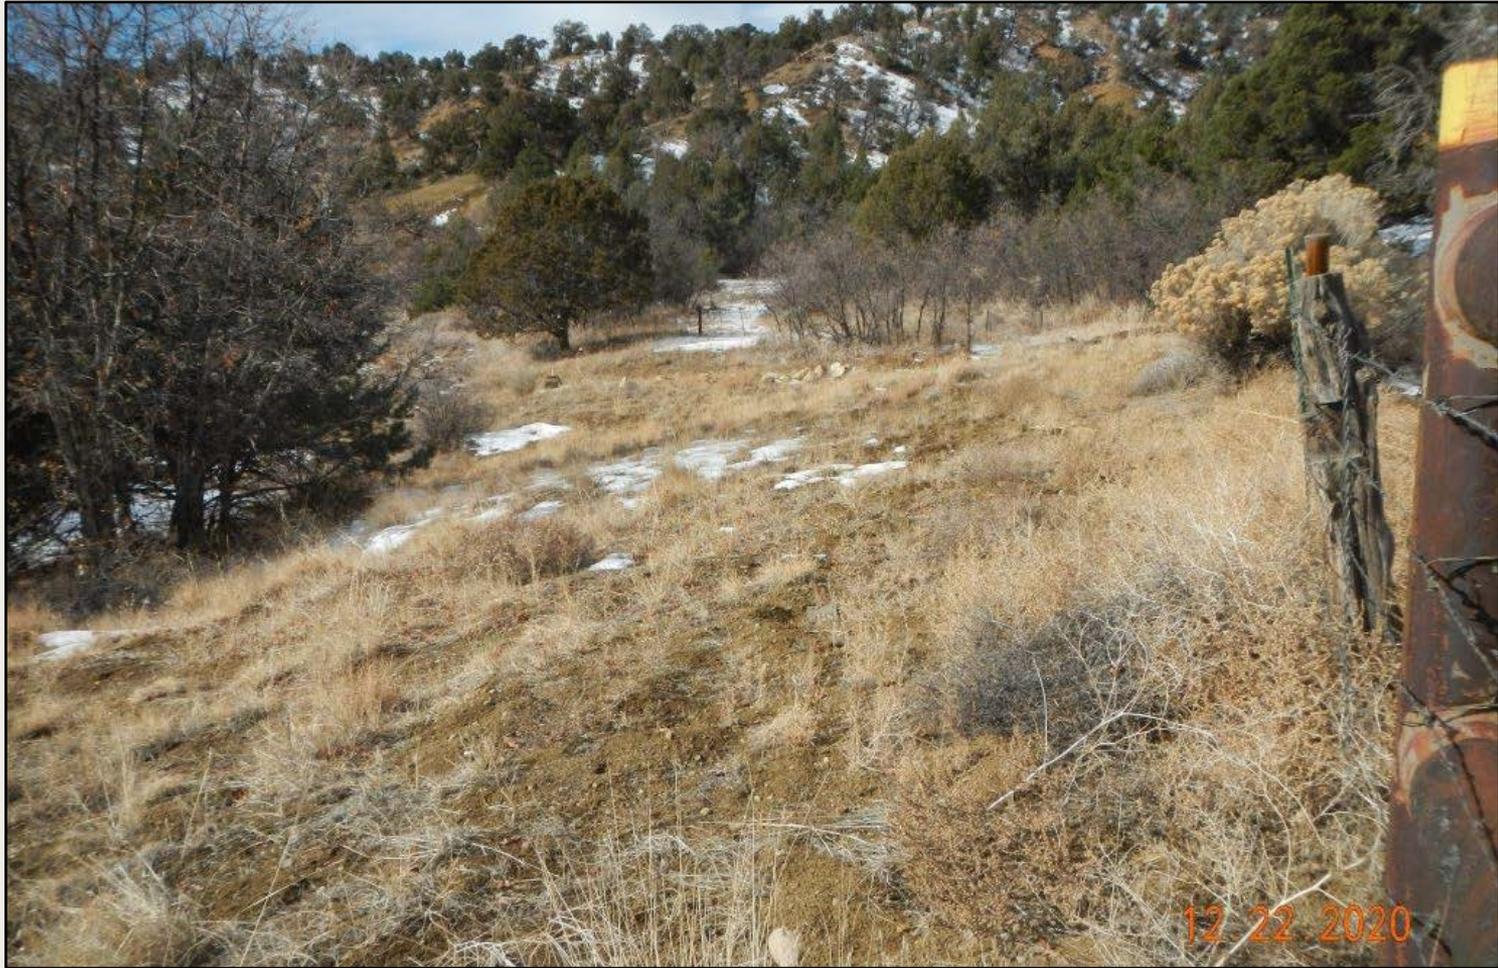
Photo 3. View of the southern project area from the southeastern corner facing westward.

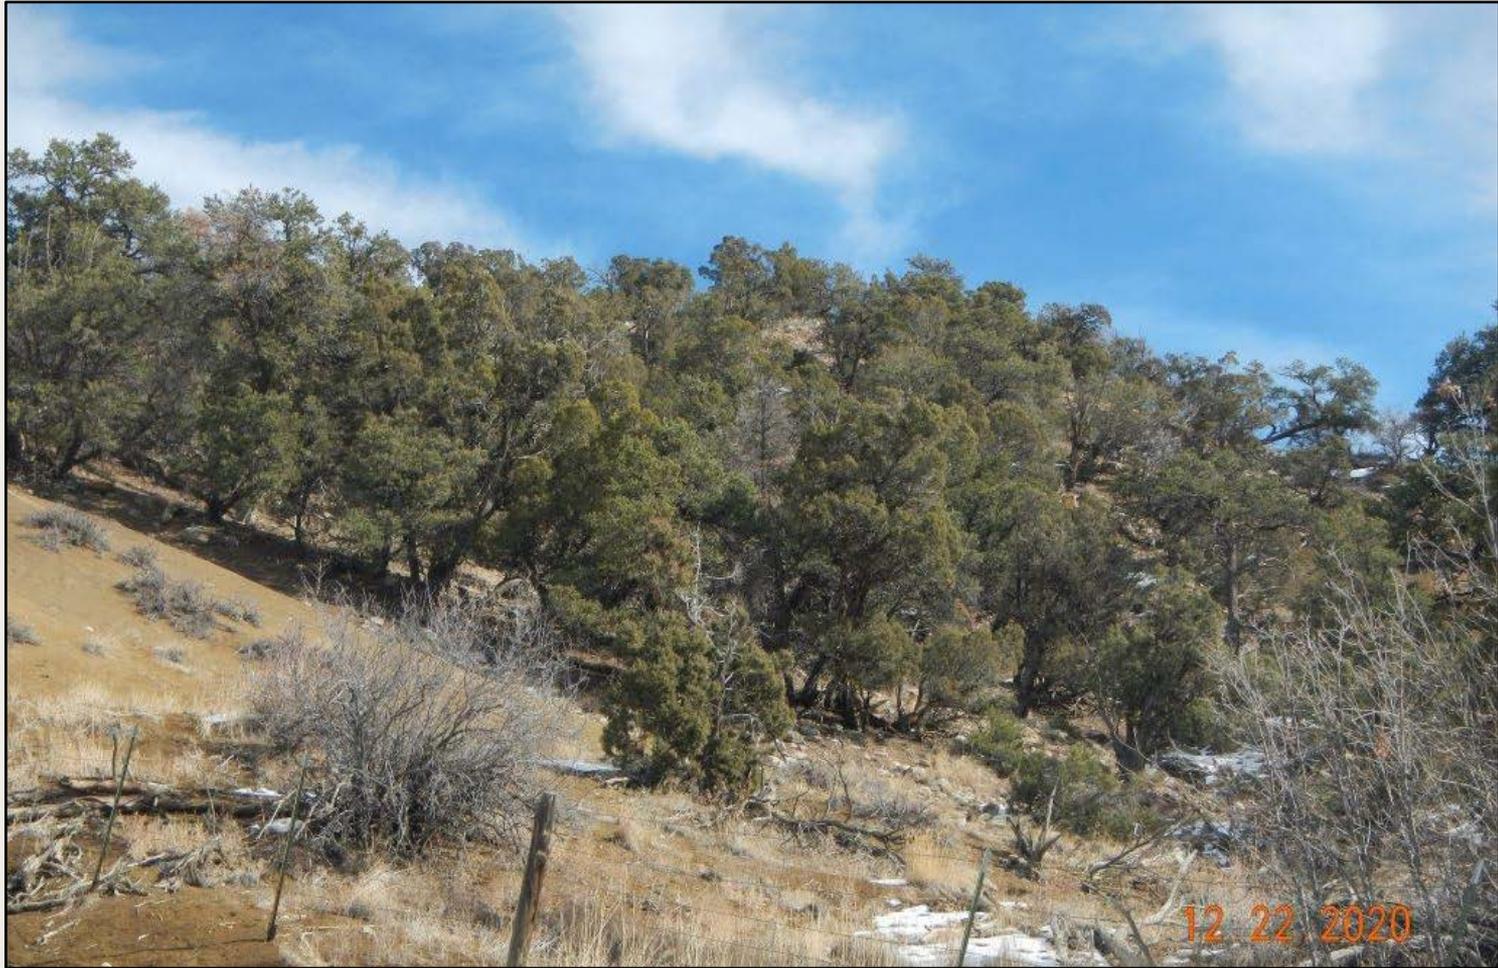
Photo 4. View of reference area comprised of pinyon and juniper woodland with gambel oak, antelope bitterbrush, Indian ricegrass, and mountain mahogany.
