Inspection Photos

11/24/2020

Operator: CAERUS PICEANCE LLC - 10456

Location ID: 312672

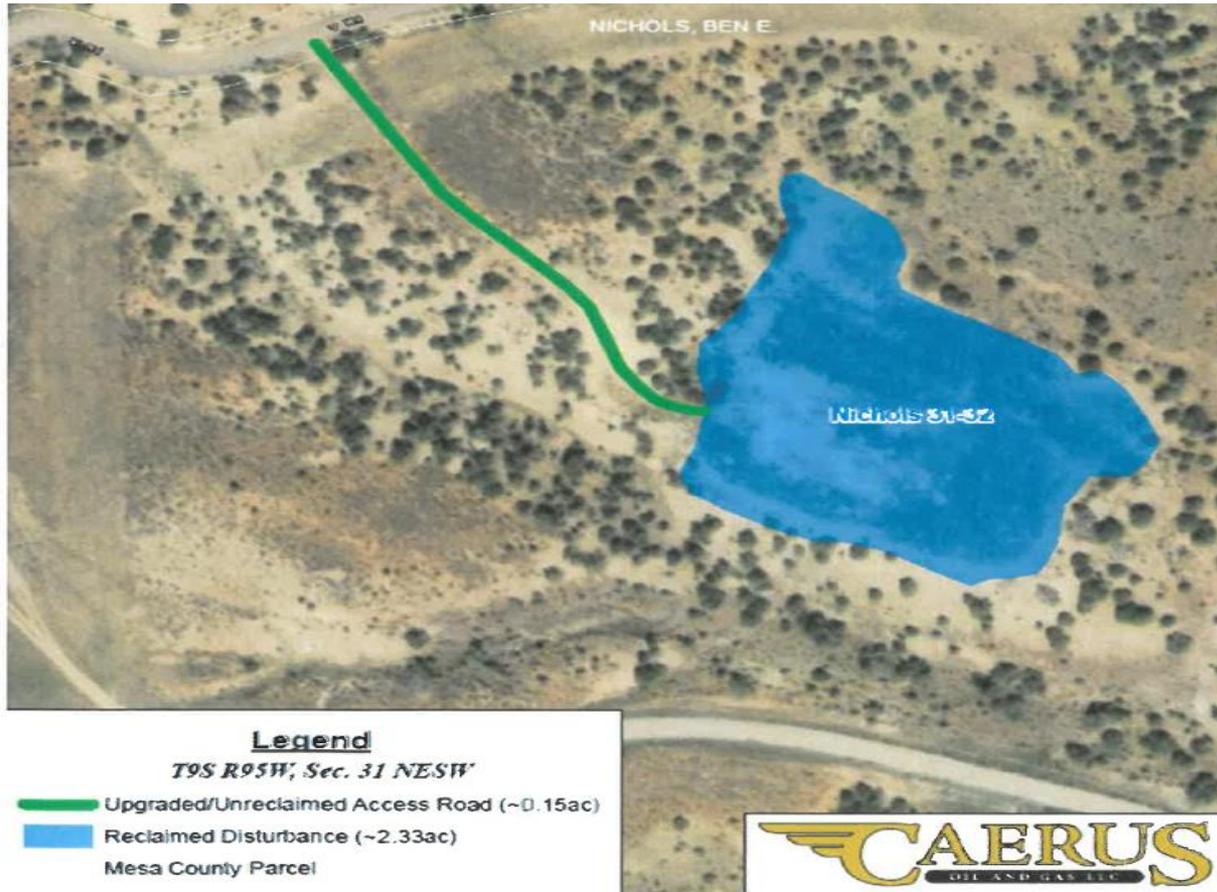
Photo 1: Figure attached to SOVR #402525408 provided by Caerus; Photo shows access road (green) not to be reclaimed, and the well Location (Blue) that remains subject to COGCC 1000 series requirements. Access road requires graveling per COAs.

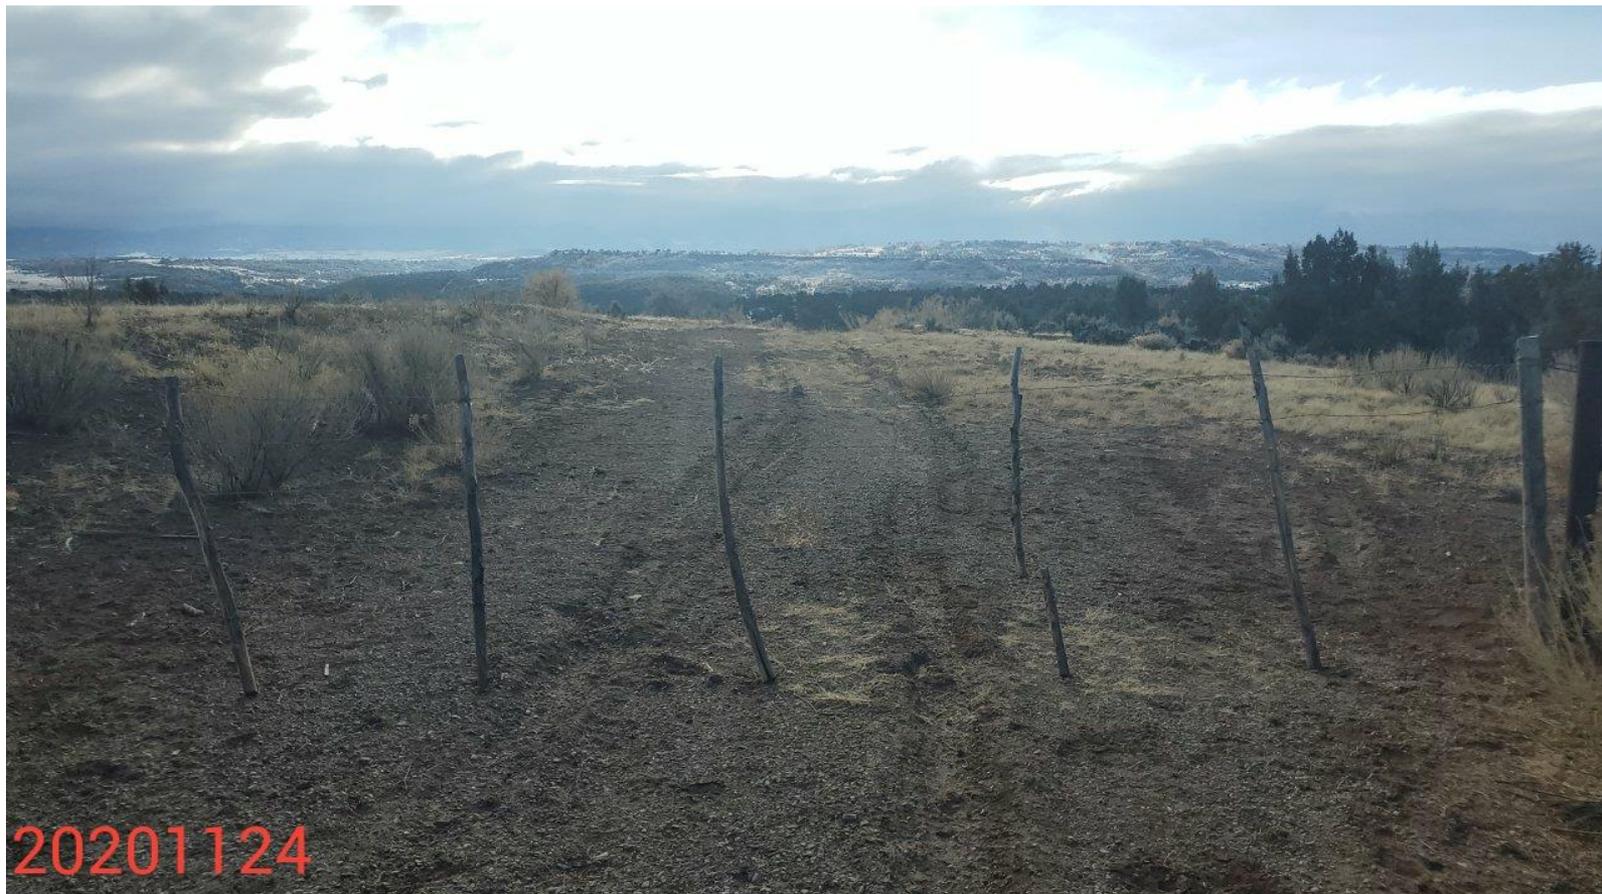
Photo 2: Photo taken from the access road entrance north of the Location, facing south. Per doc. #402525408, 1004 reclamation requirements of the access road has been waived; access road requires gravelling.

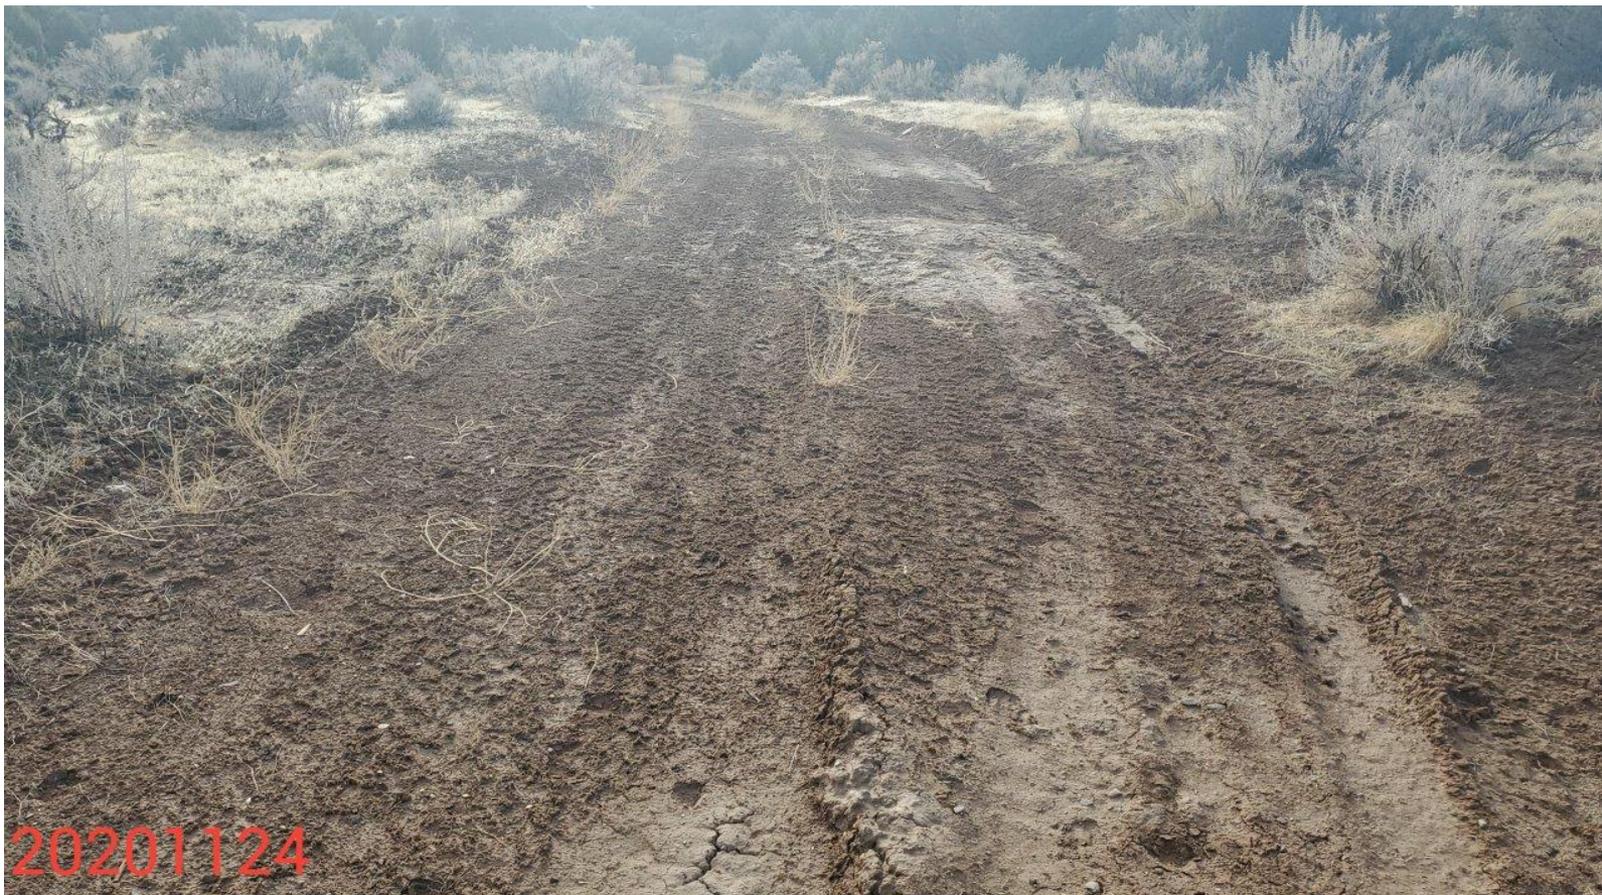
Photo 3: Continued from photo 2. Access road requires graveling. BMPs installed on/along access road need to be installed in accordance with good engineering practices pursuant to 1002.f Rules.

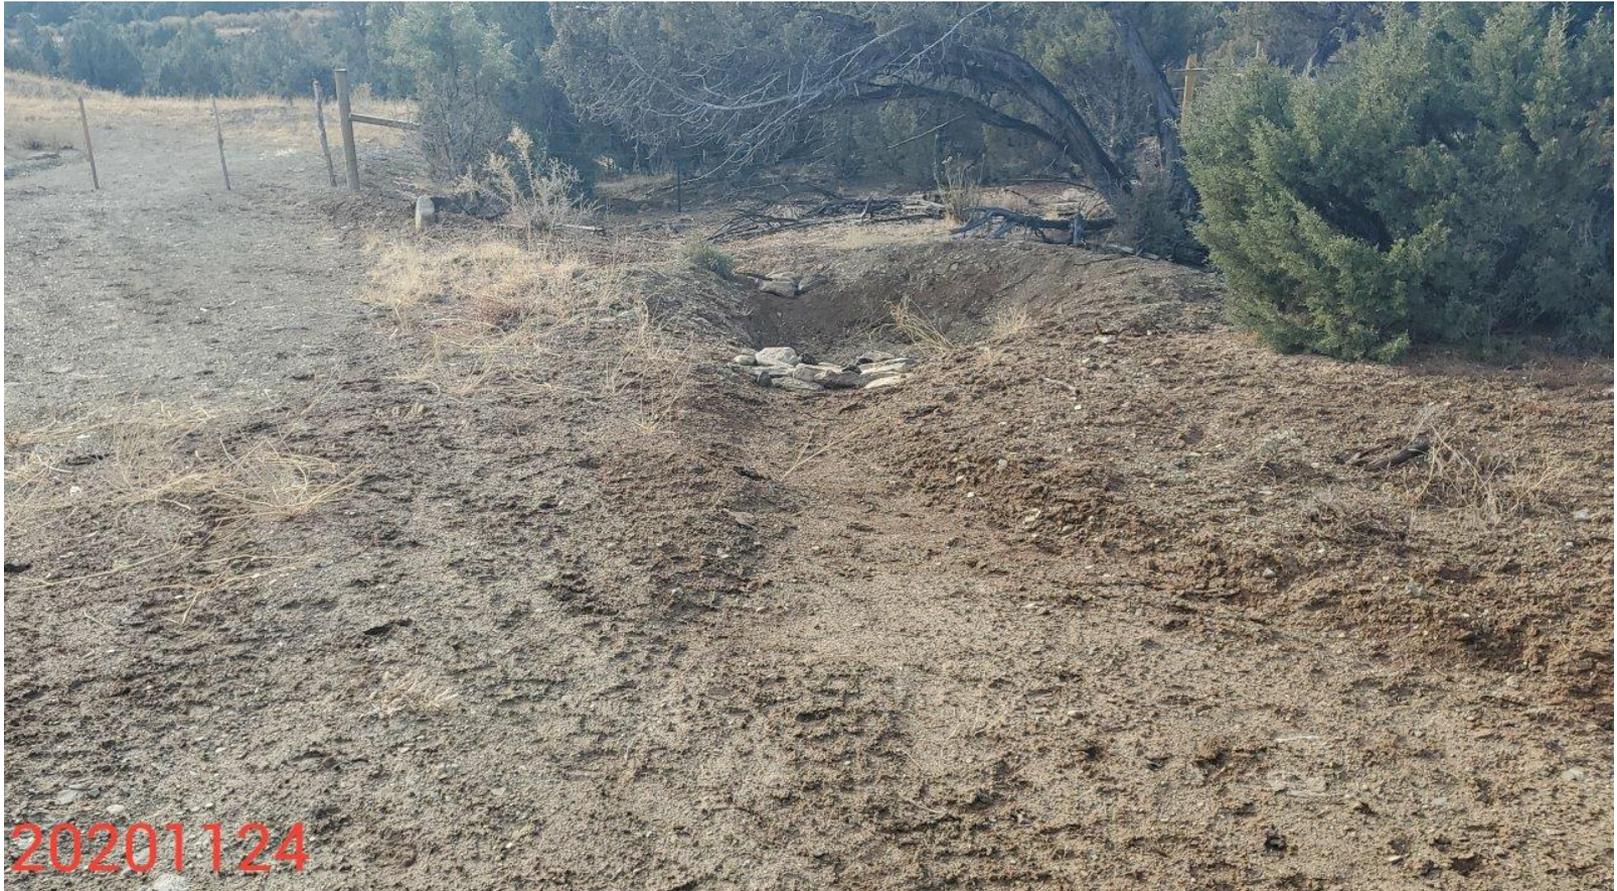
Photo 4: Photo taken from the access road, facing south. Photo shows sediment trap along access road. BMP has not been installed in accordance with good engineering practices.

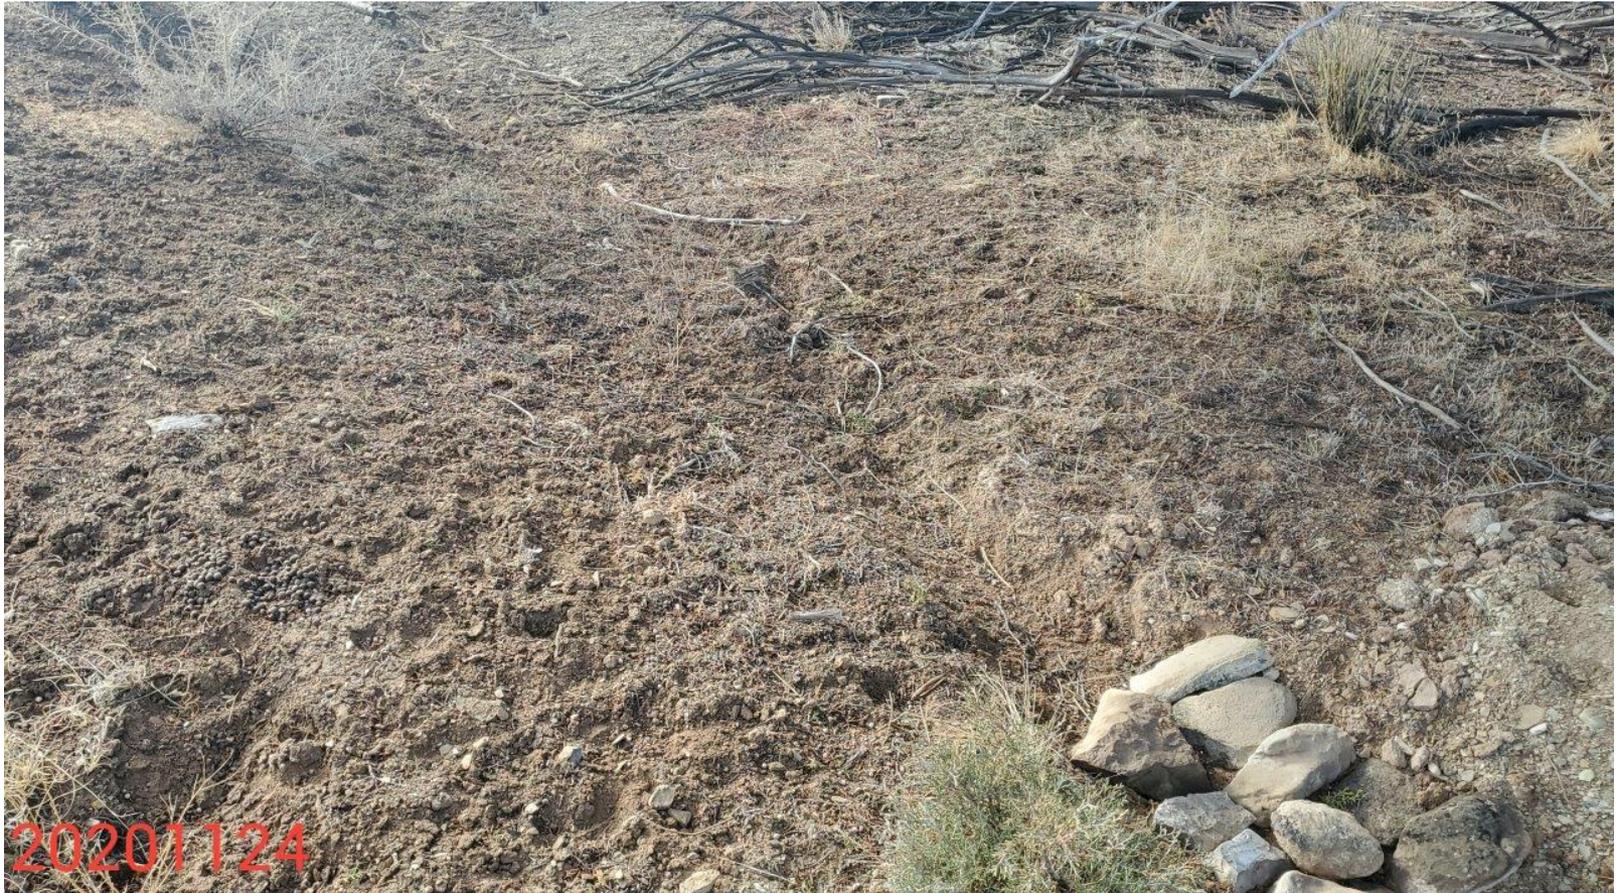
Photo 5: Continued from photo 4. Photo shows outlet at sediment trap has not been constructed in accordance with good engineering practices.

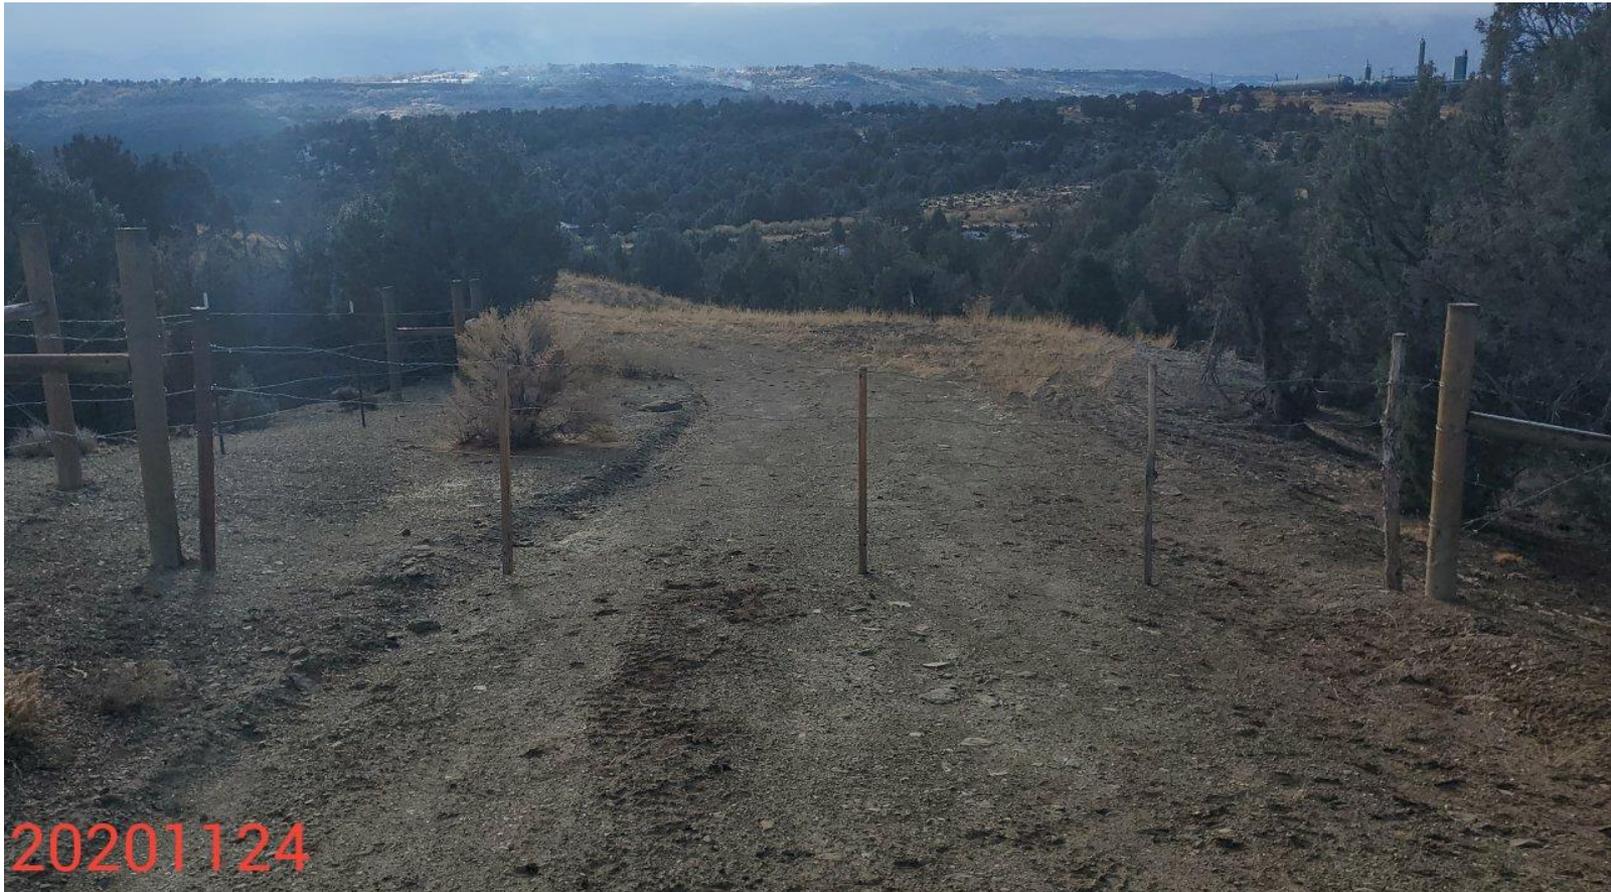
Photo 6: Photo taken from the fenced Location's entrance. Per figures provided by the Operator, these areas will be reclaimed.

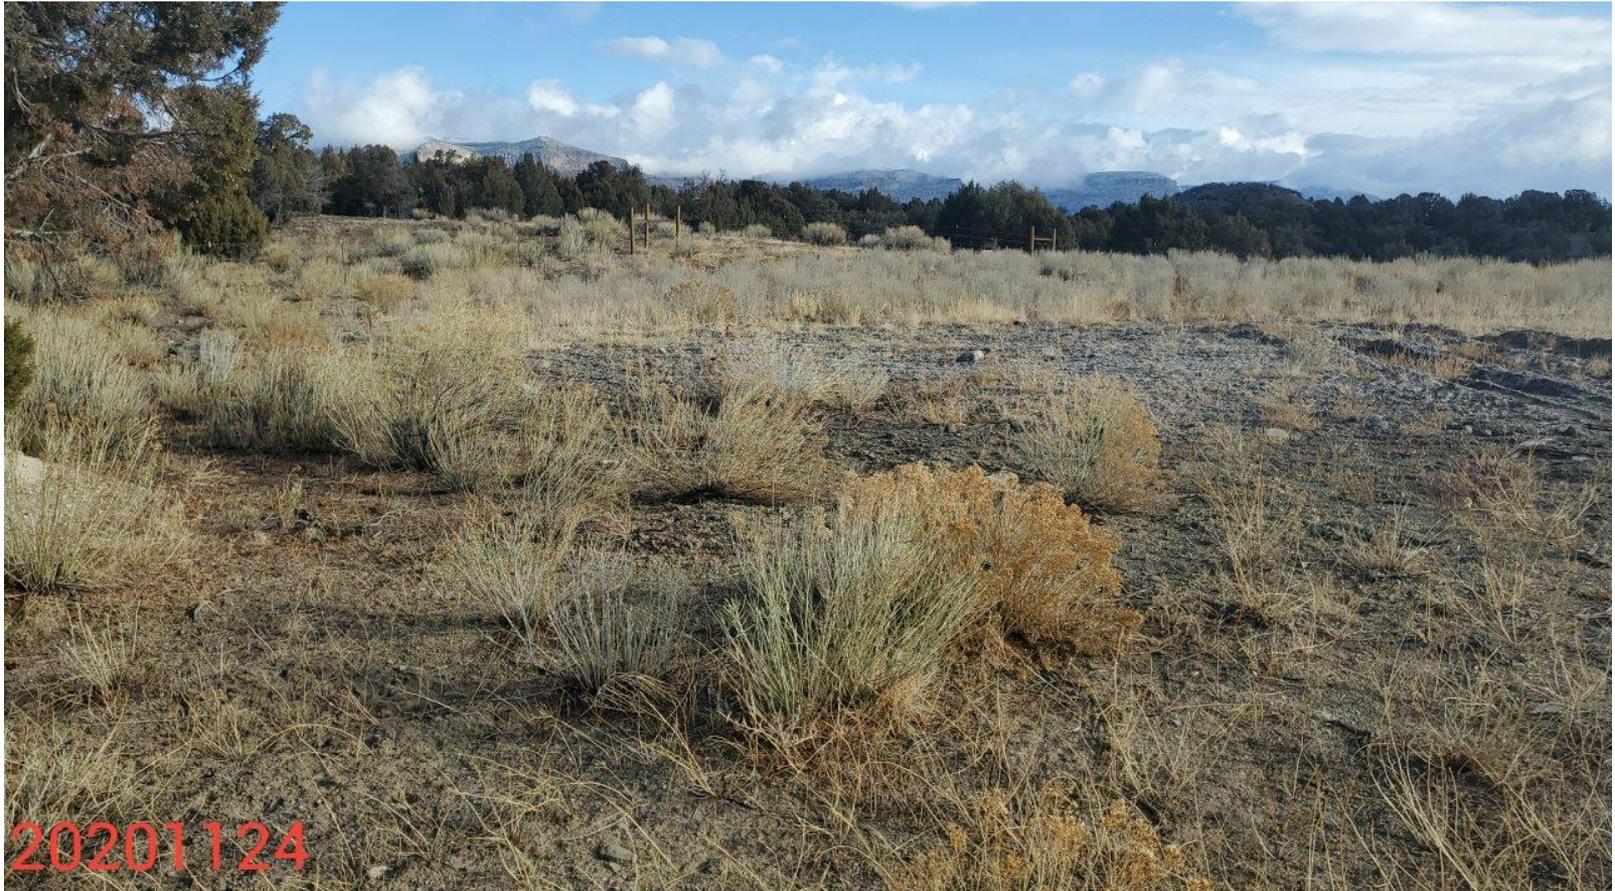
Photo 7: Photo taken from the northwest end of the Location, facing east. Photos 7-9 provide an overview of the Location from east, southeast to south.

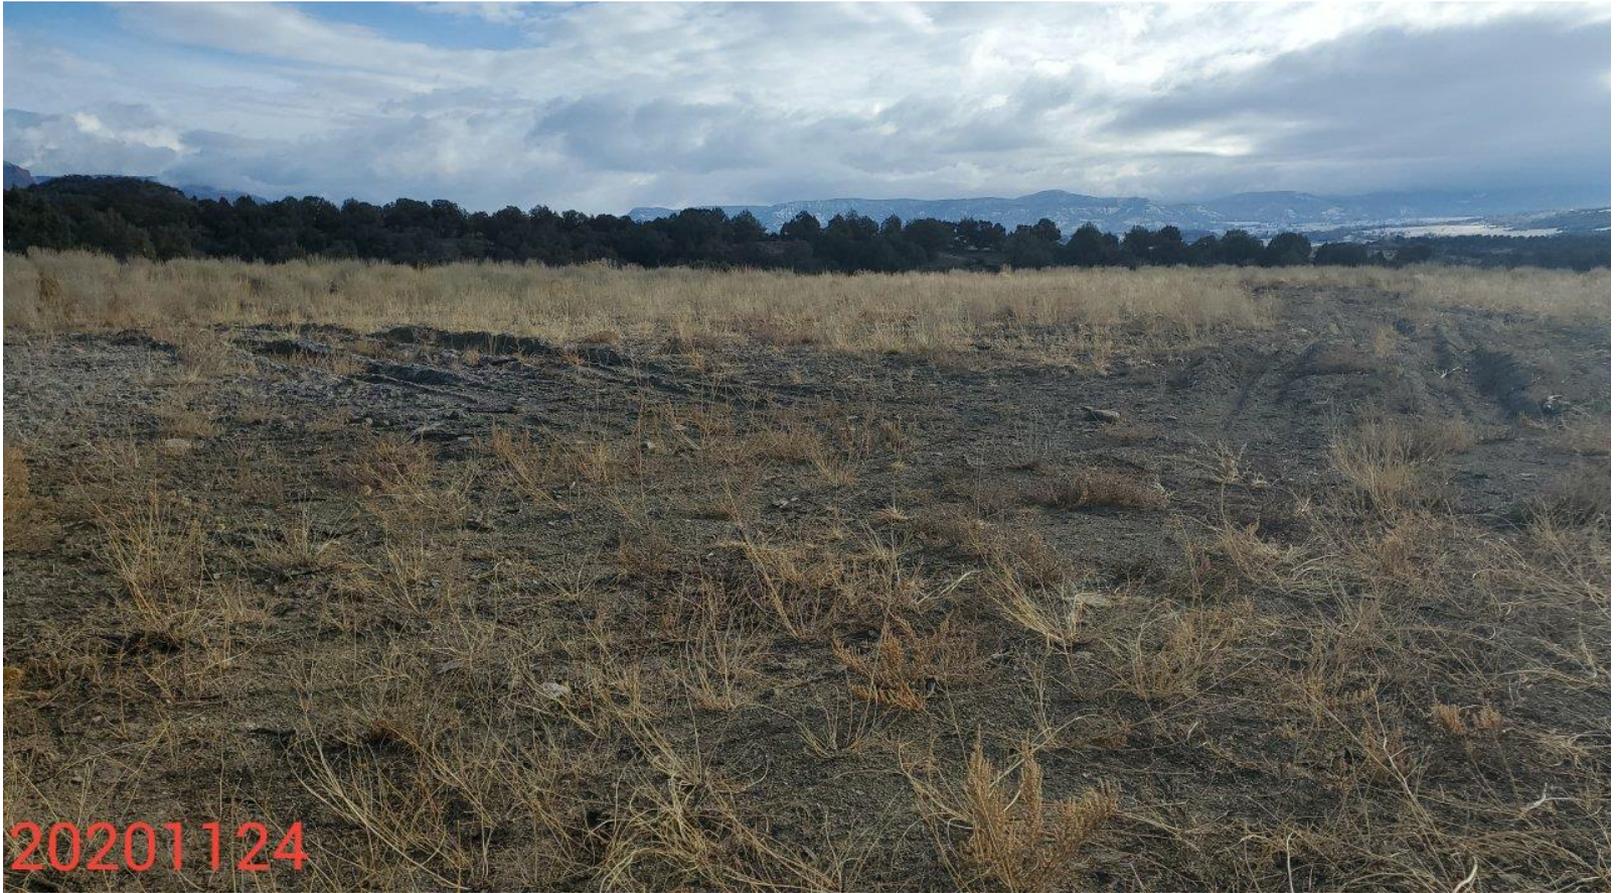
Photo 8: See comments under photo 7.

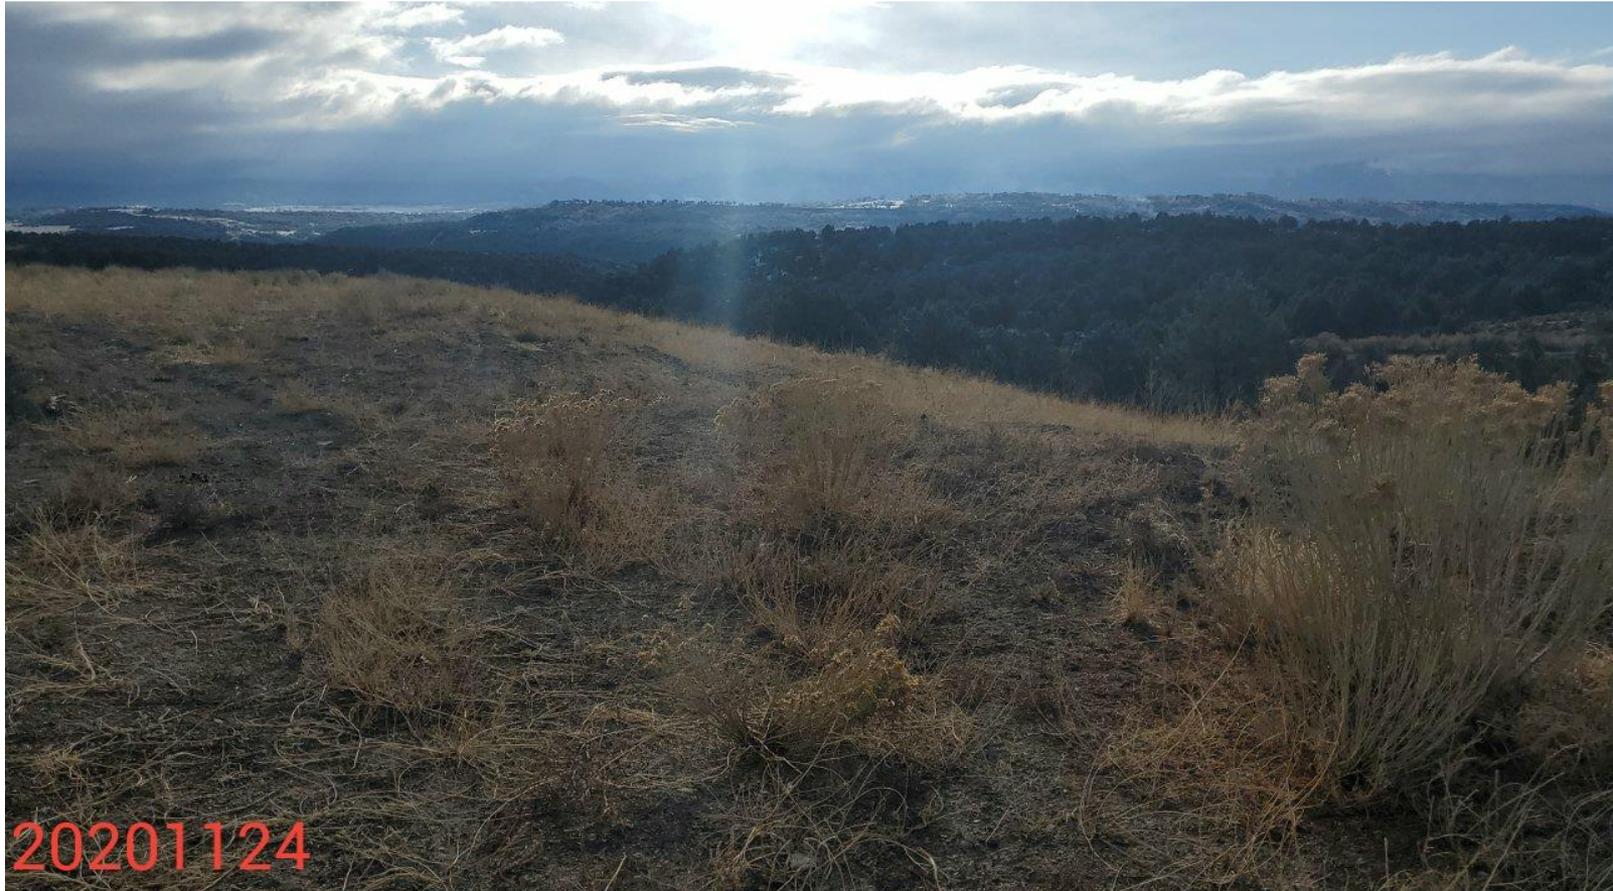
Photo 9: See comments under photo 7.

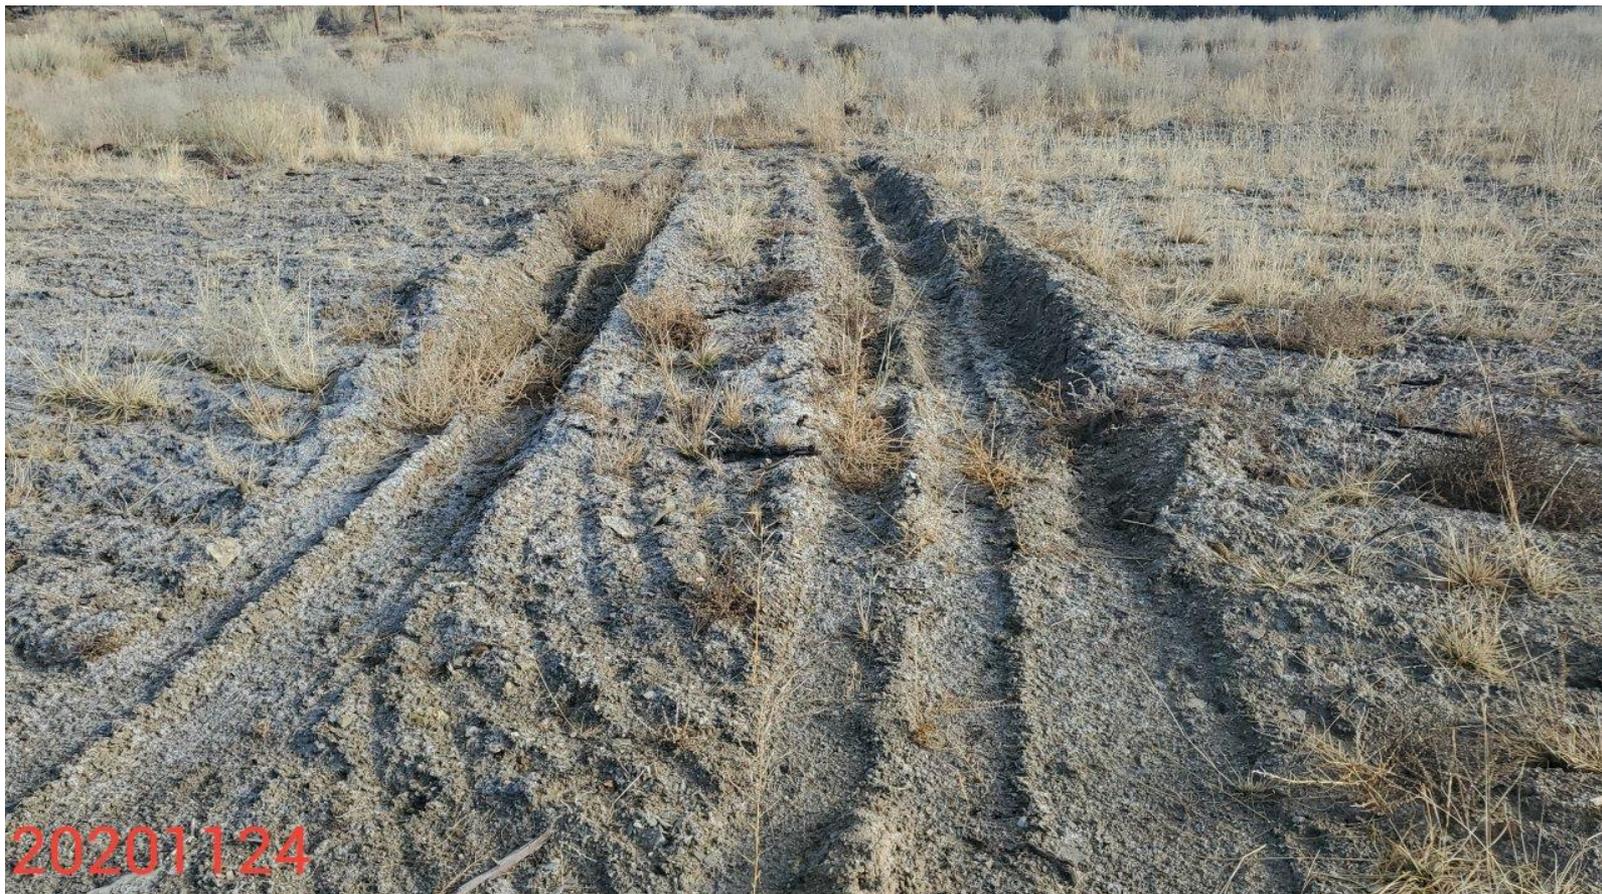
Photo 10: Photo taken from the Location, facing east. Photo shows vehicle travel on the location has resulted in deep ruts throughout the reclamation area; Additional reclamation work will be required in these areas to repair rutting, address potential compaction and revegetation concerns resulting from vehicle use.

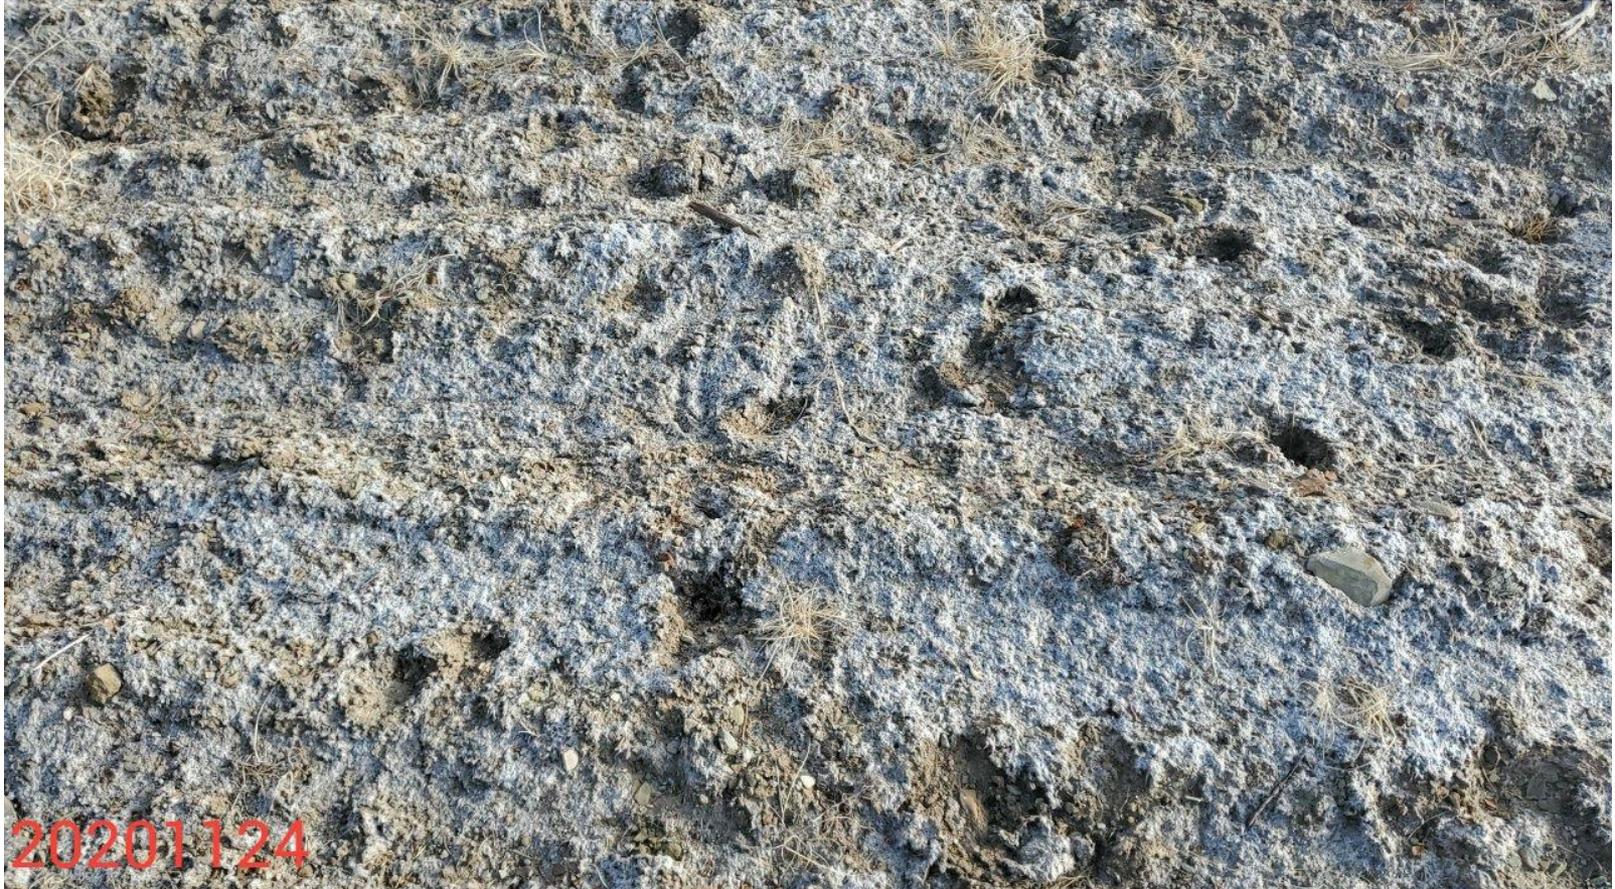
Photo 11: Photo taken from the Location. Photo shows additional seeding/stabilization activities appear to have recently been conducted.

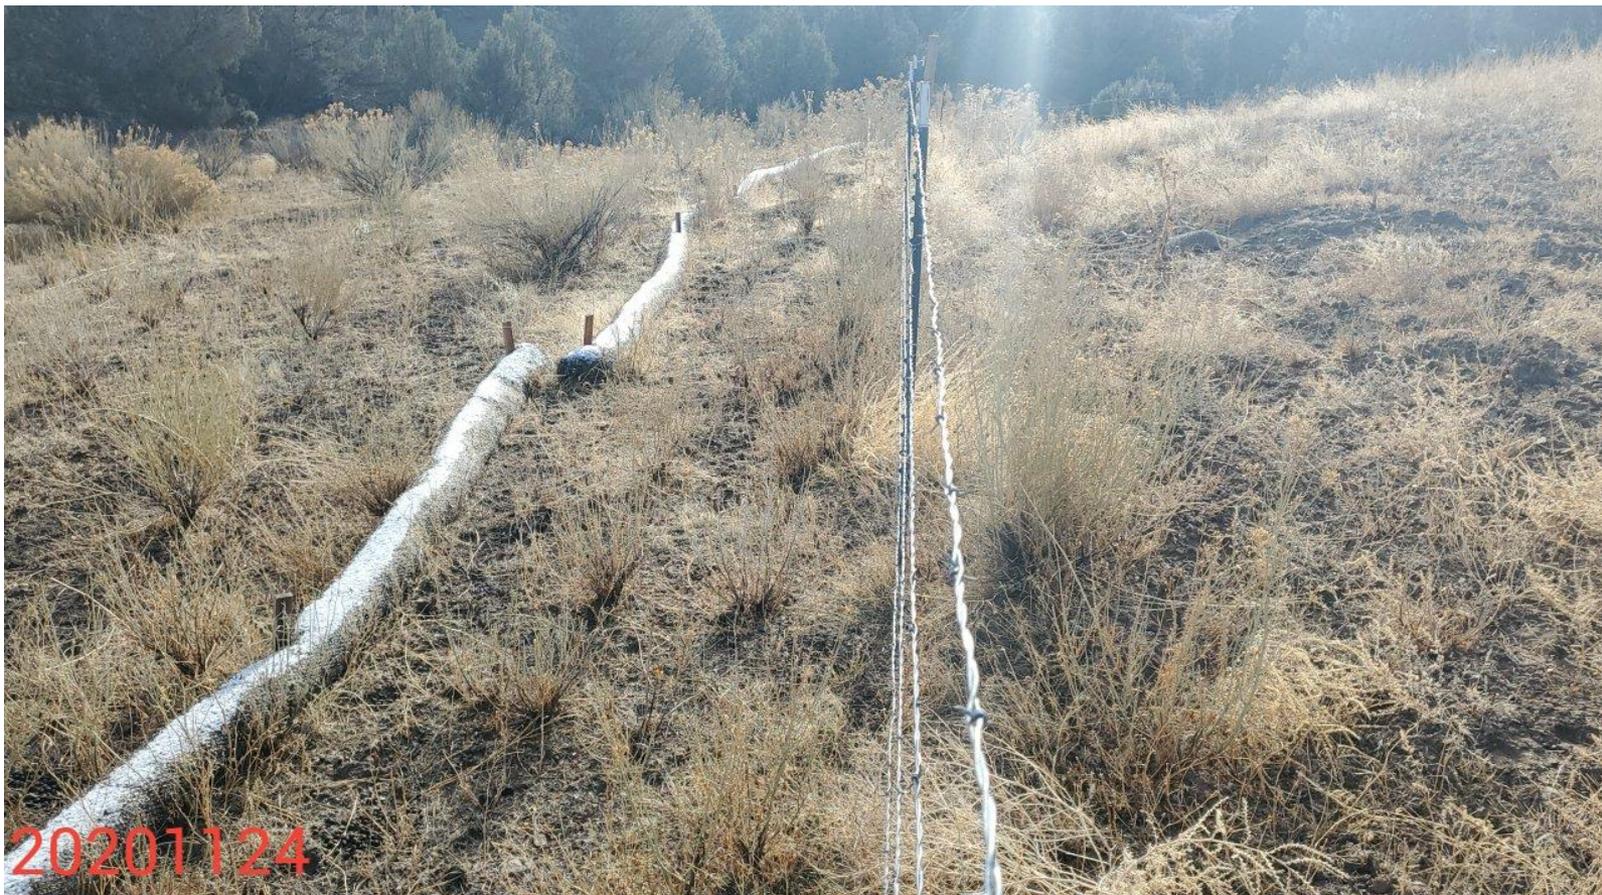
Photo 12: Photo taken from the east end of the Location, facing southeast. Photo shows example of perimeter BMPs that have not been installed in accordance with good engineering practices.

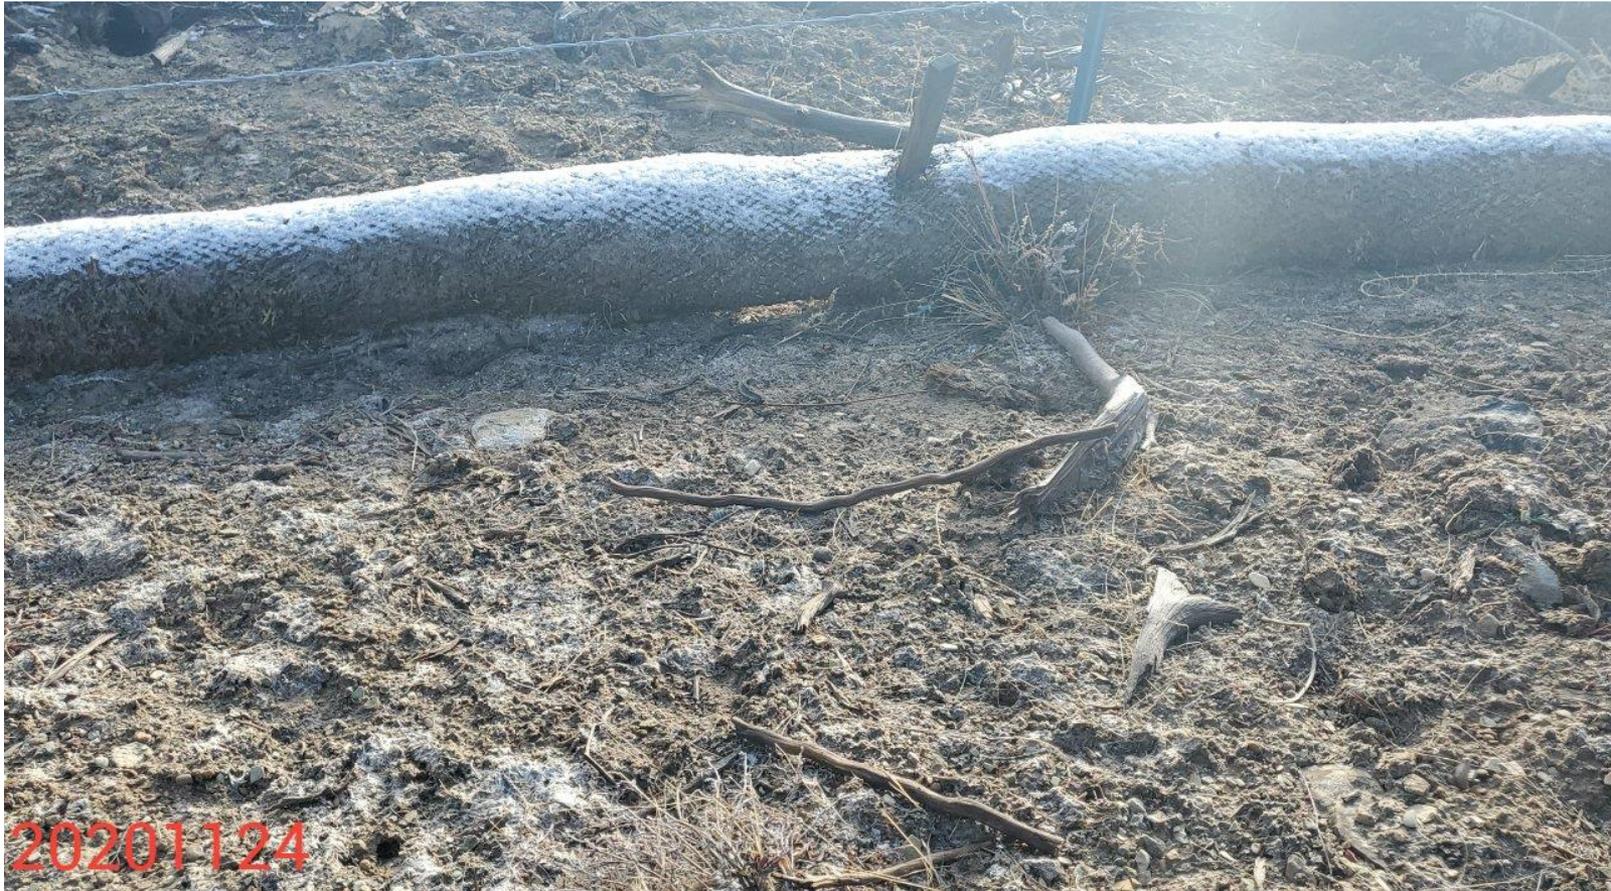
Photo 13: Continued from photo 12. Photo shows perimeter BMPs have not been installed in accordance with good engineering practices.

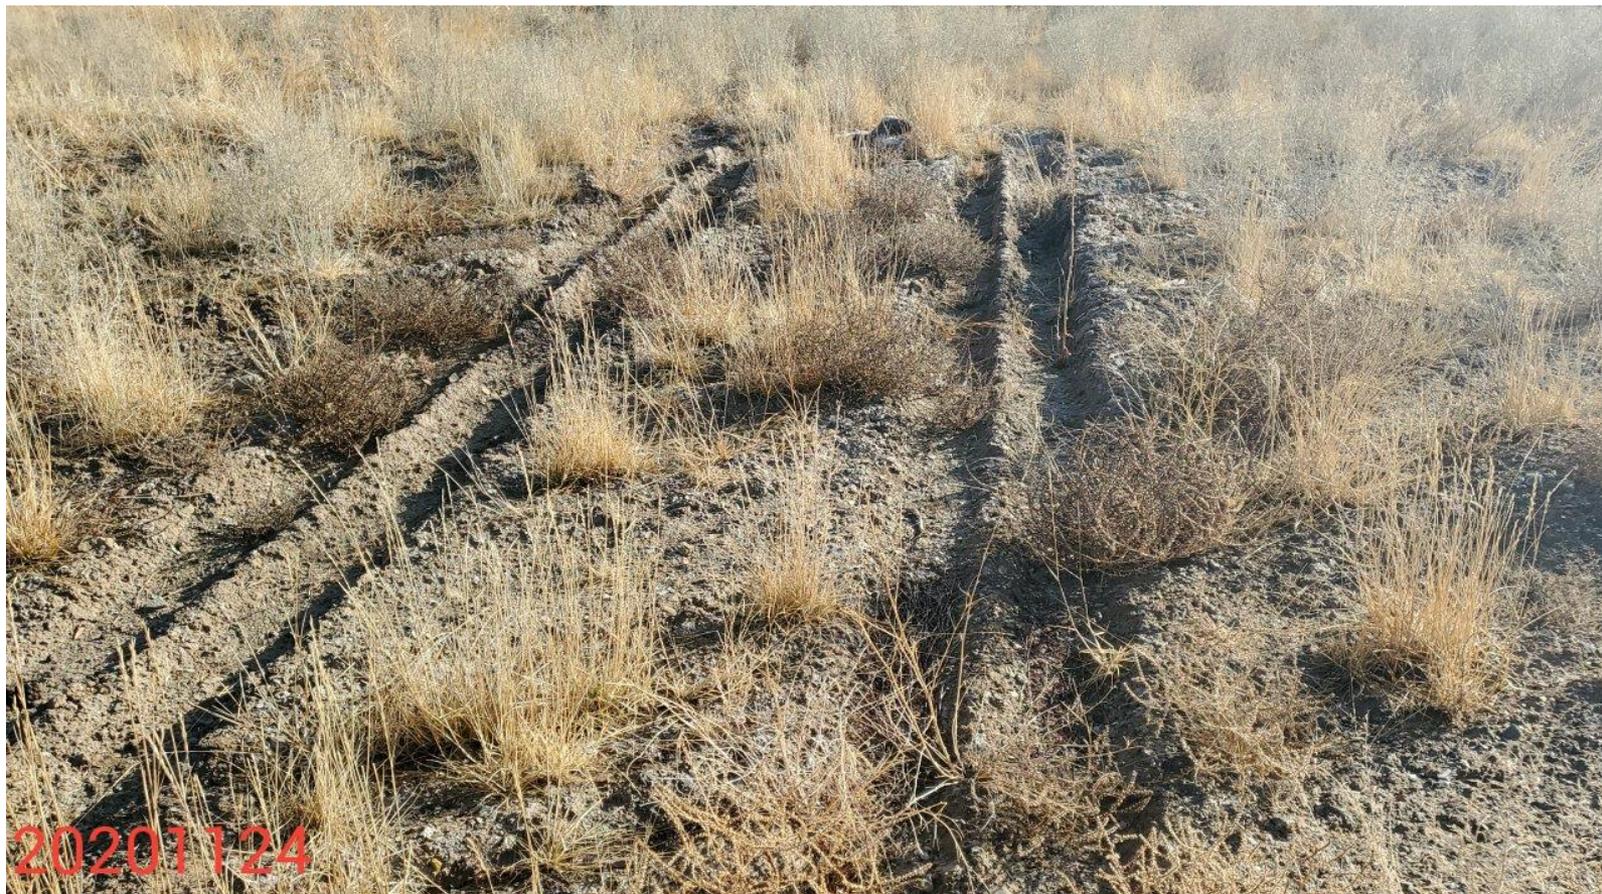
Photo 14: Photo taken from the southern area of the Location, facing east. Photo shows vehicle travel on the location has resulted in deep ruts throughout the reclamation area; Additional reclamation work will be required in these areas to repair rutting, address potential compaction and revegetation concerns resulting from vehicle use.

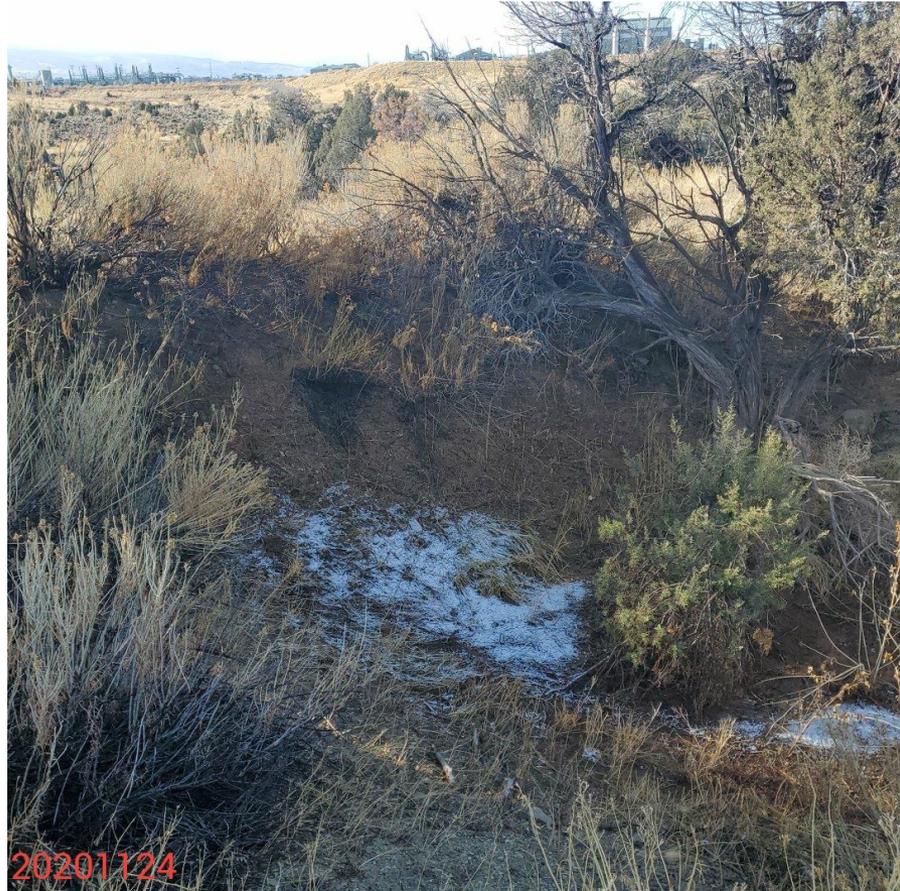
Photo 15: Photo taken from the northwest end of the Location, facing west. Photo shows Access road at location entrance was constructed in a manner that dammed a drainage on the west end of the Location; BMPs missing or insufficient to allow water movement within the drainage. Access road requires graveling

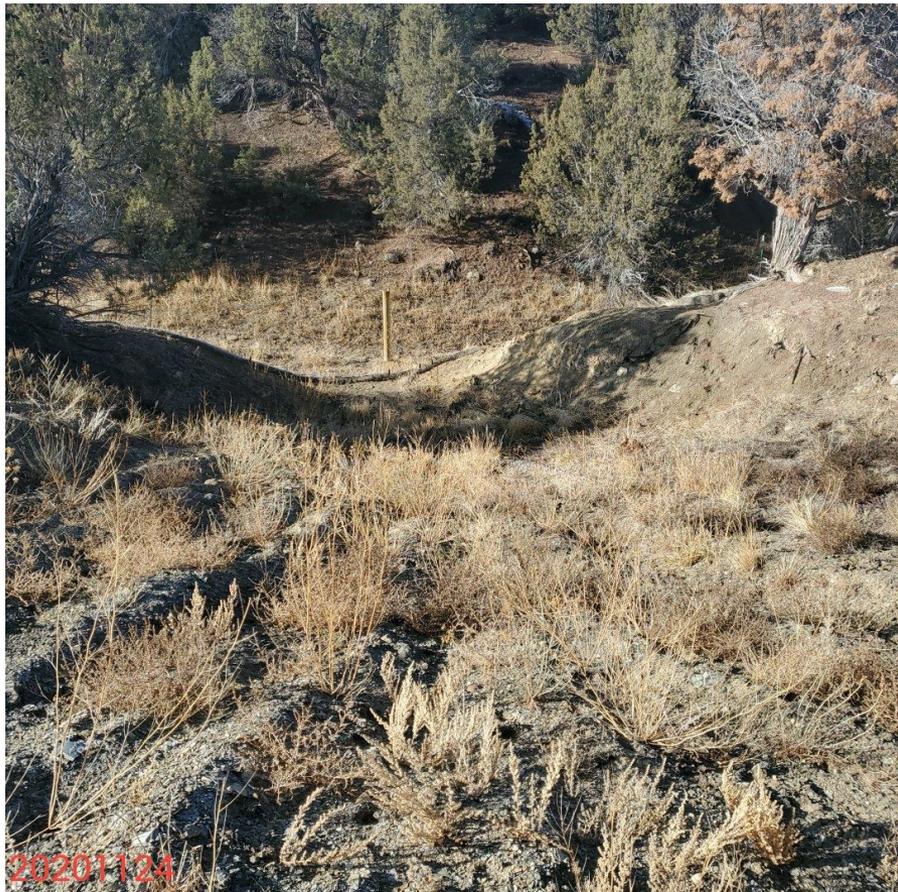
Photo 16: Continued from photo 15. Photo shows Access road at location entrance was constructed in a manner that dammed a drainage on the west end of the Location; BMPs missing or insufficient to allow water movement within the drainage. Access road requires graveling. Photo also example of BMPs missing, or insufficient to stabilize slopes of the Location.
