Inspection Photos
Operator: Simcoe
API: 067-07418
Date: 12/23/2020

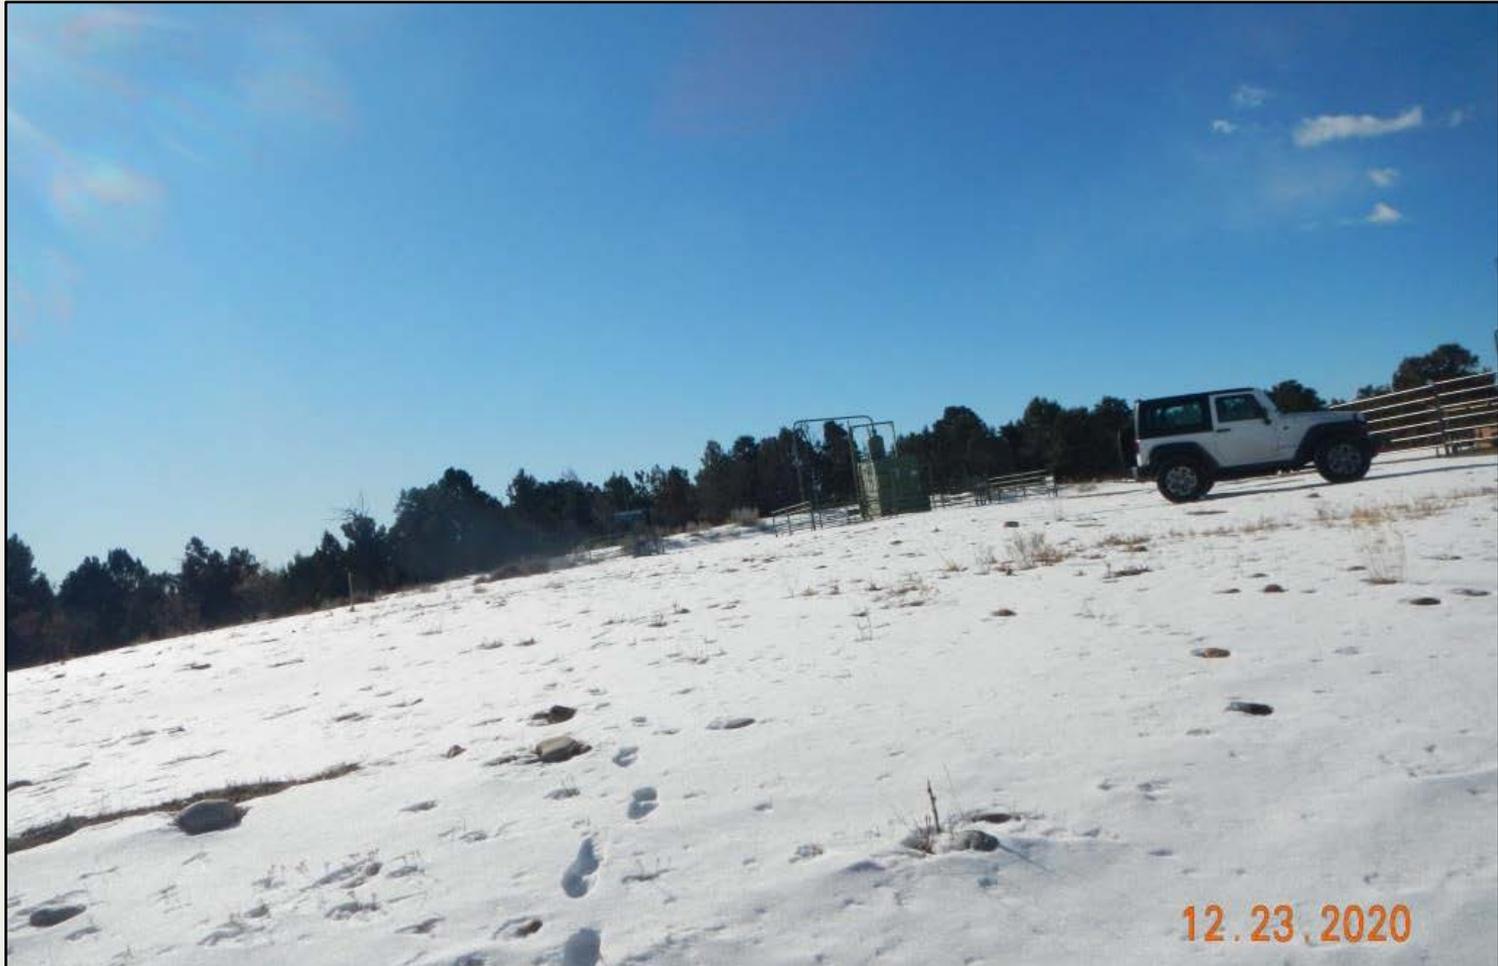
Photo 1. View of the project area from the northeastern corner facing center.

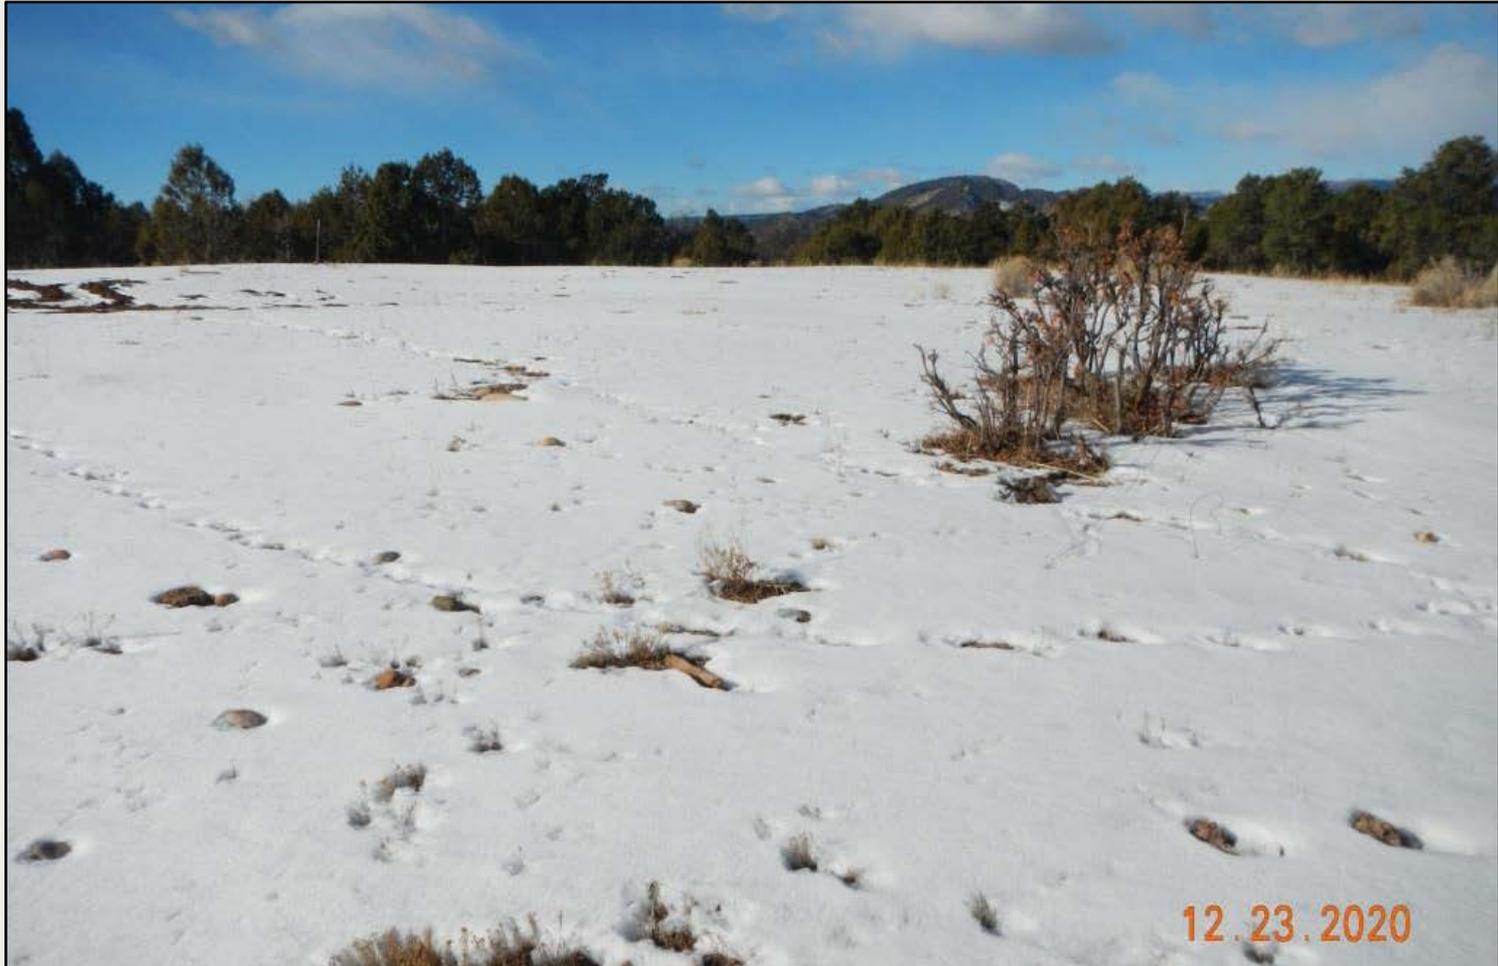
Photo 2. View of the northern project area from the northeastern corner facing westward. Location is largely snow covered. Vegetation is in a grazed condition.

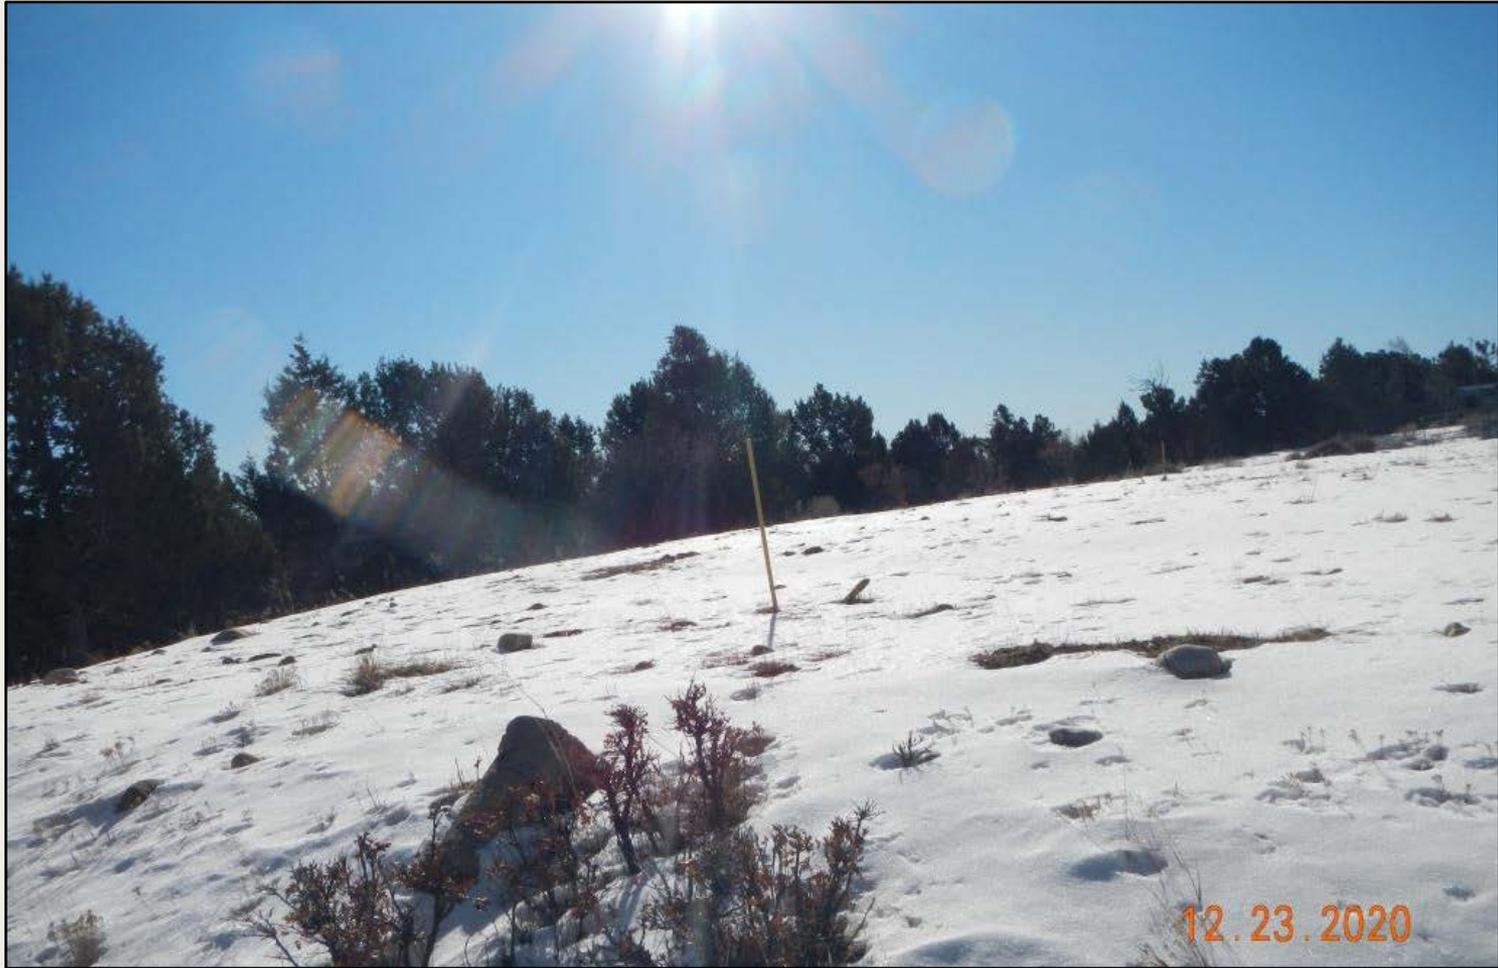
Photo 3. View of the eastern project area from the northeastern corner facing southward. Final reclamation will require revegetation with vegetation representative of the reference area.
