Inspection Photos
Operator: Enduring
API: 067-08845
Date: 12/23/2020

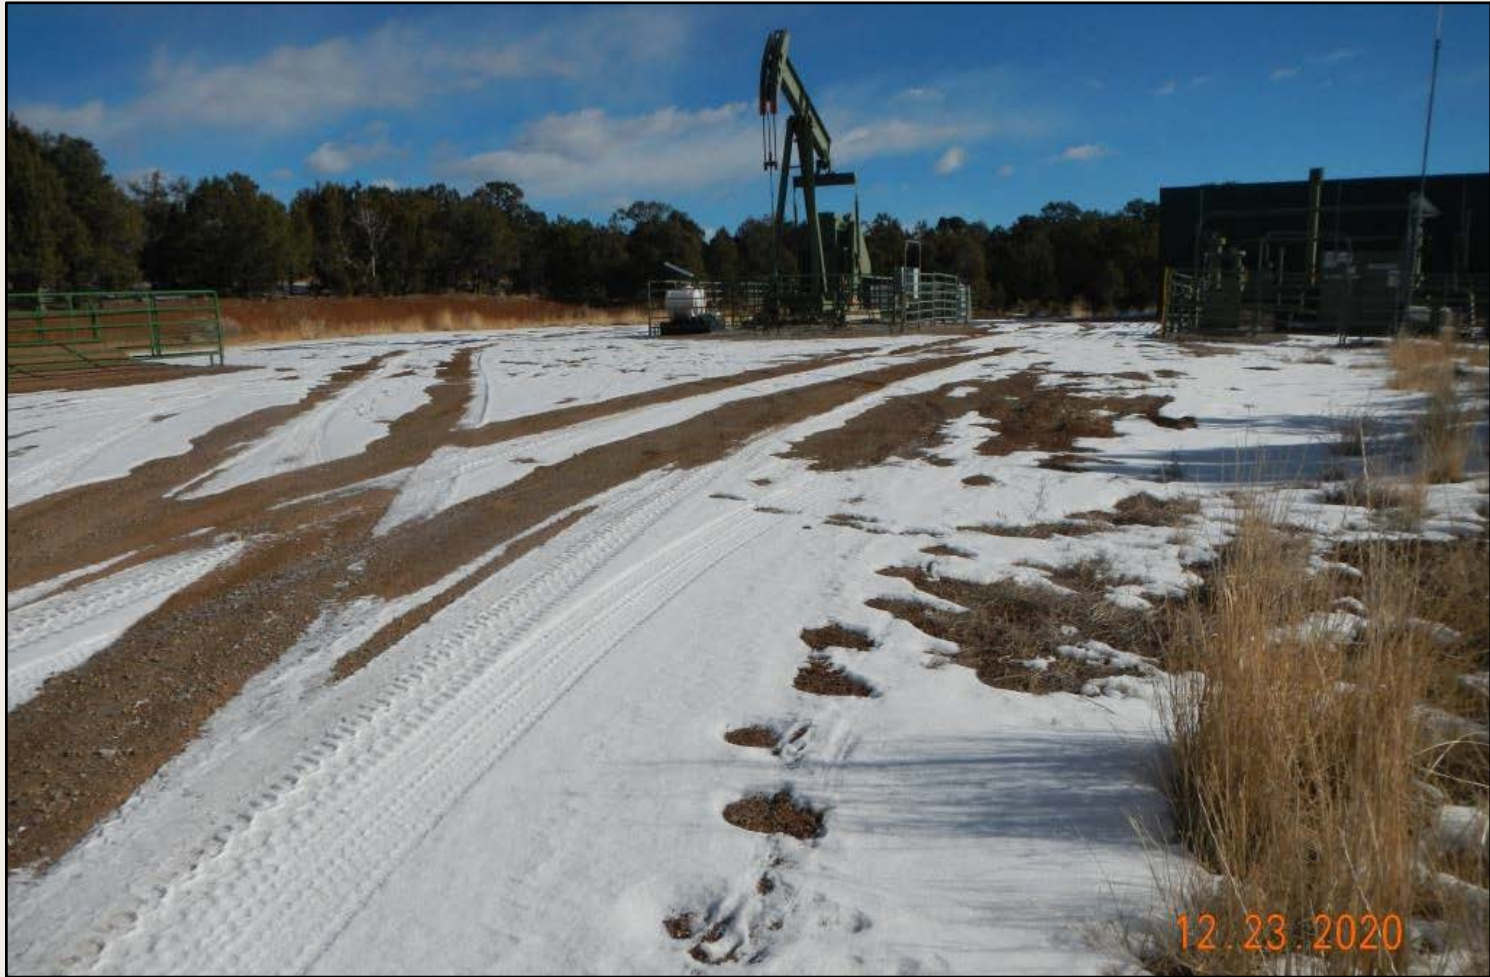
Photo 1. View of the project area from the well pad entrance facing center.

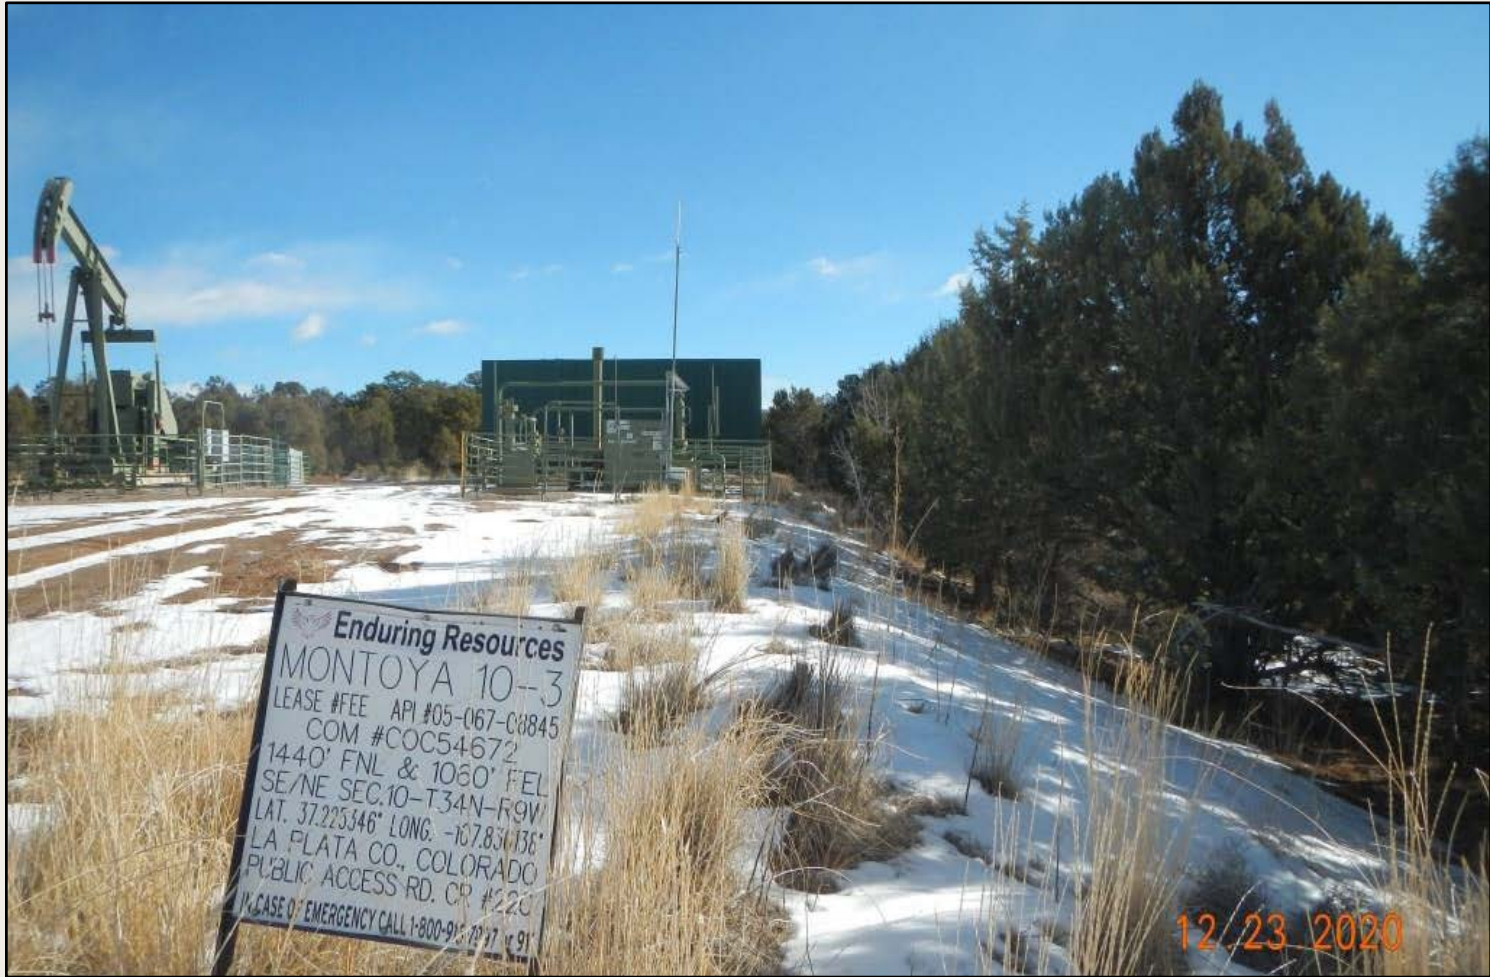
Photo 2. View of the southern project area from the southwestern corner facing eastward. Location is largely snow covered. Perennial vegetation is comprised of intermediate wheatgrass.

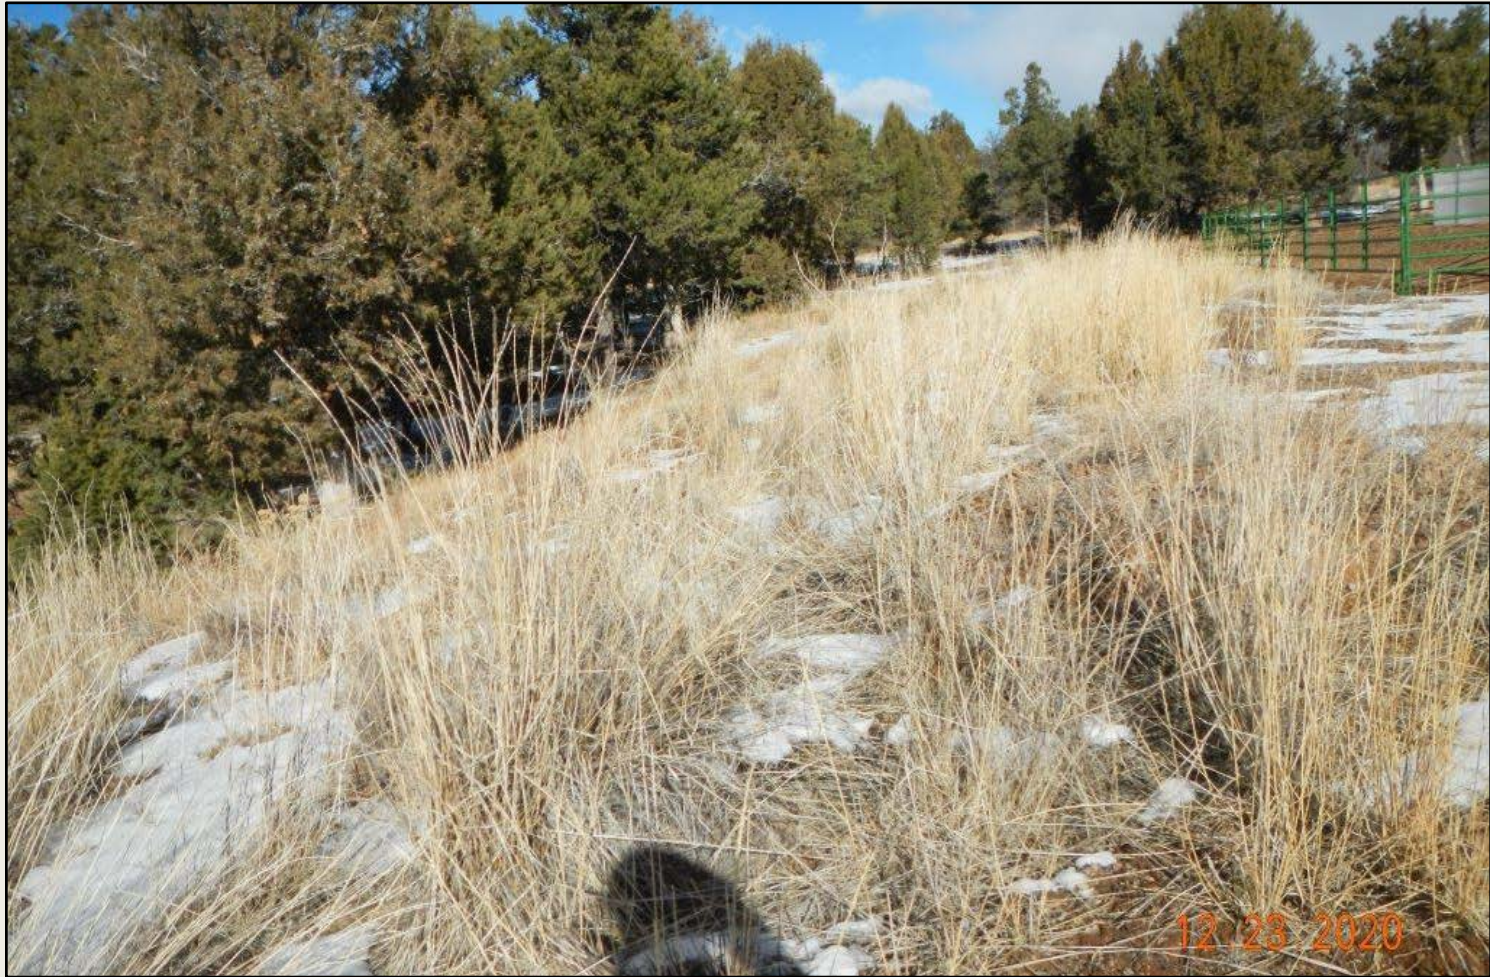
Photo 3. View of the western project area from the southwestern corner facing northward. Final reclamation will require revegetation with vegetation representative of the reference area.

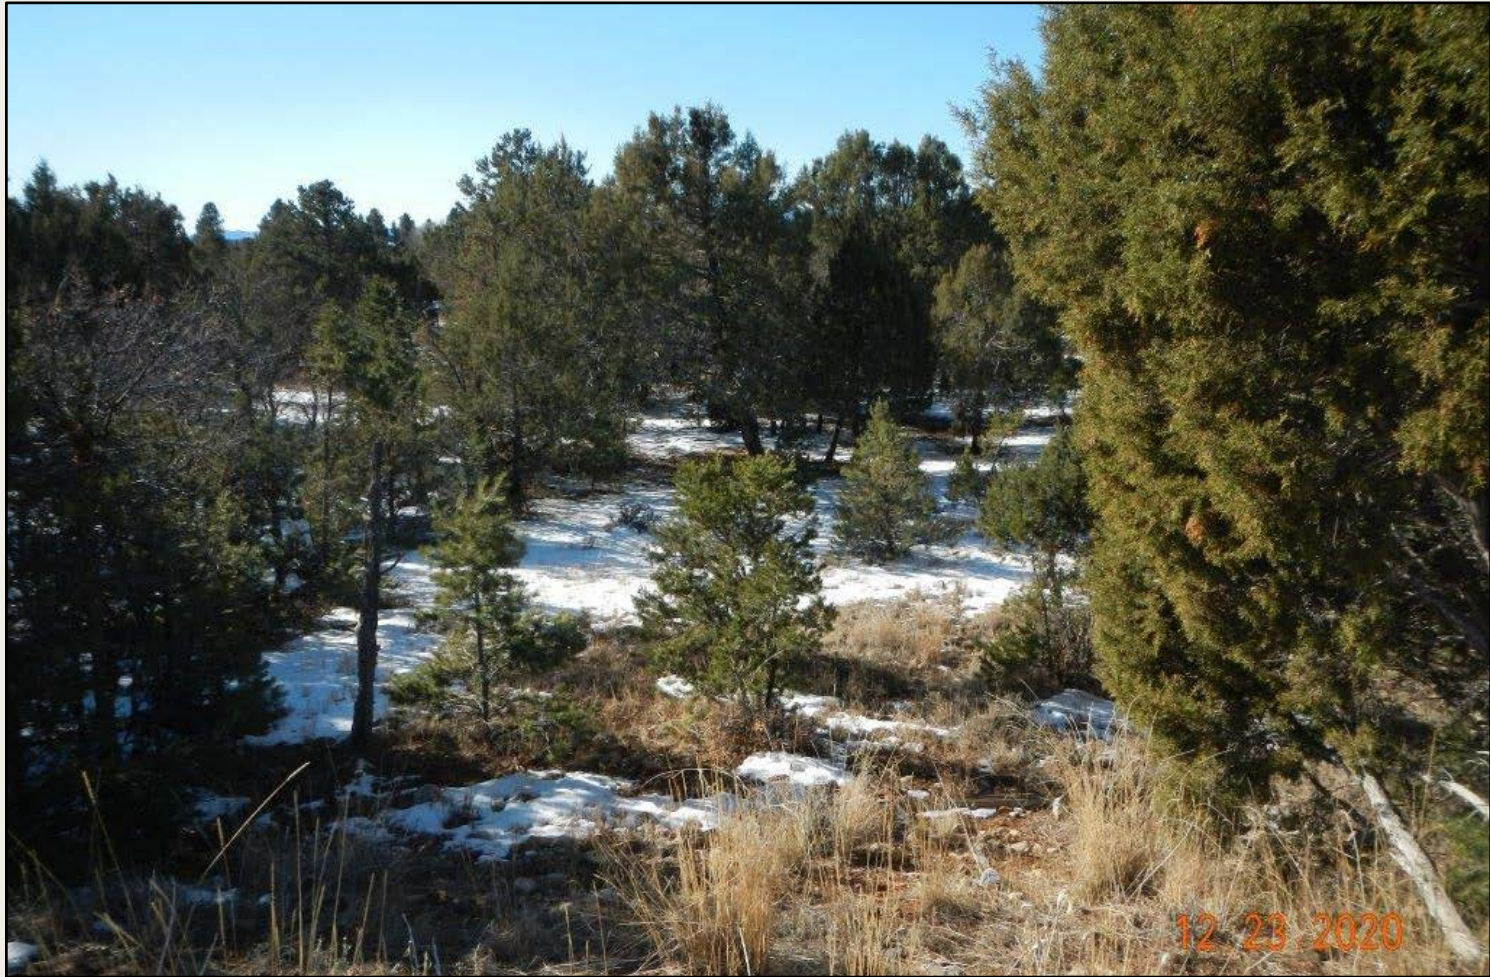
Photo 4. View of reference area comprised of pinyon and juniper woodland with understory of sagebrush, sand dropseed, blue grama, and James galleta.

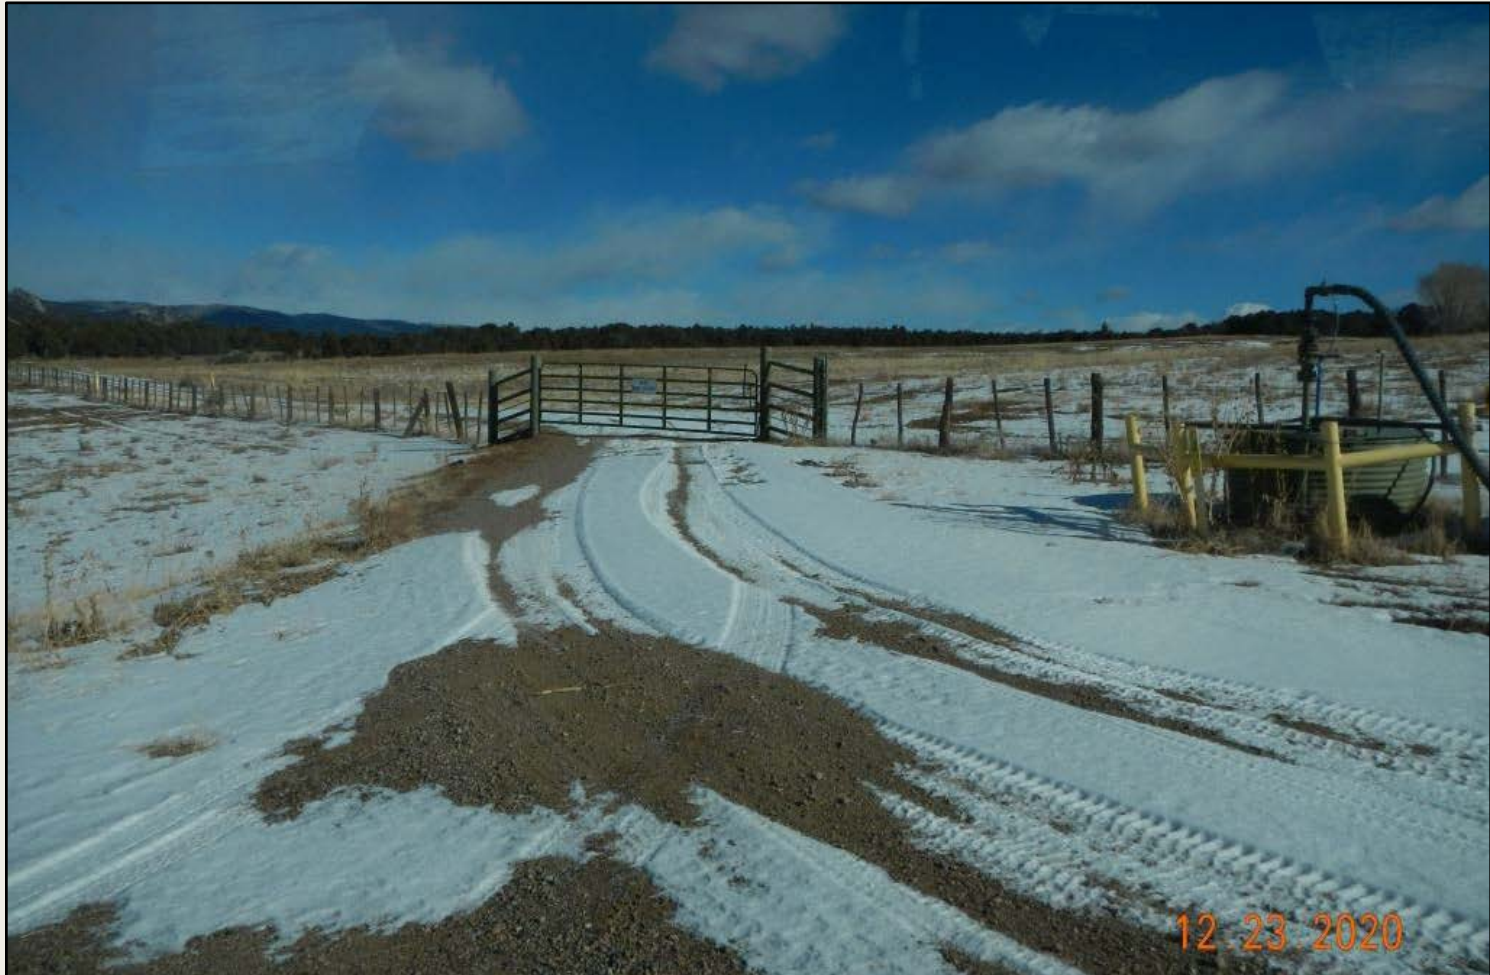
Photo 5. View of closed gate after leaving location
