Inspection Photos  
Operator: Simcoe  
API: 067-08877  
Date: 12/23/2020

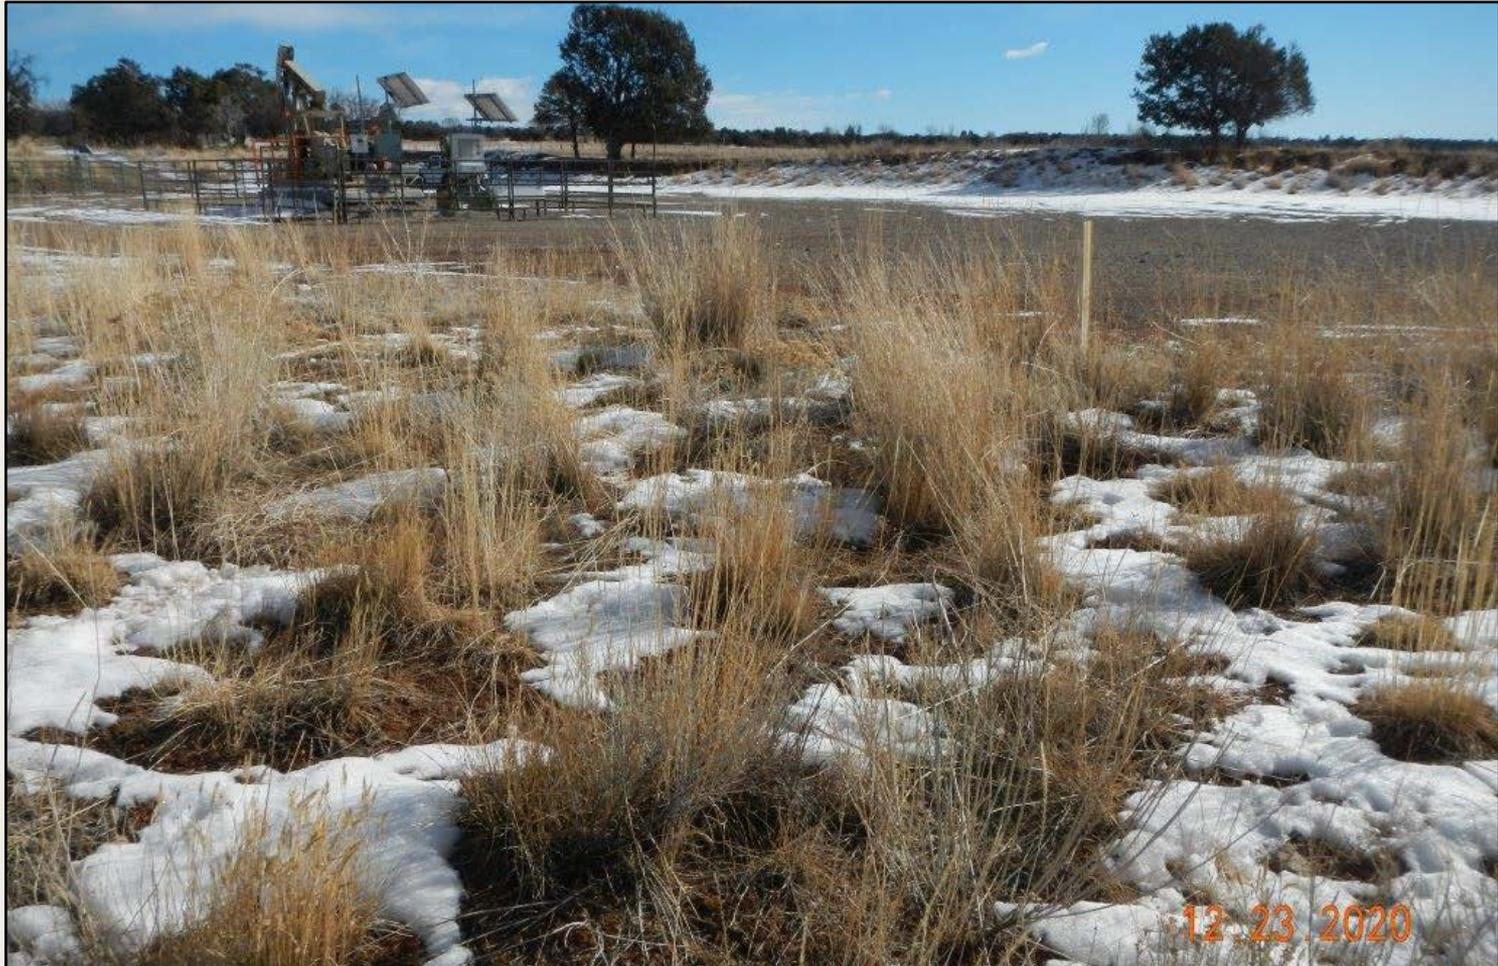
Photo 1. View of the project area from the western corner facing center.

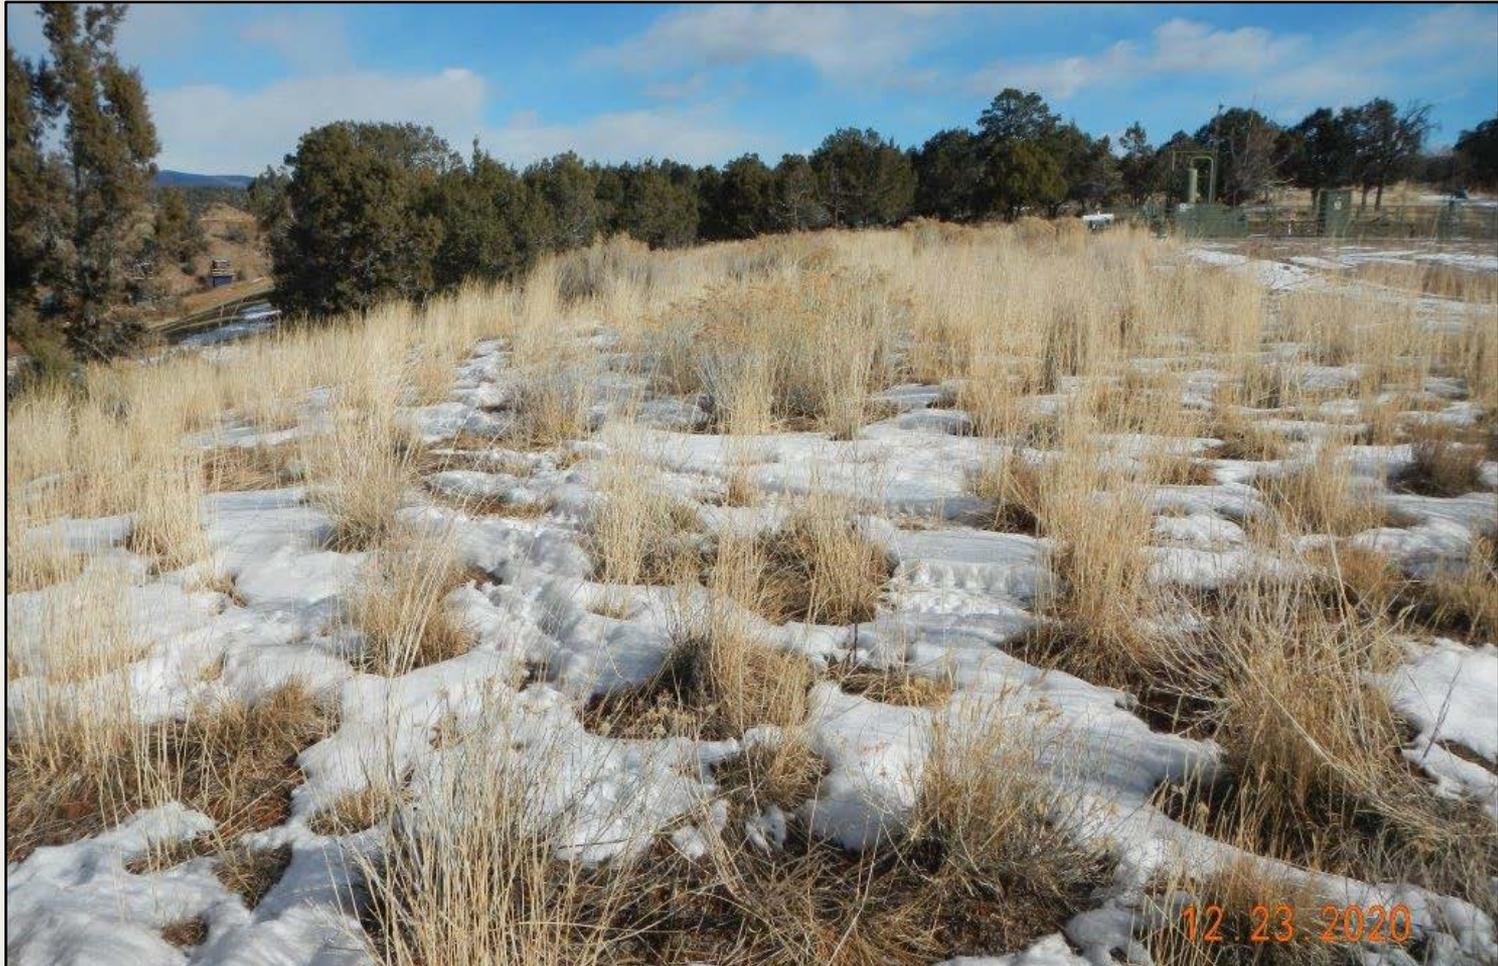
Photo 2. View of the northern project area from the western corner facing northeastward. Location is largely snow covered. Perennial vegetation is comprised of intermediate wheatgrass and crested wheatgrass. Final reclamation will need to be comprised of native vegetation representative of the reference area.

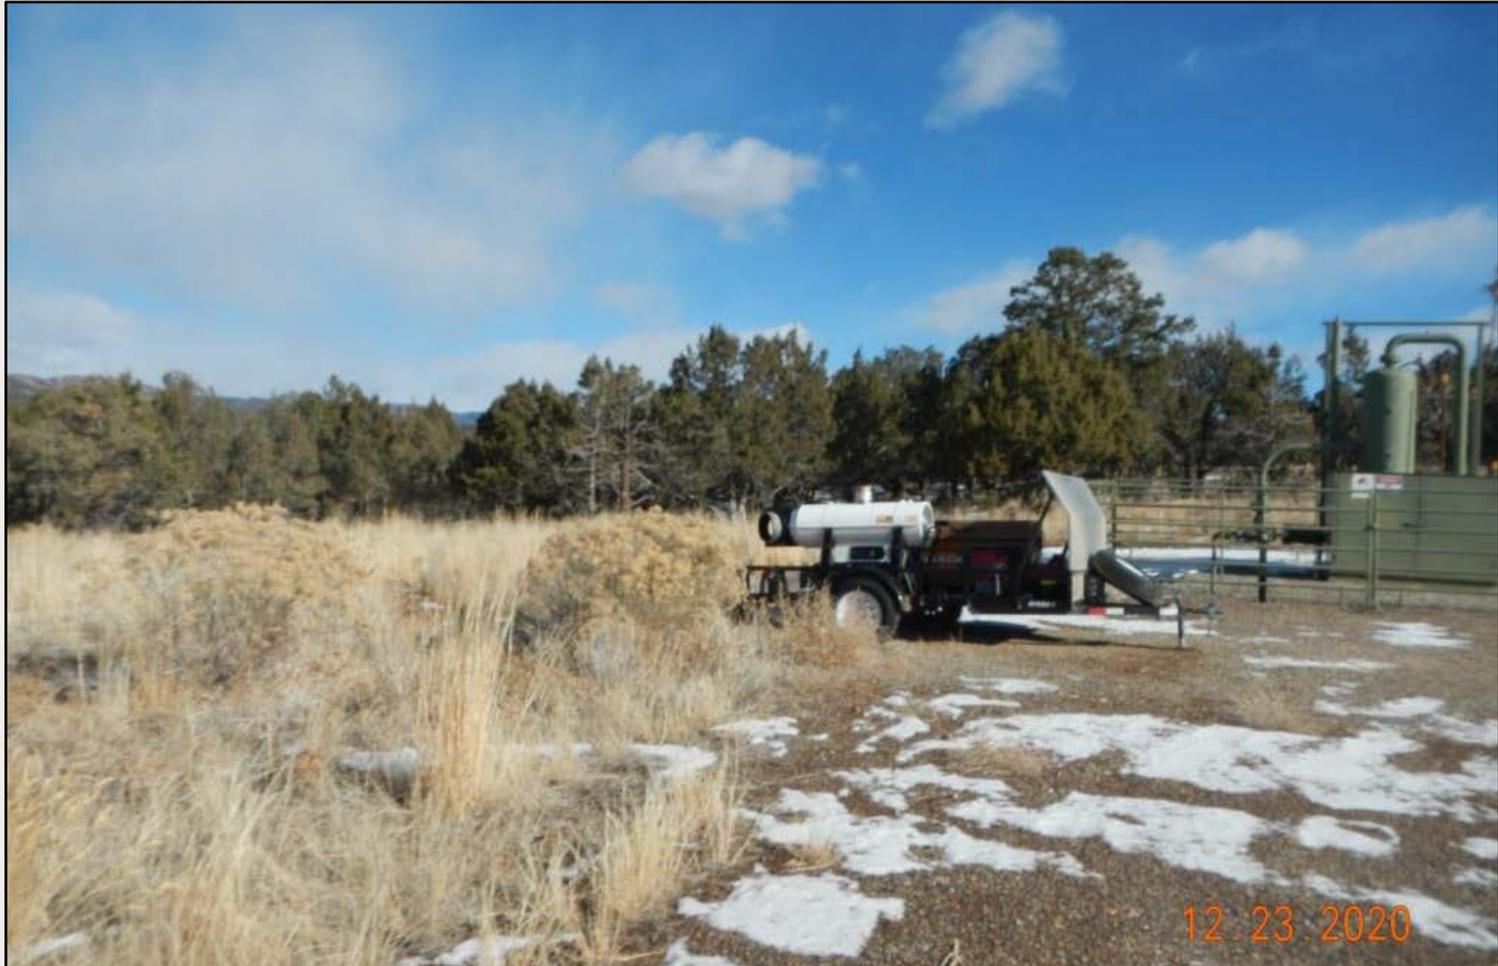
Photo 3. View of unused equipment parked within the northern project area.

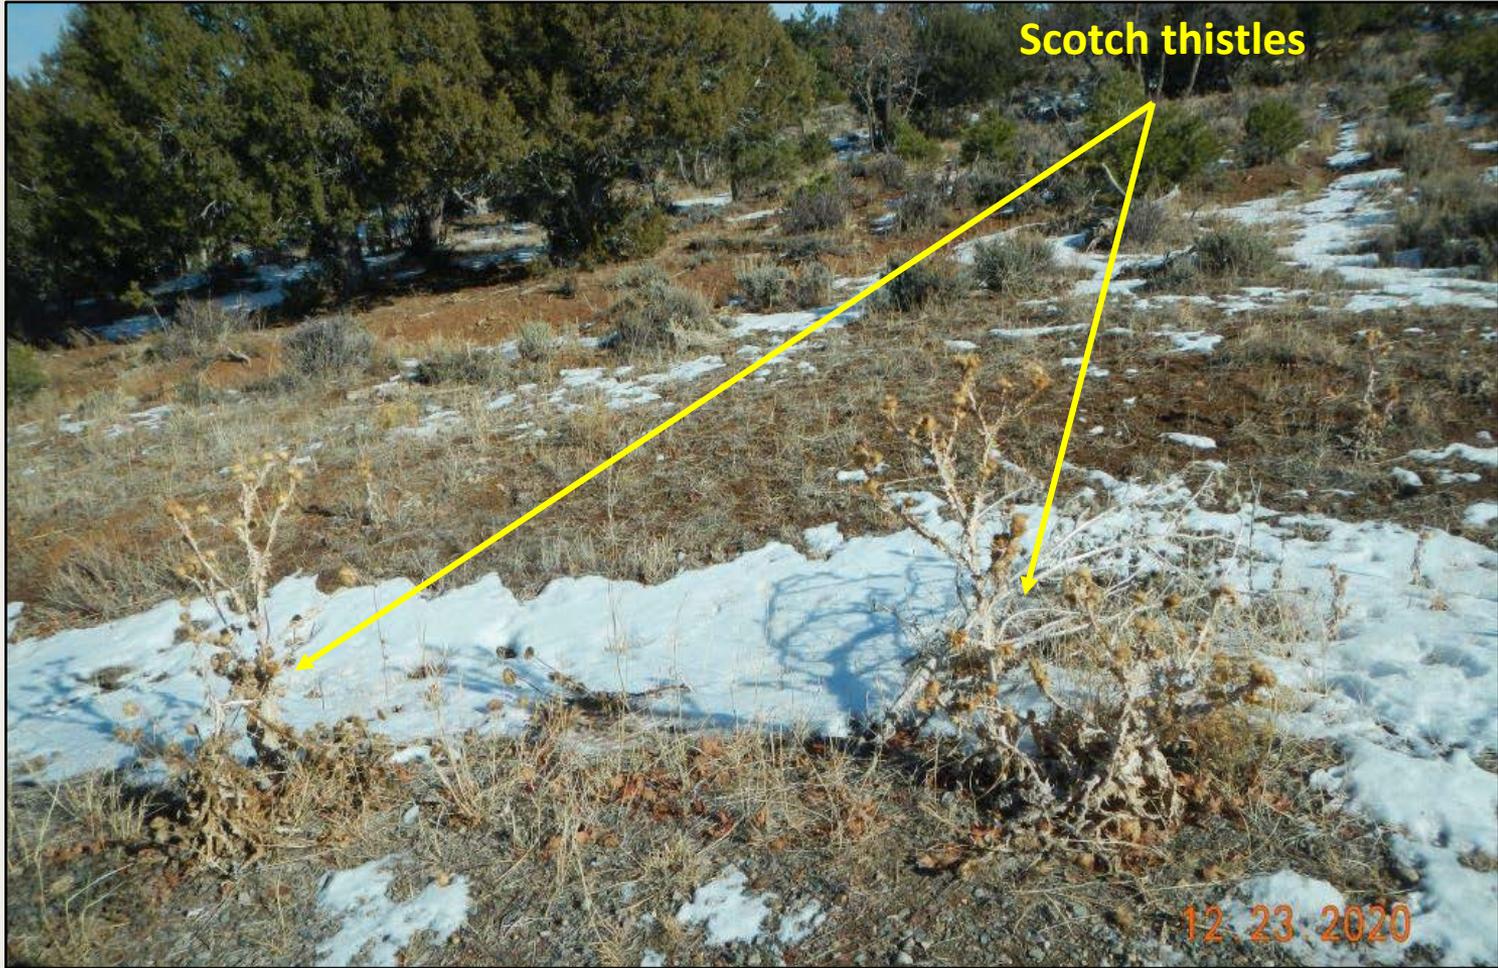
Photo 4. View of Scotch thistles along the access road. Approximately 100 individuals observed.

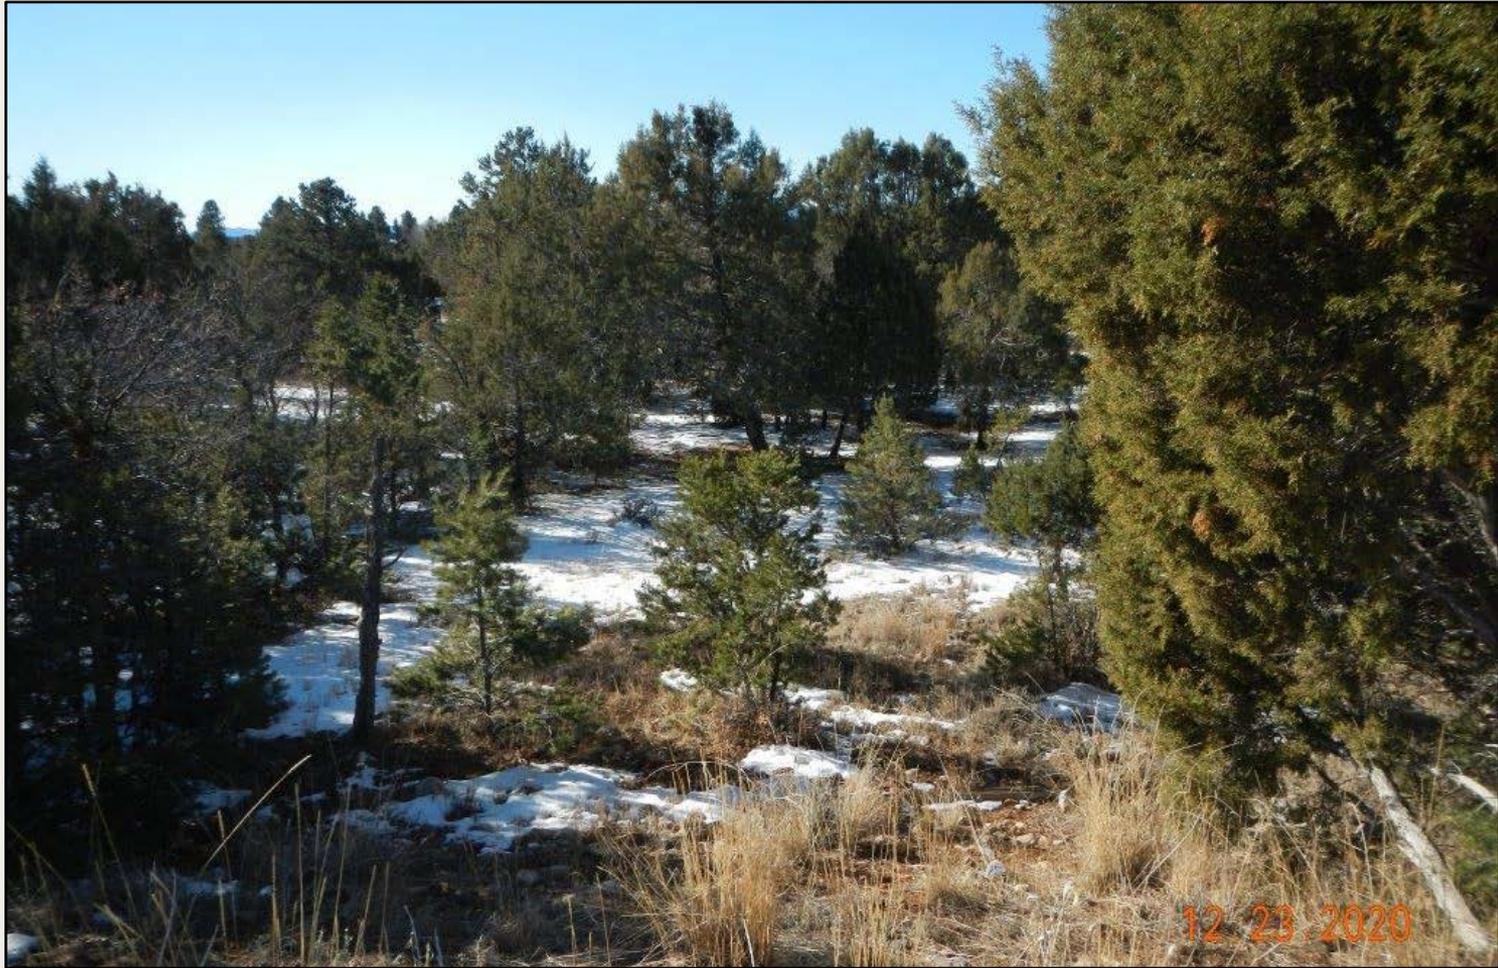
Photo 5. View of reference area comprised of pinyon and juniper woodland with understory of sagebrush, sand dropseed, blue grama, and James galleta.

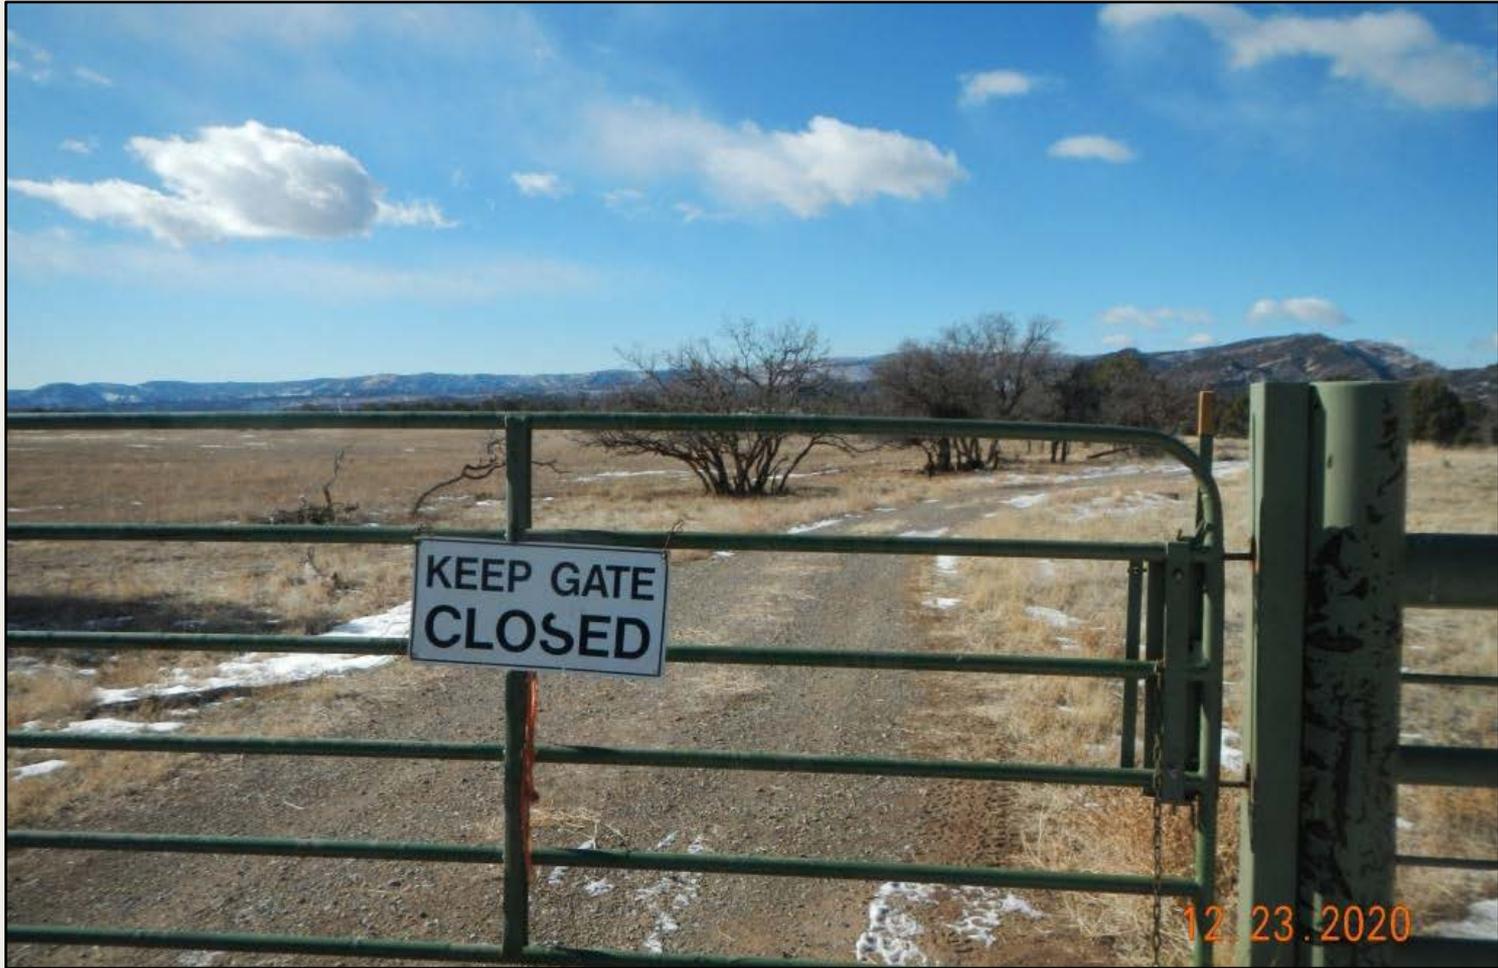
Photo 6. View of closed gate after leaving location
