Inspection Photos

ID:429852

Operator: DOVER ATWOOD CORPORATION

Inspection Date: 12/29/2020

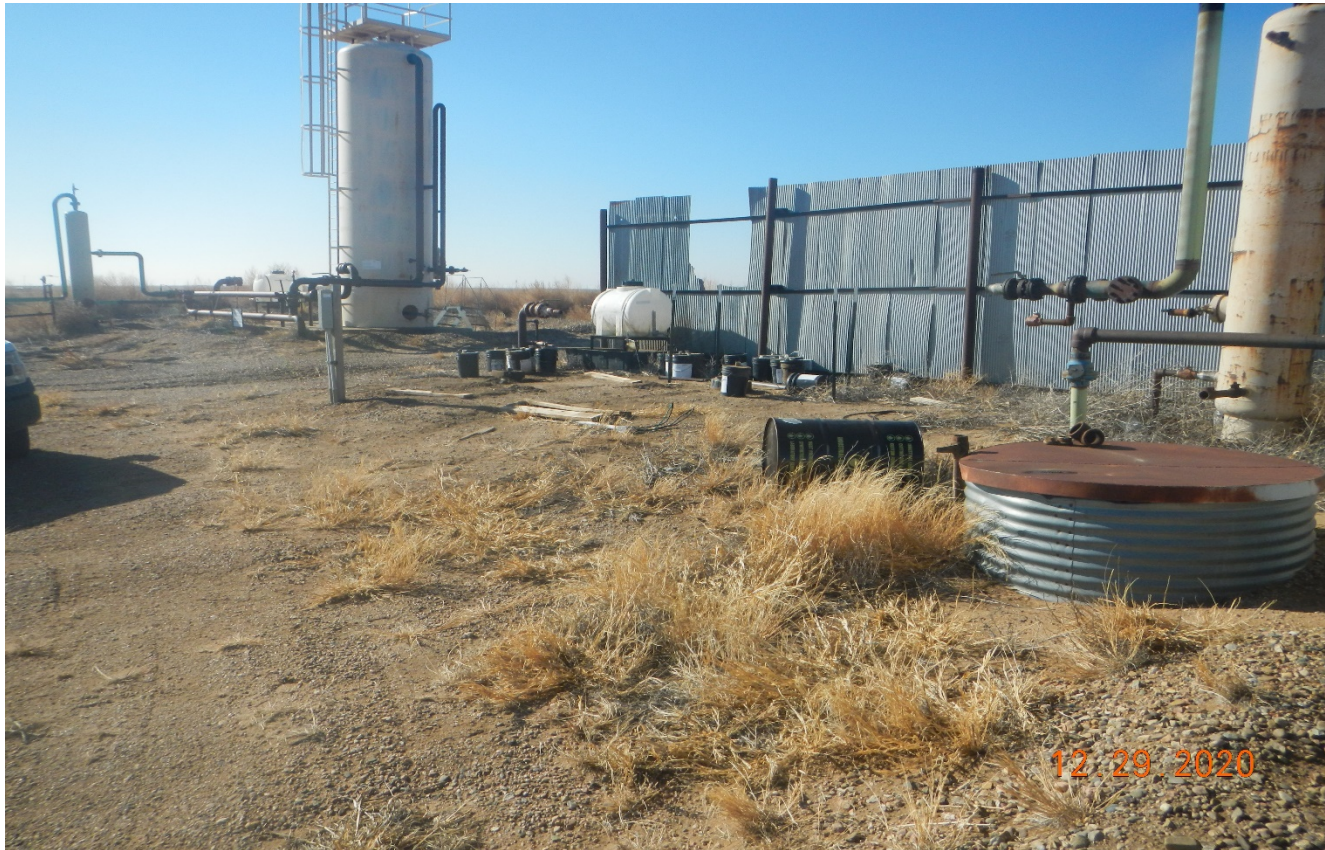
Photo 9. Facing southwest toward the location which is adjacent to County Rd. 44. The facility is not maintained and there are numerous issues observed.

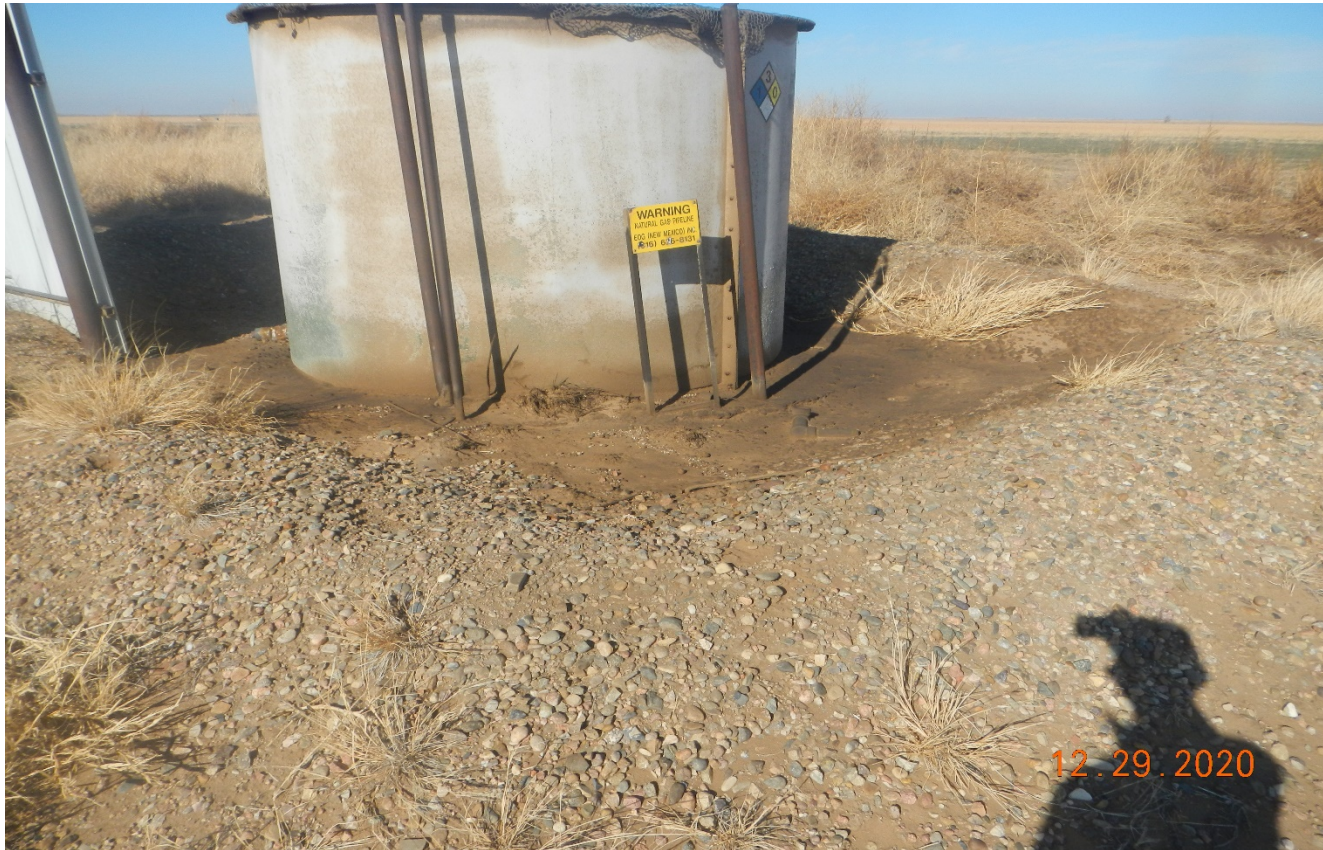
Photo 2. There is oil stained soil near the Produced Water tank. The tank is labeled produced water but appeared to contain oil inside. Netting was over the top of tank. Additionally the berm does not appear to be sufficient to contain a spill.

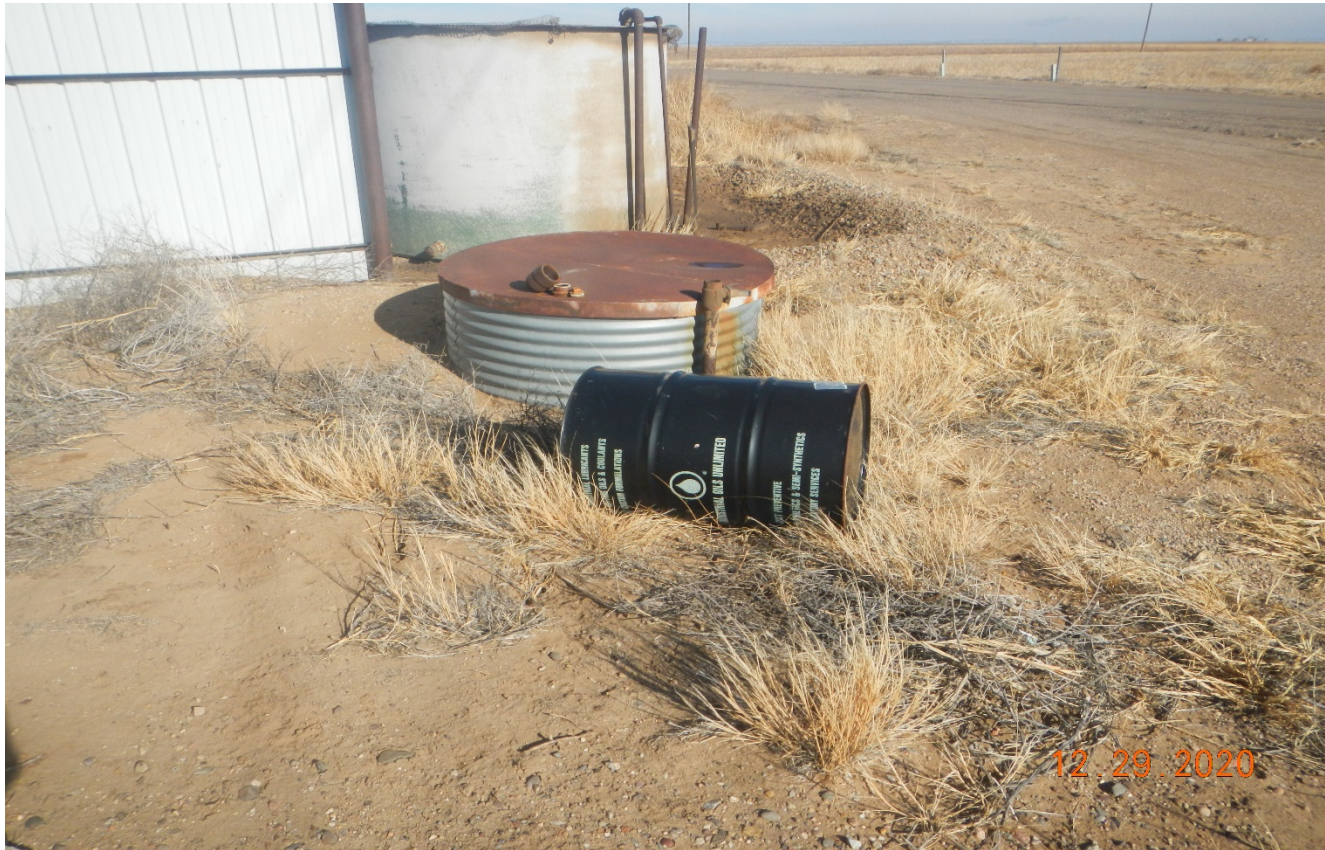
Photo 3. There is a barrel tipped over which is not sealed .

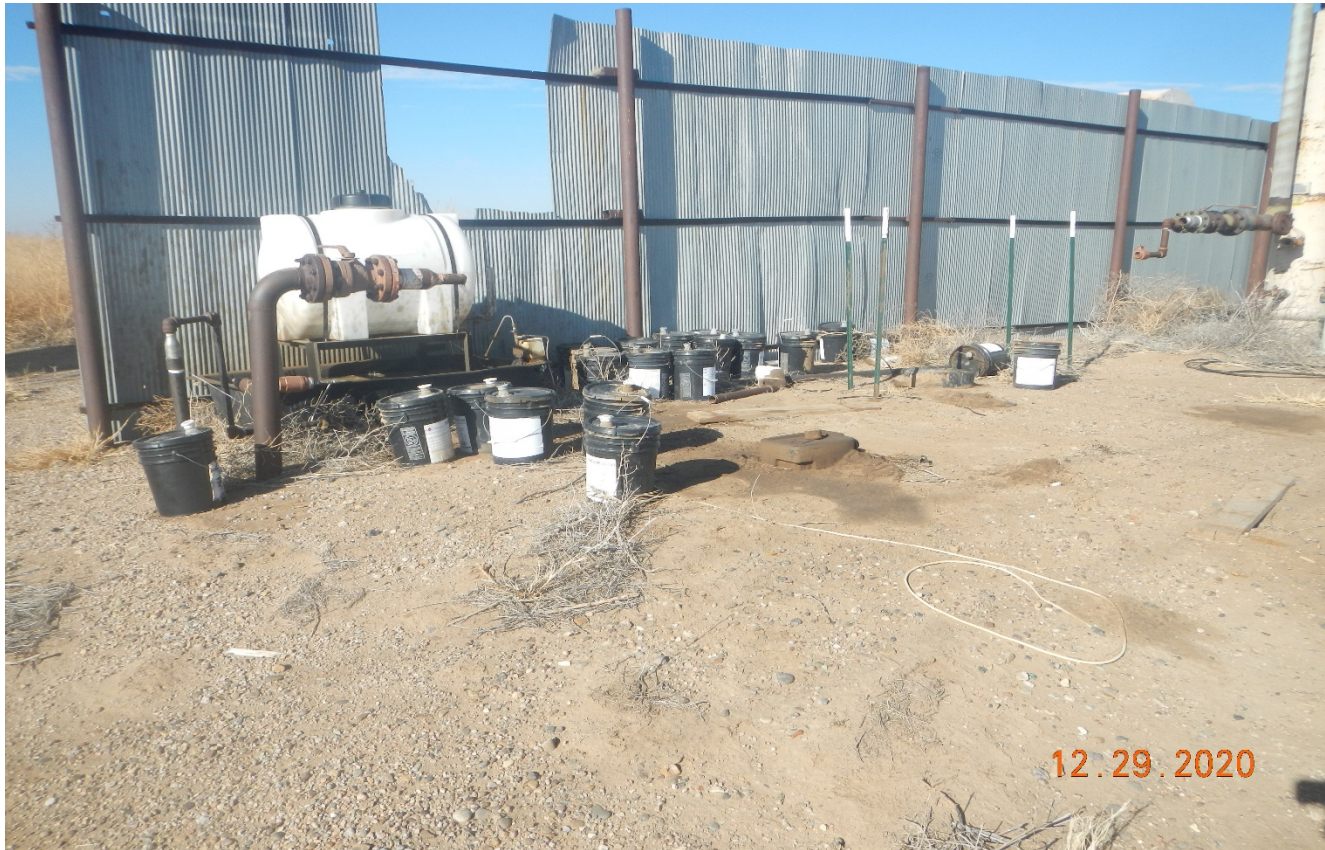
Photo 4. There are numerous buckets with faded labeling stored with no containment.

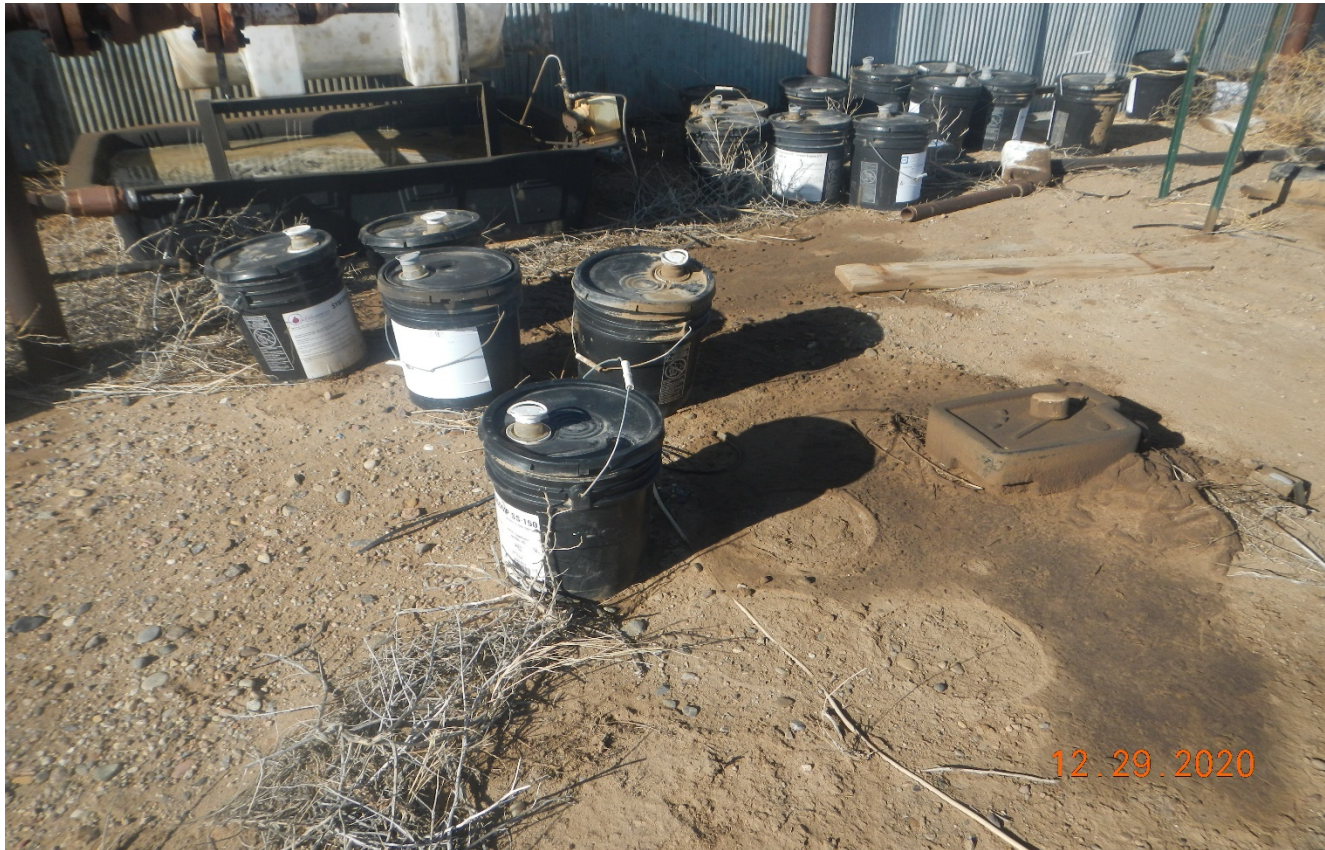
Photo 5. There is oil stained soil from spills that have occurred. There are several containers that are not labeled and appear to contain oil.

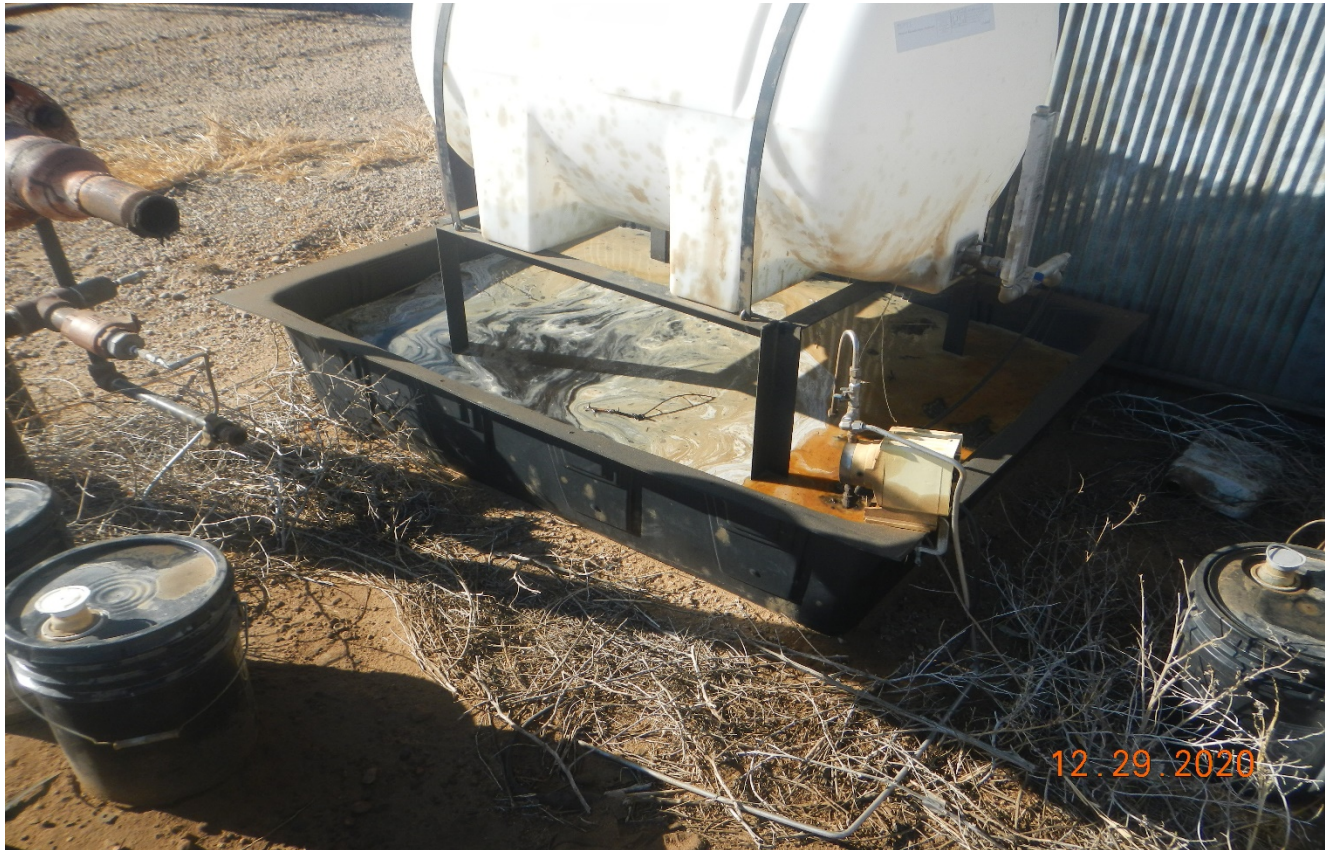
Photo 6. There is oily waste inside this containment which is near the top of the containment and appears to have spilled over.

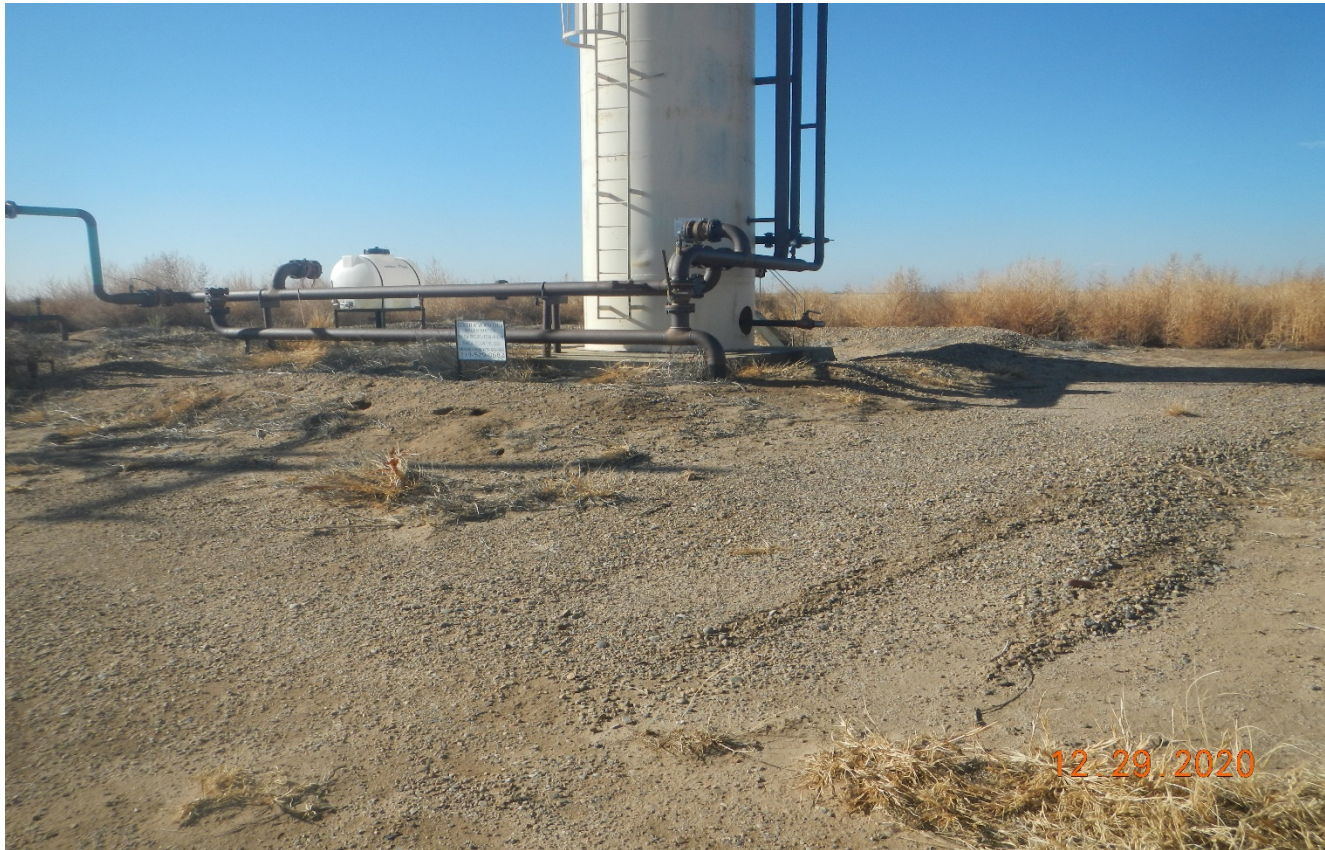
Photo 7. Facing toward the southwest side. The berm around the tank vessel is inadequate in size and has animal burrows in it.

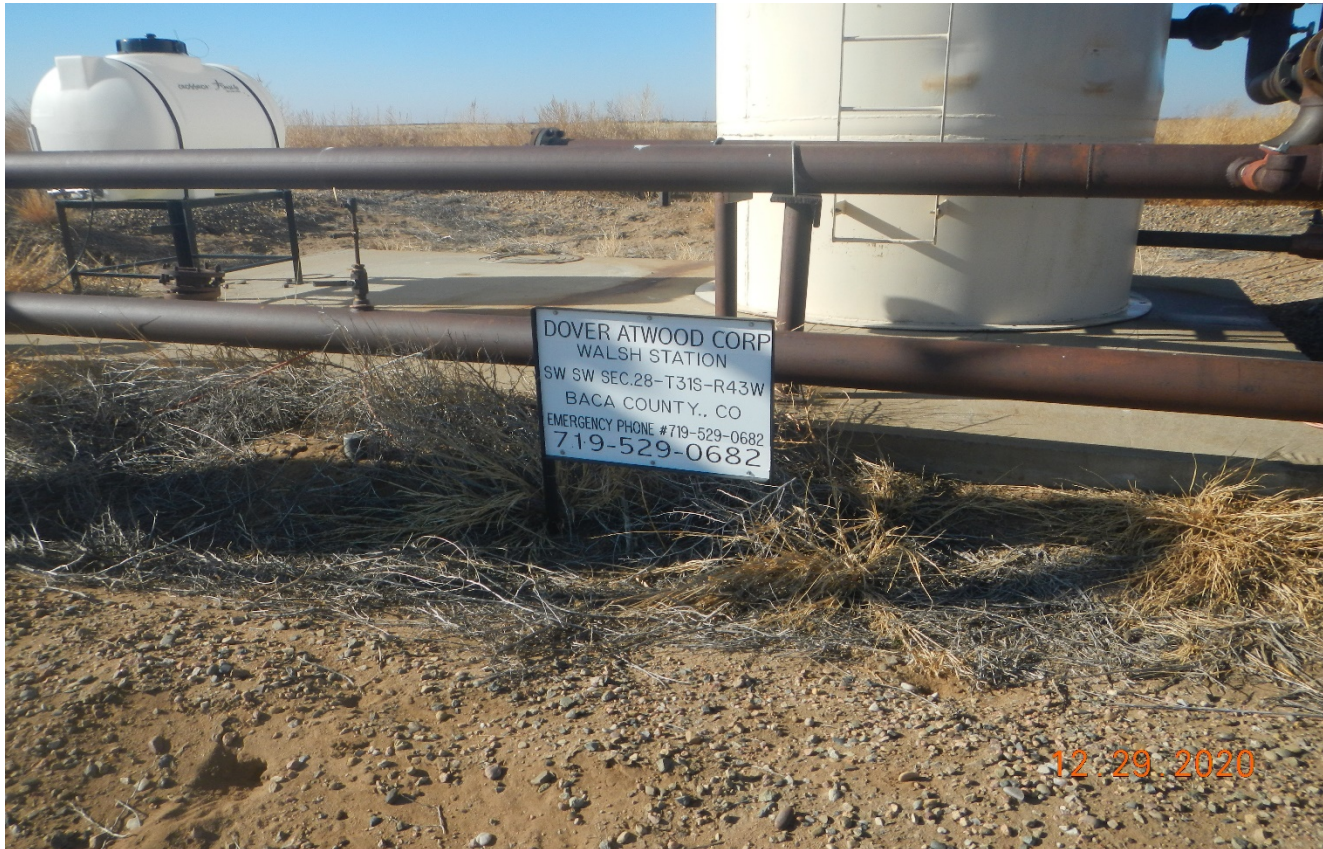
Photo 8. The facility sign is posted but contains incomplete and inaccurate information.

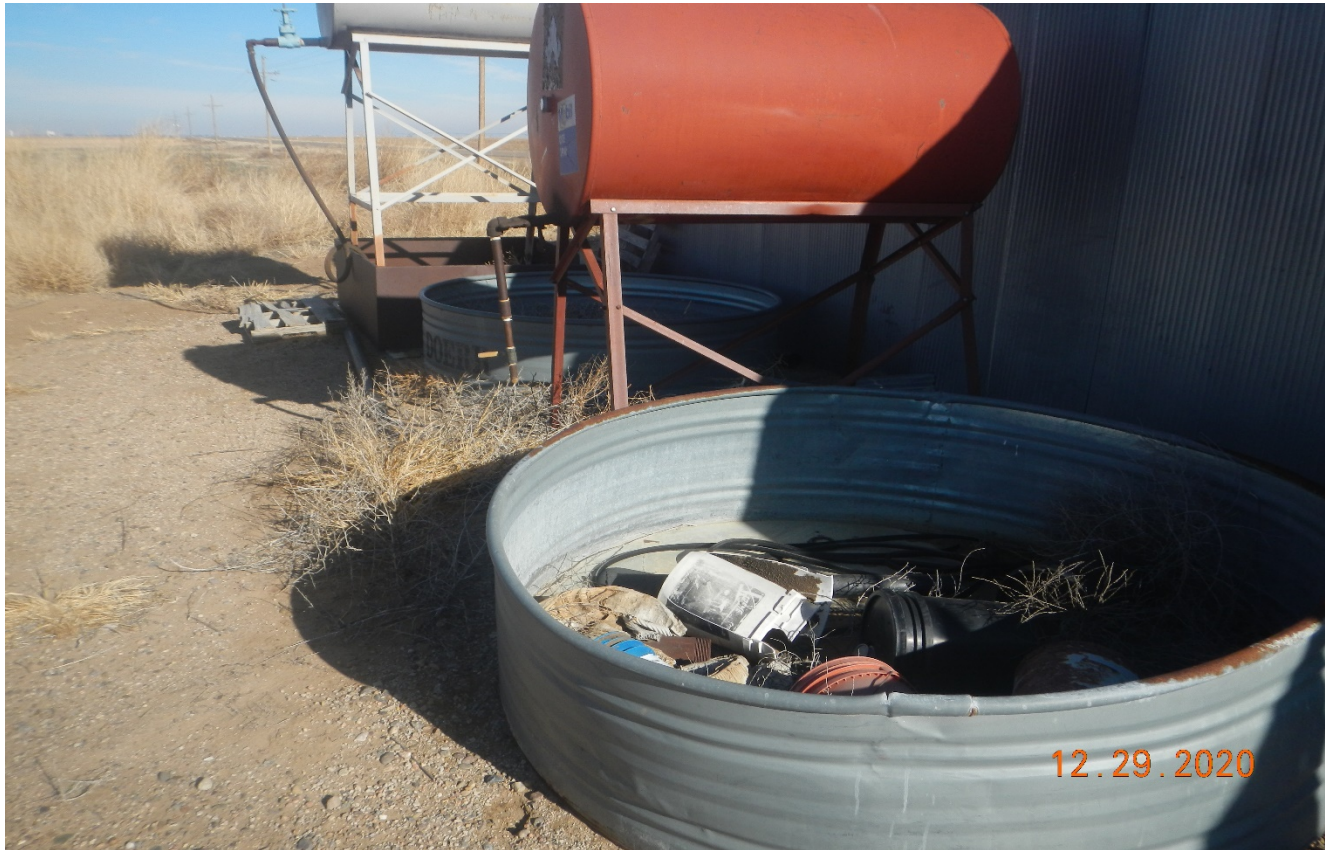
Photo 9. On the backside of the metal panels is unused equipment. There is various supplies and waste stored in the tanks.

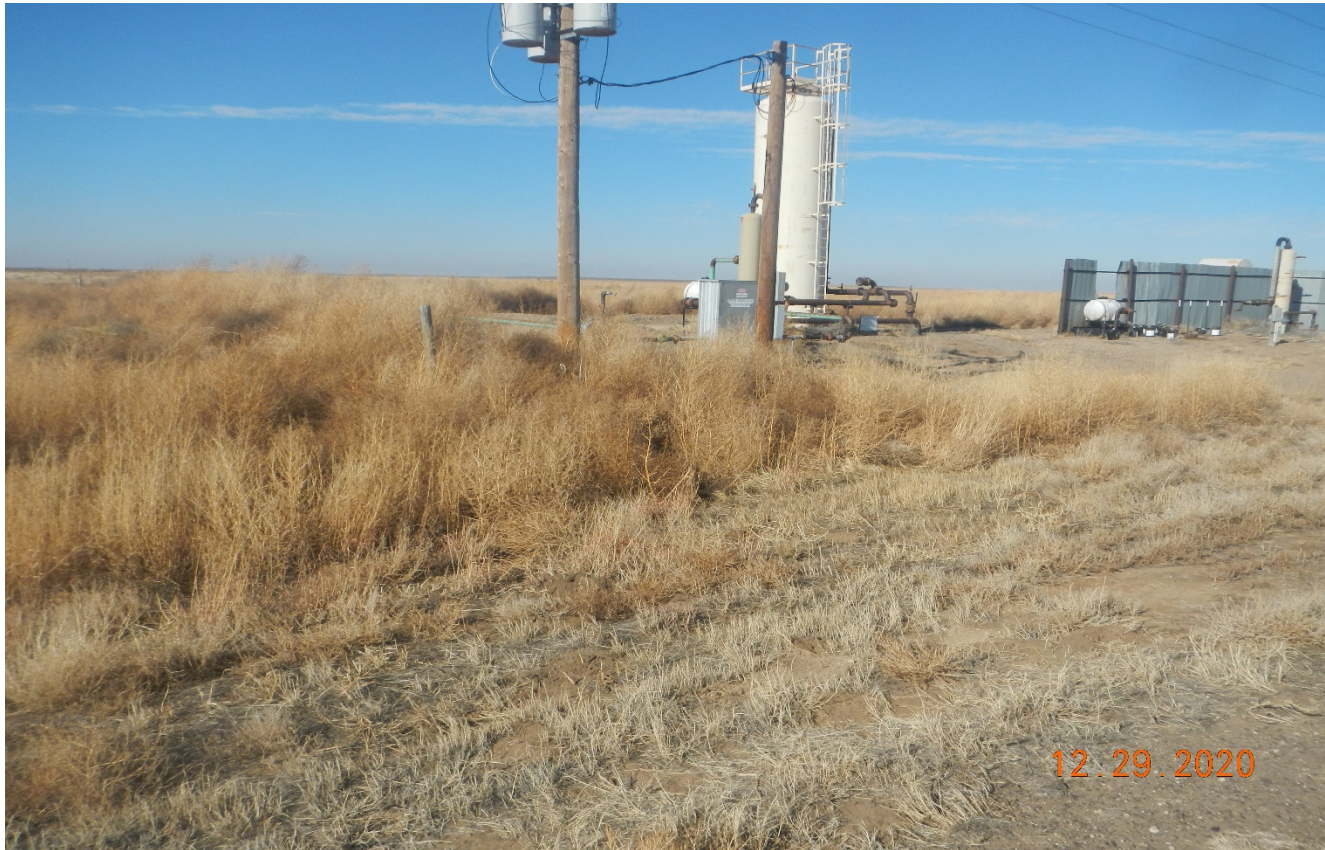
Photo 10. Facing northwest toward the location. The perimeter of the location consists of tall weeds (Kochia) debris which is a fire hazard. The weeds around the perimeter of the location need to be cut and removed.
