Inspection Photos

API: 009-06322

Operator: DOVER ATWOOD CORPORATION

Inspection Date: 12/29/2020

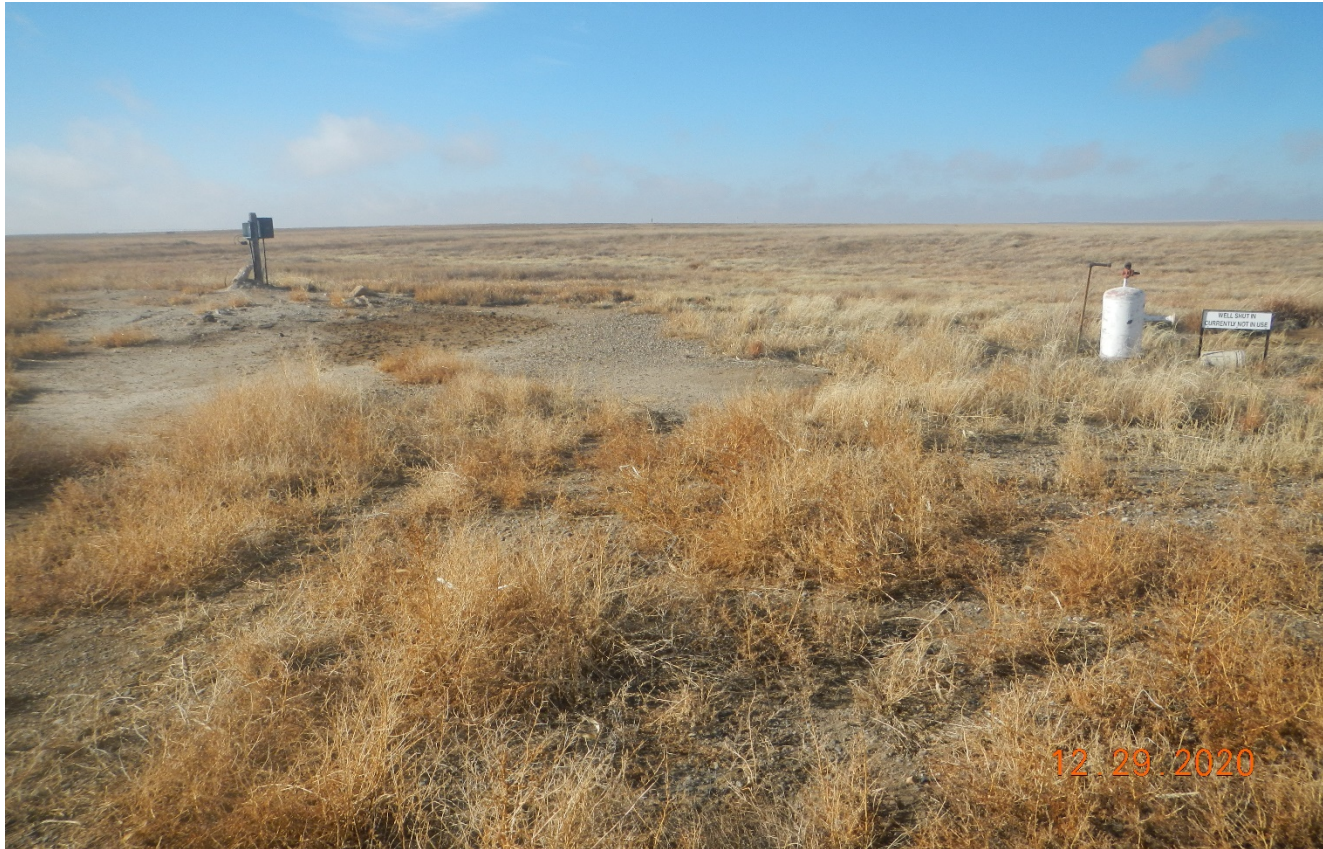
Photo 1. Facing west toward the location. There is equipment that remains and the location has not been reclaimed.

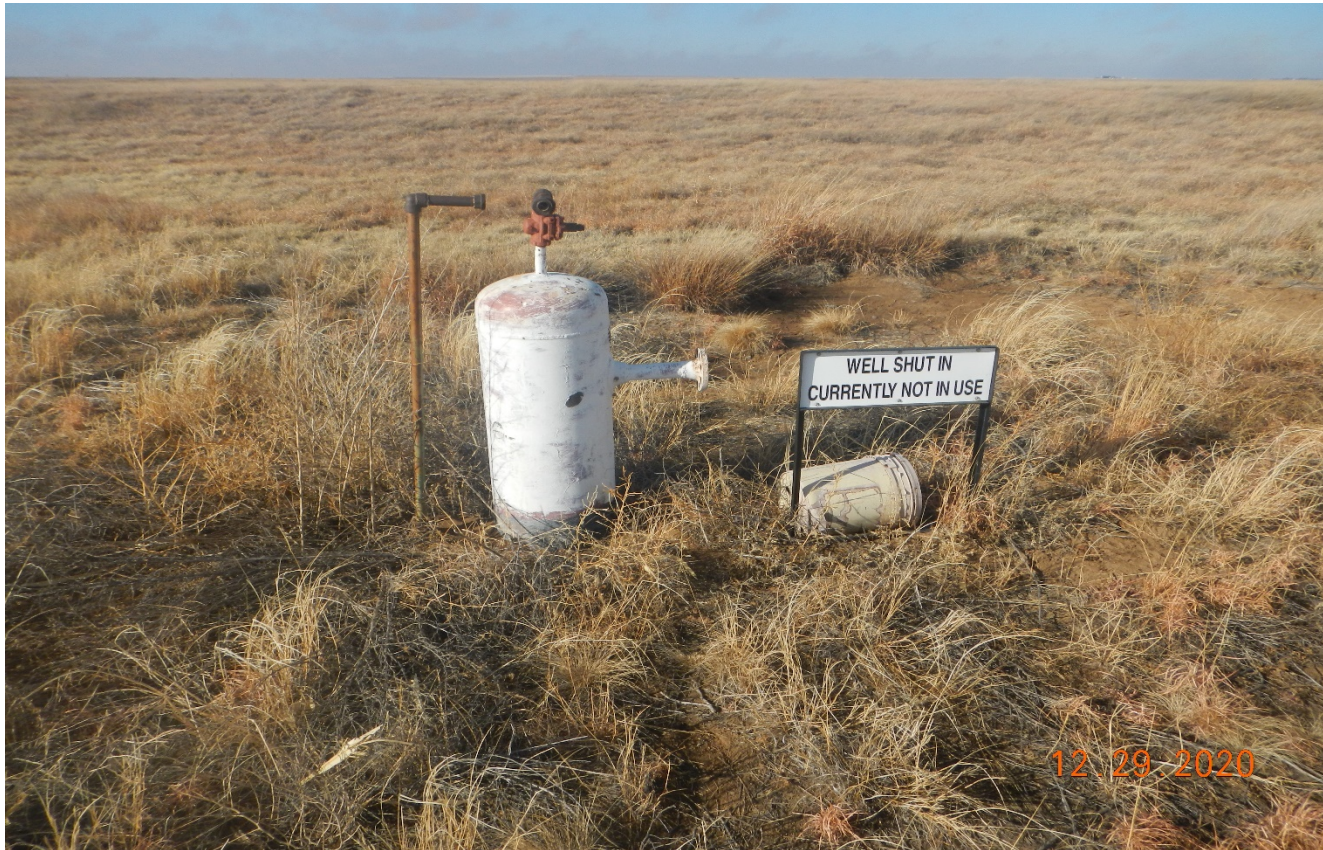
Photo 2. There is a sign, tank, and pipe riser that remains. The well was plugged and abandoned on 9/1/2017. All equipment should have been removed within 3 months of abandonment.

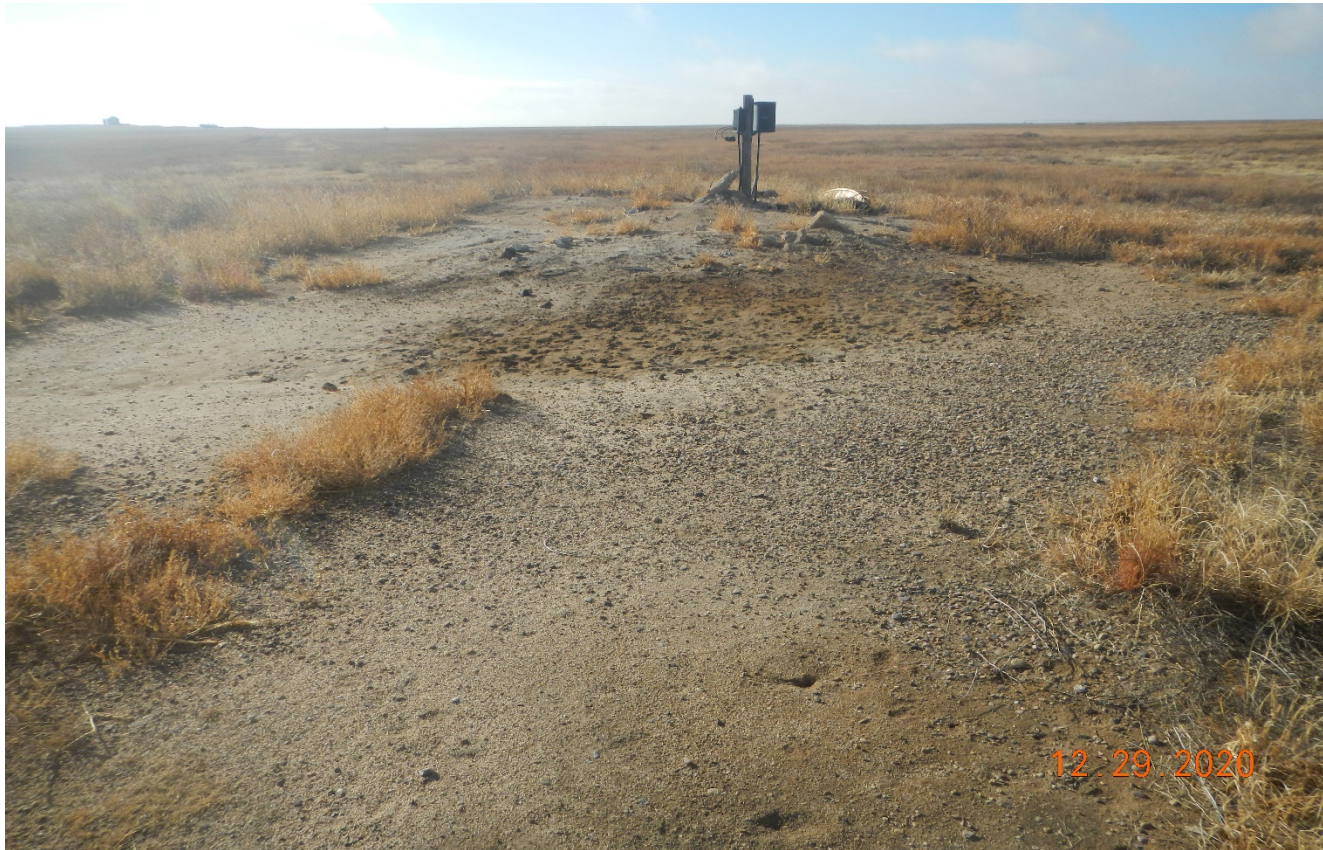
Photo 3. Facing southwest. This area has no vegetation growth and has not been regraded and leveled. Soils need to be decompacted by cross ripping to 18 inches.

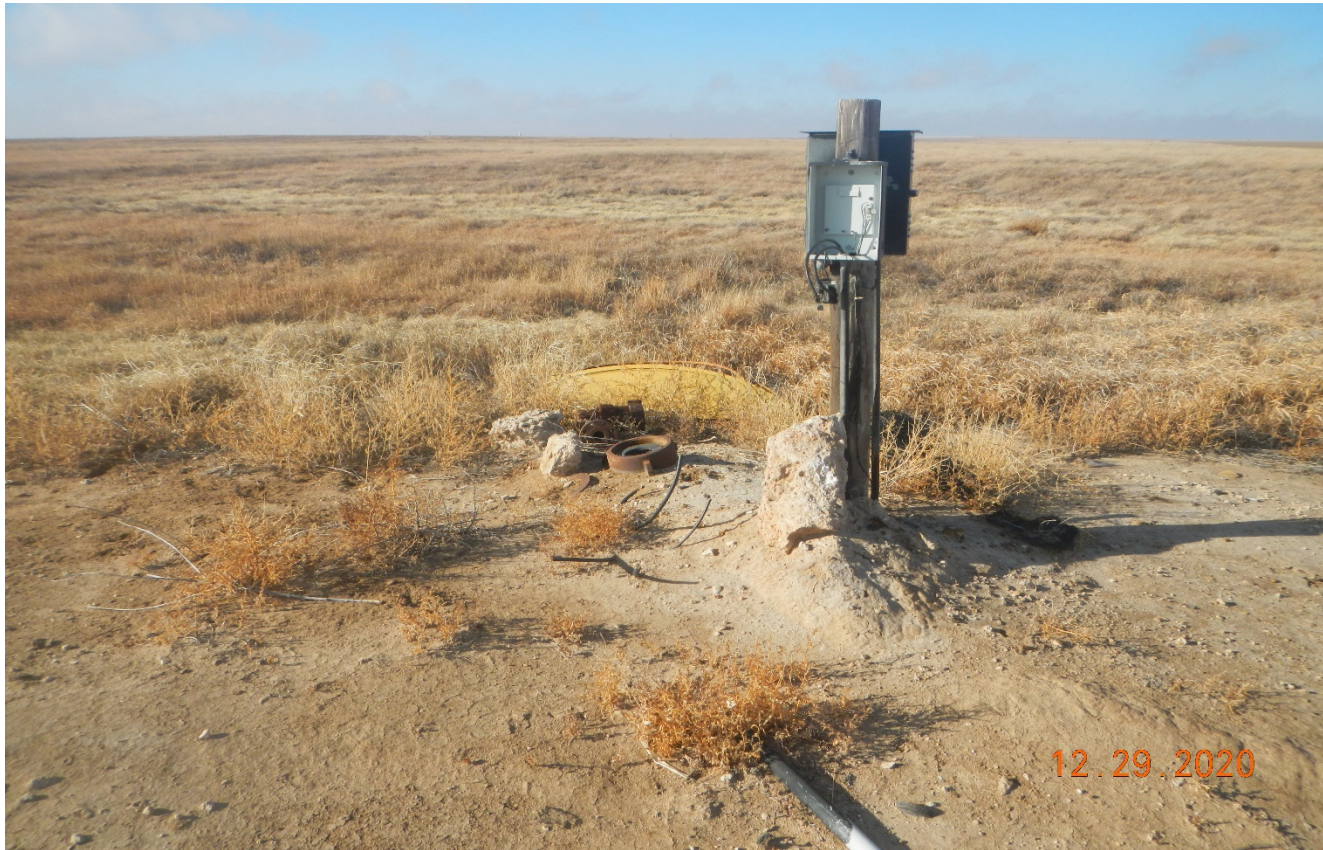
Photo 4. There is an eclectic utility and various parts that remain. All equipment should have been removed within 3 months of abandonment.

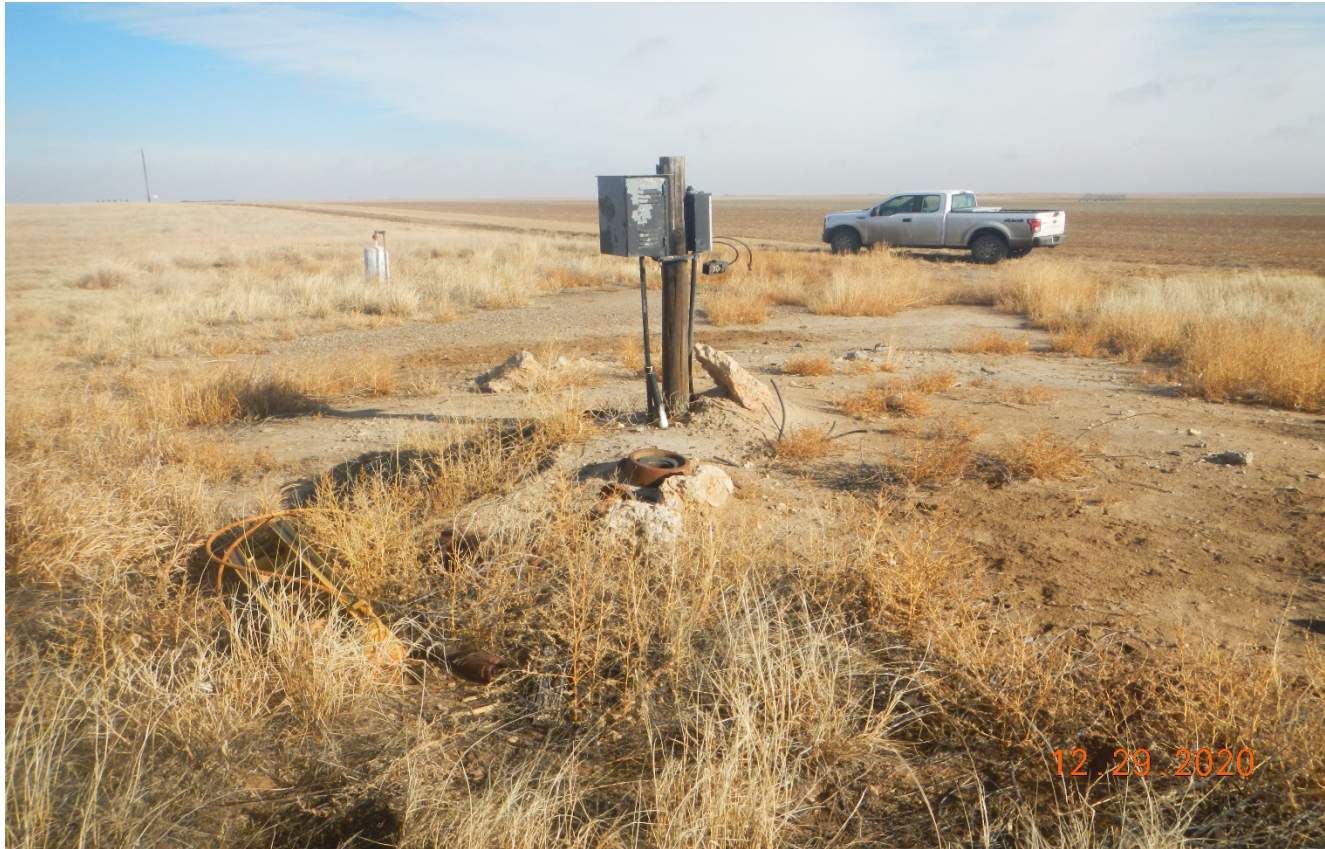
Photo 5. Facing northeast toward the location.

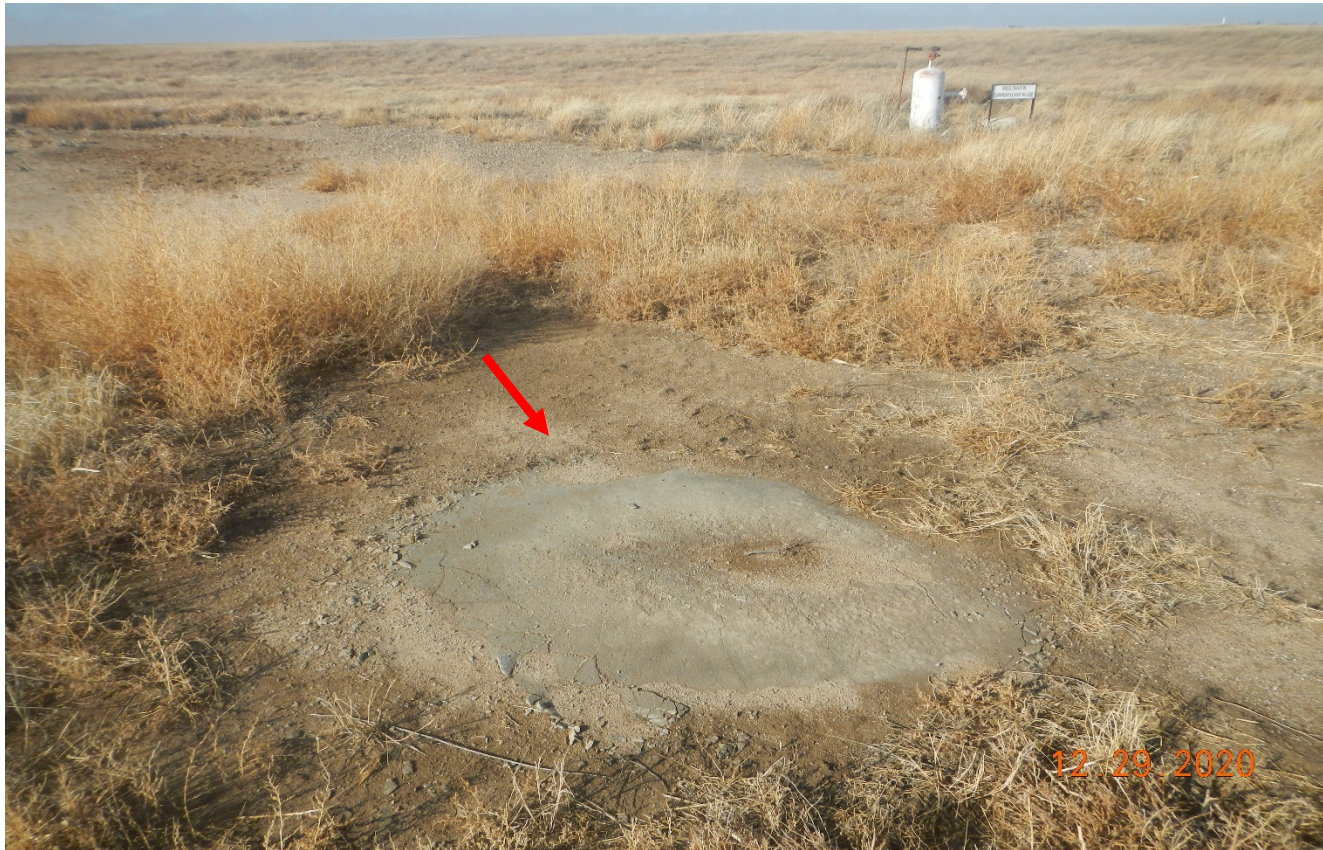
Photo 6. There is cement that remains at the east side. The cement needs to be removed.
