Inspection Photos

API: 009-06554

Operator: LORENTZ OIL & GAS LLC

Inspection Date: 12/29/2020

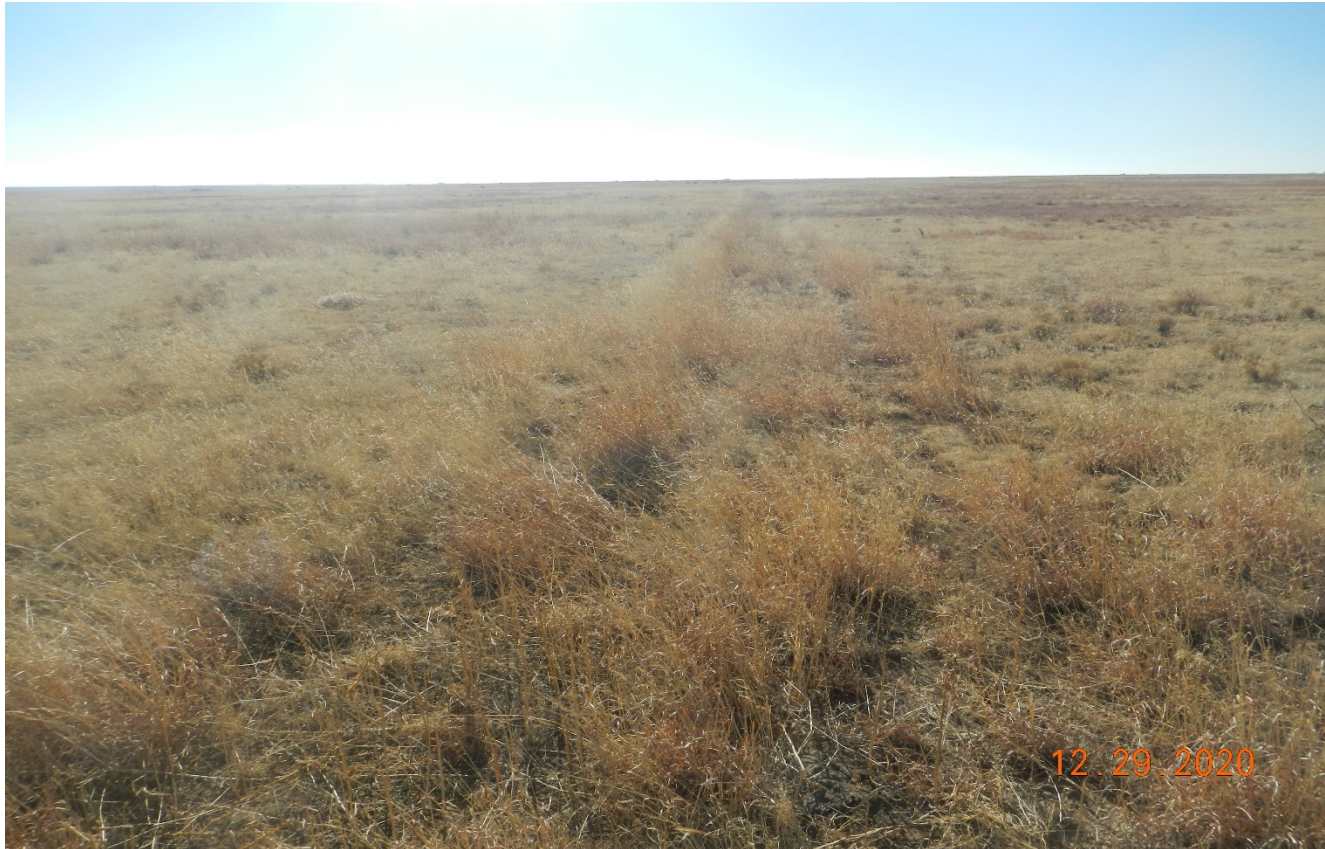
Photo 1. Facing south toward the access road. Vegetation is well established along the former road.

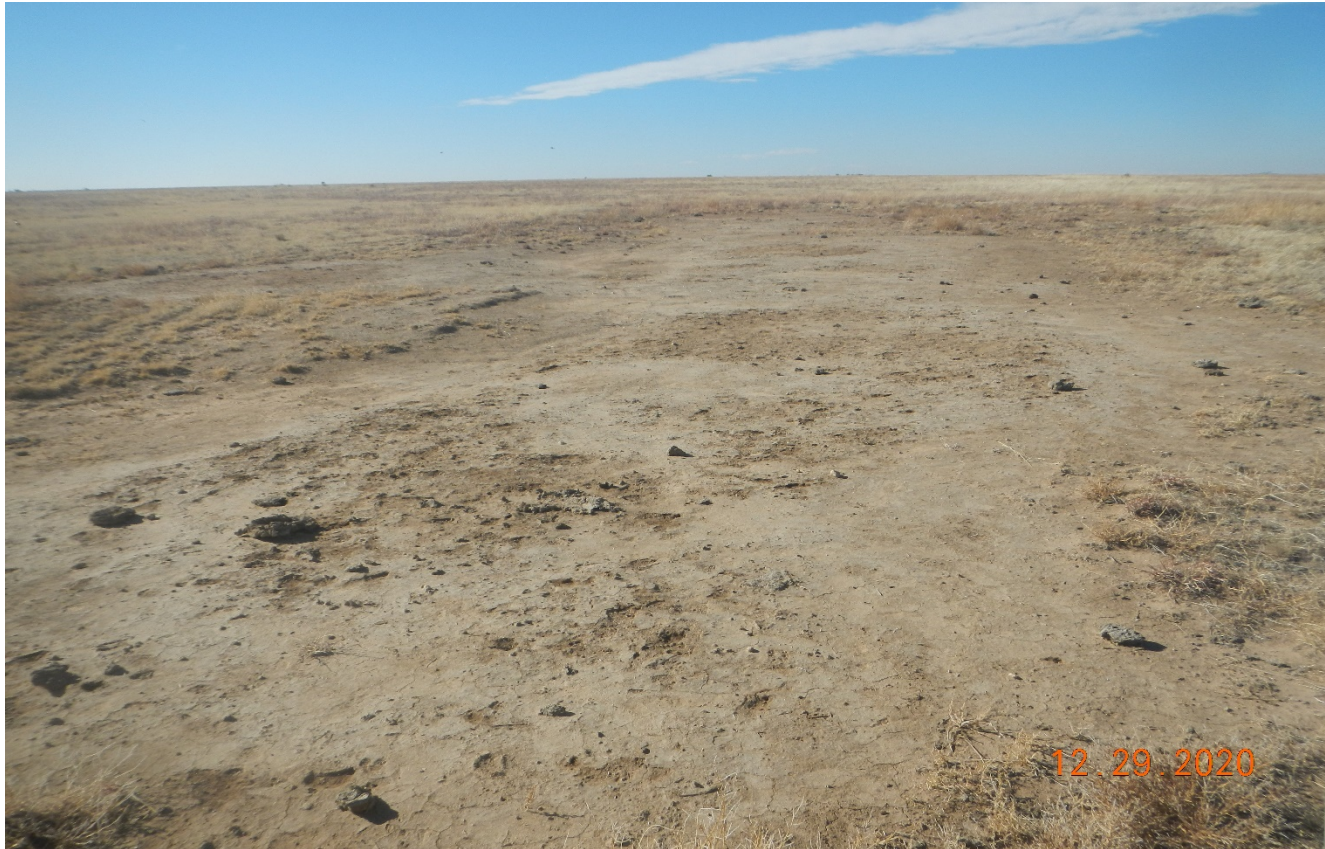
Photo 2. Facing west toward the location. There is no vegetation growth at the location. It does not appear reclamation has been performed.

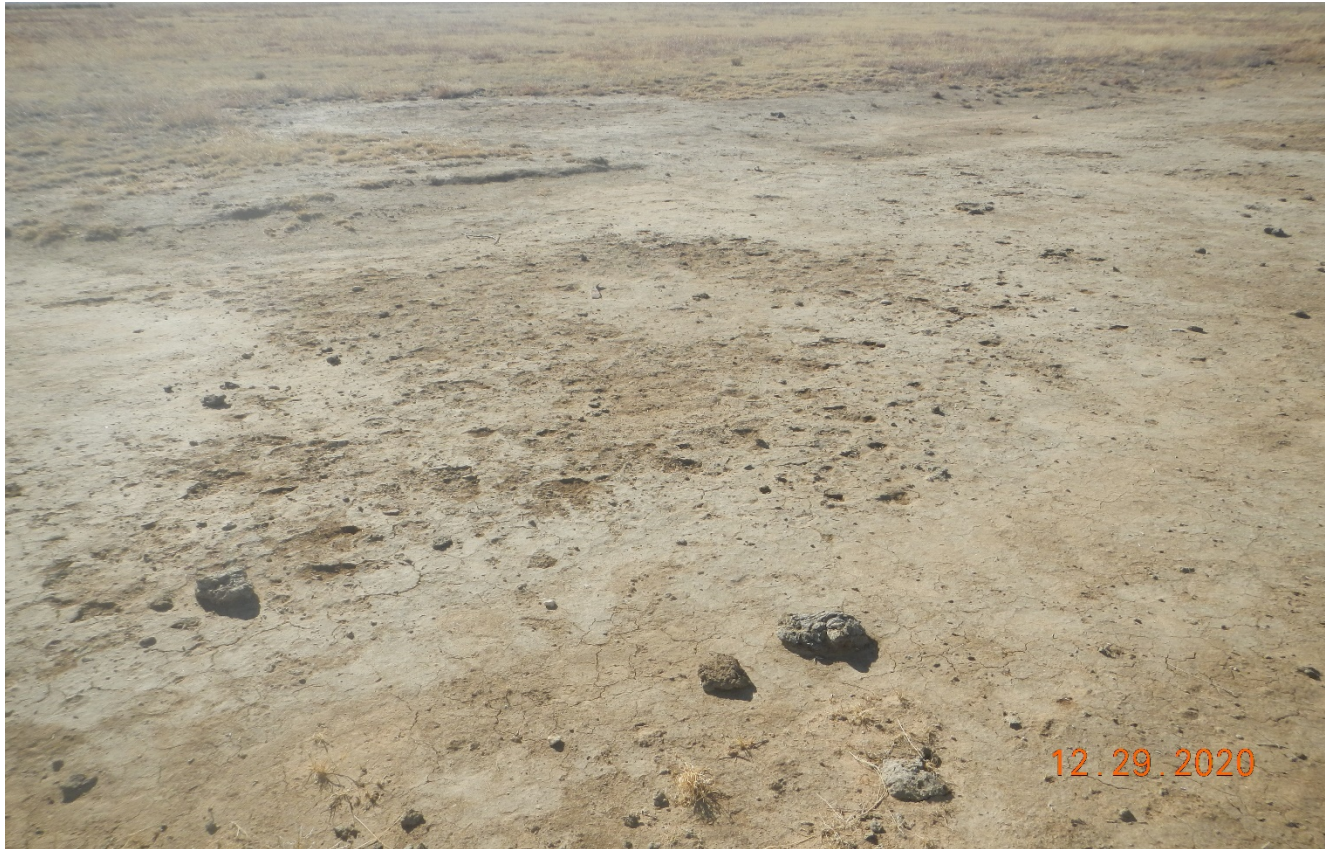
Photo 3. View of ground cover shows no vegetation growth.

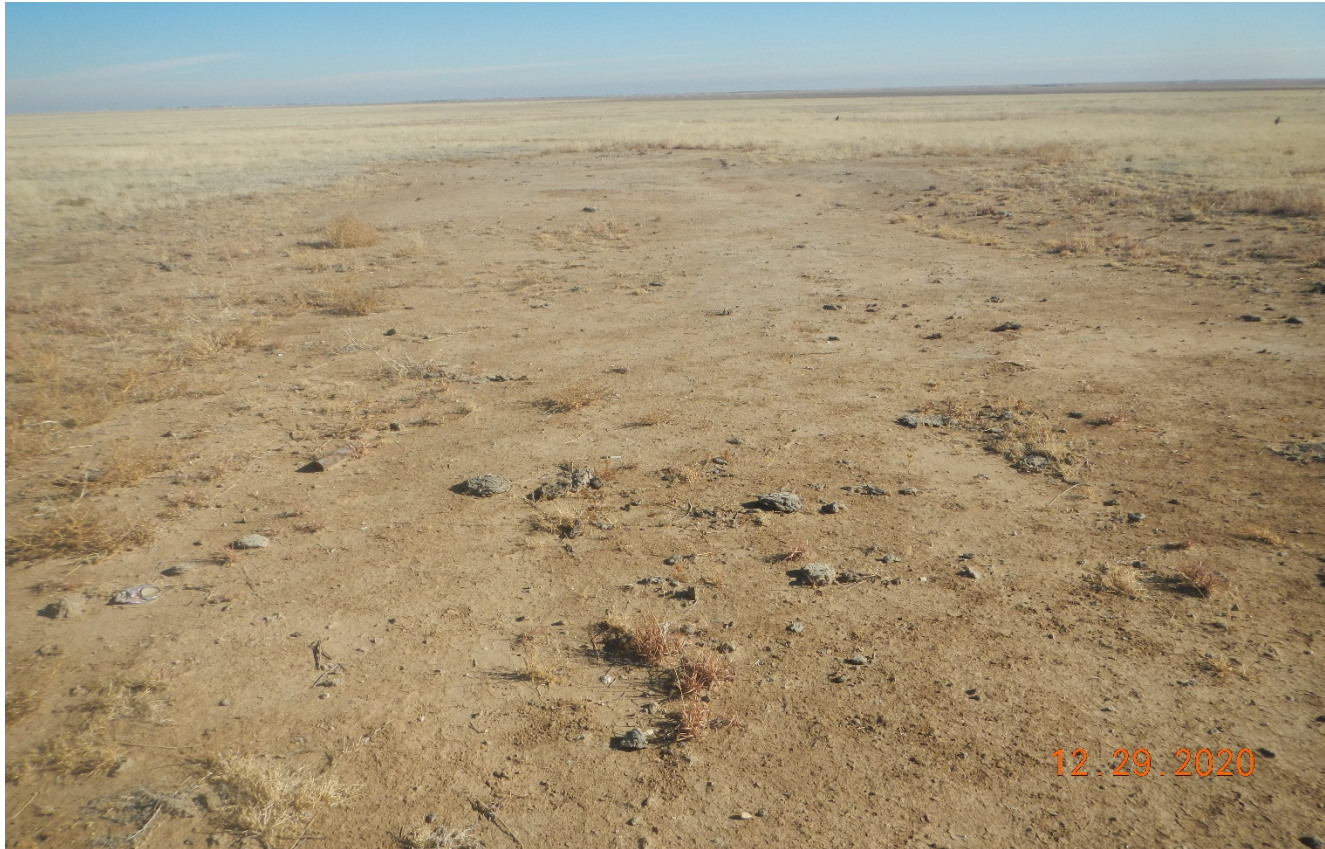
Photo 4. Facing east toward the location. There is no vegetation growth at the location. It does not appear reclamation has been performed.

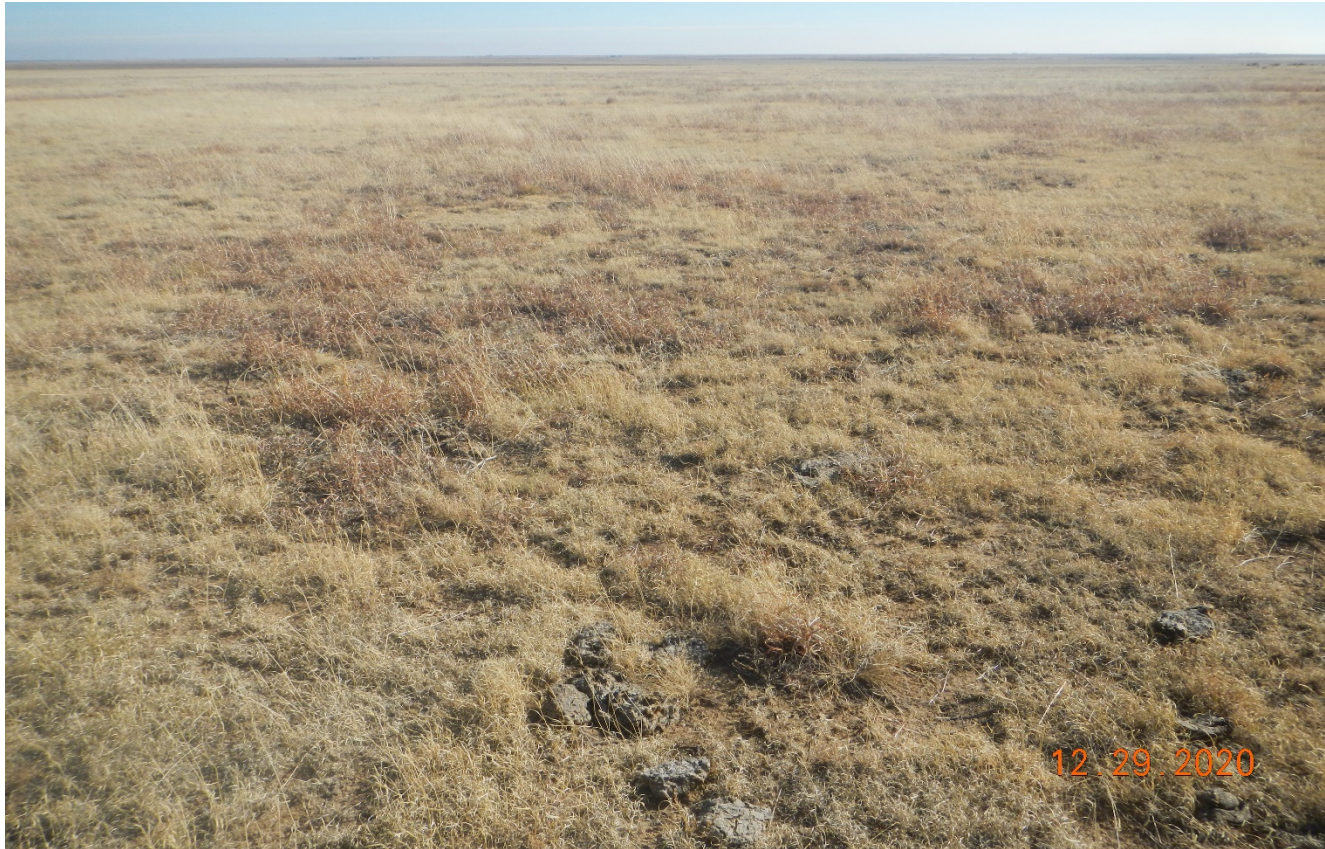
Photo 5. Facing east toward the surrounding undisturbed reference area.
