Inspection Photos

API: 009-06553

Operator: LORENTZ OIL & GAS LLC

Inspection Date: 12/29/2020

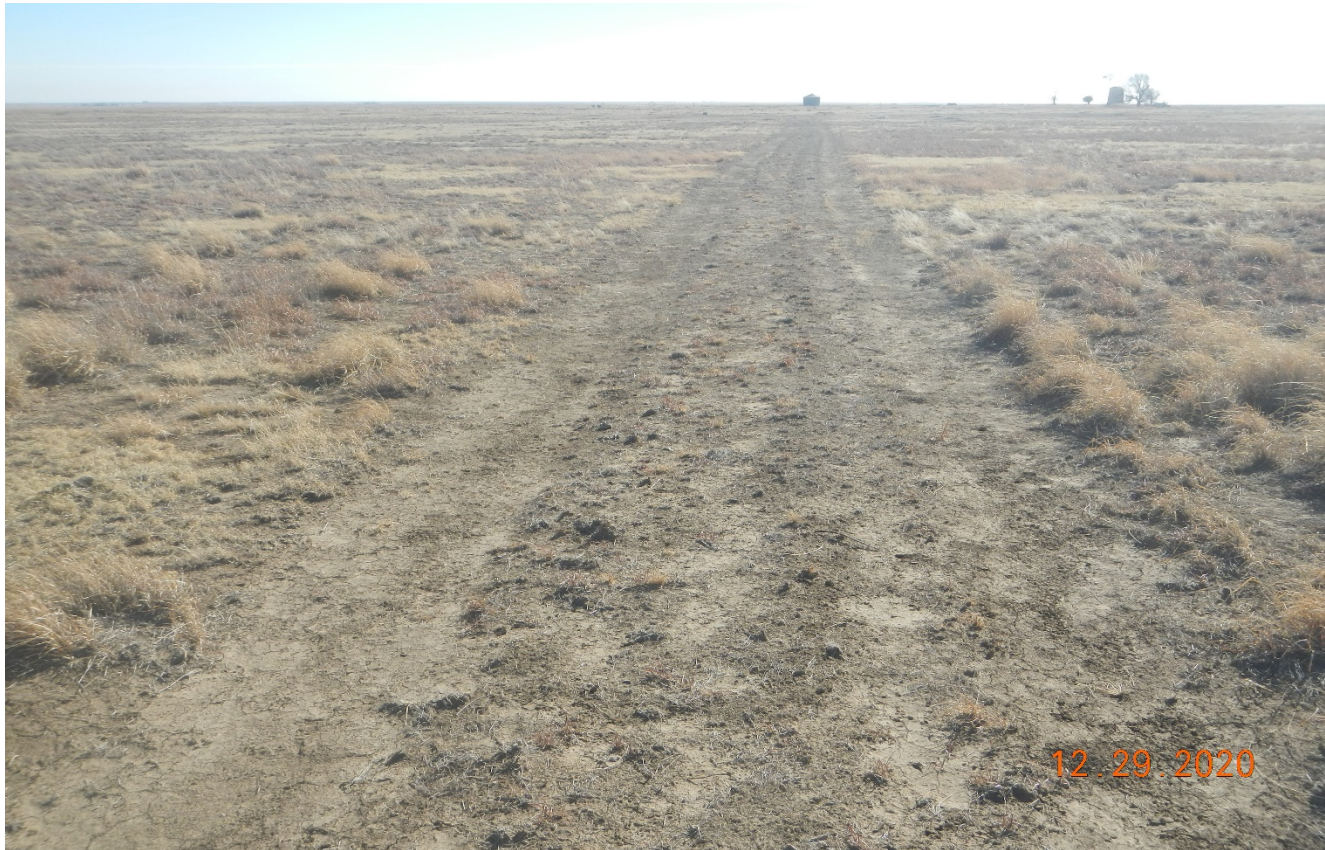
Photo 1. Facing southeast toward the access road. Desirable vegetation has not established along the road. It does not appear reclamation was performed.

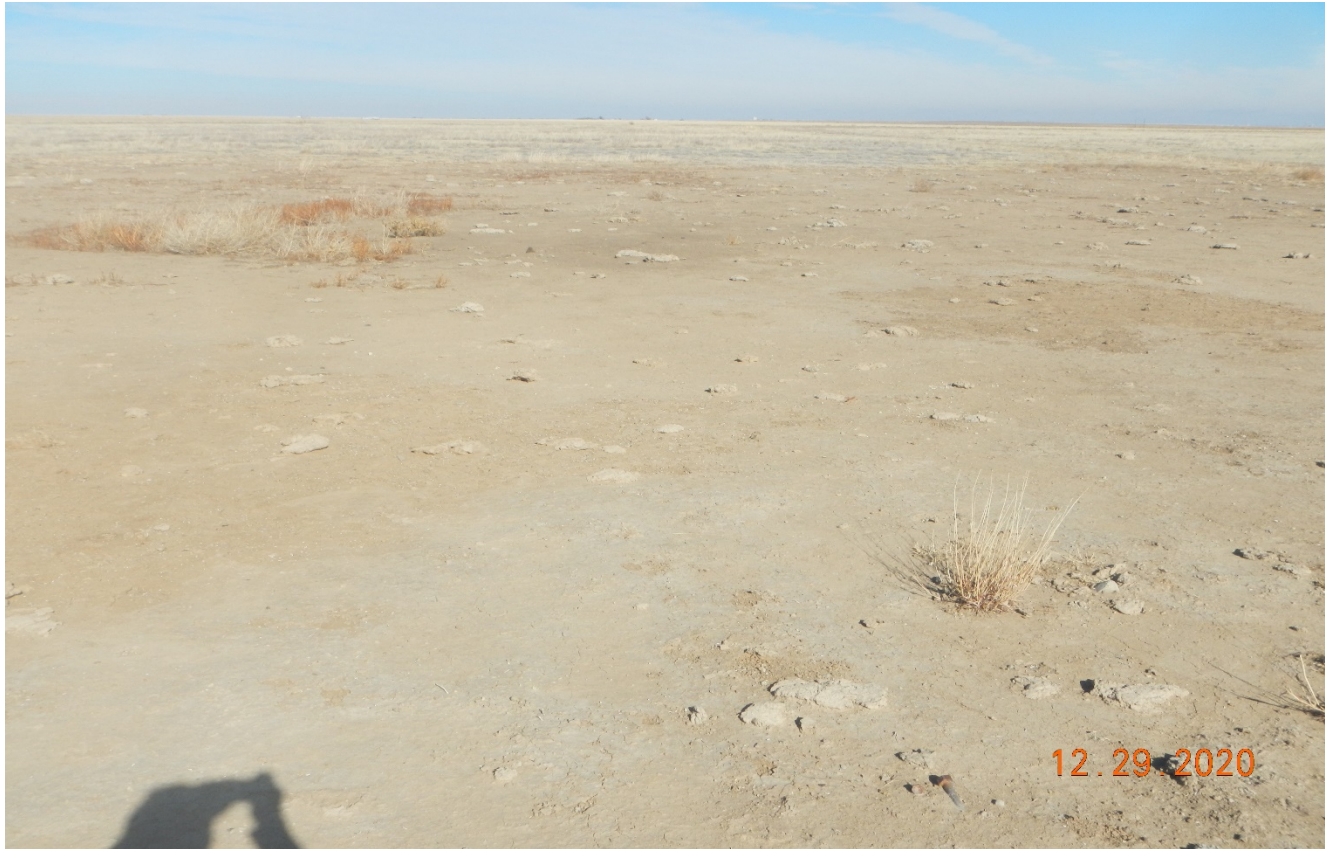
Photo 2. Facing north toward the location. There is no vegetation growth at the location. It does not appear reclamation has been performed.

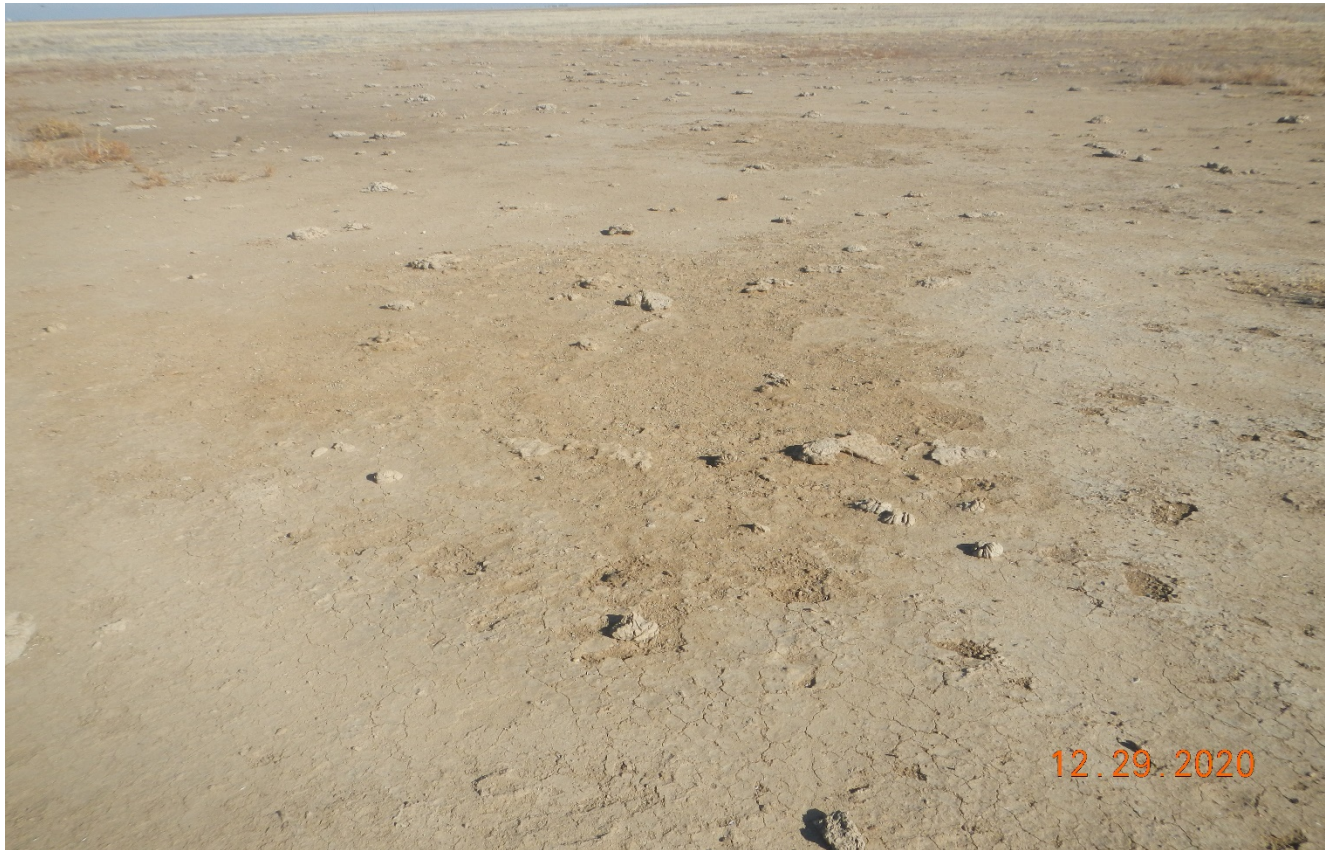
Photo 3. View of ground cover shows no vegetation growth.

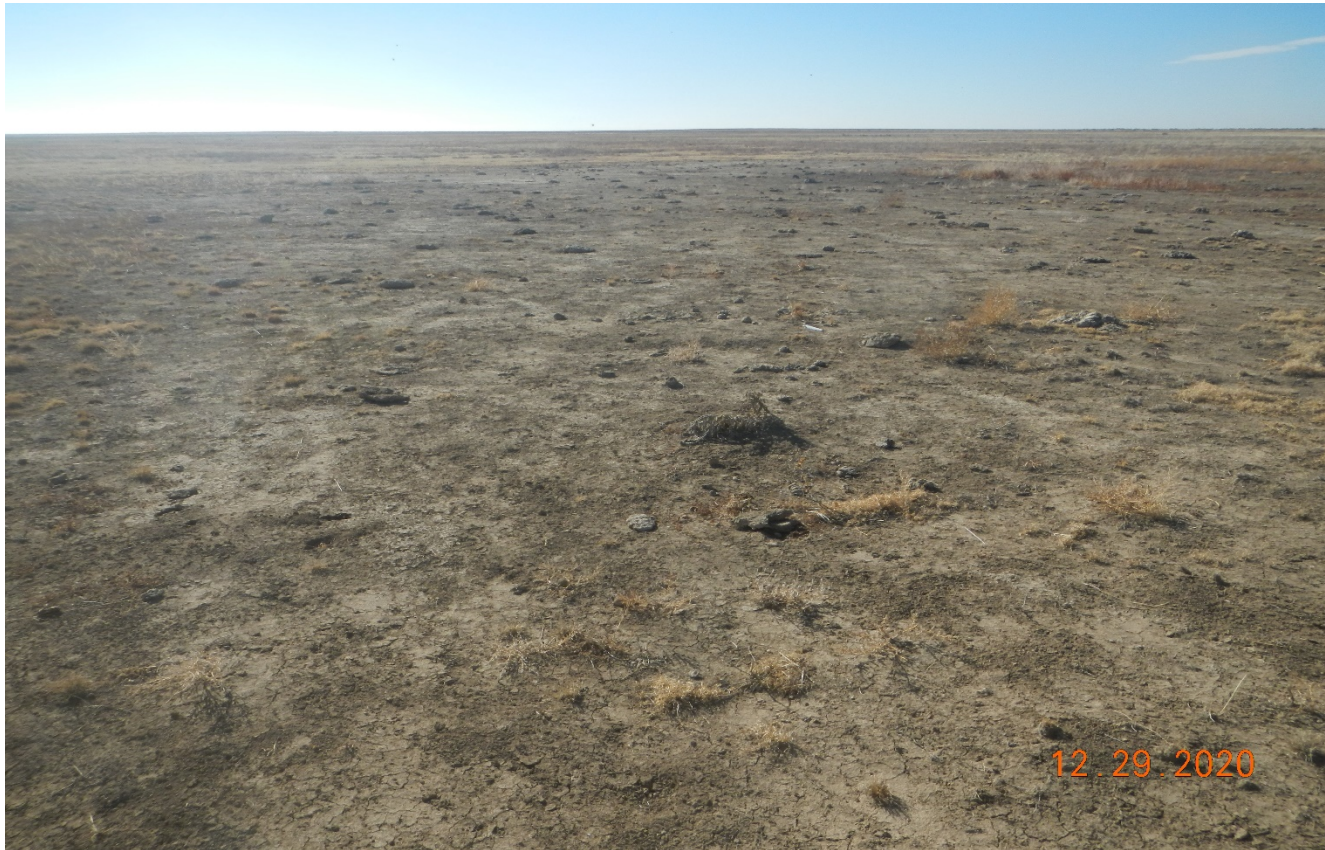
Photo 4. Facing south toward the location. There is no vegetation growth at the location. It does not appear reclamation has been performed.

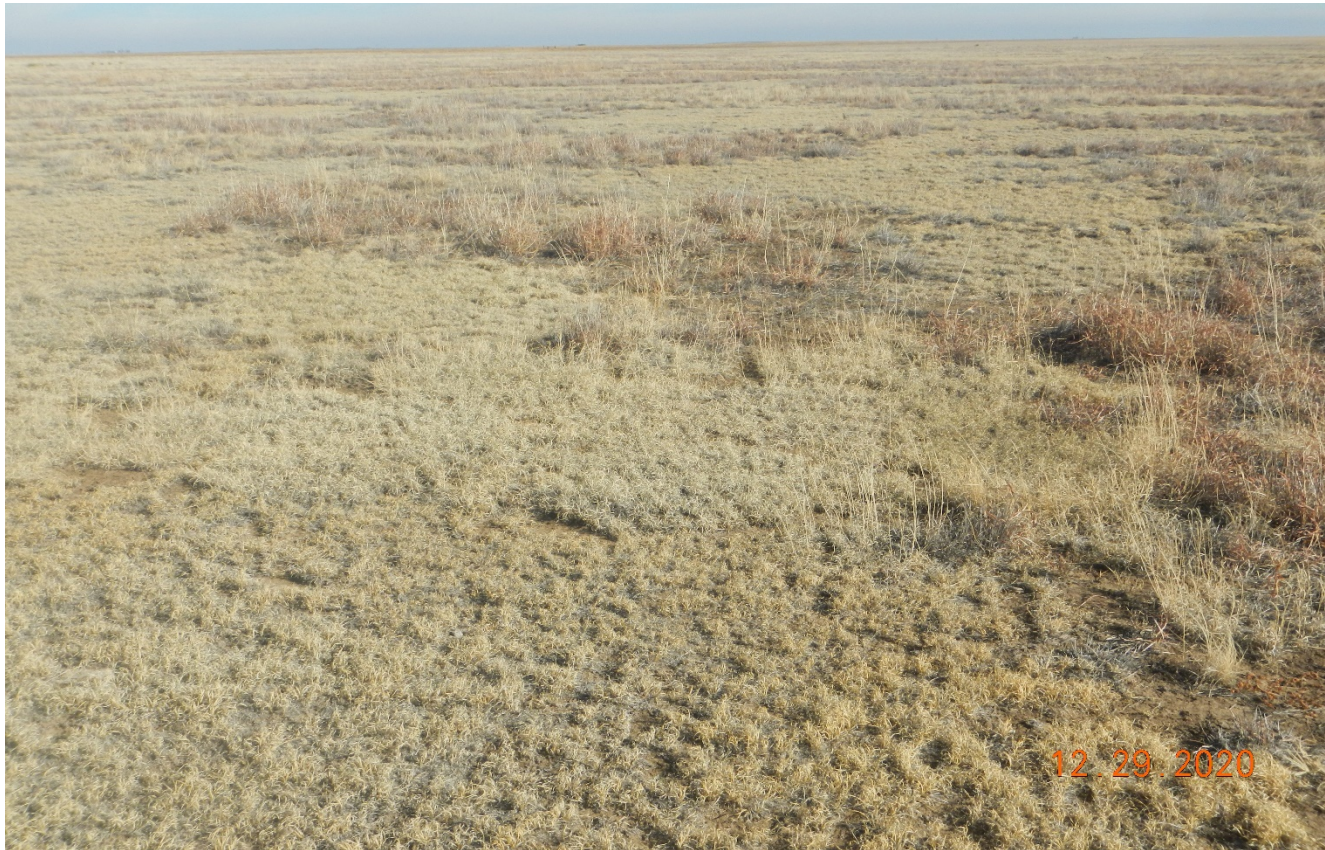
Photo 5. Facing east toward the surrounding undisturbed reference area.
