# Inspection Photos

API: 009-06014

Operator: JONES ENERGY LTD

Inspection Date: 12/29/2020

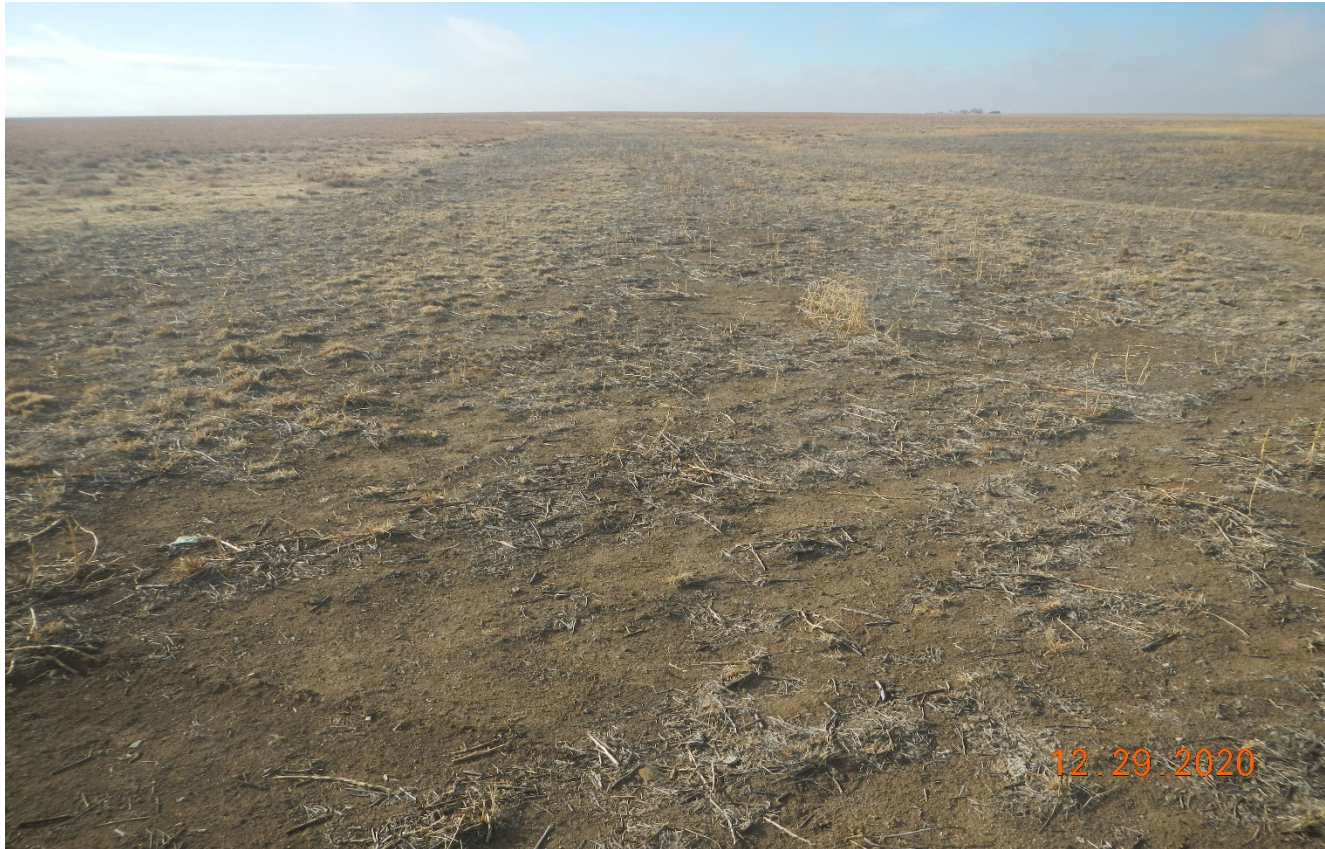
**Photo 1.** Facing southwest at the beginning of the access road. Desirable vegetation has not established along the road. It does not appear reseeding was performed.

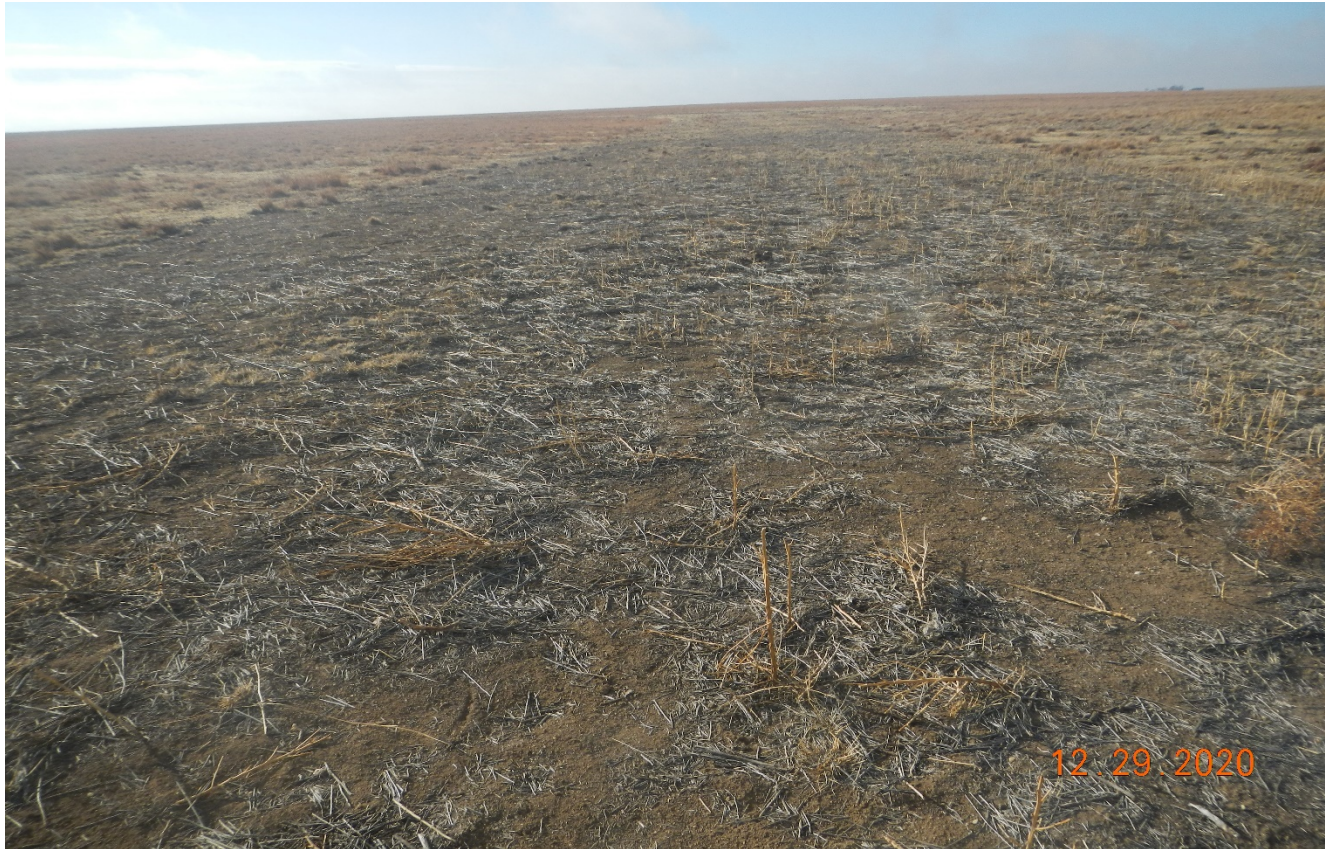
**Photo 2.** Facing southwest along the access road. The greyish vegetative debris is remains of undesirable weeds (Kochia). Desirable vegetation has not established along the road.

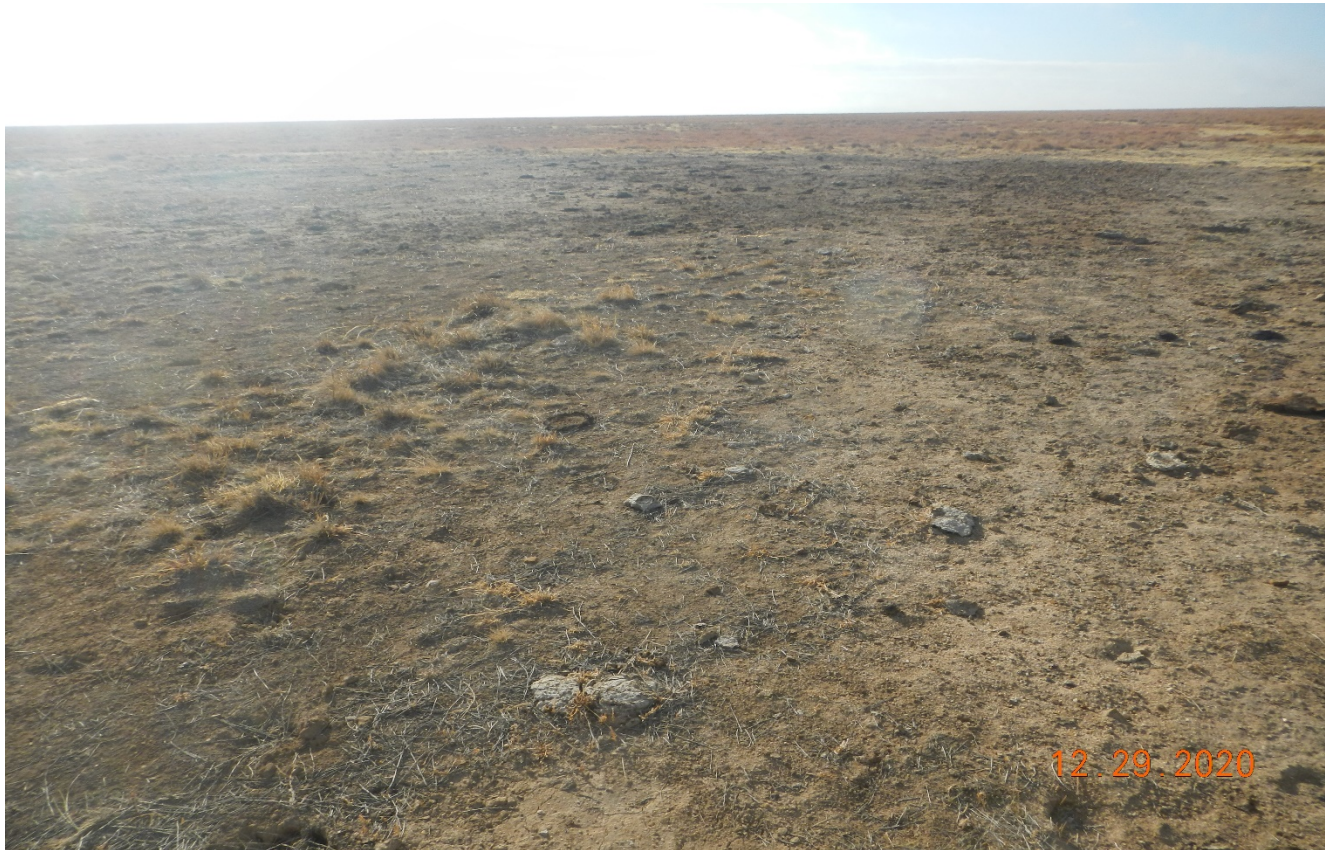
**Photo 3.** Facing southwest toward the location. The location is bare of vegetation. Does not appear any work was performed since the previous inspection.

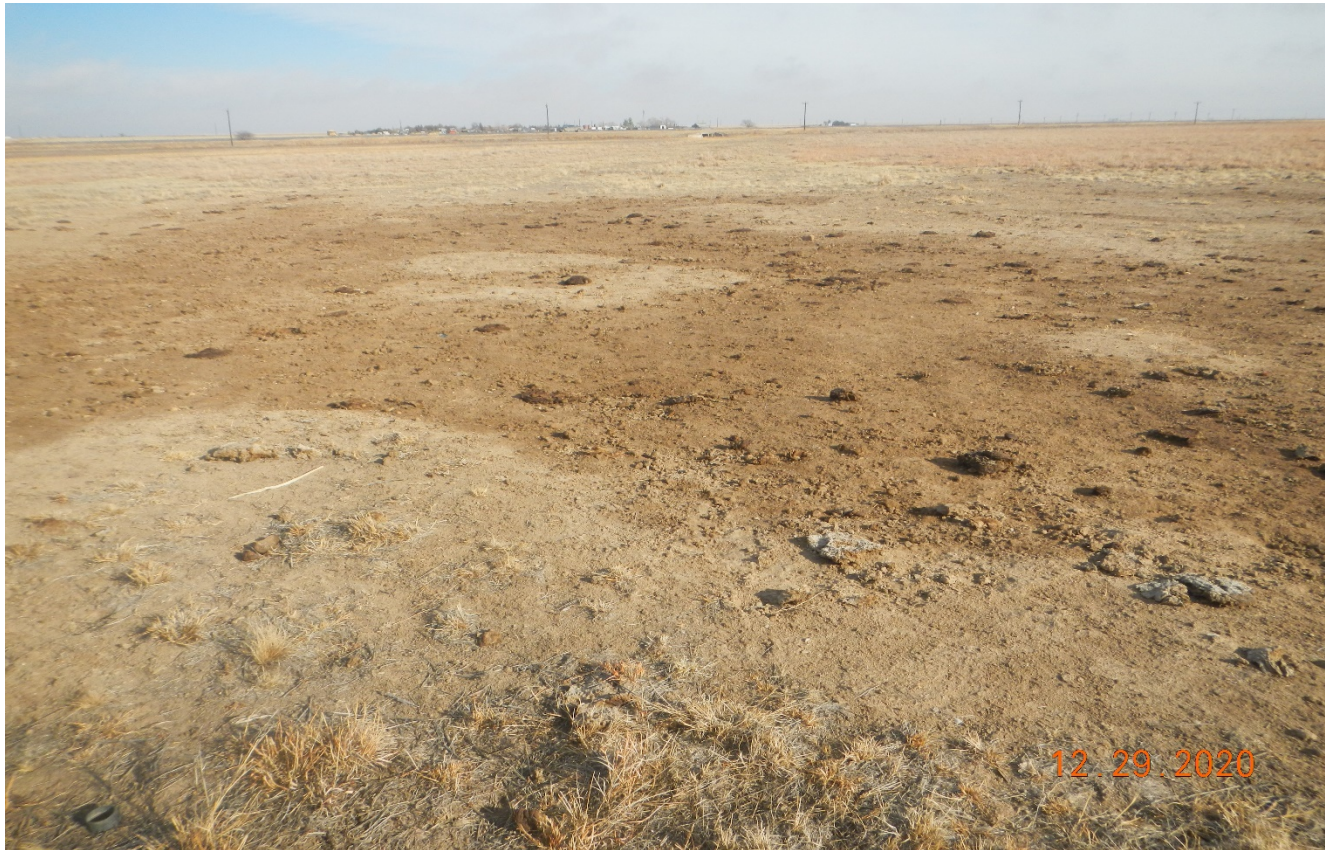
**Photo 4.** Facing northeast toward the location. The location is bare of vegetation. Does not appear any work was performed since the previous inspection.

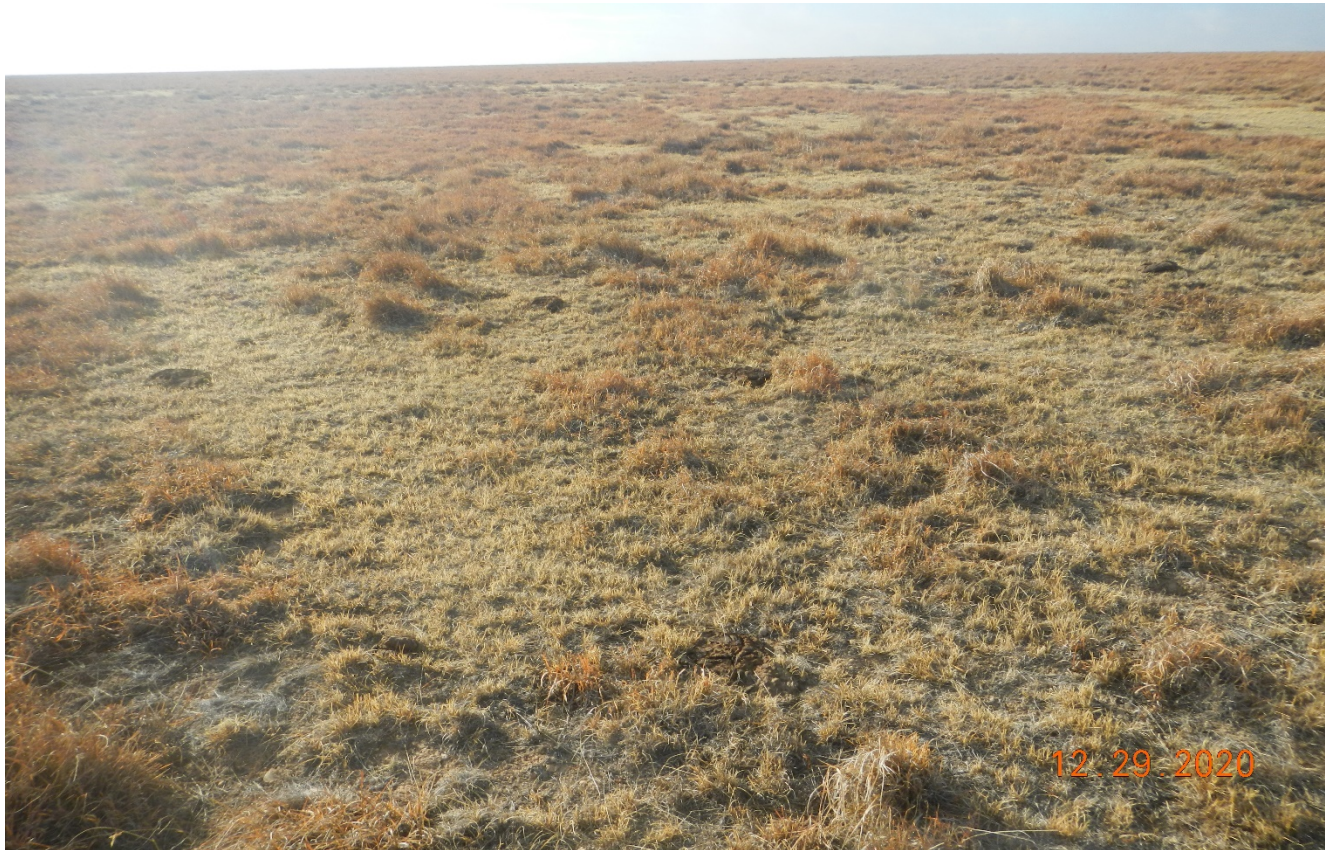
**Photo 5.** Facing west toward the surrounding undisturbed reference area.
