# Inspection Photos

API: 009-05050

Operator: COLORADO INTERSTATE GAS  
COMPANY LLC

Inspection Date: 12/29/2020

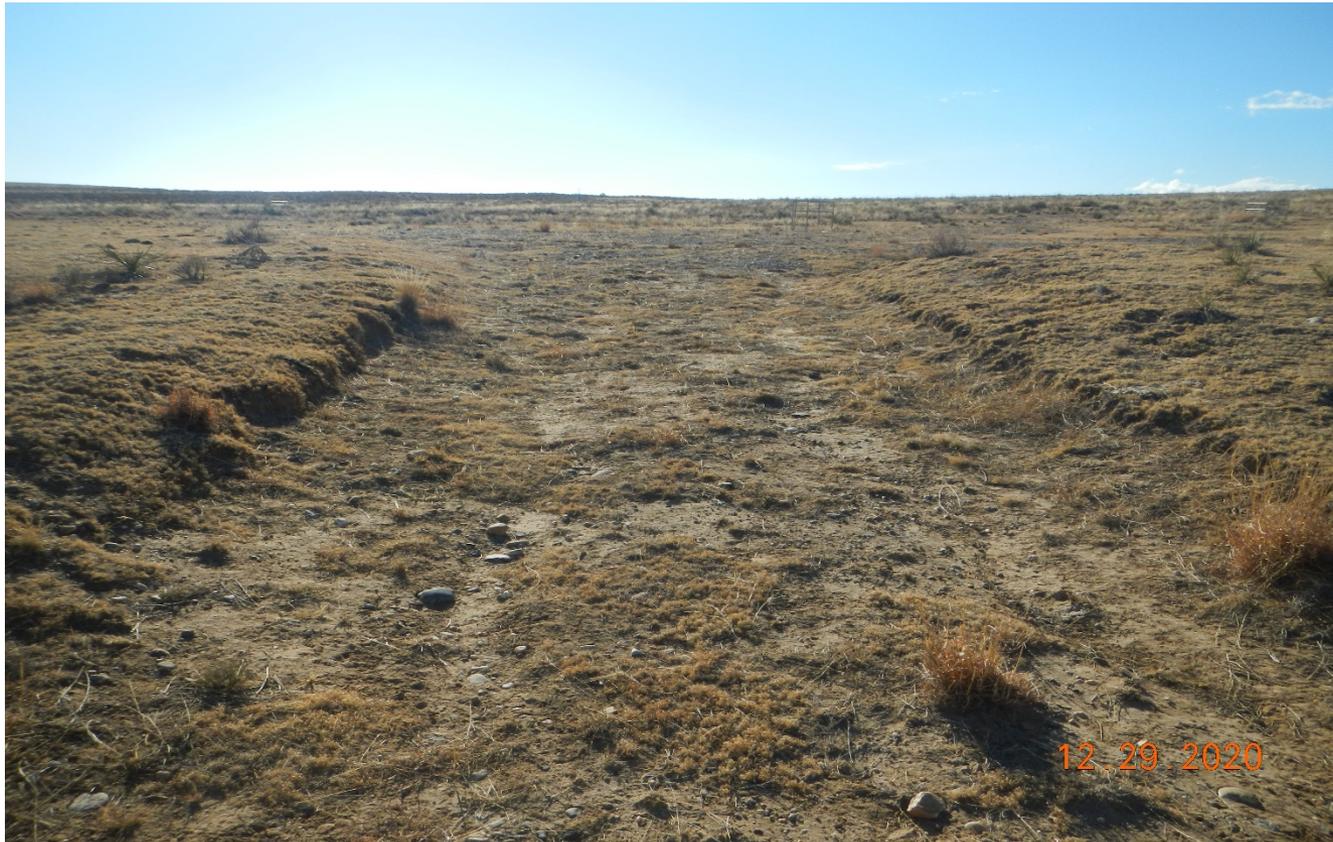
**Photo 1.** Facing southwest along the access road near the location. This area of the road has not been recontoured.

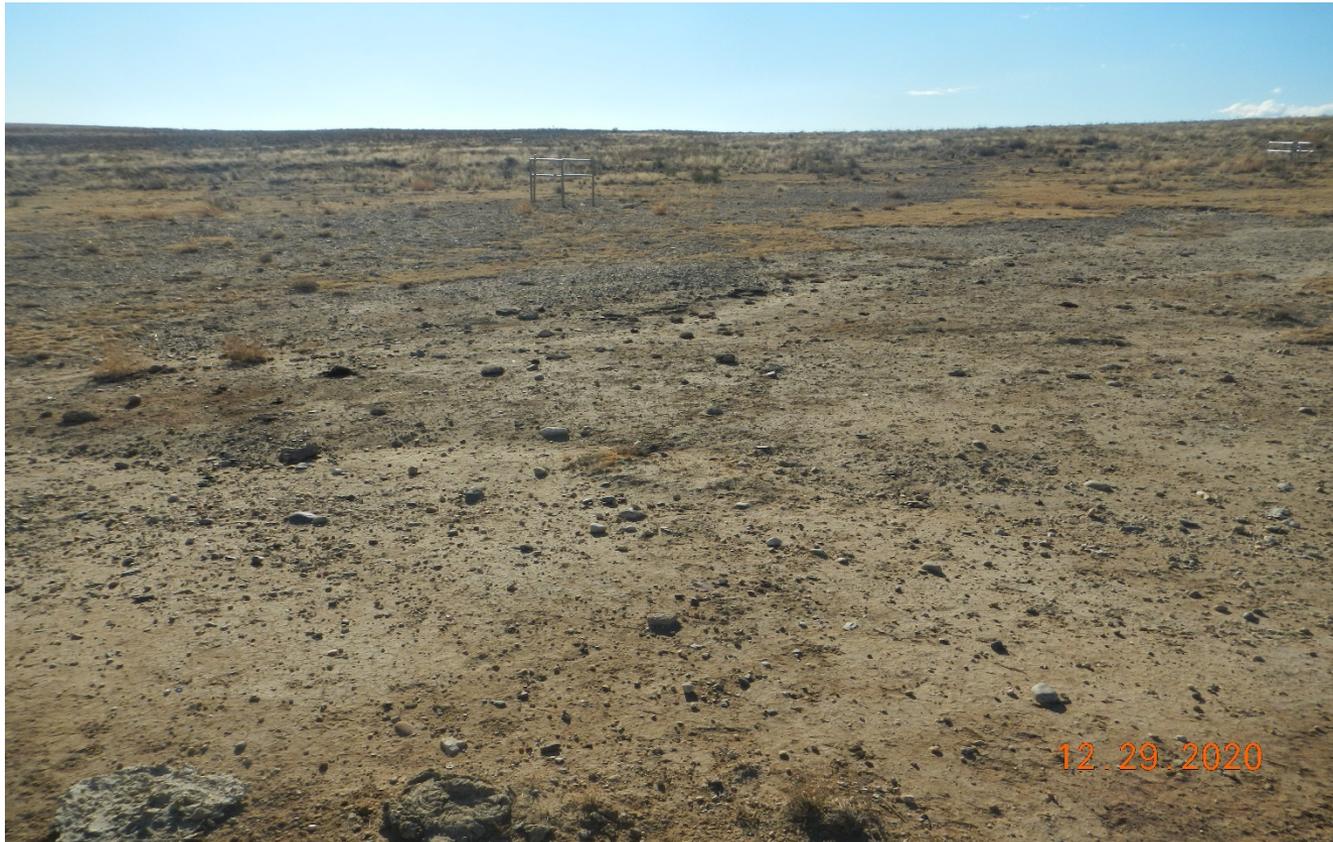
**Photo 2.** Facing southwest toward the location. The location has not been reclaimed.

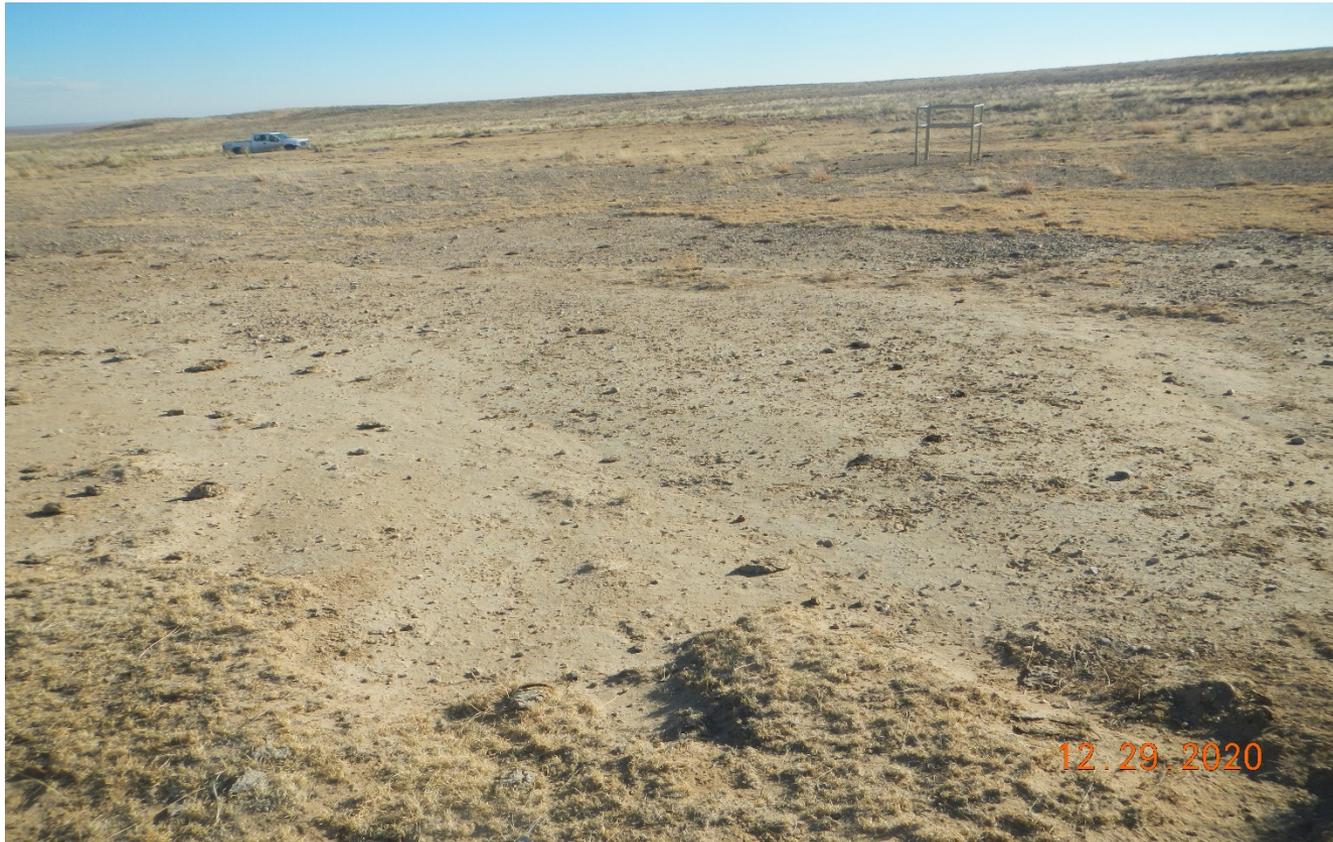
**Photo 3.** Facing south at the location. There are areas of the location that have no vegetation growth.

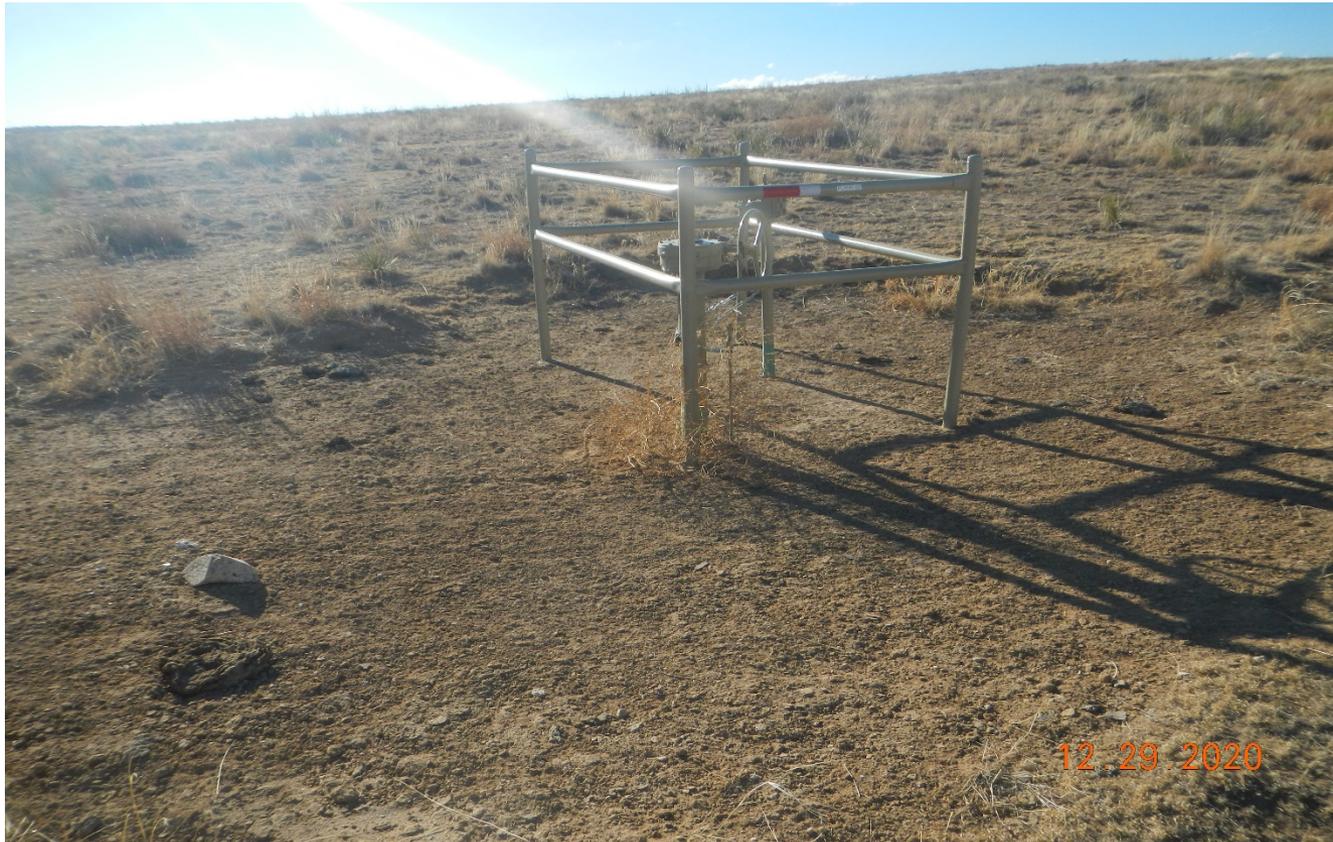
**Photo 4.** There is a pipe riser that remains at the west side of the location. All equipment should have been removed within 3 months of abandonment of the well.

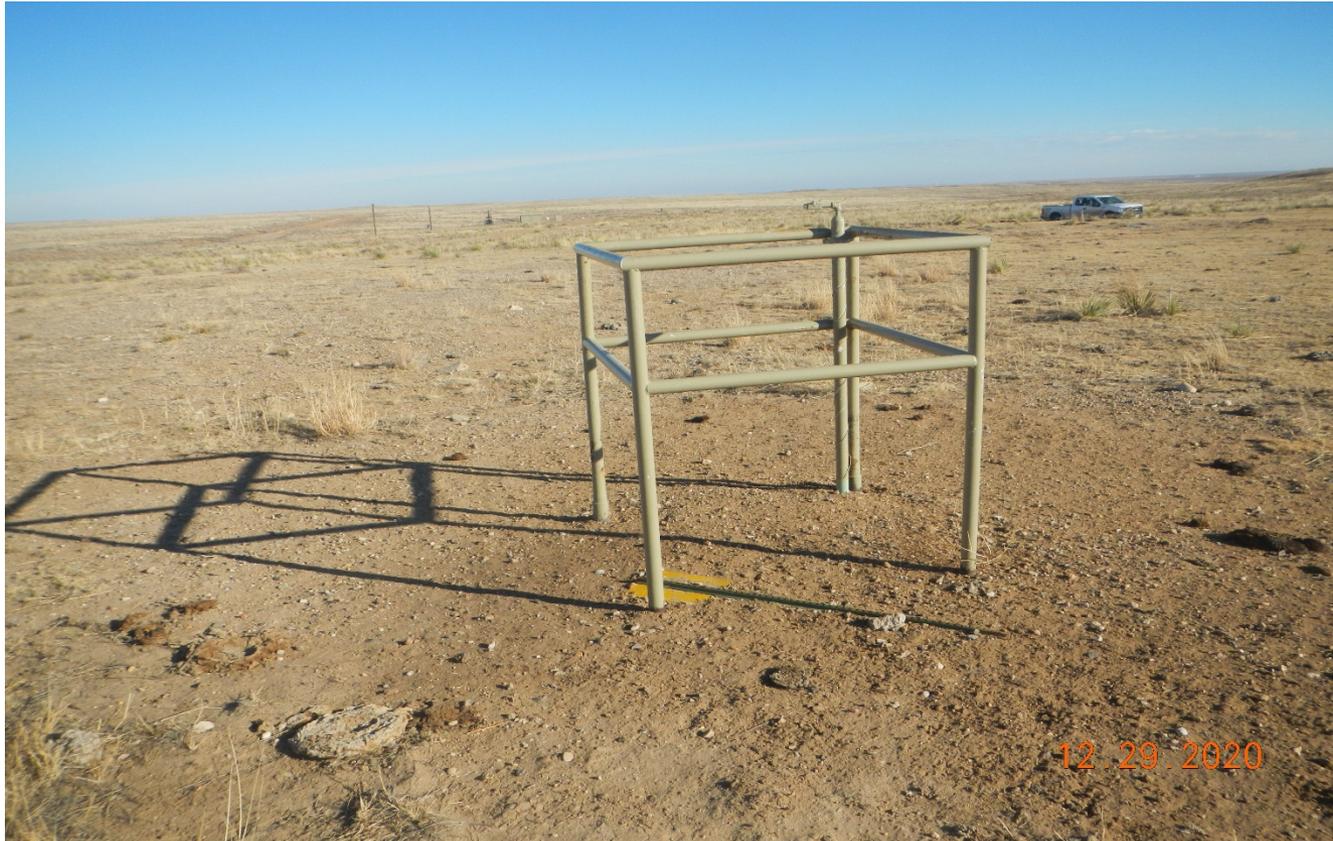
**Photo 5.** There is another pipe riser that remains at the center of the location. All equipment should have been removed within 3 months of abandonment of the well.

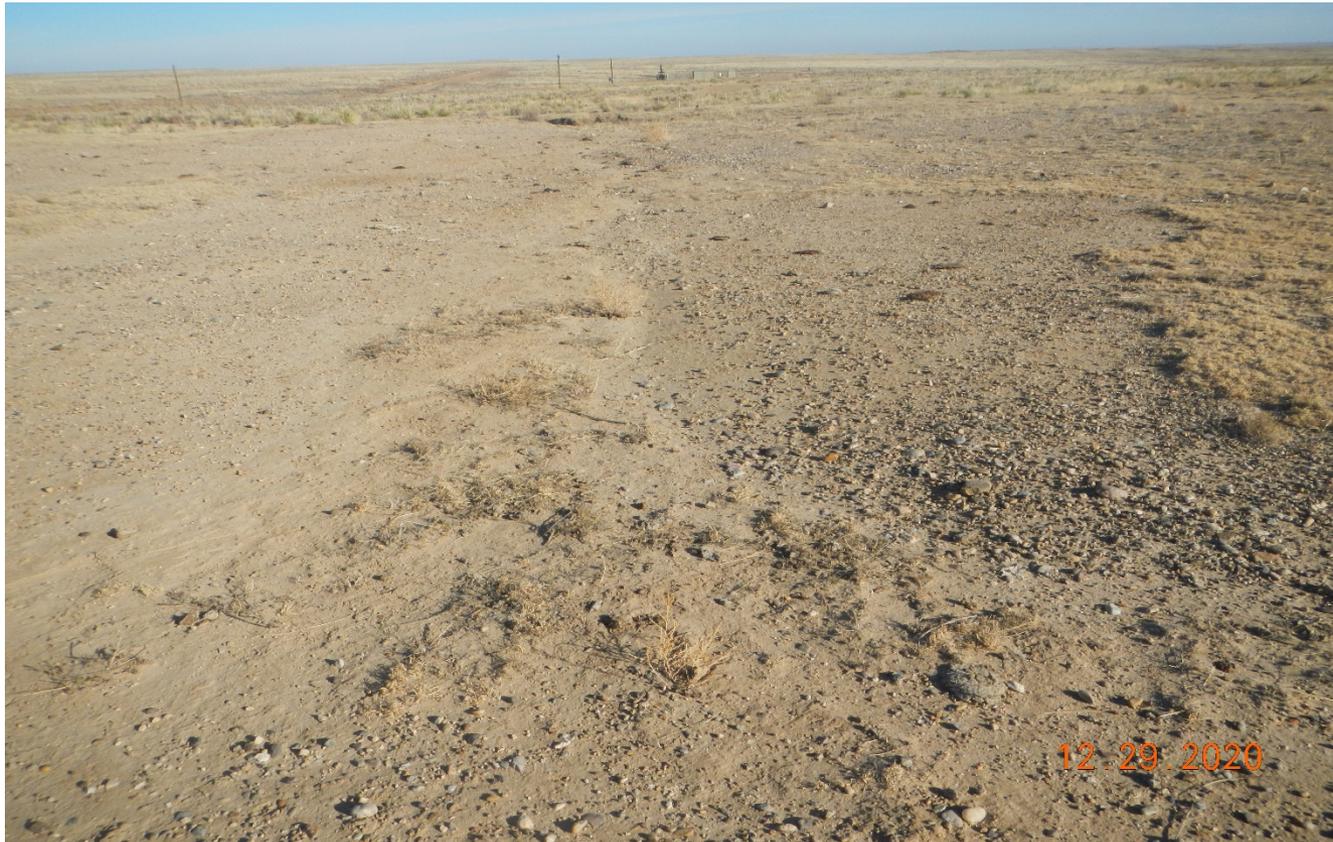
**Photo 6.** Facing northwest toward the location. The location has not been reclaimed and is bare of vegetation.
