Inspection Photos

API: 009-06099

Operator: SOVEREIGN OPERATING COMPANY

Inspection Date: 12/29/2020

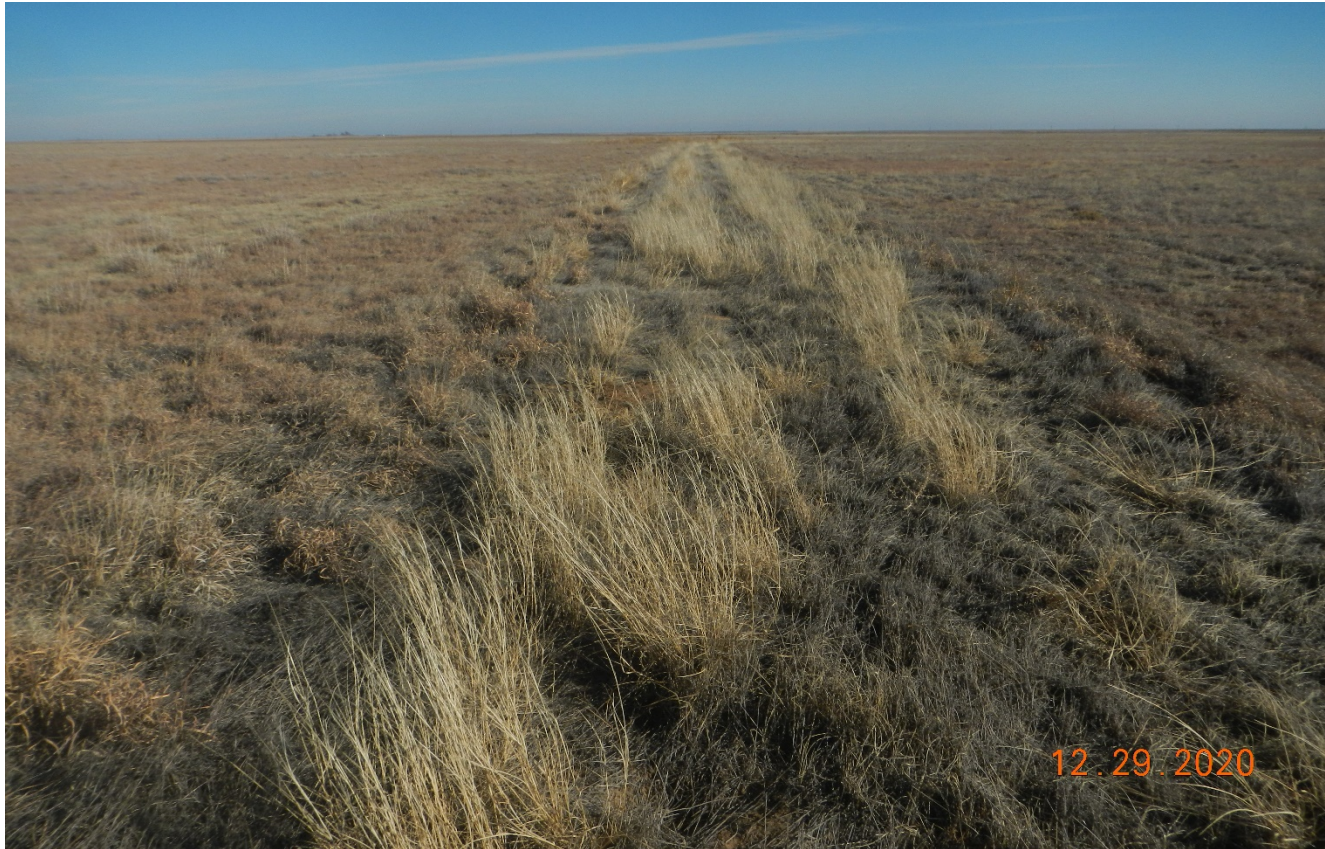
Photo 1. Facing east toward the access road. The road is recontoured and reclaimed. Vegetation has re-established along the former road.

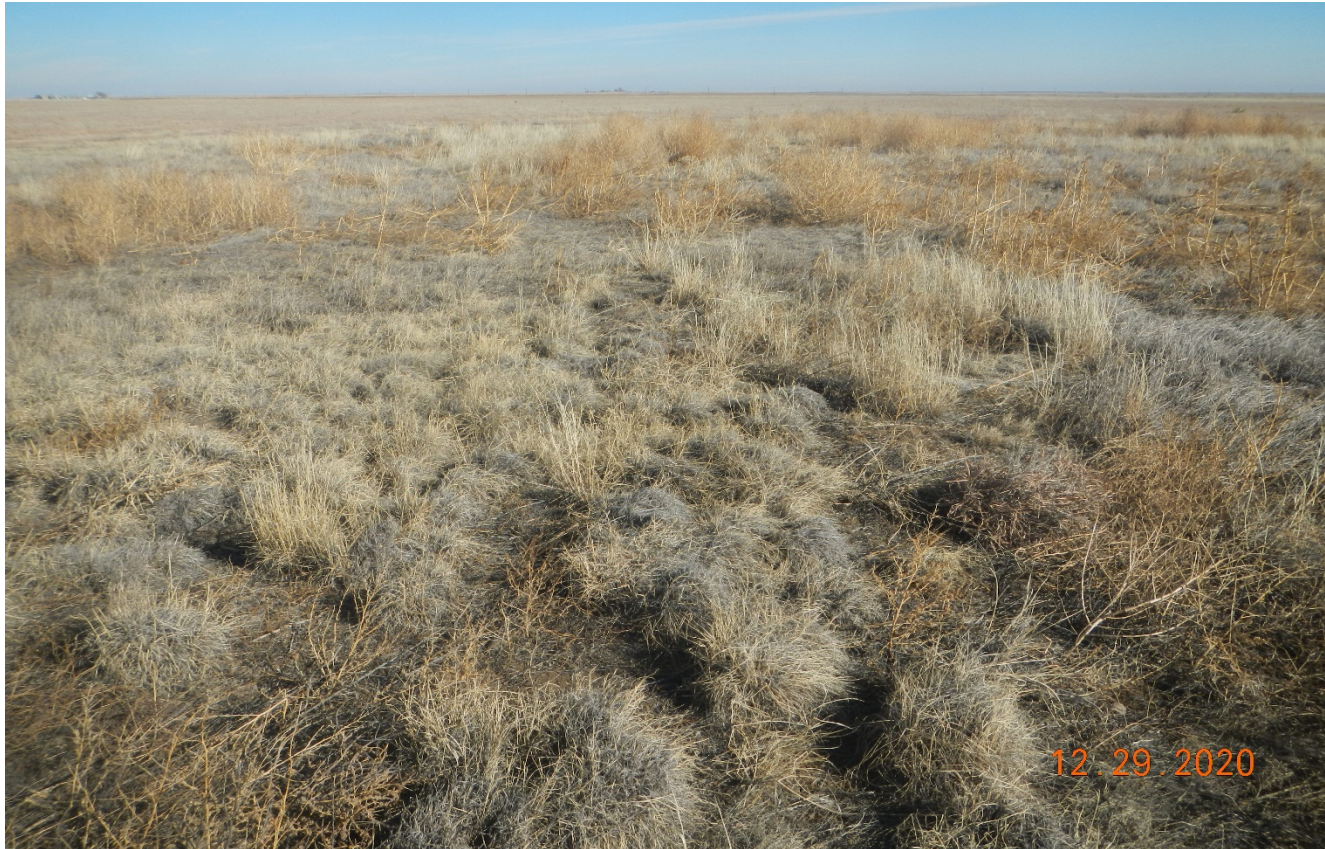
Photo 2. Facing east toward the location. Desirable vegetation has re-established at the location.

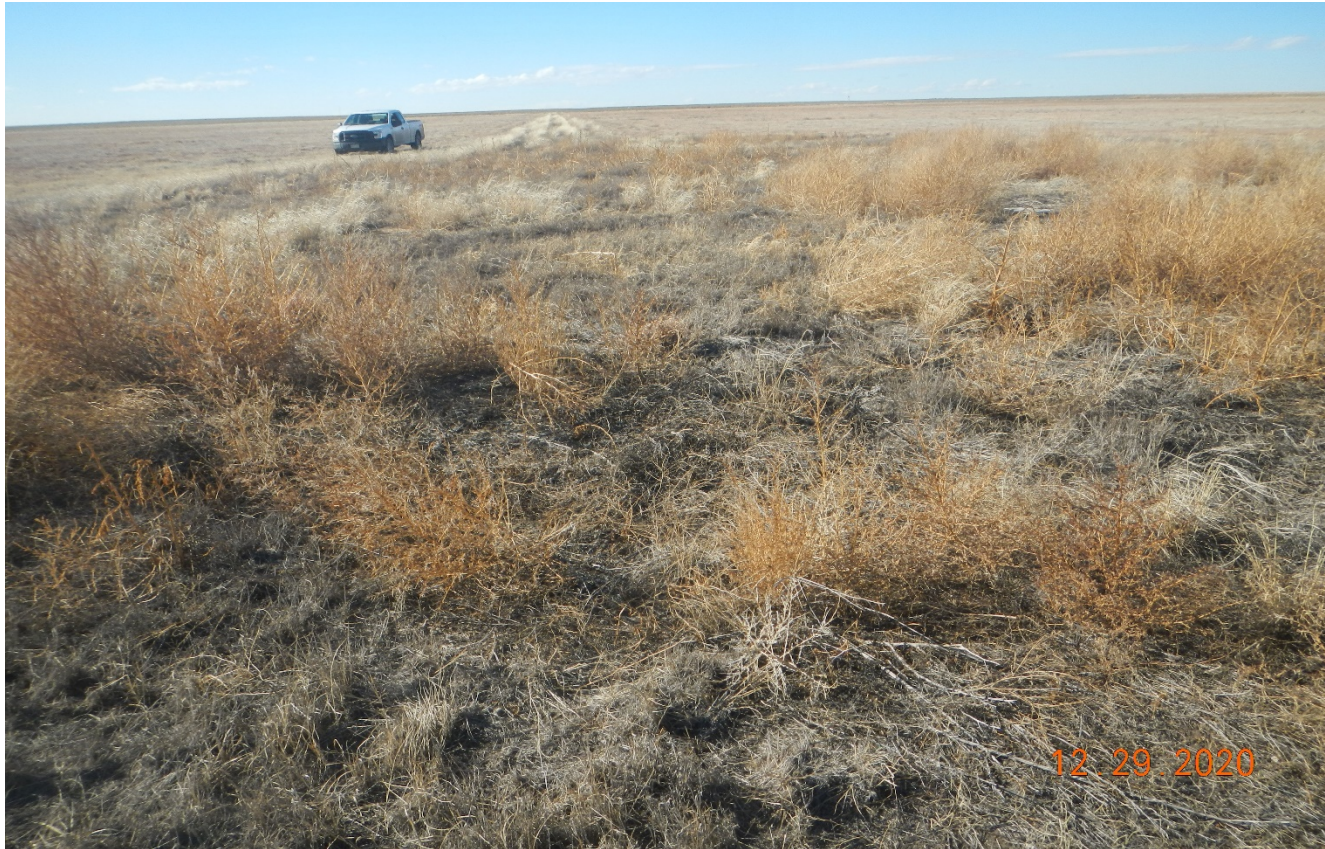
Photo 3. Facing west toward the location. Desirable vegetation has re-established at the location. There are some undesirable weeds (Kochia) however, underneath the weeds are desirable vegetation.

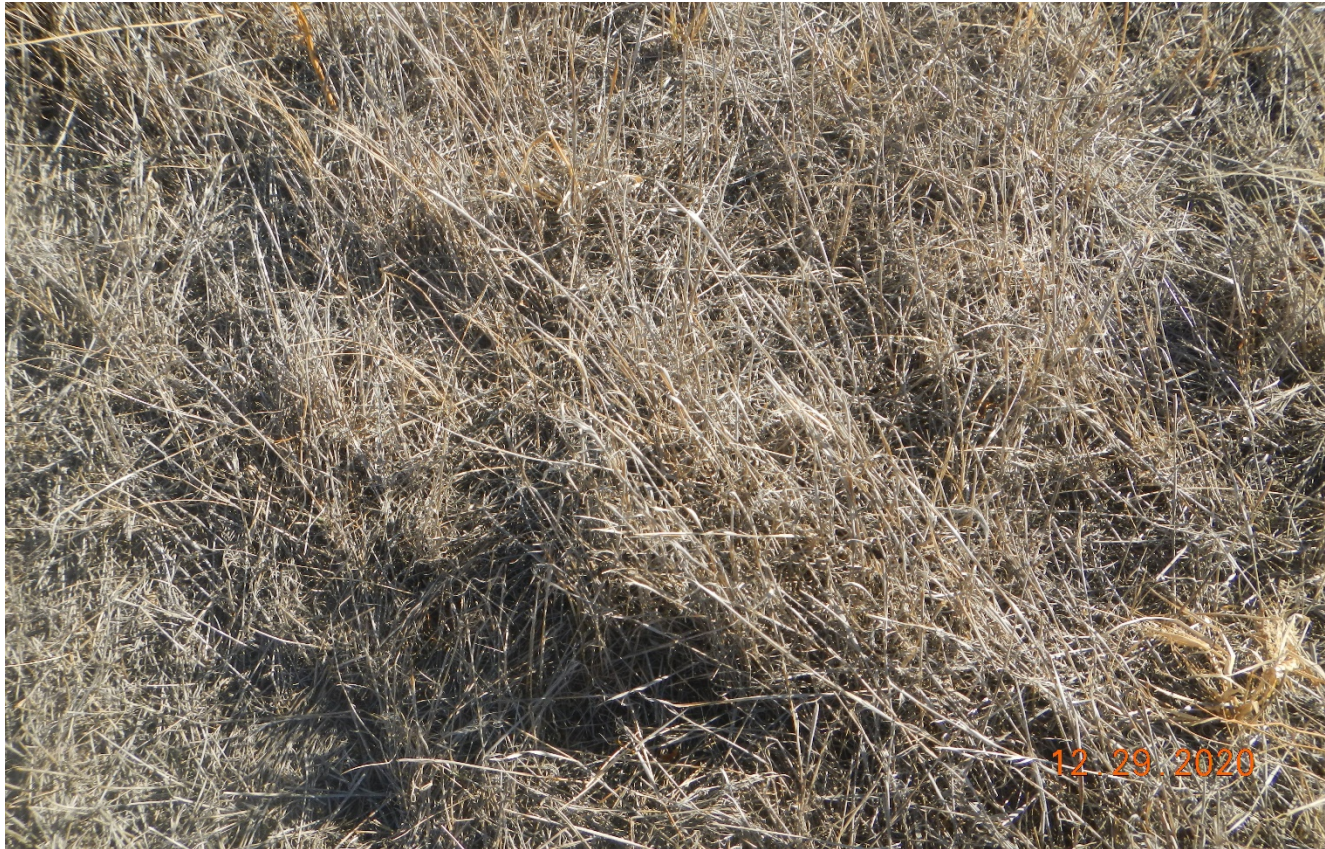
Photo 4. View of groundcover at the location shows desirable vegetation consisting of Sand dropseed, Blue grama, Western wheat grass, among other species.

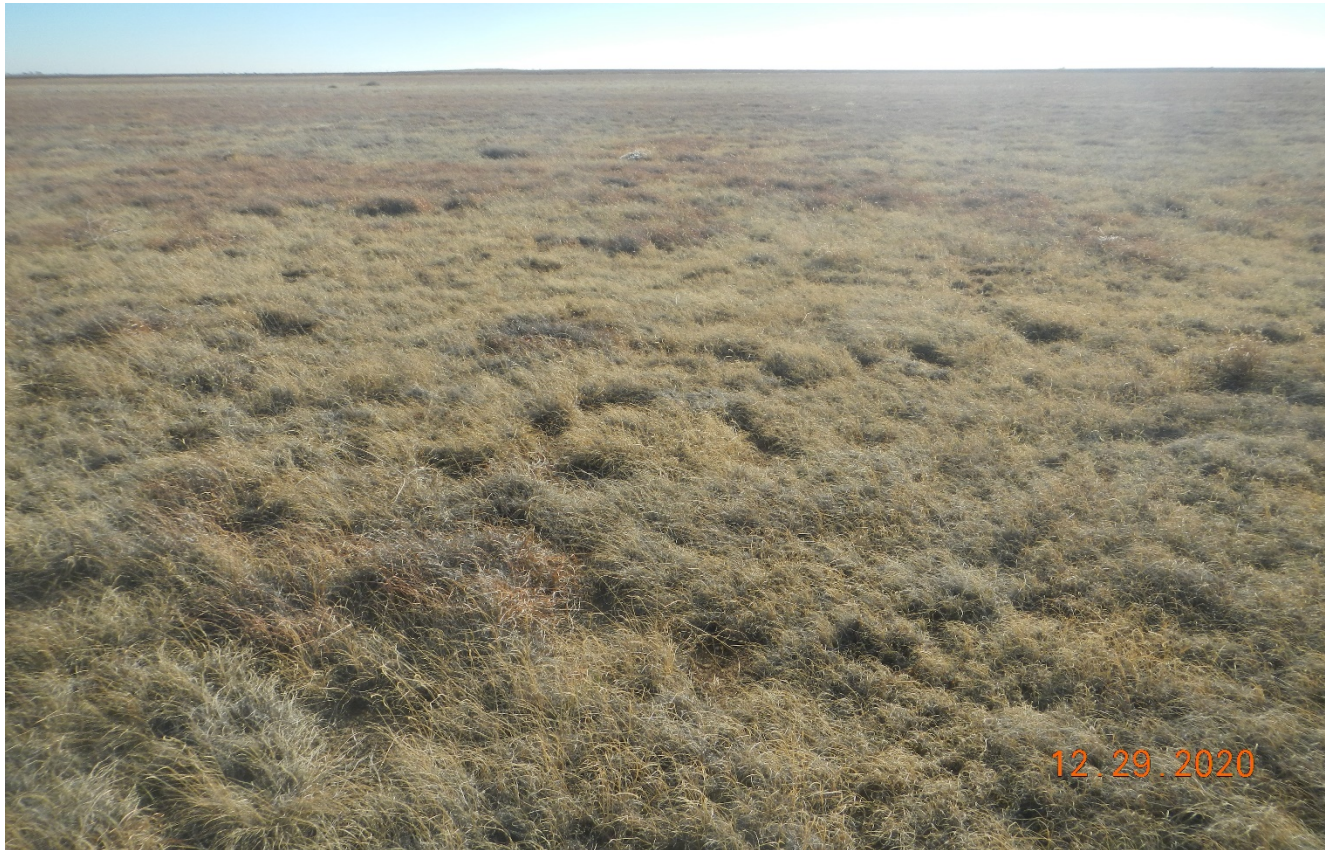
Photo 5. Facing south toward the surrounding undisturbed area.
