Inspection Photos

API: 071-08734

Operator: OGRIS OPERATING LLC

Inspection Date: 1/6/2021

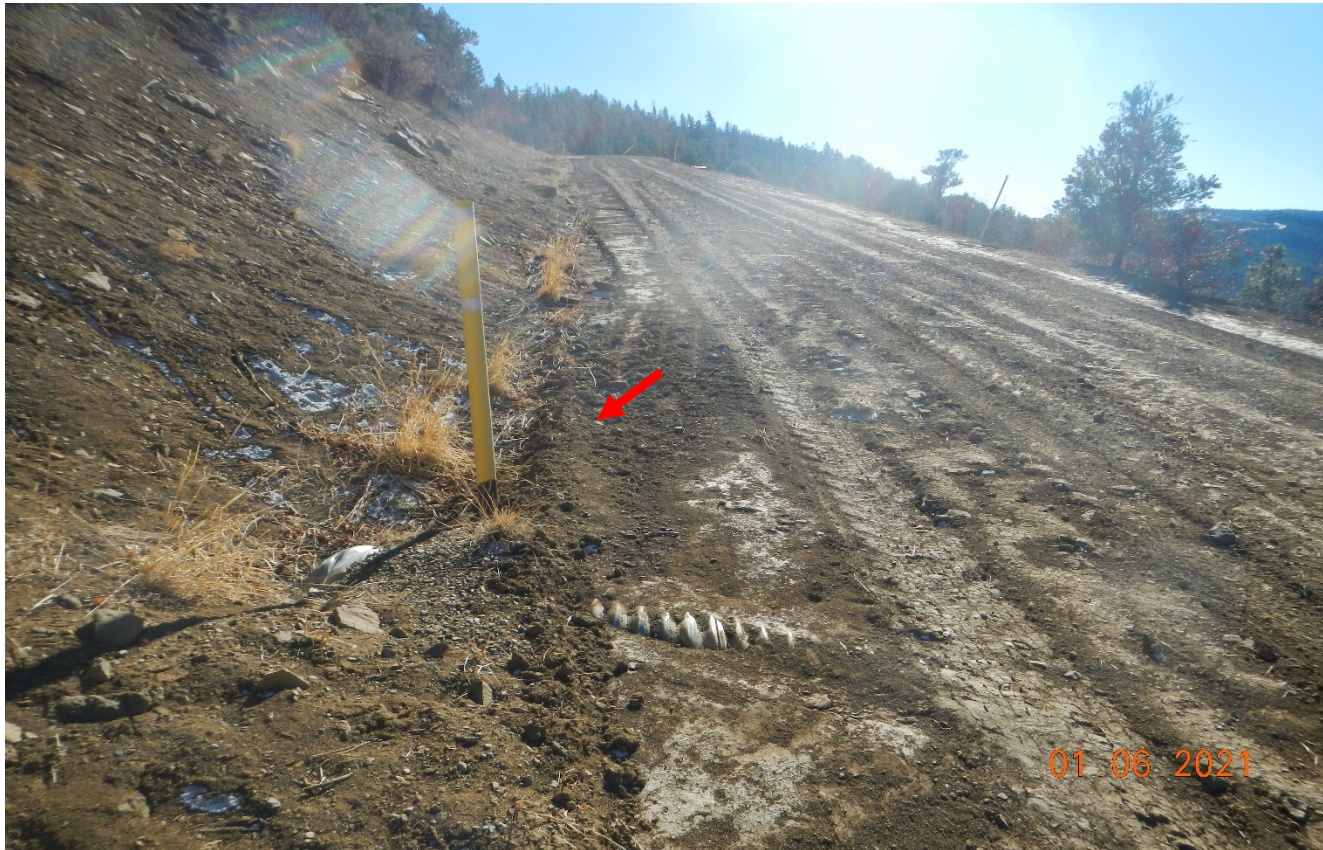
Photo 1. Facing south along the main road ascending the hill side. The road has been regraded. Red arrow points to dirt row which will prevent stormwater flow toward the culvert. Better diversion is needed.

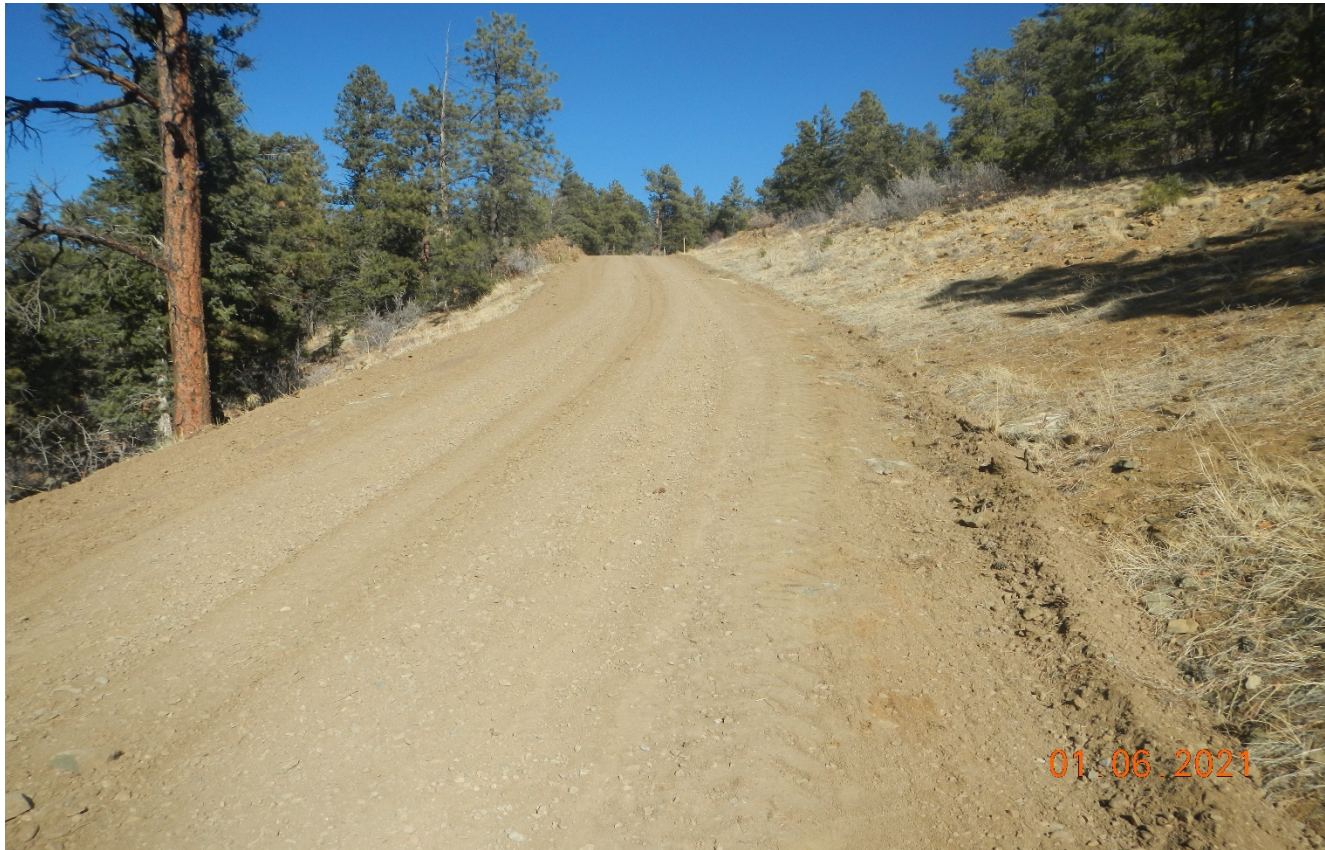
Photo 2. Facing northwest along the road ascending the hill side.

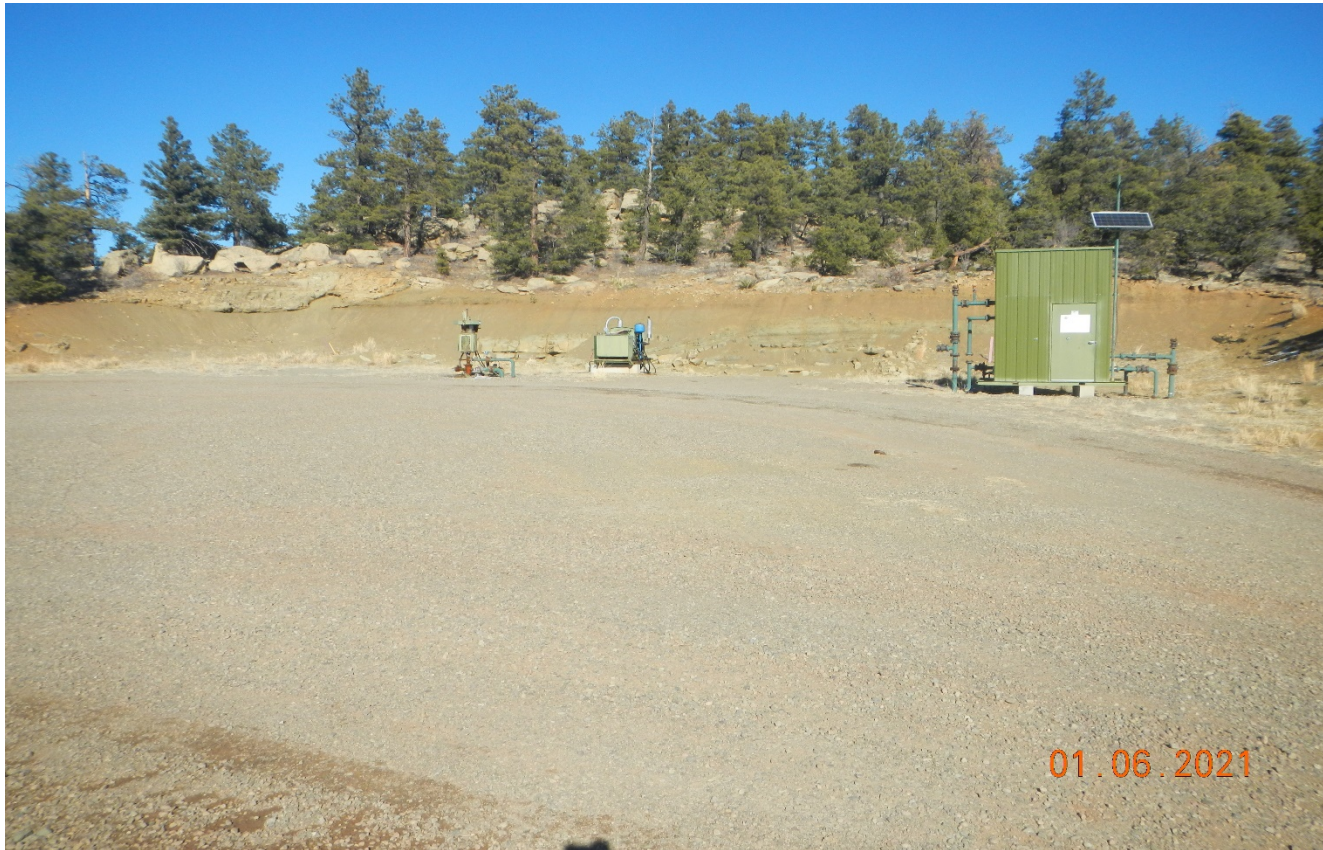
Photo 3. Facing north toward the location.

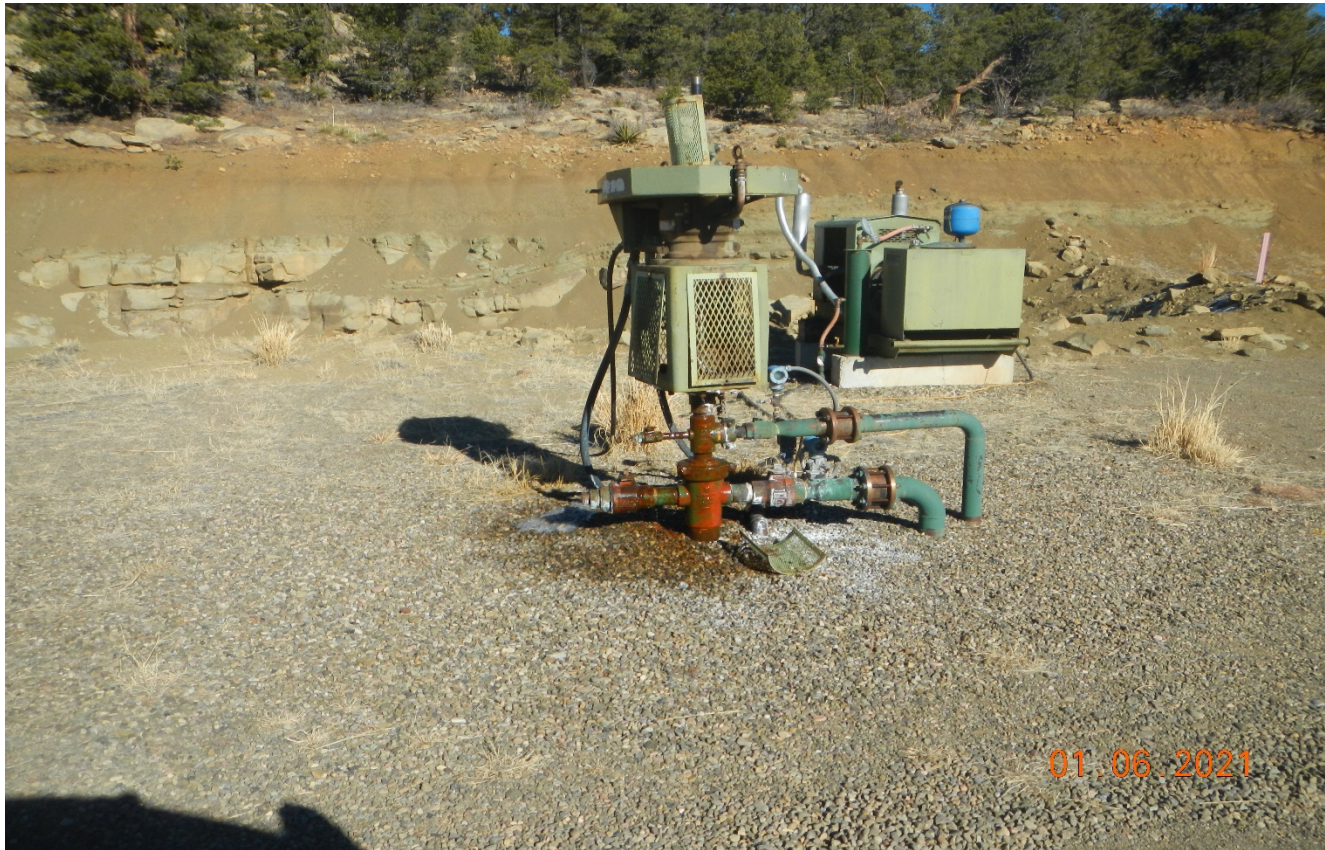
Photo 4. Water is leaking from the wellhead.
