COLORADO
Oil & Gas Conservation
Commission
Department of Natural Resources

Sheridan 11-2

API: 05-103-11920

Inspection: 700404864

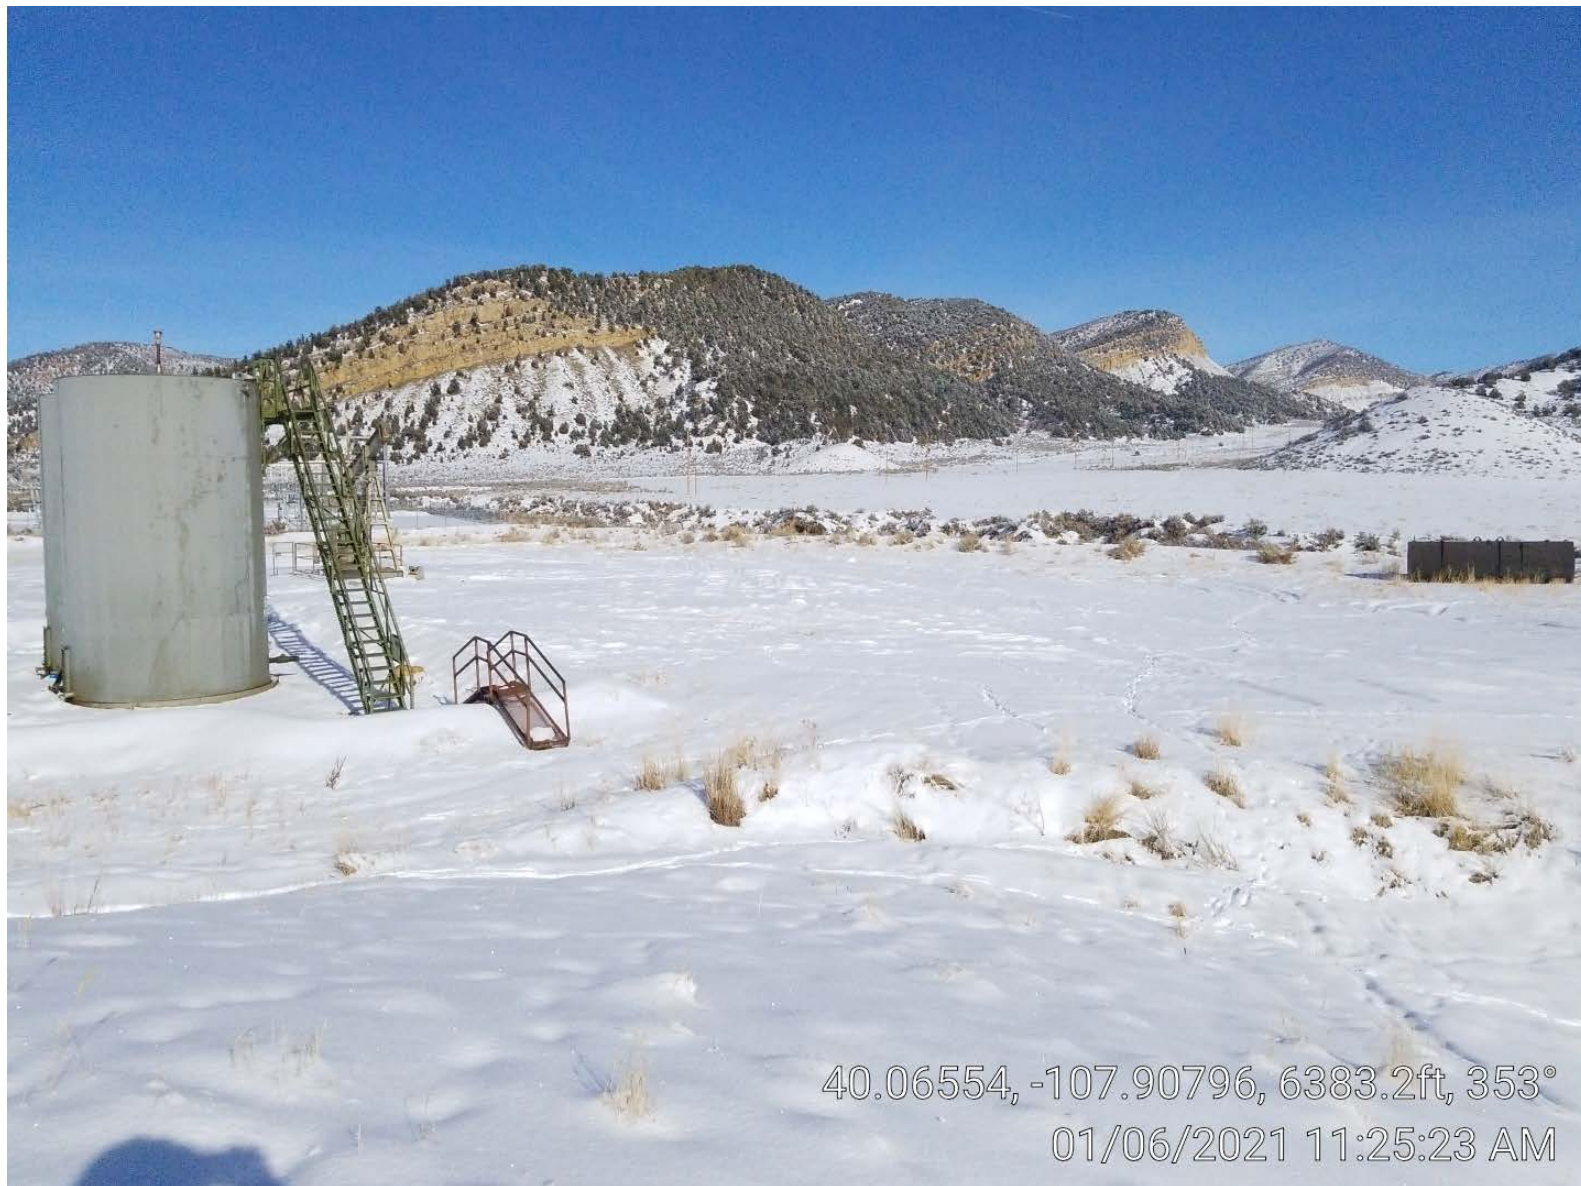
Photo 1. Location.

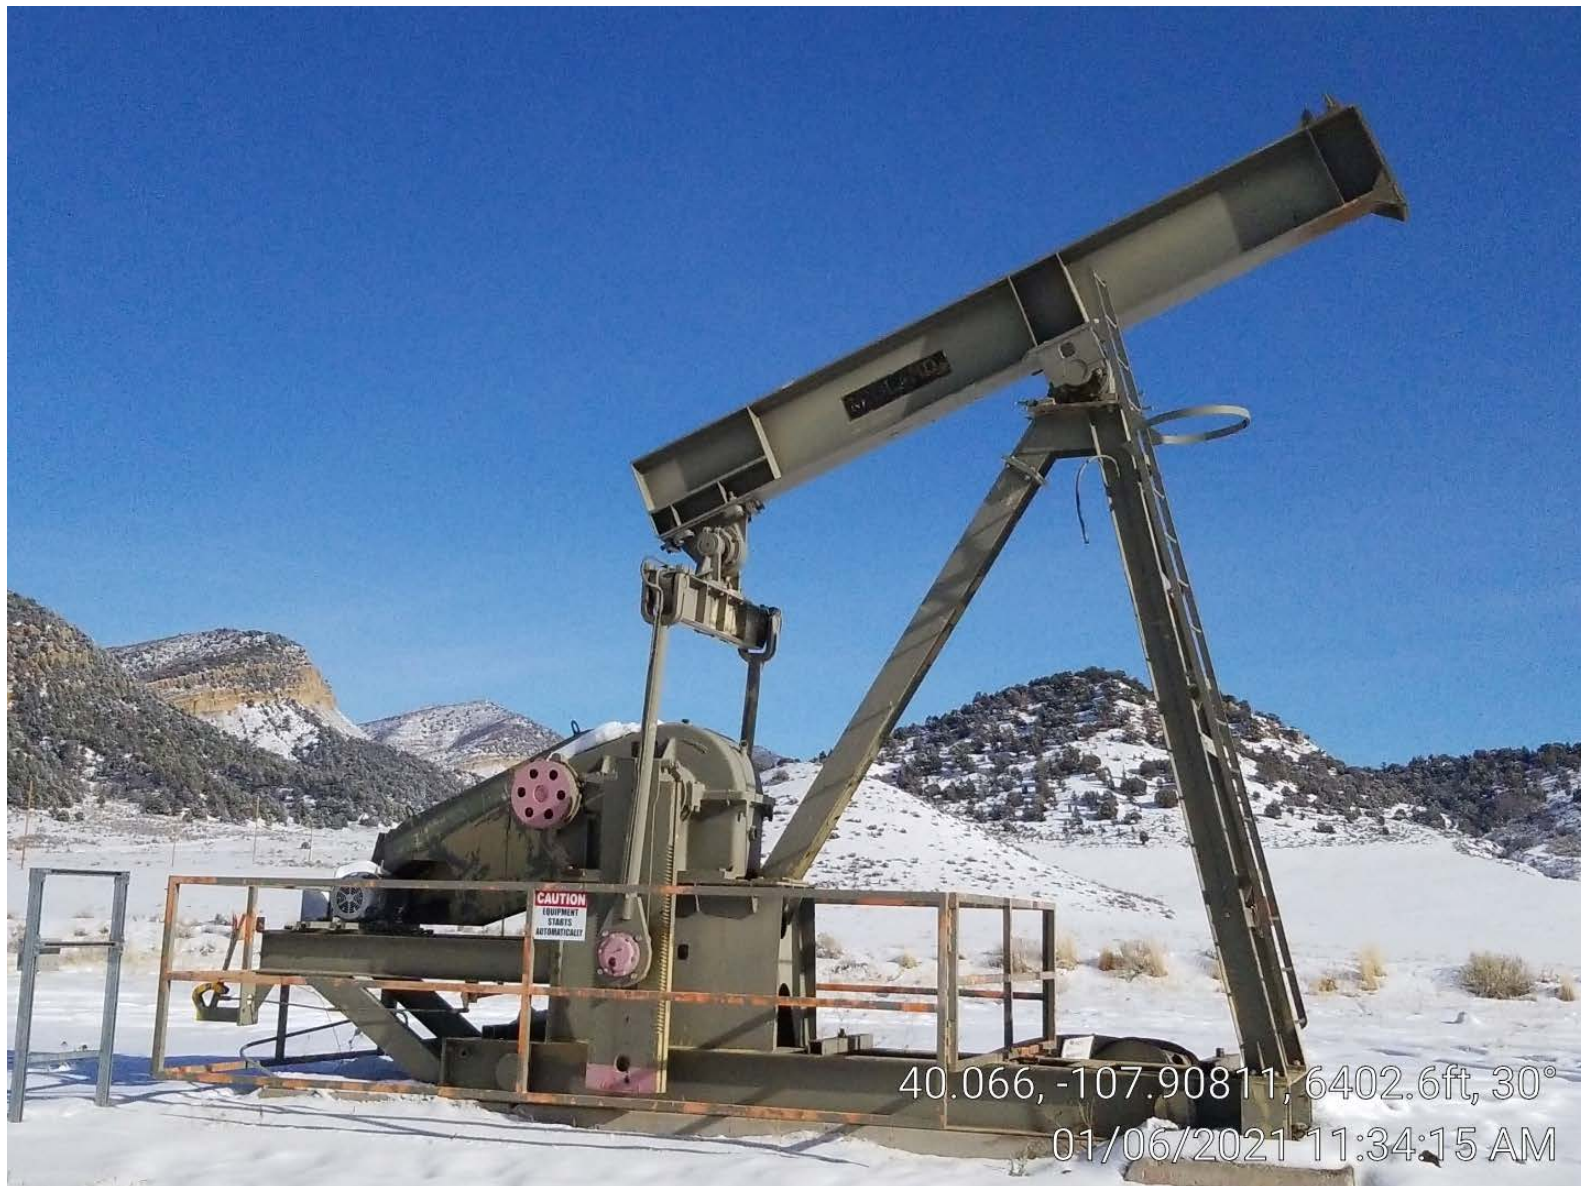
Photo 2. Pump jack.

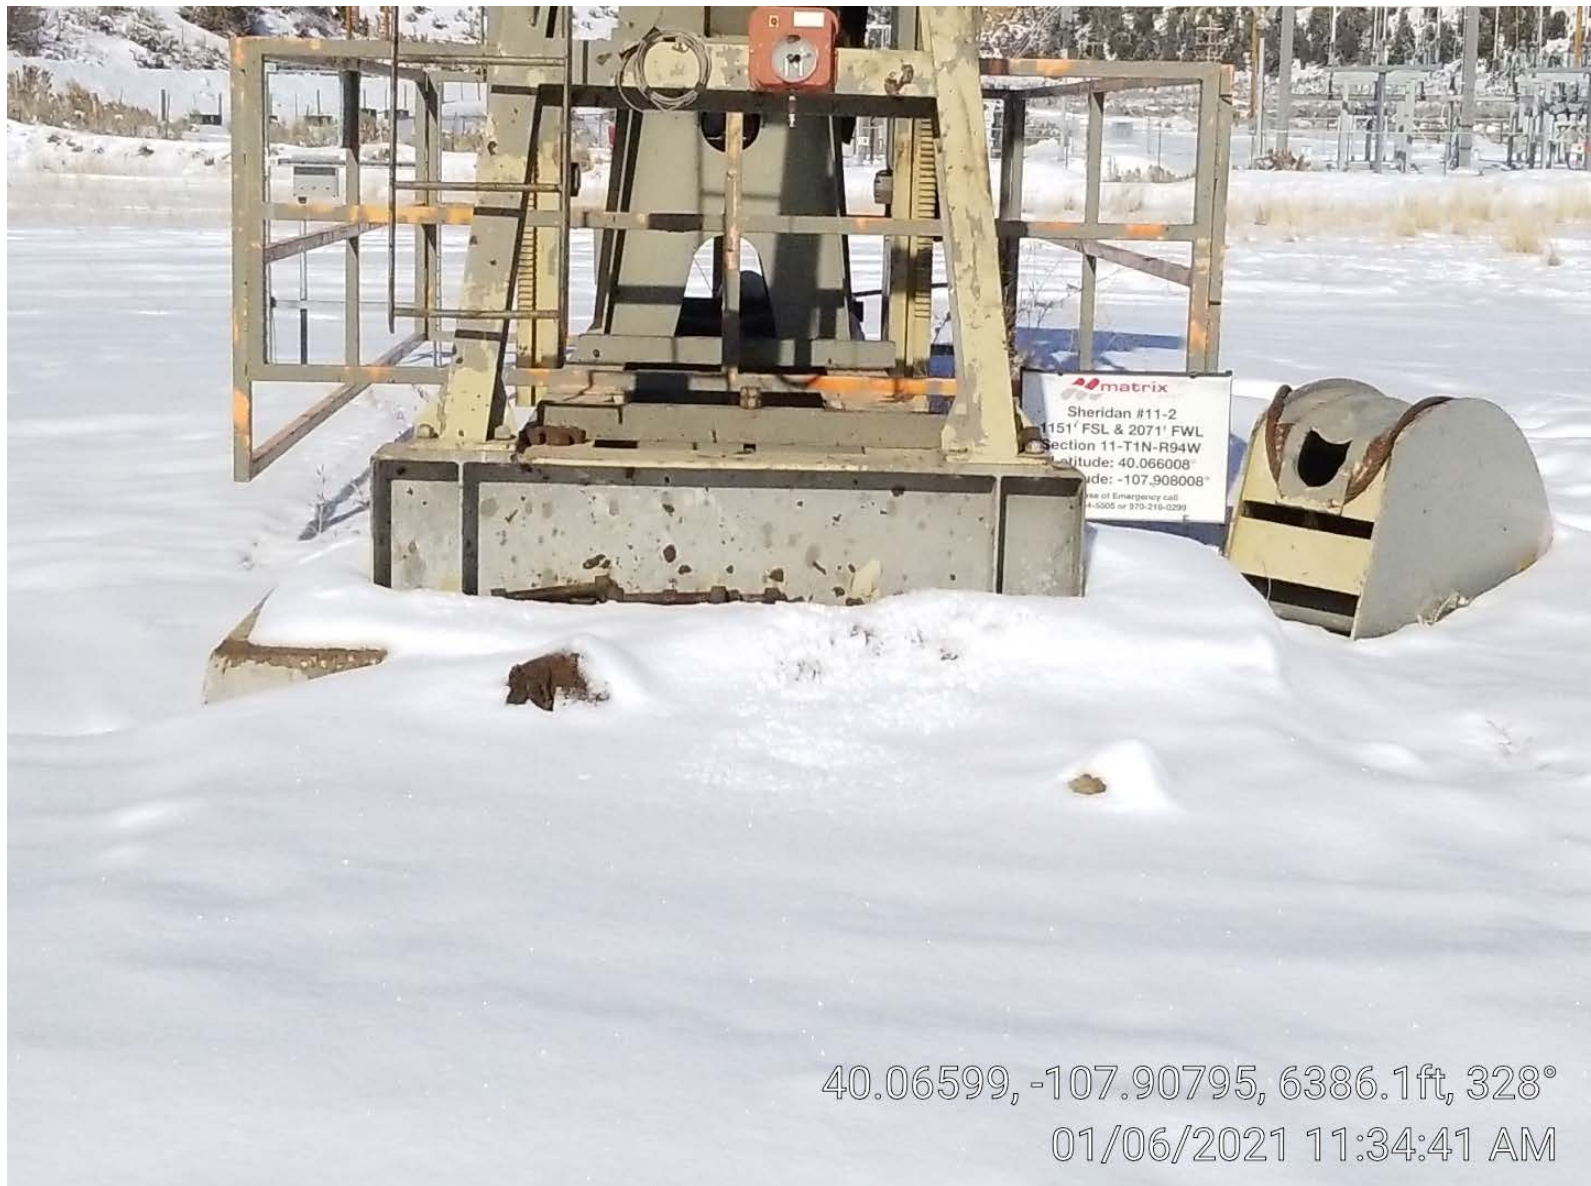
Photo 3. Plugged well.

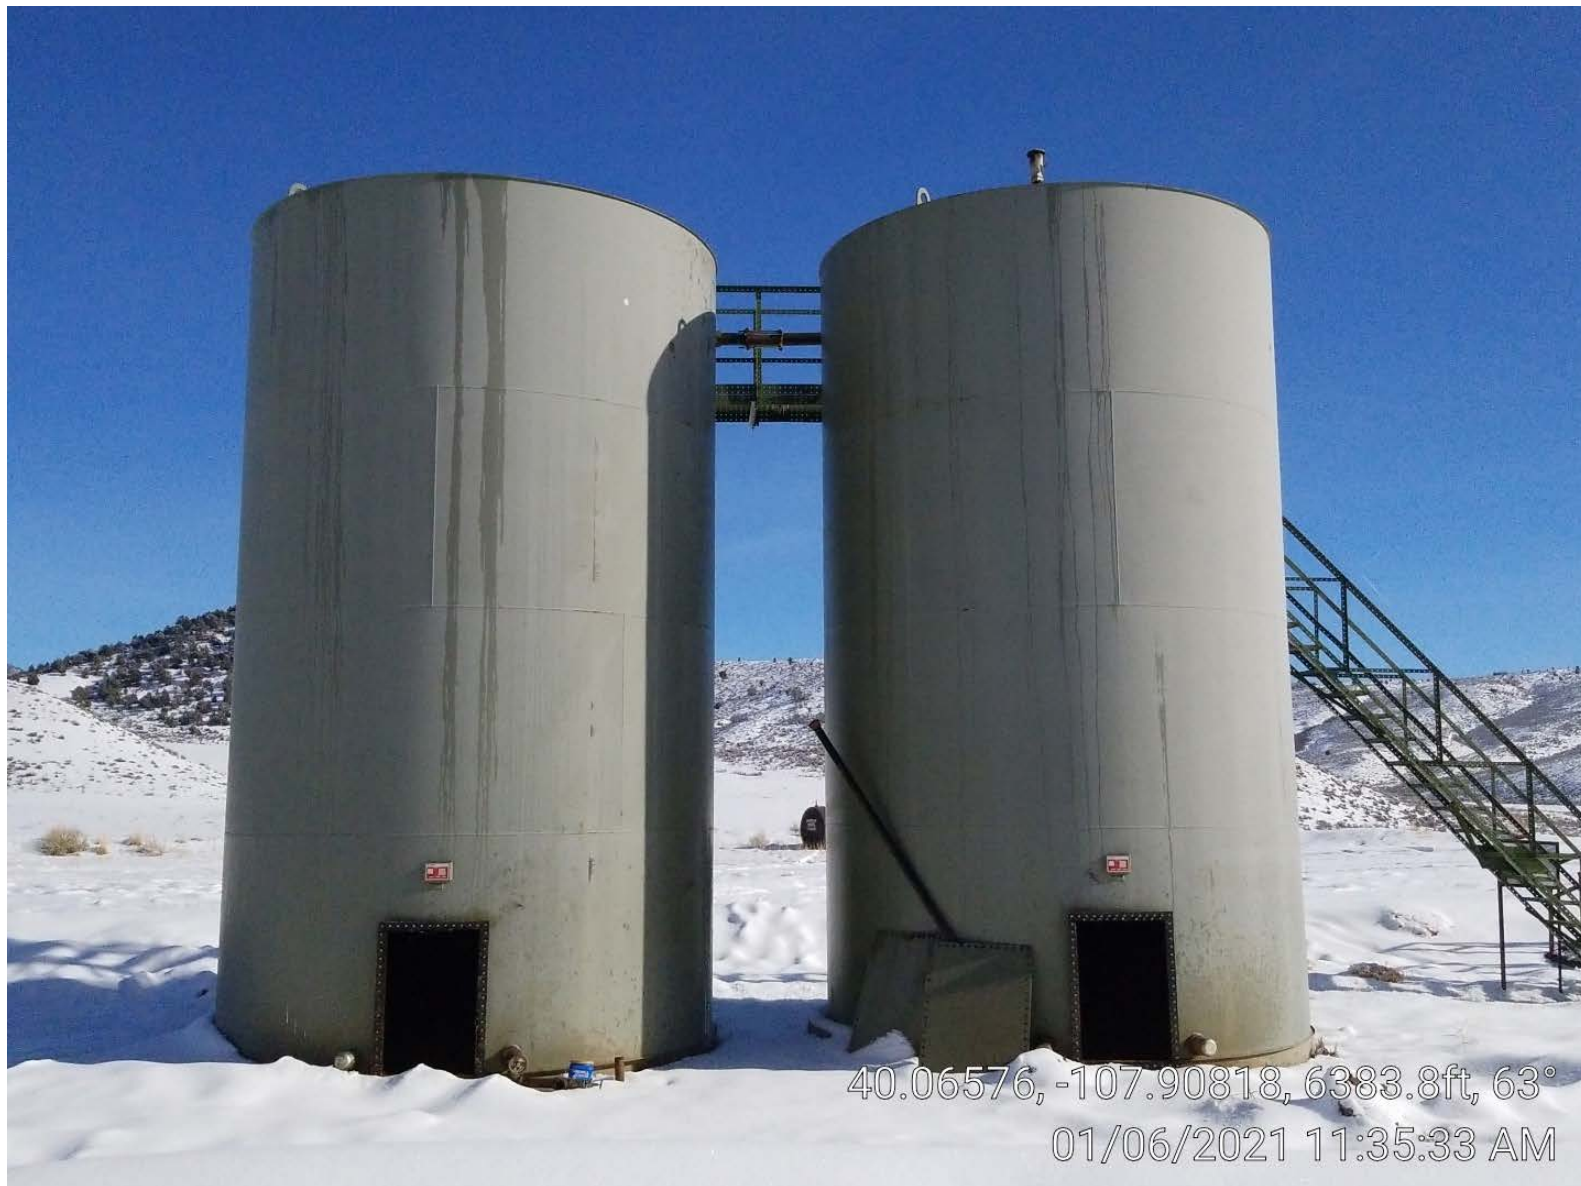
Photo 7. Tanks.

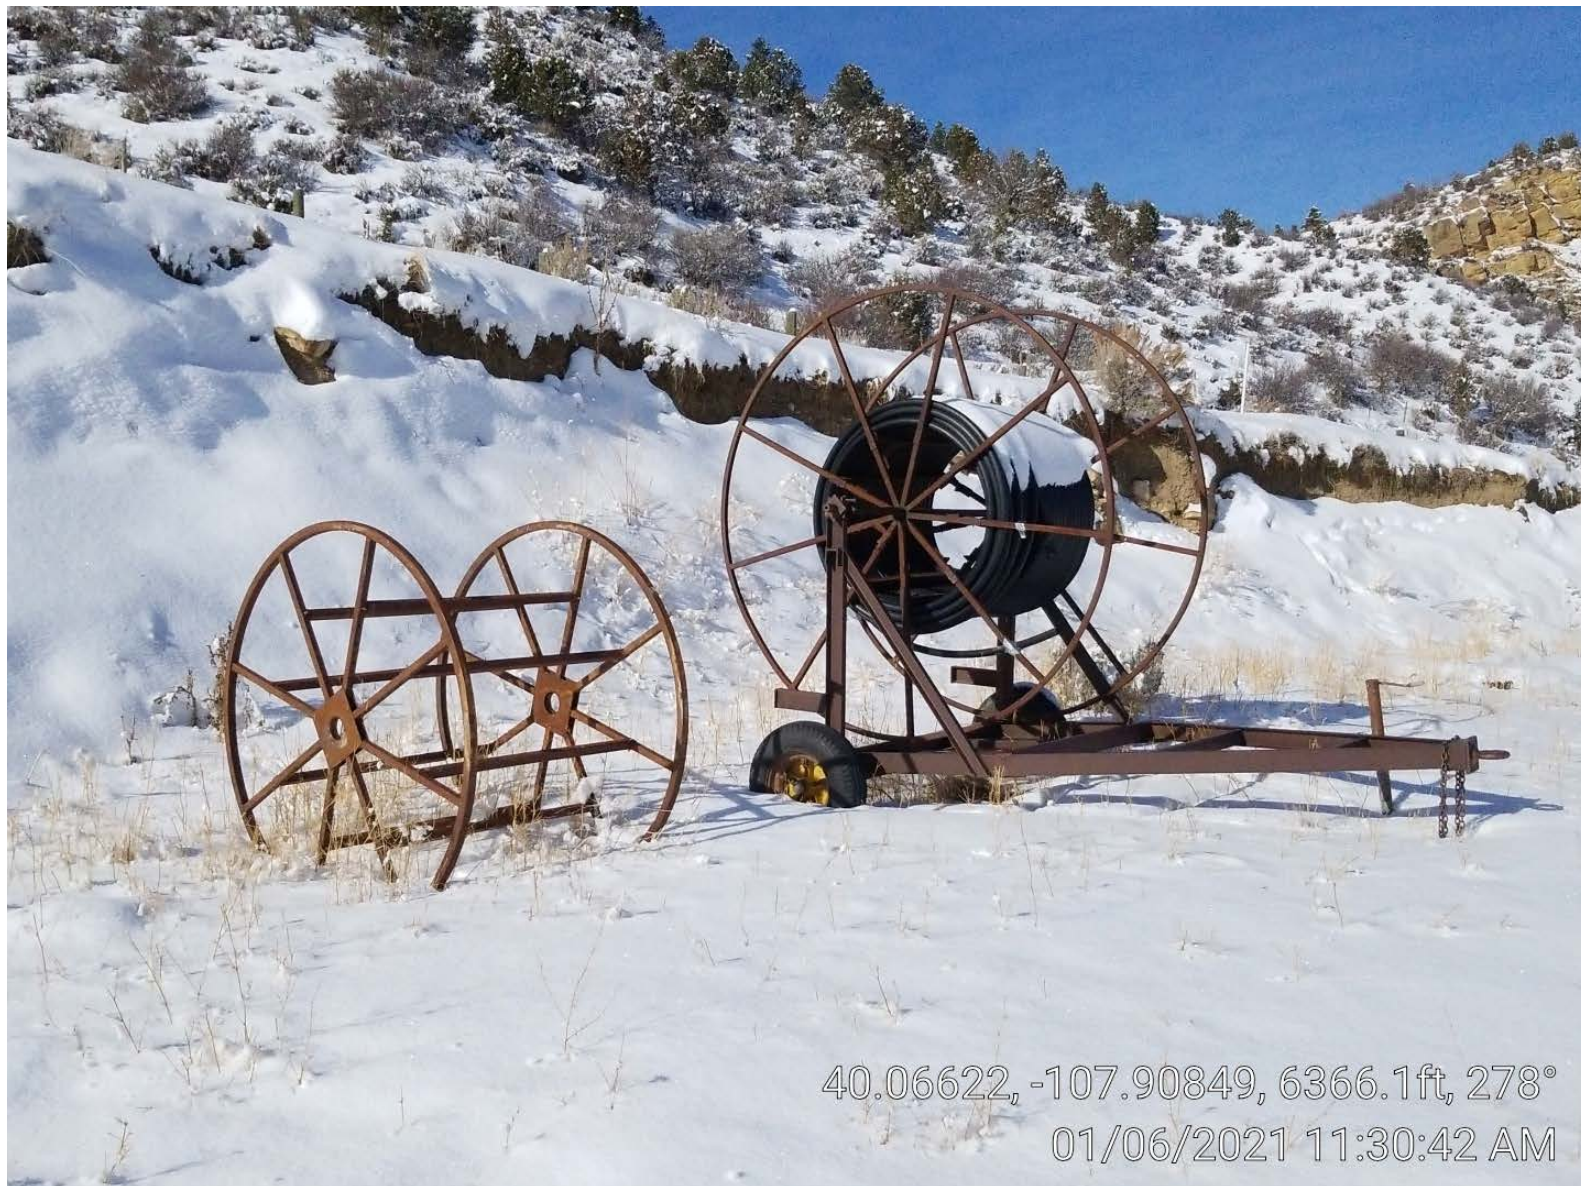
Photo 8. Pipe or cable reels.

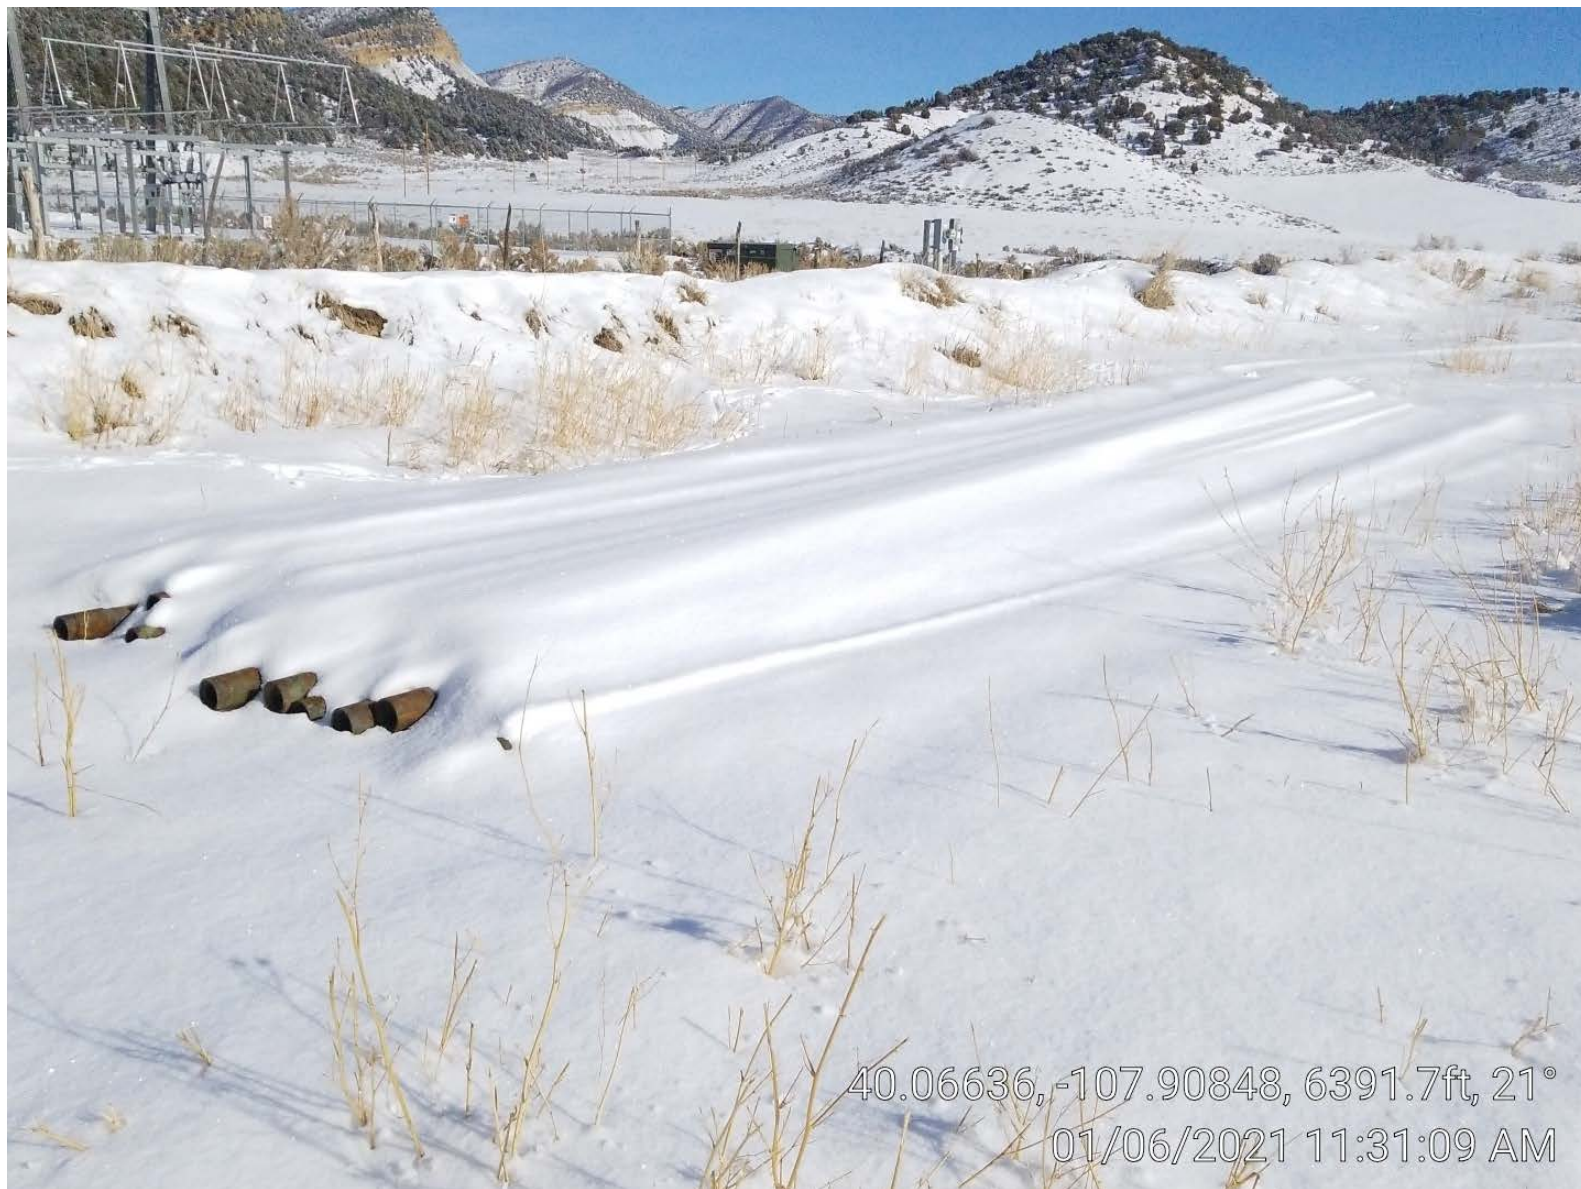
Photo 9. Tubing.
