Inspection Photos

API: 071-07680

Operator: OGRIS OPERATING LLC

Inspection Date: 1/6/2021

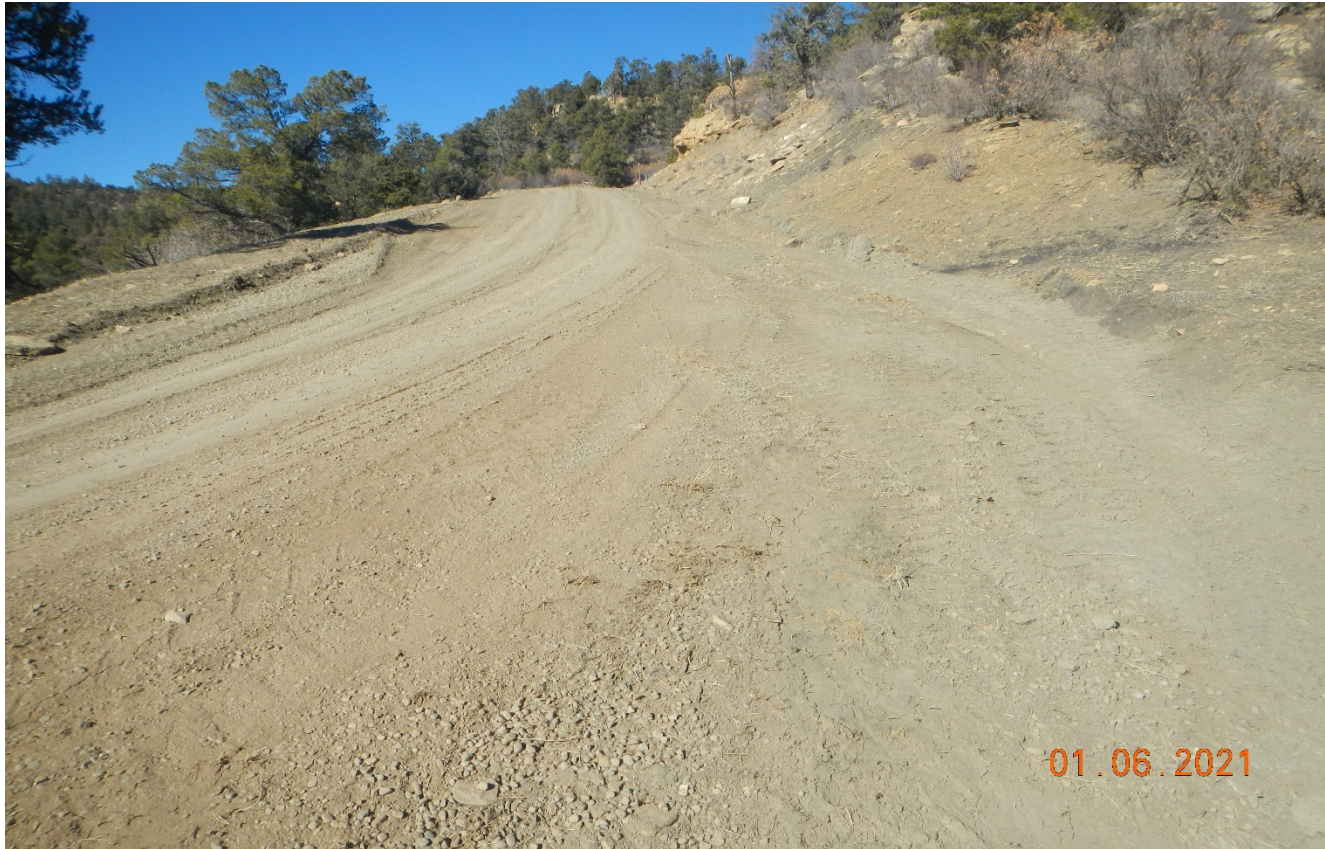
Photo 1. Facing northwest toward the access road. The erosion along the road has been repaired. Additional stabilization should be performed to prevent erosion.

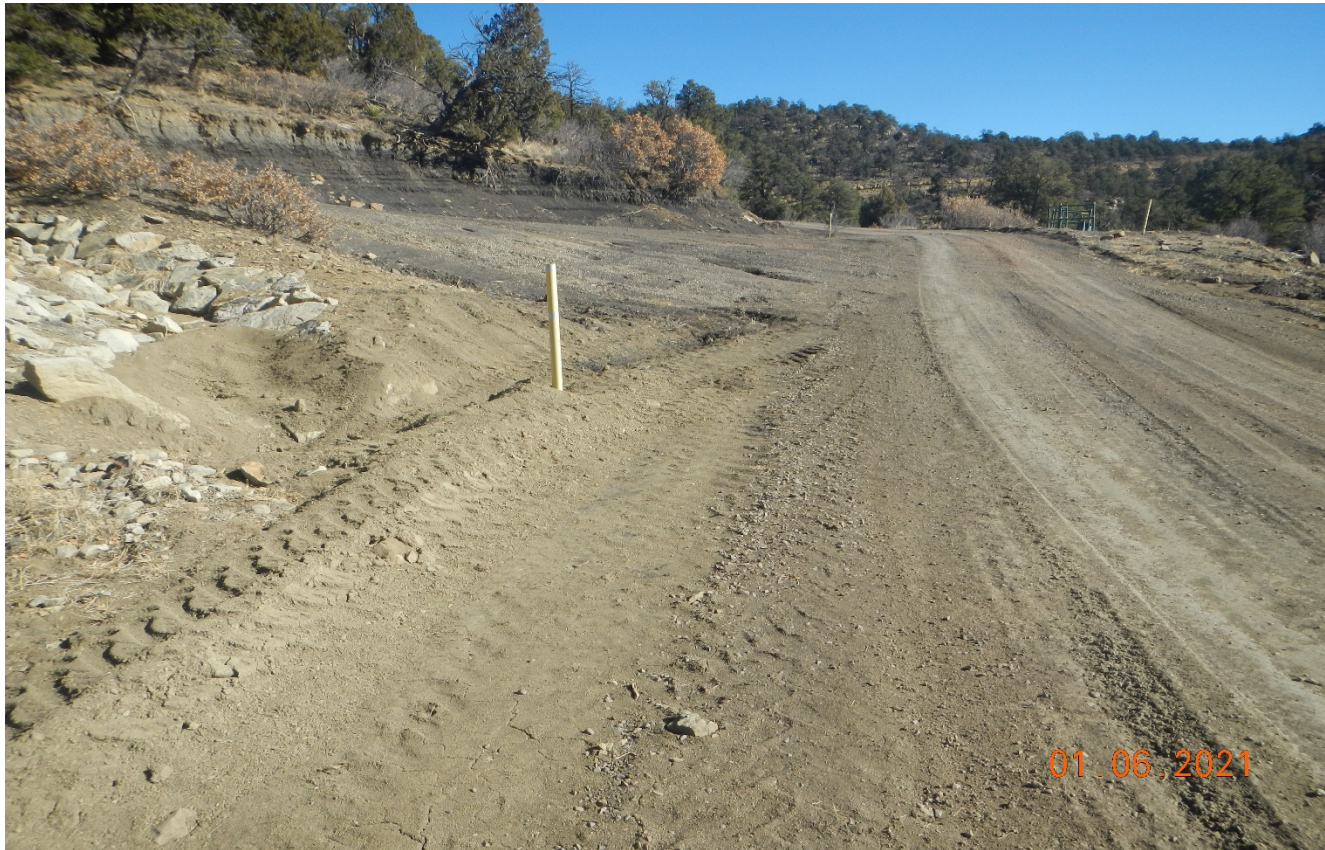
Photo 2. The culvert along the access road has been cleaned out and maintained.

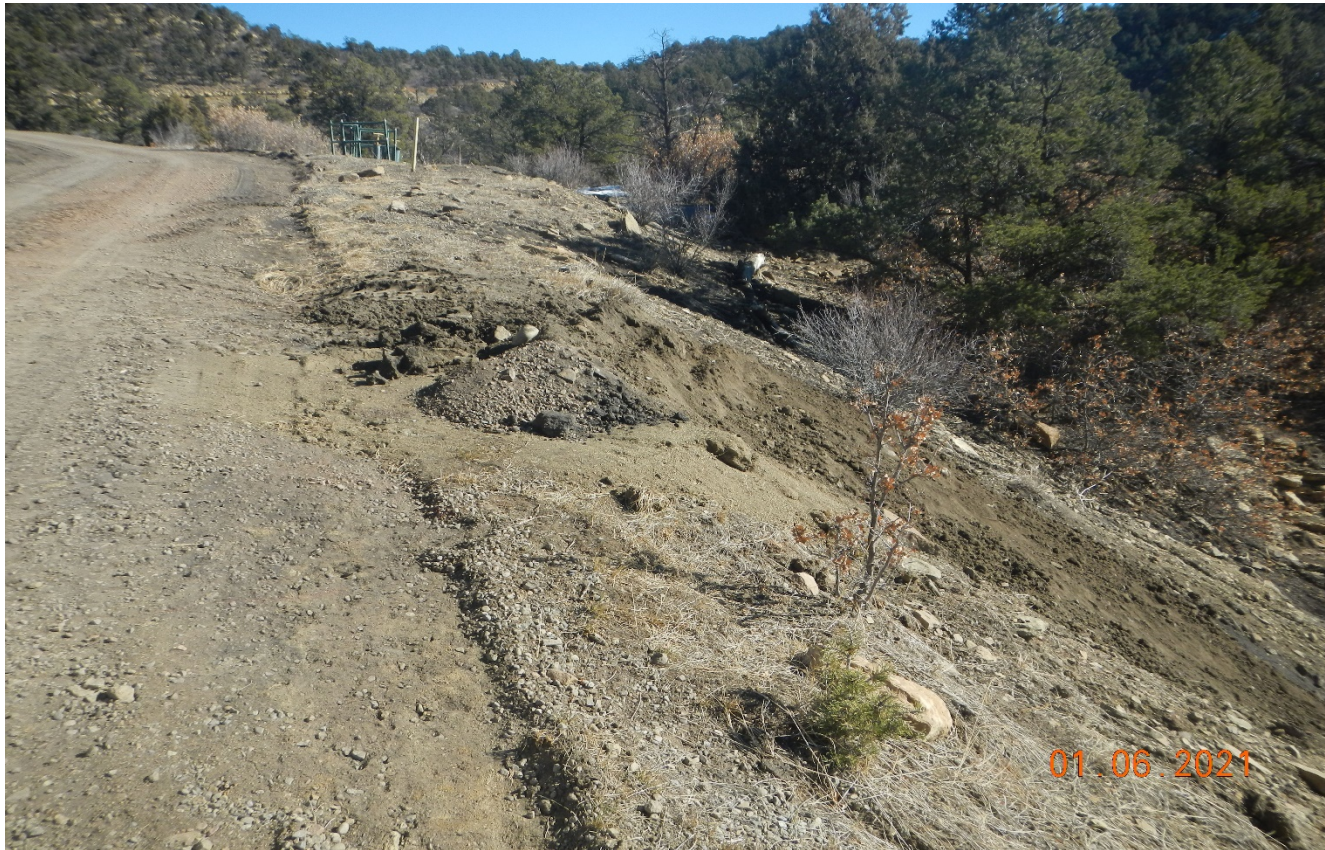
Photo 3. The erosion off the fill slope of the road has been filled in. This area will need to be seeded and stabilized.

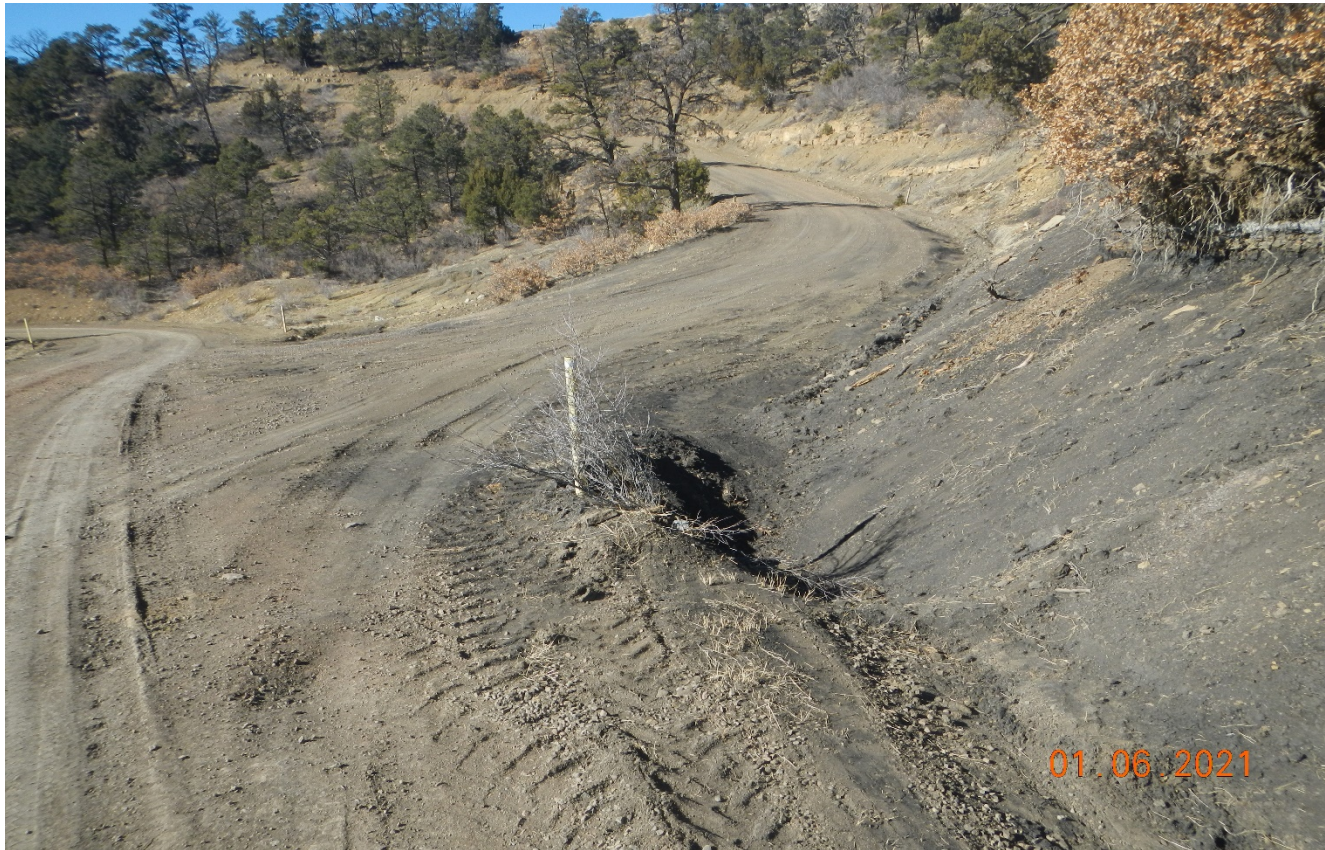
Photo 4. Facing northeast toward the access road. Stormwater The culvert has been cleaned out and diversion toward the culvert repaired.

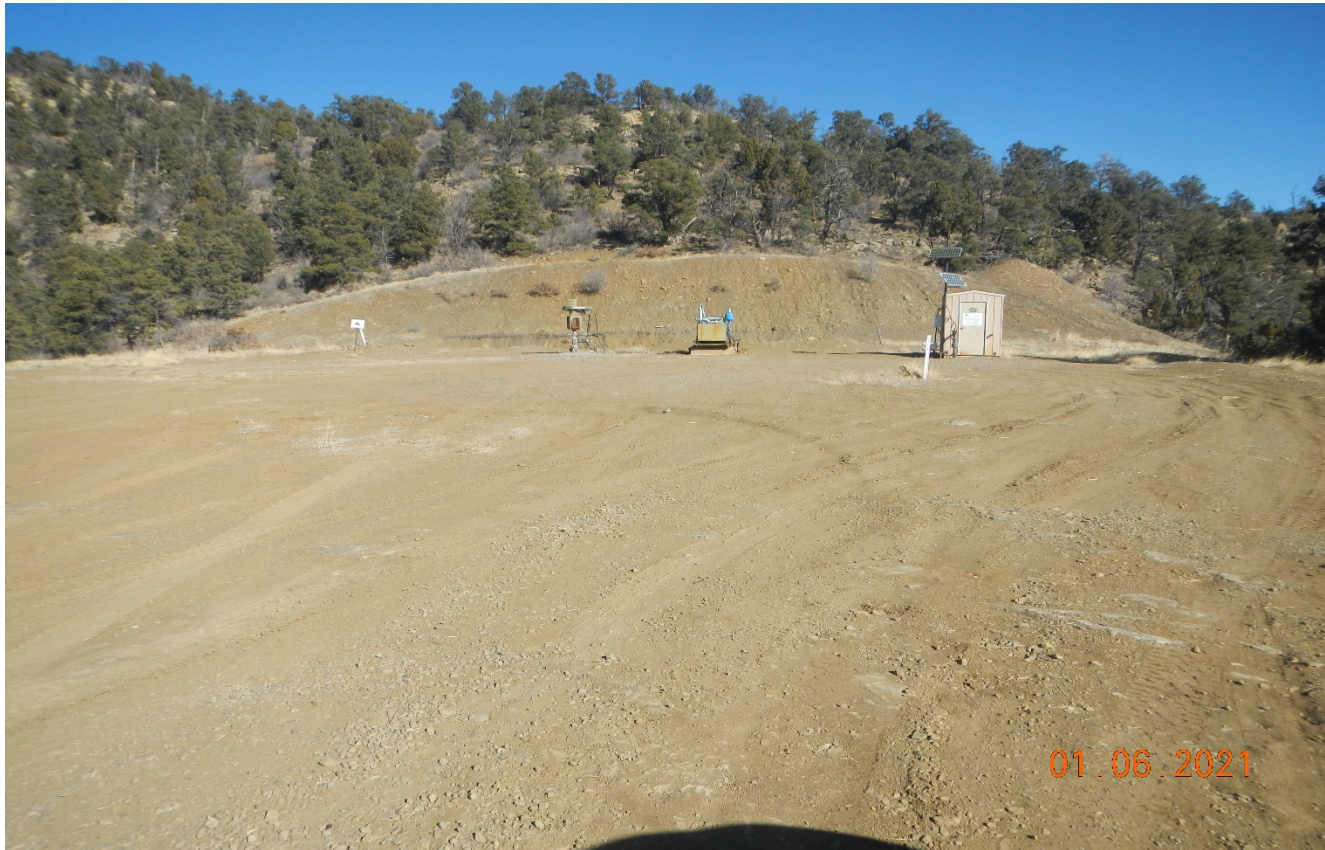
Photo 5. Facing northeast toward the location.
