Inspection Photos

1/04/2021

Operator: TEP ROCKY MOUNTAIN LLC - 96850

Location ID: 475753

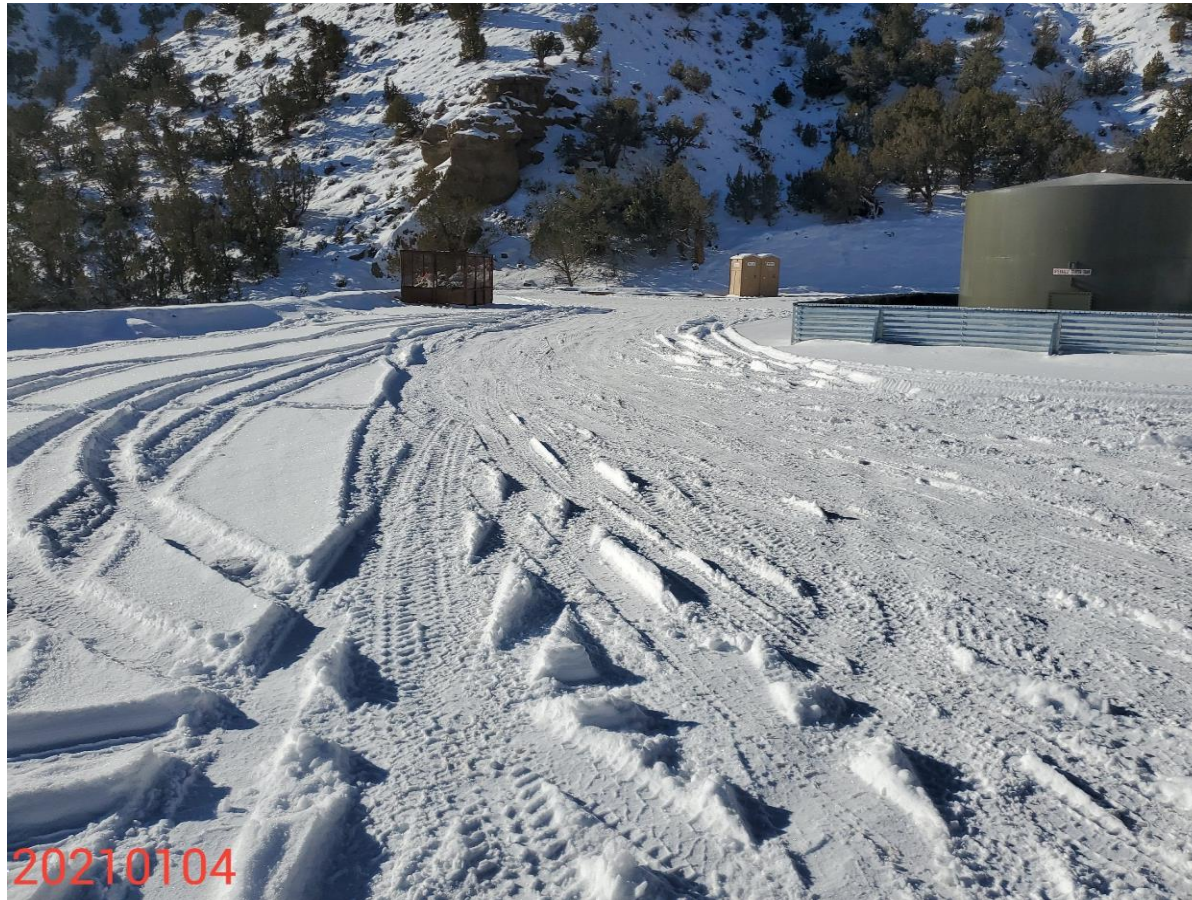
Photo 1: Photo taken from the southeast corner of the Pad, facing west. Photo 1-3 provide an overview of the Location from west, northwest to north.

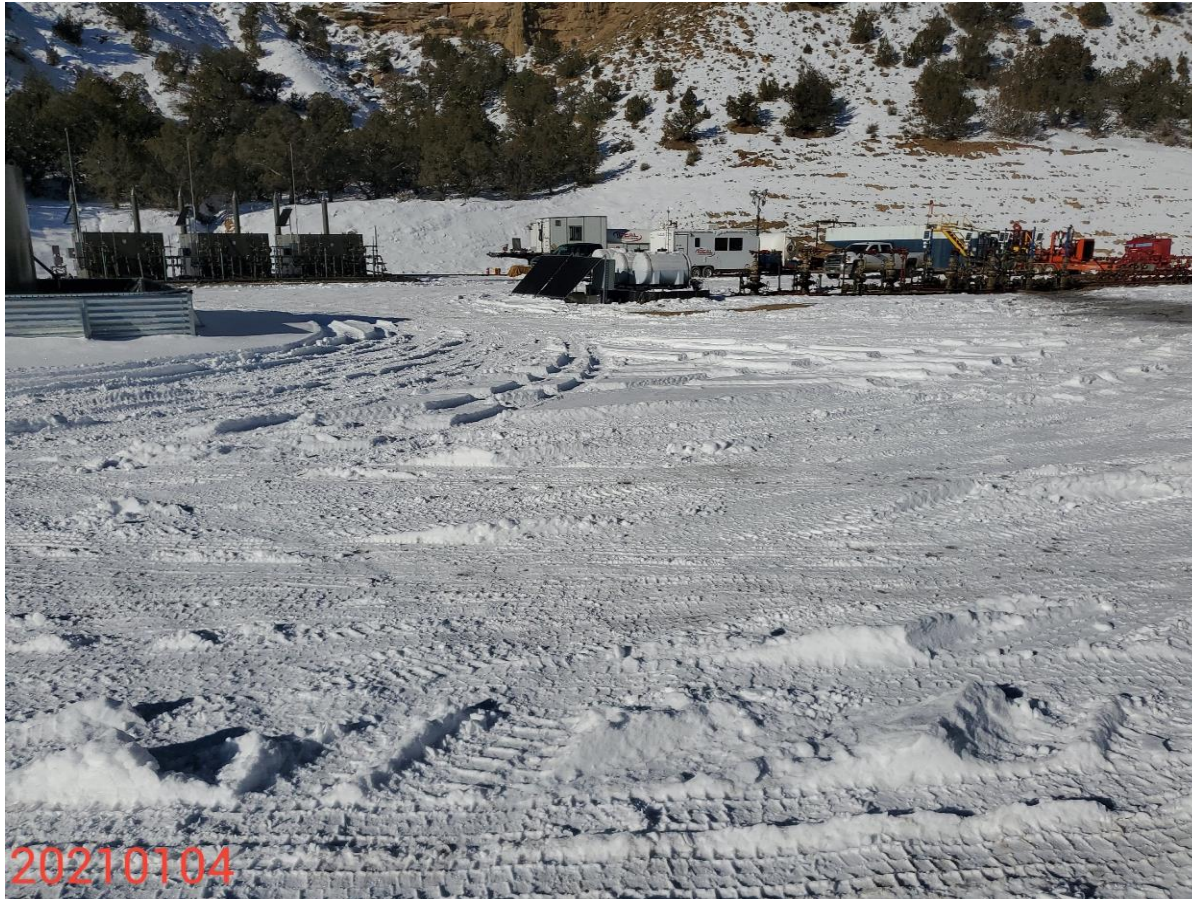
Photo 2: See comments under photo 1.

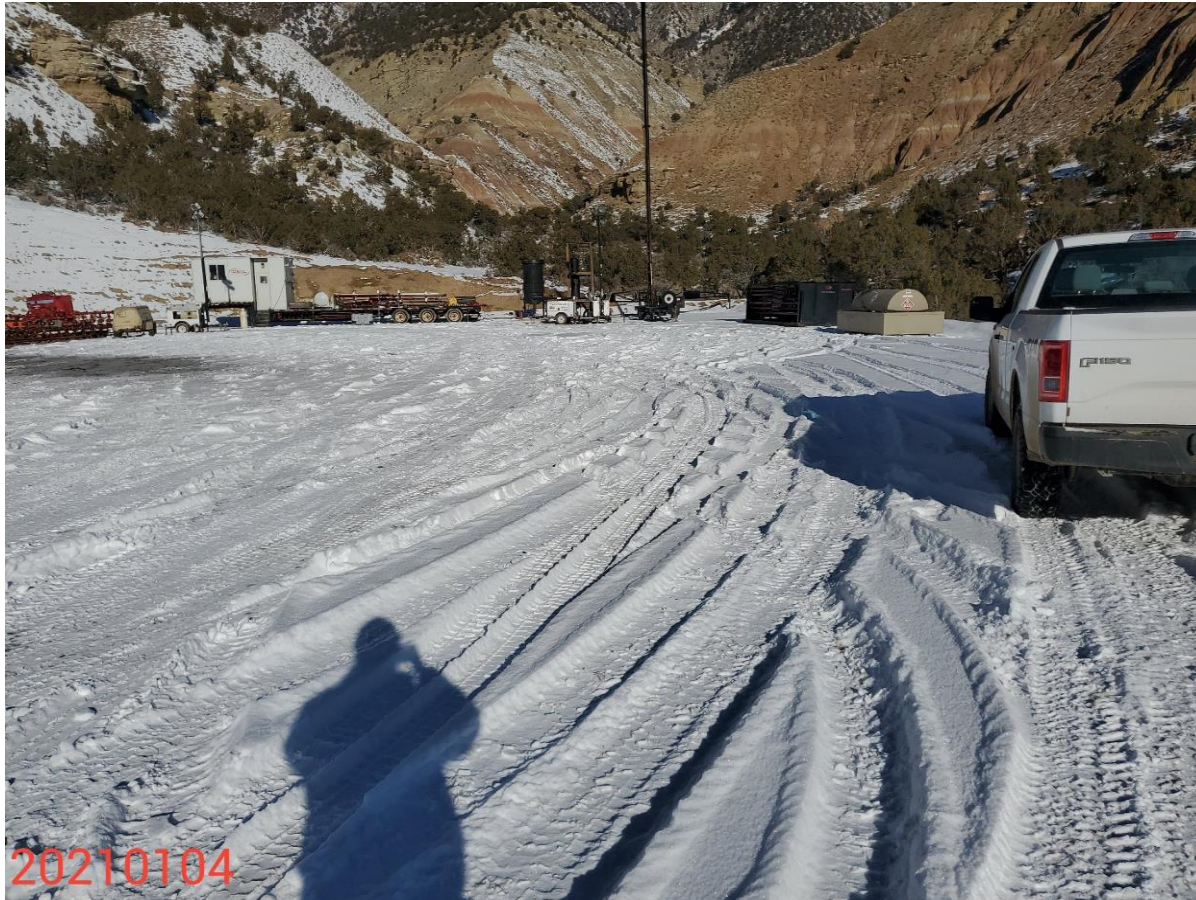
Photo 3: See comments under photo 1.

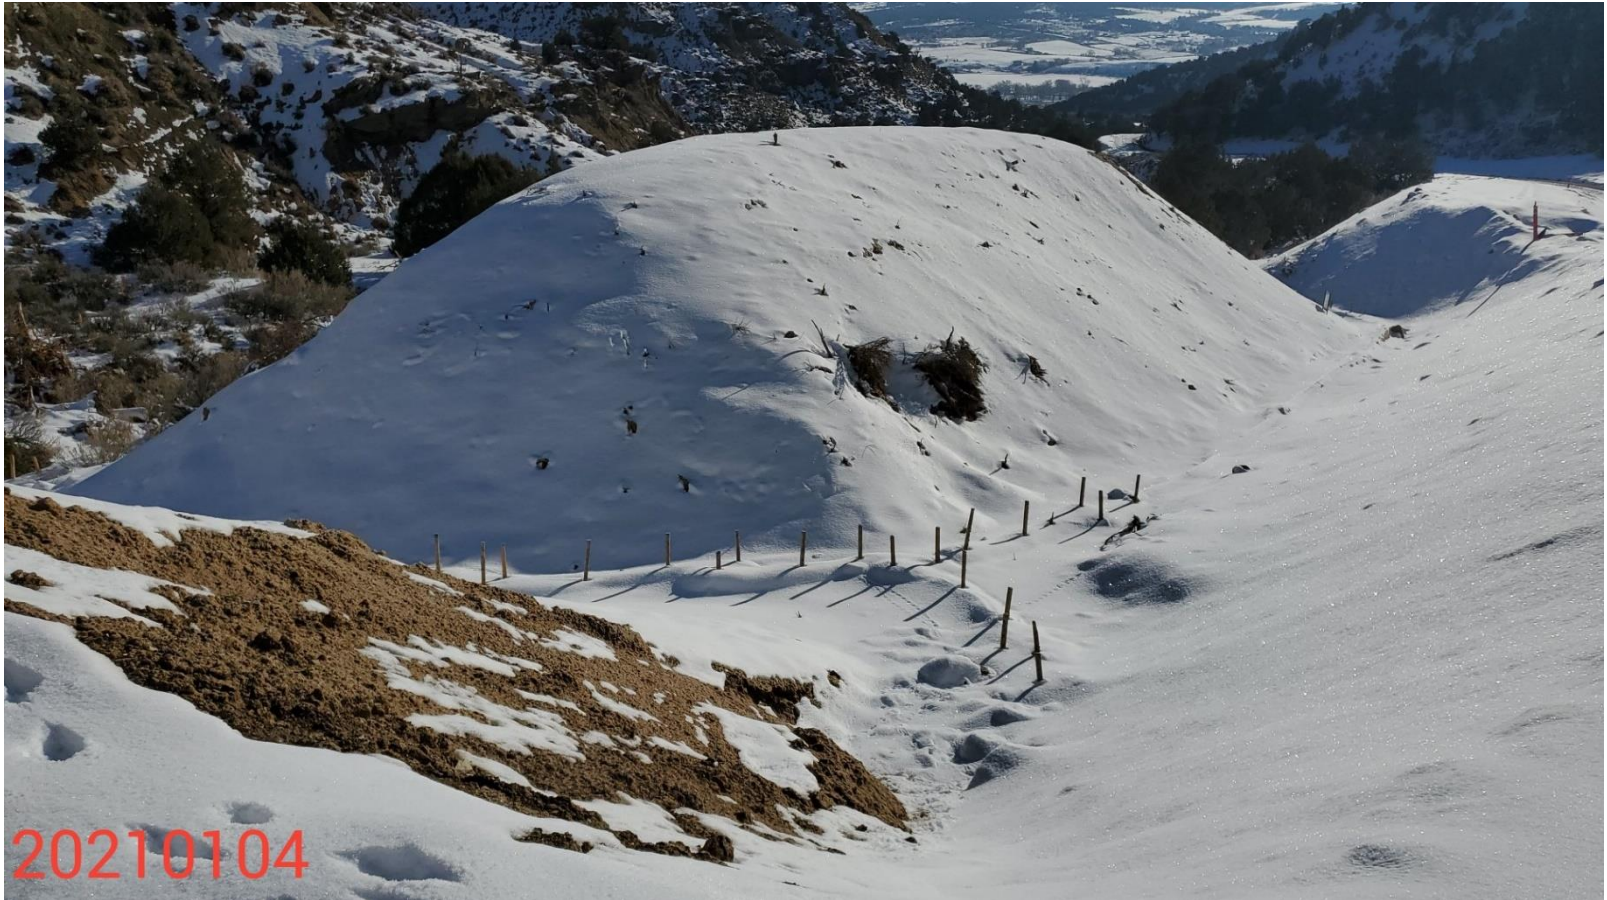
Photo 4: Photo taken from the south end of the Location, facing south. Photo shows topsoil stockpile. Hydromulch observed on soils not covered with snow.

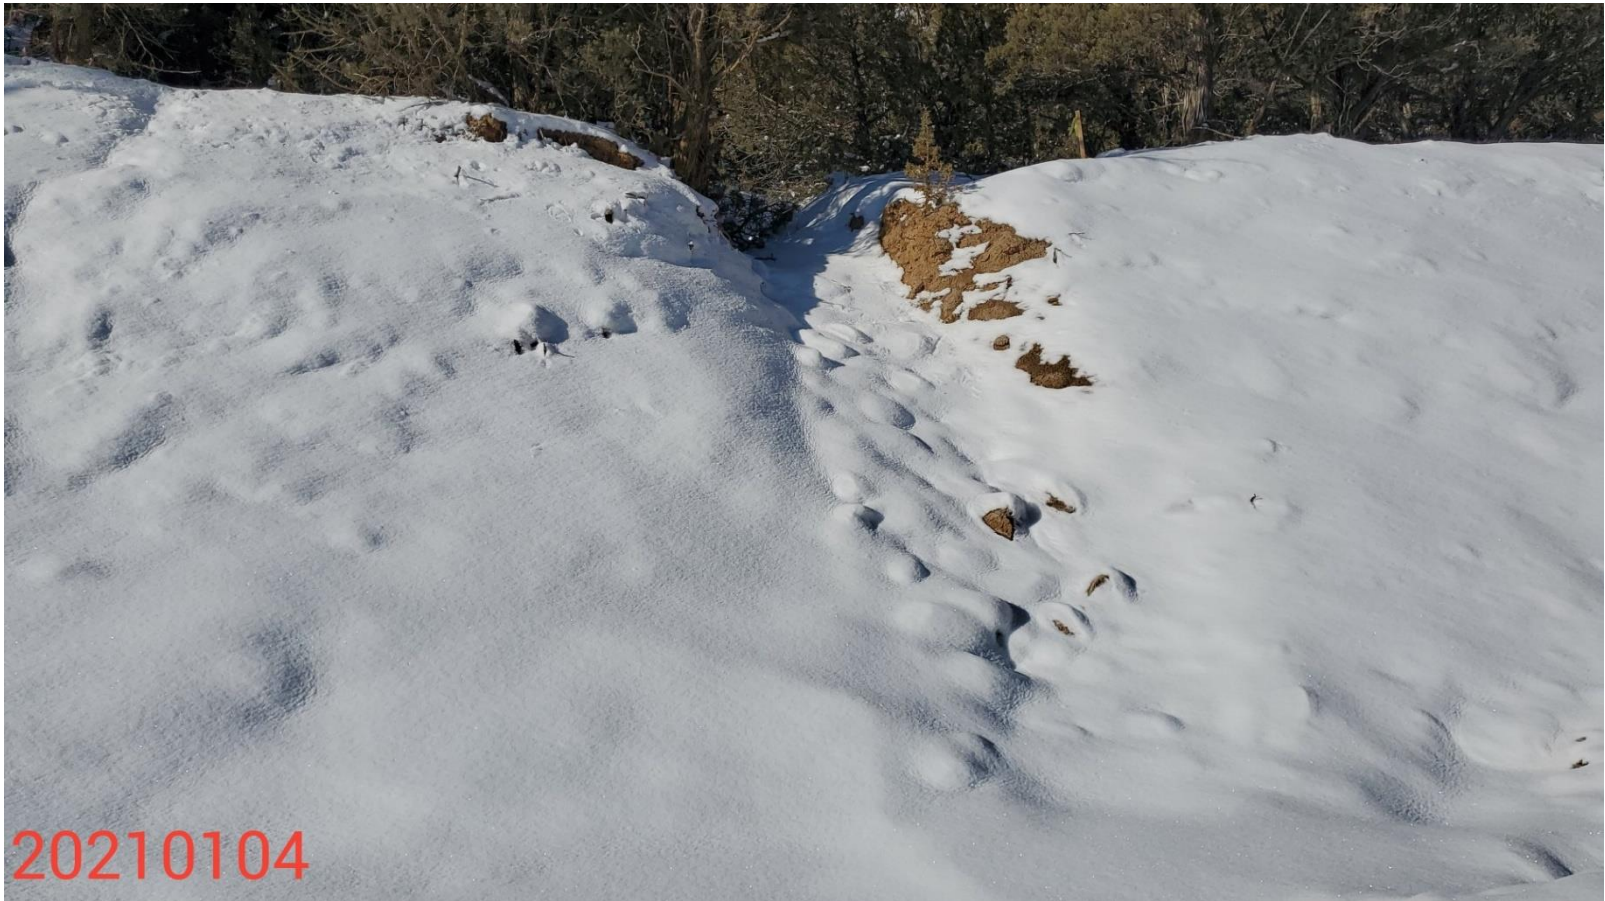
Photo 5: Photo taken from the cuts lope on the west end of the Location, facing west. Photo shows areas where erosion degradation previously documented; Due to snow cover, inspector was unable to accurately assess if BMPs have been installed in accordance with good engineering practices, are sufficient for the sites conditions and maintained in proper functioning condition. A followup inspection will need to be conducted.

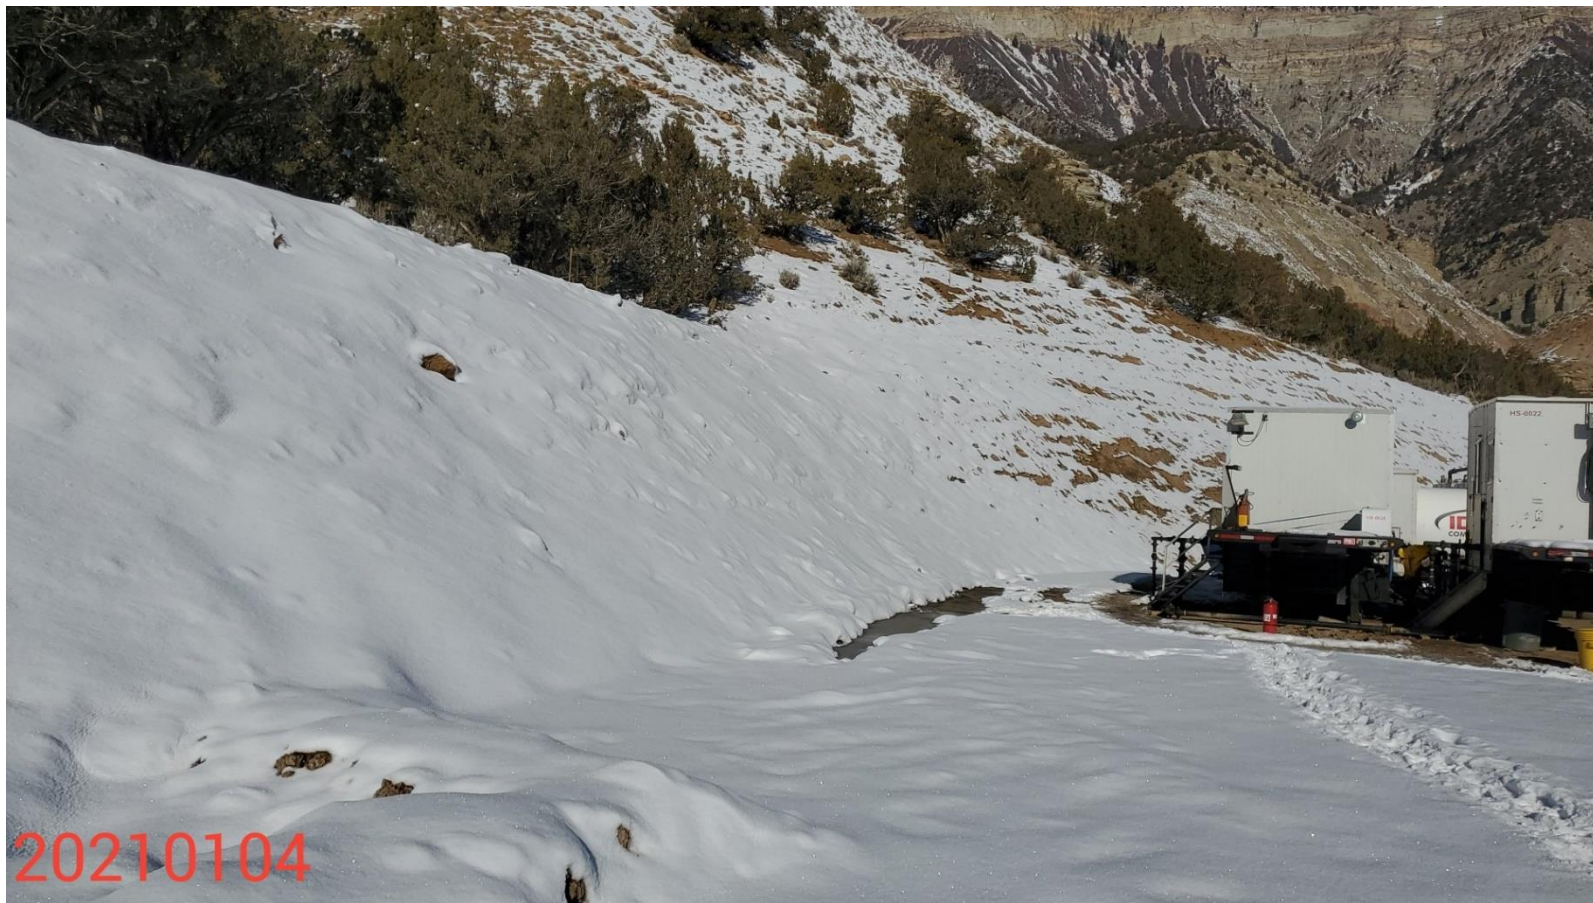
Photo 6: Photo taken from the west end of the Location, facing north. See comments under photo 5.

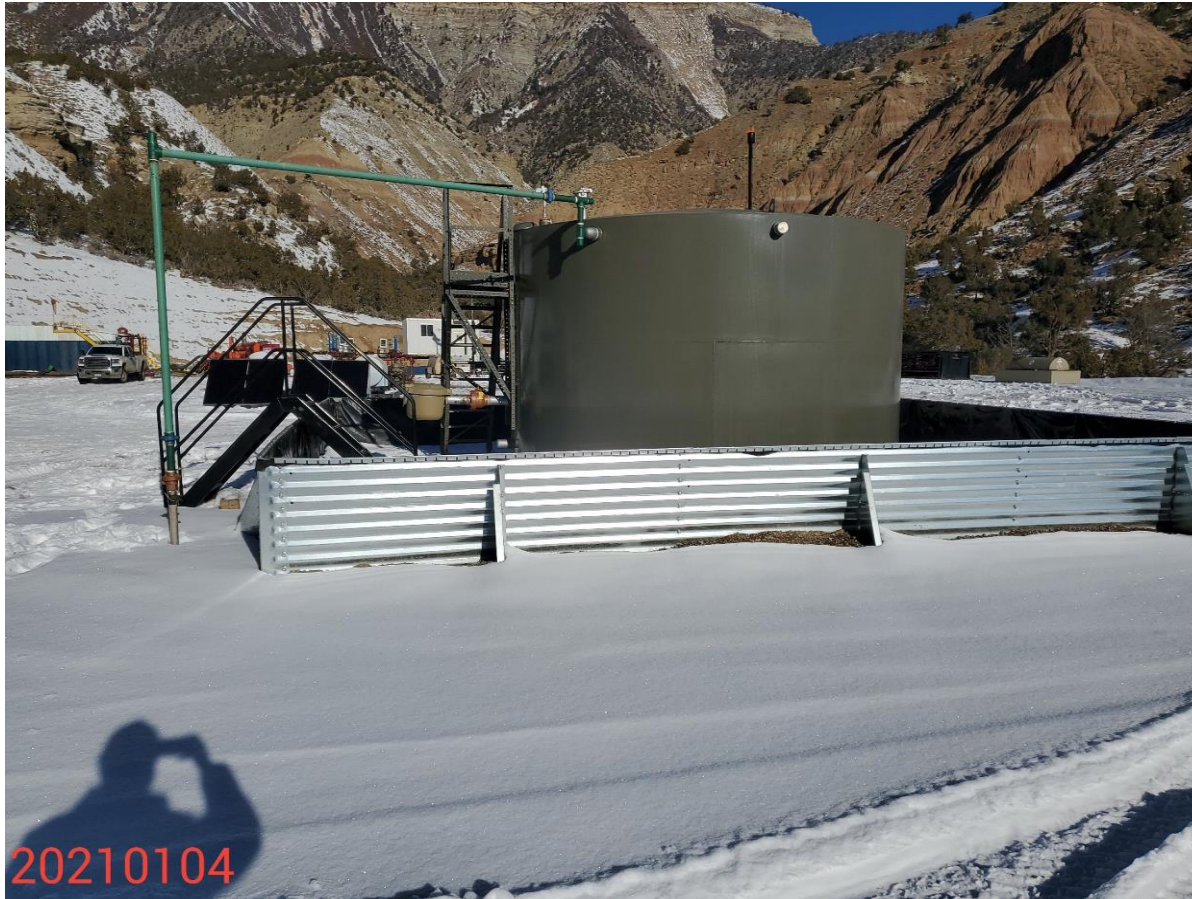
Photo 7: Photo taken from the south end of the Location, facing north. Photo shows tank on Location missing signage and labeling. Signage due within 60 days of installation per Rule 210.b.(2). Labeling required on tanks per 210.d.(1).

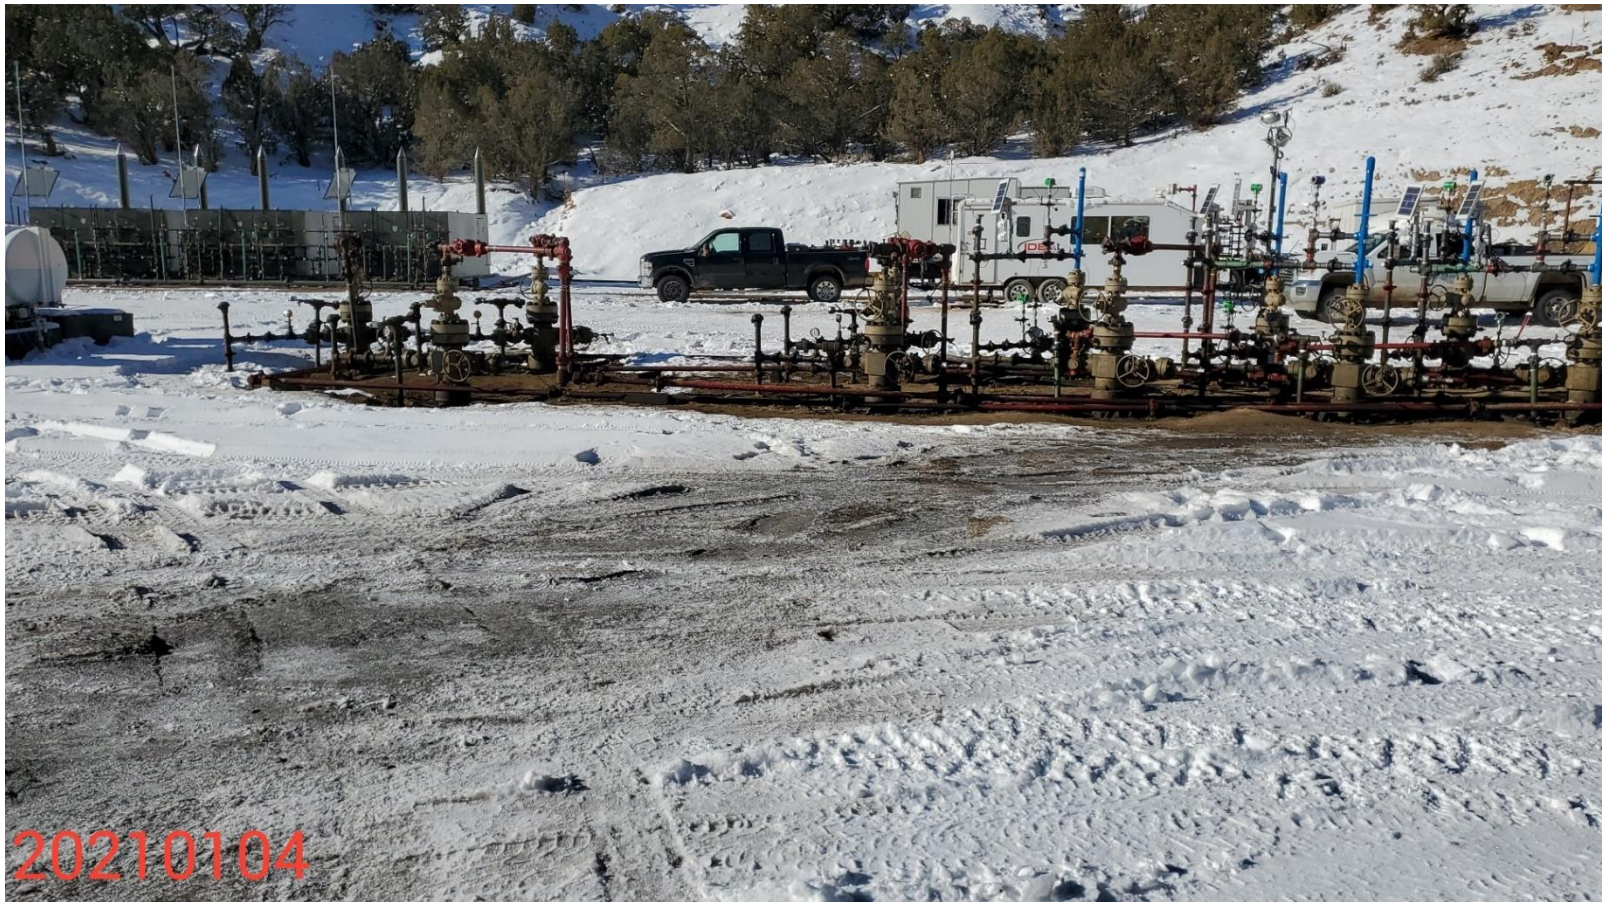
Photo 8: Photo taken from the Location, facing west. Photo shows wells; All permitted wells on the Location have been drilled; wells on Location missing signage. Signage due within 60 days of completion per Rule 210.b.(2)

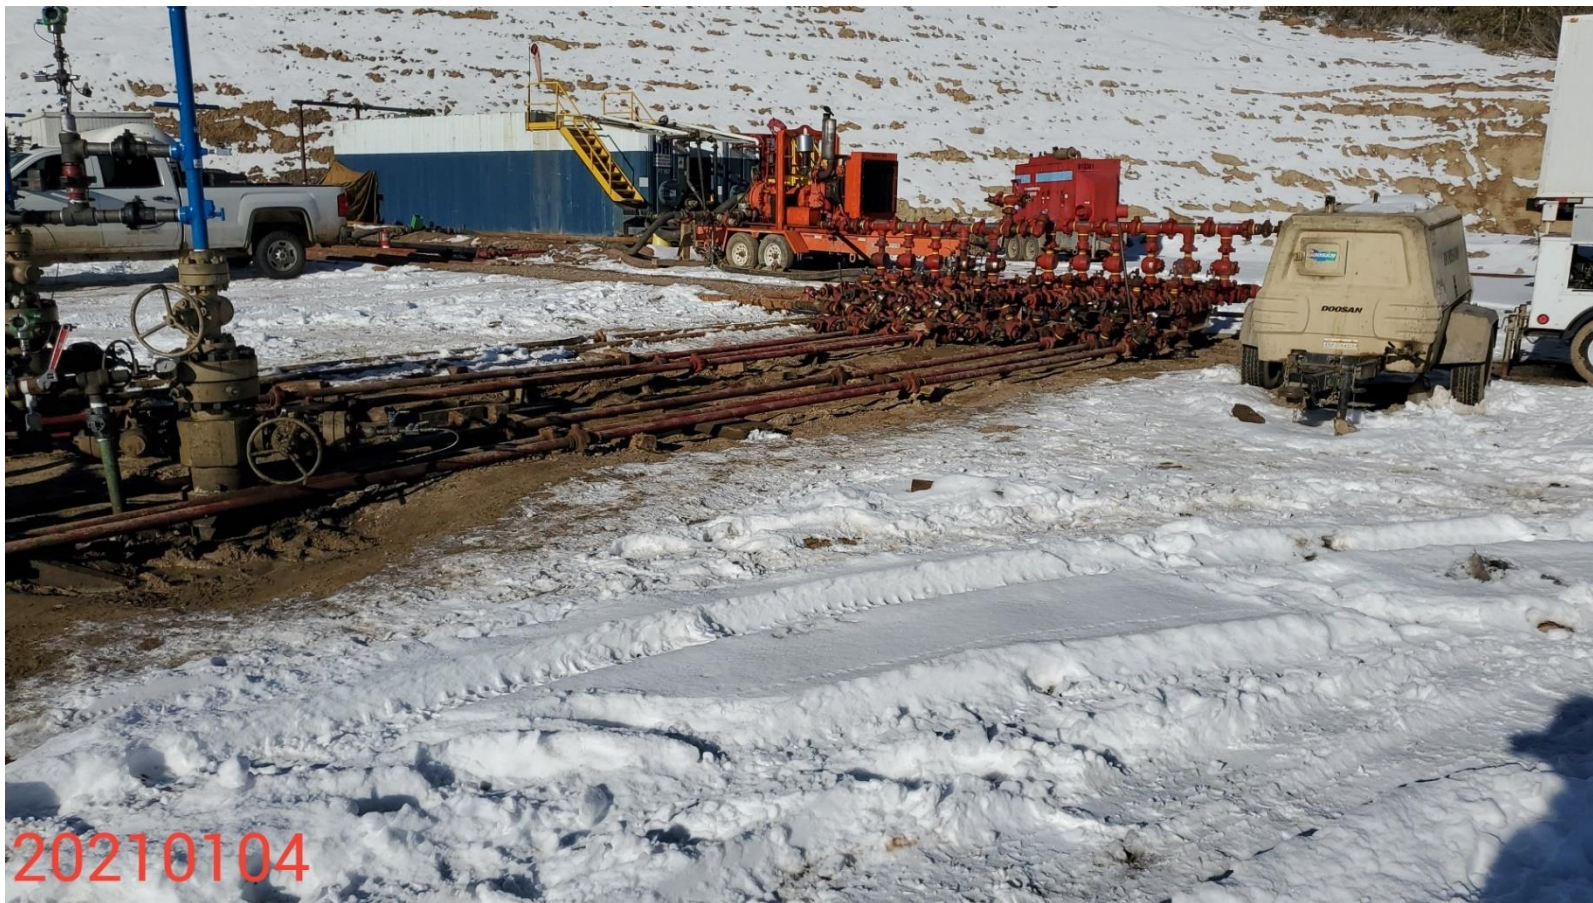
Photo 9: Continued from photo 8. Photo shows equipment observed on Location.

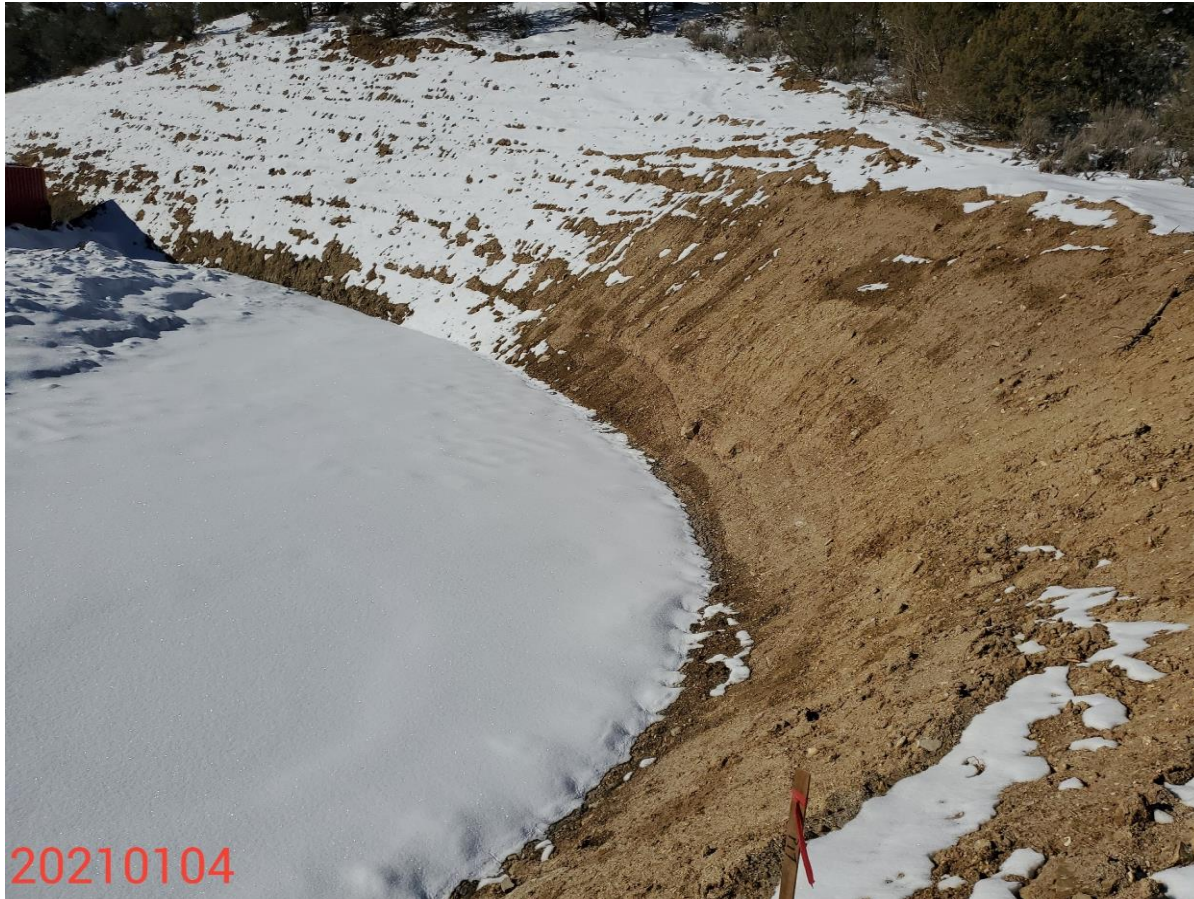
Photo 10: Photo taken from the northeast end of the Location, facing west. Photo shows cut slopes of Location; Hydromulch observed on slopes. Due to snow cover, it is unclear if additional BMPs, such as run-on controls, have been installed in conjunction with the hydromulch.

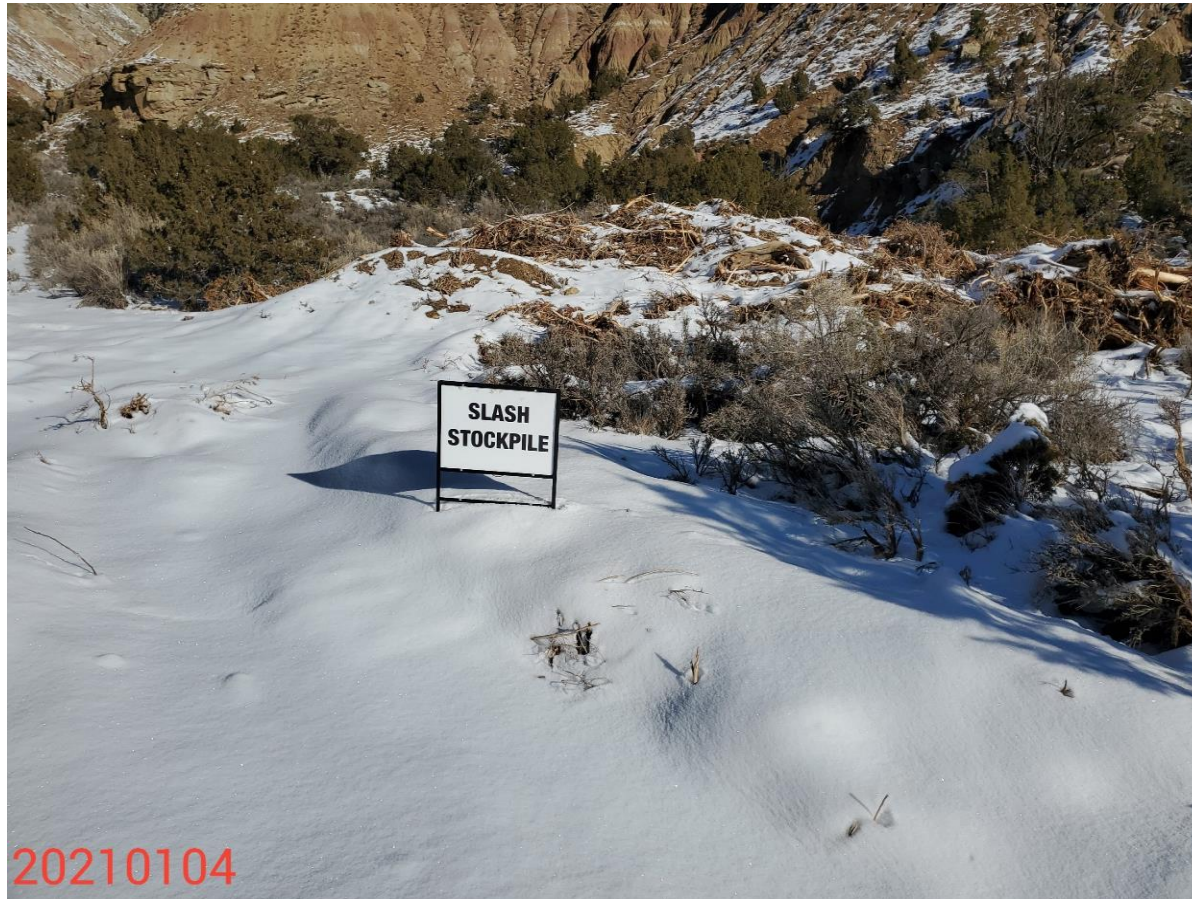
Photo 11: Photo taken from the north end of the Location, facing northeast. Photo shows "Slash Stockpile" and sign.

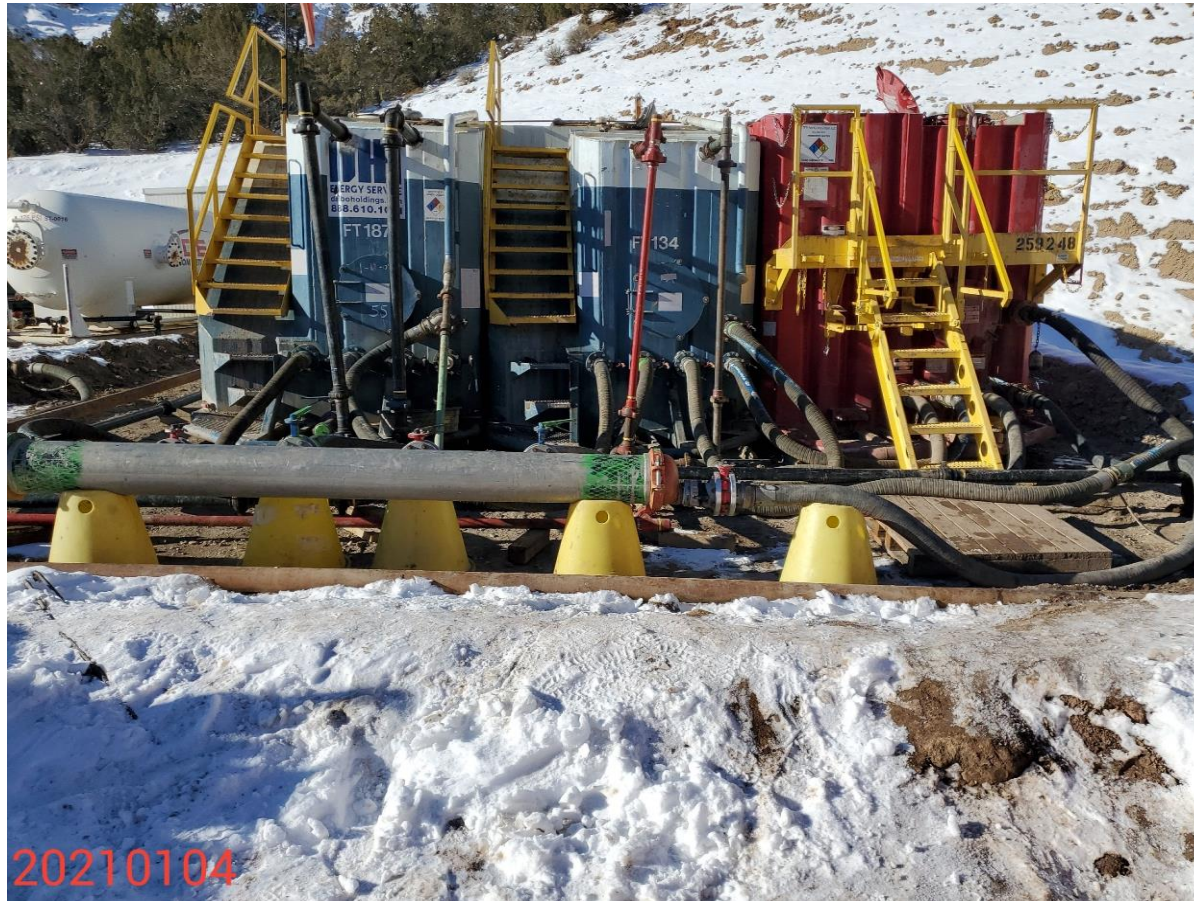
Photo 12: Photo of tanks on the northeast end of the Location. Signs on tanks state "Produced Water".

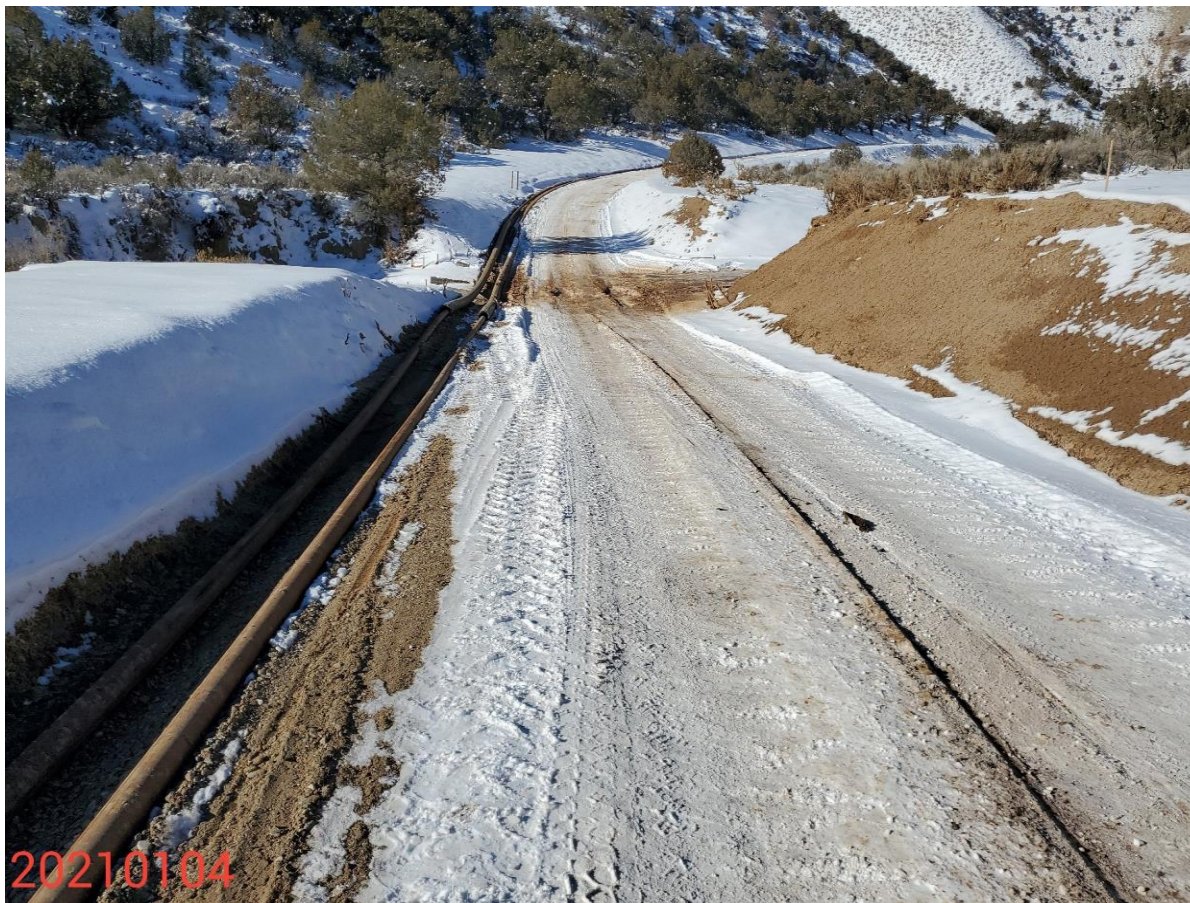
Photo 13: Photo taken from the access road at the stream crossing, facing west. Photo shows proper BMPs per good engineering practices remain missing, or insufficient to stabilize access road at stream crossing

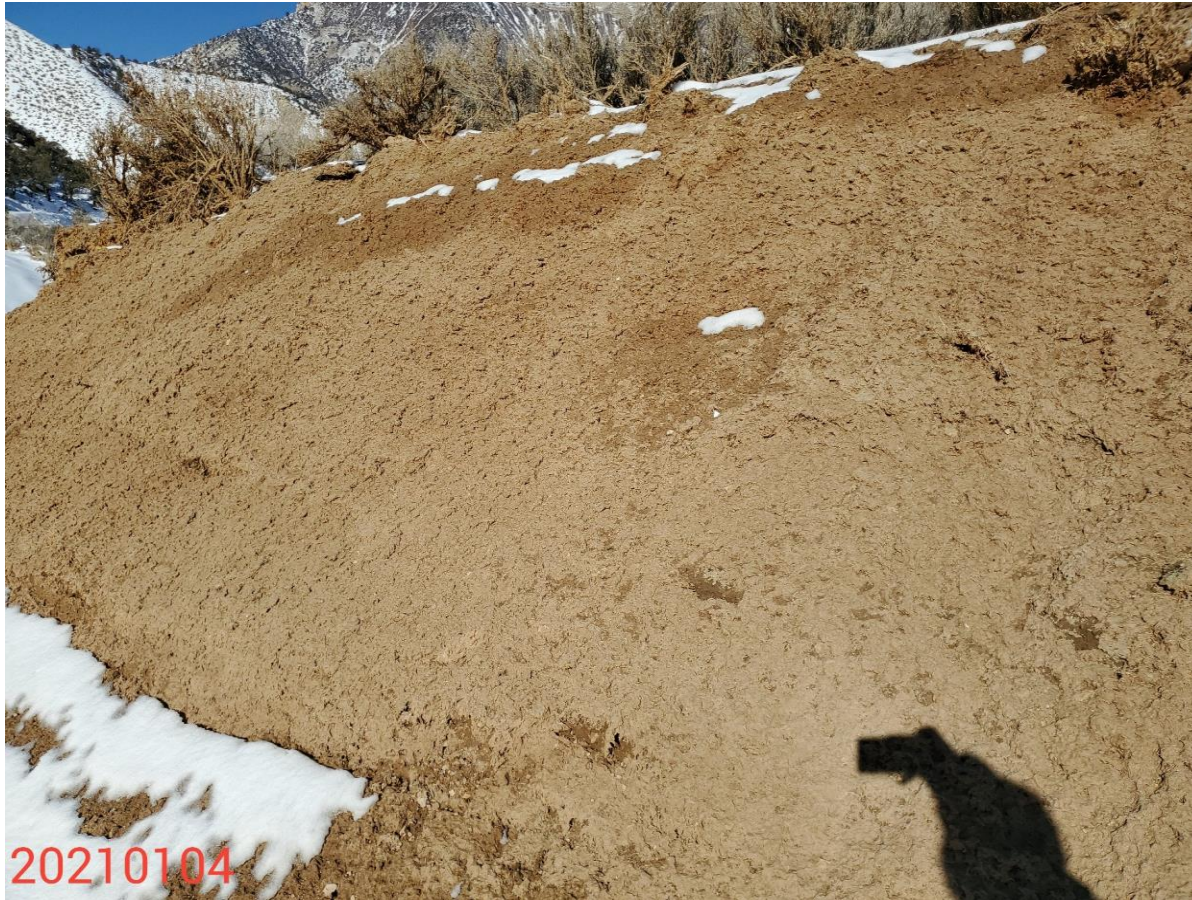
Photo 14: Continued from photo 13. Photo shows Operator installed hydromulch on slopes along areas cut during construction of the access road.

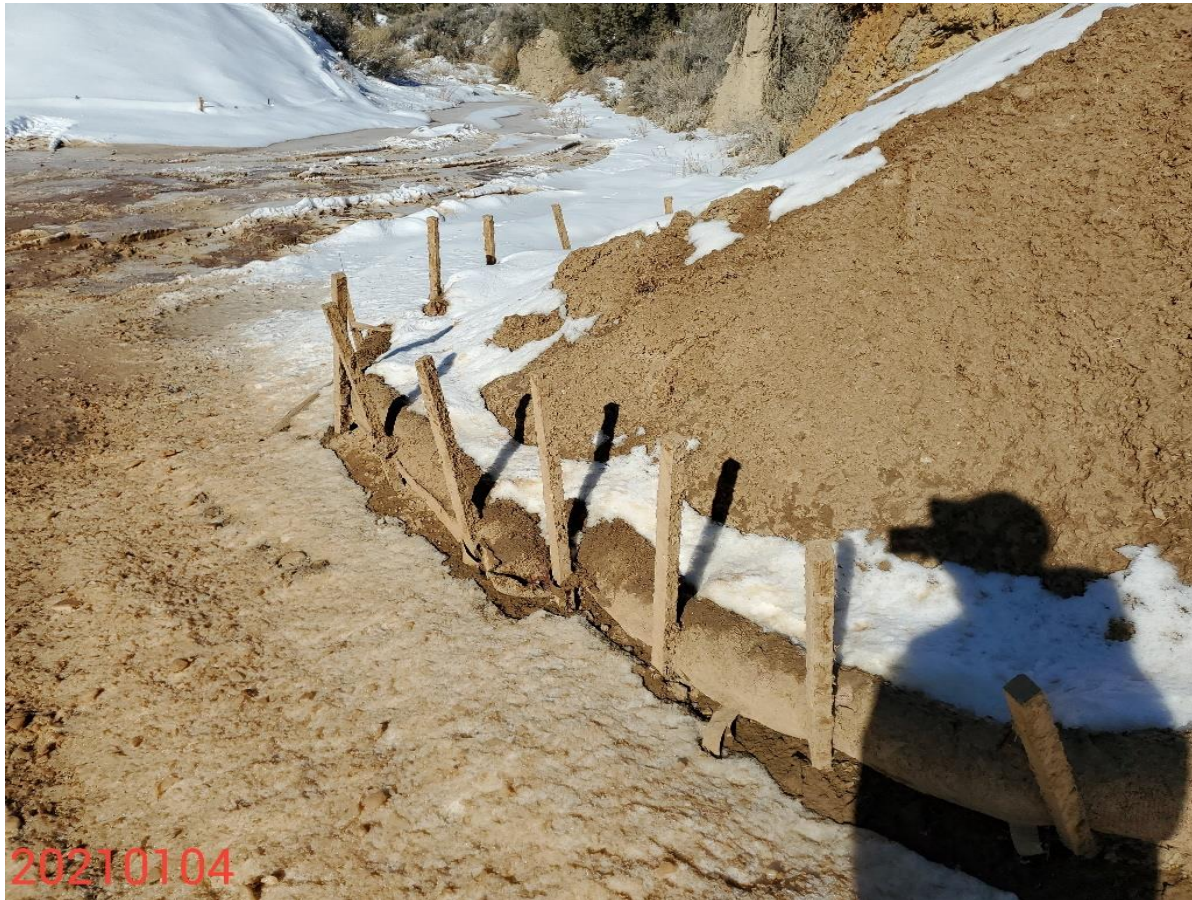
Photo 15: See comments under photo 15. Photo also shows the streambed has been used as a turn-around area.

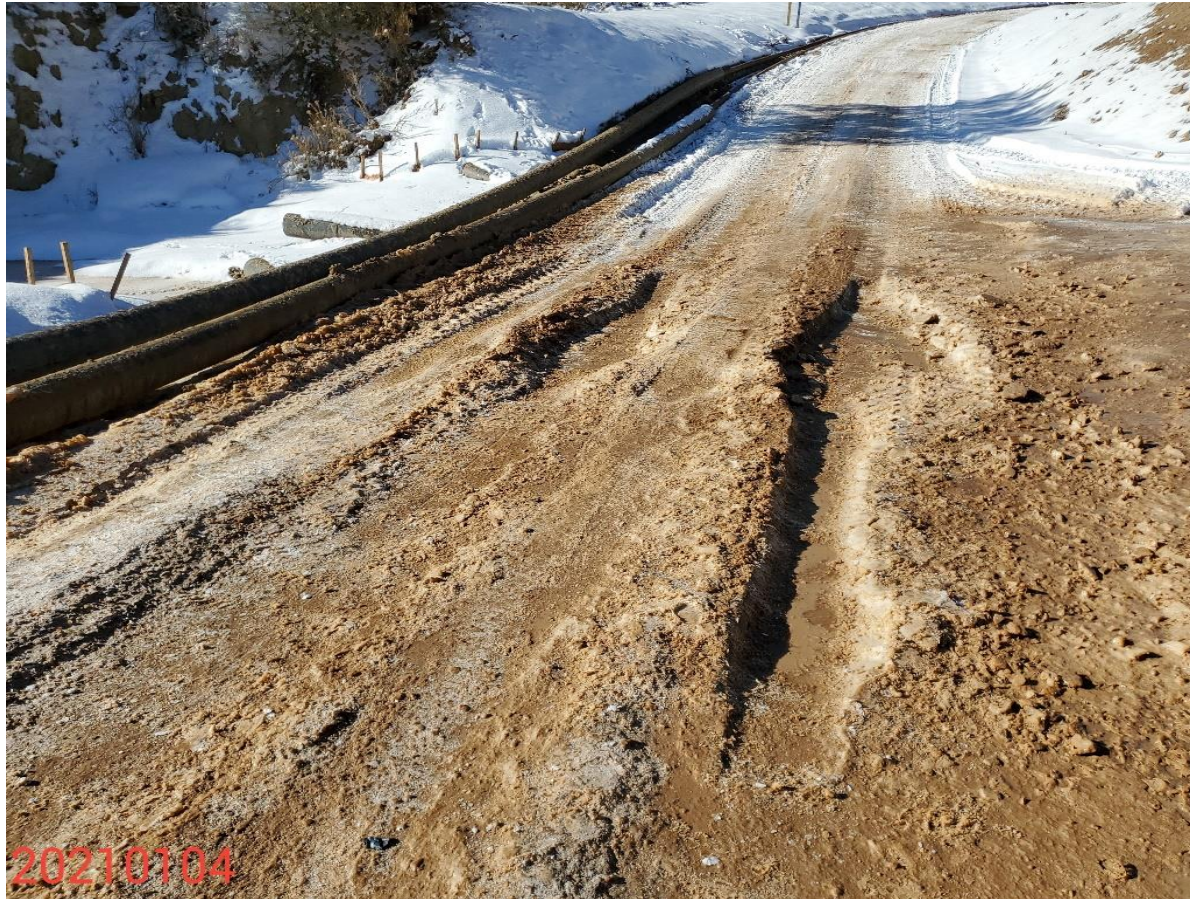
Photo 16: Photo taken from the access road at the stream crossing, facing west. Photo shows proper BMPs per good engineering practices remain missing to protect the waterway and stabilize access road at stream crossing

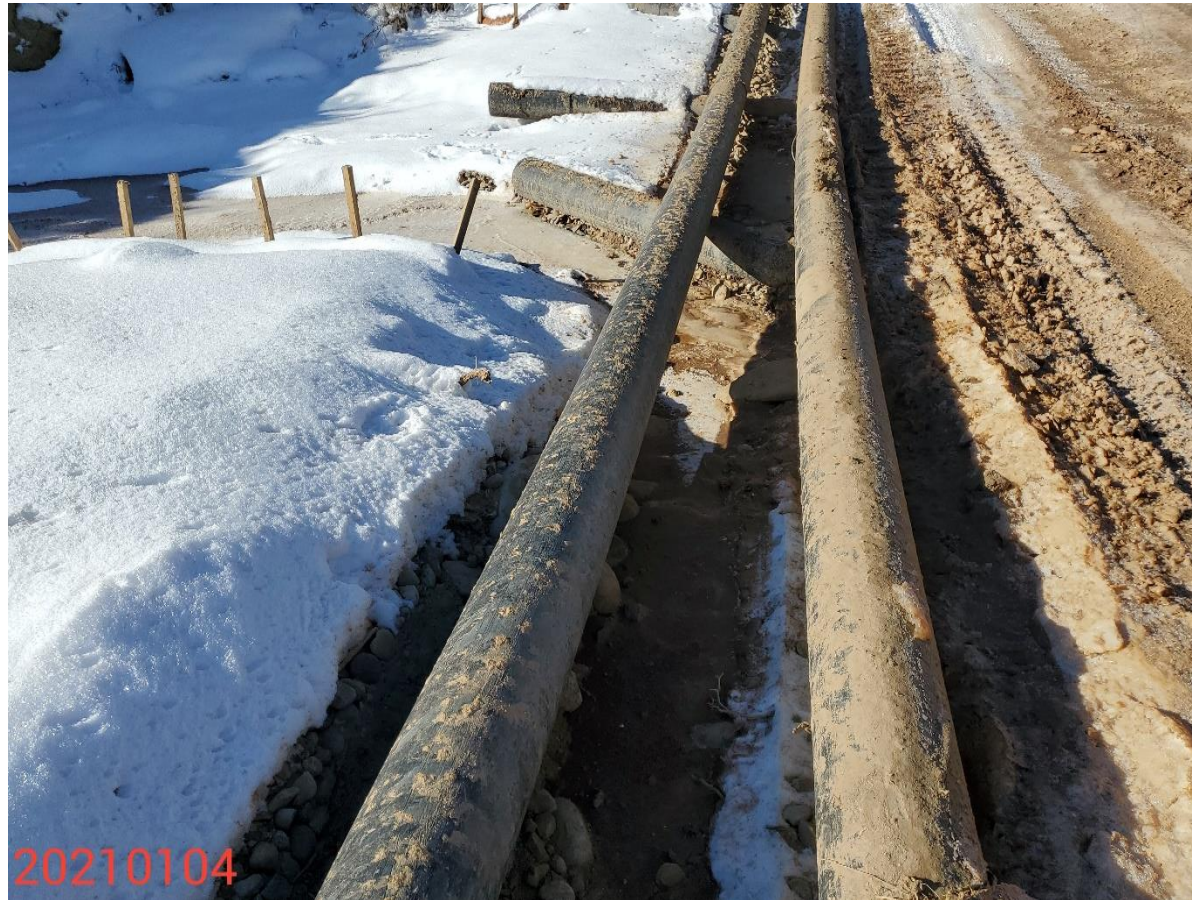
Photo 17: See comments under photo 16.

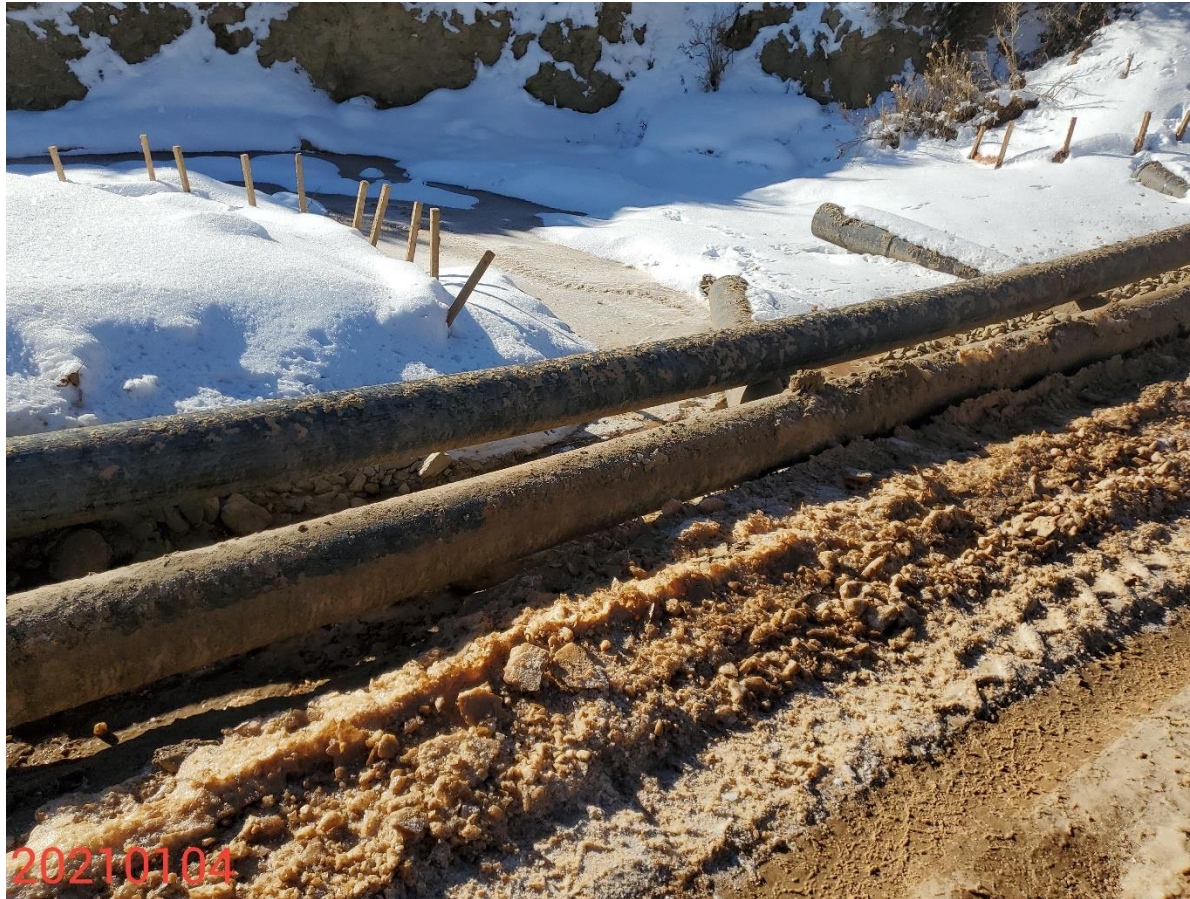
Photo 18: See comments under photo 16.

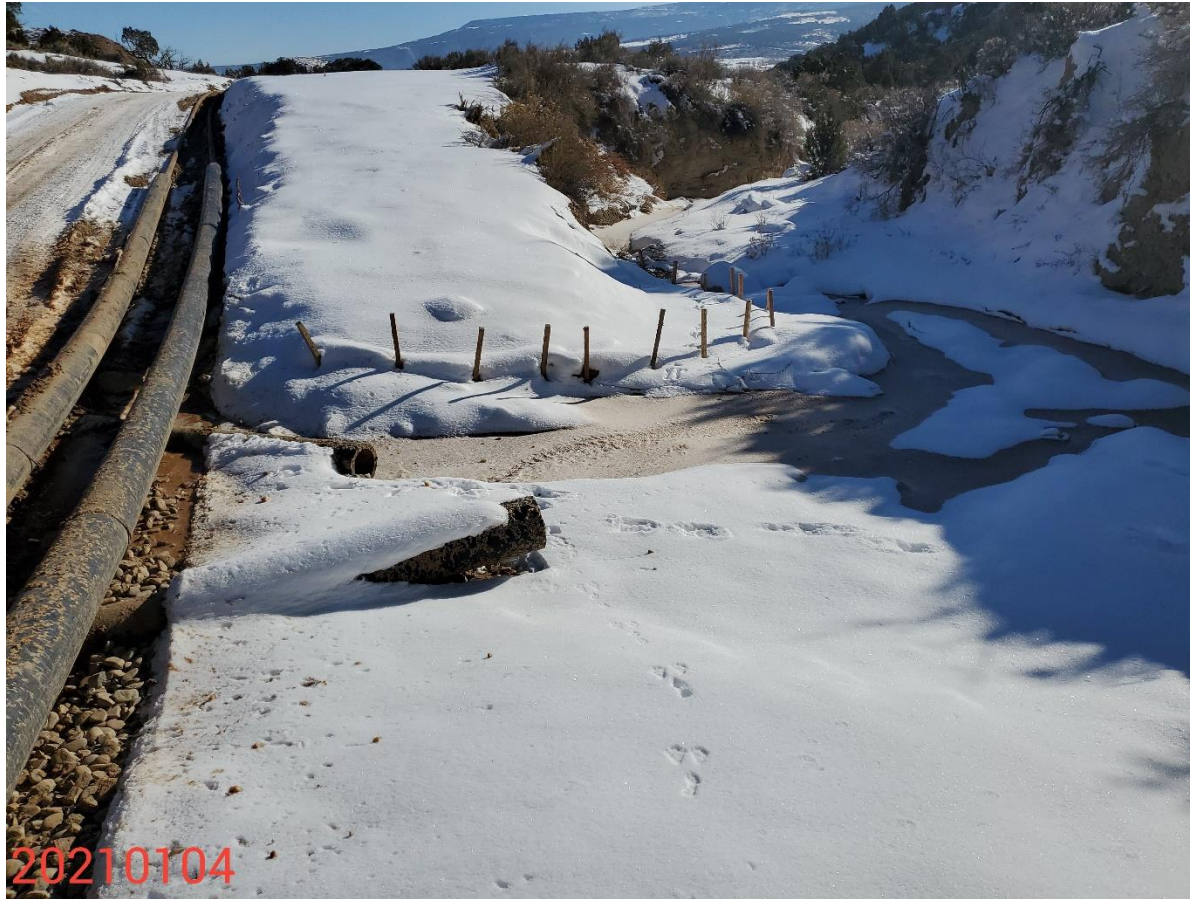
Photo 19: See comments under photo 16.
