Inspection Photos

1/04/2021

Operator: TEP ROCKY MOUNTAIN LLC - 96850

Location ID: 475753

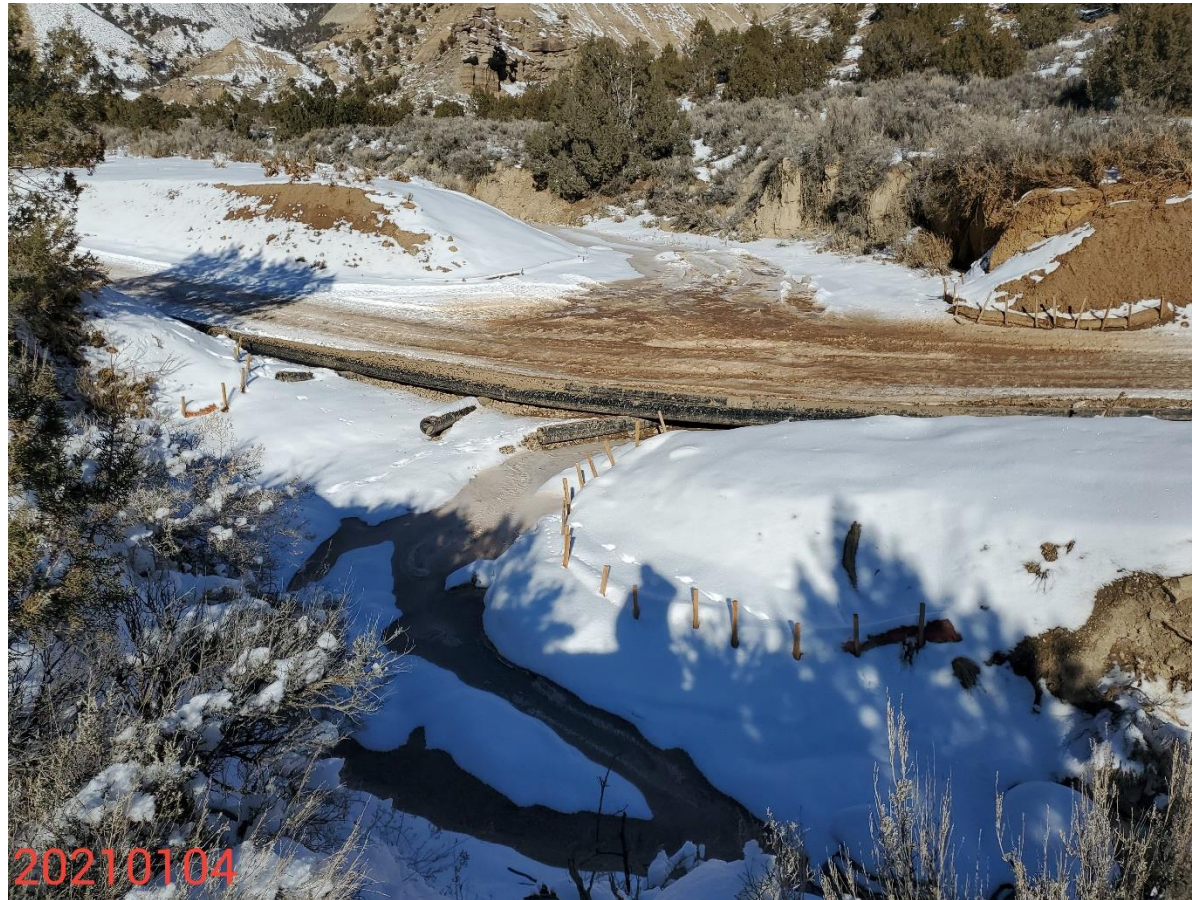
Photo 16: Photo taken from the access road at the stream crossing, facing west. Photo shows proper BMPs per good engineering practices remain missing to protect the waterway and stabilize access road at stream crossing

Photo 20: See comments under photo 16. It was also observed that the streambed has been used as a turn-around area
