Inspection Photos  
Operator: Epic Energy  
API: 067-08220  
Date: 1/6/2021

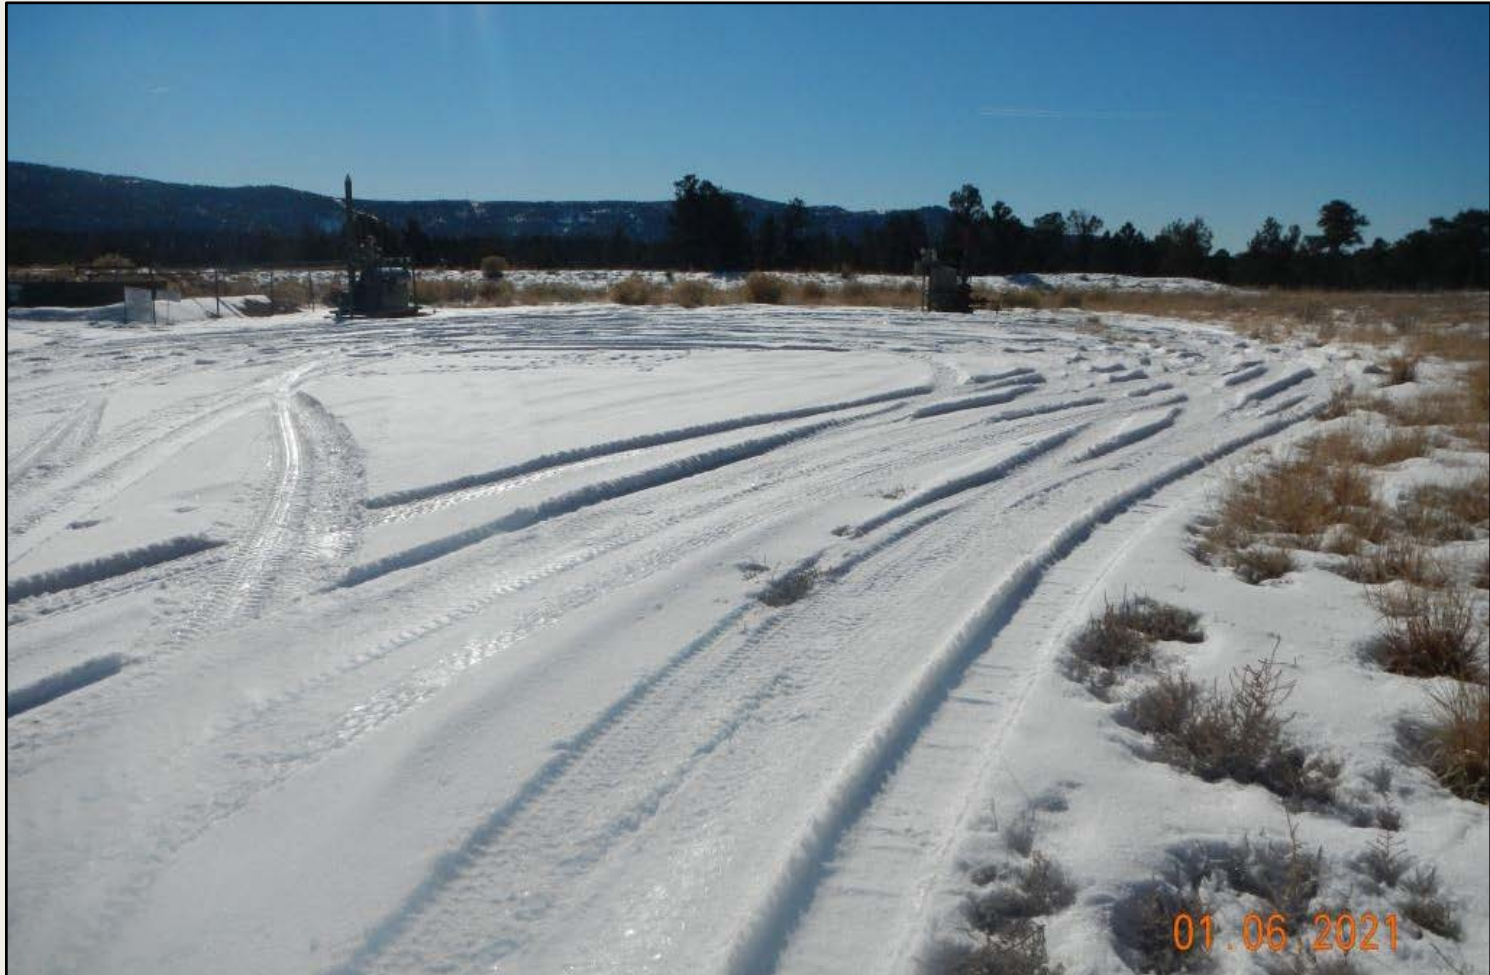
Photo 1. View of the project area from the well pad entrance facing center.

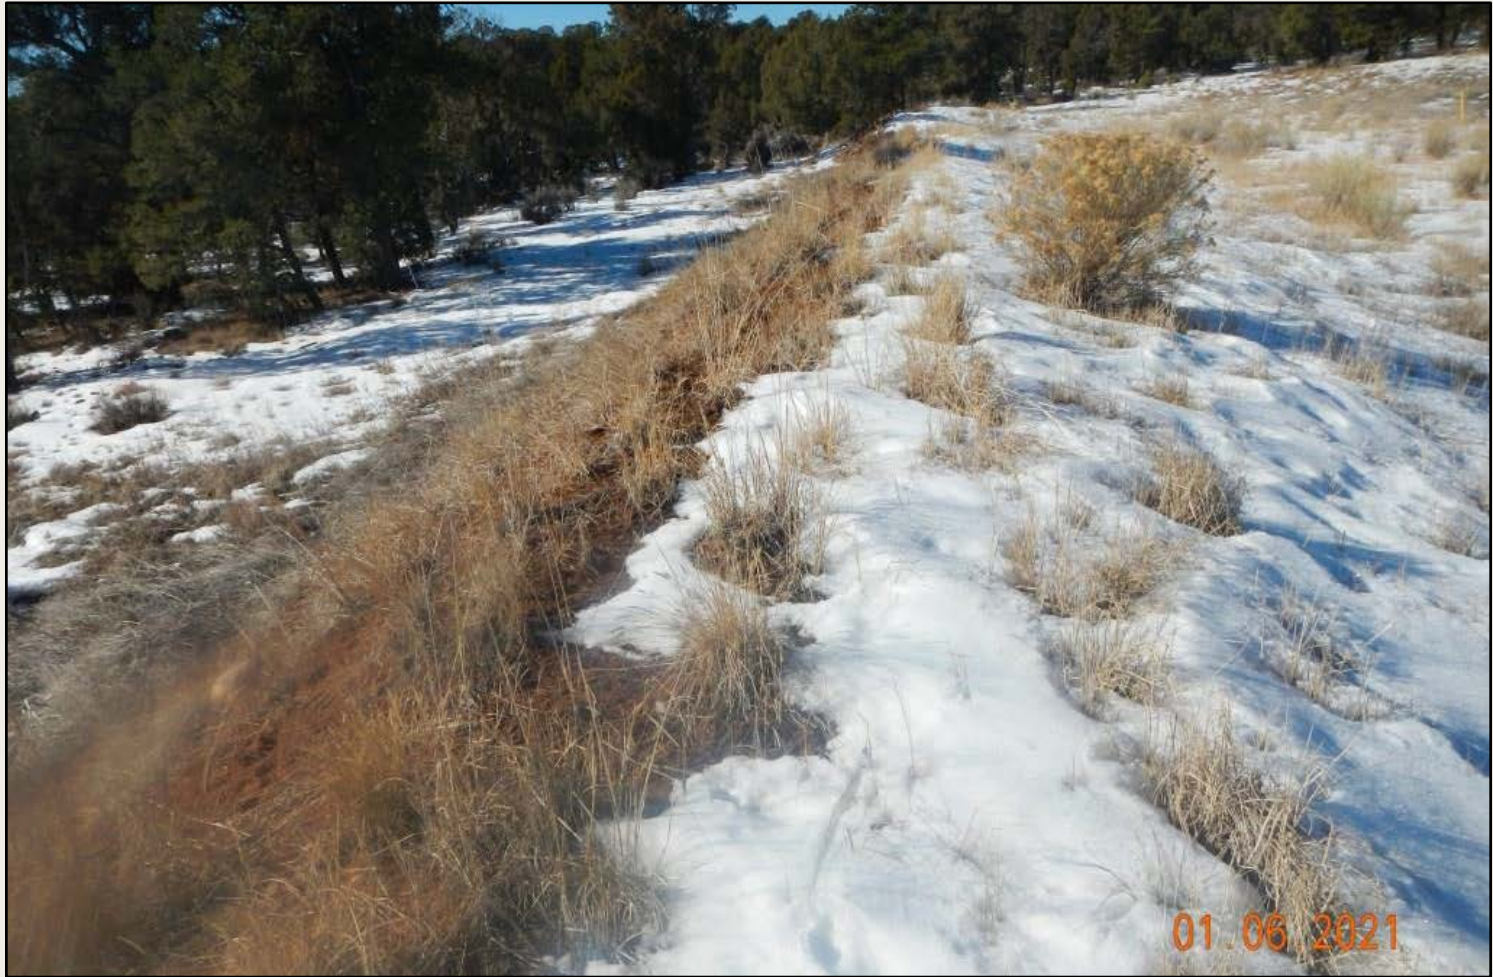
Photo 2. View of the southern project area from the southeastern corner facing westward. Revegetation is progressing with grasses such as western wheatgrass, smooth brome, and crested wheatgrass.

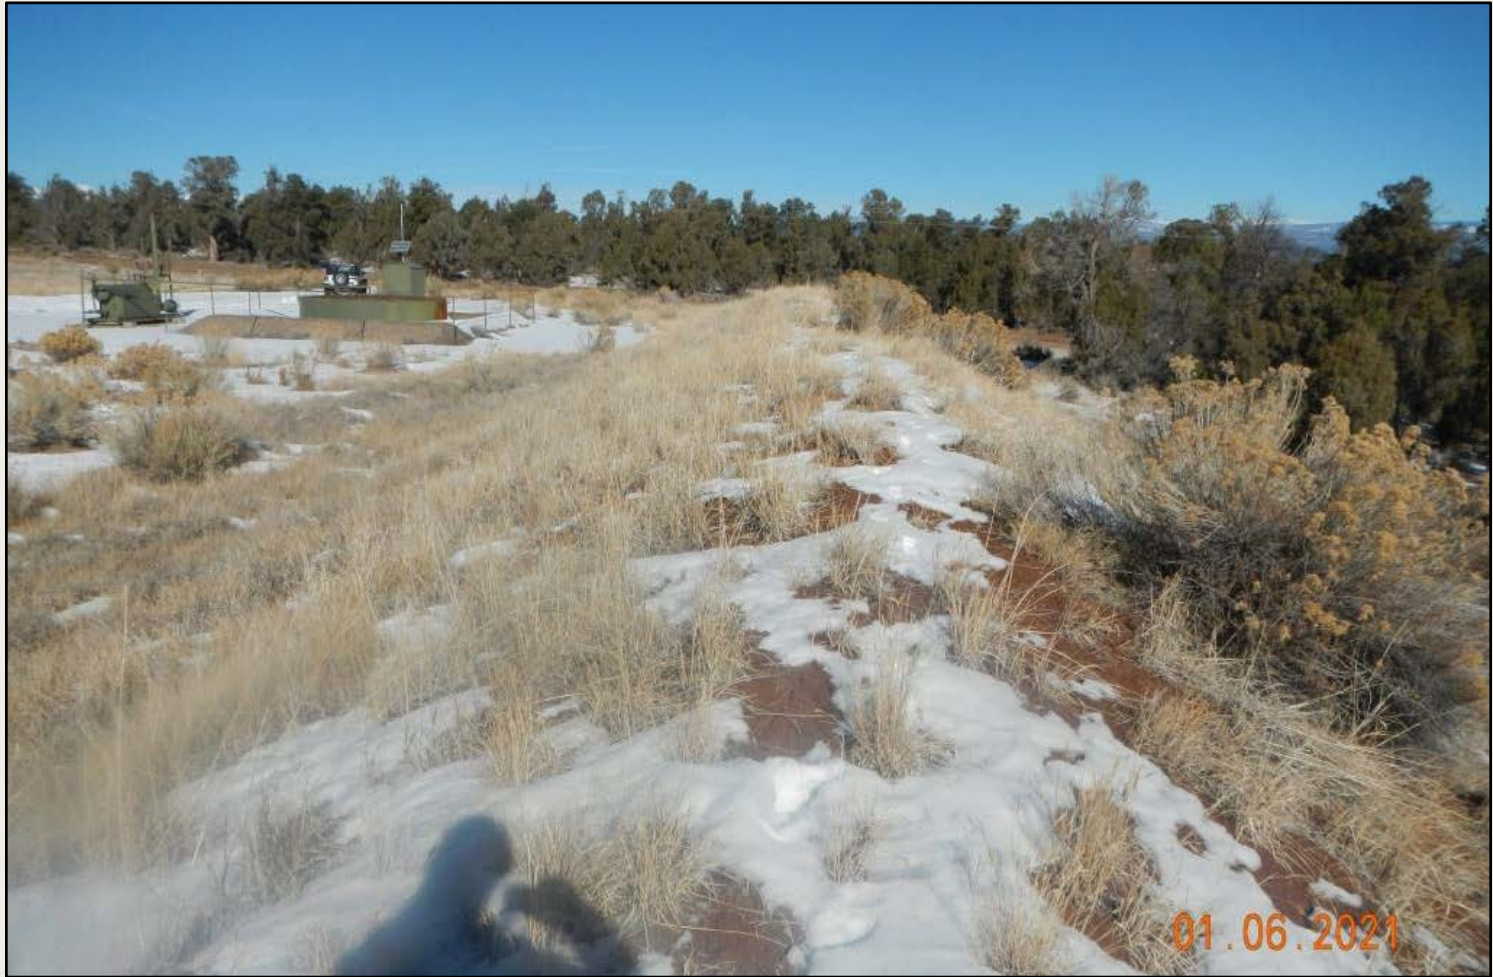
Photo 3. View of the eastern project area from the southeastern corner facing northward. Fill slopes are bermed and revegetating.

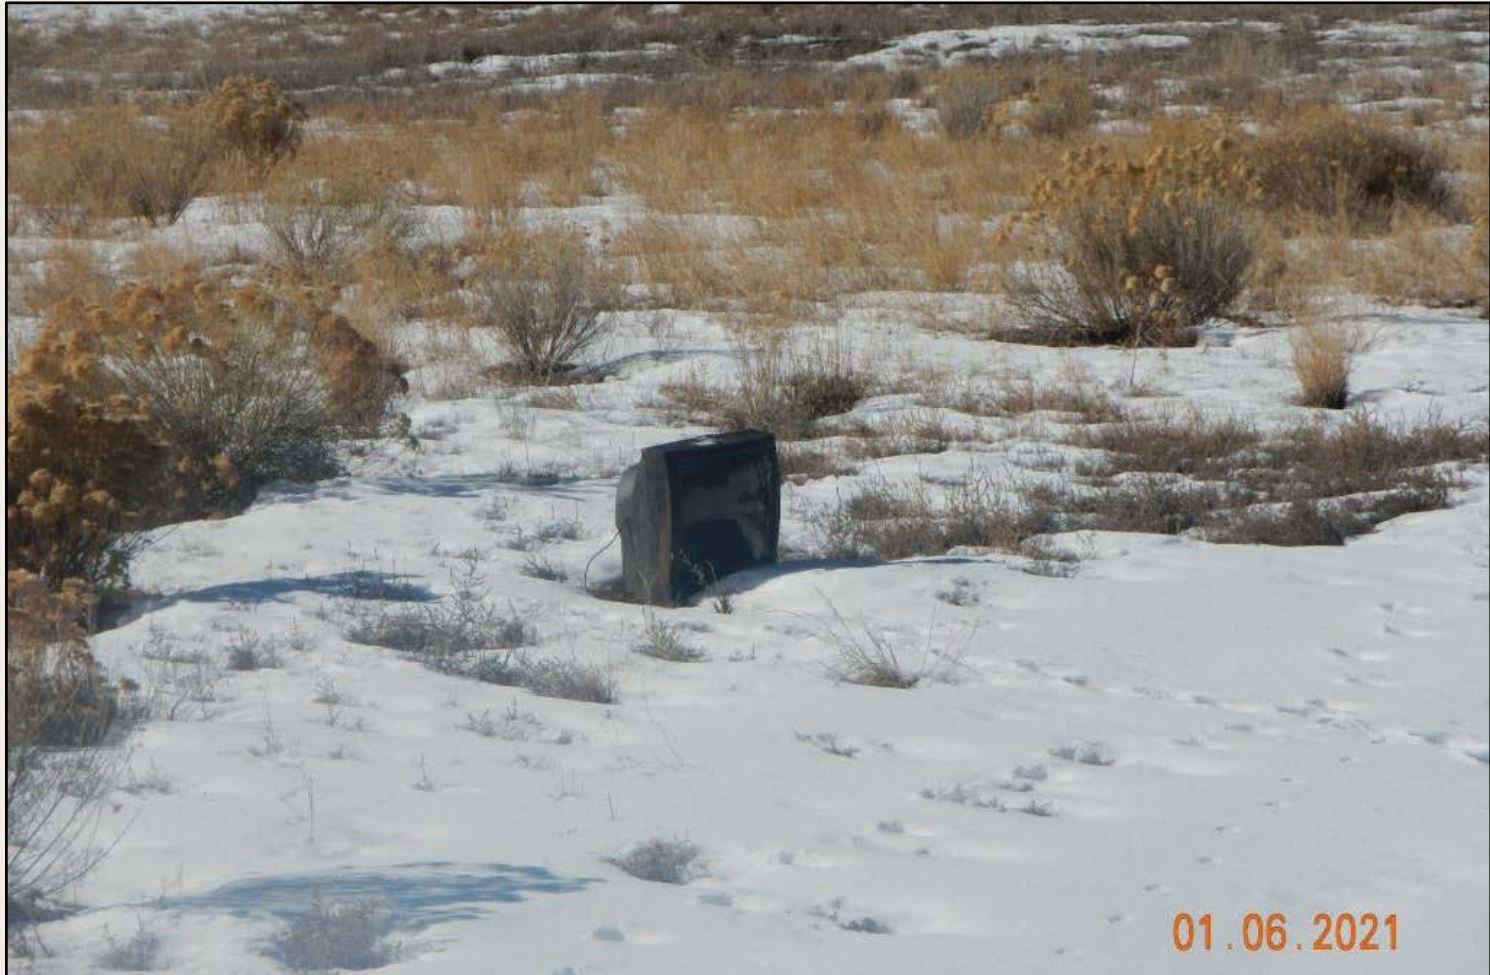
Photo 4. View of debris within the southern project area.

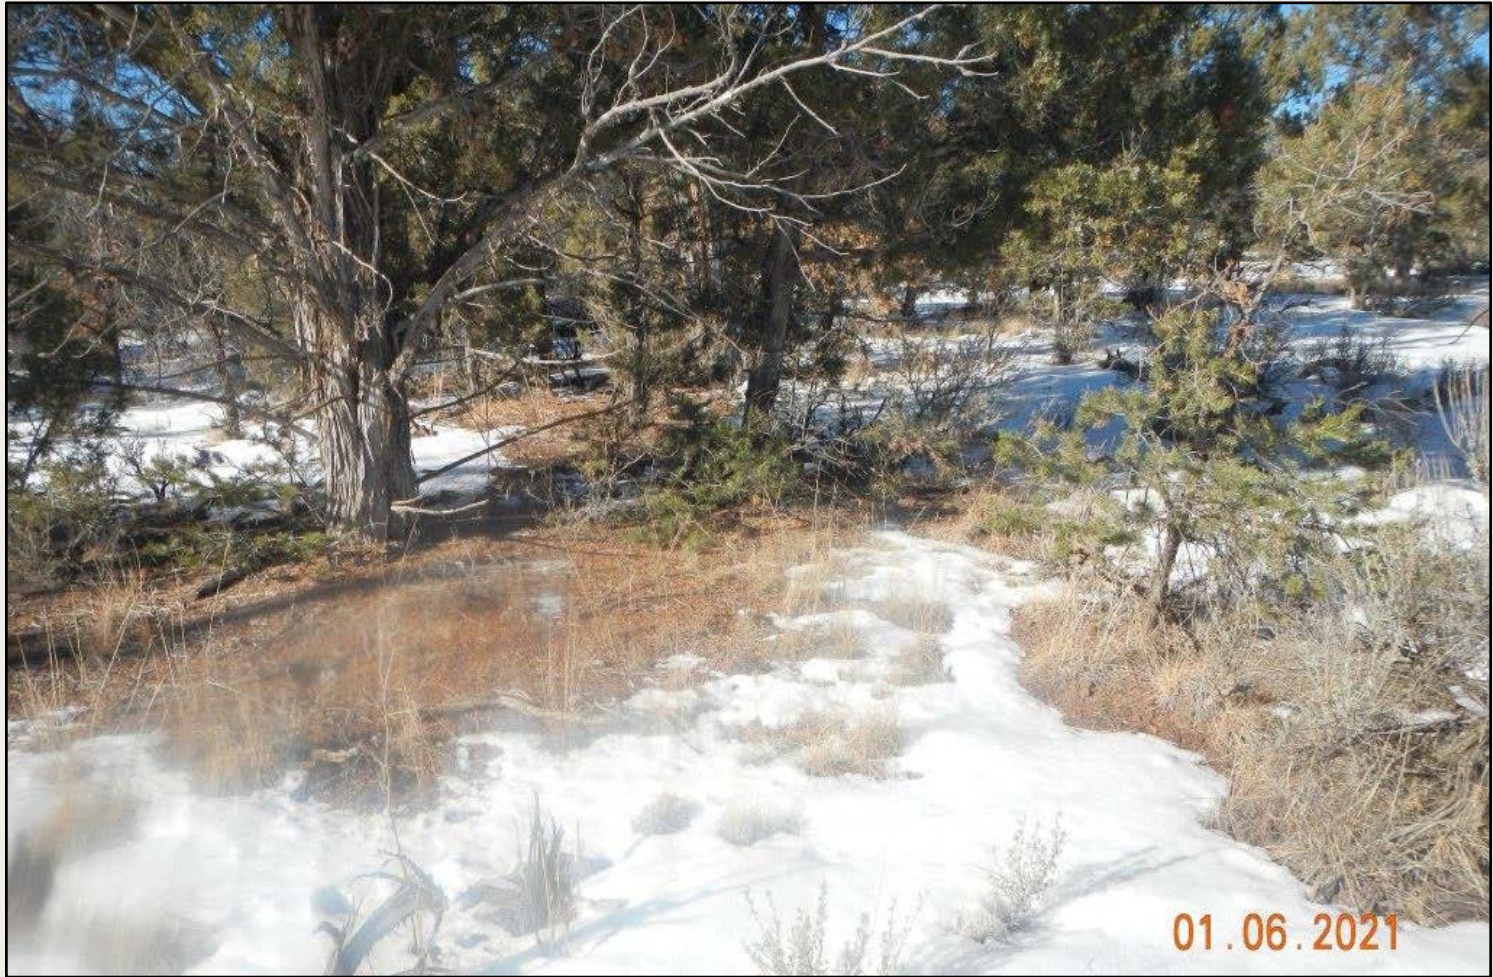
Photo 5. View of reference area comprised of pinyon and juniper woodland with sagebrush, squirreltail, and narrow leaf penstemon.
