Inspection Photos
Operator: Simcoe
API: 067-07956
Date: 1/6/2021

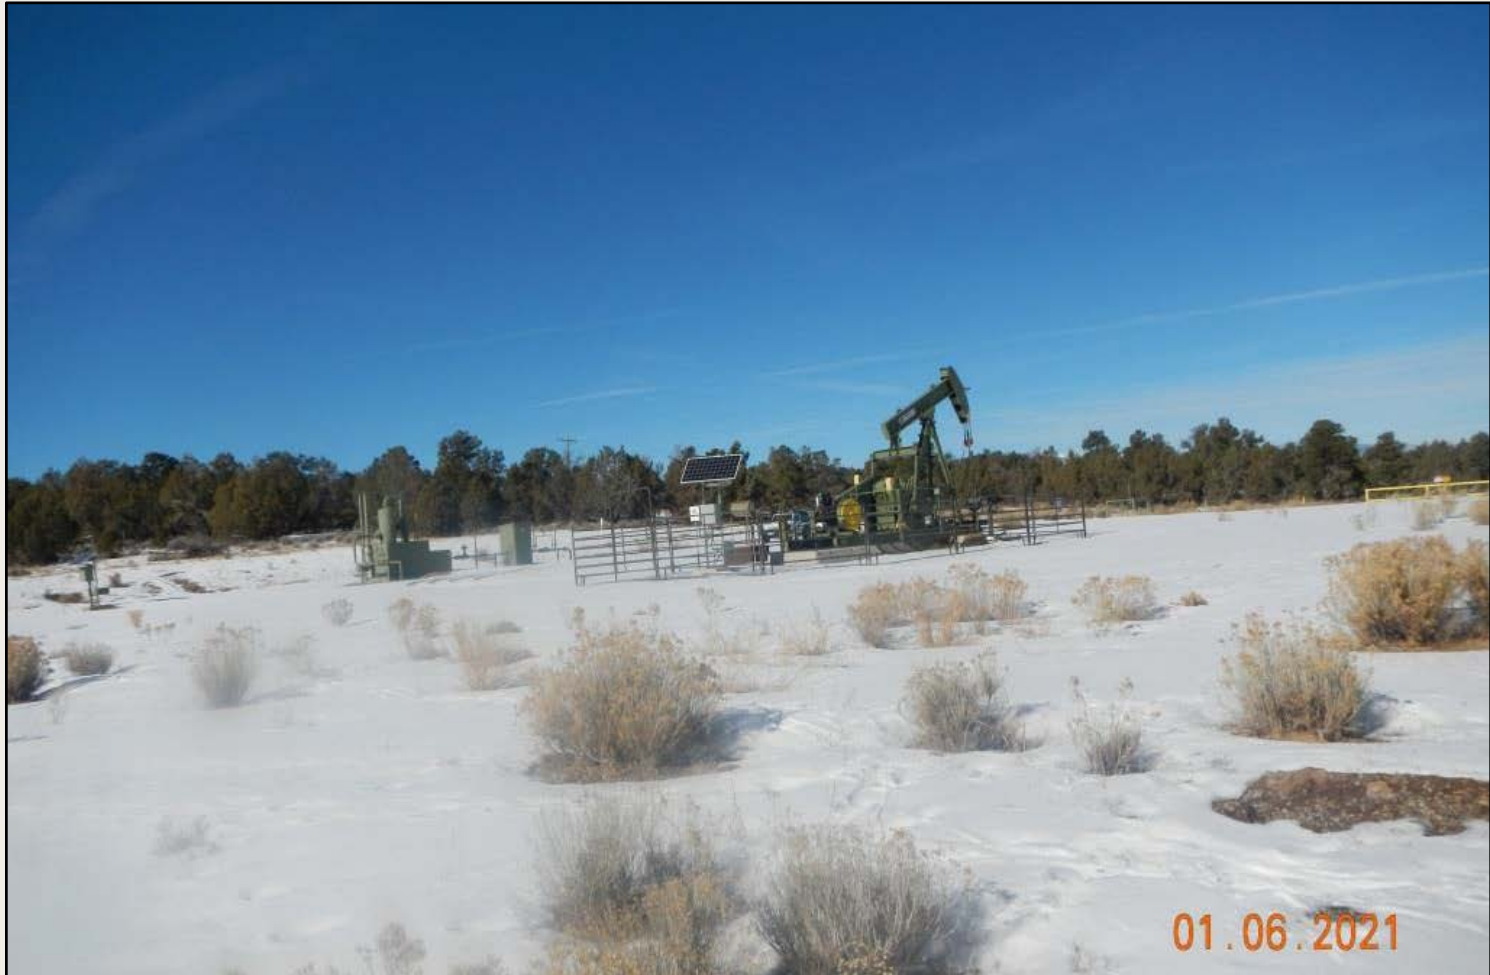
Photo 1. View of the project area from the southeastern corner facing center.

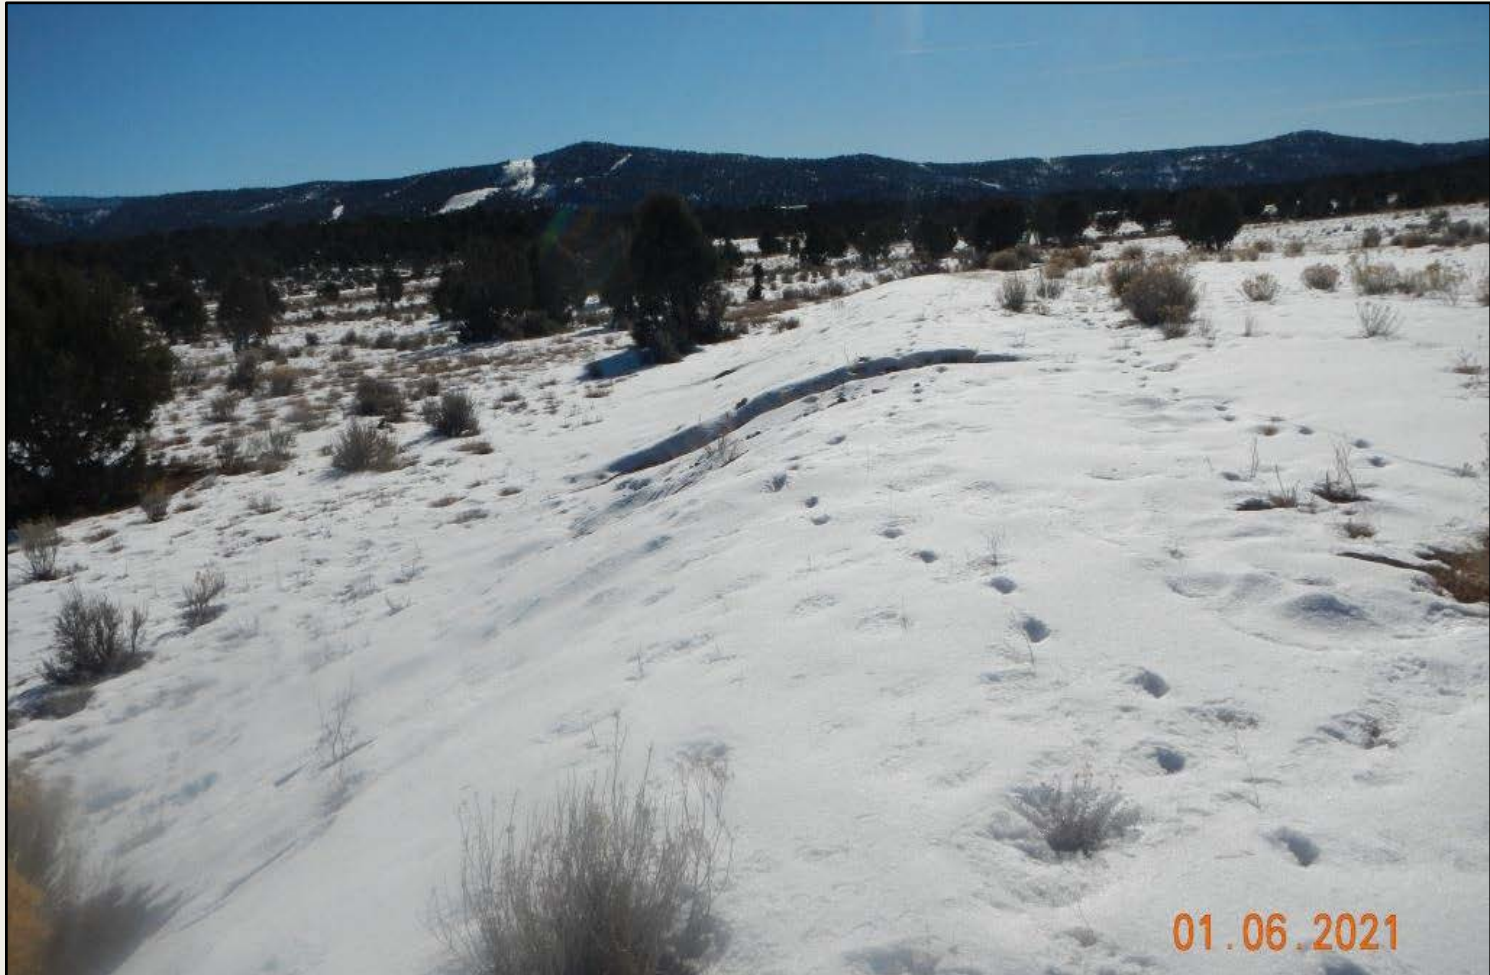
Photo 2. View of the eastern fill slope from the northeastern corner facing southward. Location is largely snow covered. Erosional channels appear to be forming in the fill slope.

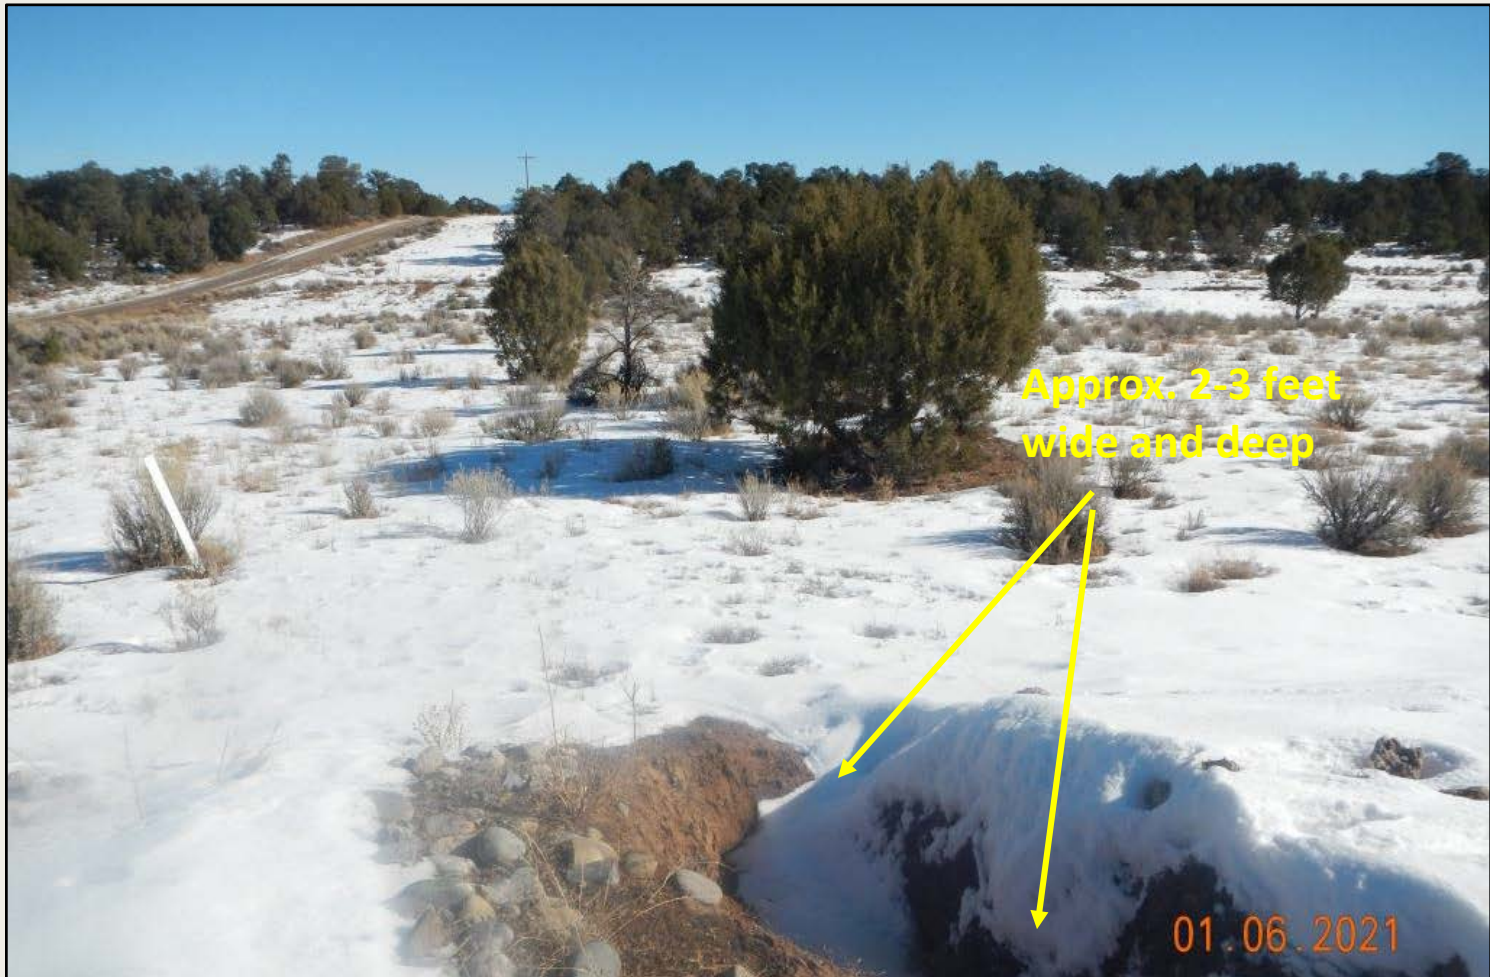
Photo 3. View of erosional channel in the eastern project area.

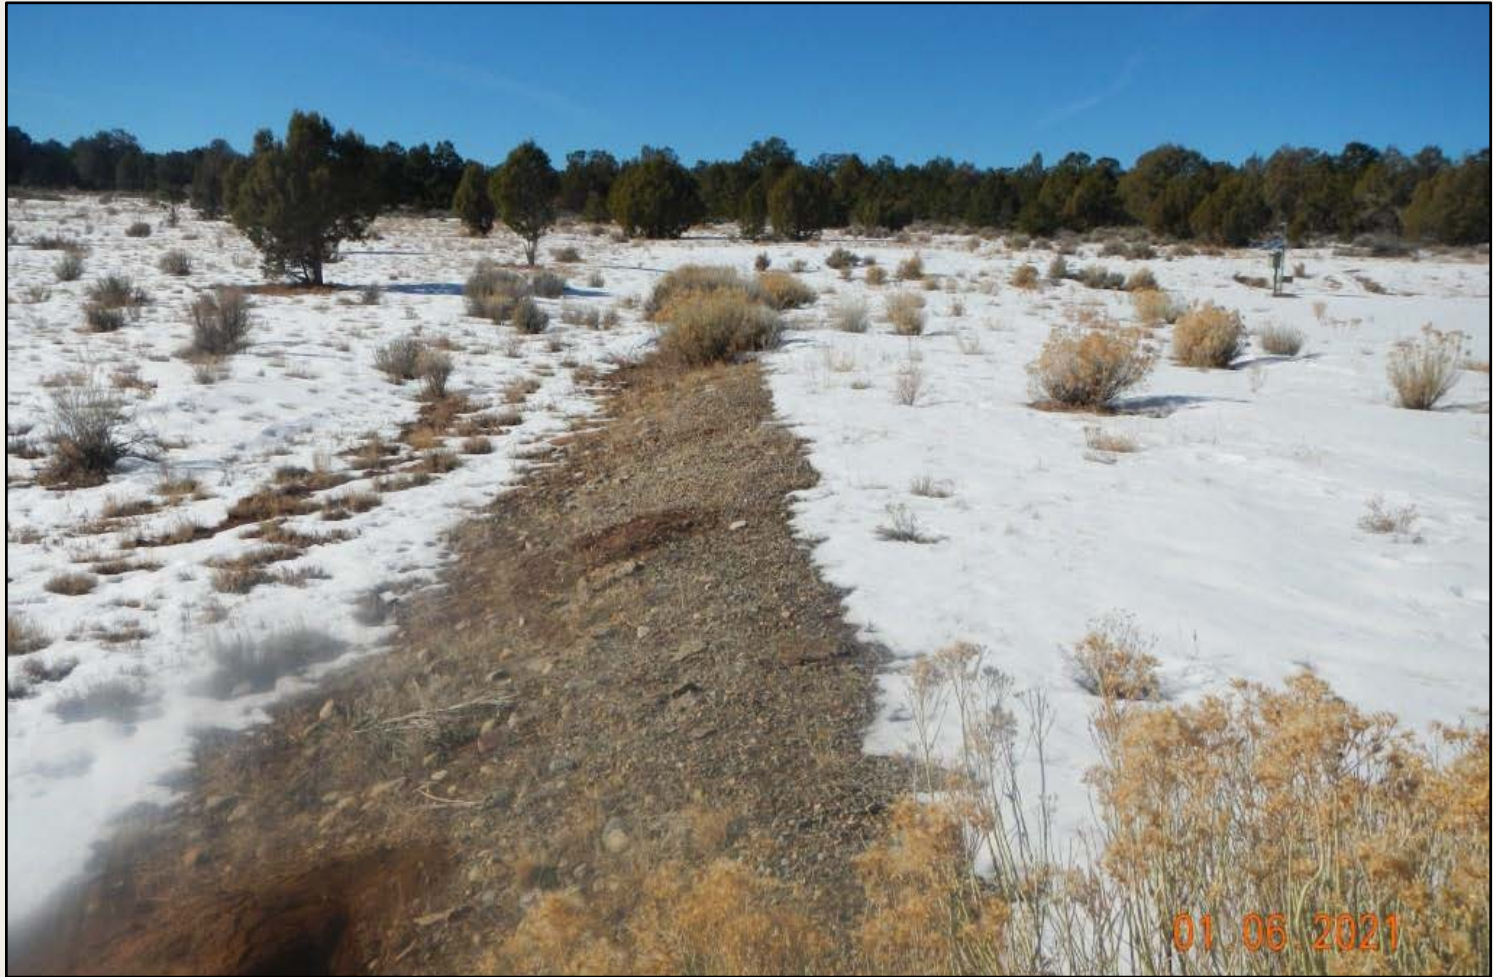
Photo 4. View of the southern project area from the southeastern corner facing westward.

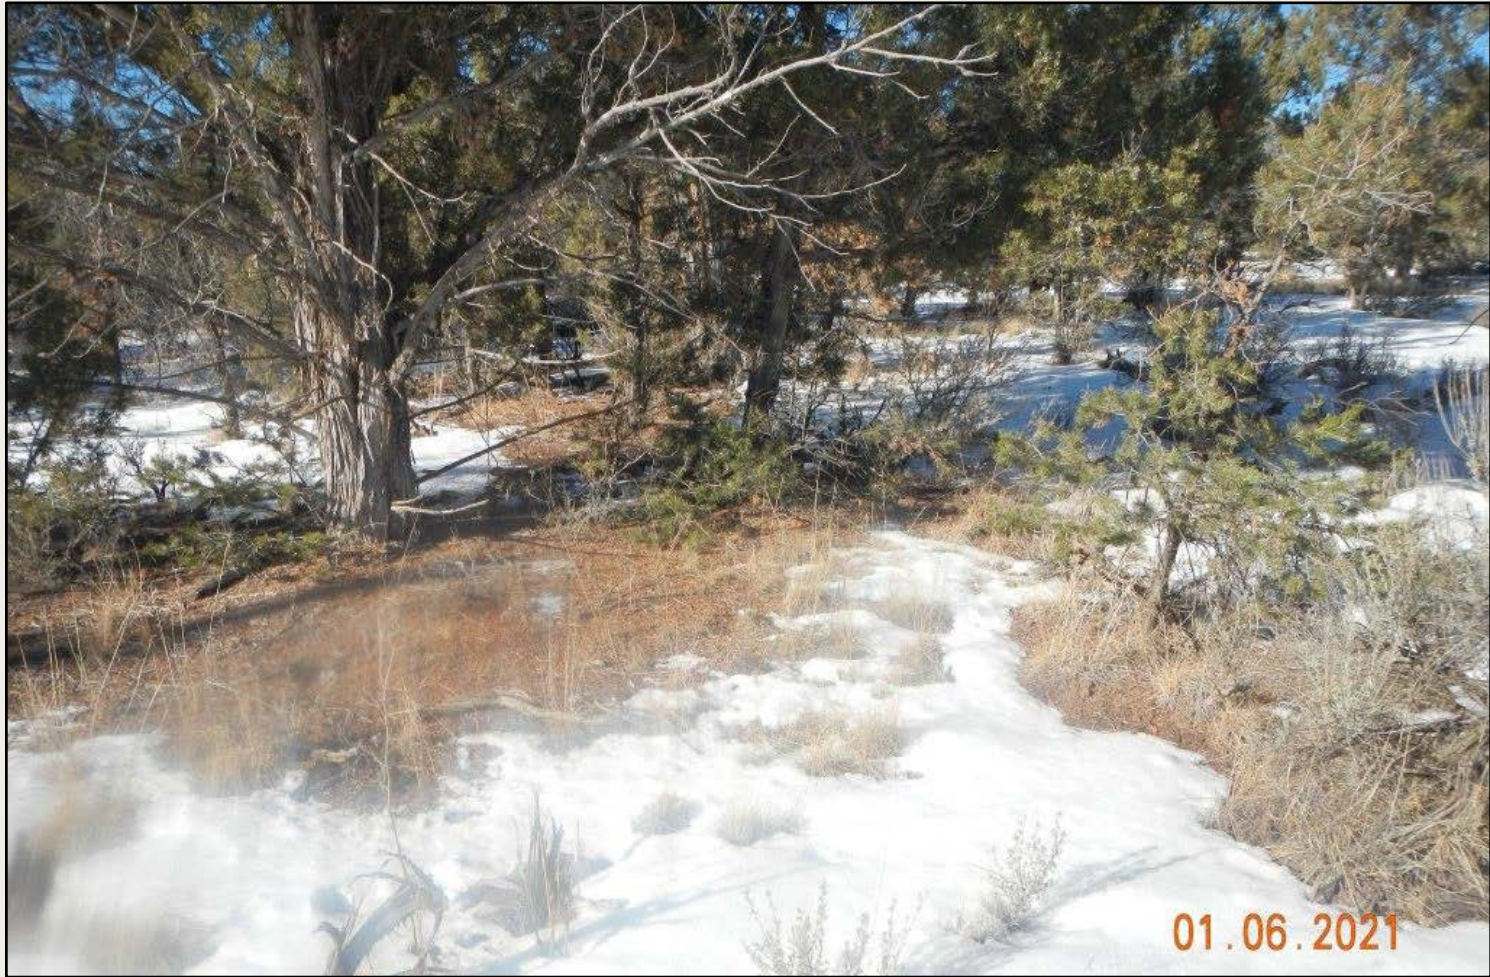
Photo 5. View of reference area comprised of pinyon and juniper woodland with sagebrush, squirreltail, and narrow leaf penstemon.
