Inspection Photos

Operator: WPX

API: 067-07066

Date: 1/6/2021

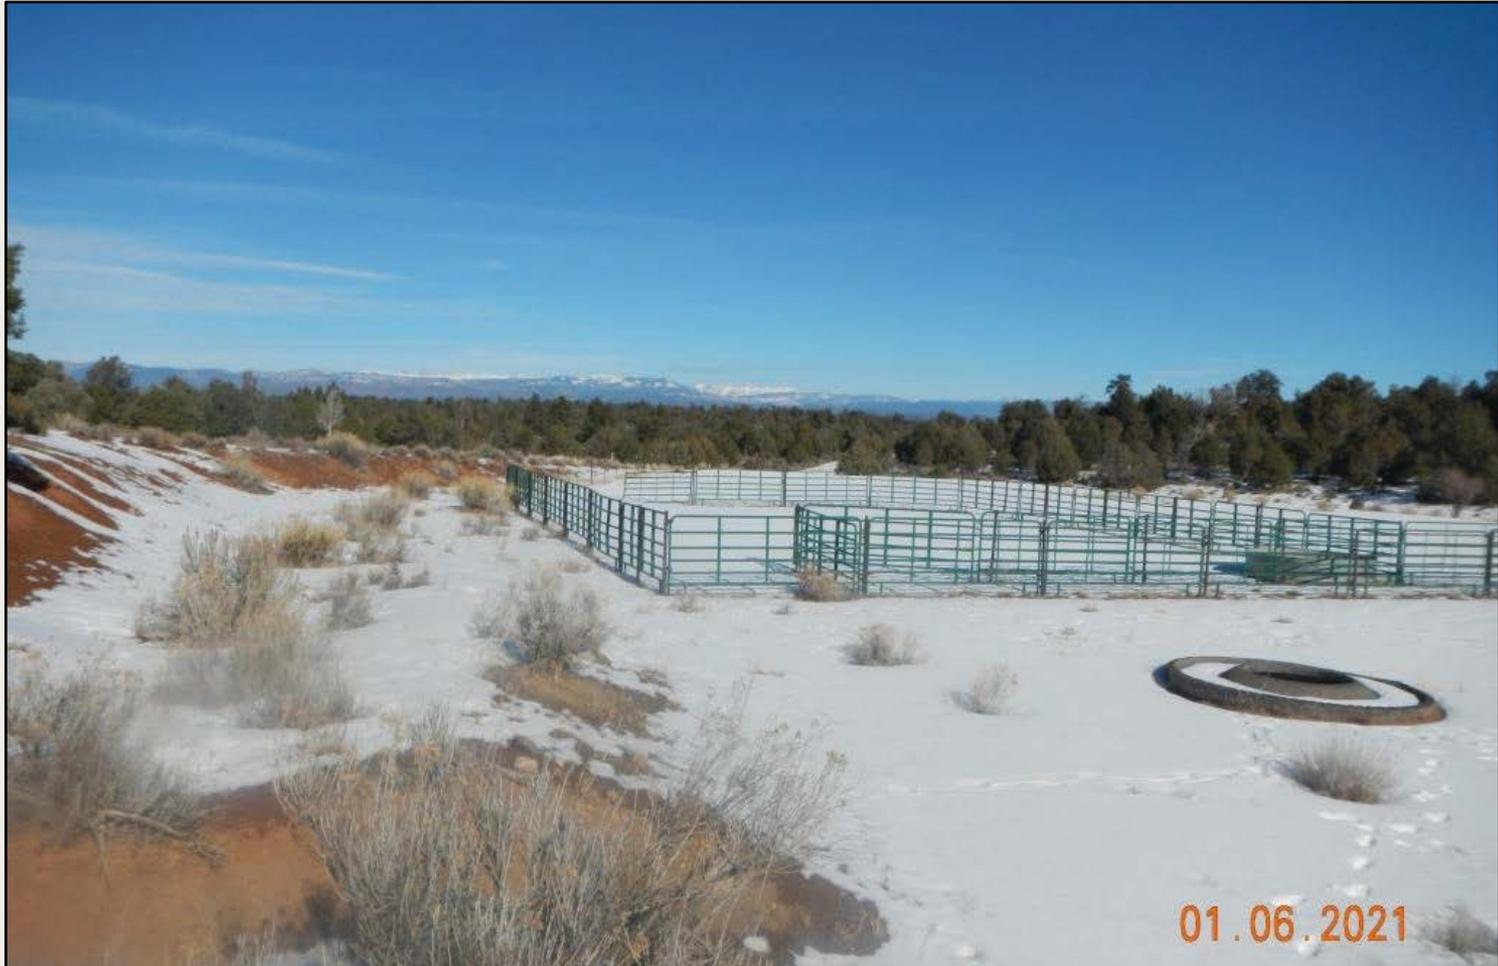
Photo 1. View of the project area from the southwestern corner facing center. Location is not recontoured.

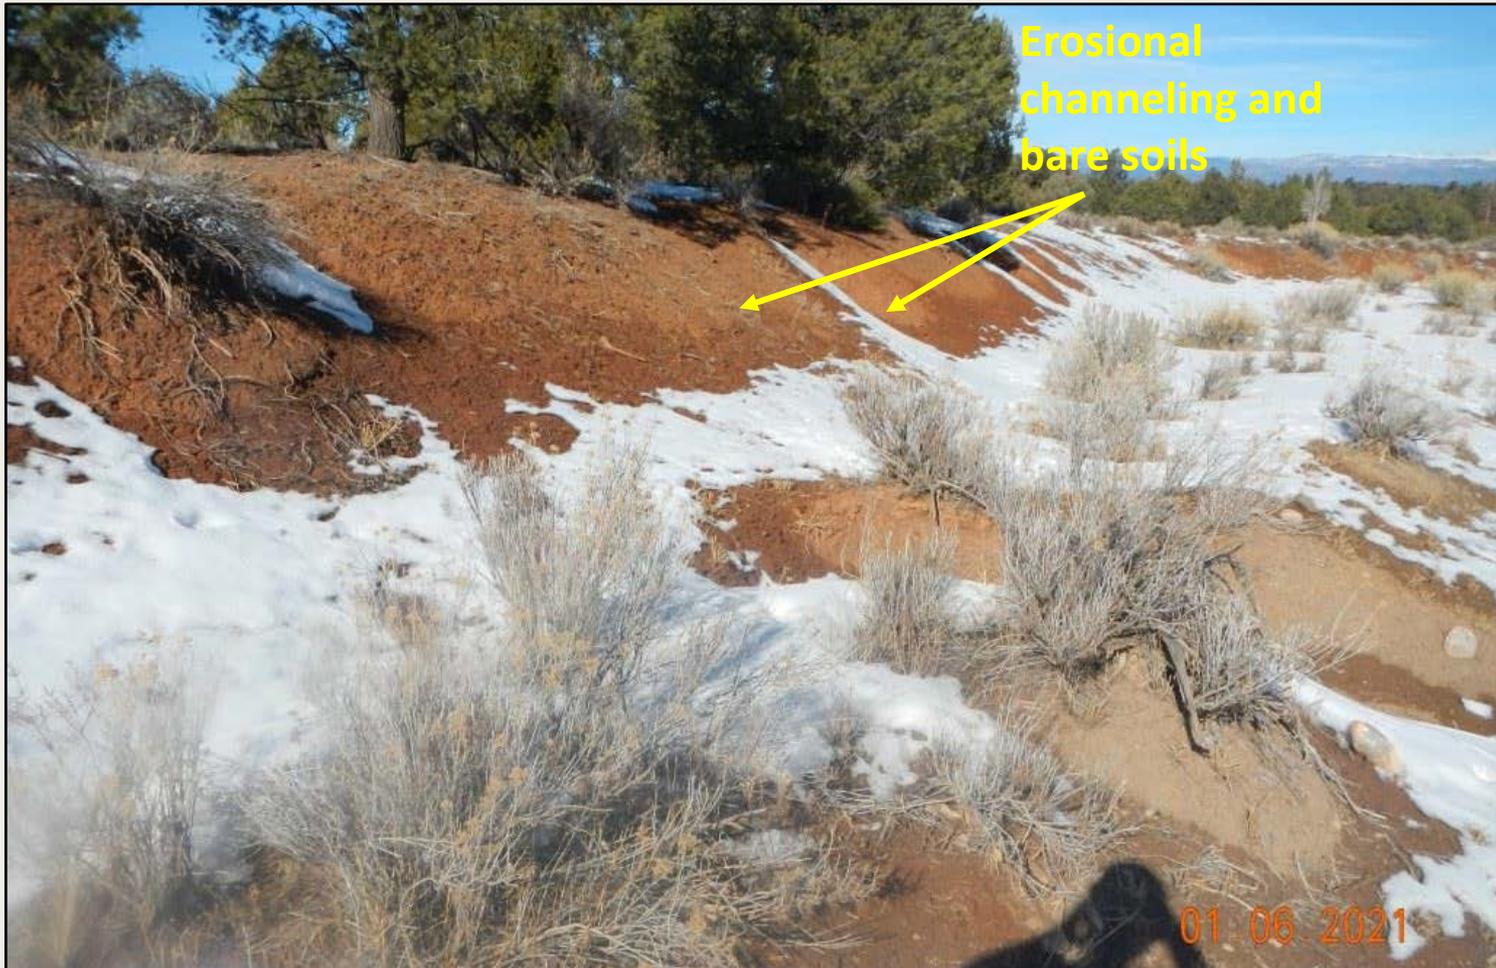
Photo 2. View of the western cut slope facing northward. Evidence of erosional channeling and bare soils observed. Cut slope was not recontoured.

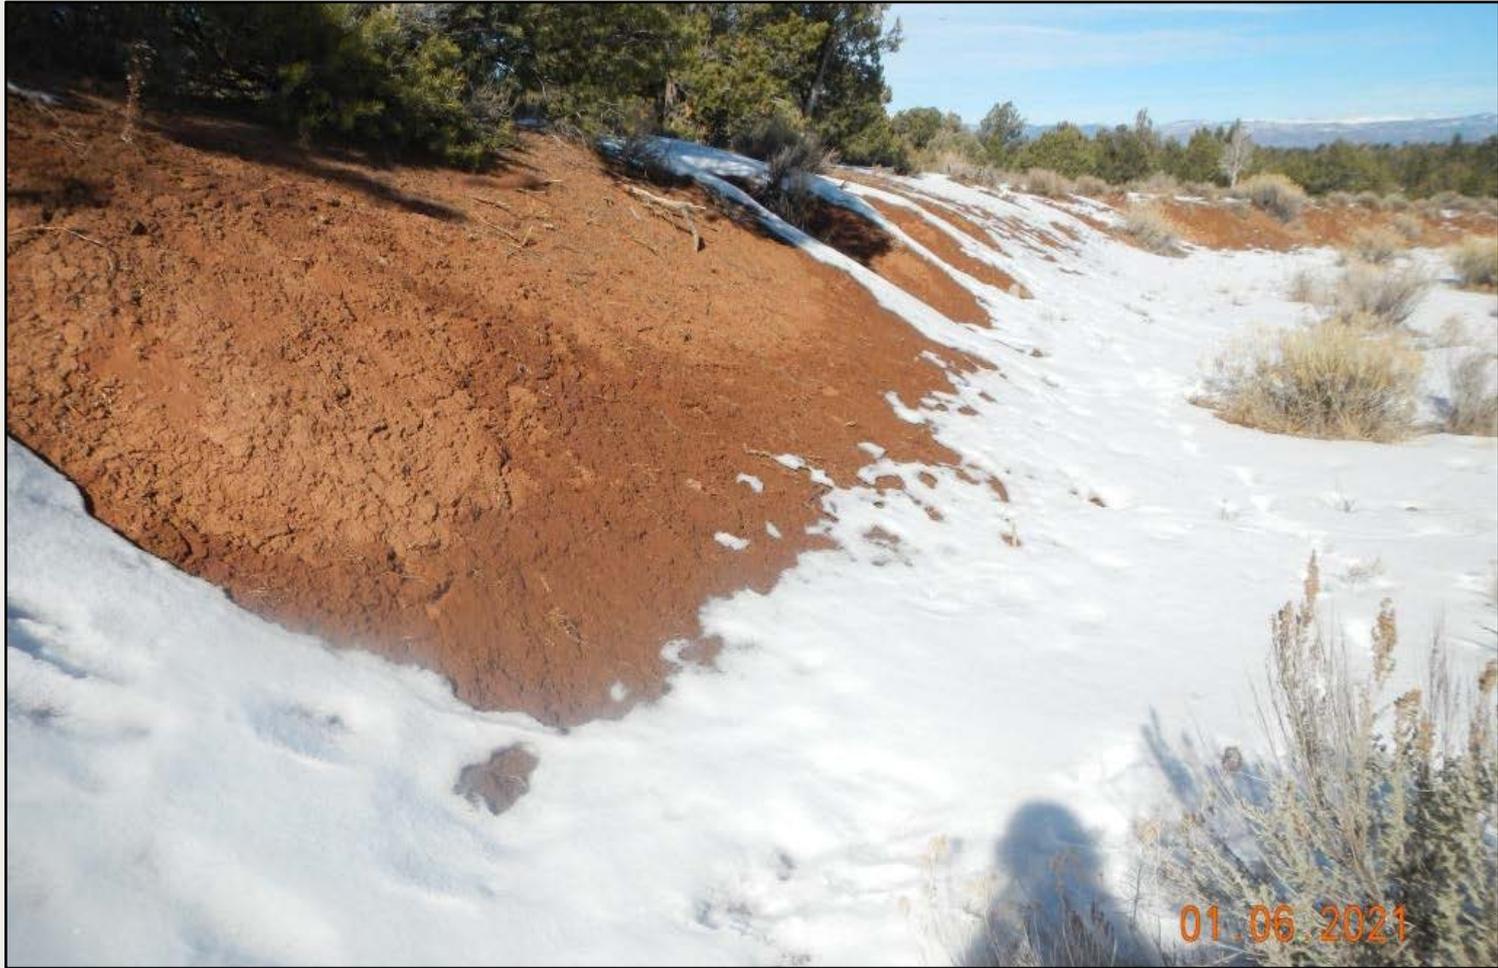
Photo 3. Another view of bare soils and steep cut-slopes lacking recontouring.

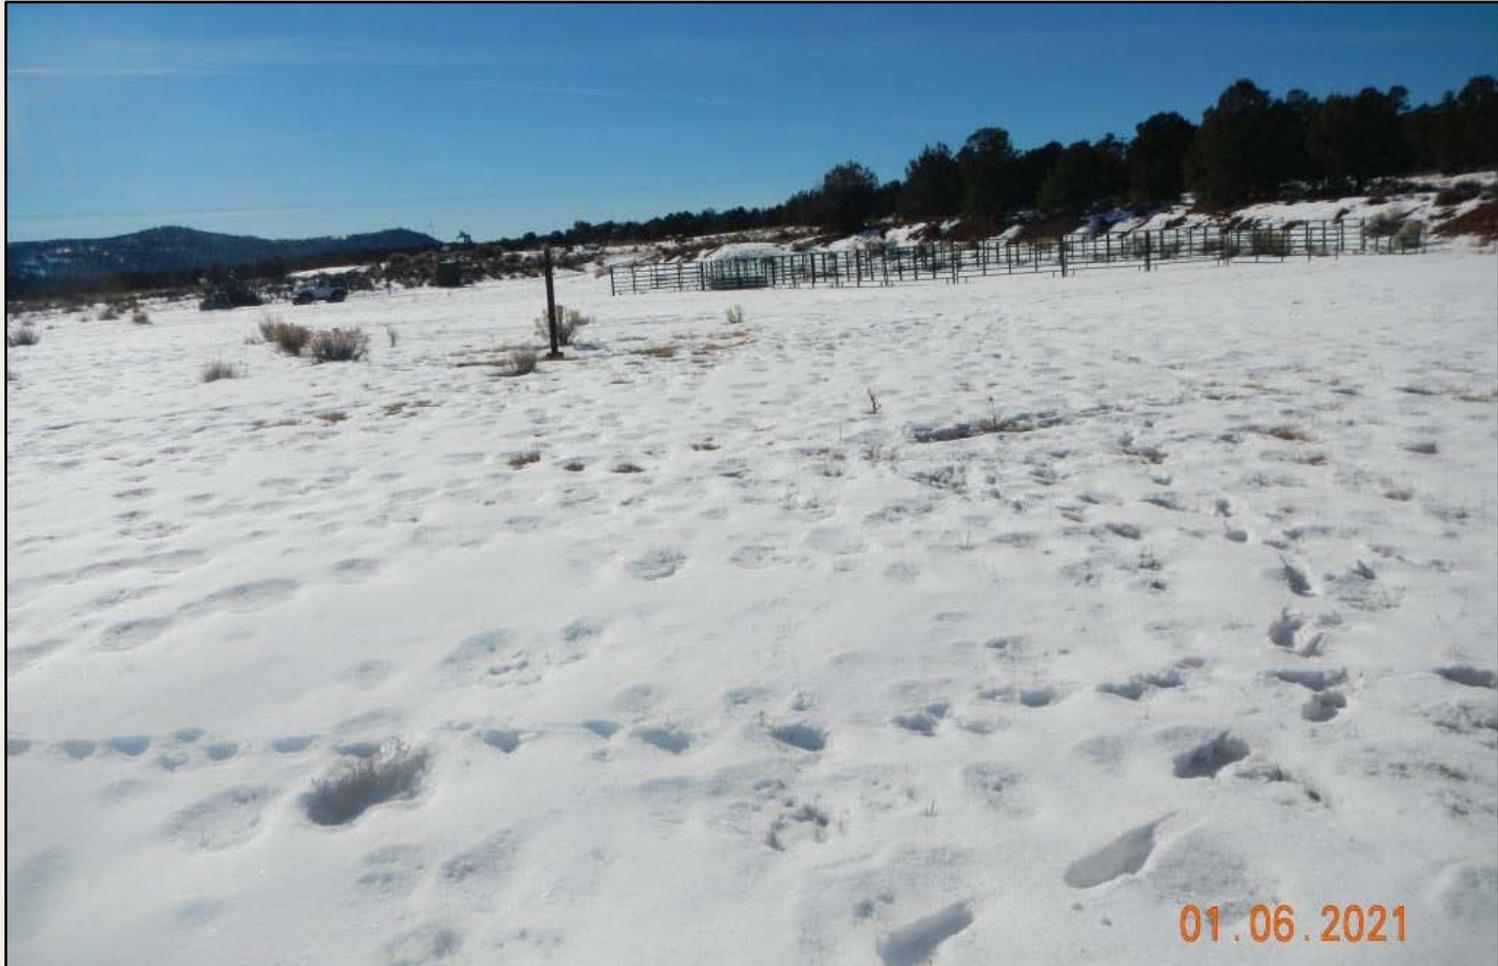
Photo 4. View of location from the northeastern corner facing center. Large flat location remains.
