Inspection Photos

API# 045-06745

Operator: Chevron

Insp #:692402874

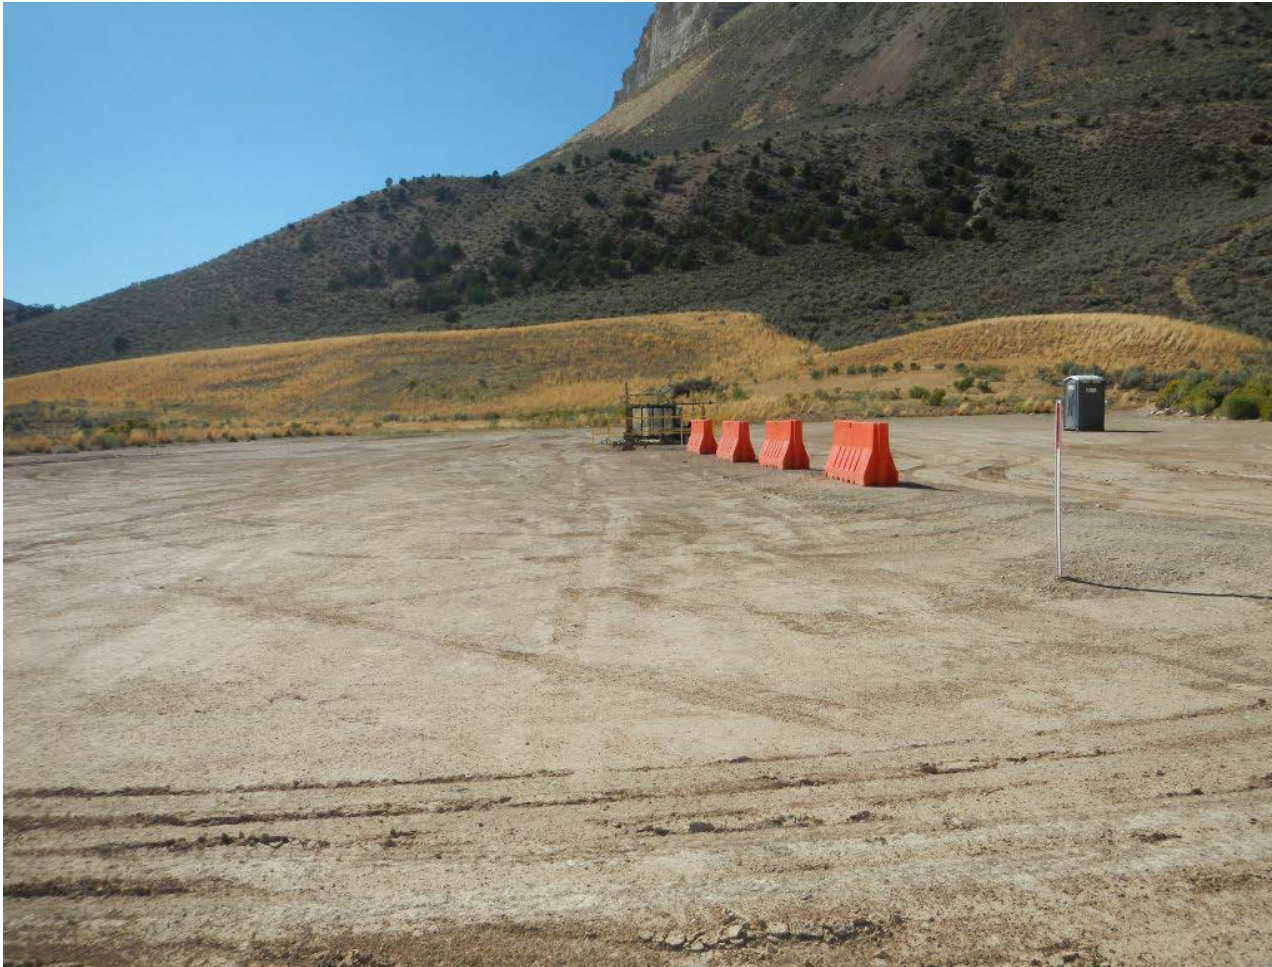
Photo#1:
There is No Evidence of the DA Well on this Active Location.

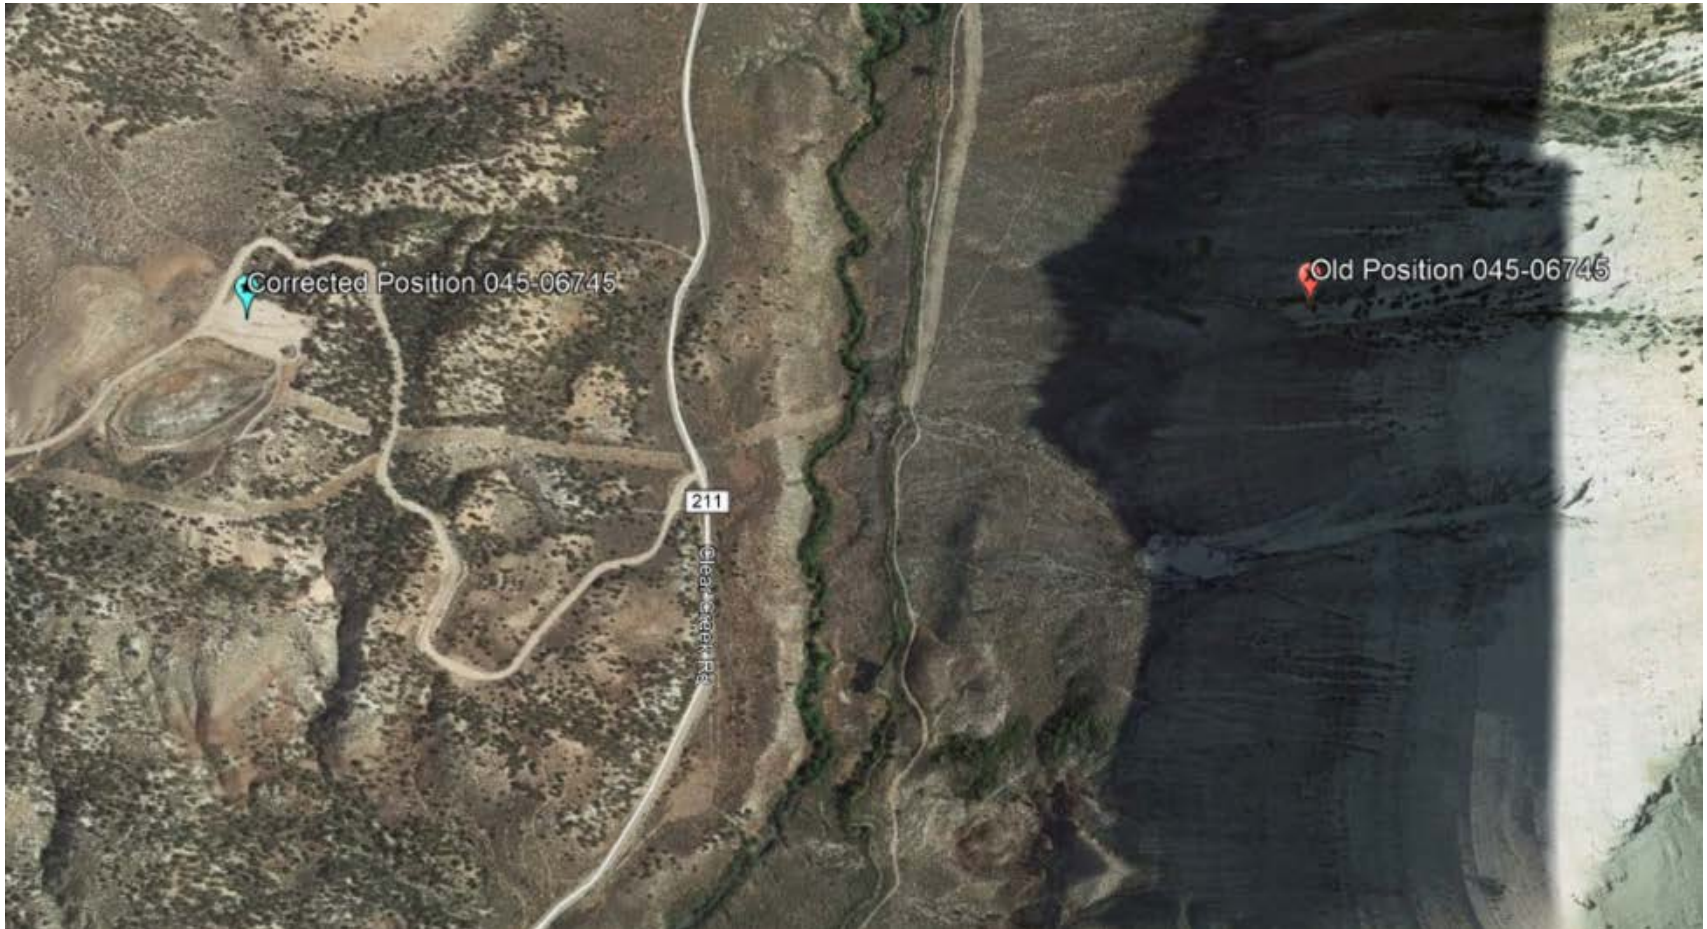
Photo#2:
Google Earth; Aerial view of corrected Well position.
