# Interim Reclamation and Stormwater Inspection

January 11, 2021

Operator: EXTRACTION OIL & GAS LLC- #10459

Location ID: 441811

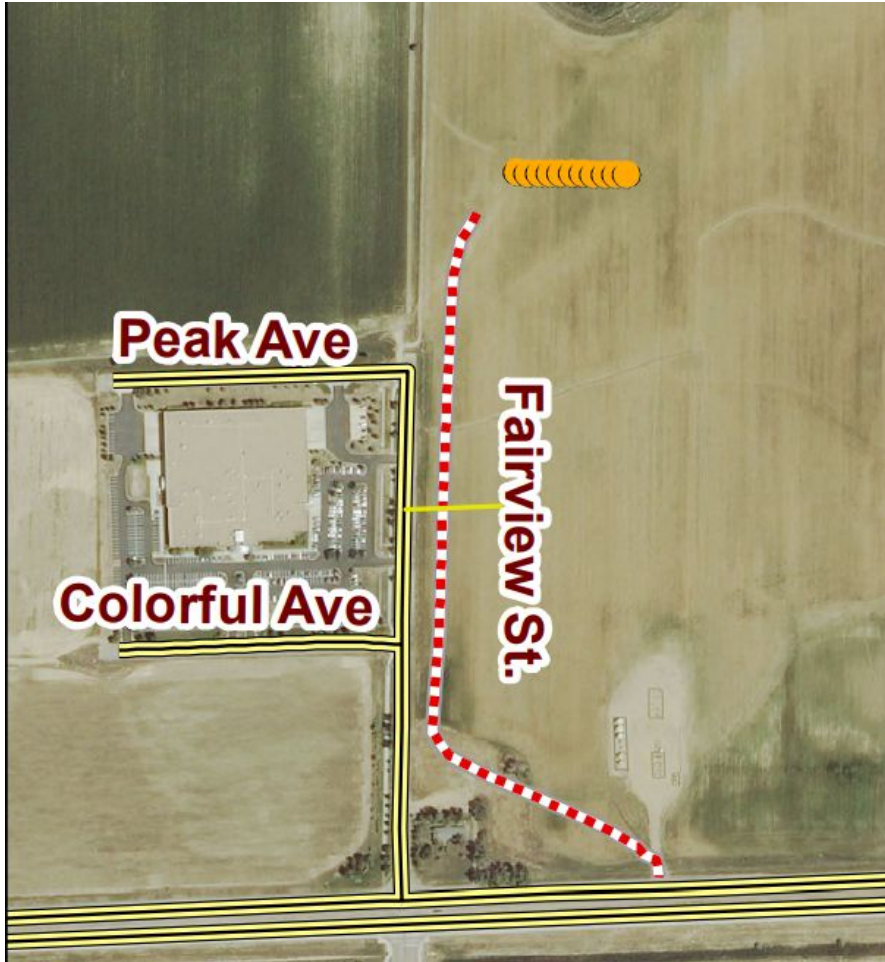
**Photo 1.** The above imagery illustrates the approved Fairview/5-I Pad access route.

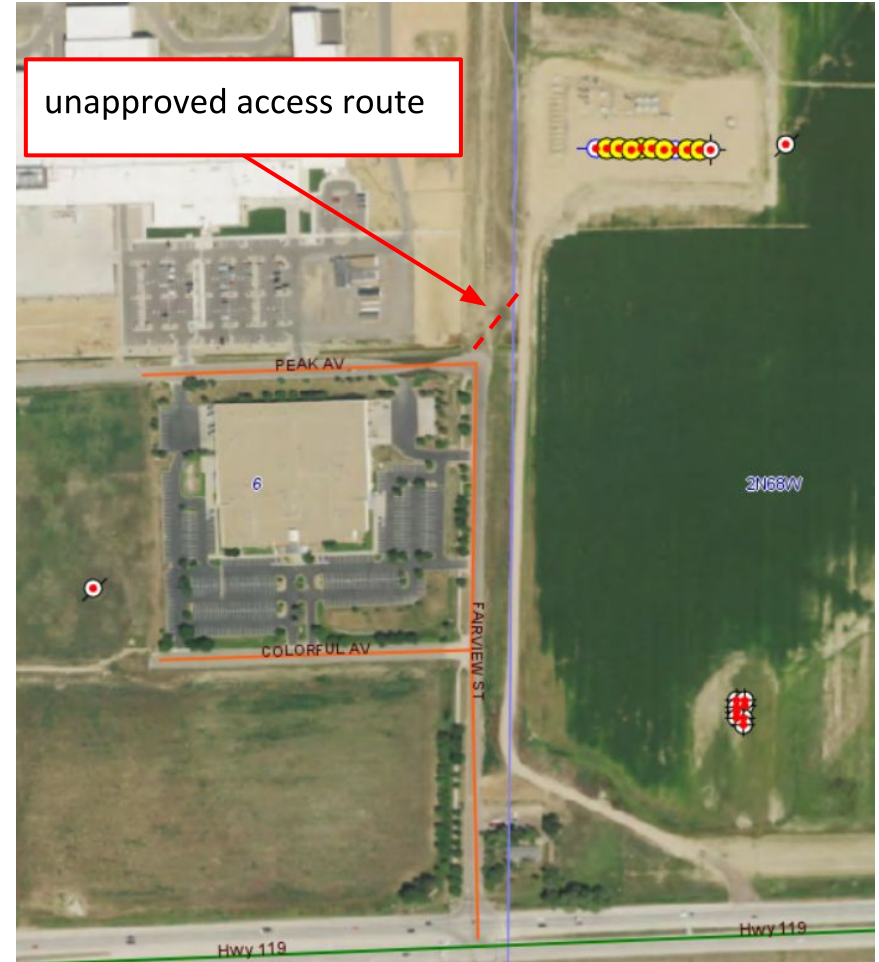
**Photo 2.** The above imagery illustrates an unapproved access route that is being utilized (red dashed line). Refer to Photos 3- regarding the unapproved access route.

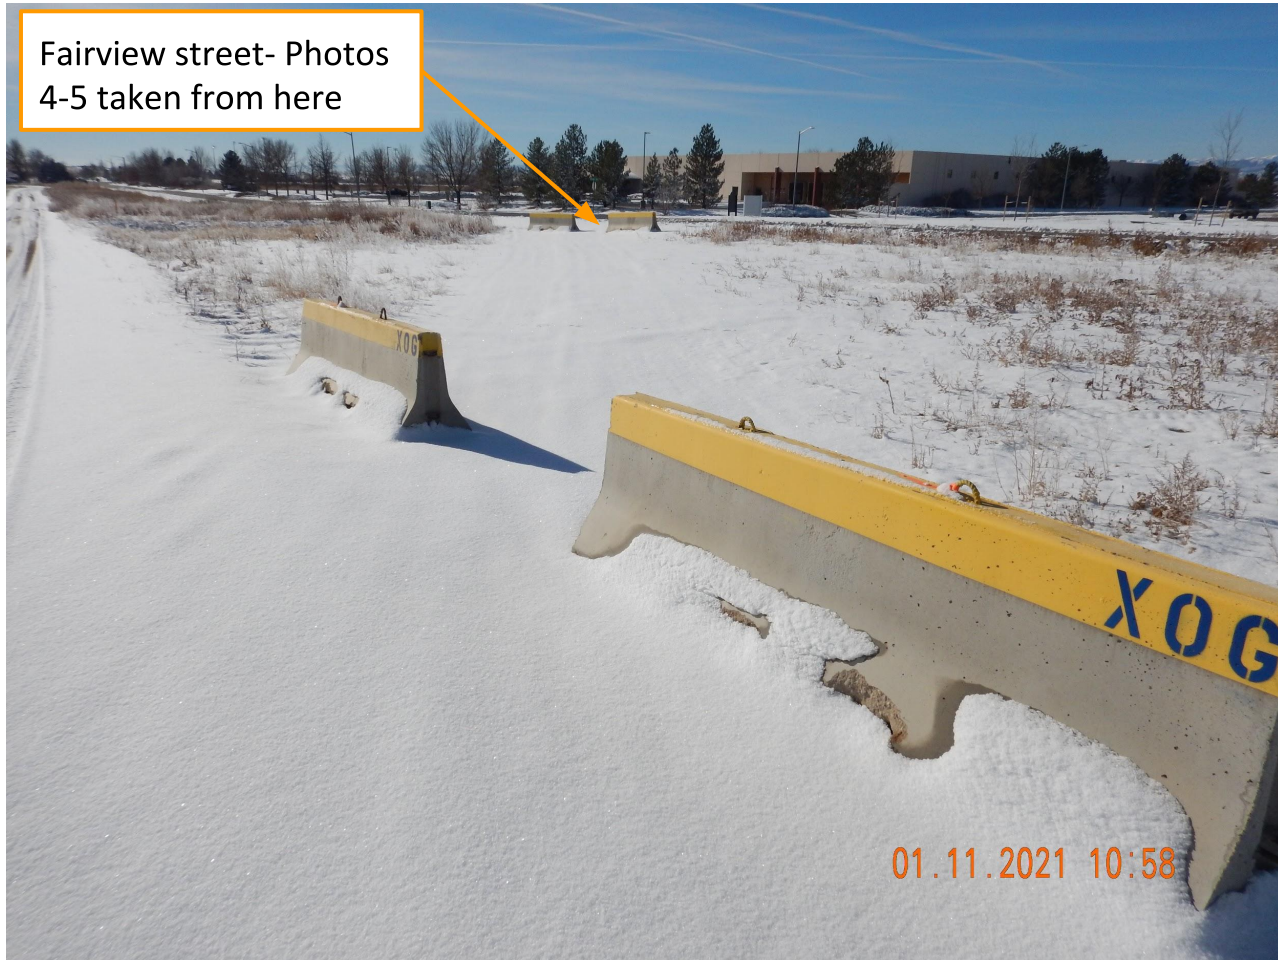
**Photo 3.** Photo taken from the approved oil and gas access road, facing Southwest. Photo illustrates a portion of an unapprove access route that has been utilized. Vehicle traffic is departing the access road traveling southwest to access Fairview St. On January 7, 2021, Extraction put up temporary barriers to prohibit further use.

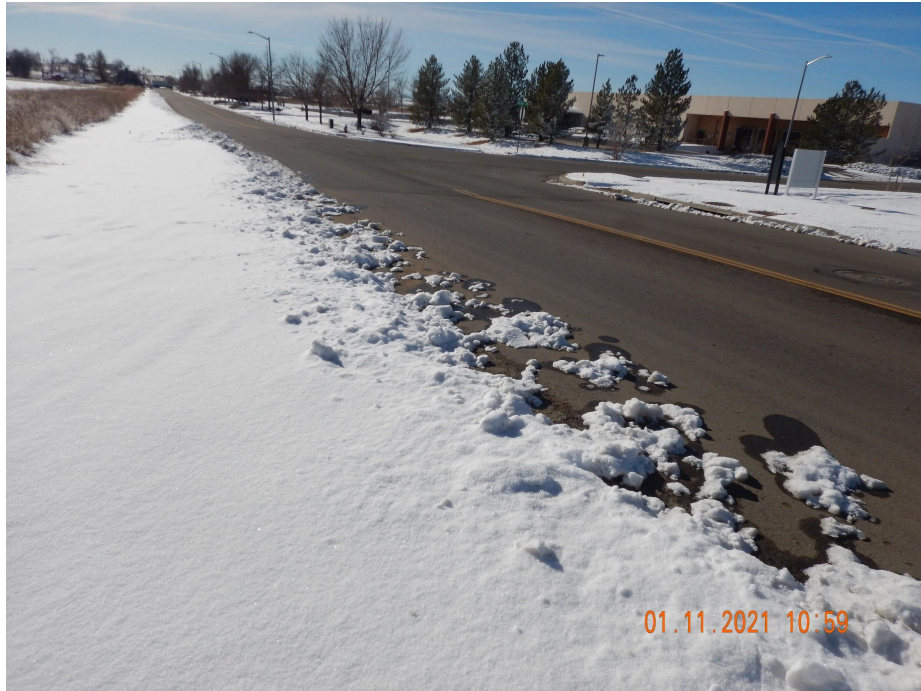
**Photo 4.** Photo taken from Fairview St, facing South. Photo illustrates no evidence of vehicle track out at the time of this inspection. City of Longmont stated there was some damage to Smuckers vegetation due to this vehicle traffic. Snow cover prevented further investigation of that matter.

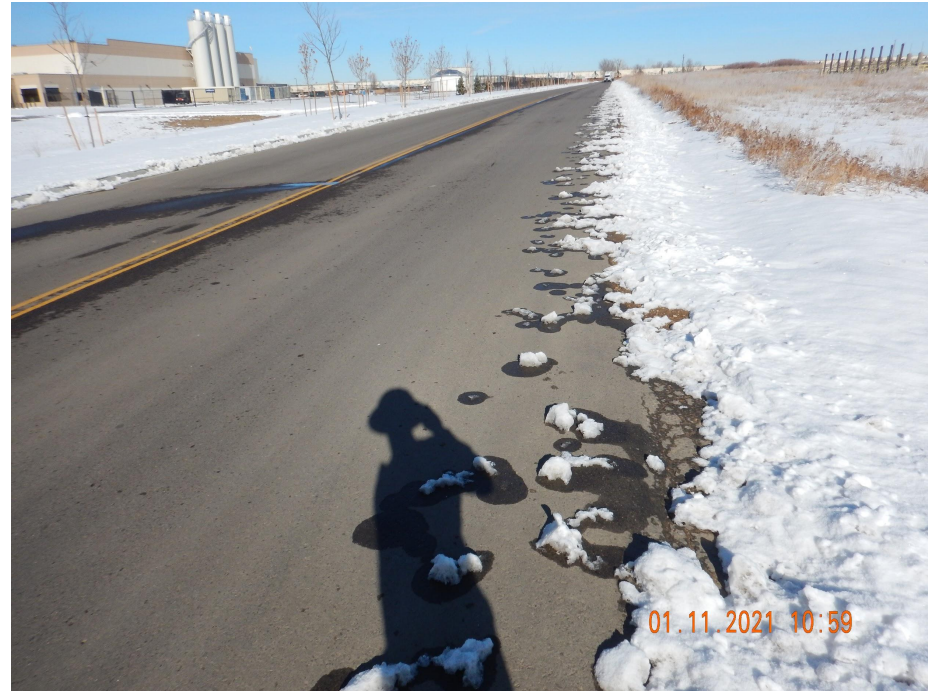
**Photo 5.** Photo taken from Fairview St, facing North. See comments under Photo 4.

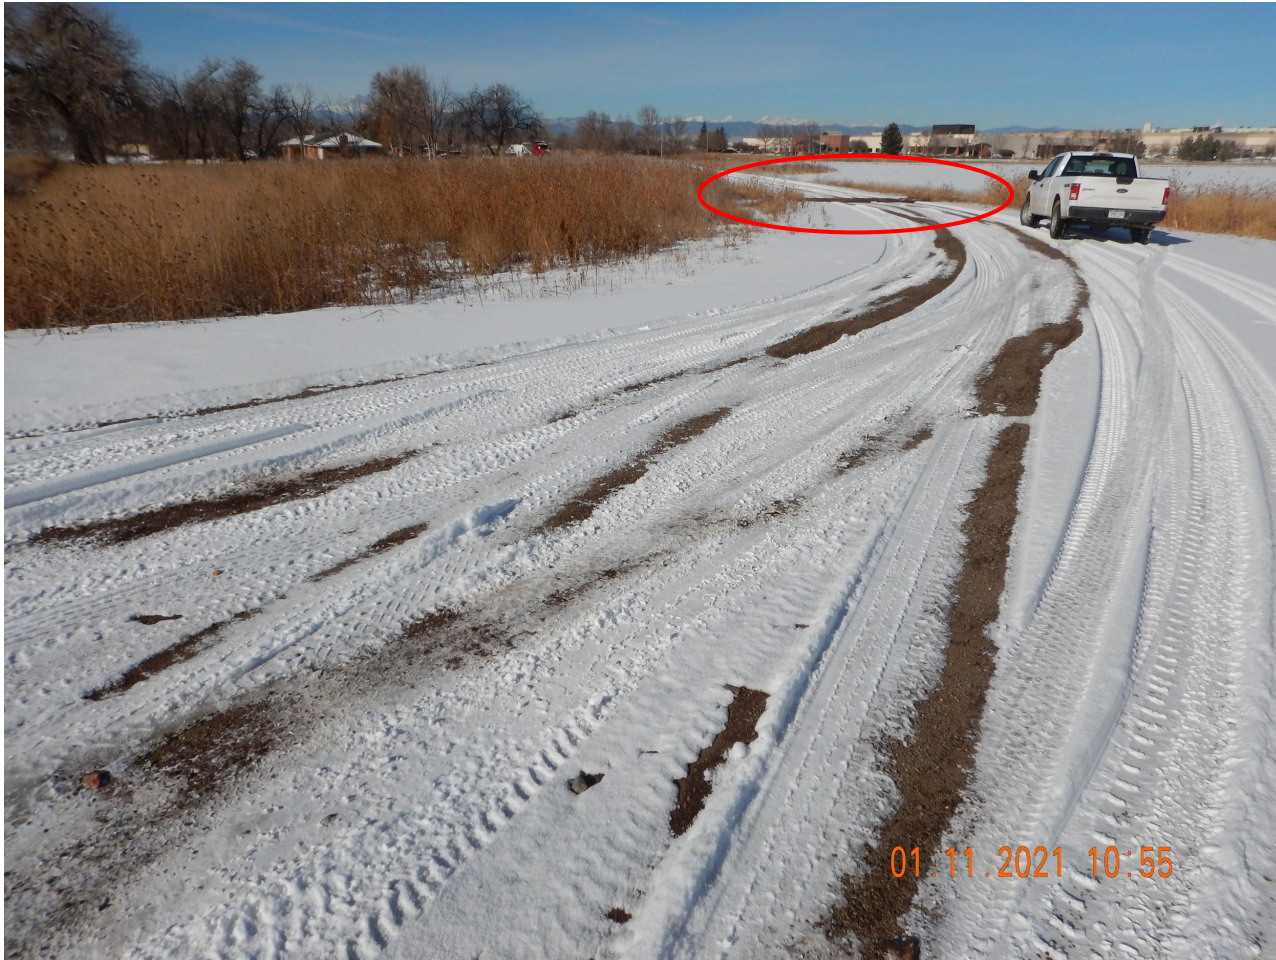
**Photo 6.** Photo taken from the entrance of the access road off Hwy 119, facing Northwest. Photo illustrates the entrance/exit portion of access road- from the cattle guard (red circle) to Hwy 119- has been sufficiently stabilized with recycled asphalt. There was no evidence of vehicle rutting or vehicle track out, which further indicates the access road has been sufficiently stabilized.

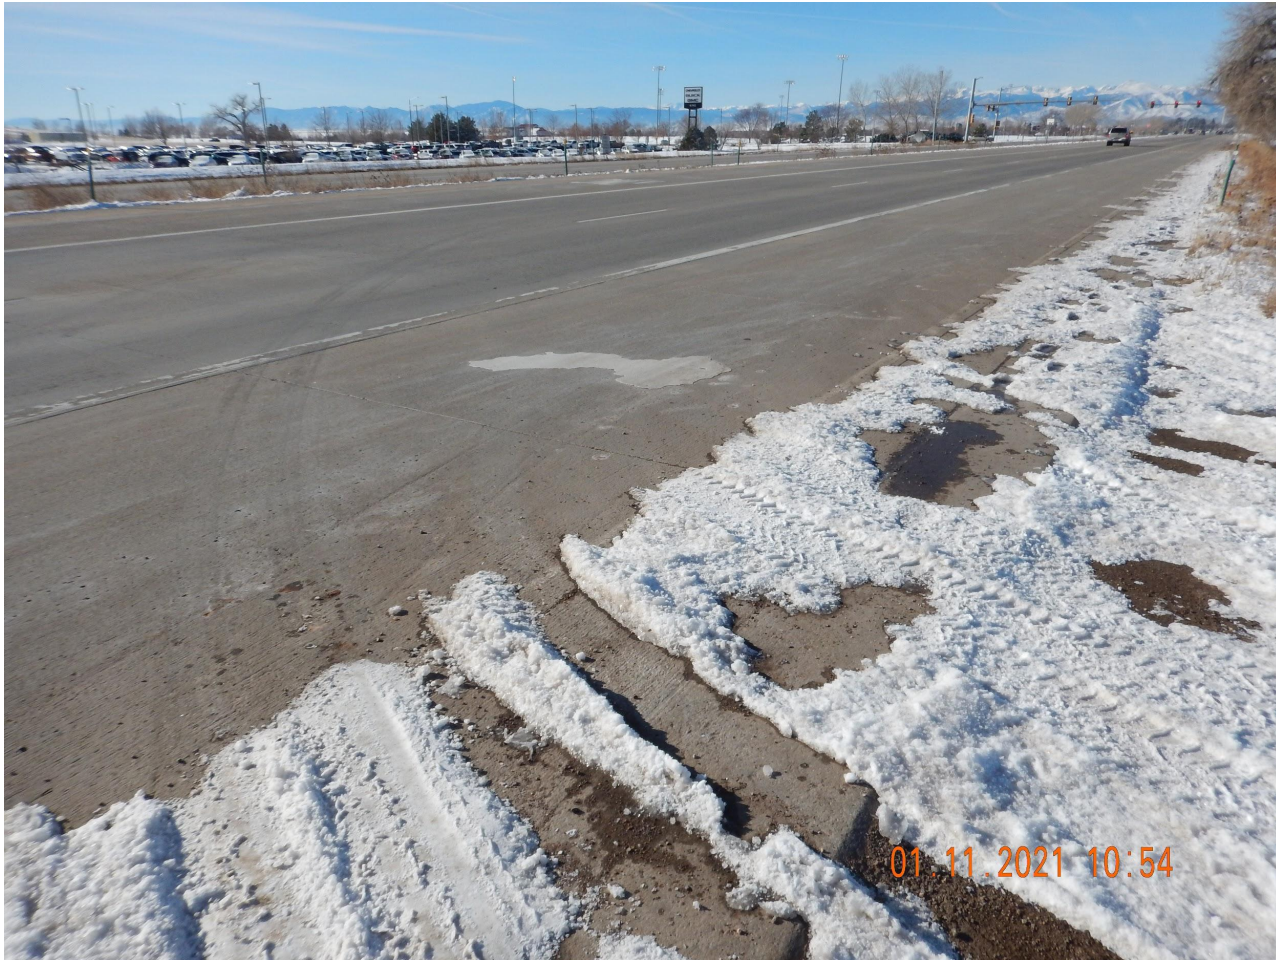
**Photo 7.** Photo taken from the entrance of the access road off Hwy 119, facing West. Photo illustrates no evidence of vehicle track out at the time of this inspection.

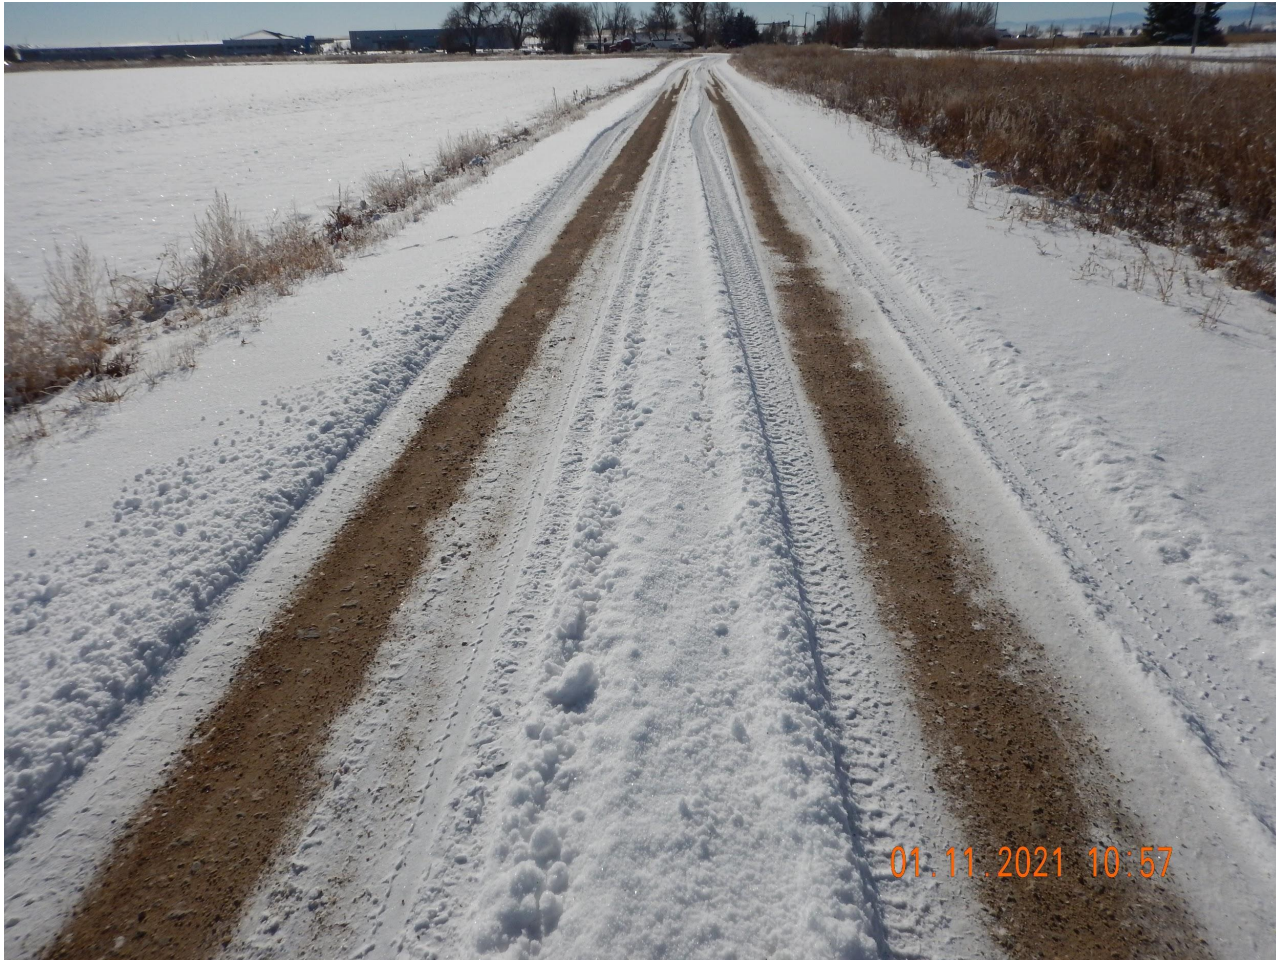
**Photo 8.** Photo taken from a portion of the northern access road, facing South. Photo illustrates the access road has been sufficiently stabilized and there was no evidence of vehicle rutting.

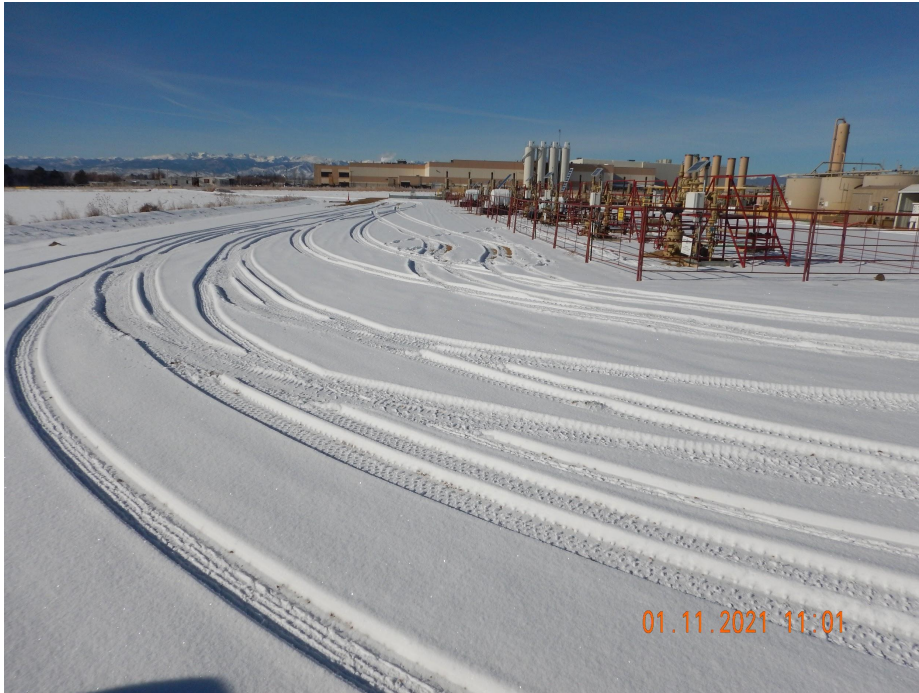
**Photo 9.** Photo taken from the southeastern location, facing West. Photo illustrates Extraction has performed interim reclamation to reduce all disturbance area only needed for production operations.

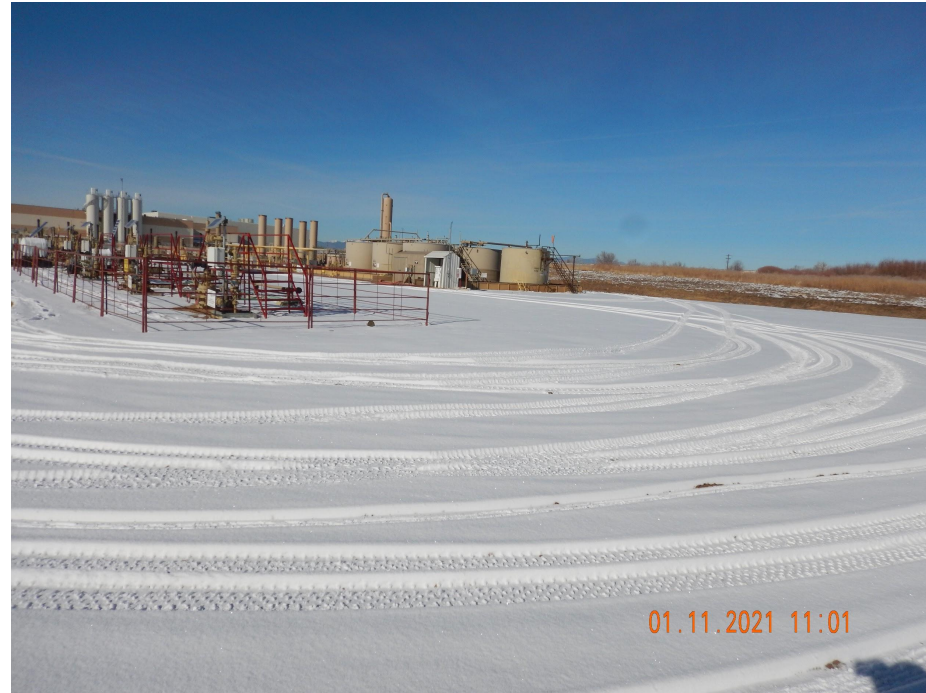
**Photo 10.** Photo taken from the southeastern location, facing Northwest. See comments under Photo 9.

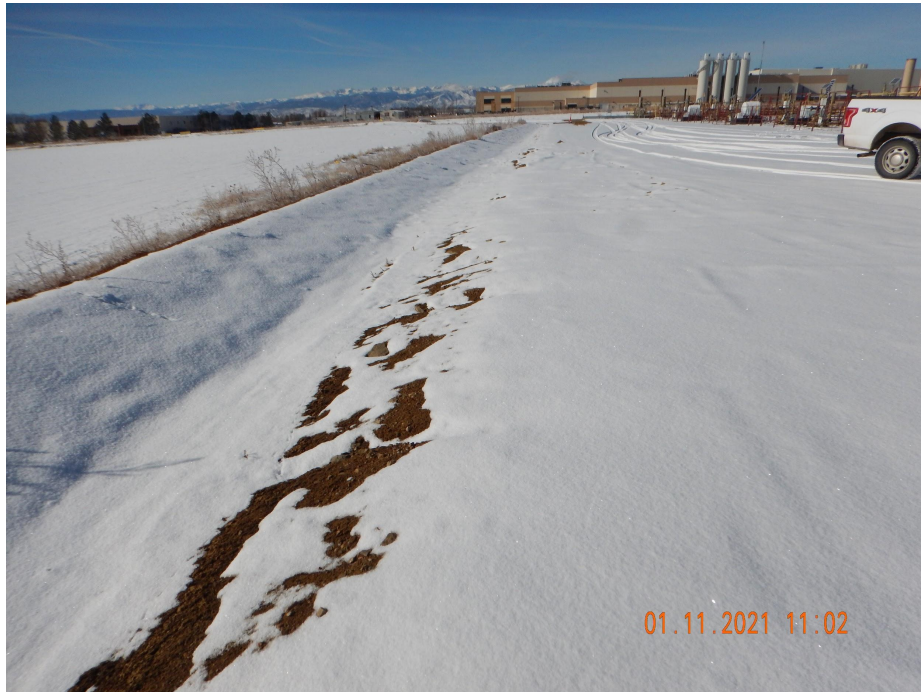
**Photo 11.** Photo taken from the southeastern location, facing West. Photo illustrates a ditch and berm BMP, which is directed to a stabilized outlet along the southeastern location.

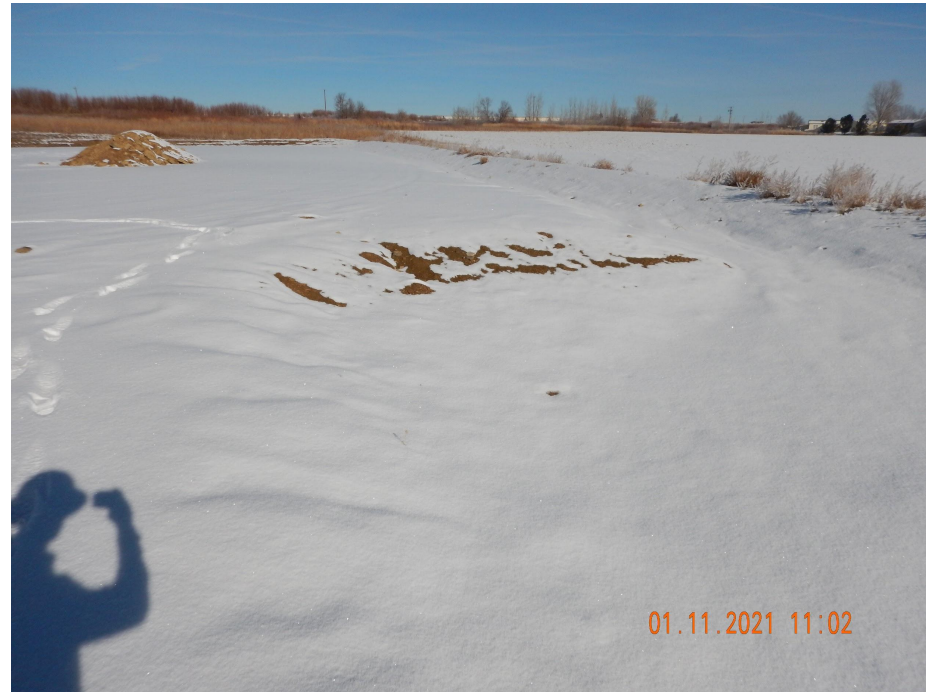
**Photo 12.** Photo taken from the southeastern location, facing North. See comments under Photo 11.

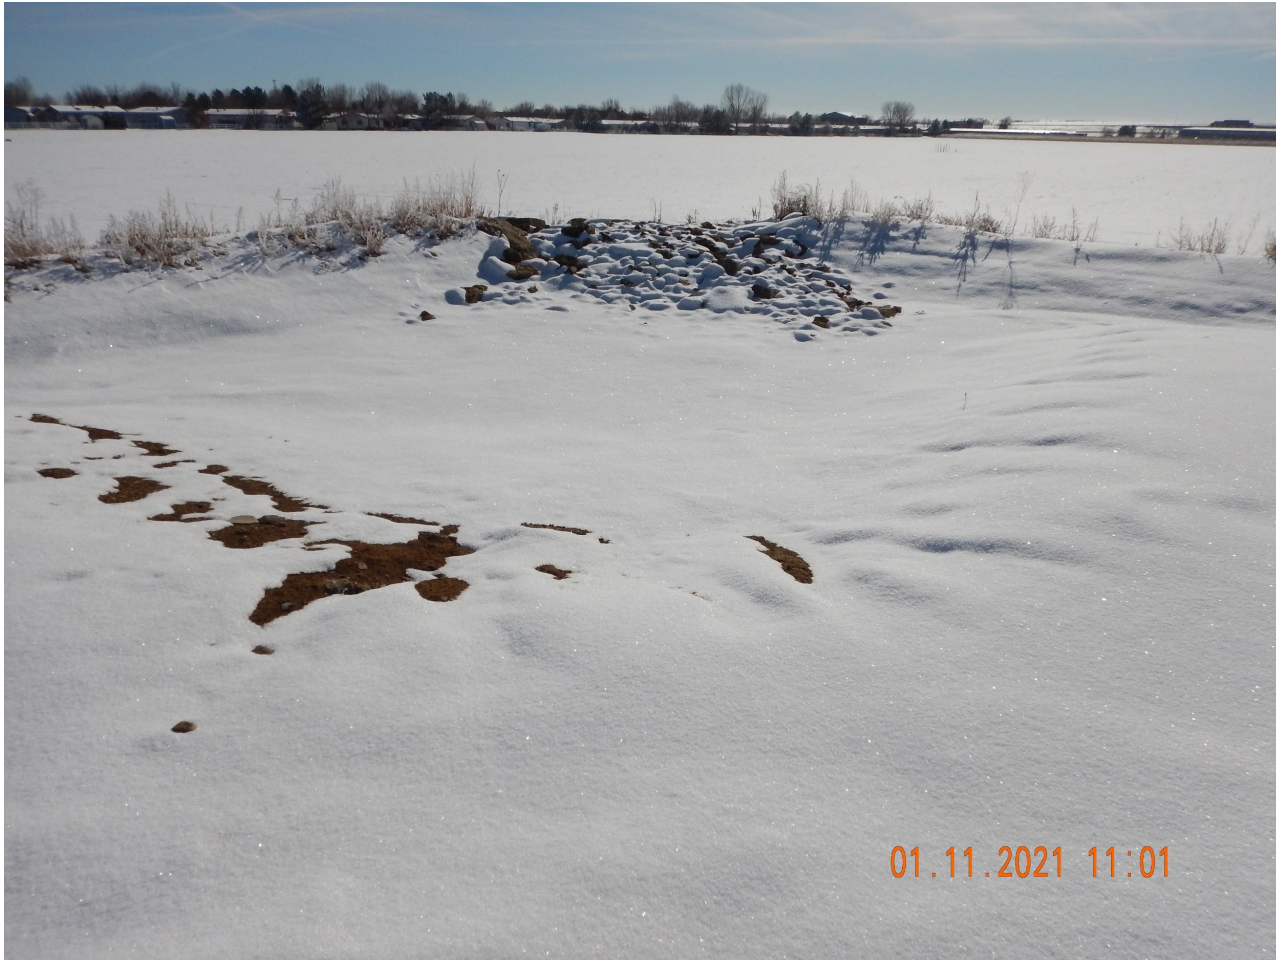
**Photo 13.** Photo taken from the southeastern location, facing Southeast. Photo illustrates the stabilized outlet BMP. At the time of this inspection, all BMPs are in proper functioning condition.
