Inspection Photos
Operator: Simcoe
API: 067-06295
Date: 1/11/2021

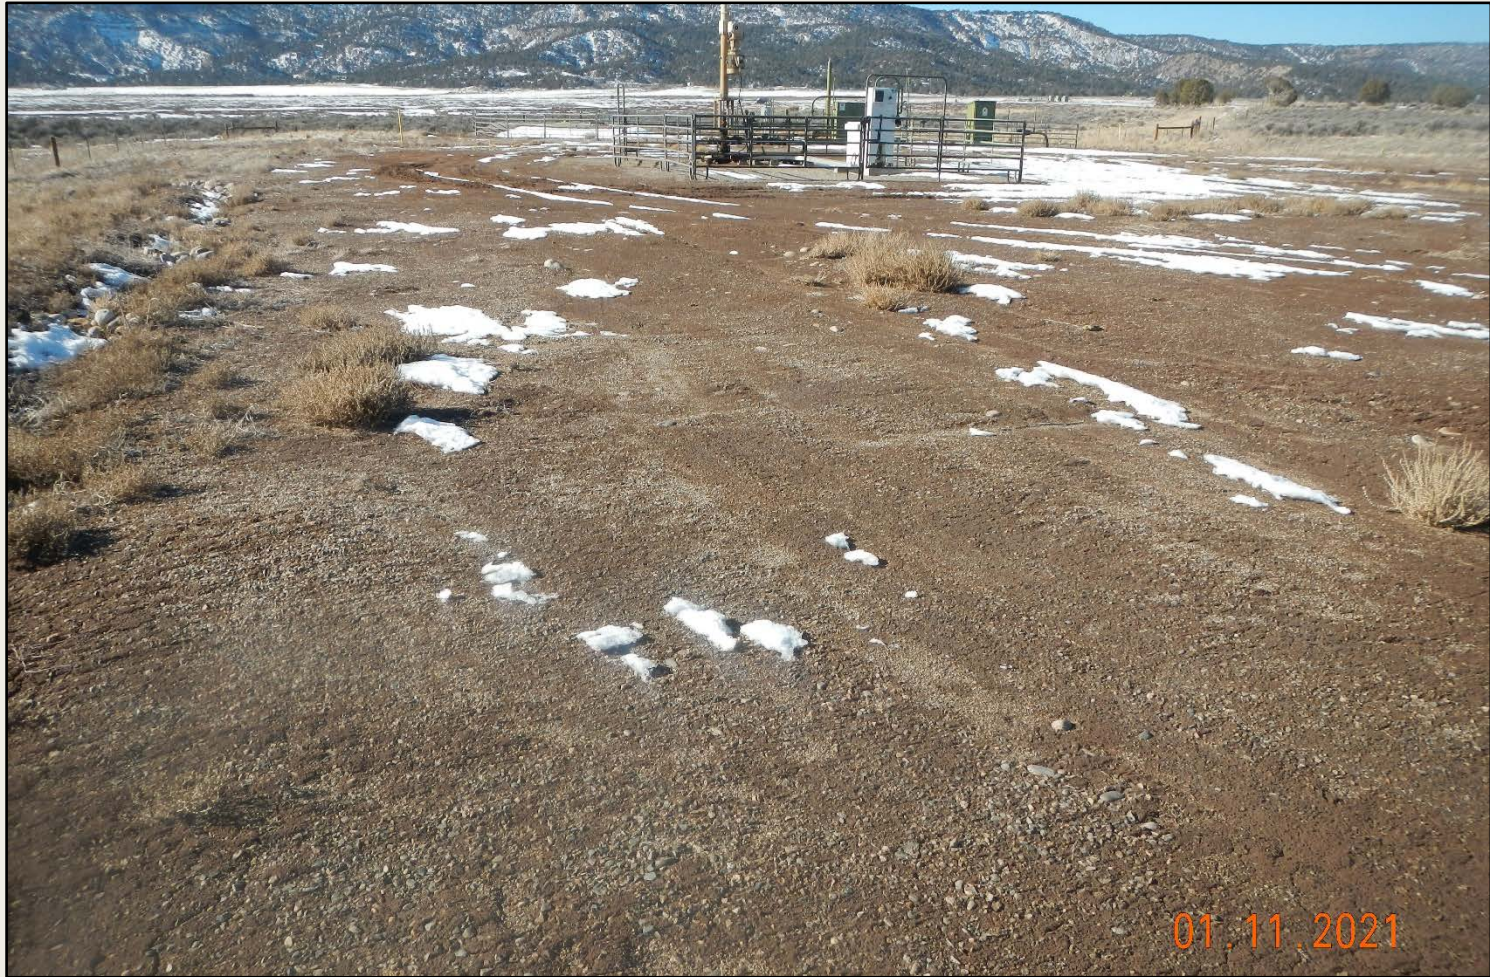
Photo 1. View of the project area from the southeastern corner facing center.

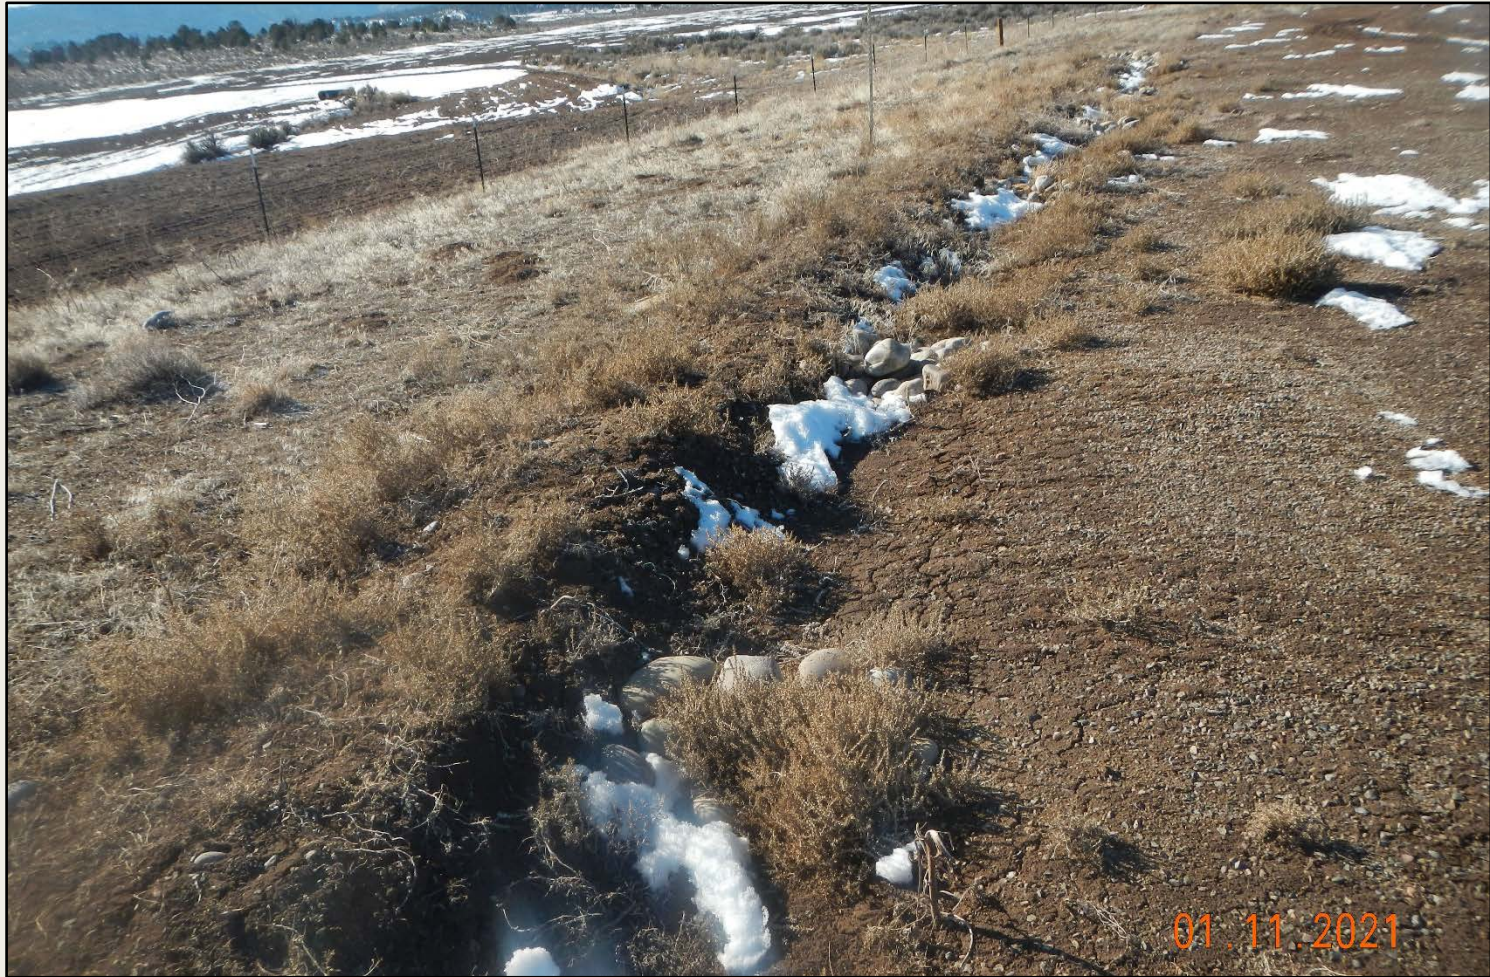
Photo 2. View of the southern fill slope from the southeastern corner. Revegetation is progressing in portions of the project area with western wheatgrass and Indian ricegrass. Portions of the interim area remain weedy and need to be monitored.

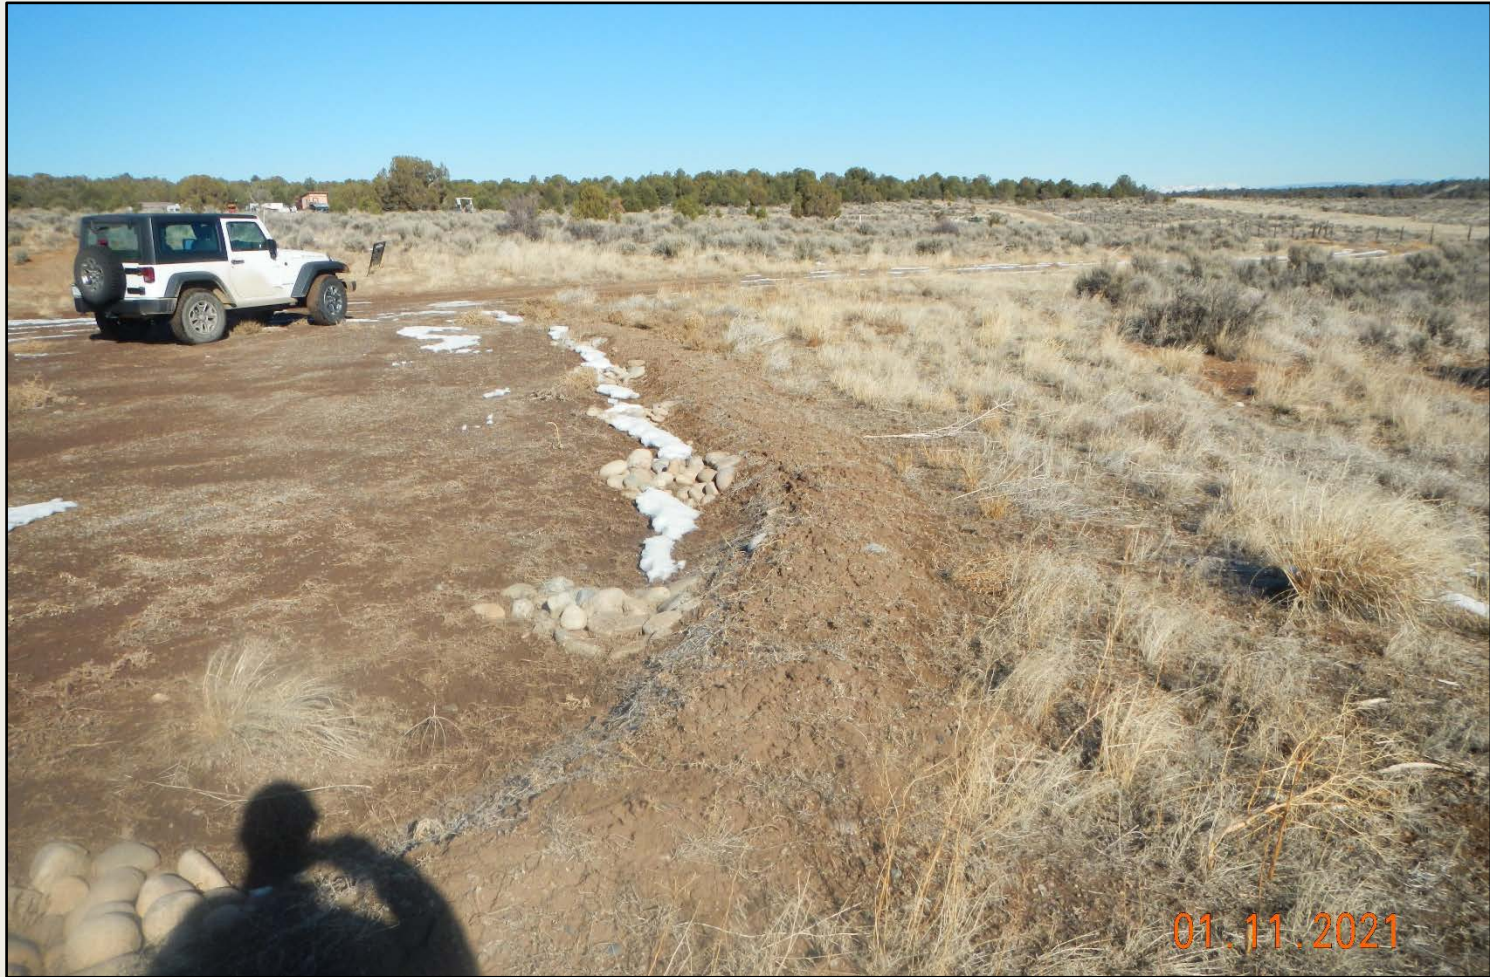
Photo 3. View of the eastern project area facing northward.

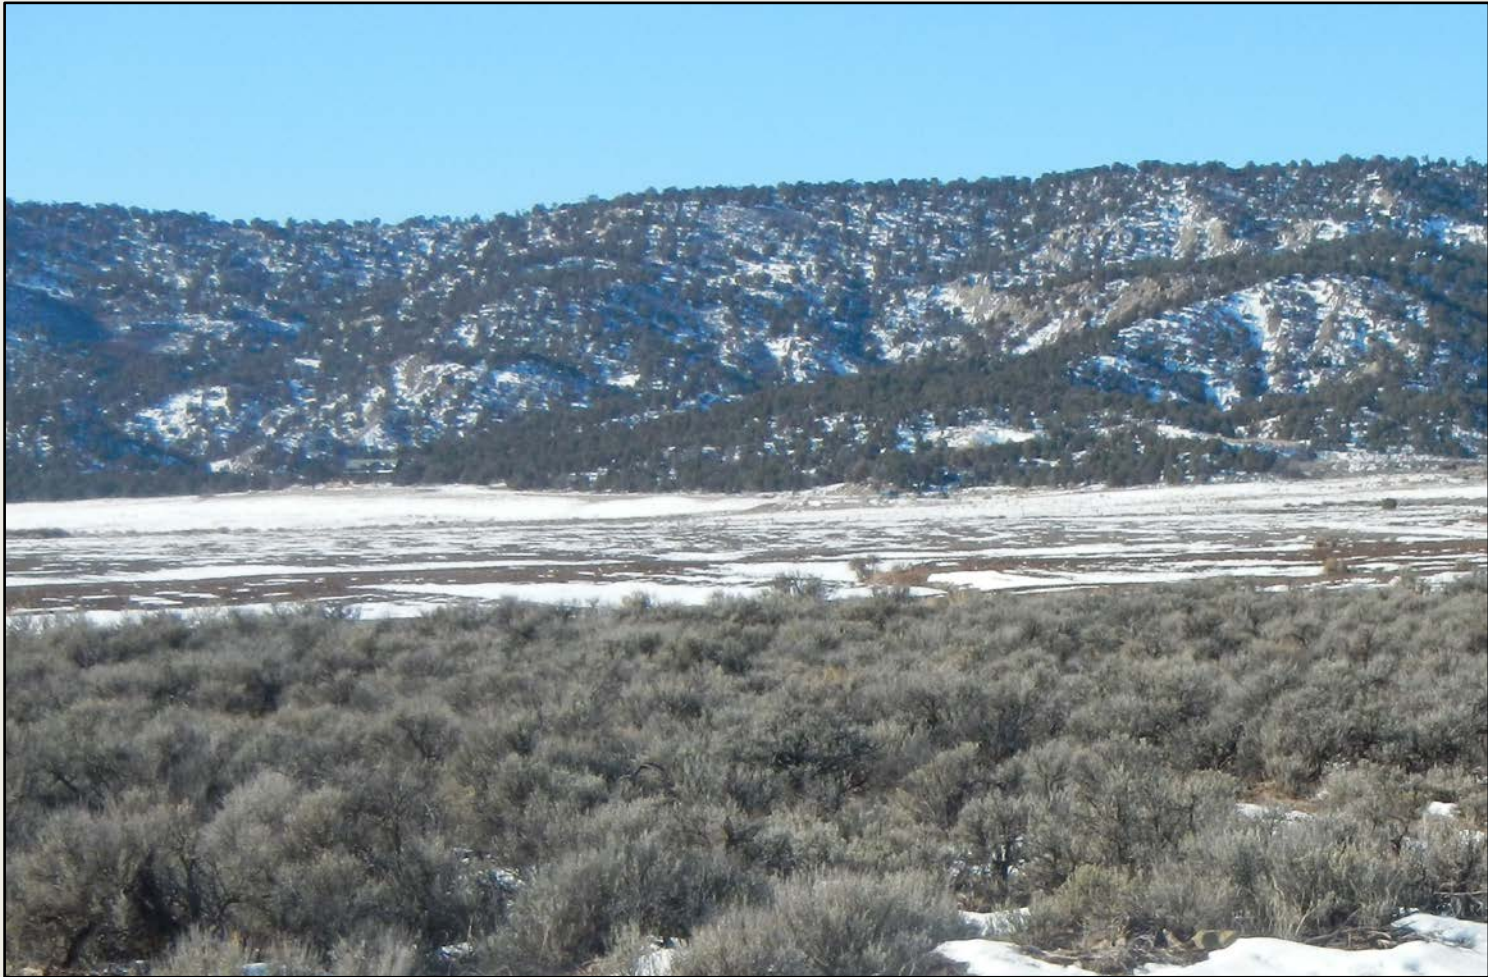
Photo 4. View of reference area comprised of sagebrush shrubland with a mix of grasses and forbs such as buckwheat, blue grama, and western wheatgrass.
