Inspection Photos
Operator: High River Resources
API: 067-07306
Date: 1/11/2021

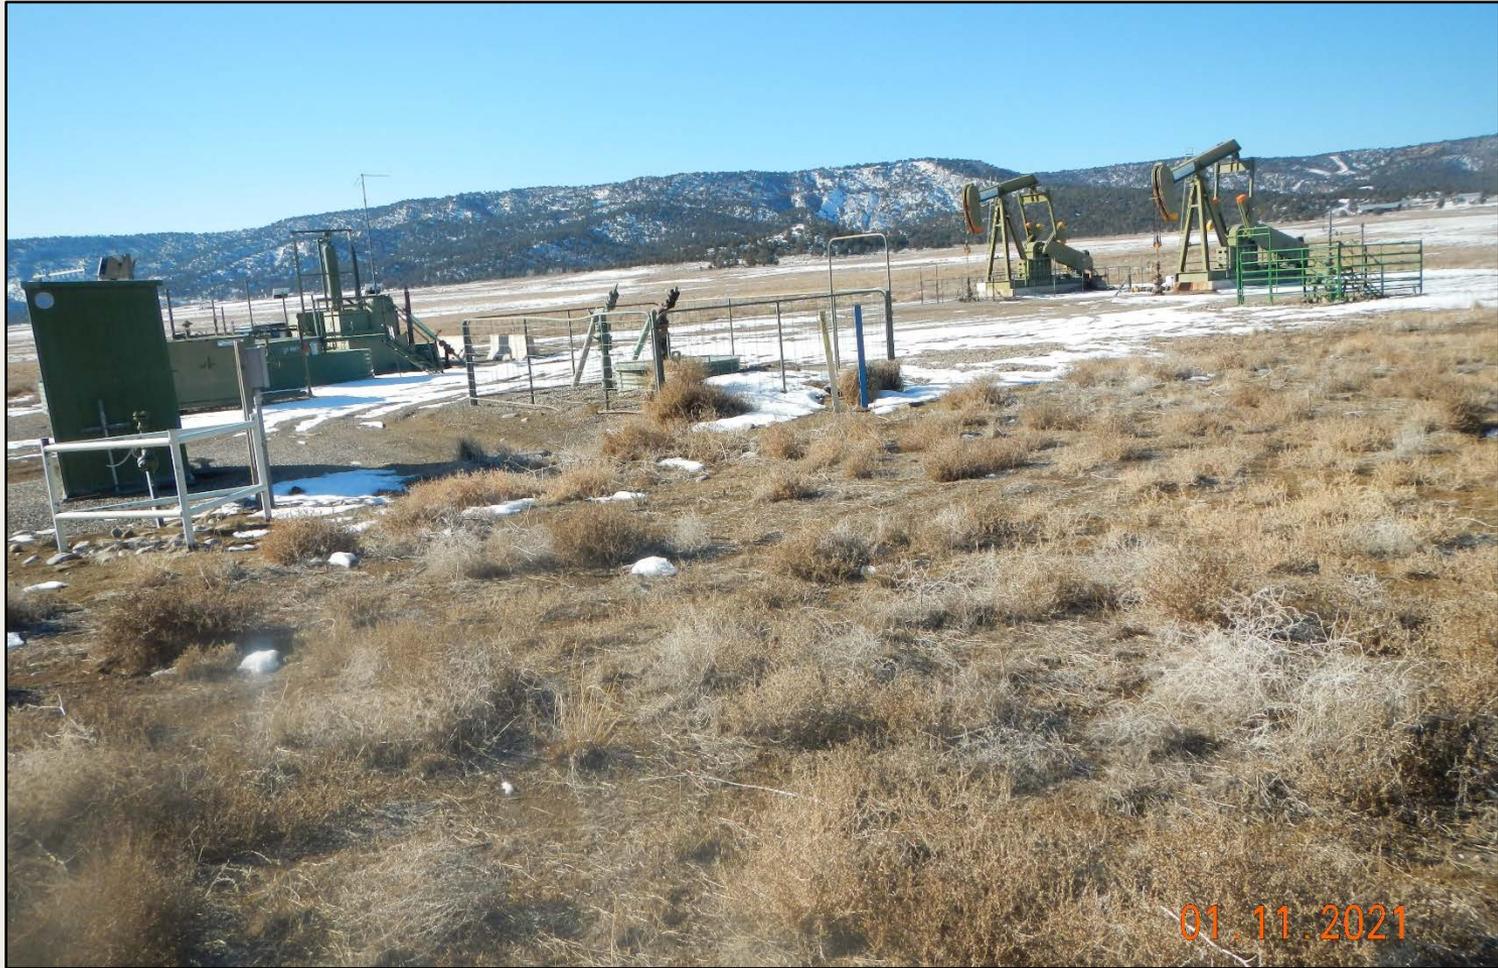
Photo 1. View of the project area from the northeastern corner facing center. Location is shared with two Red Willow wells.

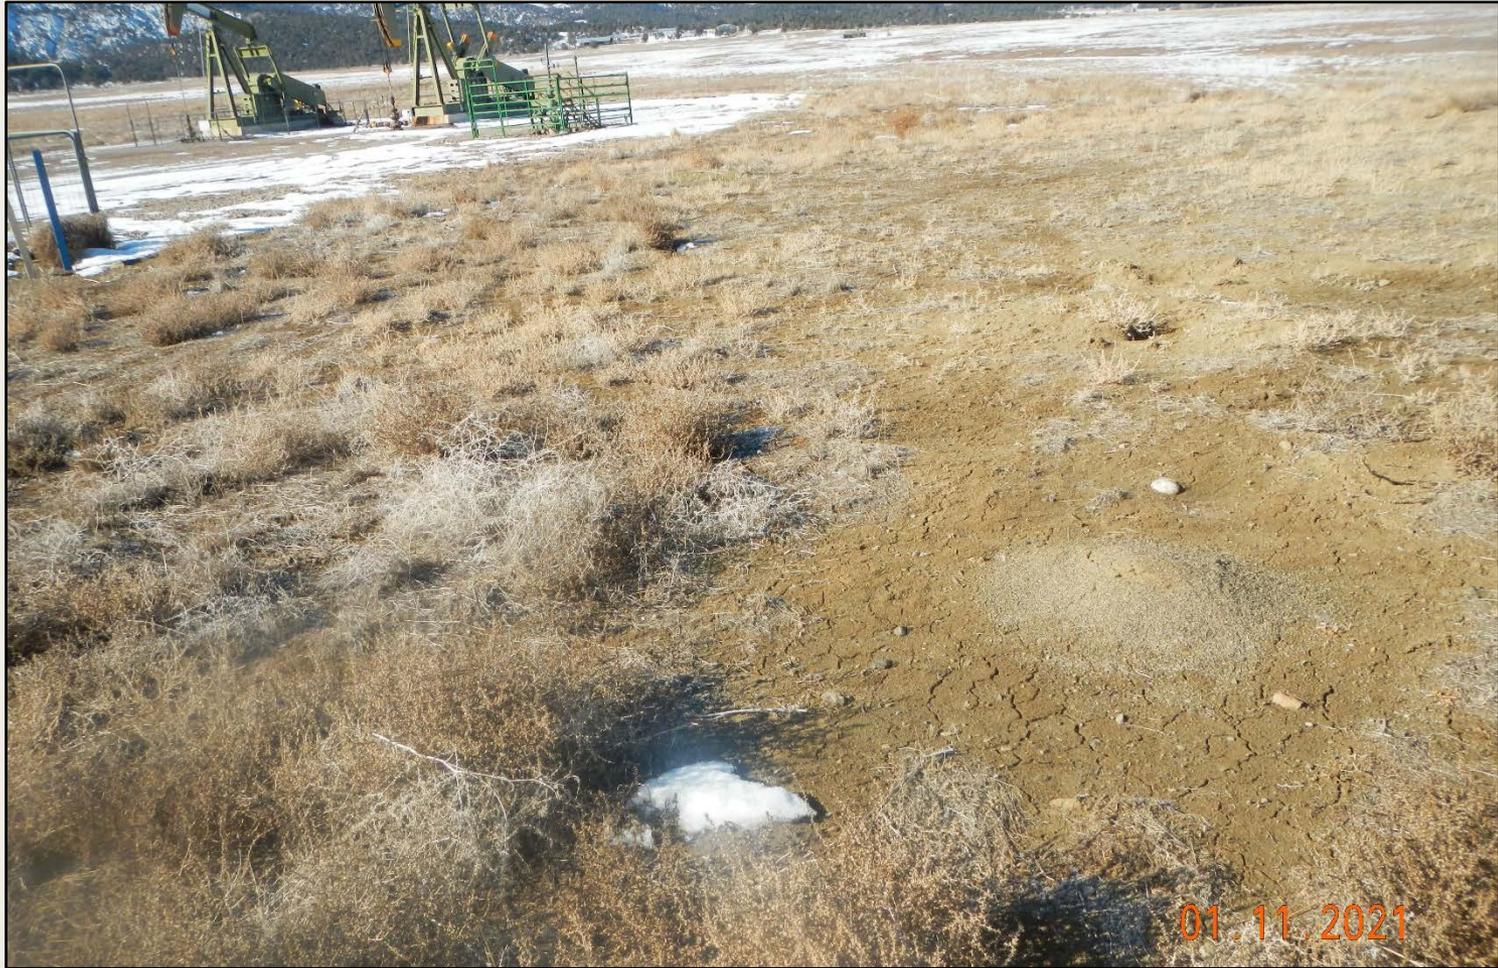
Photo 2. View of the northern project area from the northeastern corner facing westward. Vegetation is in a grazed and dormant vegetative condition and needs to be monitored during the active growing season.

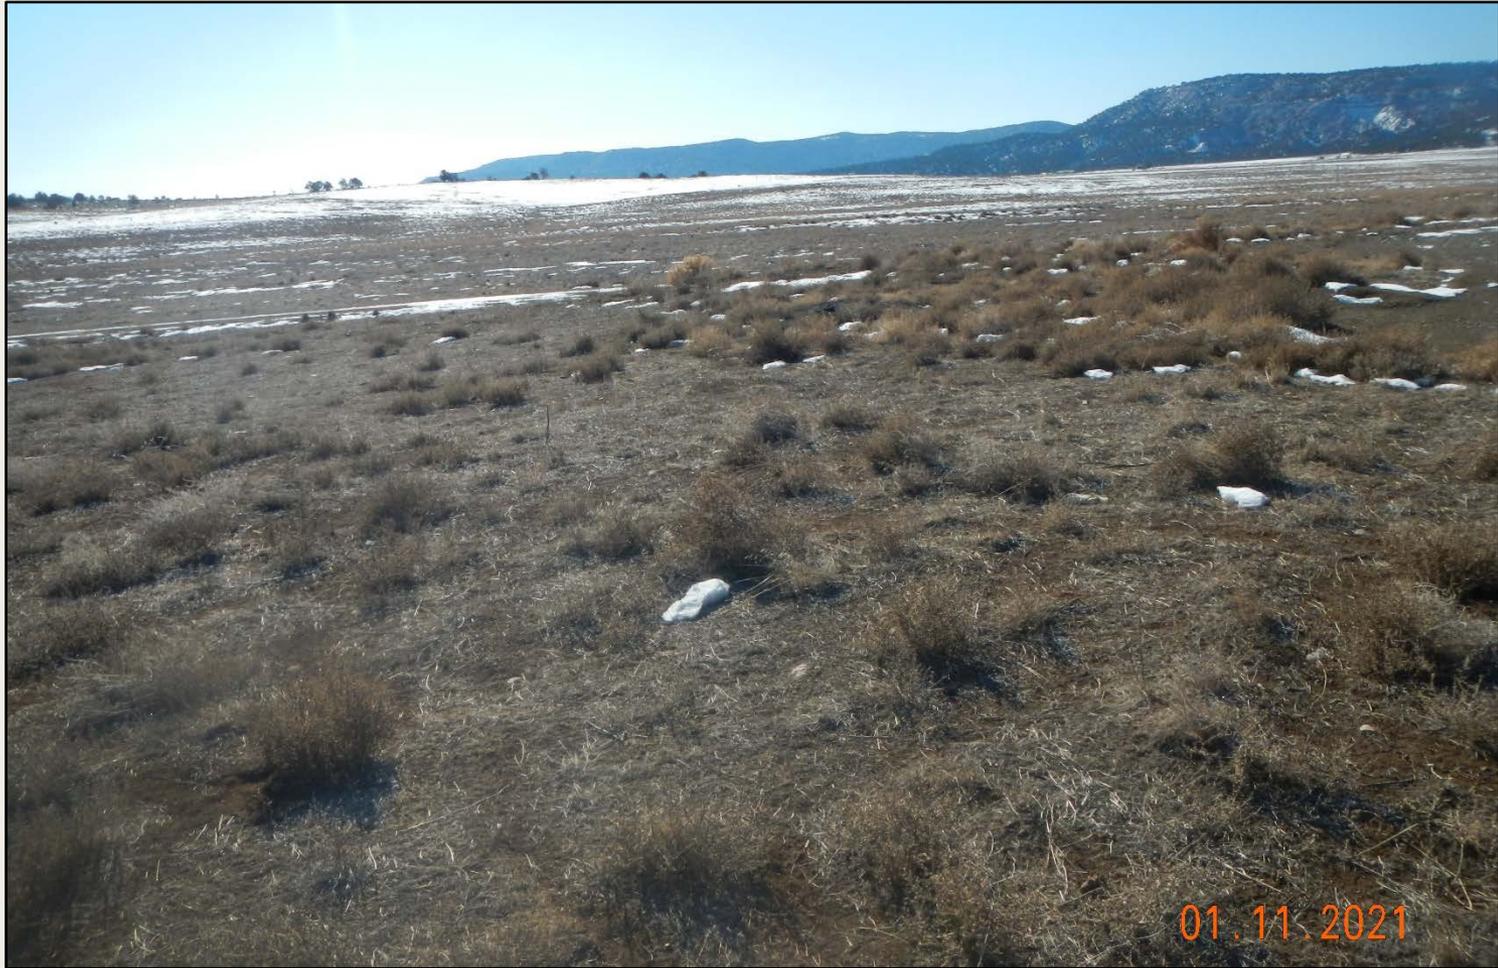
Photo 3. View of the eastern project area facing southward.

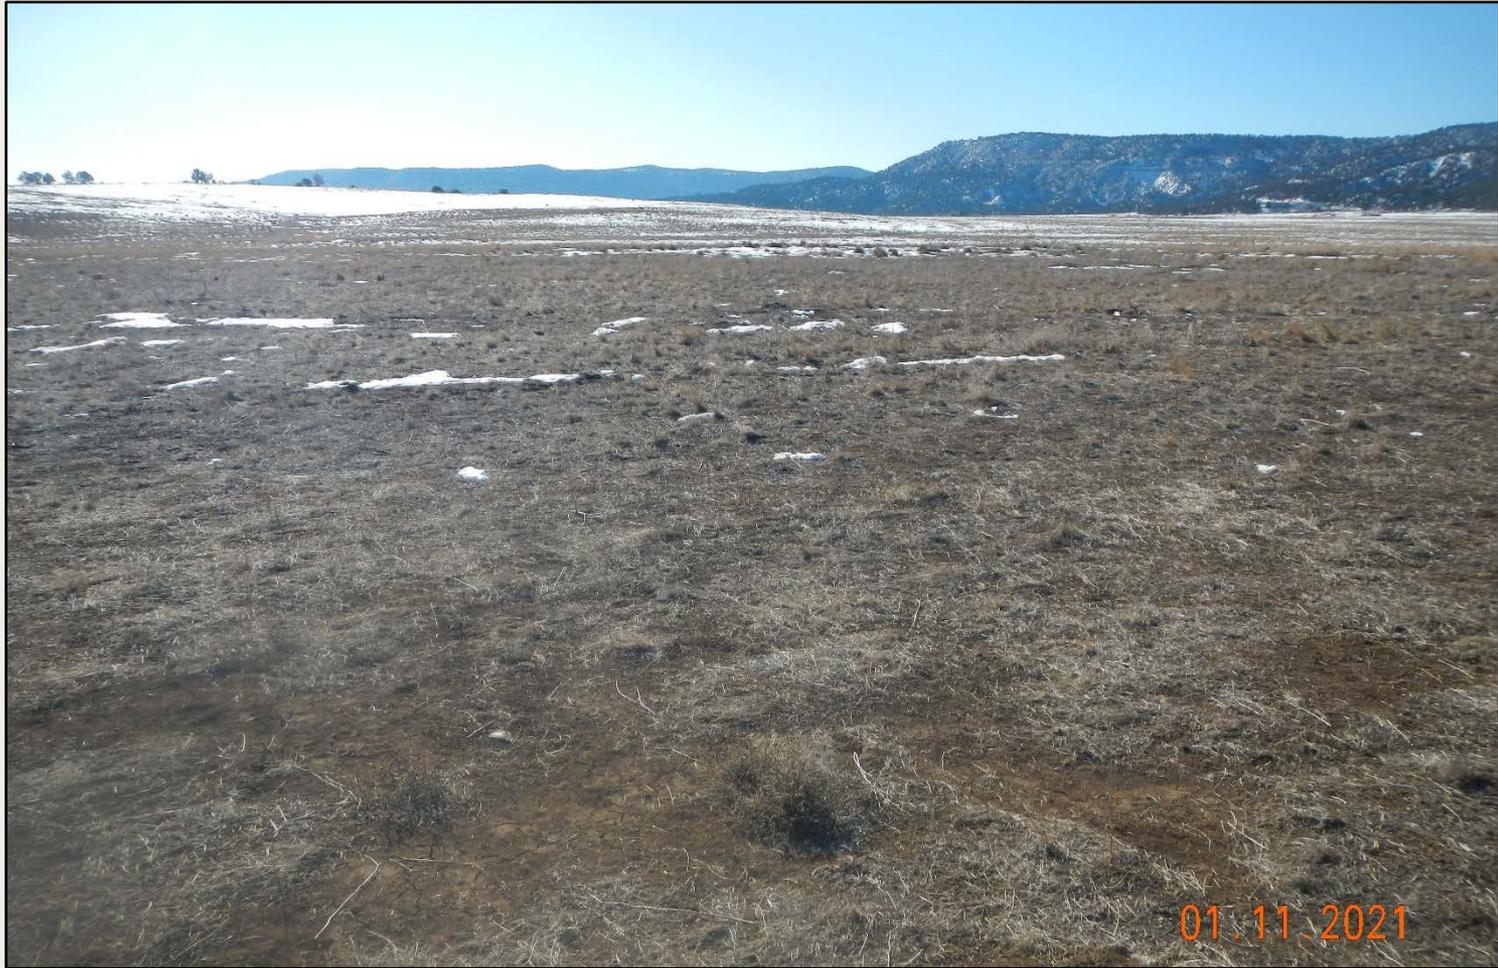
Photo 4. View of reference area comprised of open grass field in a grazed/dormant vegetative condition.
