Inspection Photos
Operator: Simcoe
API: 067-05157
Date: 1/11/2021

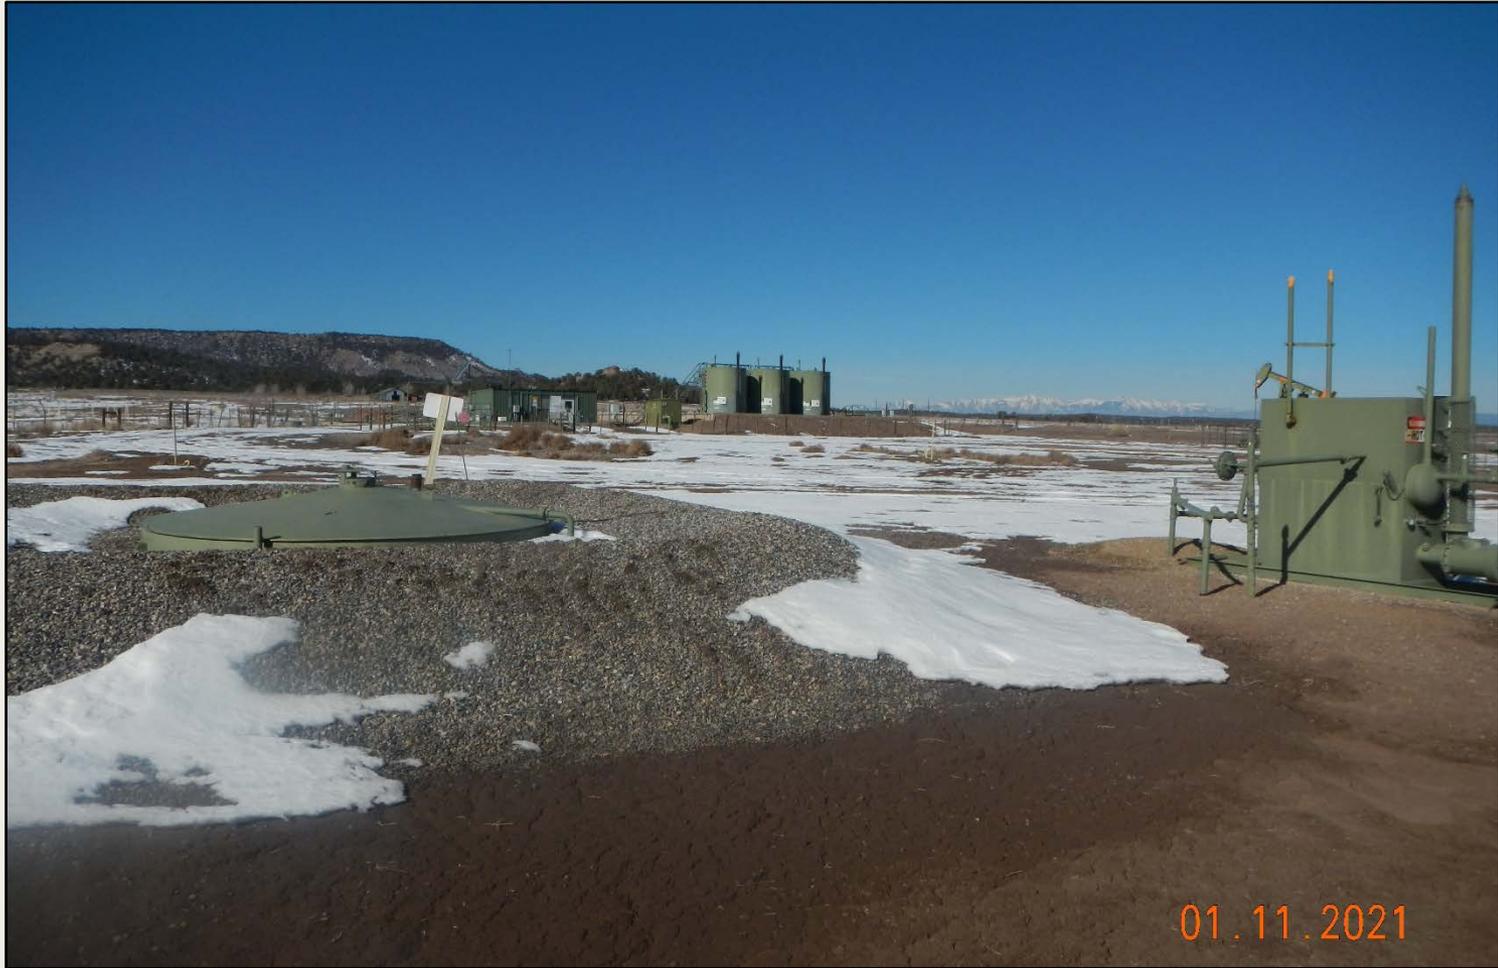
Photo 1. View of the project area from the southeastern corner facing center.

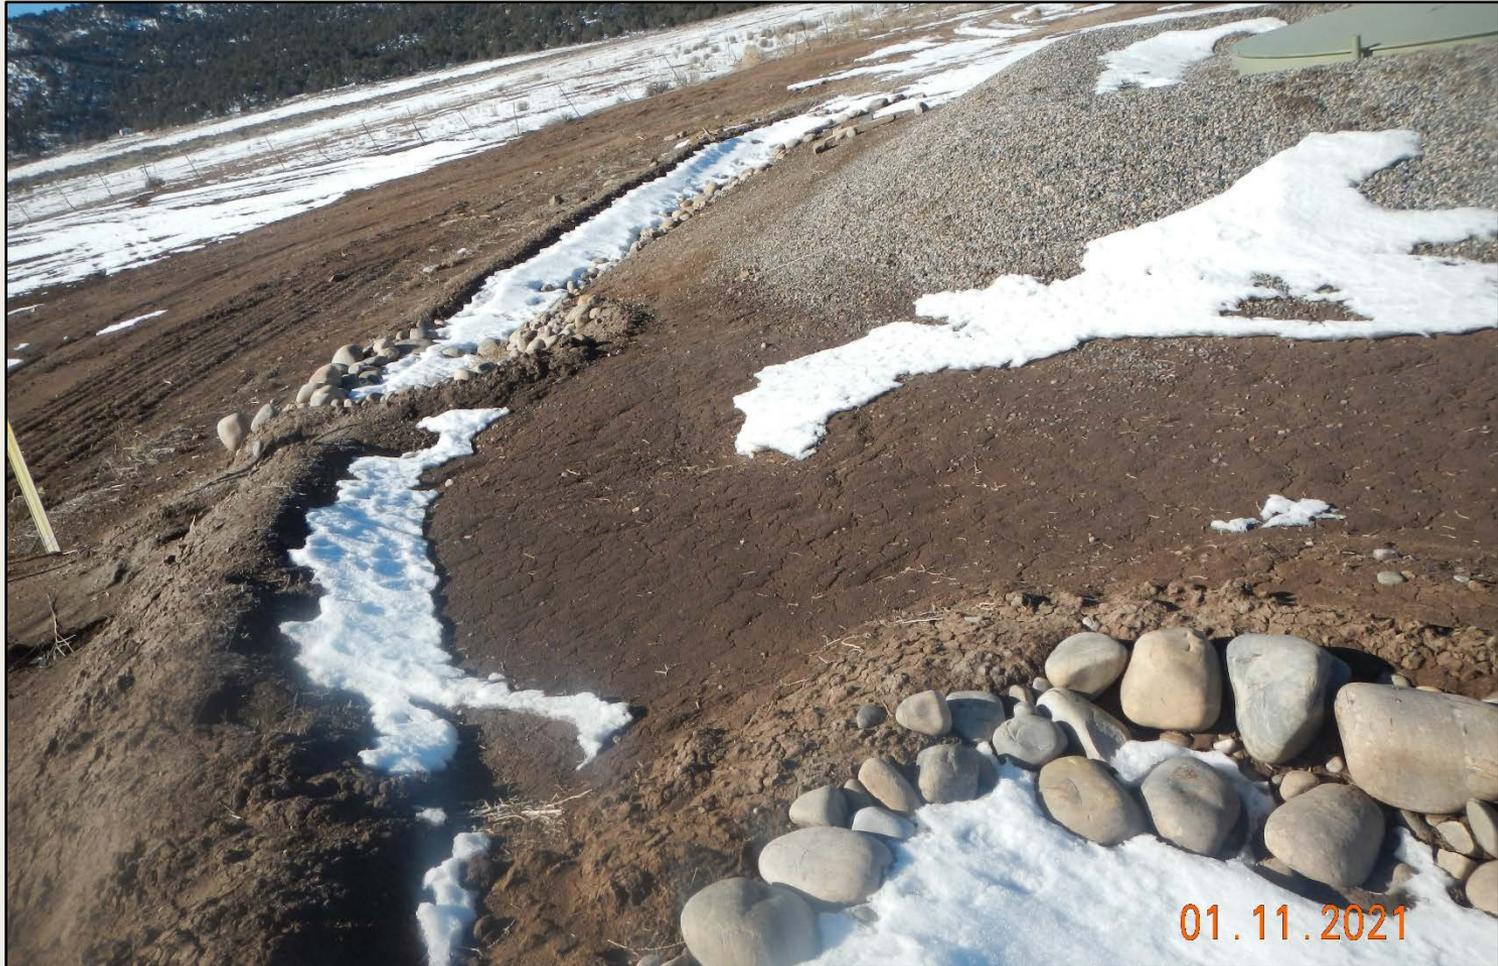
Photo 2. View of the southern project area from the southeastern corner facing westward. Stormwater controls such as berm and cobble lined diversion, are installed and need to be monitored and maintained for function.

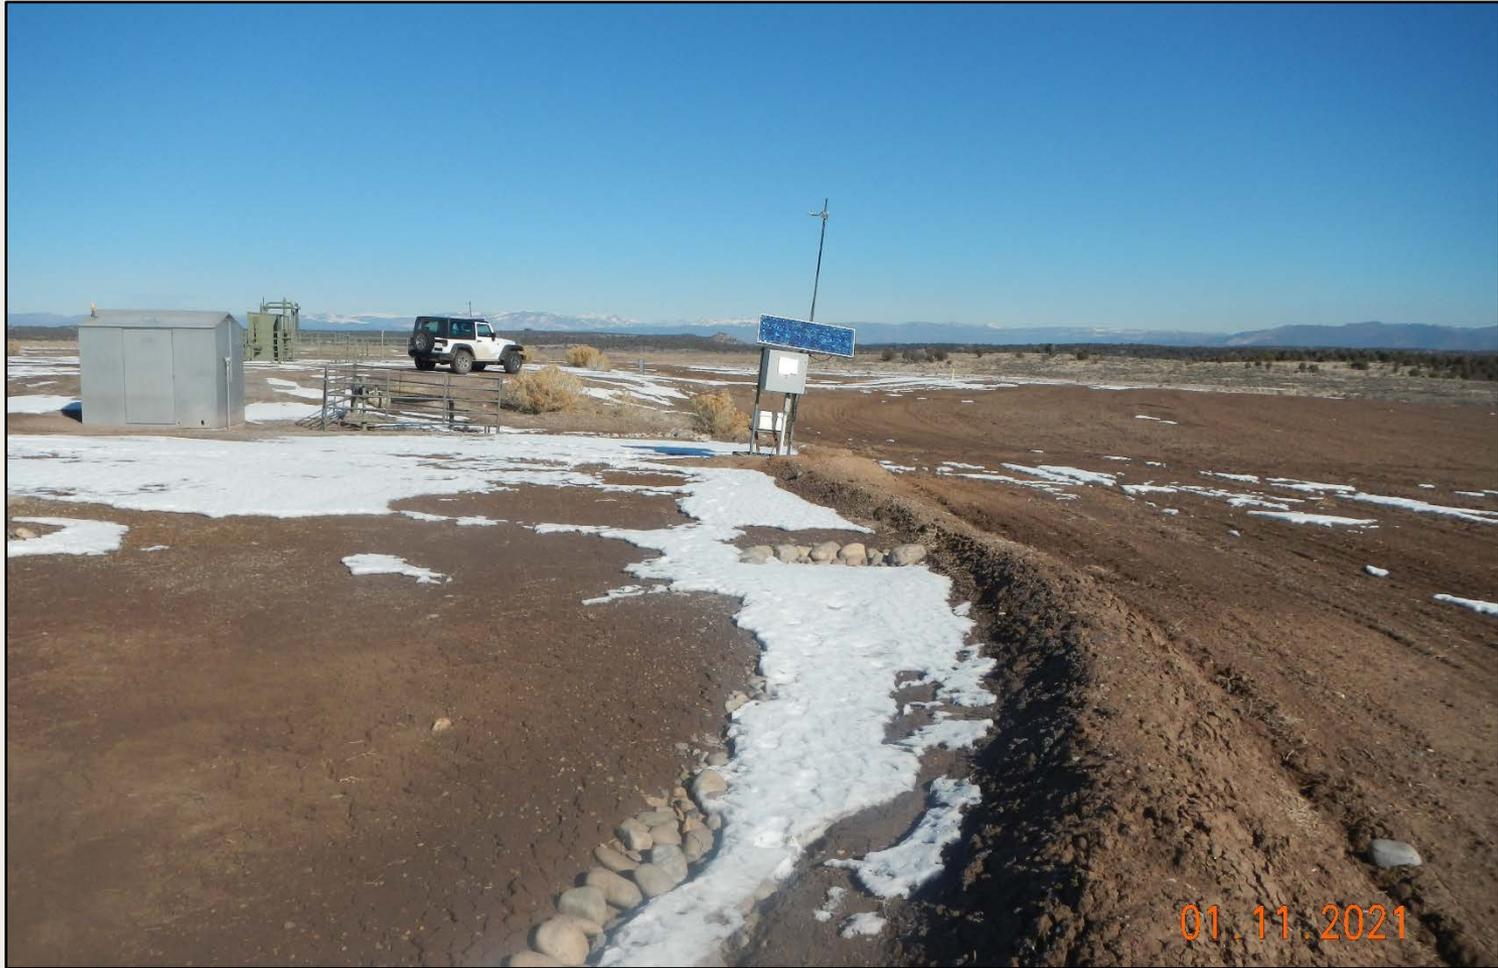
Photo 3. View of the eastern project area facing northward.

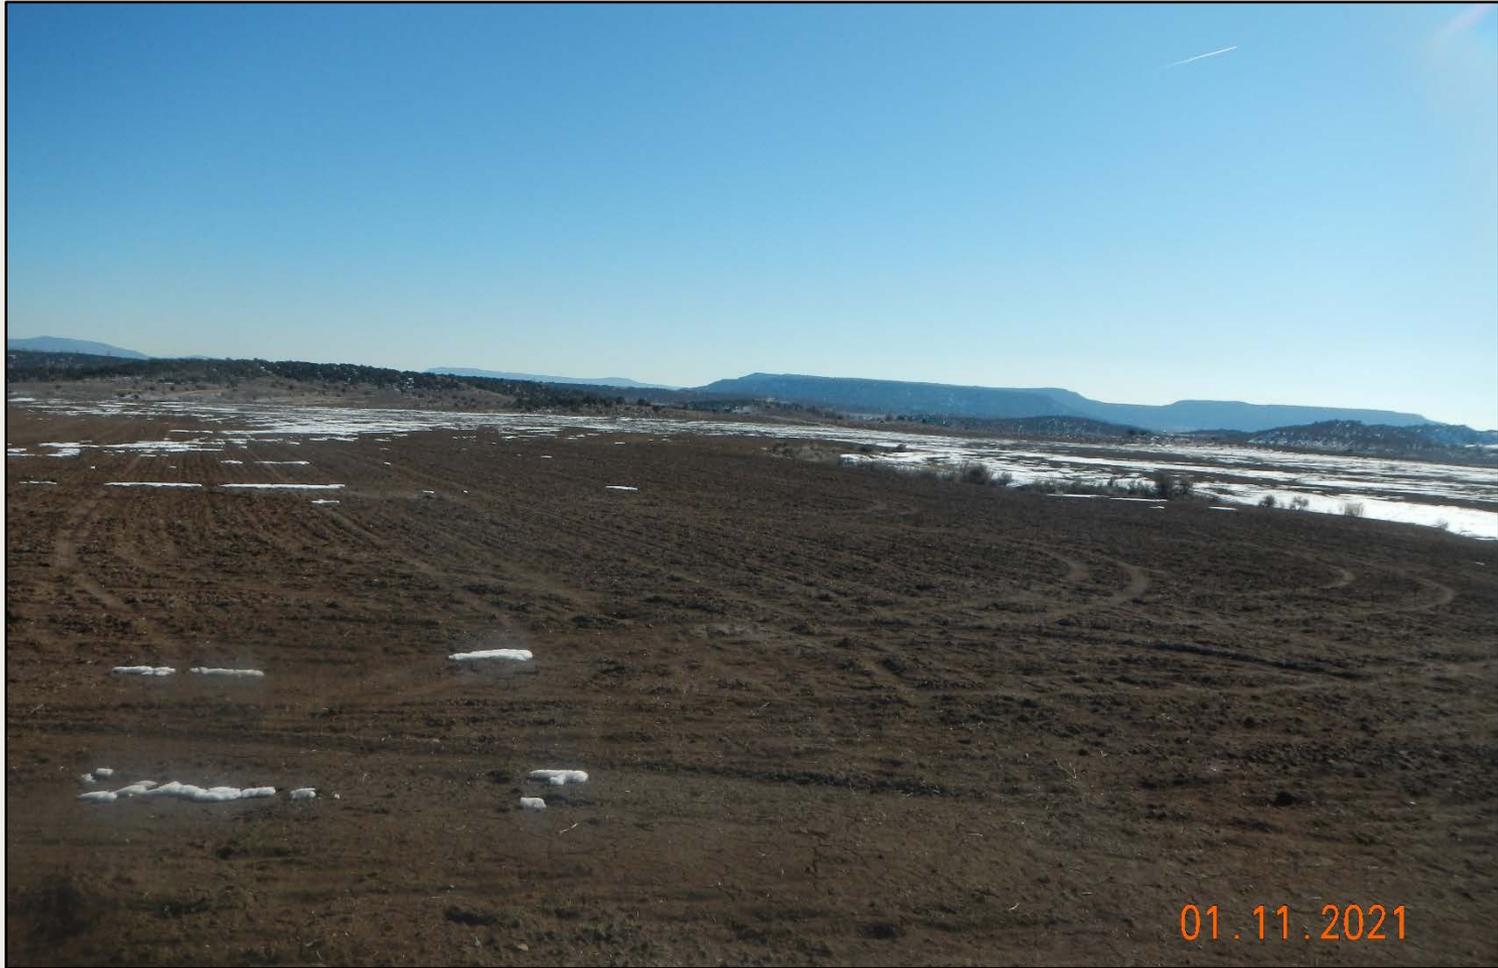
Photo 4. View of reference area comprised of a crop field in a non-vegetative condition at this time.
