Inspection Photos

Operator: High River Resources
API: 067-07316
Date: 1/11/2021

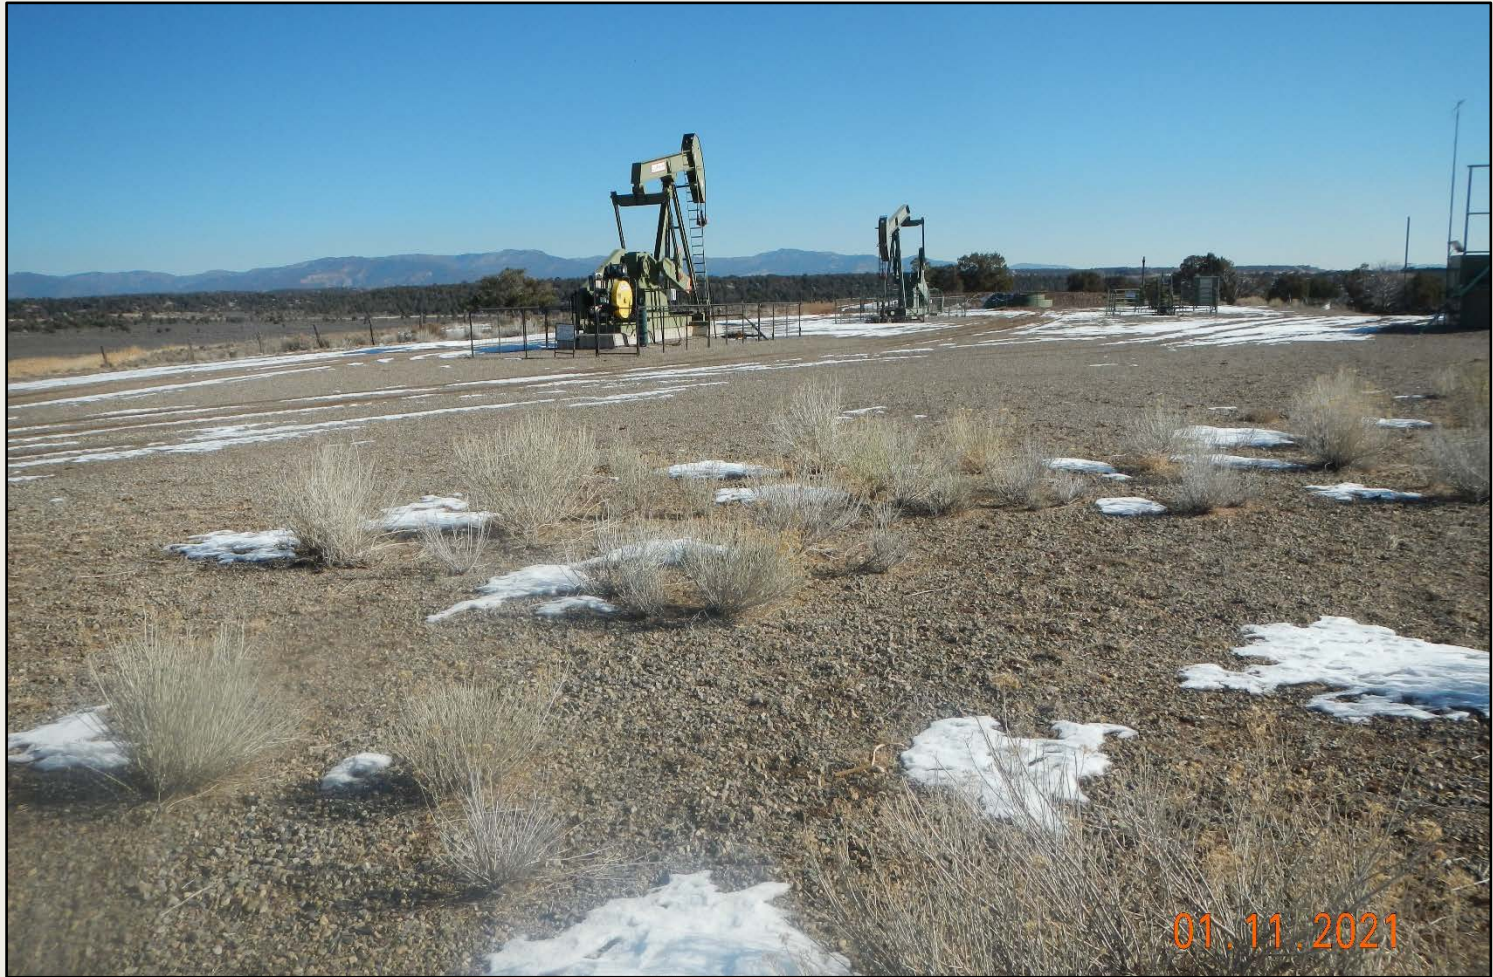
Photo 1. View of the project area from the southwestern corner facing center.

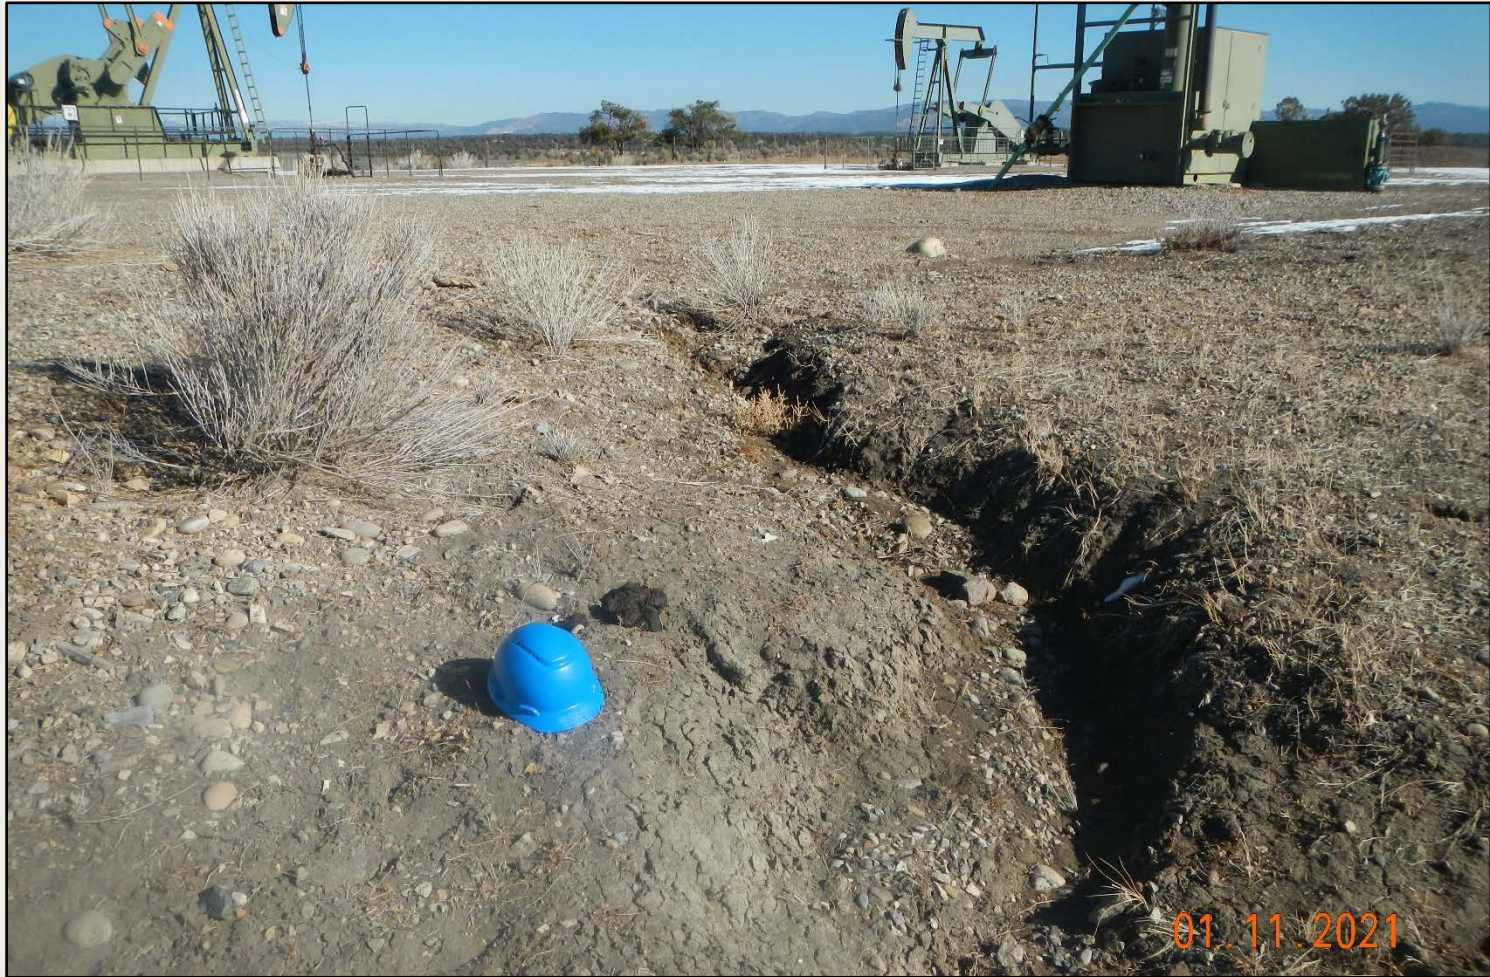
Photo 2. View of erosional channel, approx. 2-3 ft wide and deep, in the southern project area.

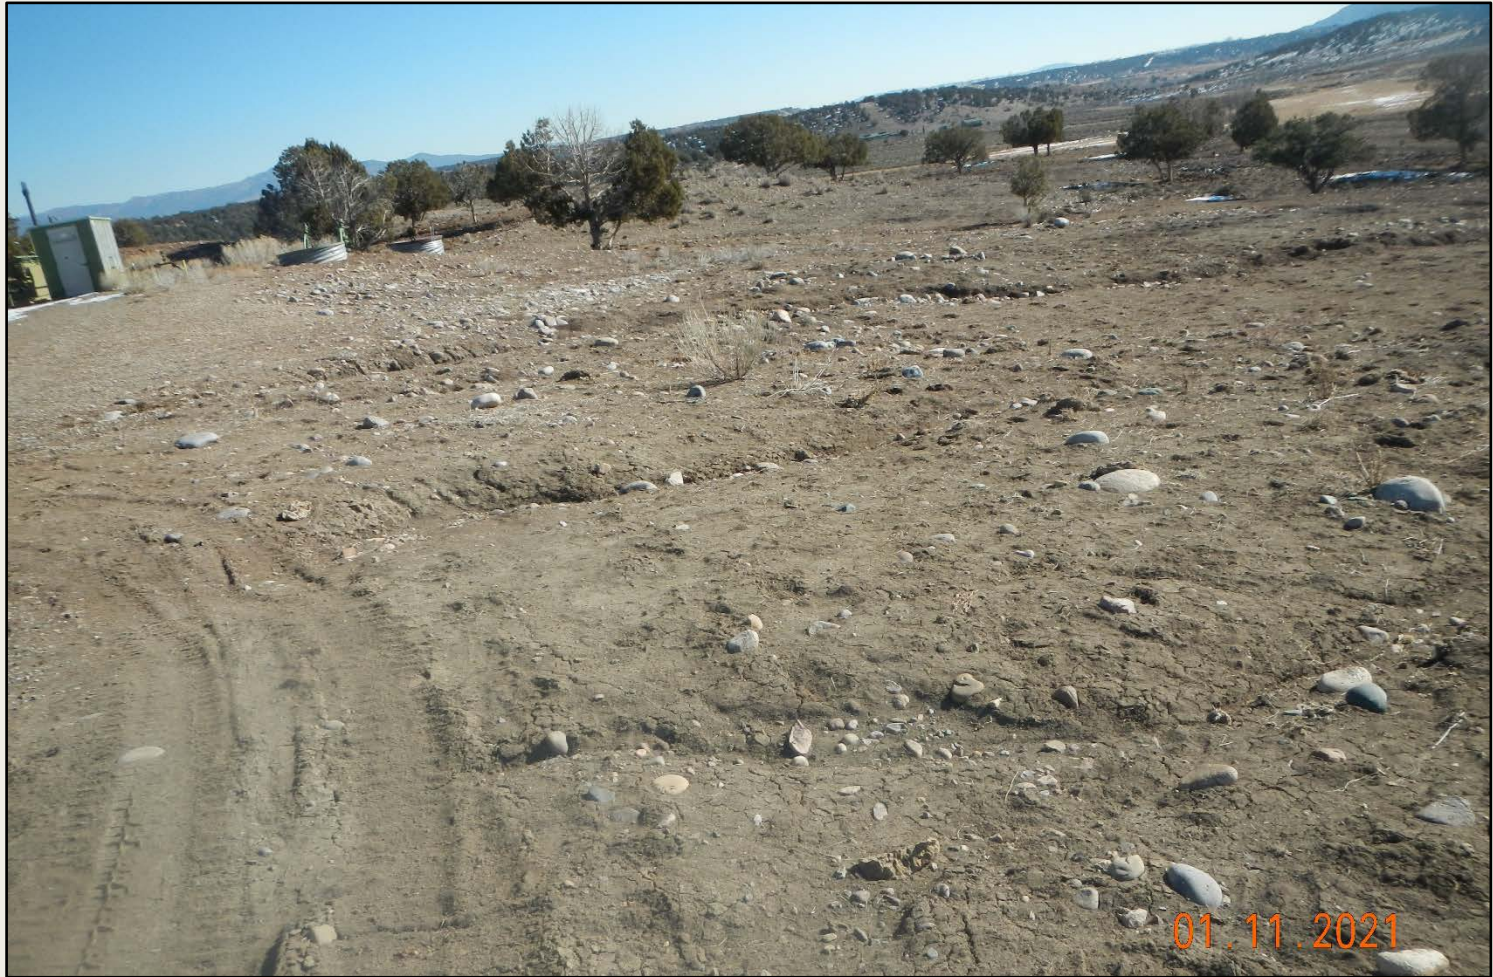
Photo 3. View of the southern project area facing eastward. Multiple erosional channels are present.

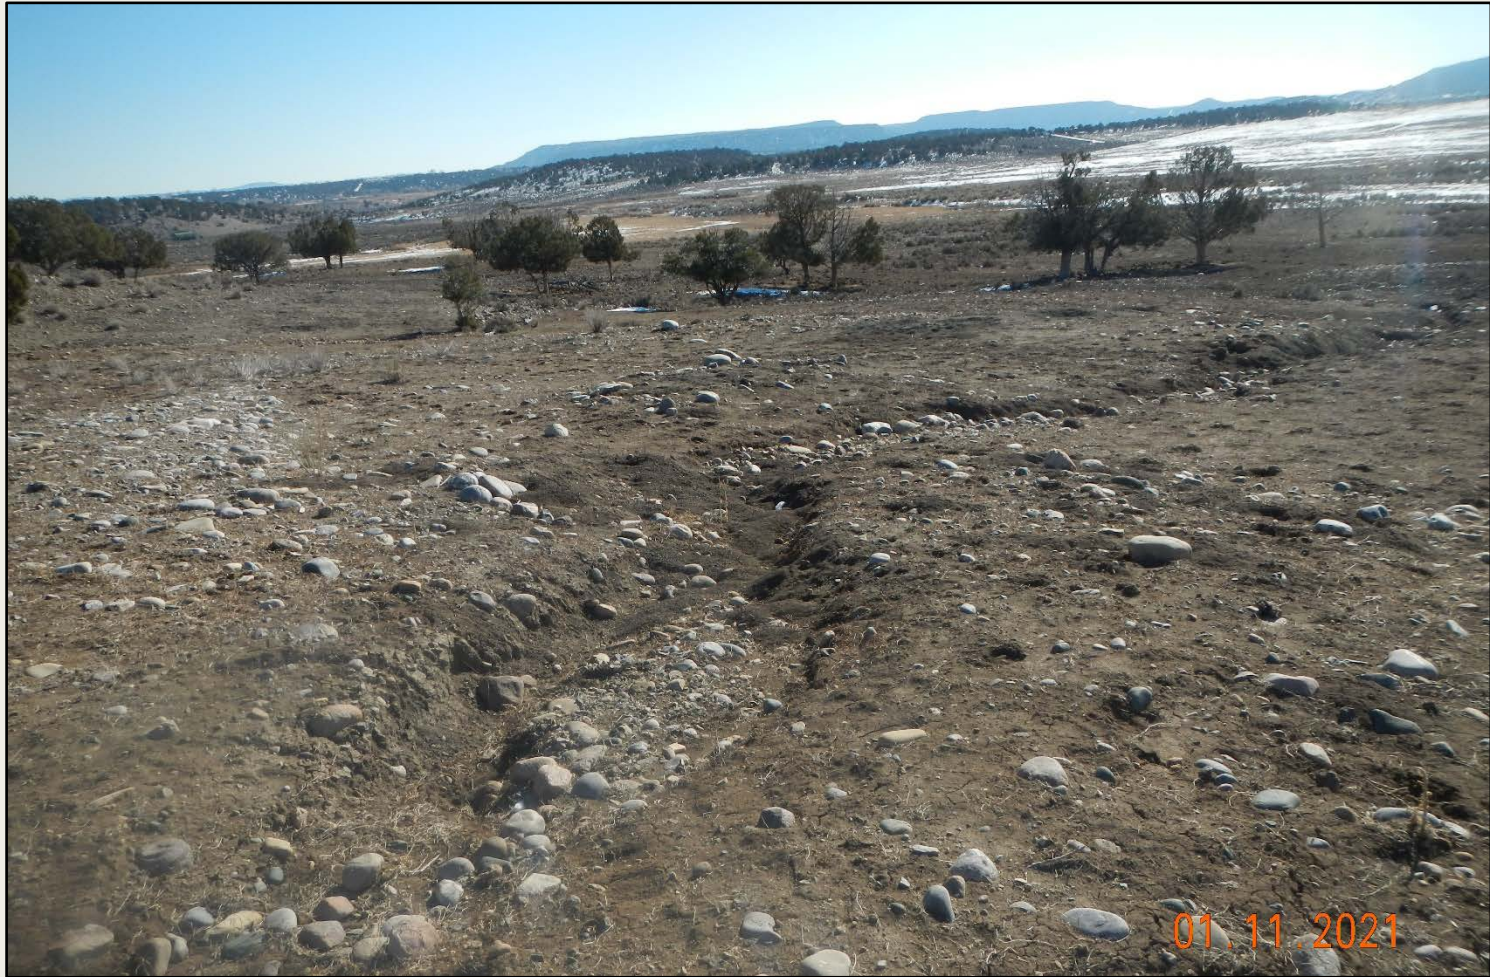
Photo 4. View of another erosional channel in the southern project area, approx. 4-5 feet wide and 2-3 feet deep.

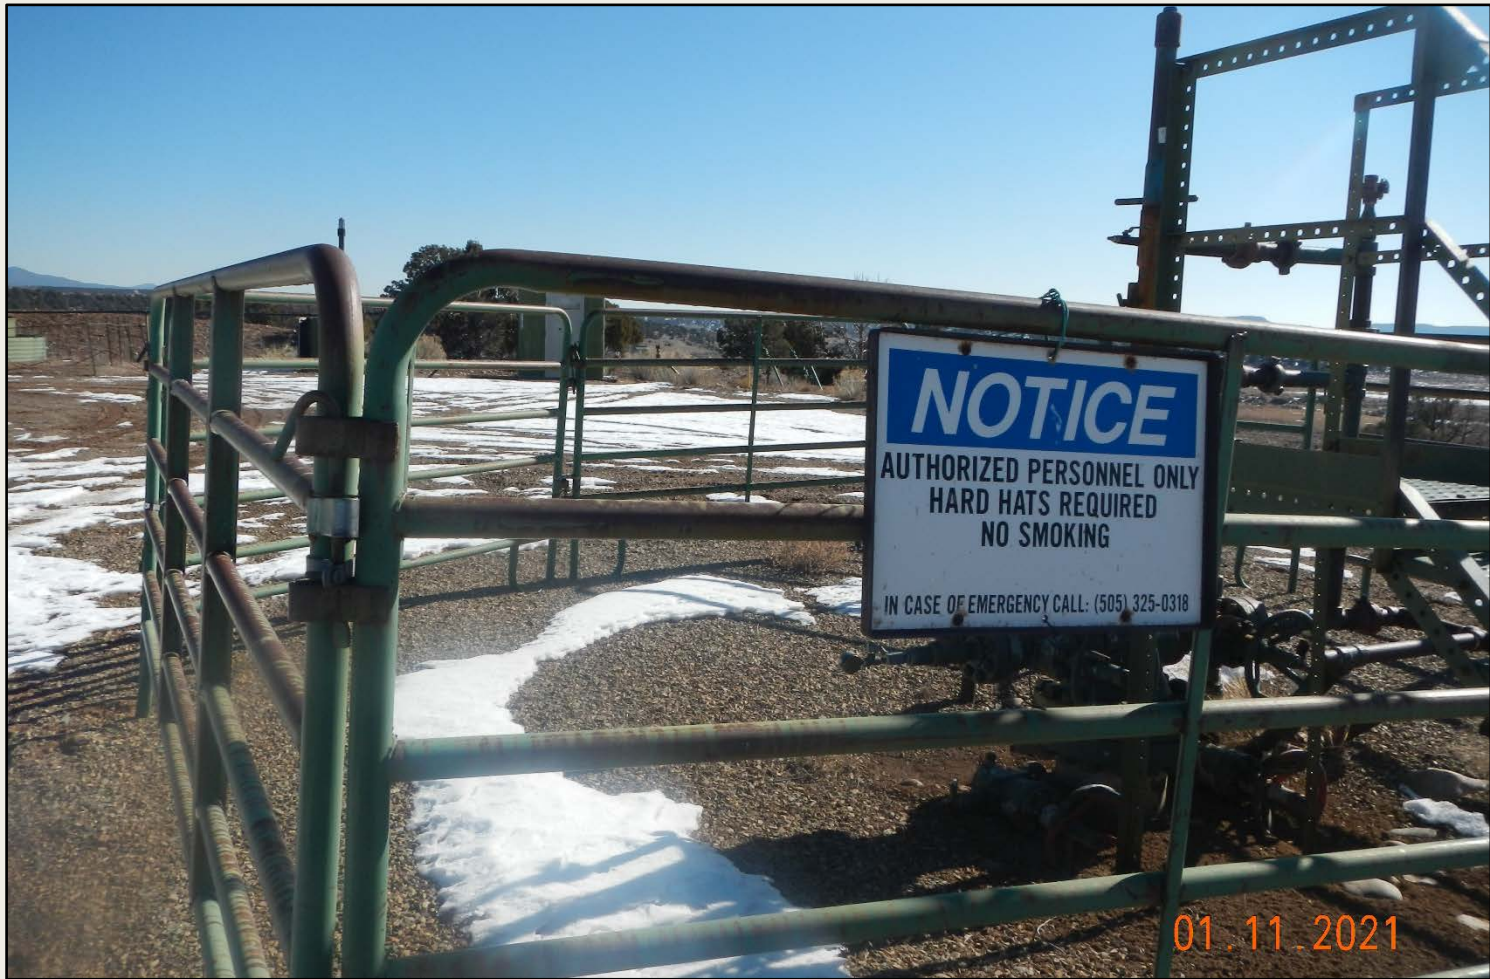
Photo 5. View of well area, no evidence of well sign observed.

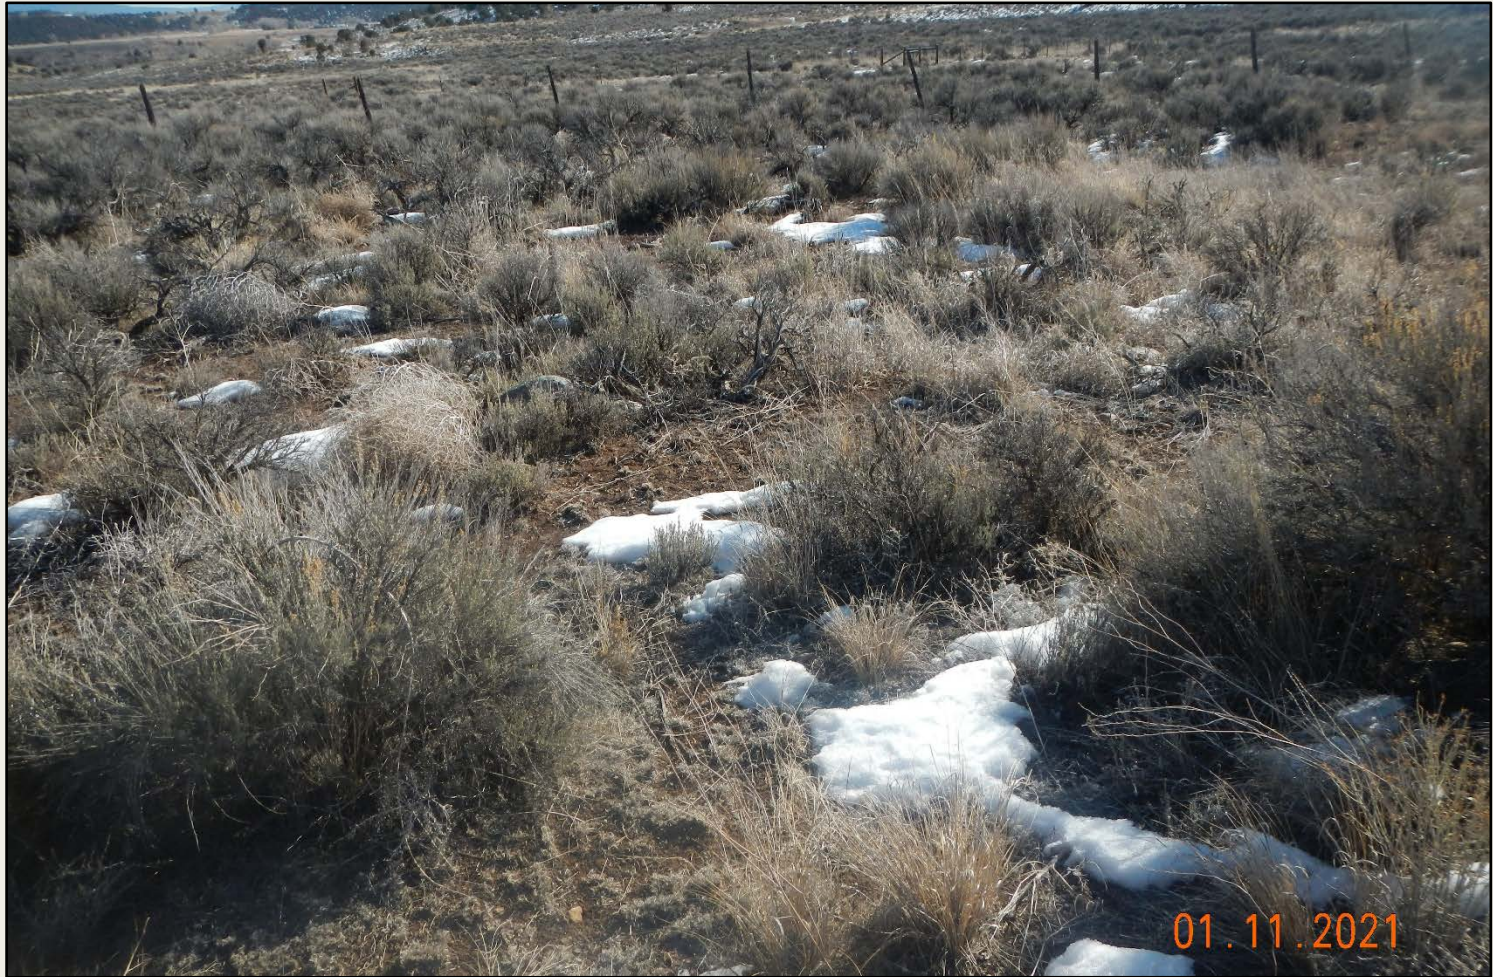
Photo 6. View of reference area comprised of sagebrush shrubland with western wheatgrass, sand dropseed, and buckwheat. Project area is above irrigation alignment.
