Inspection Photos

API: 099-06328

Operator: BERRY ENERGY INC

Inspection Date: 1/12/2021

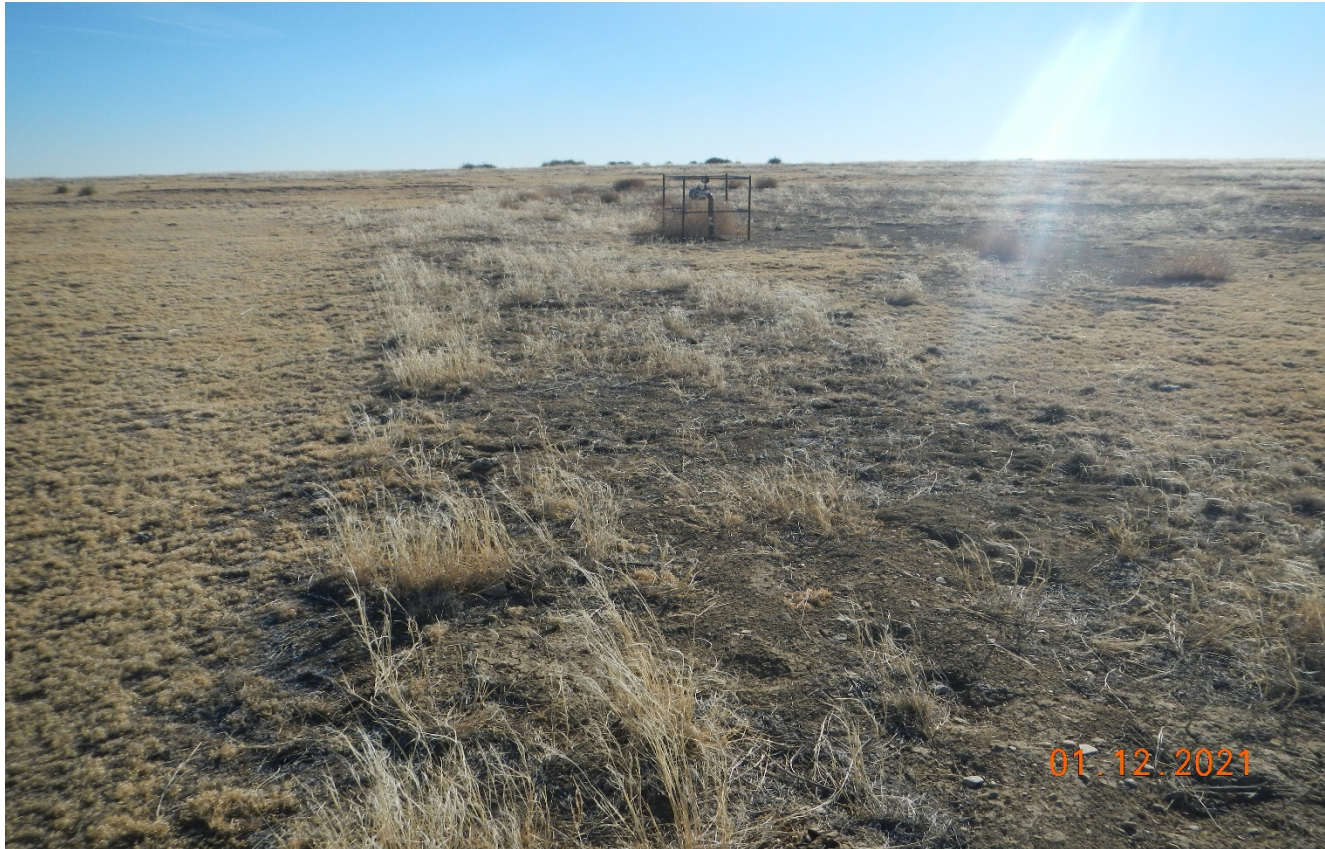
Photo 1. Facing east along the former access road toward the location. Vegetation has not adequately re-established.

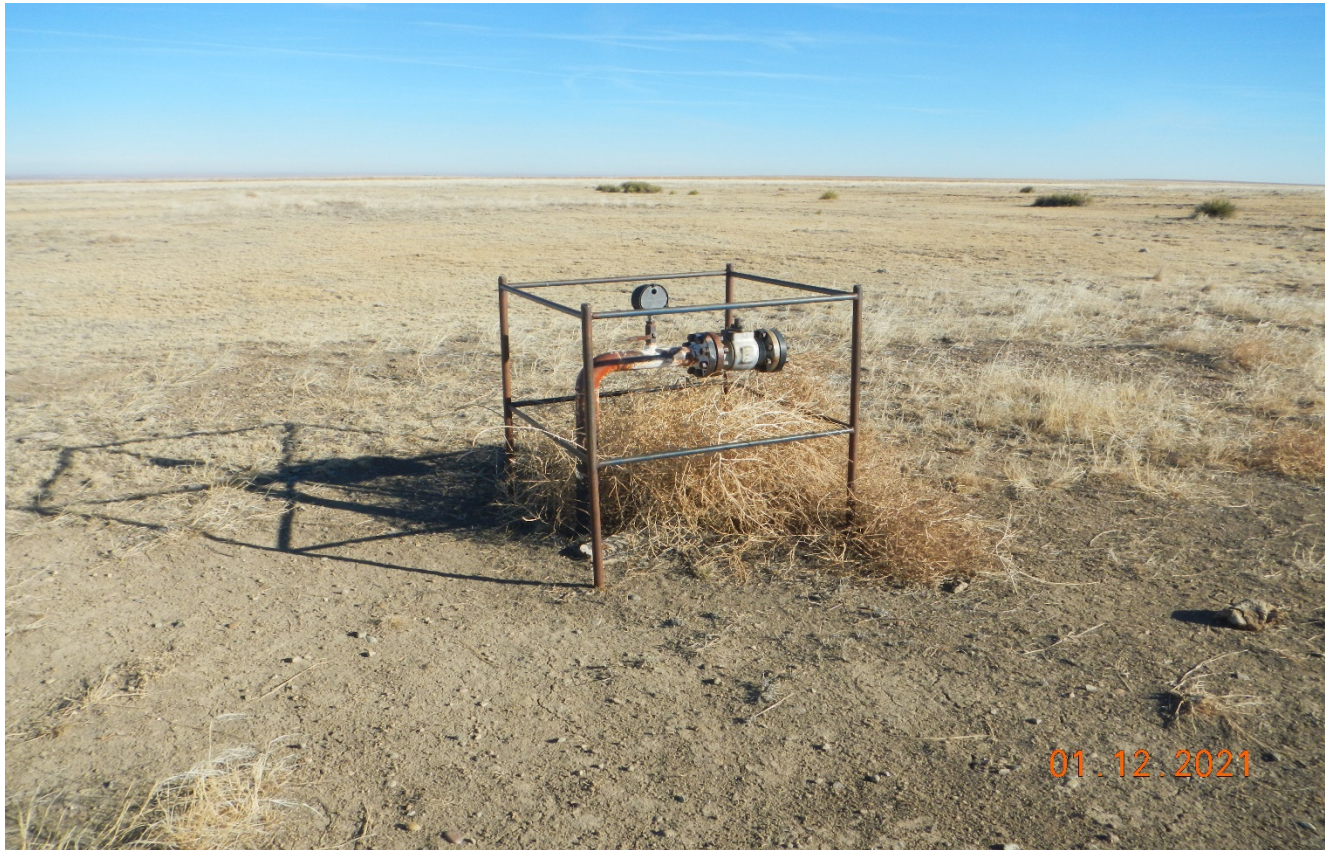
Photo 2. Pipe riser remains at the center of the location. Lat/Long:37.95992,-102.50066

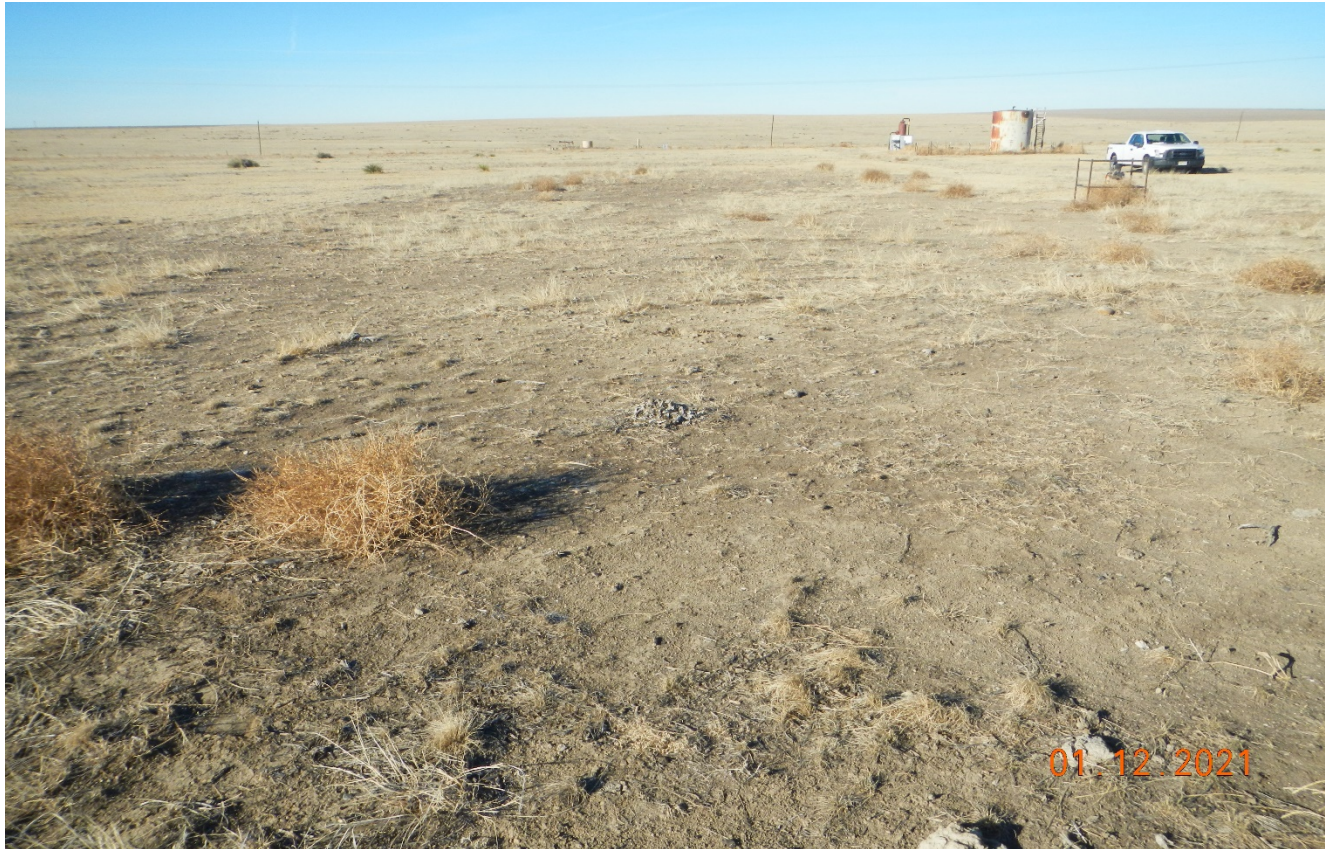
Photo 3. Facing west toward the location. Vegetation has not adequately re-established.

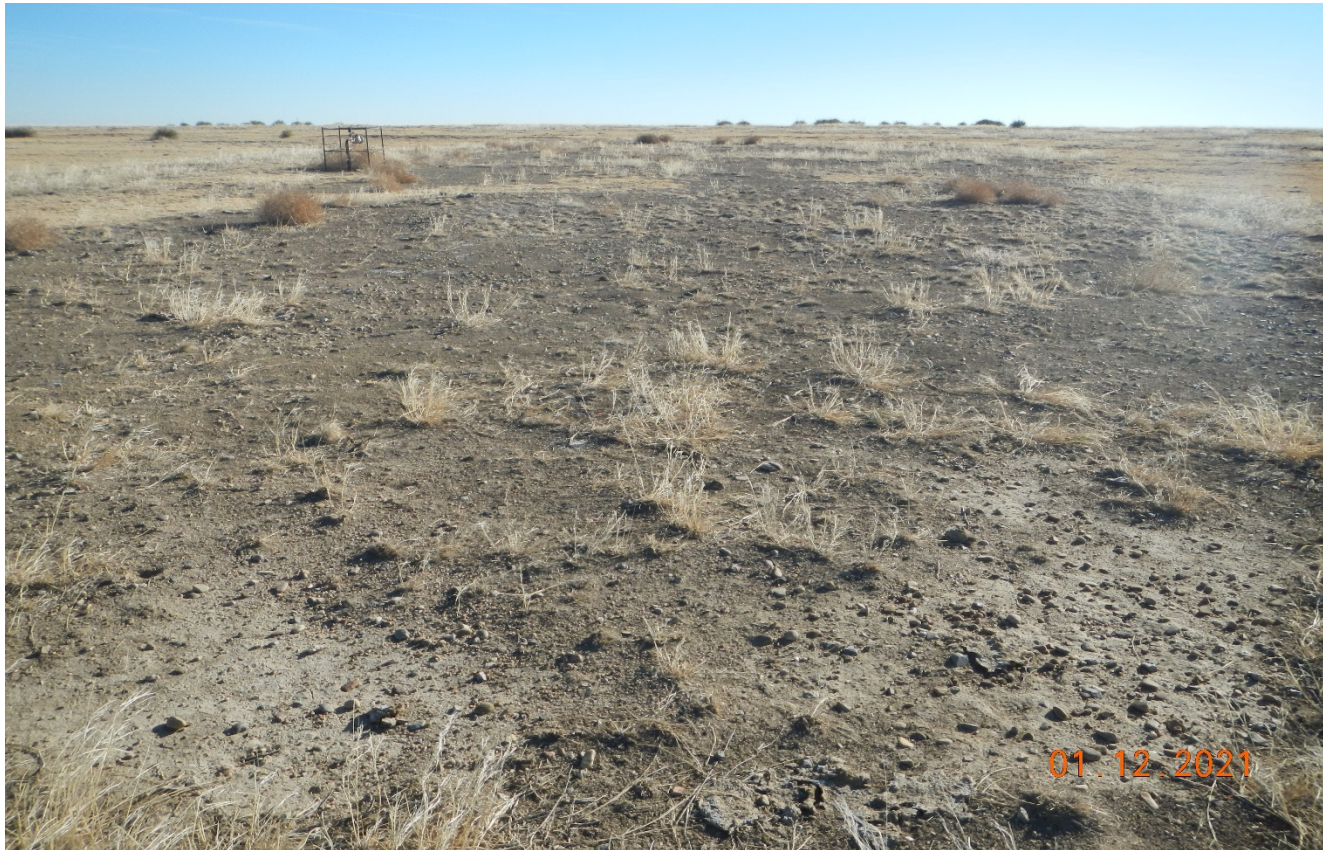
Photo 4. Facing east toward the location. Vegetation has not adequately re-established.

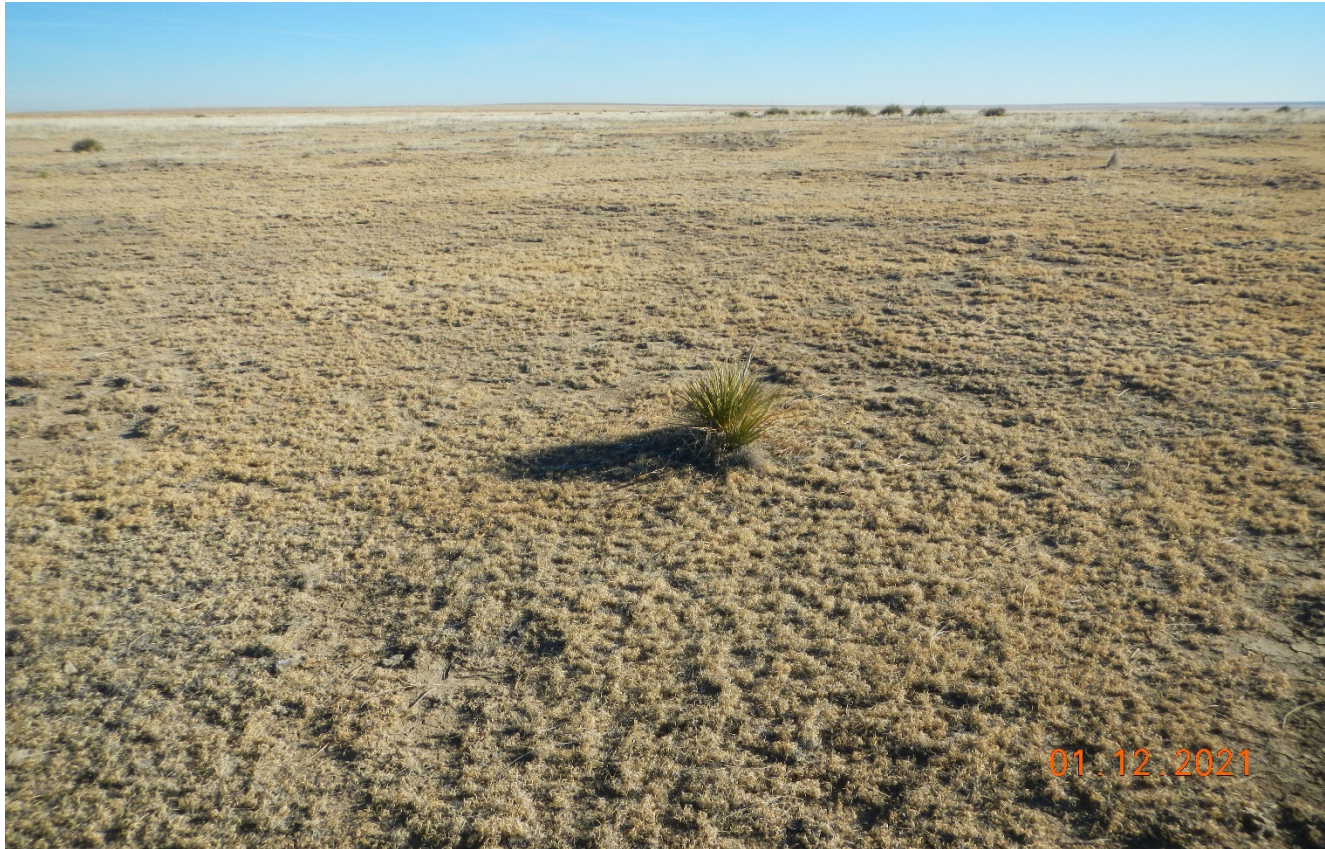
Photo 5. Facing east toward the surrounding undisturbed reference area.
